MUNDENBURY **Great Munden, Herts.**

HN1067

ARCHAEOLOGICAL MONITORING REPORT

Archaeological Monitoring Report

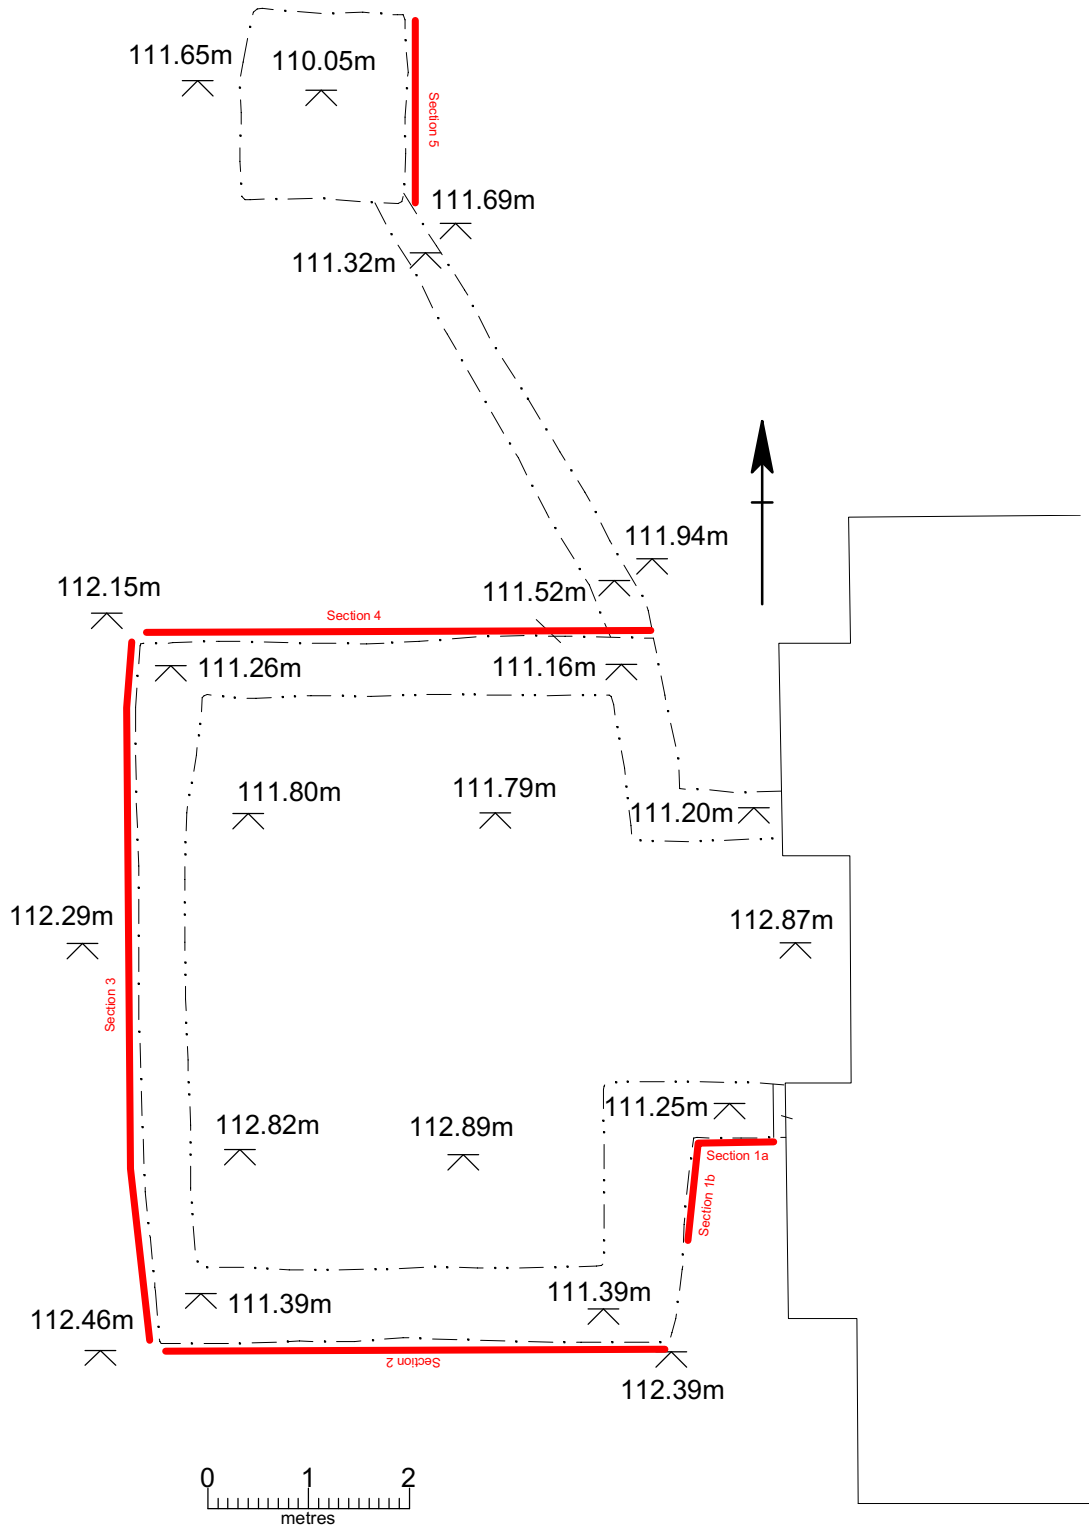
Figure 2

2.11 Due to the slope of the site, rising gently from north to south, the footprint was reduced to a depth of 0.35m from the surface at the northern end and to 0.65m at the southern end (Plate 1). The footings, following the perimeter of the footprint, were excavated to a depth of 0.90-1m from the surface, cutting into the natural (Figure 2, Plate 2).

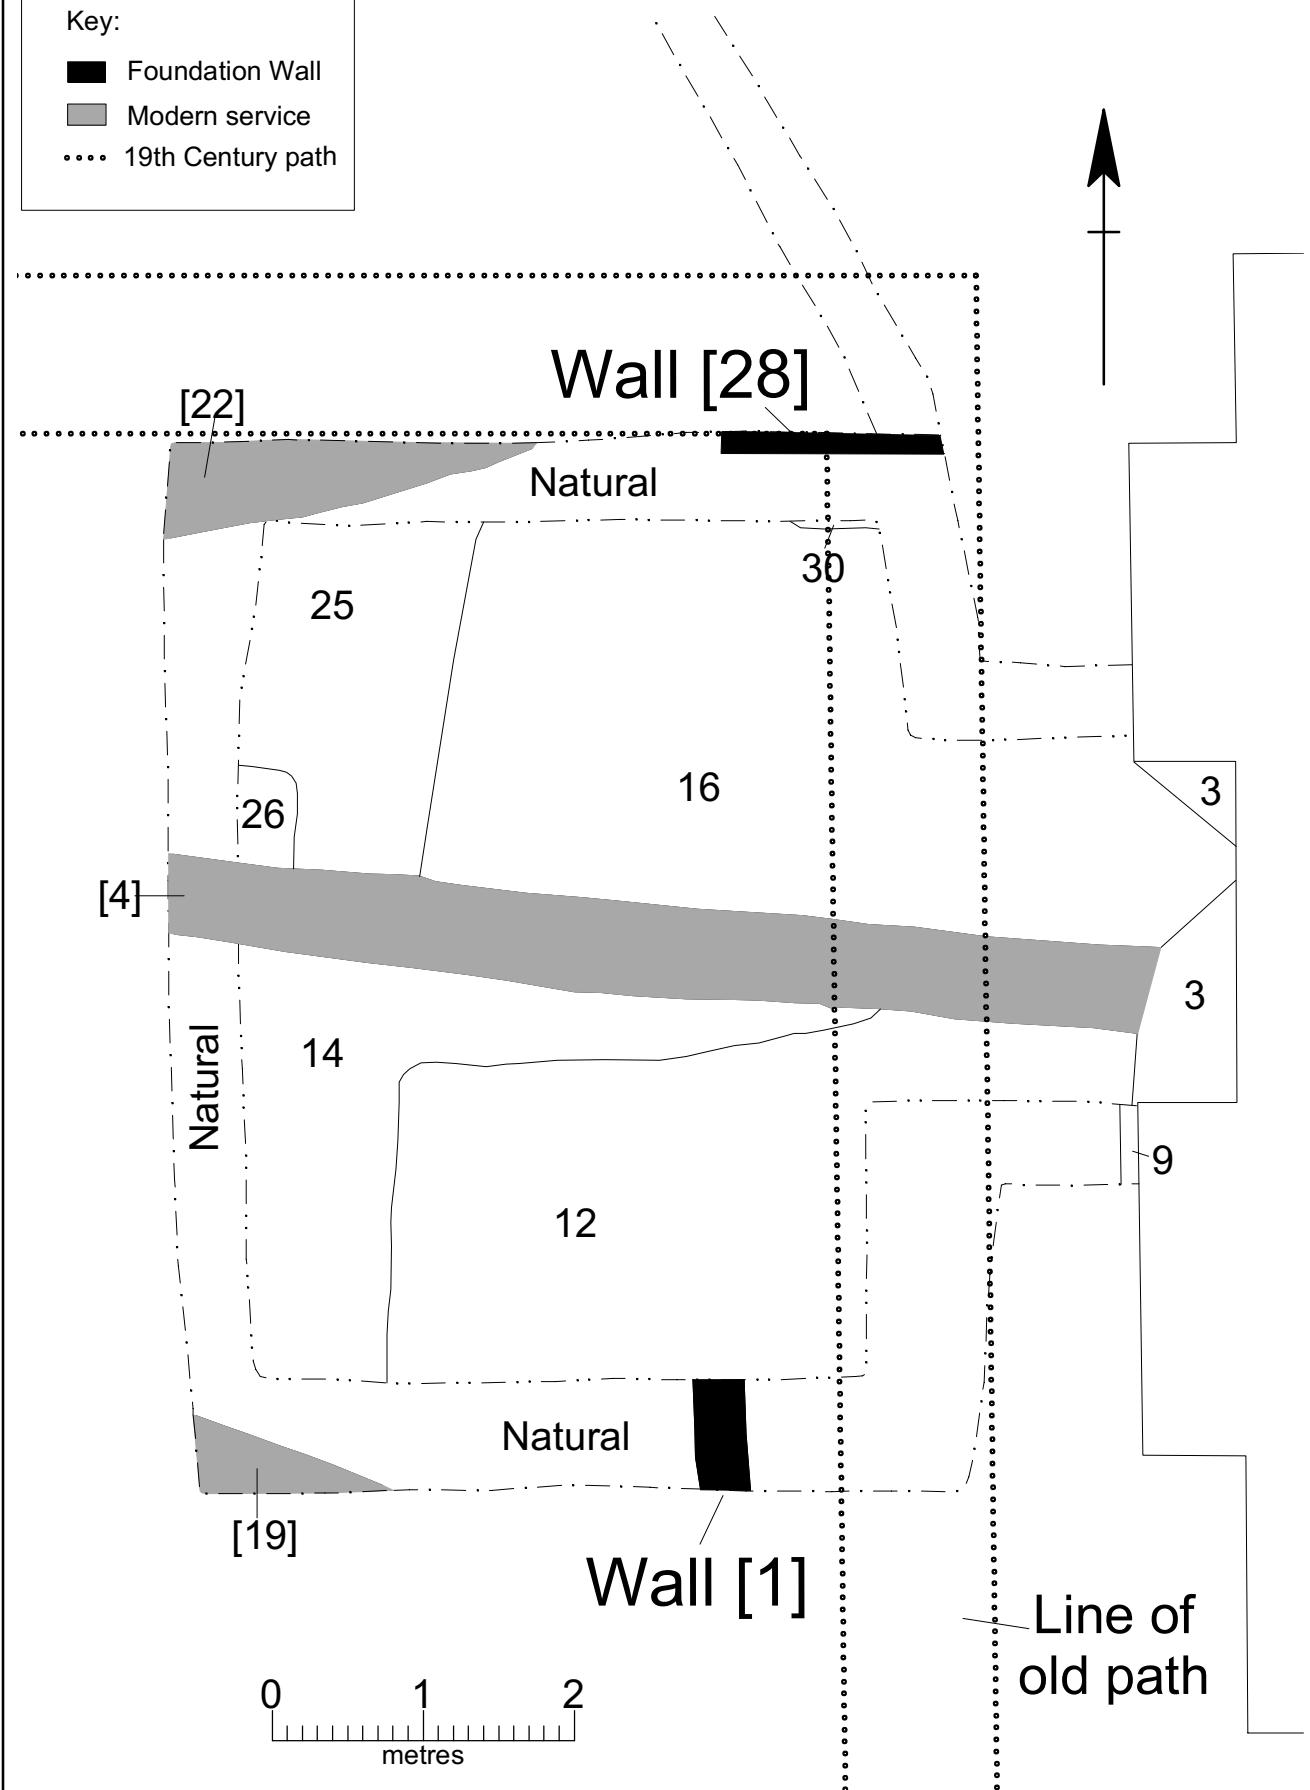
Figure 3

2.15 The excavation of the footings revealed two archaeological features beneath the made ground (see Figure 3). Both were foundation walls, [1] and [28], and were cut into the natural. These features were constructed primarily from flint set in a lime mortar. No dating evidence was recovered from either of these features.

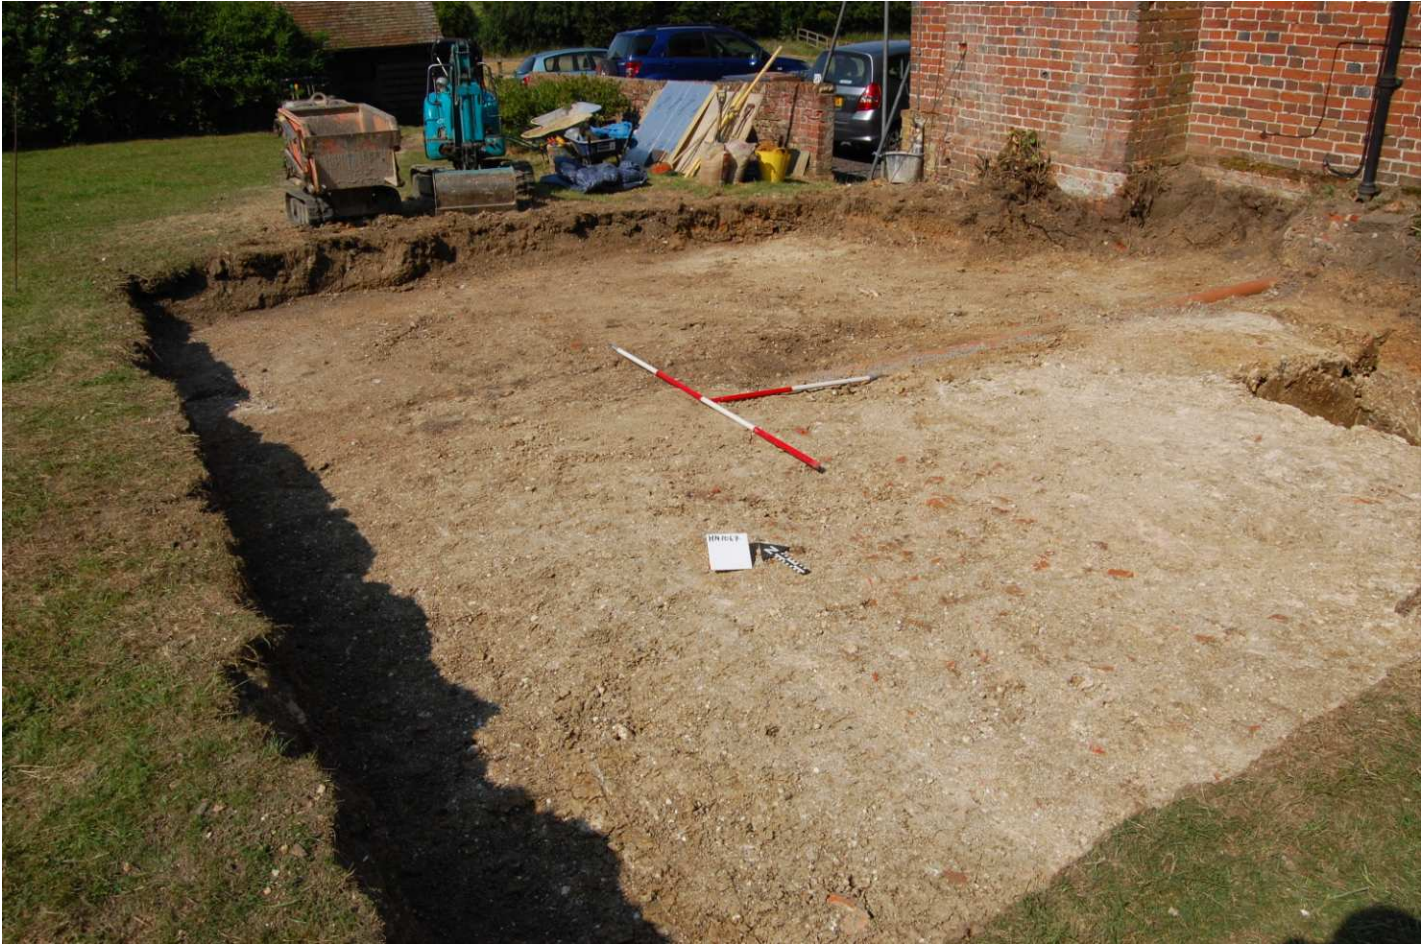
Plate 01 - Reduced footprint, looking north

2.12 The reduction of the footprint exposed the disturbed nature of the made ground. No natural deposits or archaeological features were observed during this stage of the work (Figure 3, Plate 1).

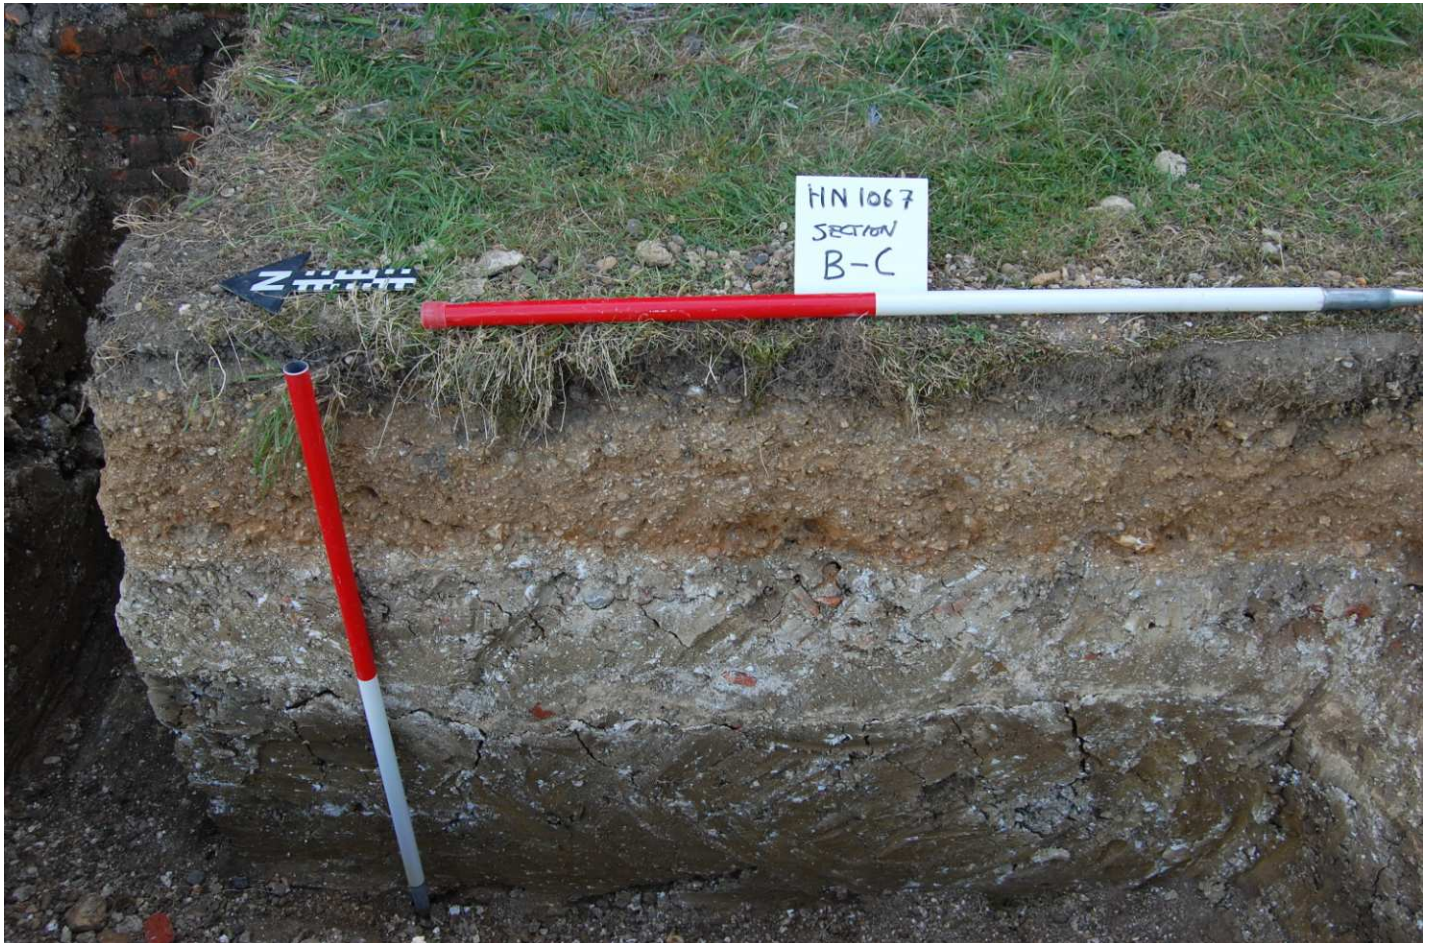
Plate 03 - Stratigraphy in south-east corner, looking east

2.14 Beneath the turf [38] and topsoil [3], the made ground was formed of four layers consisting of multiple dumps, all of which contained mixed material characteristic of demolition (Figures 4 & 5, Plates 3 & 4, 7 & 8):

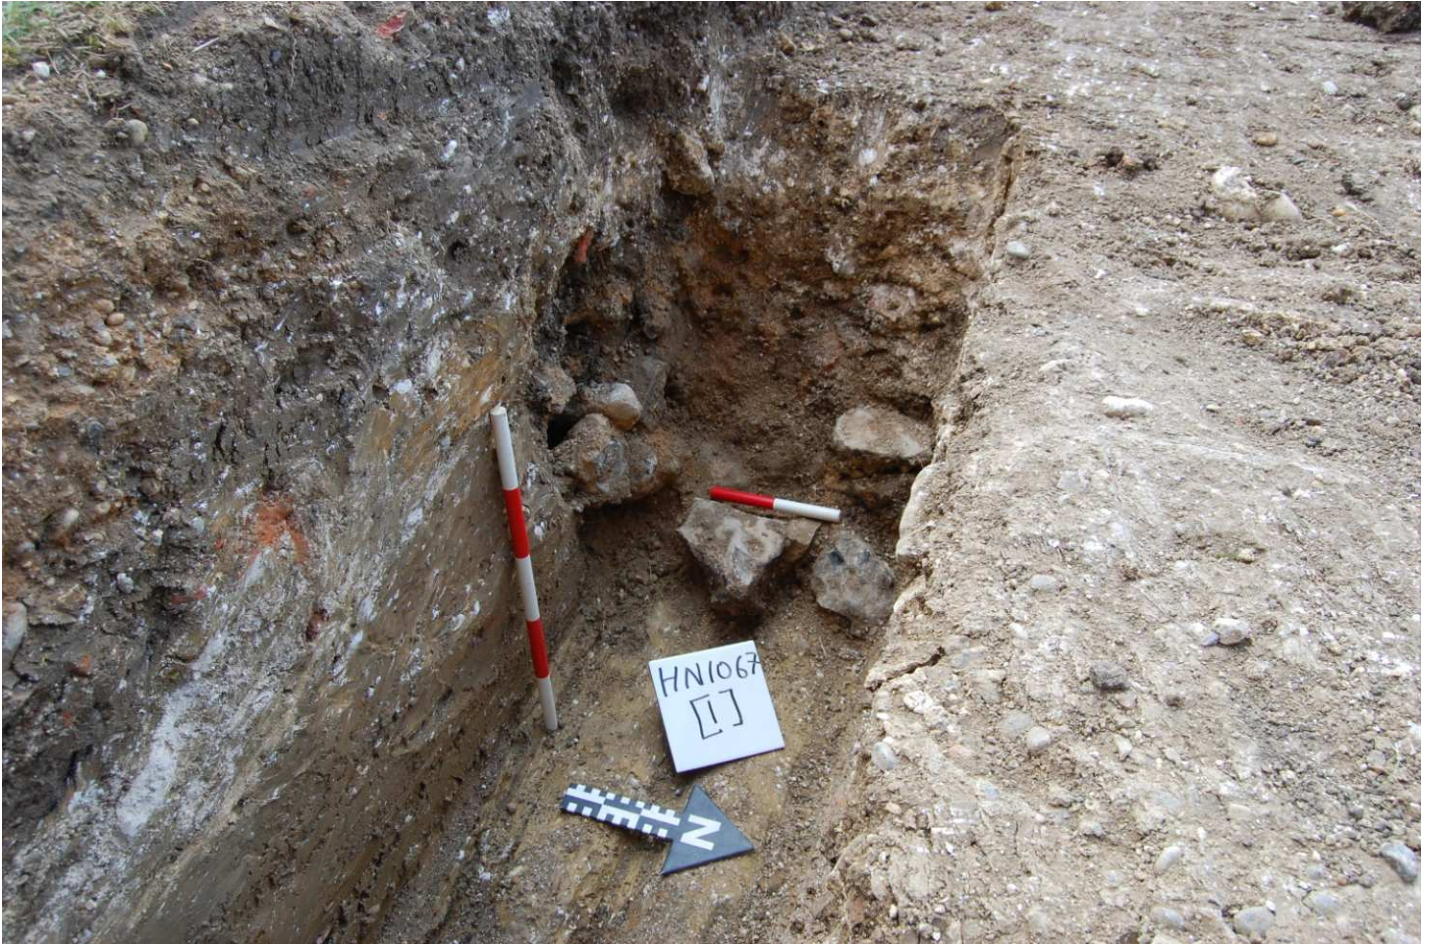
Plate 05 - Wall foundation 1, looking west

- Foundation wall [1] was observed in the southern footings, orientated broadly north – south (Plates 5 & 6). The foundation cut [2] measured 0.45m wide and 0.38m deep. The wall itself measured c. 0.30m wide. Some fragments of Reigate stone were also observed within the wall matrix.
- Foundation wall [28] was located in the northern footings and orientated east – west along the axis of the excavation (Plate 9). The foundation cut [27] survived to a depth of 0.15m and was observed running for 1.40m within the northern section. The wall measured at least 0.25m wide.

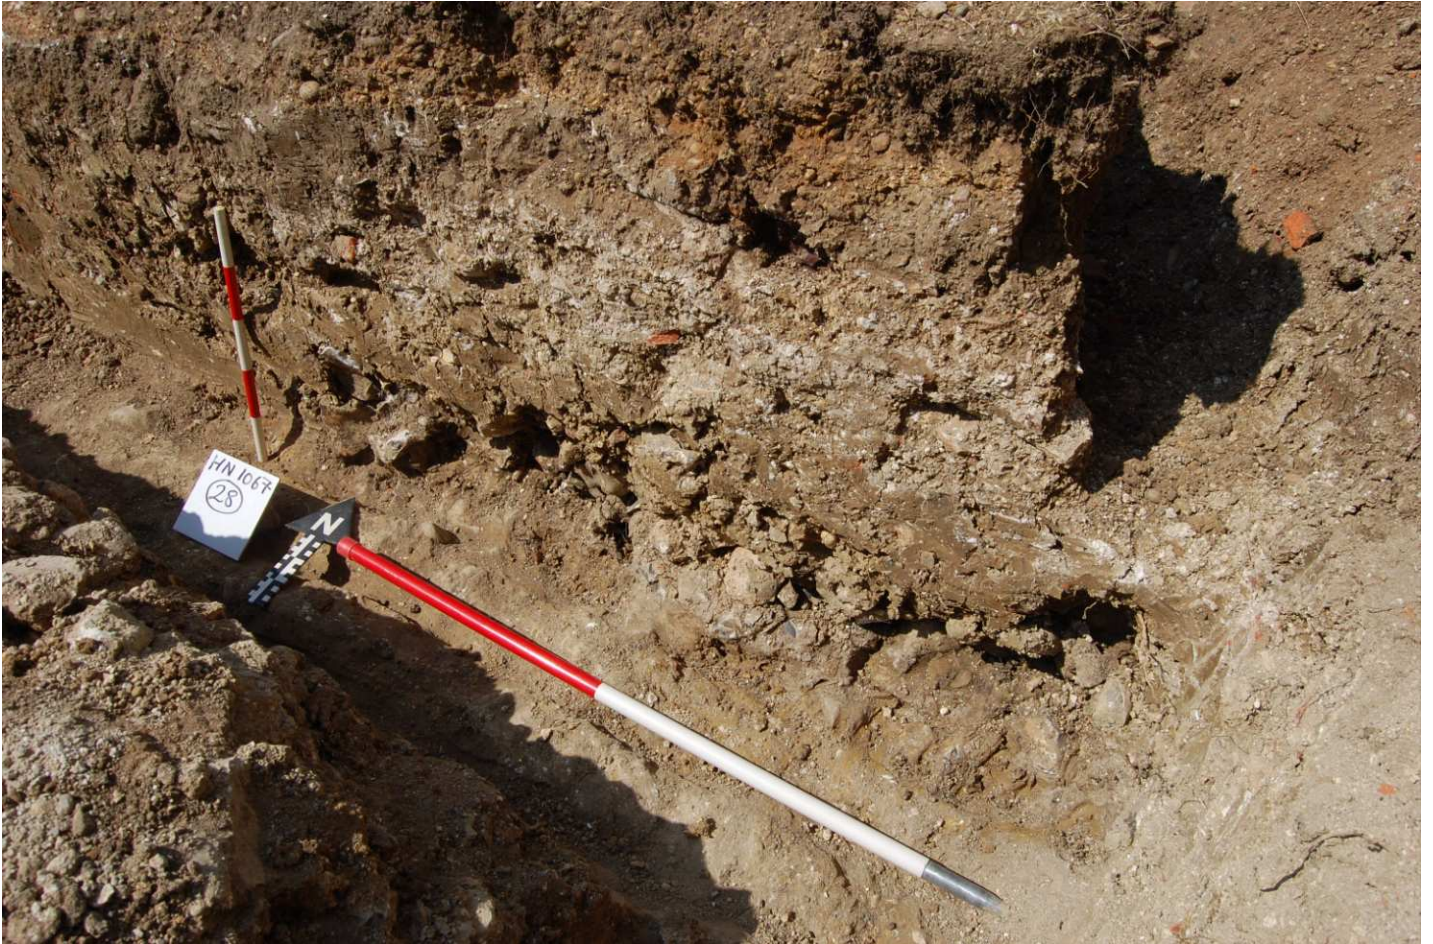
Plate 09 - Wall foundation 28, looking north

3.10 The two wall foundations [1] and [28] form the earliest identified phase. They are both of similar flint and mortar construction cut into the natural geology, and lie beneath extensive demolition/dump layers. These foundations lie at right angles to each other and may represent an outbuilding associated with the earlier part of the existing house. These foundations appear to be too robust for garden walls and the amount of brick and tile in the layers above suggest

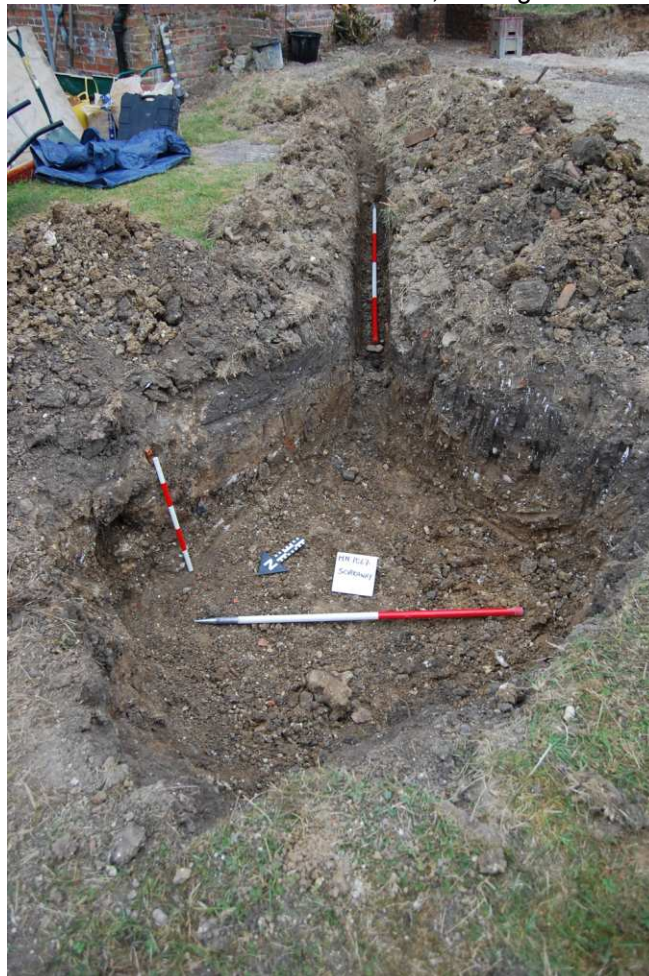
Plate 10 - Soakaway and service run, looking south-east

2.16 The stratigraphy in the soakaway was broadly consistent with the rest of the site, except that there were only three layers of disturbed ground over the natural [35] (Figure 5, Plate 10).

2.18 Modern pit [36] cut into the north-eastern corner of the soakaway. This measured 0.40m wide, 0.75m long, and 0.28m deep. It had steep sides with a flattish base and contained a single brown sandy silty clay fill (37), which had frequent fragments of chalk and tile inclusions. This pit cut into four made layers [31]-[34].
