**BURGESS BUILDING,
Wratten Road East,
Hitchin, Herts.**

HN1113

***HISTORIC BUILDING
RECORD &
ARCHAEOLOGICAL
MONITORING REPORT***

Historic Building Record and Archaeological Monitoring

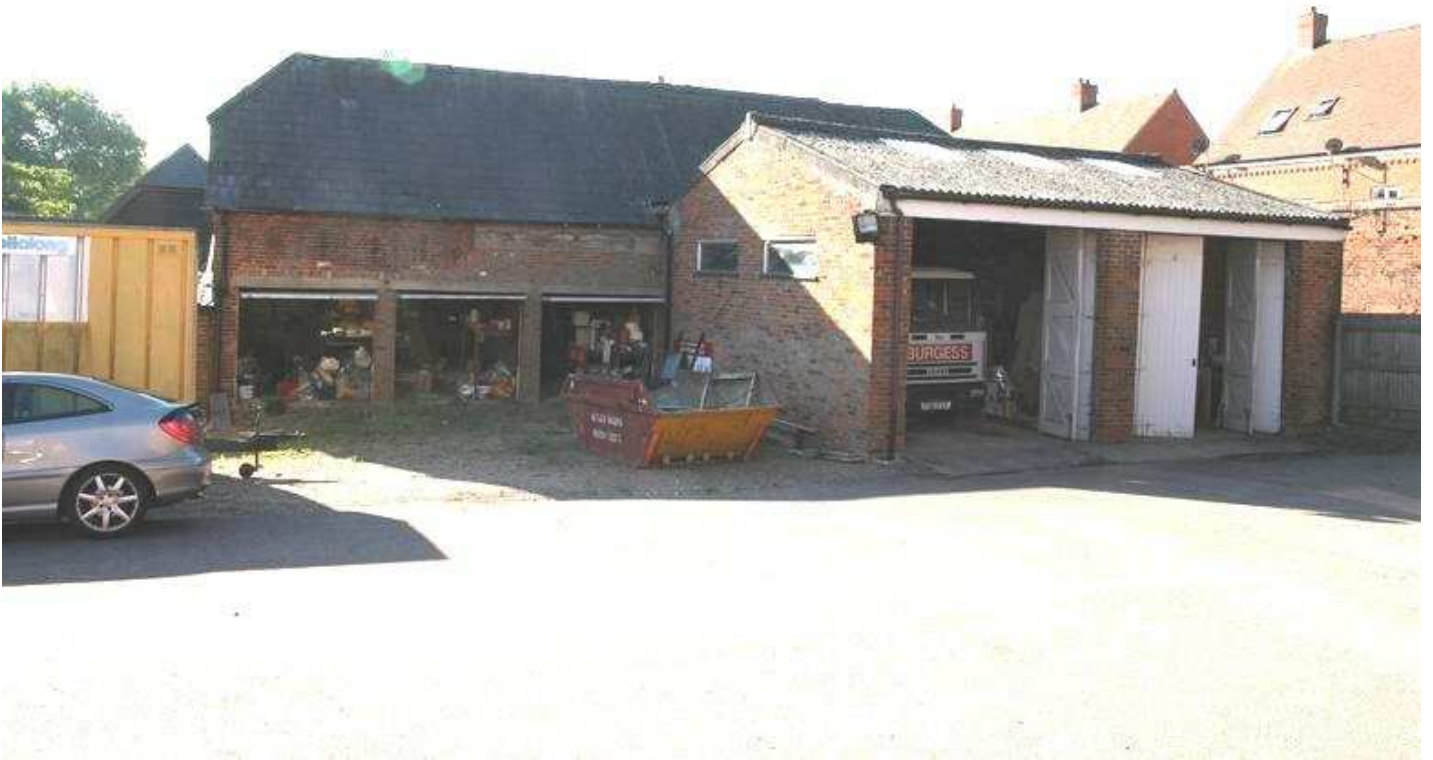
Plate 03 - NW elevation of barn

3.5 The barn appears to be brick-built with a half-hipped slate roof, and originally comprised four bays (Plate 3). To the north of the shed, the north-west elevation has been remodelled to create three garage bays, with up-and-over doors, concrete lintels and modern brick piers. At the northern end of the exposed elevation, between the lintels and the eaves, the wall is constructed of red brick with some burnt headers, laid in Flemish bond with lime mortar, topped by a dentilled cornice. This extends to the line of the original northern bay (i.e. half-way along the second garage bay), beyond which the elevation above the lintels is formed of reclaimed brick bonded with cement mortar, below wooden boarding. The elevation is no longer extant where it butts the later shed.

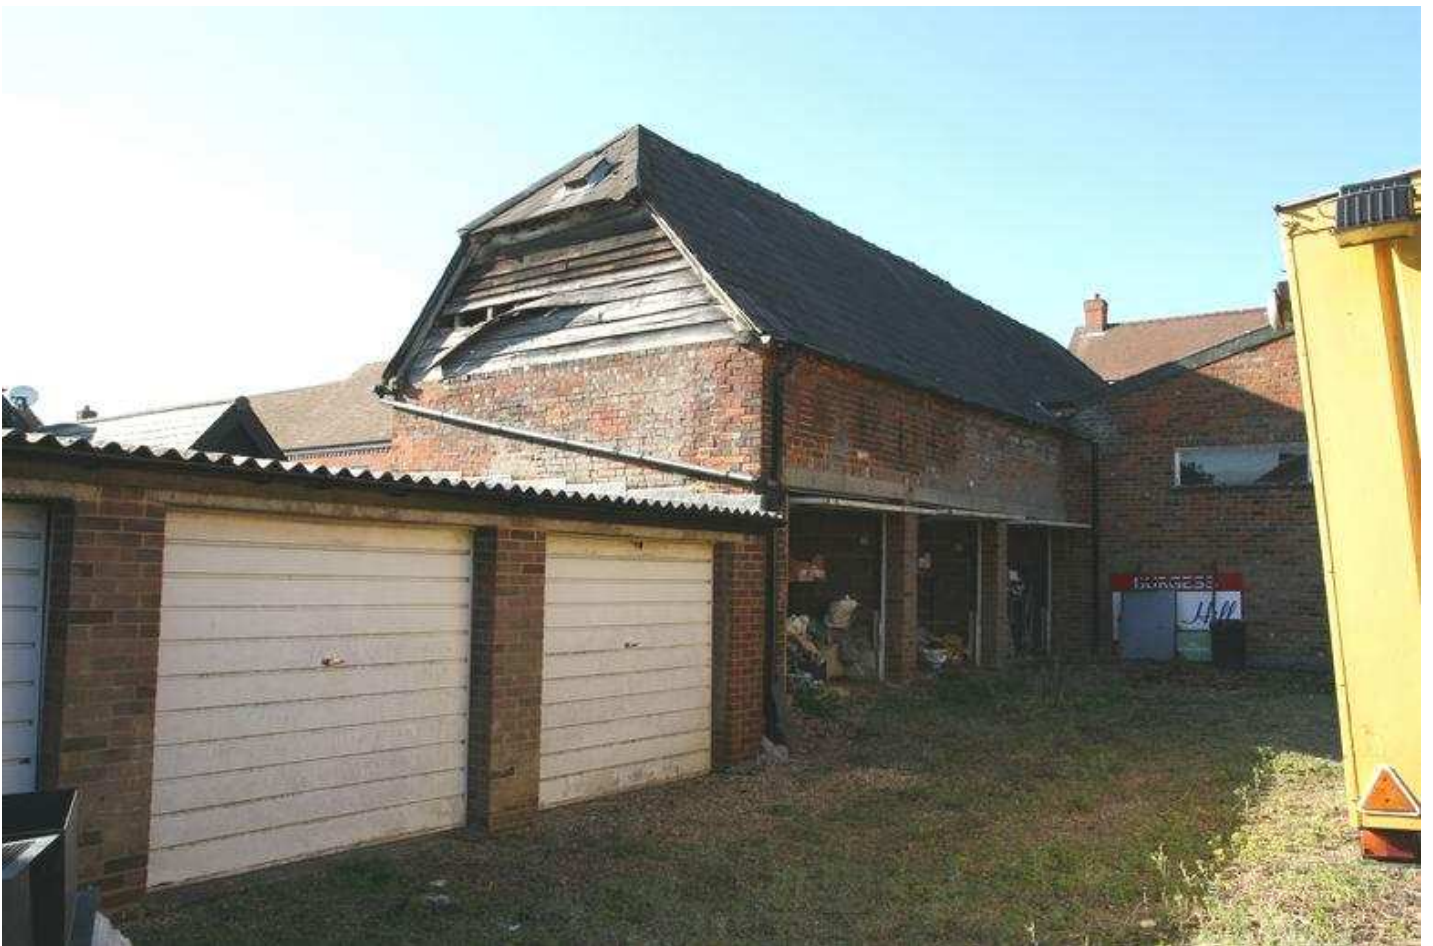
Plate 04 - NE elevation of barn
(c) The Heritage Network Ltd.

3.6 The north-eastern elevation is formed of red brick to the level of the eaves and may have been rebuilt using reclaimed materials (Plate 4). The bricks are laid in Flemish bond, with a line of headers at eaves level, and the gable has been in-filled with weatherboard including some older, wider planks of elm, with later softwood above.

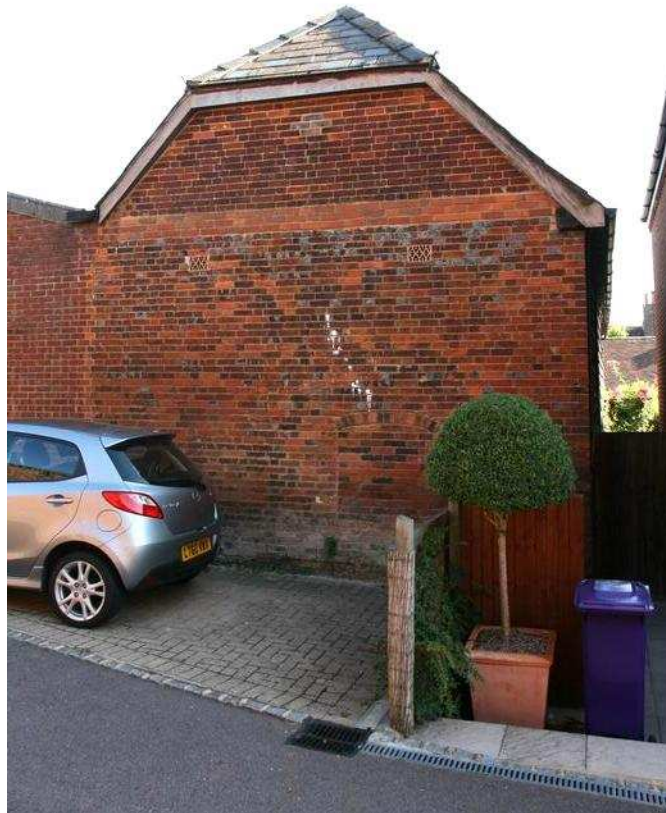
Plate 05 - SW elevation of barn

3.7 The south-western elevation is also formed of red brick, with some burnt headers, laid in Flemish stretcher bond, with a line of headers at eaves level (Plate 5). A three-brick high band of modern red bricks, possibly marking the location of an earlier tie-beam, separates this from the gable, which has been infilled with more red brick laid in Flemish stretcher bond. Two cast-iron vents have been inserted in the wall, just below the level of the eaves, and a blocked window opening with brick arch can be seen towards the base of the wall towards the southern corner.

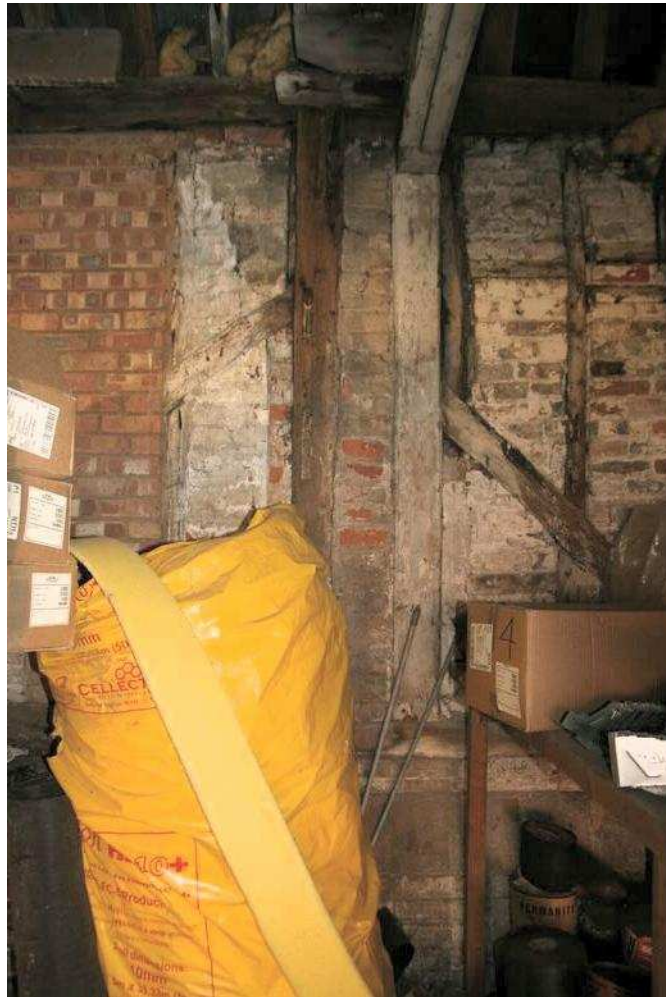
Plate 07 - Introduced post and tie-beam at S end of Bay 1

3.9 The interior of the barn was originally divided into four bays, now remodelled to five by the insertion of the modern garage doors at the northern end, and associated partitioning. Bay 1 (to the north) in the original scheme, has a suspended lath and plaster ceiling that suggests, together with the brickwork in the north-west exterior elevation, that this end of the barn had been remodelled to provide an enclosed living or working space, probably in the mid-19th century (Plate 6). At the same time a new, independent wall post was introduced, supporting an additional tie-beam which sits just below the level of the existing wall-plate (Plate 7).

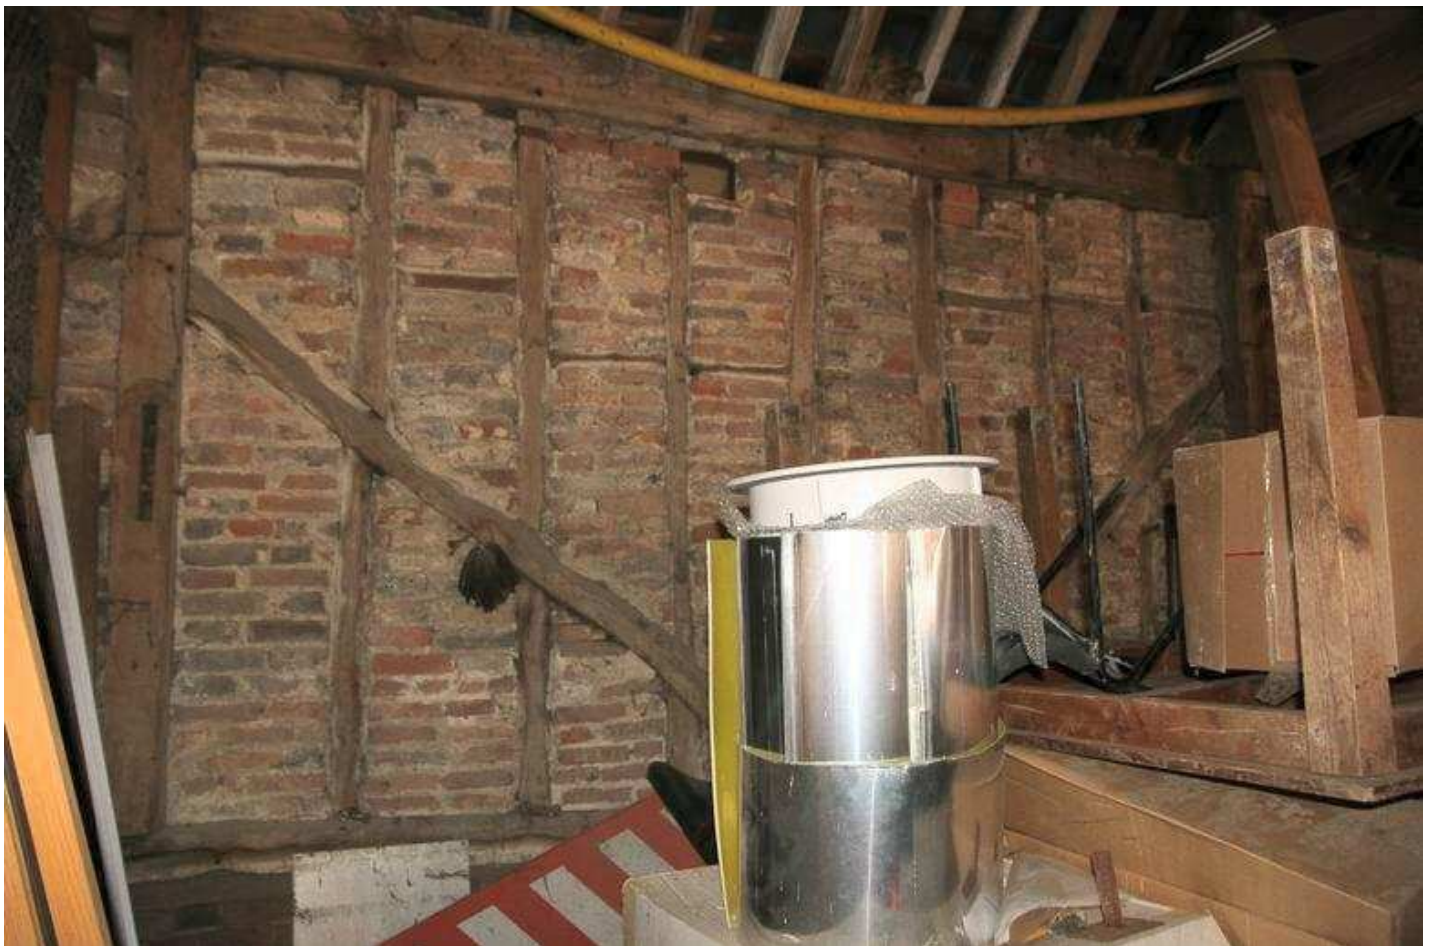
Plate 08 - Timber framing in SE elevation of Bay 3
(c) The Heritage Network Ltd.

3.10 The north-eastern interior elevation retains largely original timber framing, including the wall-plate and studs, staggered primary bracing, and a sole plate resting on a later brick plinth (Plate 8). Some repairs to the wall plate are apparent, particularly in Bay 4. Substantial tie beams separate the bays, with mortices indicating that they were originally braced to the principal posts, which are jowled but half the width of the tie-beams (Plates 9 & 10). The framing is infilled with brick nogging.

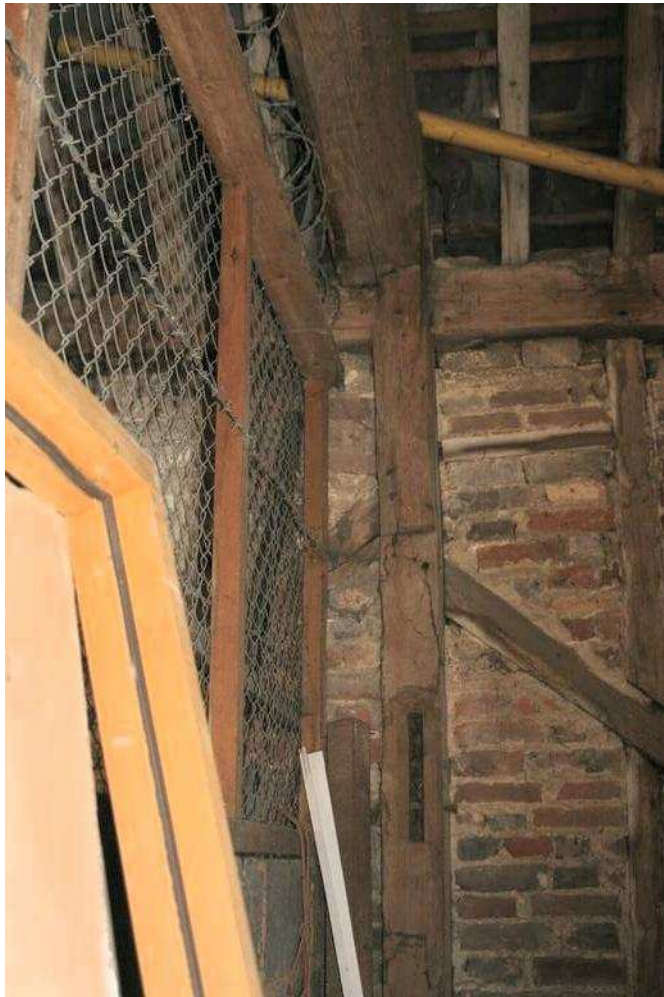
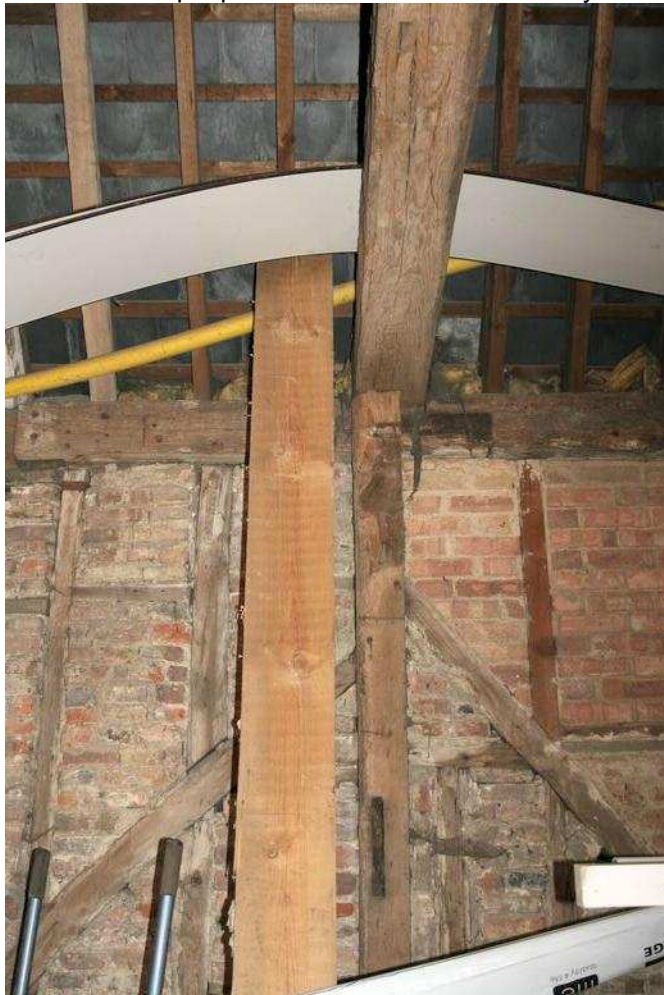
Plate 09 - Principal post and tie-beam between Bays 2 and 3

Plate 10 - Principal post and tie-beam between Bays 3 and 4
(c) The Heritage Network Ltd.

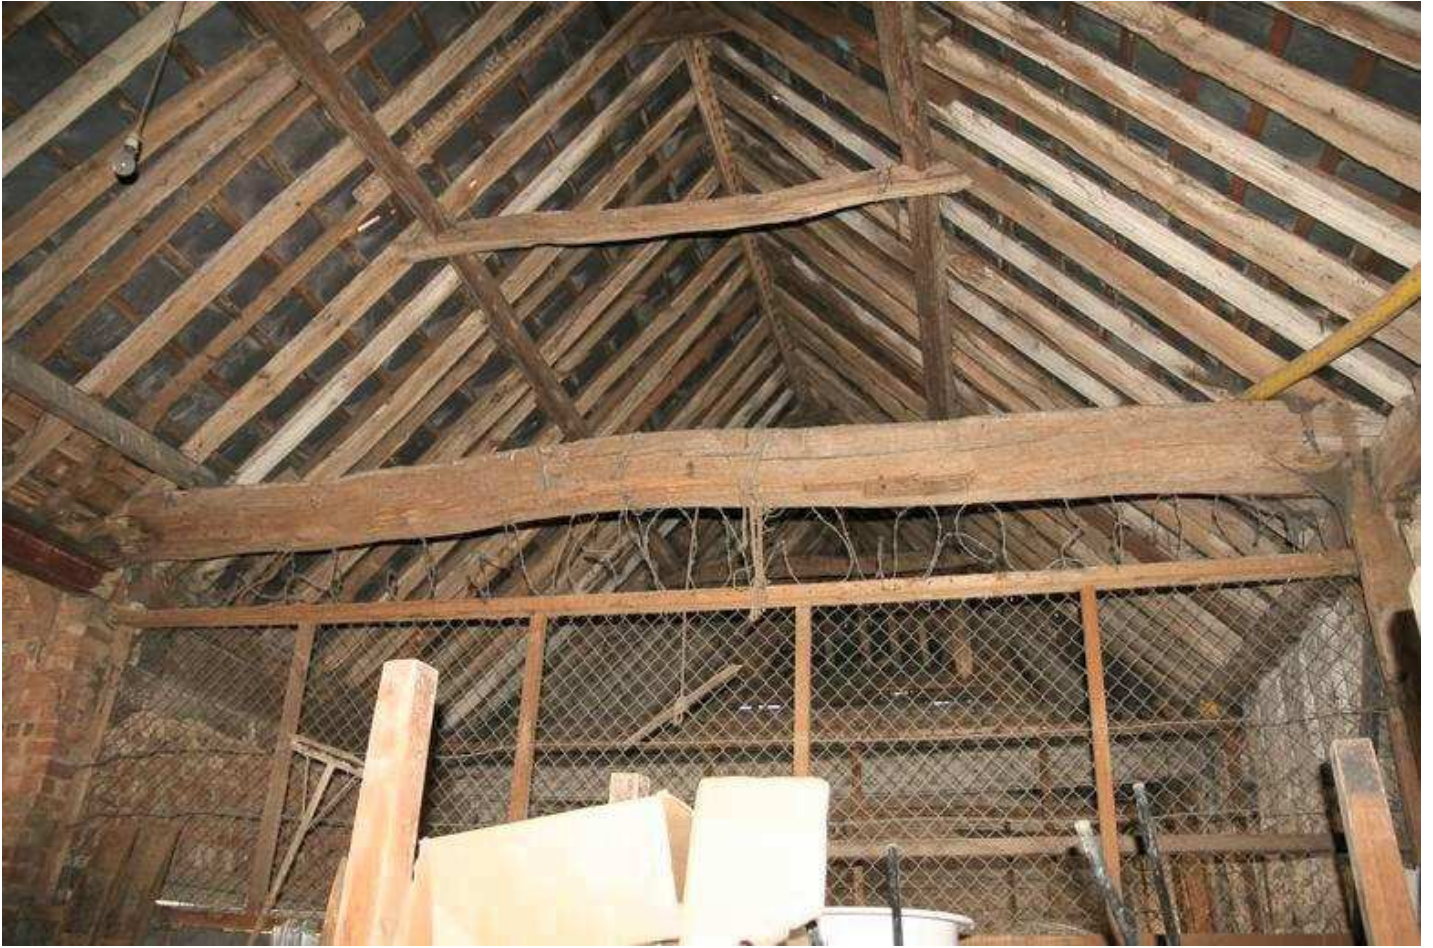
Plate 11 - Roof structure

3.11 The roof structure is formed of paired rafters, meeting at a ridge plate, with collars and a single clasped purlin in each slope (Plate 11). This appears to be a 19th or early 20th century rebuild, with some more modern repair to the south. It is likely that the barn was originally thatched.

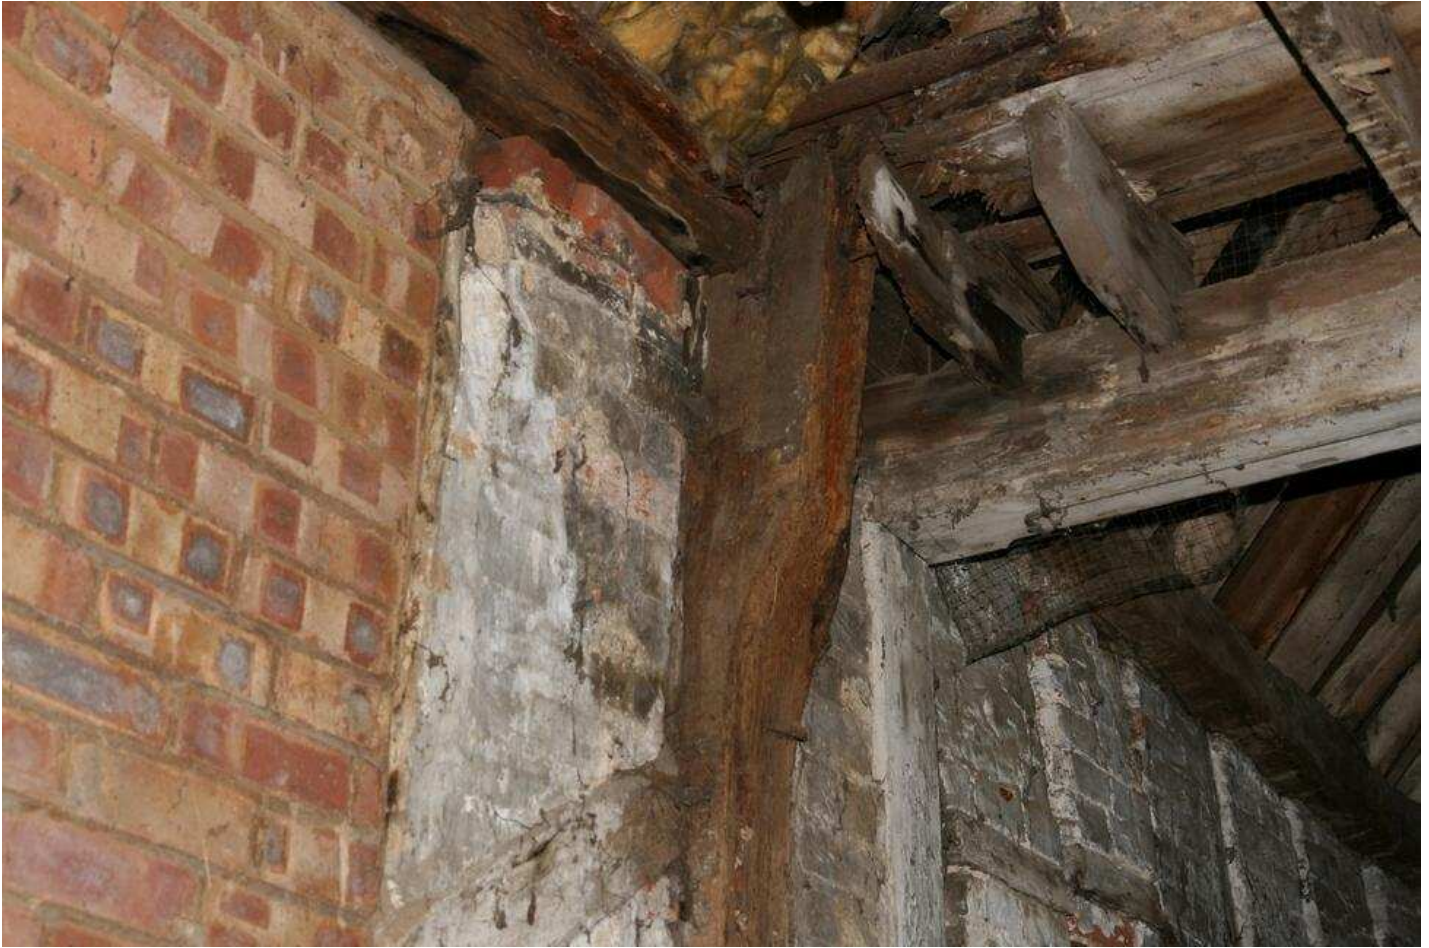
Plate 19 - Detail of the principal posts between Bays 1 & 2

3.16 The tie beam to the original jowled principal post between Bays 1 and 2 has been cut short and is supported on timbers resting on the replacement tie beam (Plate 19).

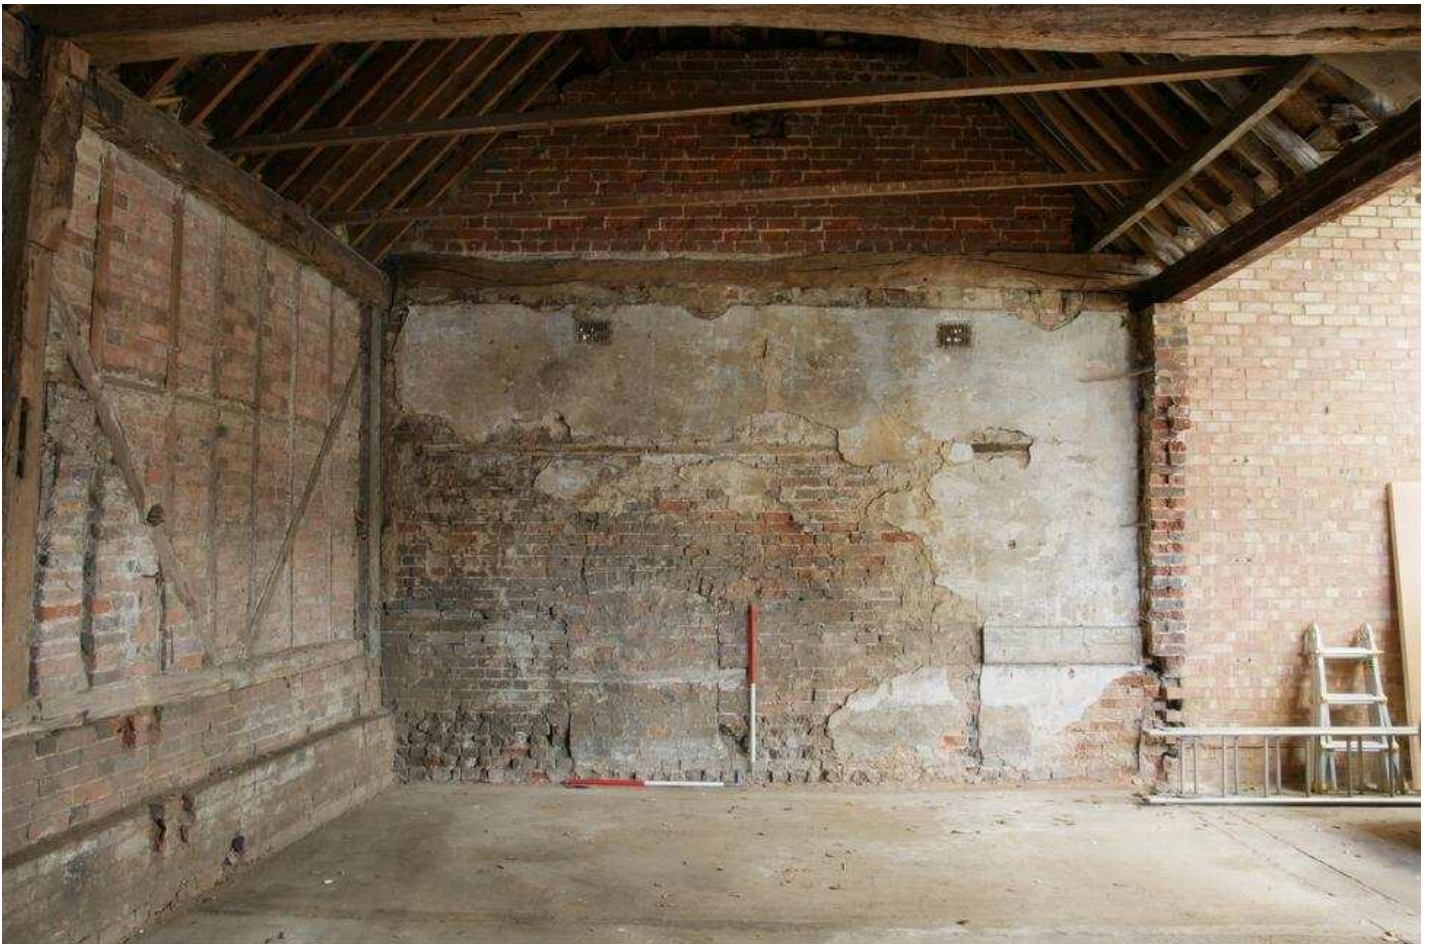
Plate 20 - South-west interior elevation after removal of plaster
(c) The Heritage Network Ltd.

3.17 Removal of the wall plaster to the south-western gable end exposed the tie beam on the interior elevation (Plate 20). A blocked opening with an arched brick header was seen at the base of the wall, offset to the south. This was previously noted on the exterior elevation (see Plate 5). It measured approximately 1m in height and 1m in width. A short length of timber ran between the blocked opening and the north-east elevation below the height of the header. A timber levelling strip was also revealed in this wall, at approximately 2m above the present ground level.

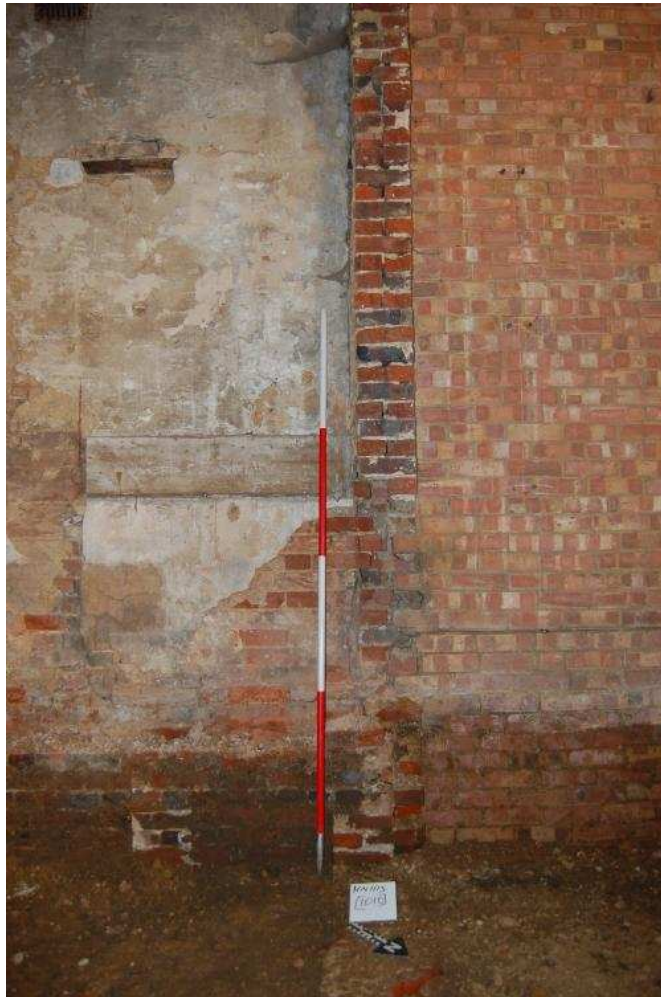
Plate 21 - Blocked opening in SW elevation

3.18 A previously hidden blocked opening was revealed at the north-western end of the south-western elevation, immediately adjacent to the former north-eastern wall. The original timber lintel is missing, and its former location plastered over (Plate 21). A horizontal timber may mark the base of the opening.

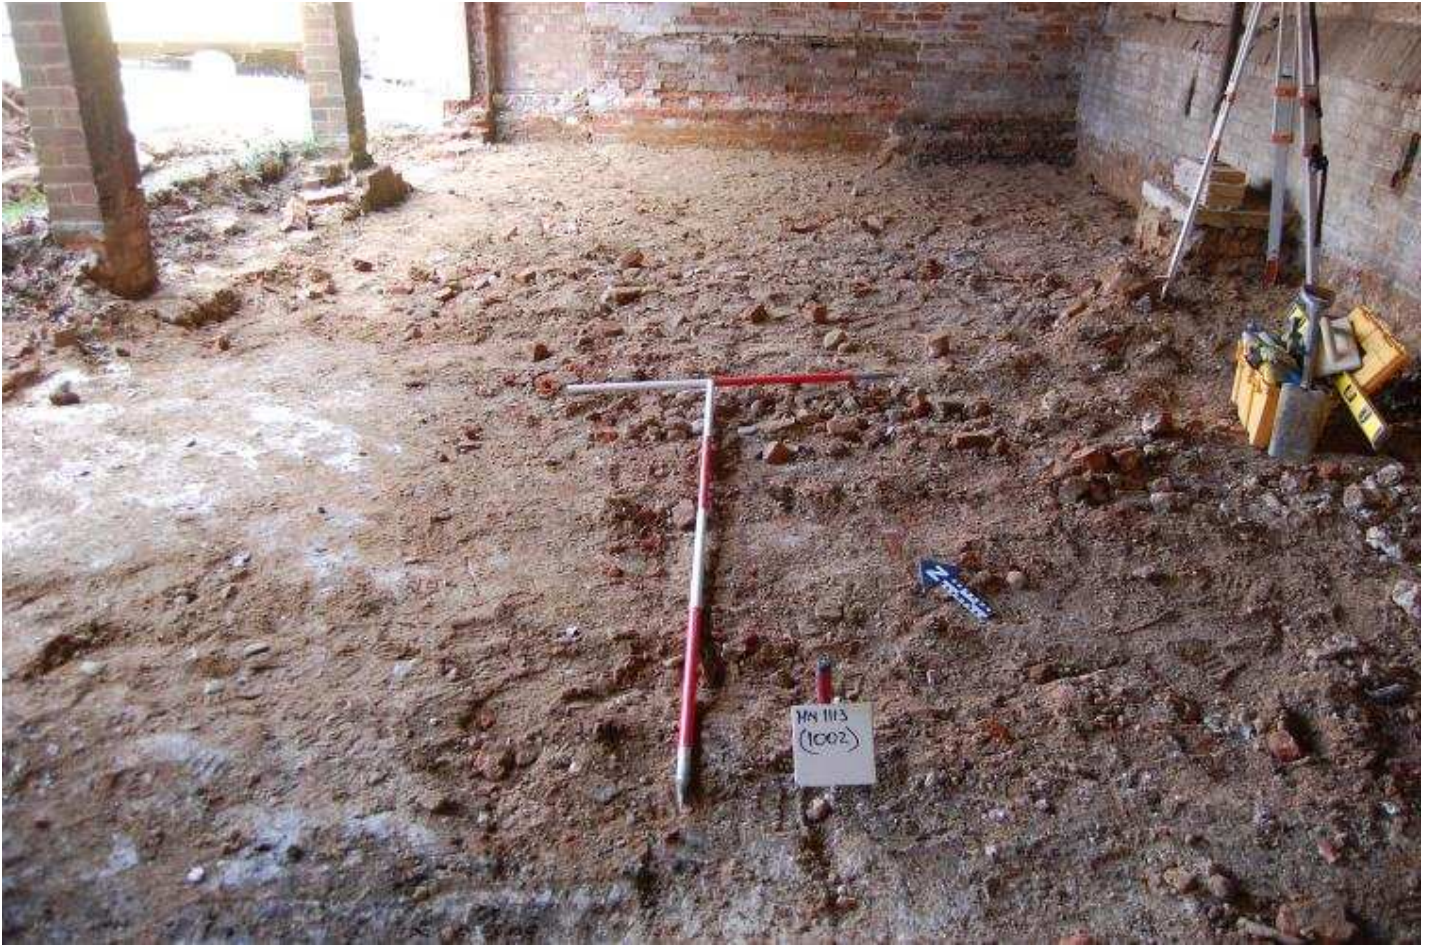
Plate 29 - Deposit (1002), looking NE

4.15 Deposit (1002) extended across the entire internal area of the barn and into the later extension at its south-western end. It comprised a brown loose silty sand, containing frequent sub-angular flint and occasional rounded flint, 0.60m in depth (Plate 29). This has been interpreted as a modern make-up layer.

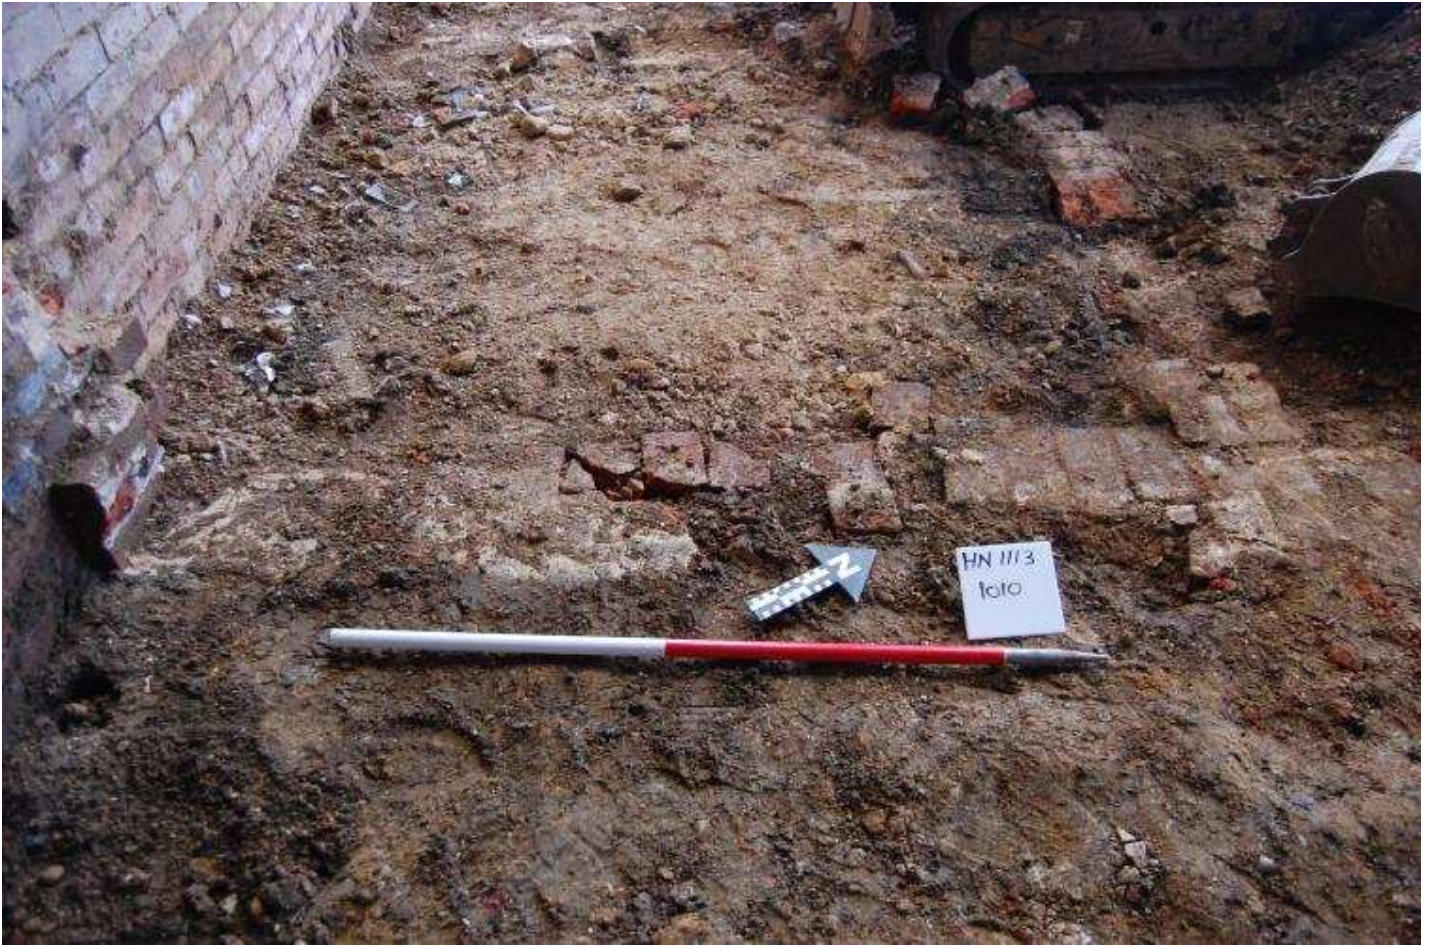
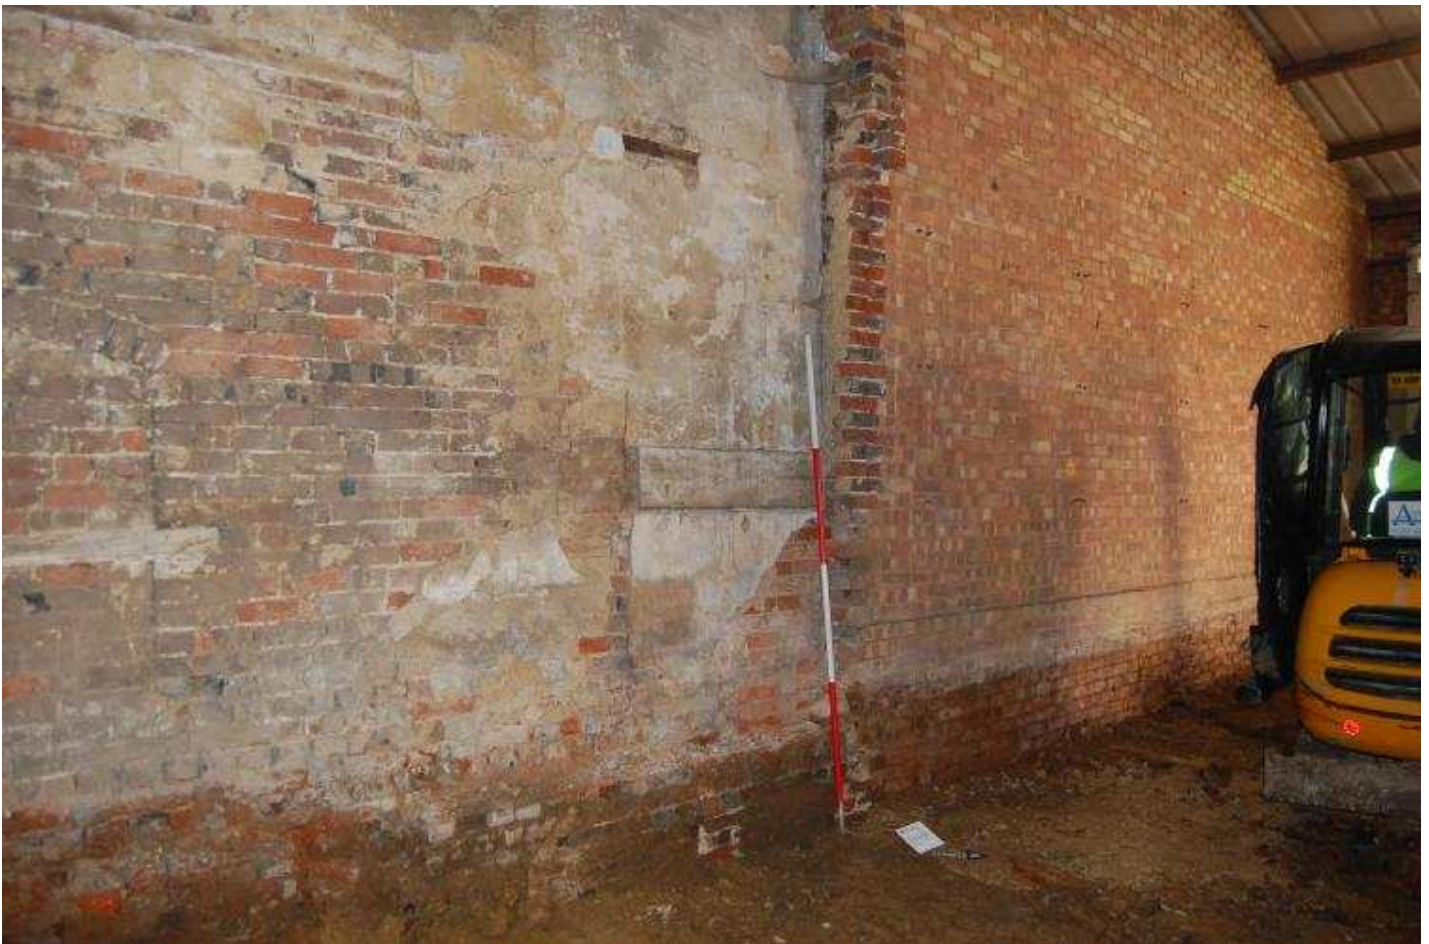
4.17.2 Wall [1010] ran on a south-west to north-east alignment for approximately 3m from the concrete base to the south-western wall of the barn (Plate 31). The wall measured 0.32m in width and had formerly stood to roof height (Plate 32). The foundations were constructed of handmade unfrogged bricks, laid in Flemish bond with lime mortar and was butted at its southern end by the south-western wall of the later 20th century extension. The individual bricks measured $8\frac{3}{4}'' \times 4\frac{1}{2}'' \times 2\frac{1}{2}''$ (222mm x 105mm x 64mm). No clear relationship between this wall and the surviving south-western elevation to the north-east could be discerned, but it was butted by the south-western wall to the later 20th century extension.

Plate 31 - Wall [1010], looking NW

Plate 32 - Wall [1010], former height, looking SW
(c) The Heritage Network Ltd.

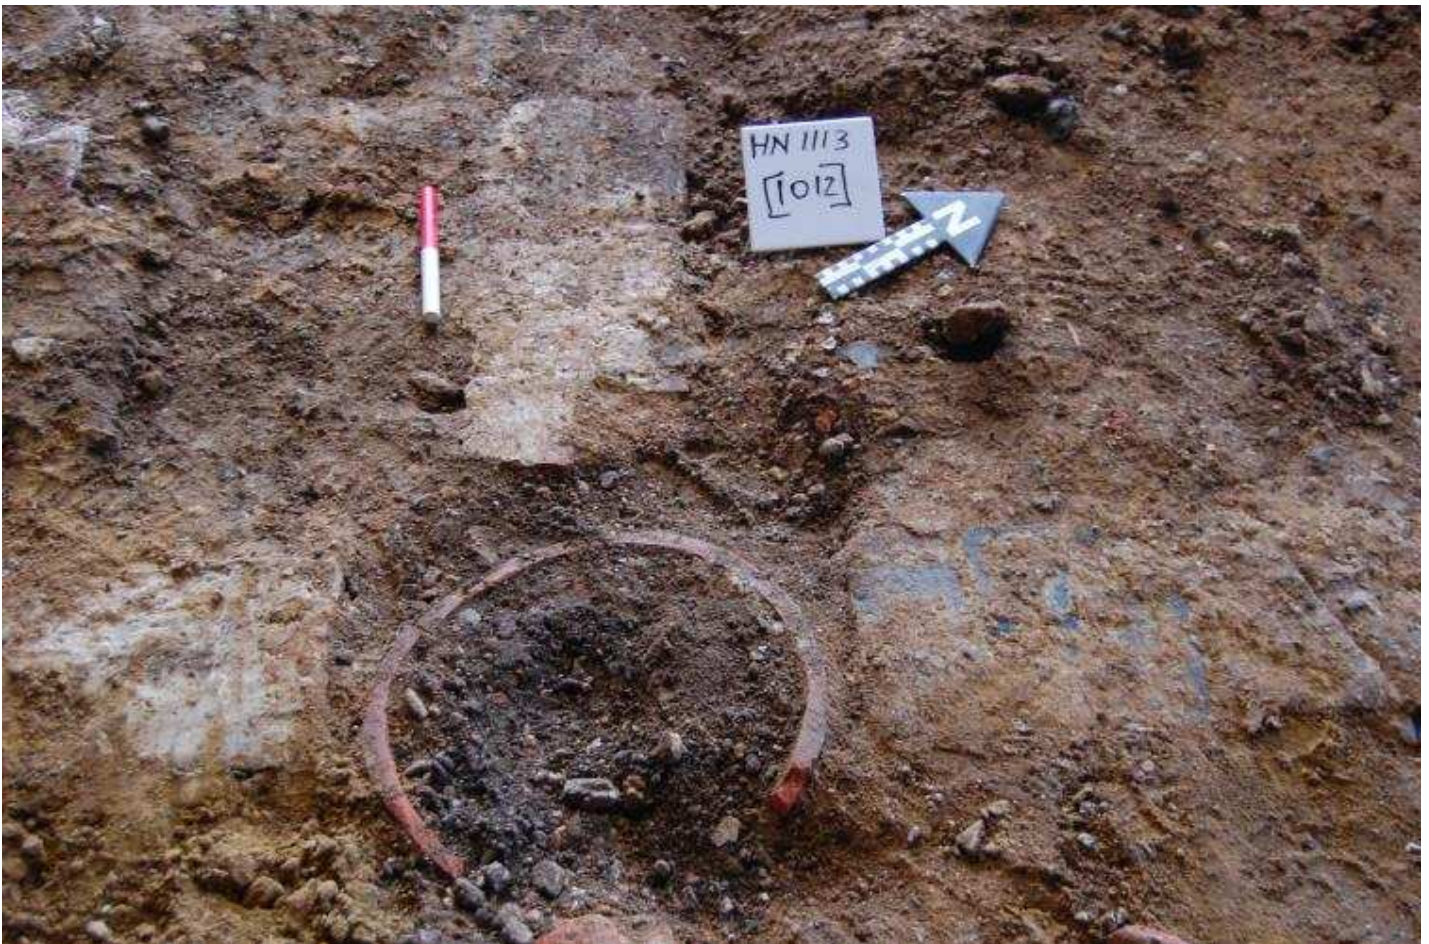
Plate 36 - Wall [1012], looking NE
(c) The Heritage Network Ltd.

4.17.6 Wall [1012] ran on a north-west to south-east alignment to the north-west of pit [1016]. Its exposed area measured 0.58m in length and 0.22m in width (Plate 36). The wall was constructed of red bricks, which appeared to be handmade and unfrosted, and bonded with lime mortar. It is possible that it once ran between walls [1010] and [1013].

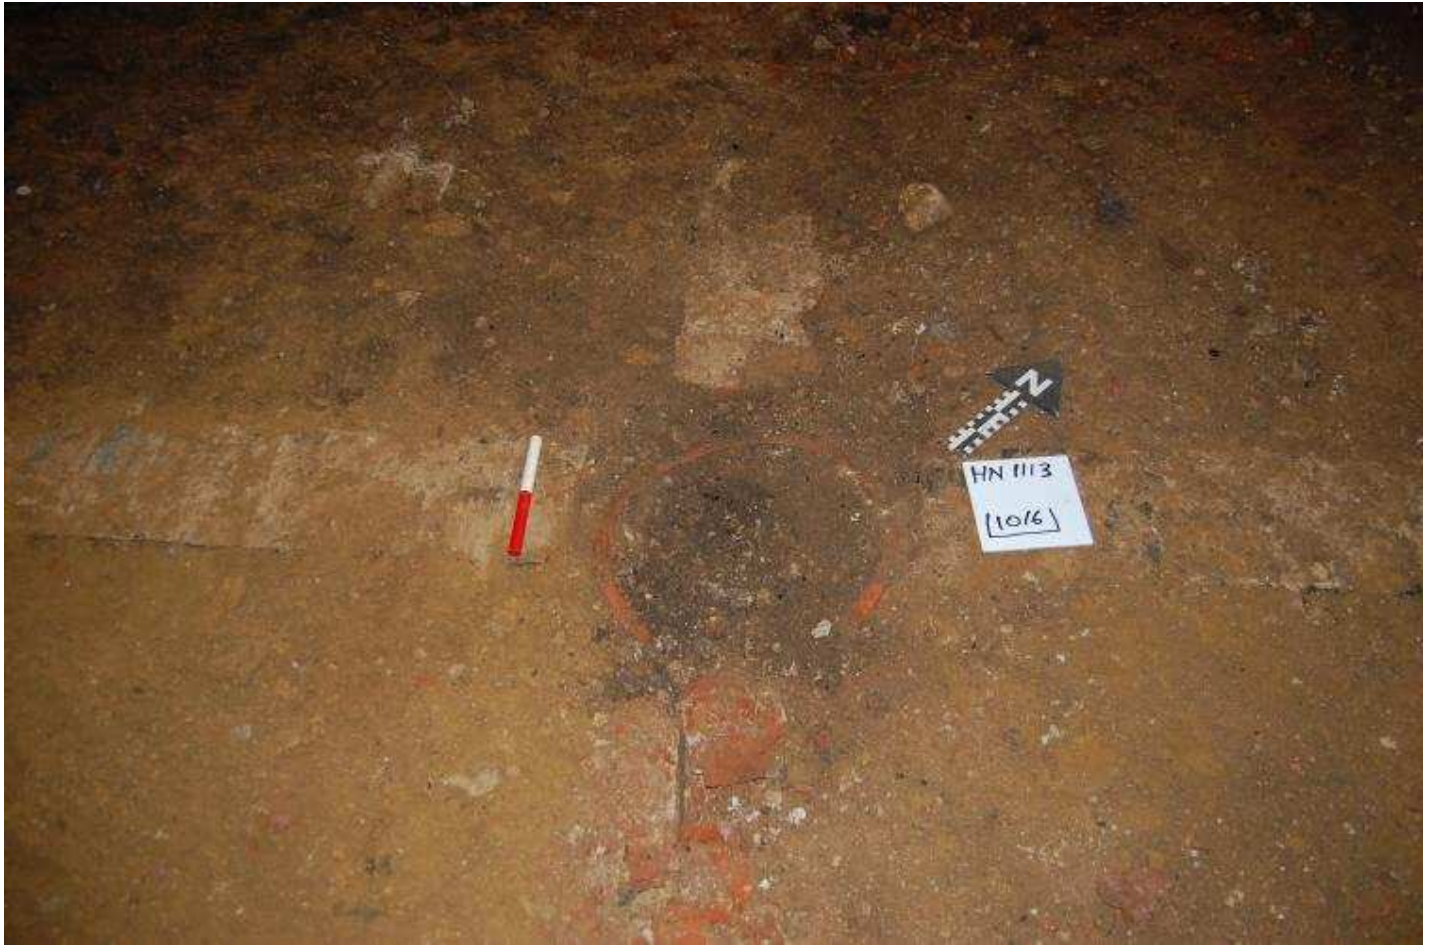
Plate 39 - Pit [1016], looking NW

4.20 Pit [1016] was cut through the junction of walls [1011], [1012] and [1013]. It was oval in plan and measured 1m in length, 0.75m in width and 0.40m in depth, with steep sides and a flat base (Plate 39). It contained fill (1017), a dark yellowish brown loose silty sand, which enclosed a ceramic vessel, (1018), at the north-western end of [1016].
