**Aisled Barn  
MANOR HOUSE  
105 Norton Road, Letchworth, Herts.**

HN583

*Historic Building Record*

Report no.354

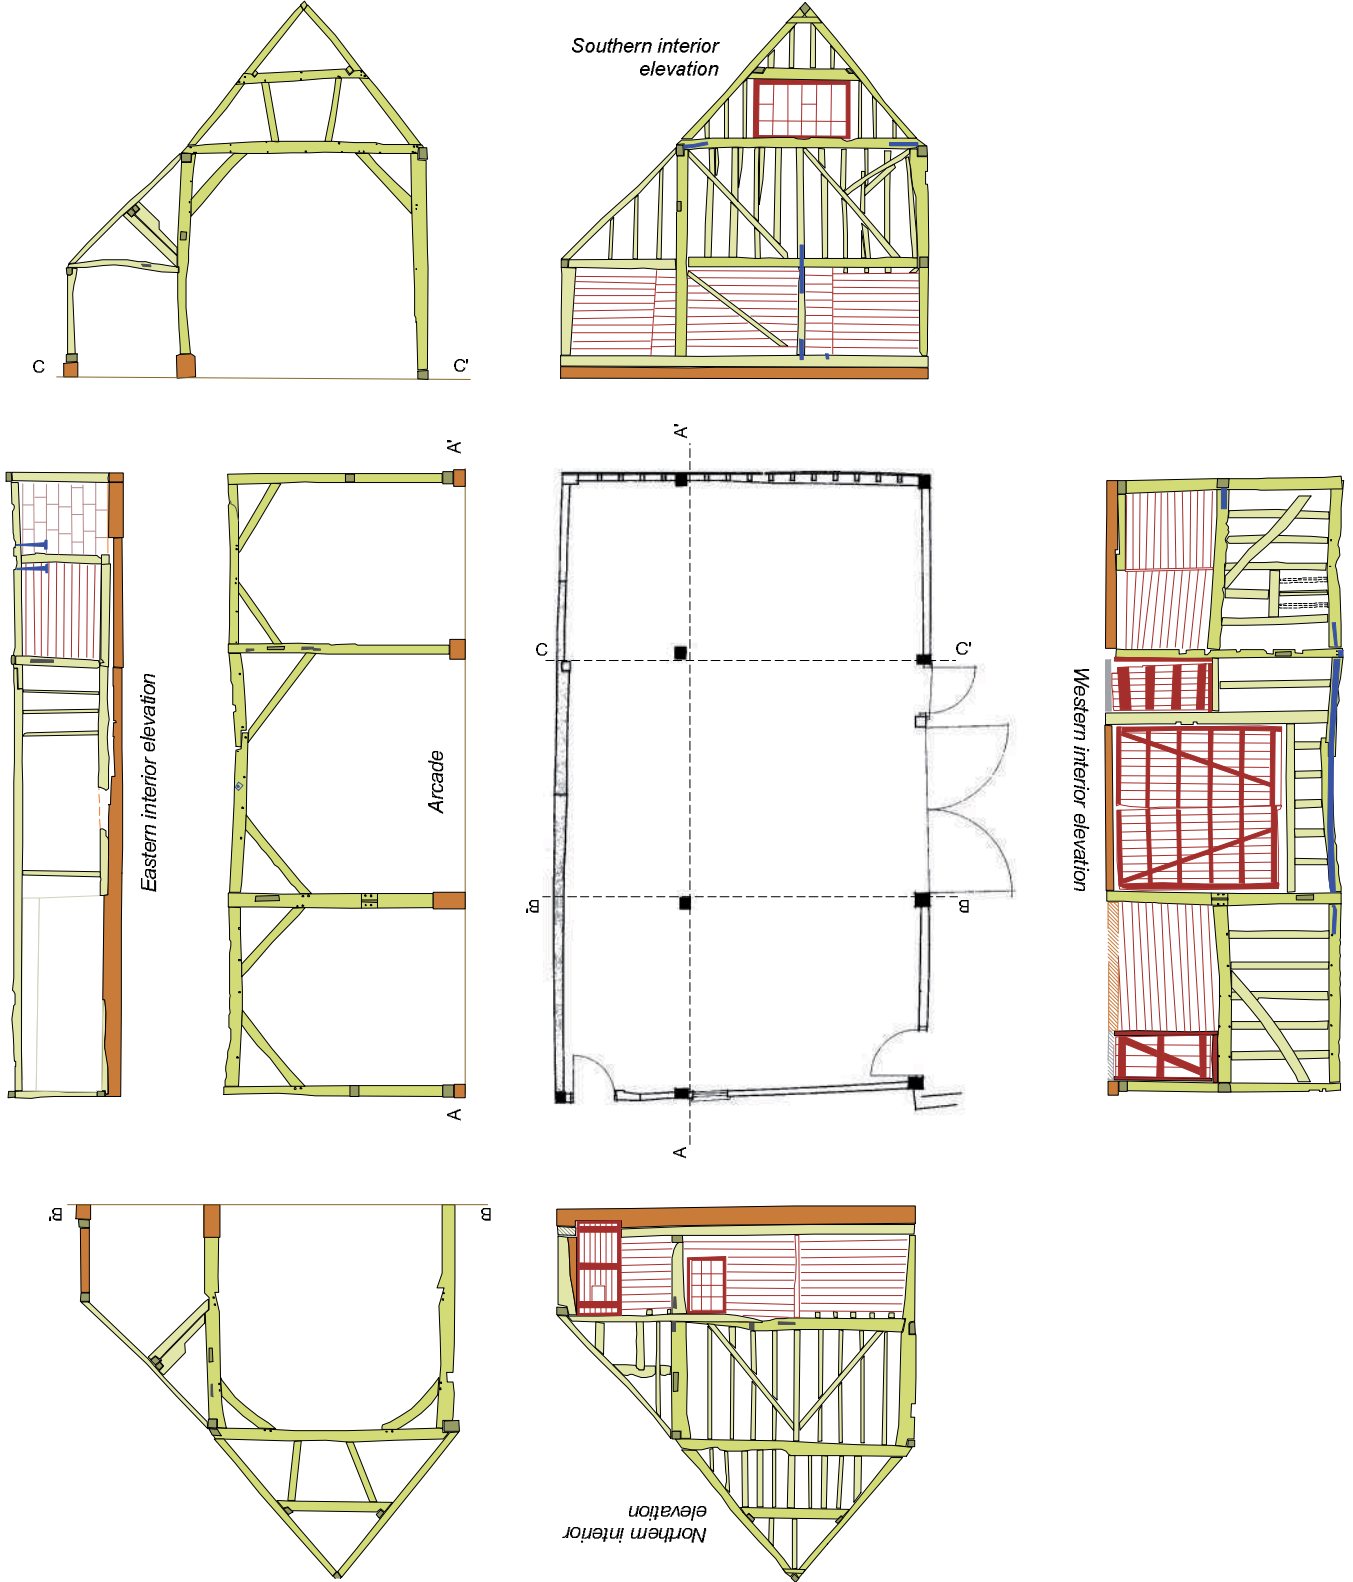
Figure 8

**2.6** The barn is an oak framed thatch roofed rectangular structure of three unequal bays and an aisle, aligned northeast to southwest (referred to in the text, for convenience, as aligned north - south) (Figure 8; Plates 1-4). The woodwork has been limewashed and the sole plate is set on a brick plinth, on average three courses high. The floor is formed of concrete.

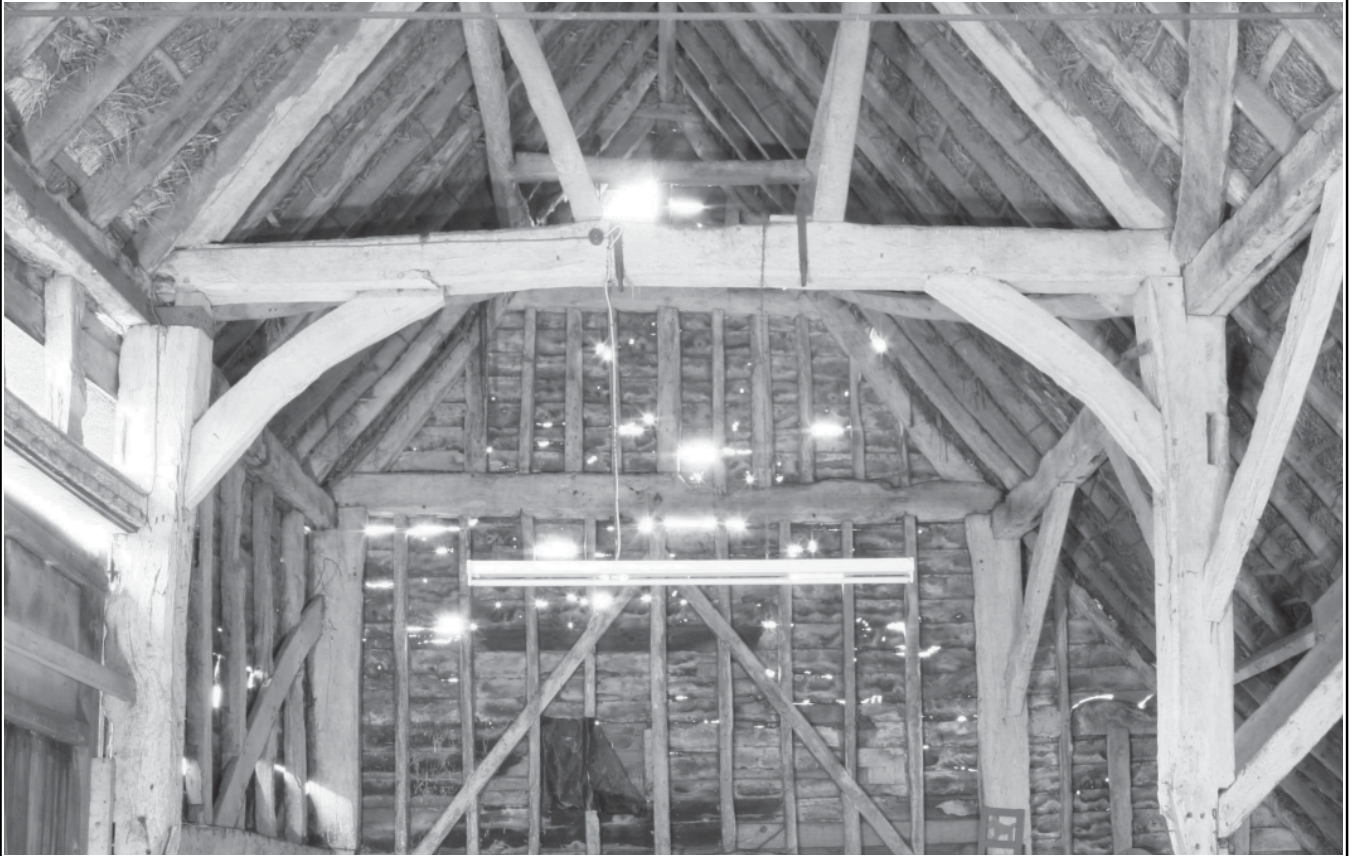
Plate 5: Framing, northern bay, looking N

**2.9** Five of the eight principal posts, the wall plates, mid-rails and roof trusses appear to be contemporary. The two northern pairs of principal posts and the south-western post have gently flared jowls which is generally indicative of a later 17<sup>th</sup> century date (Plate 5). The south-eastern post is unique but the remaining pair are chamfered and have a series of redundant notches and mortices indicating reuse. The tie-beam in this frame has mortices cut into its lower face, and the collar exhibits redundant dowel holes which also indicate reuse (Plate 6). The wall plates are jointed where they span the middle bay using edge-halved scarf joints which were in common use up until the mid-17<sup>th</sup> century (Plate 7).

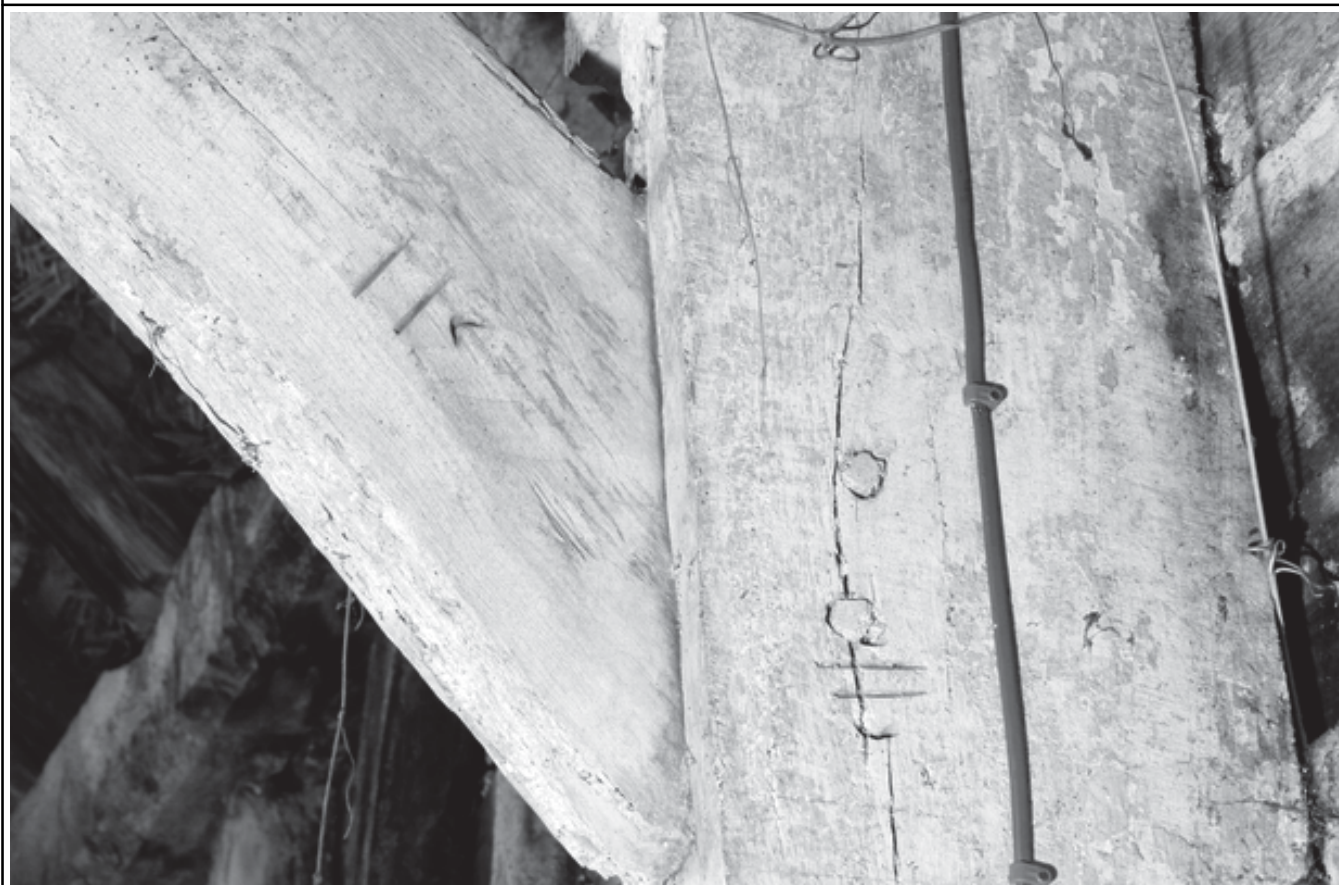
Plate 8: Carpenter's marks on northern face of the second frame from the north

**2.10** The roof structure is supported on arch-braced tie-beams which span the principal posts. From these spring raking queen struts which support a collar. The rafters support a ridge purlin. Carpenter's marks were noted on the northern side of the second frame from the north (Plate 8).

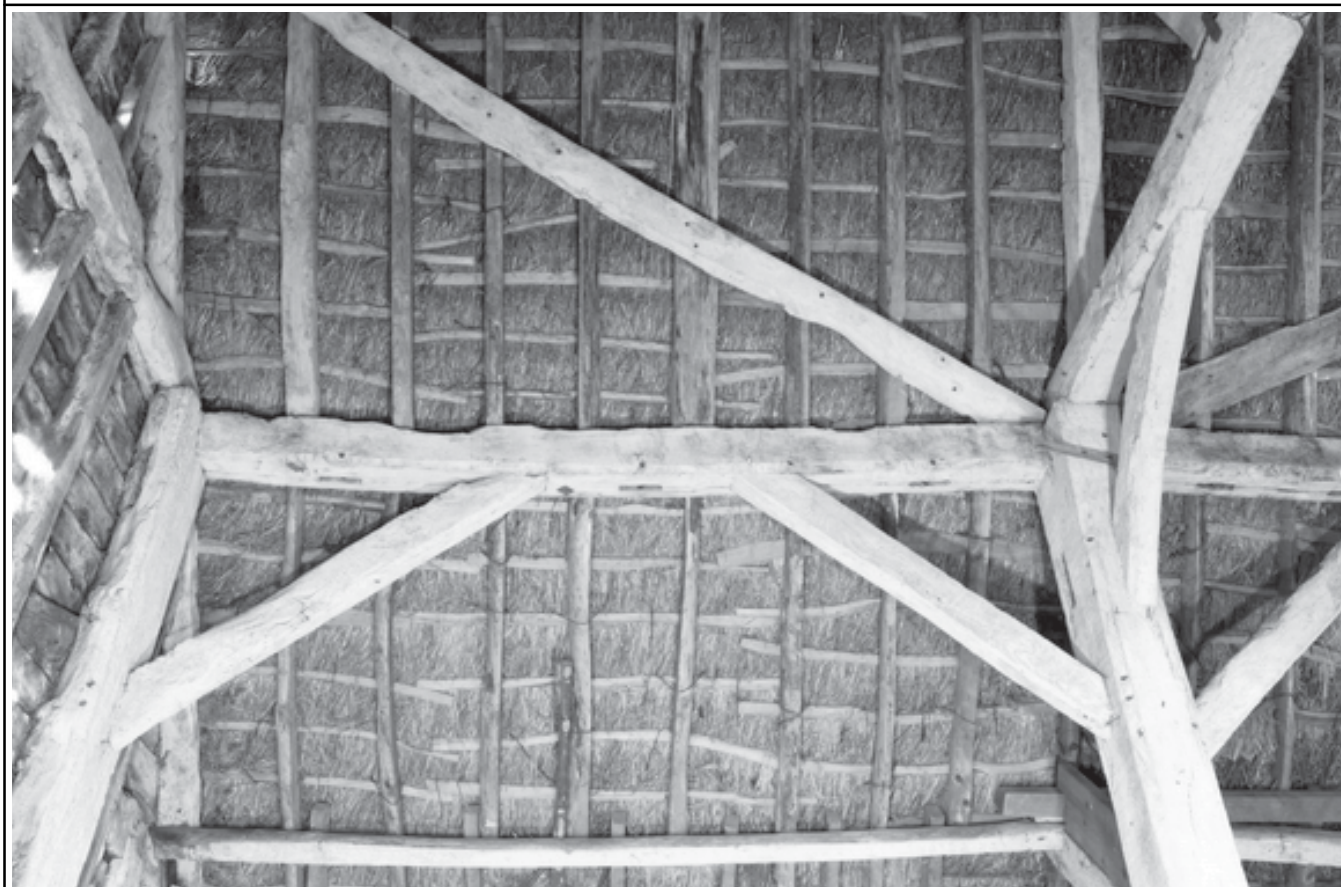
Plate 10: Mortices cut into lower face of eastern arcade plate

**2.12** A series of rectangular mortices cut into the lower face of the eastern arcade plate indicate that this elevation was originally closed (Plate 10). Mortices in the northern face of the second arcade post from the north suggest that it originally supported a mid-rail, and the integral bracket on its western face, and similar bracket on the opposing principal post, indicate the former existence of a cross-rail, probably supporting a mezzanine floor (Plate 11). No direct evidence for a similar arrangement in the southern bay survives, as all of the principal posts in this bay, with the exception of the south-western post, appear to be replacements. Nevertheless, the presence of the window may be indicative.

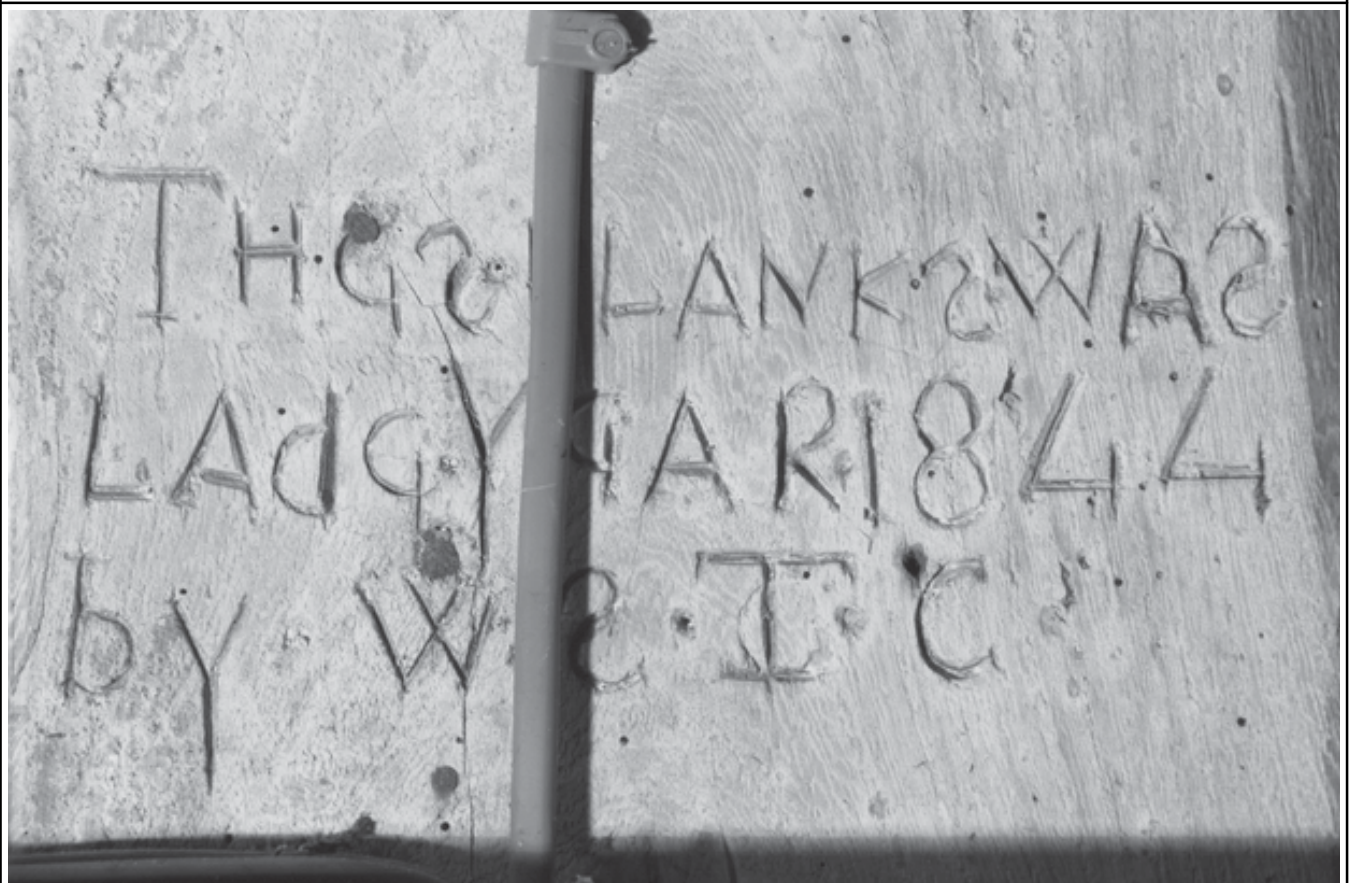
Plate 12: Graffito on the inside of the southern barn door jamb

**2.14** The barn has four entrances. Ledged and braced barn doors are offset to the north in the western elevation of the middle bay. A handcarved graffito on the inside of the southern door jamb reads *These planks was laid here 1844 by W.S.T.C.* (Plate 12). A ledged personnel door is located between the barn doors and the next principal post to the south. A ledged and braced personnel door is located in the northern corner of the same elevation, probably originally giving access to the small extension against the exterior elevation noted on the Ordnance Survey plan of 1880. A further ledged personnel door opens into the aisle from the north. Modern windows have been inserted above the collar in the southern gable end, and at the eastern end of the northern gable end, below the mid-rail.
