**Church of St Mary the Virgin, Harlington, Bedfordshire.**

Report No.849

As part of the faculty requirements for the repair of two existing buttresses supporting the north-western corner of the north aisle at the Church of St Mary the Virgin, Harlington, Bedfordshire, the Heritage Network was commissioned to undertake a watching brief on the groundworks.

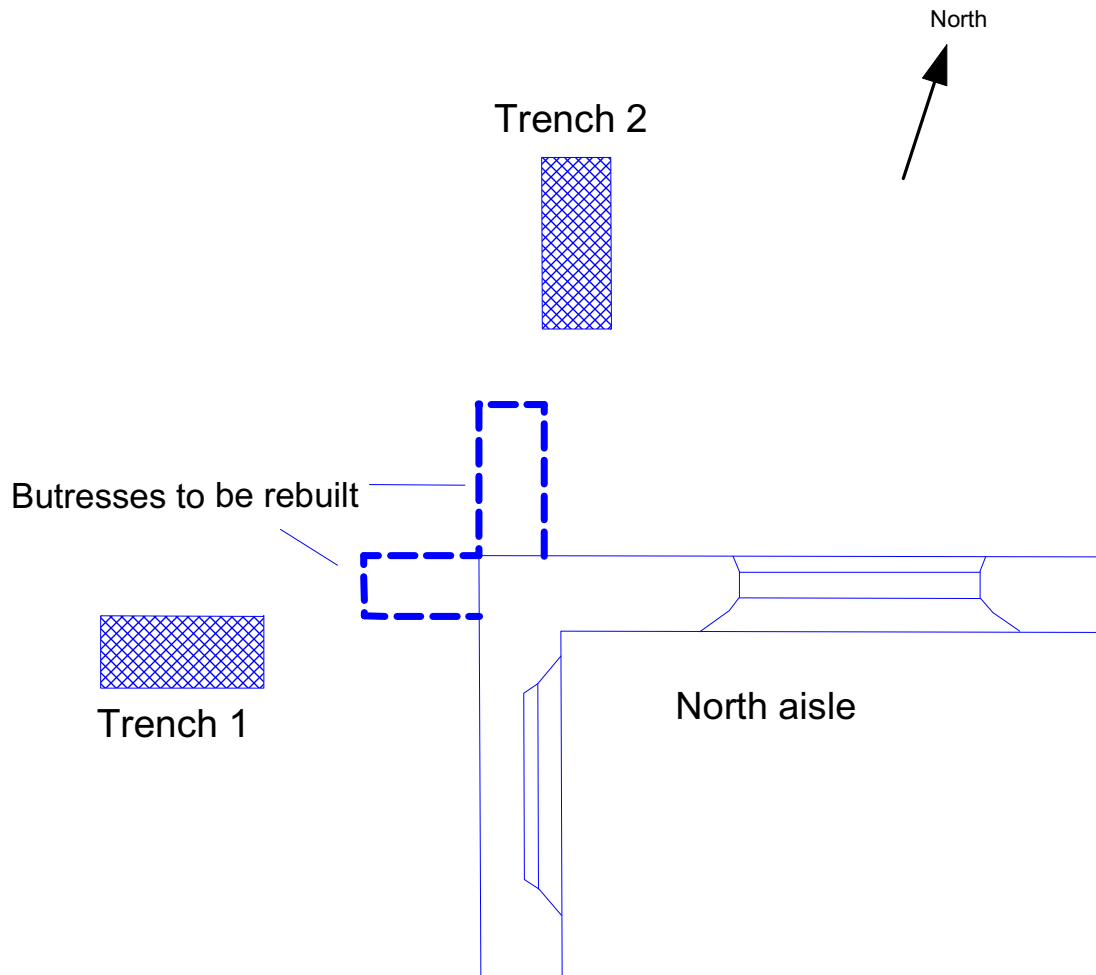
Figure 2

Trench 1 was located to the west of the western buttress and measured 1.60m in length, 0.70m in width and approximately 0.80m in depth (Figure 2). Trench 2 was located to the north of the eastern buttress and measured 1.70m in length, 0.70m in width and approximately 0.90m in depth. A modern service pipe was noted in Trench 2, at a depth of 0.20m below the present ground surface. The trench sections revealed a layer of dark grey (10YR 4/1) silty clay with moderate small pebbles. This has been interpreted as a cemetery soil. Significant root activity was observed in the upper 0.20m.

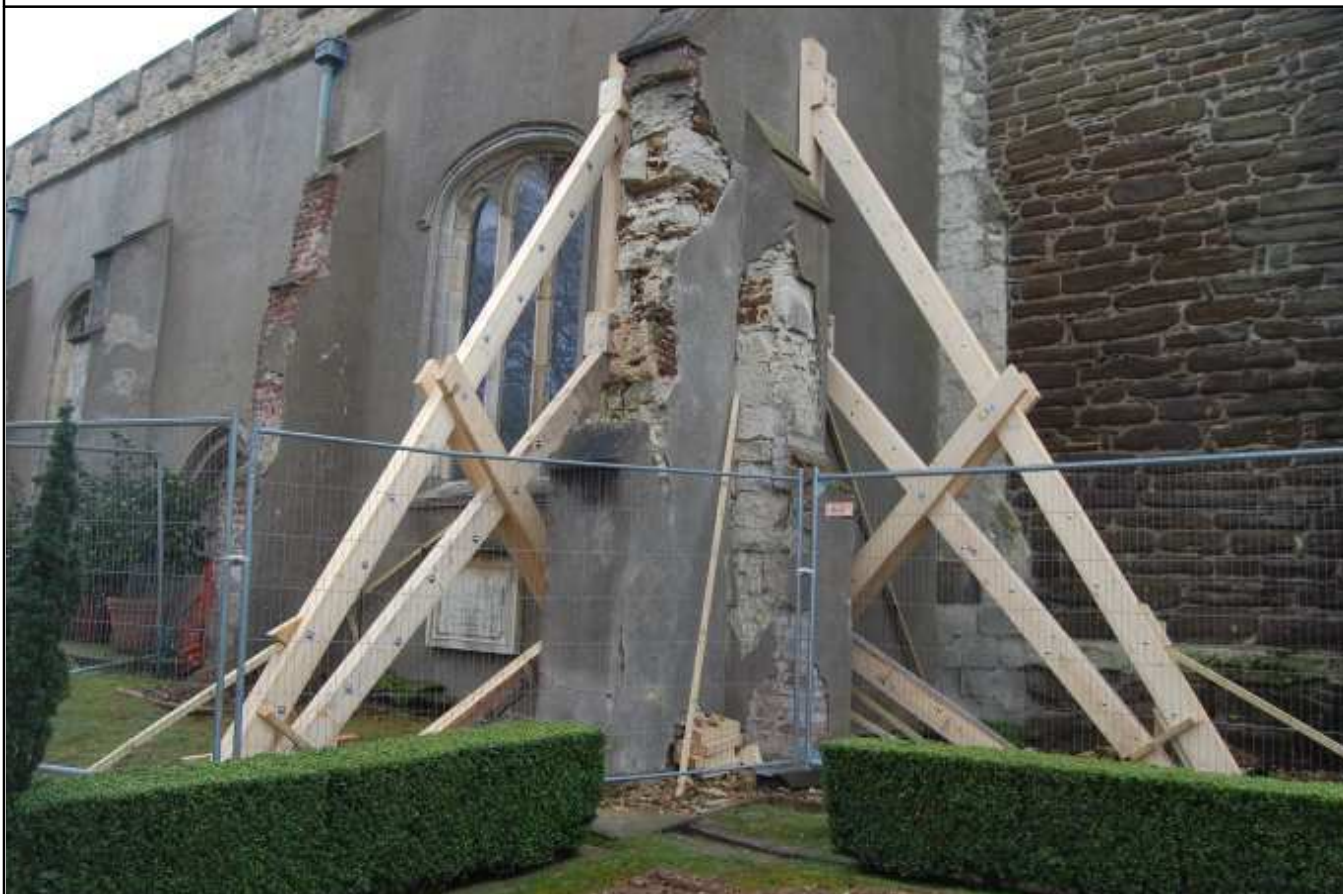
The groundwork involved the excavation of two small footing trenches against the northern and western elevations of the north aisle to accommodate wooden braces. These are designed to support the external wall of the north aisle while the buttress repair is undertaken (Plate 2).

Plate 2: Buttresses with wooden braces in place, looking southeast.

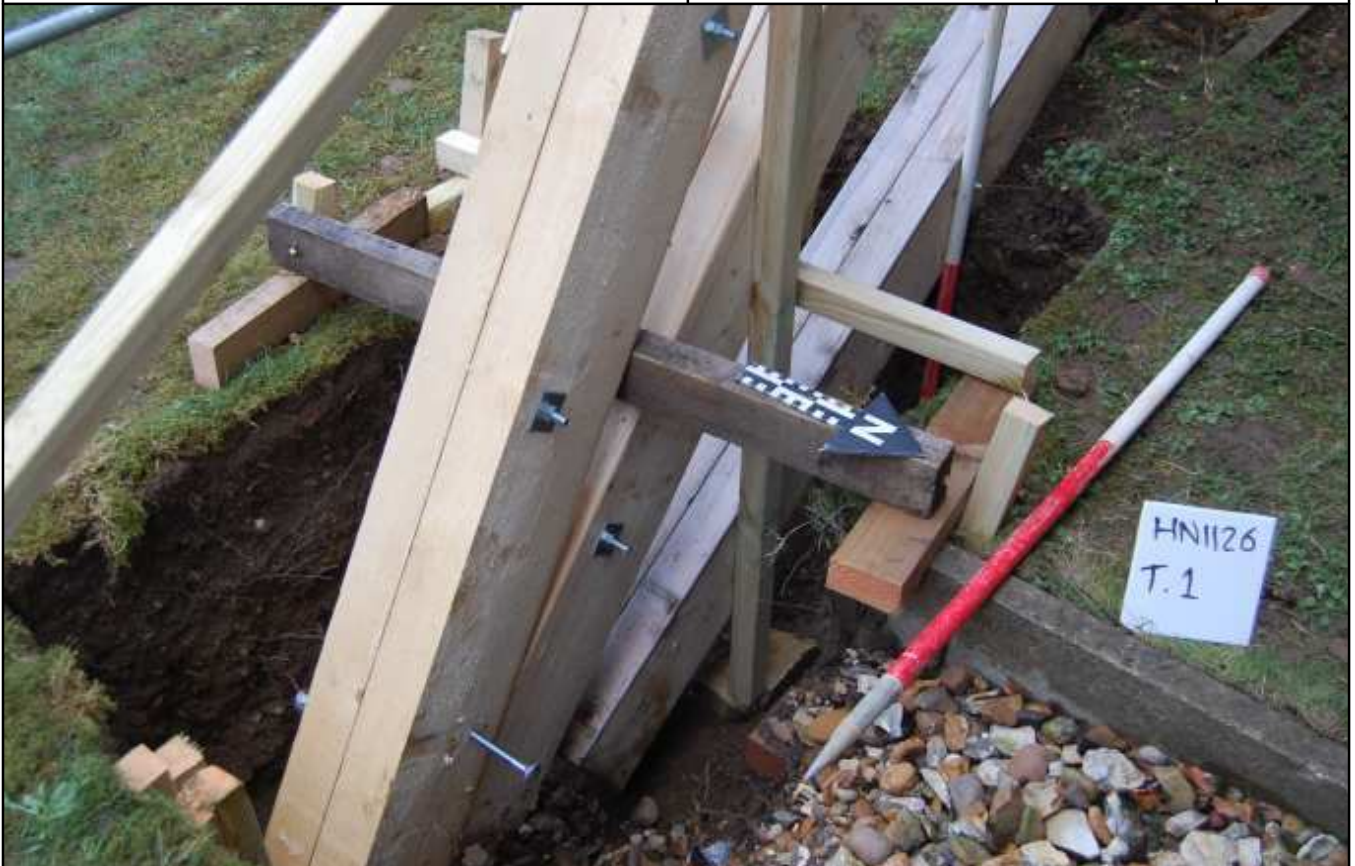
Both trenches had been excavated and the braces fixed in place by the contractor prior to the commissioning of the Heritage Network (Plate 3 and 4). This made detailed observation and recording of the trenches impossible. However, a thorough investigation of the spoil from both trenches demonstrated no disarticulated human bone or other significant archaeological finds. Trench 2 had also been previously disturbed by the insertion of a

Plate 3: Trench 1, showing wooden brace in place, looking northeast

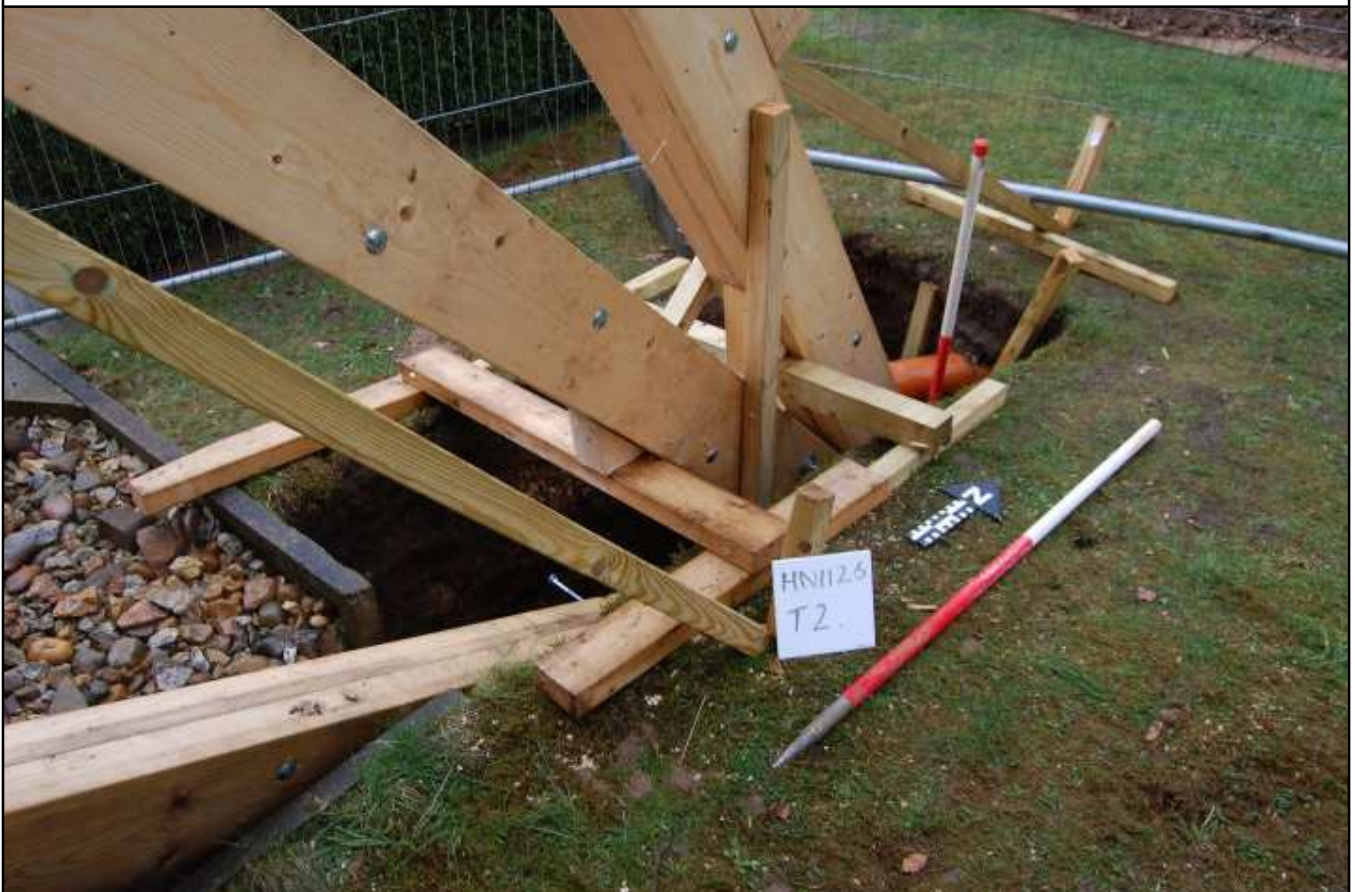
modern service pipe. It can, therefore, be suggested that there is a 75% probability that both trenches were empty and that no significant archaeological finds, features or deposits were damaged during the works.

Plate 4: Trench 2, showing wooden brace in place, looking northwest
