St Helen's Church, Wheathampstead, Hertfordshire

HN1123

Report No. 857

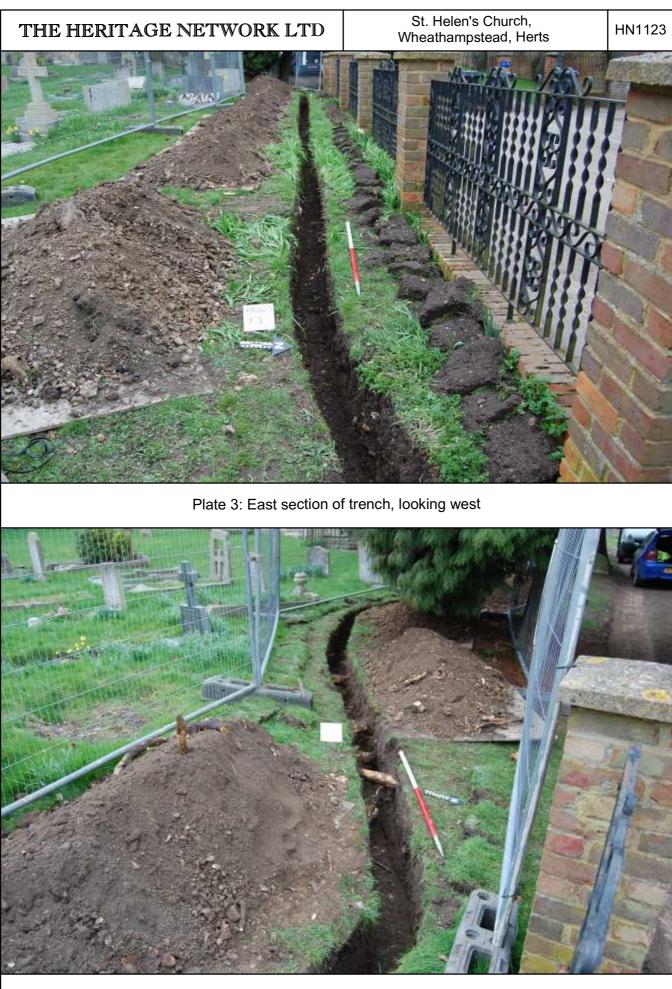
Plate 4: Middle Section of trench, looking southwest

The stratigraphy exposed in the trench sections comprised very dark greyish brown (10YR 3/2) loose sandy silty clay with occasional sub-angular flints and some root activity (Plates 3 - 5). This has been interpreted as a cemetery soil. The natural substratum was not reached during the present works.

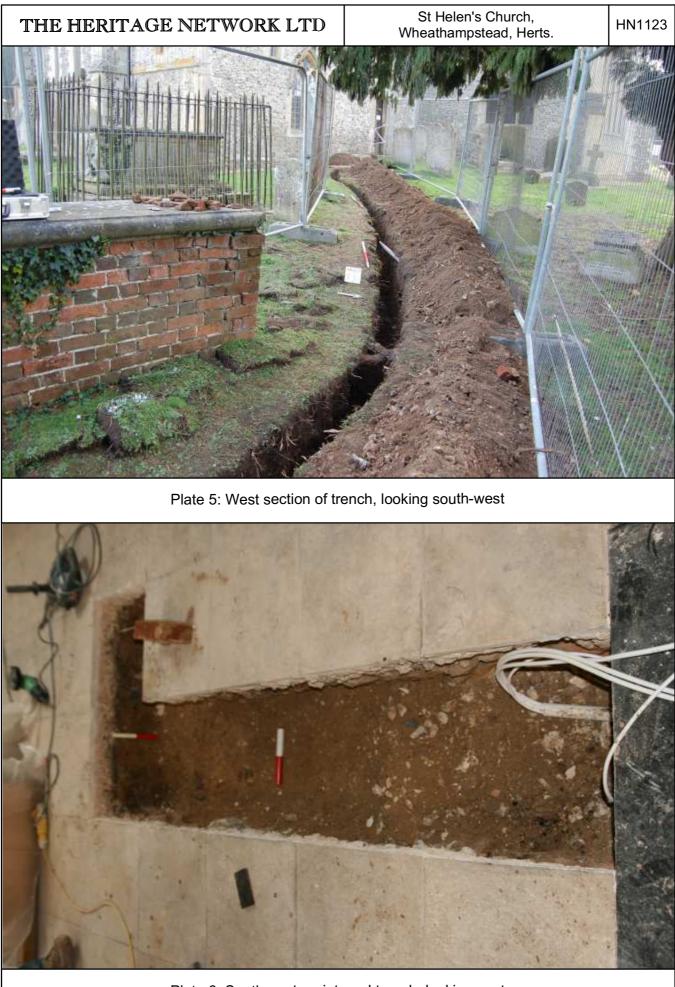
Plate 6: South-eastern internal trench, looking east

The stratigraphy exposed in both trenches was very similar, comprising modern stone slabs, 0.03m thick, above a layer of steel reinforced concrete, 0.11m in depth. Below this was light yellowish brown (10YR 6/4) loose sand, over 0.19m in depth, containing occasional flint cobbles and post-medieval brick fragments (Plates 6-8).

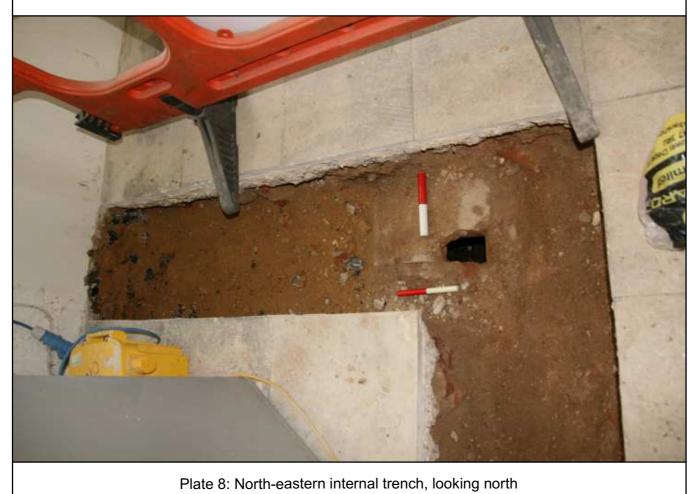
A small opening in the sand layer in the north-eastern trench revealed a brick vault below (see Plate 8). This appeared to extend east beneath the chancel. A photograph supplied by the contractors show that the vault was a narrow rectangular space, built of brick and with an arched roof (Plate 9).

The present groundworks were located at the western end of the chancel and within the north-eastern quadrant of the churchyard. The internal works exposed modern flooring above a sand bedding layer. A brick vault was encountered, but not disturbed, below this layer on the northern side of the chancel. The evidence suggests considerable modern reworking of the floor in this area.
