ST. MARY'S CHURCH **Bayford, Herts.**

Archaeological Monitoring Report

Prepared on behalf of Bayford Parochial Church Council

Report no.369

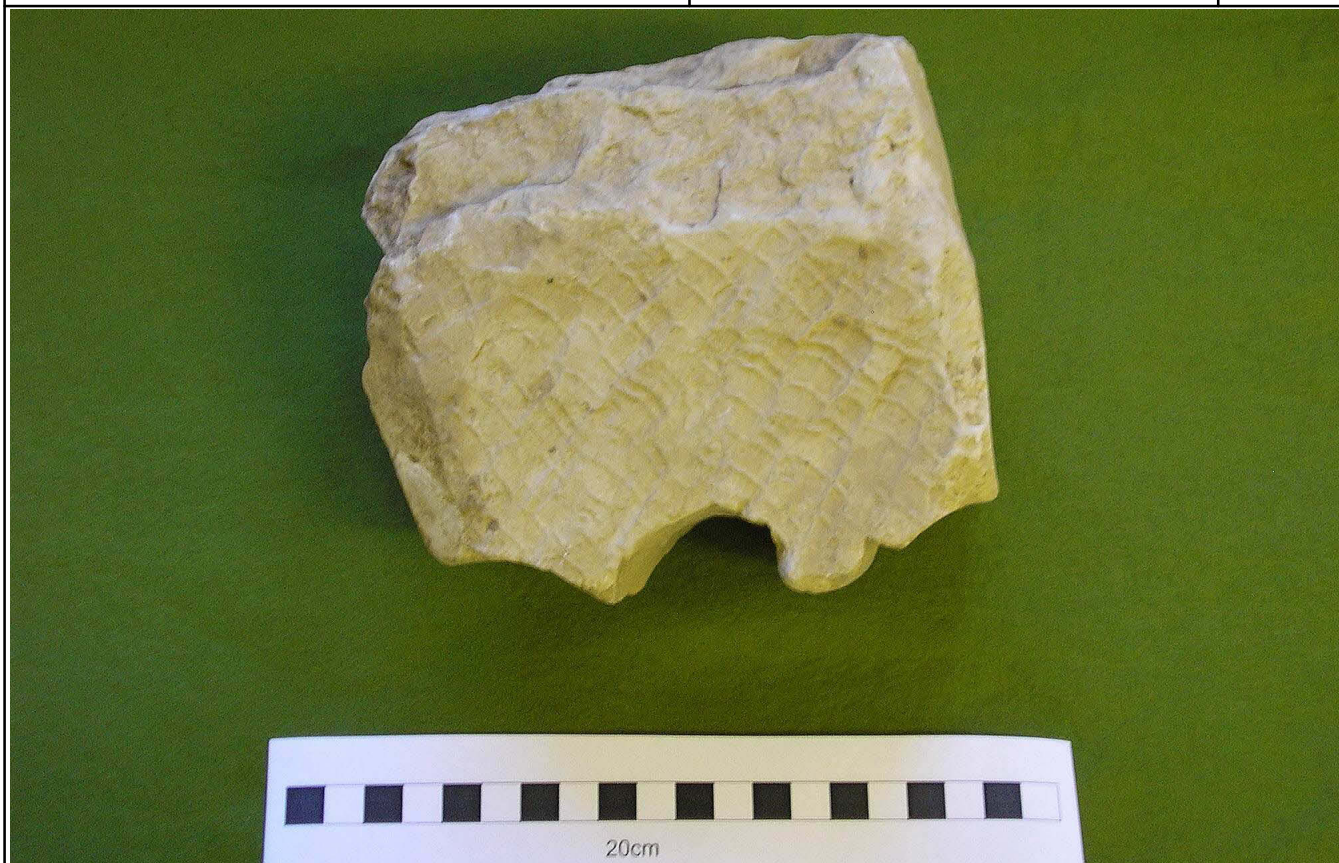
Plate 1a: Profile of worked stone

2.8 The stratigraphy of this trench was consistent along its length with 0.1 - 0.15m of black top soil overlying made ground containing a significant quantity of brick and peg tile. This material is probably derived from the earlier churches on the site, which were demolished in 1803 and 1871. A single piece of worked clunch stone was recovered from this trench weighing 3440g (Plates 1a & 1b). This may have been part of a door jamb from the original, Medieval church.
