THE CHURCH OF ST MARGARET Higham Gobion, Beds.

HN548

Archaeological Monitoring Report

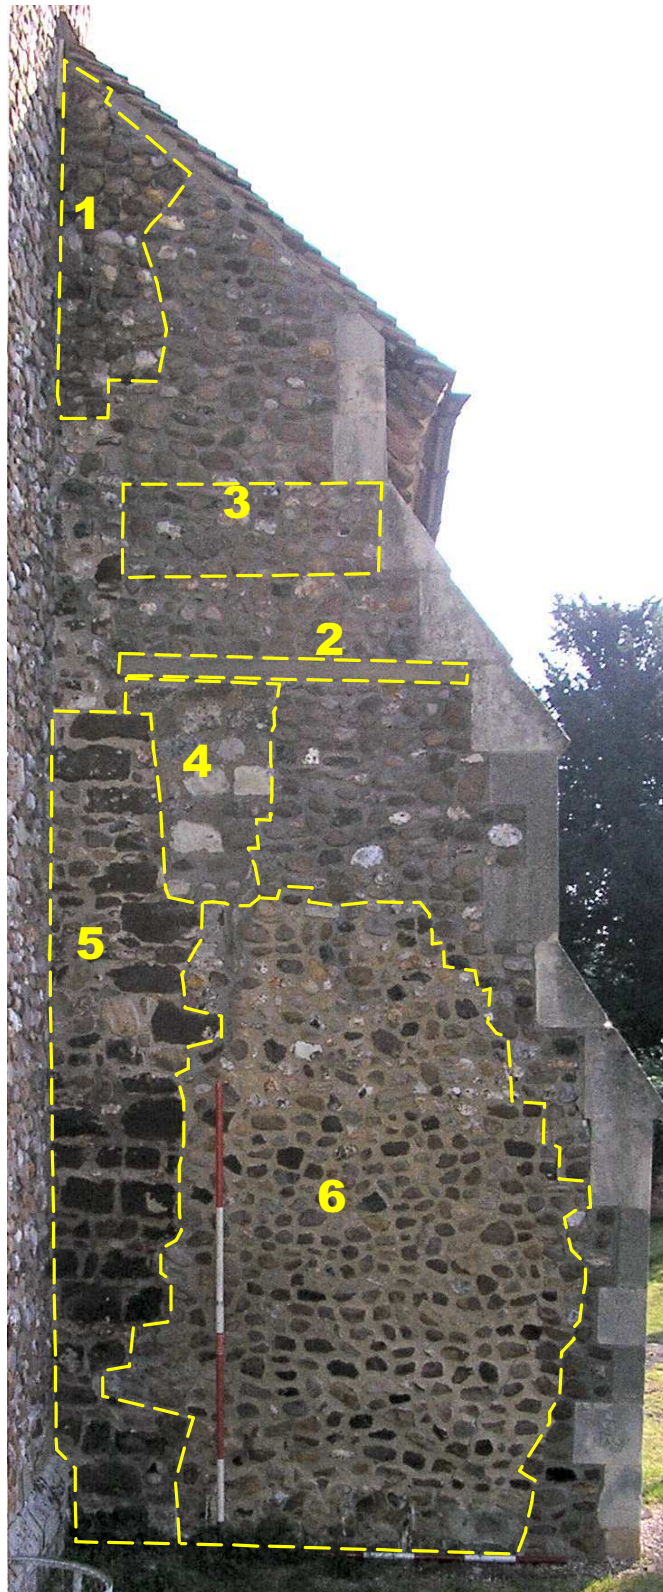
Figure 7

2.8 Prior to the start of building works, the buttress was photographed, and the following features noted (see Figure 7):

- 1 A patch of coursed fieldstones in a differently coloured mortar matrix, where the western elevation of the nave meets the southern elevation of the tower. Possibly the result of the insertion of a modern tie plate to stabilise the tower.
- 2 A York stone lintel in the upper stage of the buttress, possibly inserted to tie the buttress into the nave wall.
- 3 Building lifts in line with each level of the upper stage of the buttress.
- 4 A patch of coursed fieldstone and limestone blocks possibly representing the original facing of the buttress.
- 5 Coursed carstone at the junction between the western elevation of the nave and the southern elevation of the tower possibly representing the original facing of the nave.
- 6 A significant patch of fieldstone set in a modern cement mortar and occupying much of the lower stage of the buttress between the quoins and the facing of the nave.

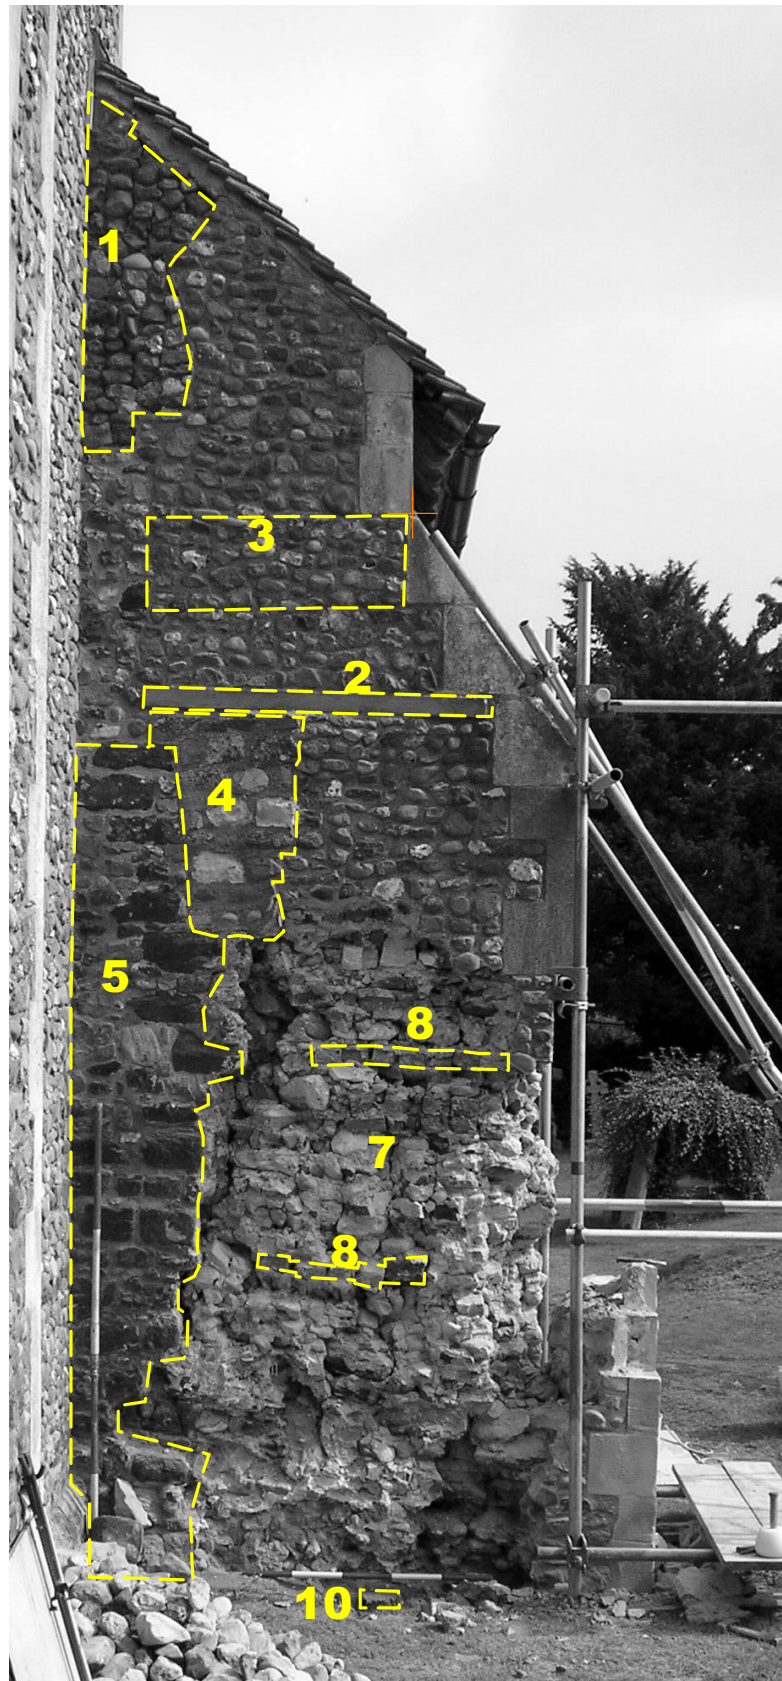
Figure 8

2.9 The buttress was dismantled from the top of the lower weathering, leaving the upper part in situ. The facing on the western elevation was also stripped from the same level. It was noted that the quoins had been bedded in a cement mortar, possibly at the same time as the repair noted at (6) above. The core of the buttress was exposed during the works, revealing the original rubble core. The chronology of the repairs was not generally apparent. A further photographic record was made, and the following features were noted (see Figure 8):

- 7 Original rubble core, formed from a mixture of carstone, chalk cobbles and red brick in a matrix of hydraulic lime mortar.
- 8 Two levelling layers of red brick noted, but whole core in poor condition.
- 9 Evidence for the injection of a lime grout at some stage in a failed attempt to consolidate the rubble core.
- 10 One block of carstone was noted at the base of the W elevation, roughly in line with the nave wall.
- 11 Slab of concrete inserted on the outside of the buttress, possibly as part of a drainage scheme.

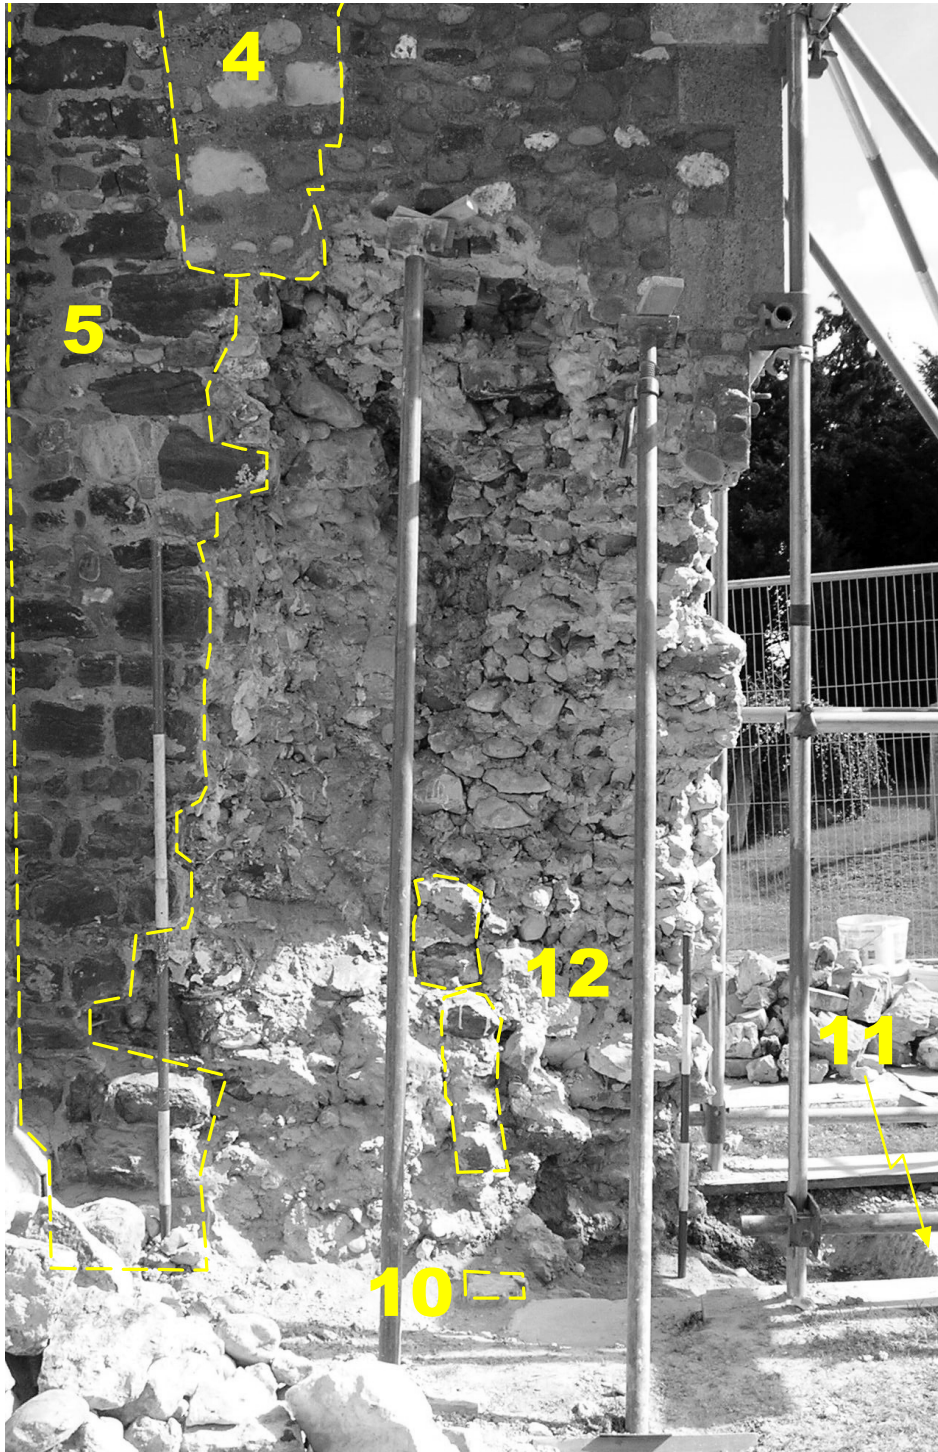
Figure 9

2.10 A further visit was made to monitor the ongoing works. Additional material from the core had been removed. A further photographic record was made, and the following features were noted (see Figure 9):

- 12 A line of carstone representing the corner of the nave was revealed following the removal of the block of cemented masonry at the base of the buttress. This lines up with the block of carstone noted at 10.
- 13 Loose packed chalk rubble beneath the buttress, representing the foundation.
- 14 Evidence for bird, or rodent nests was noted within the core, indicating that the crack had been open for some time.
- 15 A number of worked stones were removed from the rubble core. These include a section of arch and three pieces from possible window reveal. A carstone fragment showed evidence of rendering.
- 16 Facing stonework to the nave appears to have been removed to provide a key for the construction of the buttress. The core of the nave wall is solid and bedded in lime mortar.

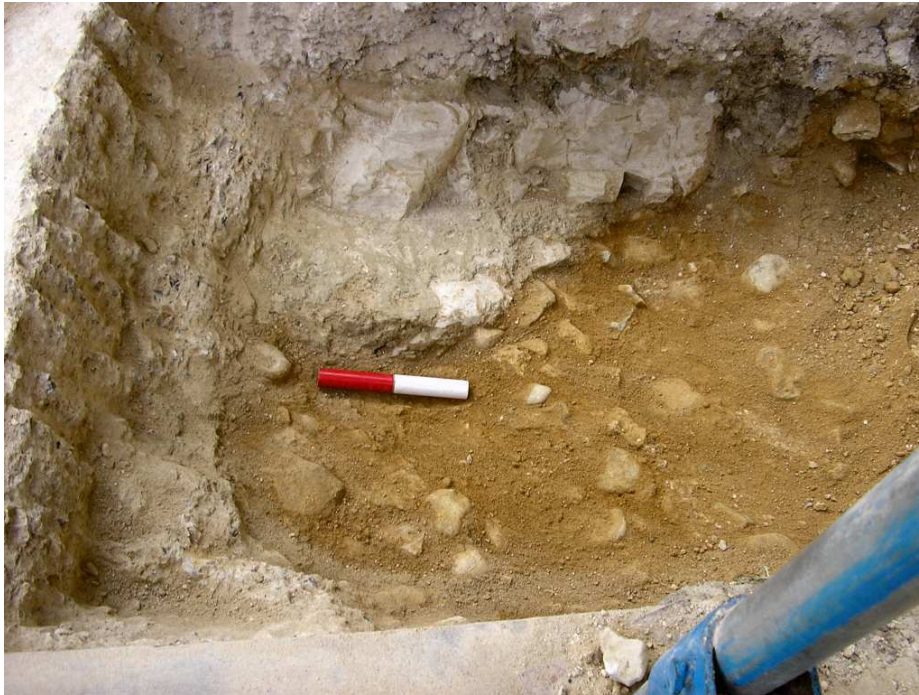
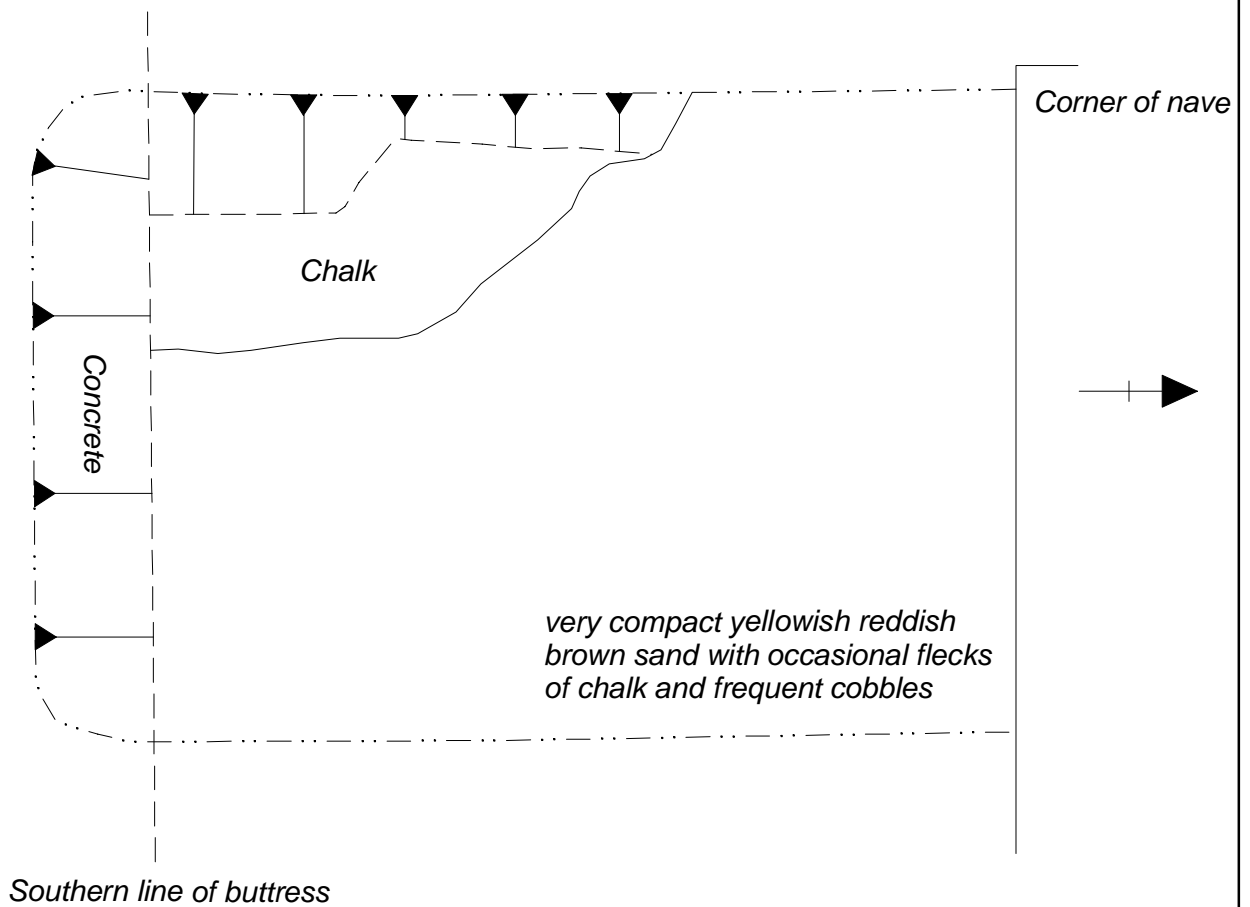
Figure 10

2.11 A final visit was made to record ongoing works before the buttress was rebuilt. A trench, measuring 1.5m in length and 0.85m in width, had been excavated to accommodate the foundation for the new buttress (Figure 10). It revealed a compact layer of cobbles in a yellowish red sandy matrix, with occasional chalk flecks. A large block of chalk was observed in south-western corner of the trench, bedded in the sand and cobble layer. This may represent a natural outcrop, but gives the impression of having been deliberately placed, possibly as part of the foundation for another structure.

3.3 Observation of the foundation trench for the new buttress revealed a layer of sand and cobble below the loose chalk rubble. A chalk block was sited in the south-western corner of the trench, bedded into the cobbles. This may represent part of the foundations for an earlier structure, possibly the earlier tower.
