All Saints' Church, Caddington, Bedfordshire.

Report No.1037

As part of the faculty requirements for the building of a screened kitchenette and toilet, with a meeting room above, located in the north-west corner of the north aisle of All Saints' Church, Caddington, Bedfordshire, the Heritage Network was commissioned to undertake a watching brief on the groundworks.

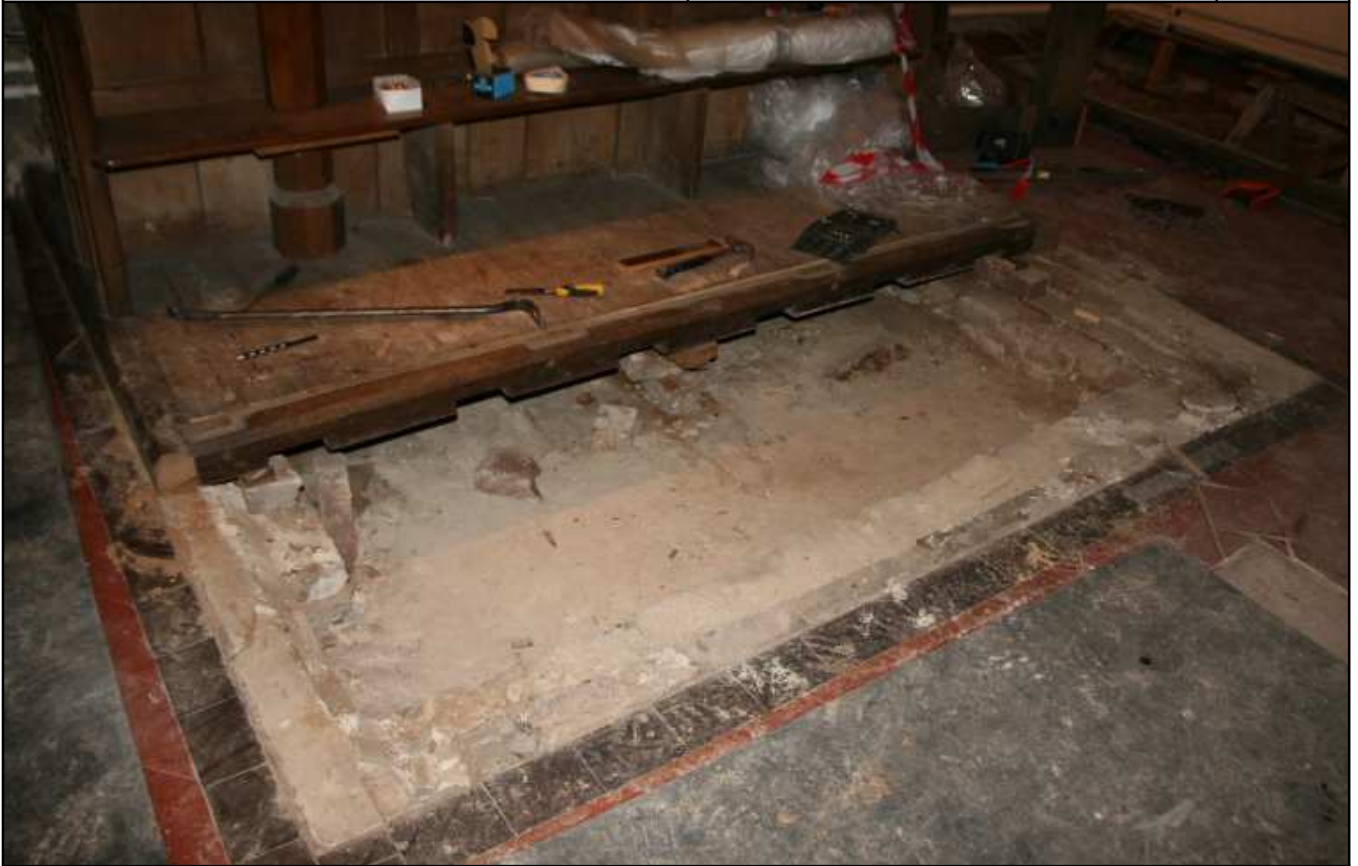
Plate 1: Removal of the pews, looking north-west

The groundworks programme included internal and external works (Figure 2). The internal works involved the excavation of three pad foundations (Test-pits 1-3), following the removal of pews within the footprint of the new construction (Plate1); the external works involved the excavation of a drainage trench to connect the new construction in the north-west corner of the church to existing services on Collings Wells Close to the north-west of the church.

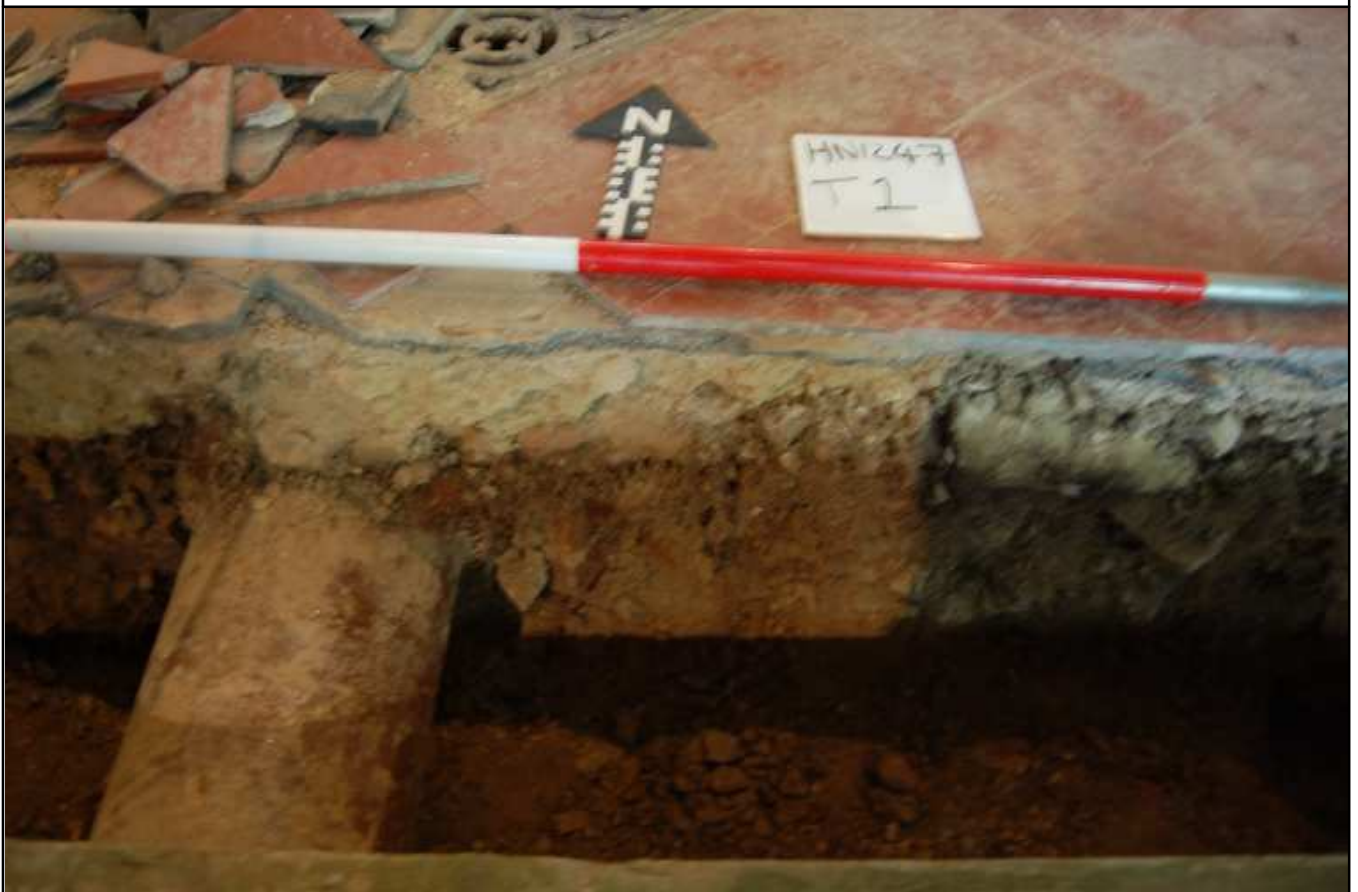
Plate 2: Test pit 1, looking north

Test-pit 1 (Plate 2) was located in the north-west corner of the north aisle, between two pillars, and measured 2.8m in length, 0.4m in width and approximately 0.5m in depth. Test pit 2 (Plate 3) was located approximately 1m to the north-east of Test-pit 1 and measured 0.6m in length, 0.5m in width and approximately 0.60m in depth. Test-pit 3 (Plate 4) was located approximately 0.5m to the north-east of Test-pit 2 and measured 0.6m by 0.6m approximately 0.60m in depth. All three test-pits revealed the same stratigraphy, comprising a mixed rubble and stone make up layer for the existing floor surface, over 0.6m deep. Test pit 1 had a rubble and mortar layer, 0.2m thick overlying this.

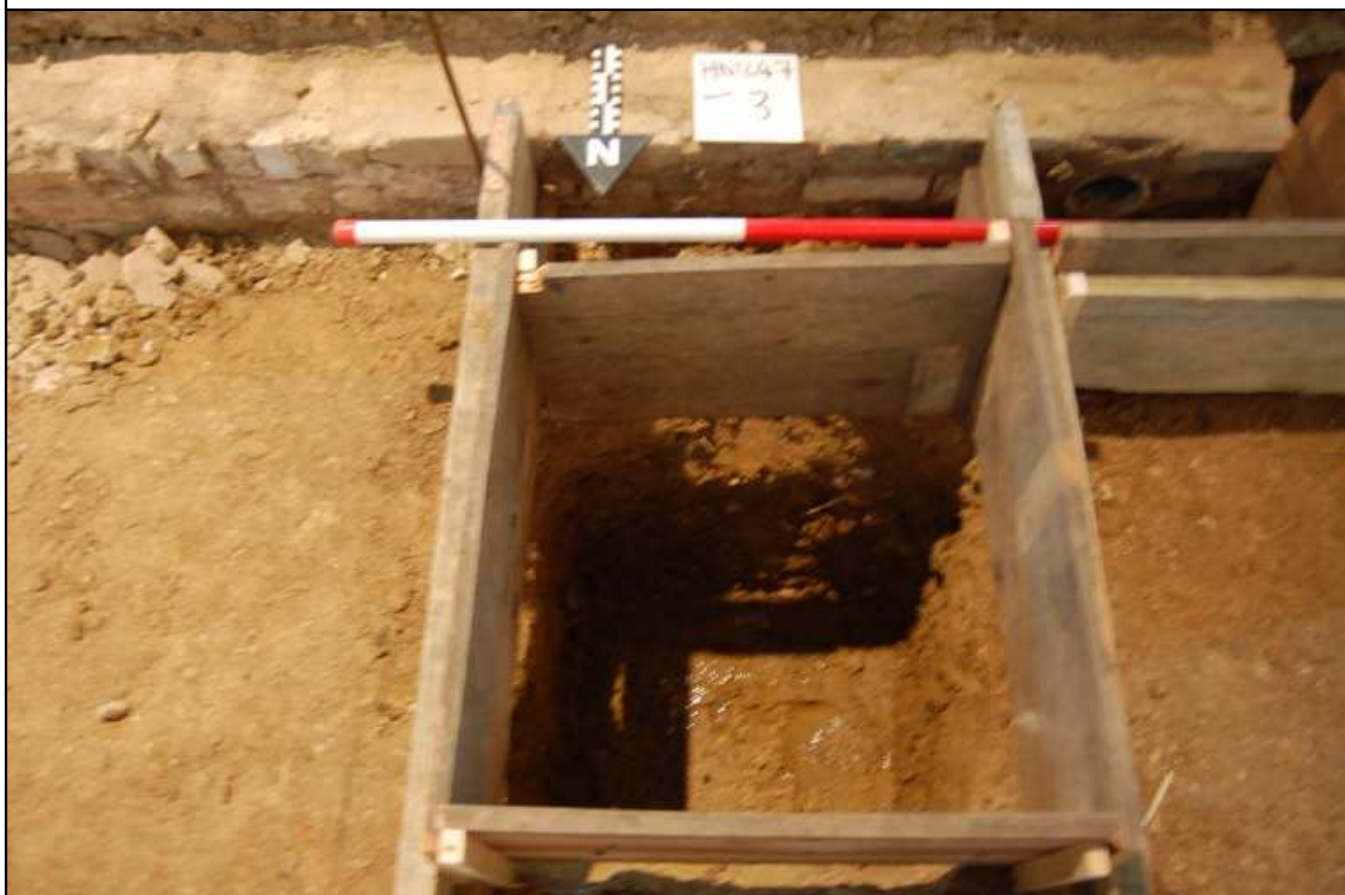
Plate 4: Test pit 3, looking south

Several fragments of disarticulated human bone were recovered during the excavation of Test-pit 3. The remains were handed to the vicar for reburial. The risk of encountering disarticulated human bone was expected and no articulated remains were exposed.

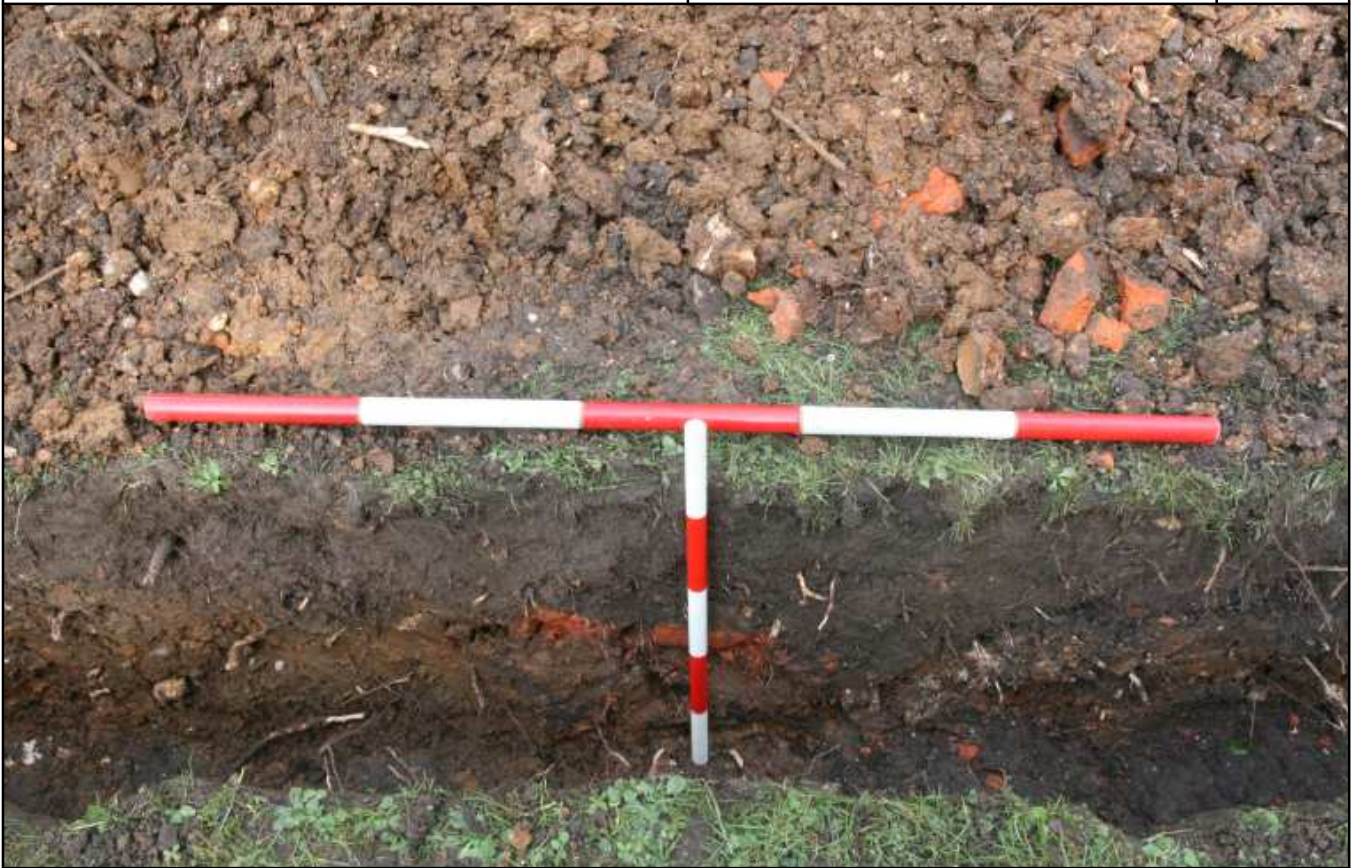
Plate 5: Section of drainage trench, looking north-west

The drainage trench was approximately 28m in length with a width of 0.5m and a depth of 0.4m. The stratigraphy in the trench was uniform, consisting of a black (10YR 2/1), soft silty clay topsoil overlying a yellowish brown (10YR 5/8) soft, sandy clay subsoil. At the north-west corner of the site the drainage trench cut through a bank defining the edge of the churchyard, which consisted of a disturbed topsoil and a redeposited natural containing modern material.
