CHURCH OF ST MARY MAGDALENE Whippsnade, Beds

***ARCHAEOLOGICAL
MONITORING REPORT***

CHURCH OF ST MARY MAGDALENE Whipsnade, Bedfordshire

Archaeological Monitoring Report

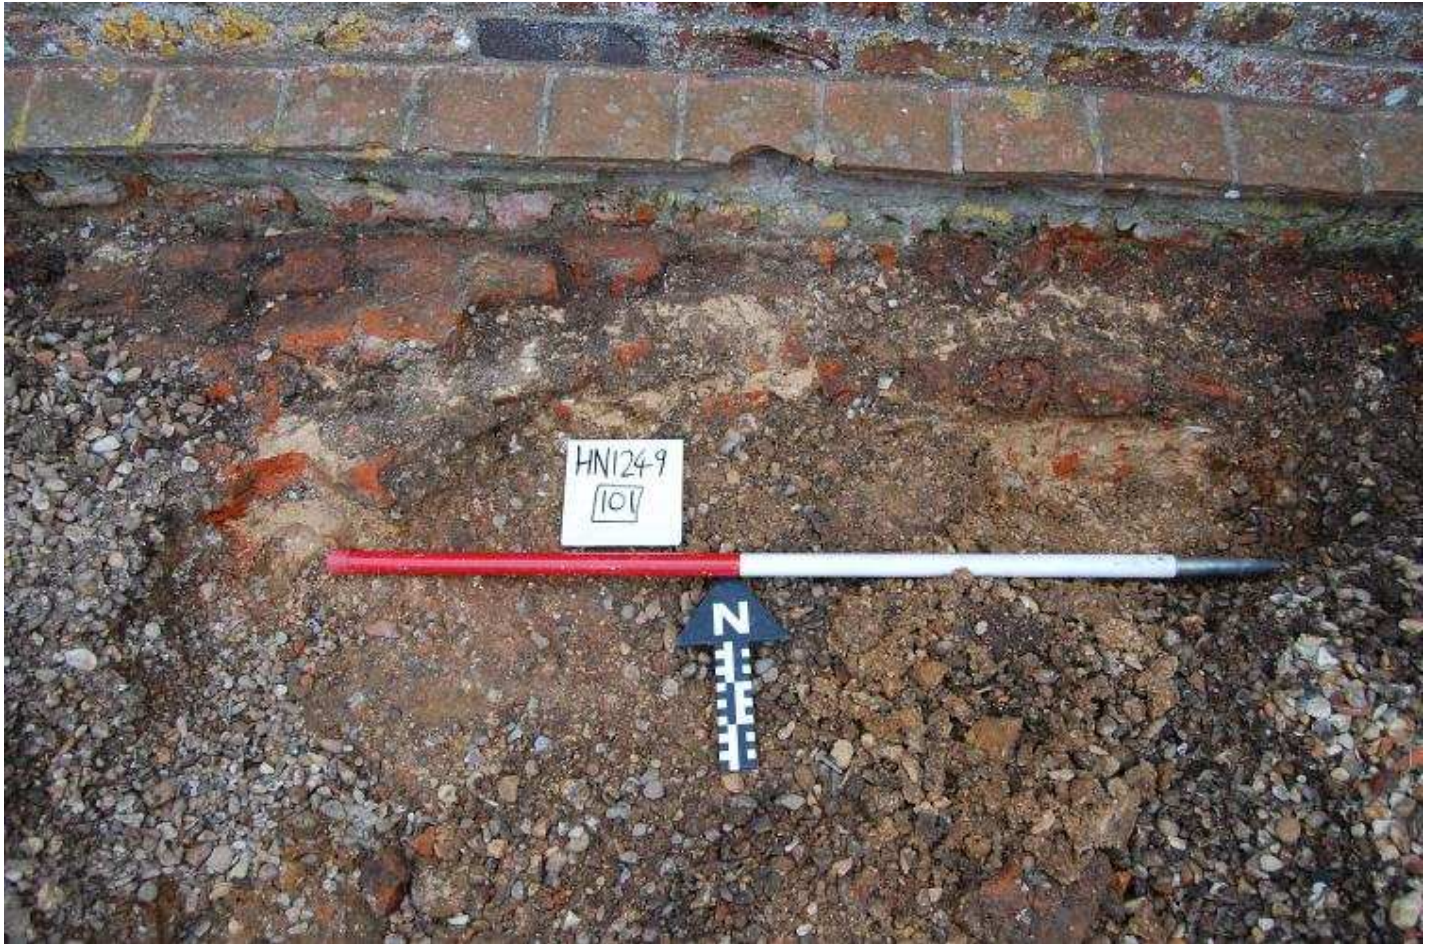
2.13 Test Pit 1, which was located on the south side of the tower, measured 1.40m x 1.20m and was excavated to a depth of 0.46m. Removal of the gravel revealed the brick foundations [101] to the 16th century tower (Plate 1). The footings, which continued below the limit of excavation, consisted of a line of tile ‘kneelers’ above at least 5 courses of red handmade bricks, which were laid in no discernible pattern. On the western side of the pit the lower courses were stepped out to approximately 0.40m from the line of the tower wall at a depth of approximately 0.40m below the surface of the gravel. On the eastern side this step extended to 0.20m from the tower wall, suggesting that the earlier drainage works had removed some of the foundation brickwork. The upper course had been repointed in cement mortar, while the lower courses were bonded with lime mortar.

3.12 The foundations to the 16th century church tower were exposed in Test Pit 1, and these were constructed of red handmade bricks bonded with dry mortar.

Plate 001 - Test Pit 1 revealing the tower foundations [101], looking N

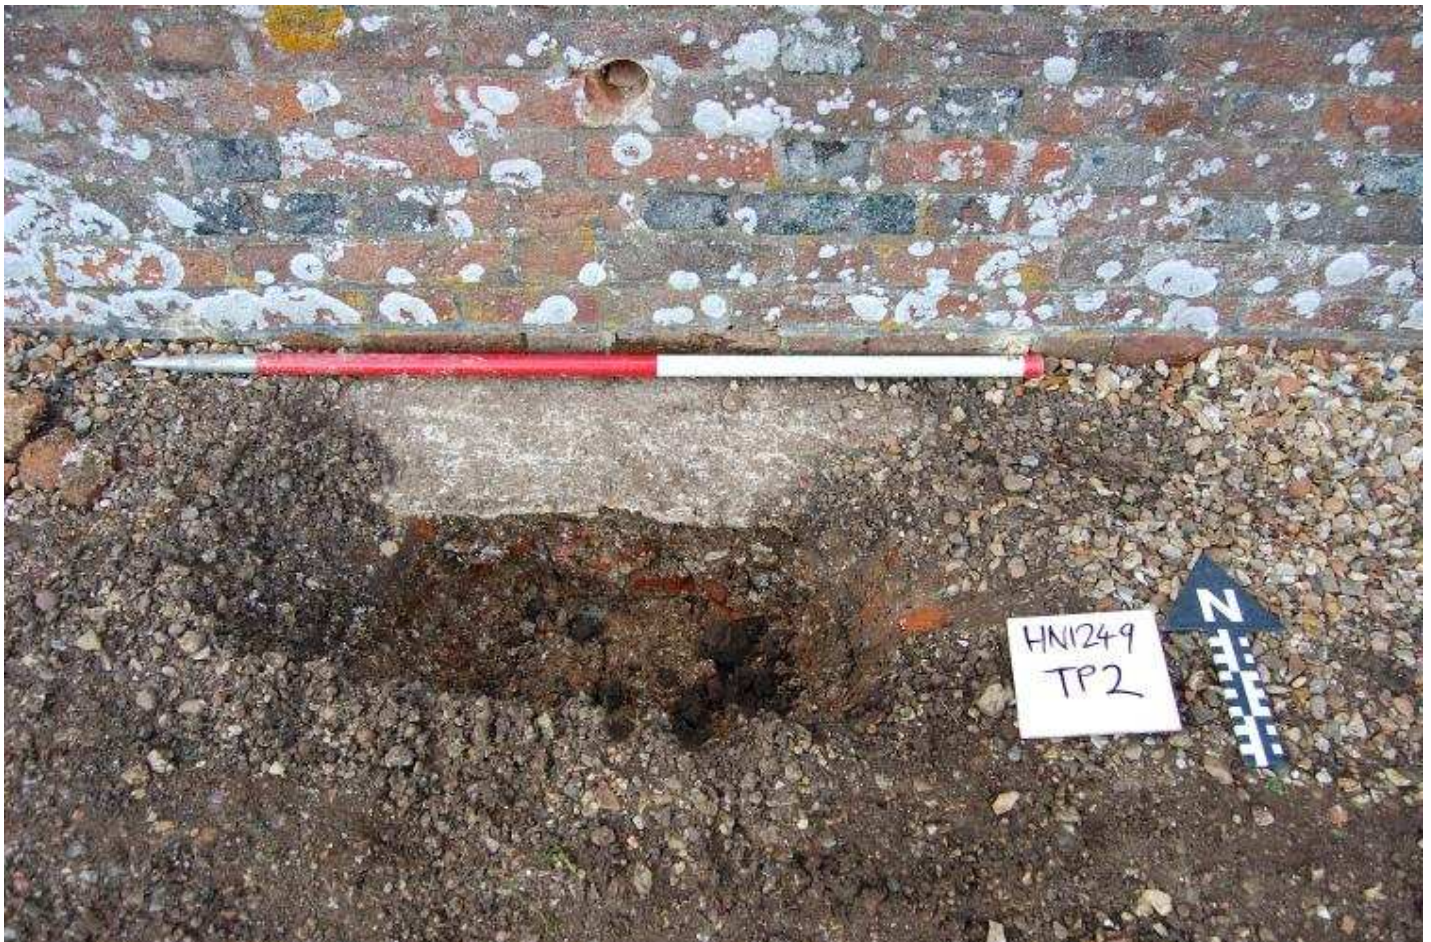
2.14 Test Pit 2, which was located on the south side of the nave, measured 0.75m x 0.55m and was excavated to a depth of approximately 0.50m. Removal of the gravel revealed that the nave wall had been supported by an apparently inserted modern concrete ‘lintel’, approximately 0.30m in height (Plate 2). Brick foundations were visible below the lintel and appeared to continue below the base of the test pit.

Plate 002 - Test Pit 2 revealing modern concrete plinth, looking N
(c) The Heritage Network Ltd.

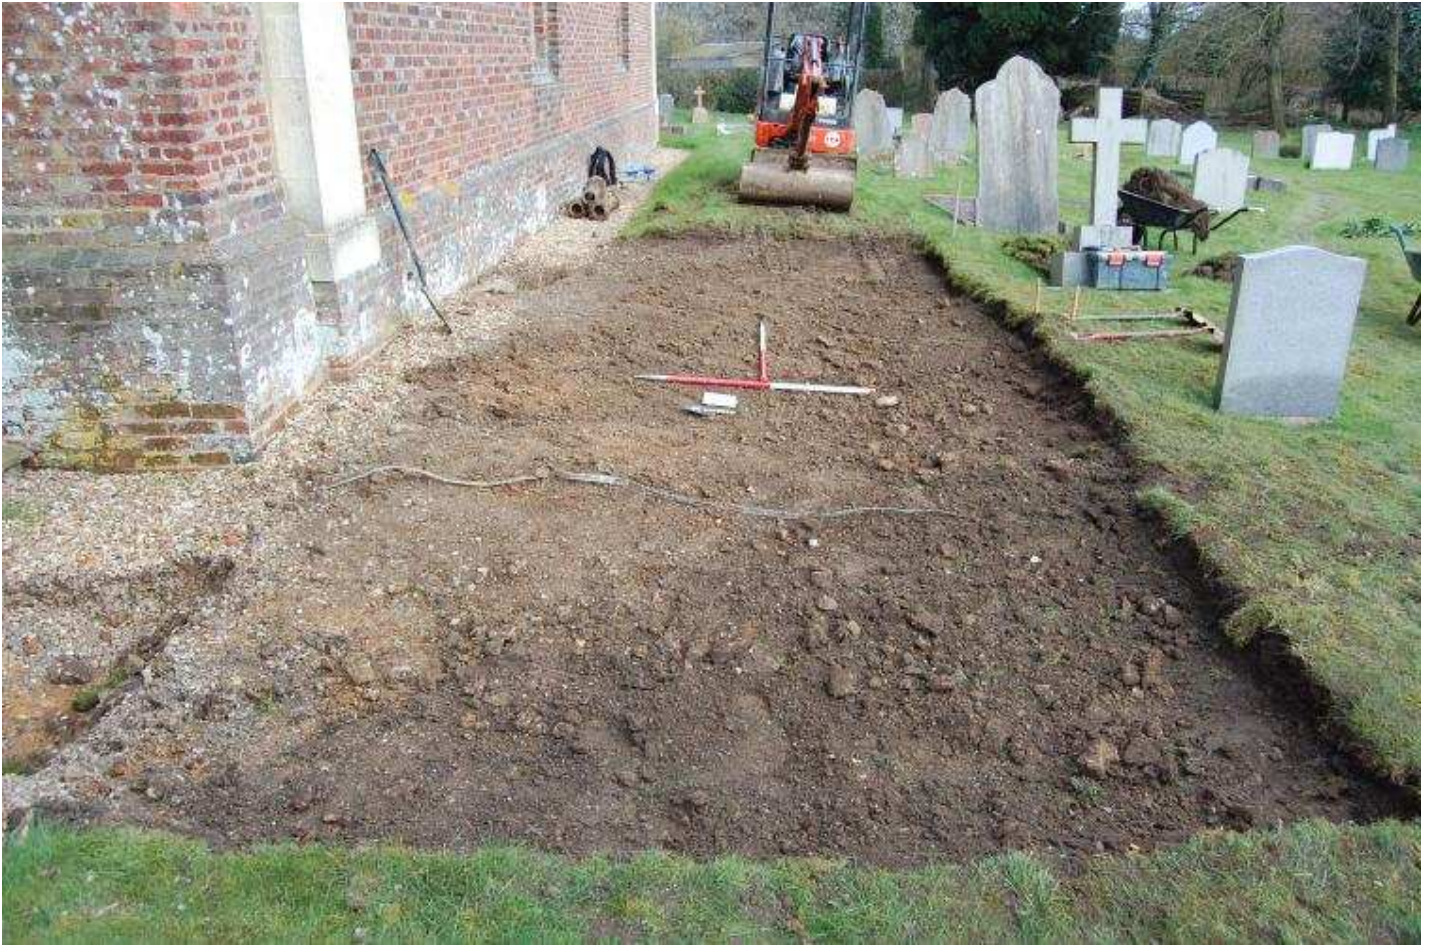
2.16 A soil bank was located approximately 1.40m to the south of the church and measured approximately 2.12m in width, with a maximum height of approximately 0.40m above the surface of the gravel drain. An area measuring 5.90m in length and 2.50m in width was reduced by machine, under direct archaeological supervision, to the level of the gravel, in order to ascertain the make-up of the bank (Figure 3, Plate 3). The stripping revealed a layer of loose dark grey sandy silty clay topsoil, approximately 0.30m in depth, above a pale brown silty sandy clay subsoil, in excess of 0.10m in depth. The western end of the reduced area revealed disturbed ground where a soakaway, fed by the adjacent drain, had been inserted.

Plate 003 - Extension footprint excavated down to subsoil, looking E

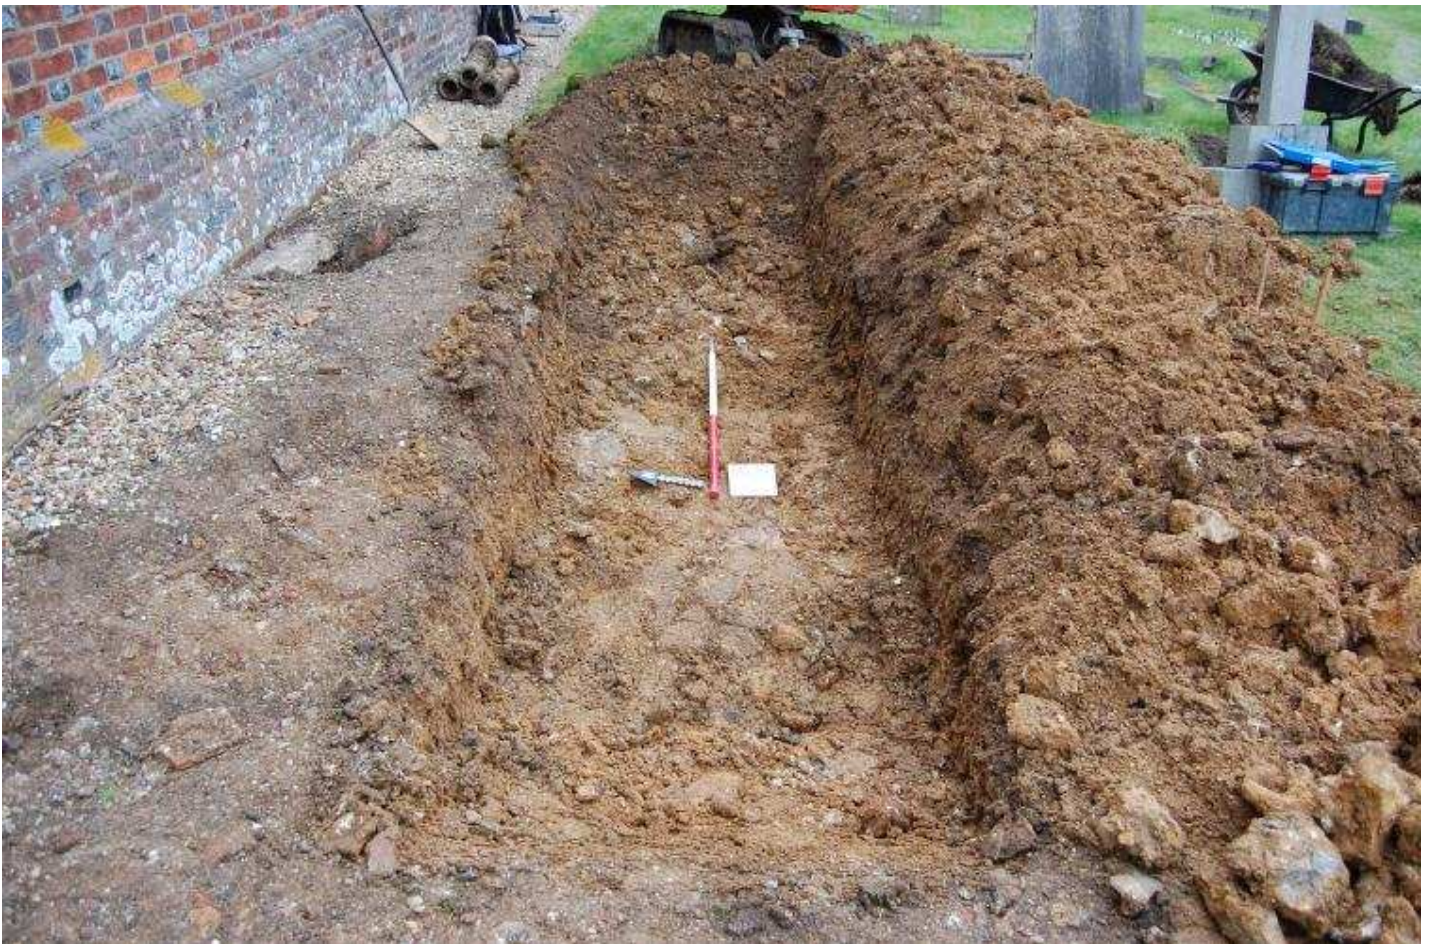
2.17 A 1m wide sondage was subsequently excavated across the footprint of the extension level with the bottom of the drain, which exposed the natural brownish yellow sandy clay containing large quantities of flint (Plate 4). This was reached at a depth of between 0.40m and 0.50m below the top of the bank.

Plate 004 - The excavated sondage, looking E
(c) The Heritage Network Ltd.

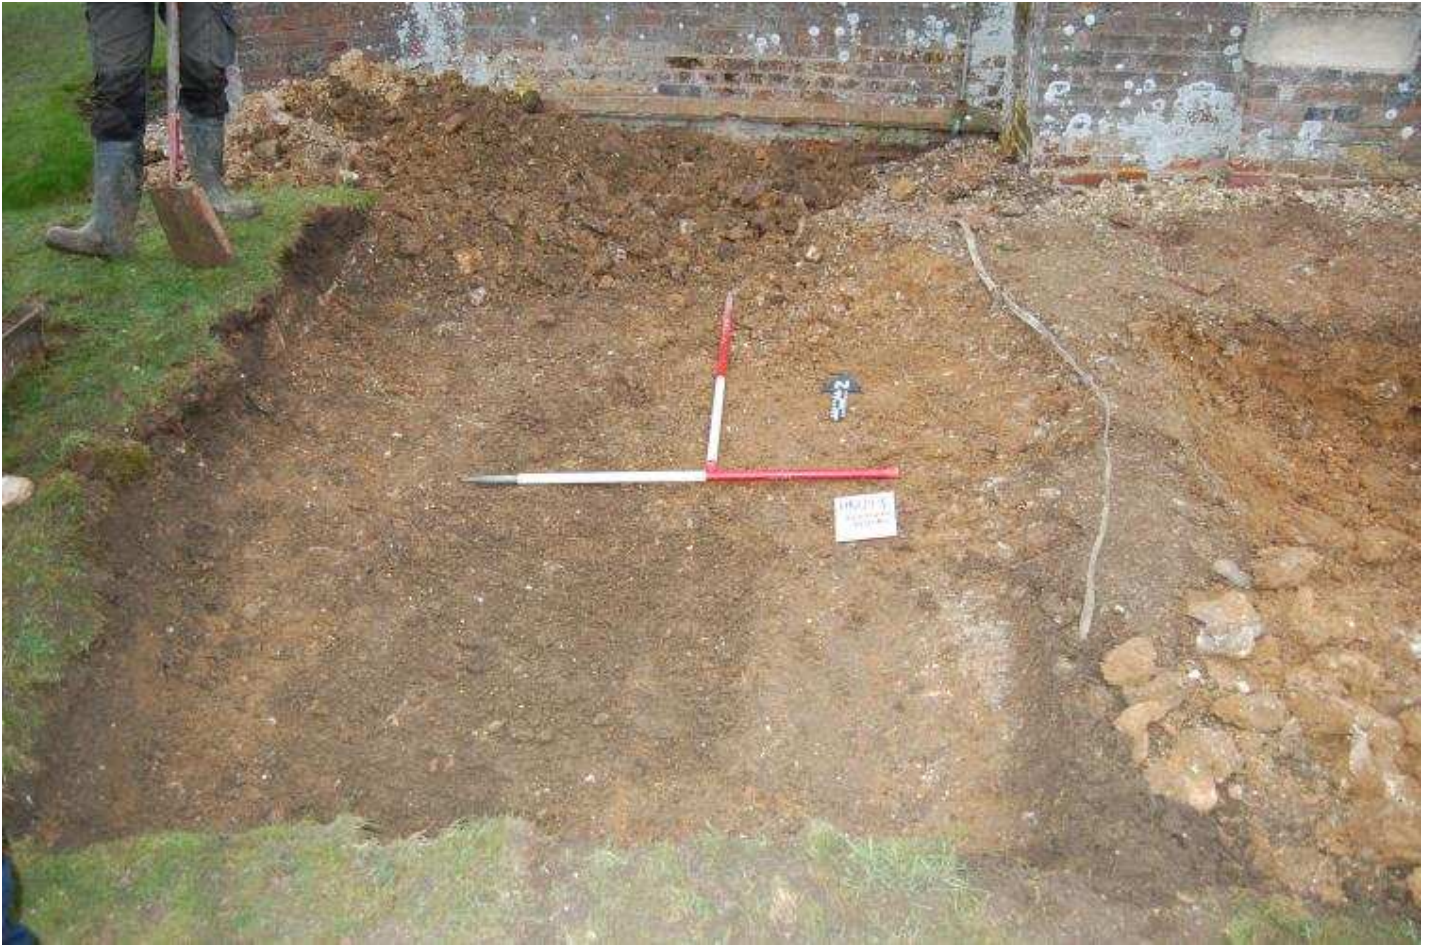
2.18 In consultation with the Planning Archaeologist, the decision was taken to strip the remaining subsoil from the western part of the extension footprint to expose the natural clay (Plate 5). This work, which was done with the Planning Archaeologist present, confirmed both the absence of a cemetery soil and of human burials across the extension footprint.

Plate 005 - Reduction of western part of extension footprint, looking N

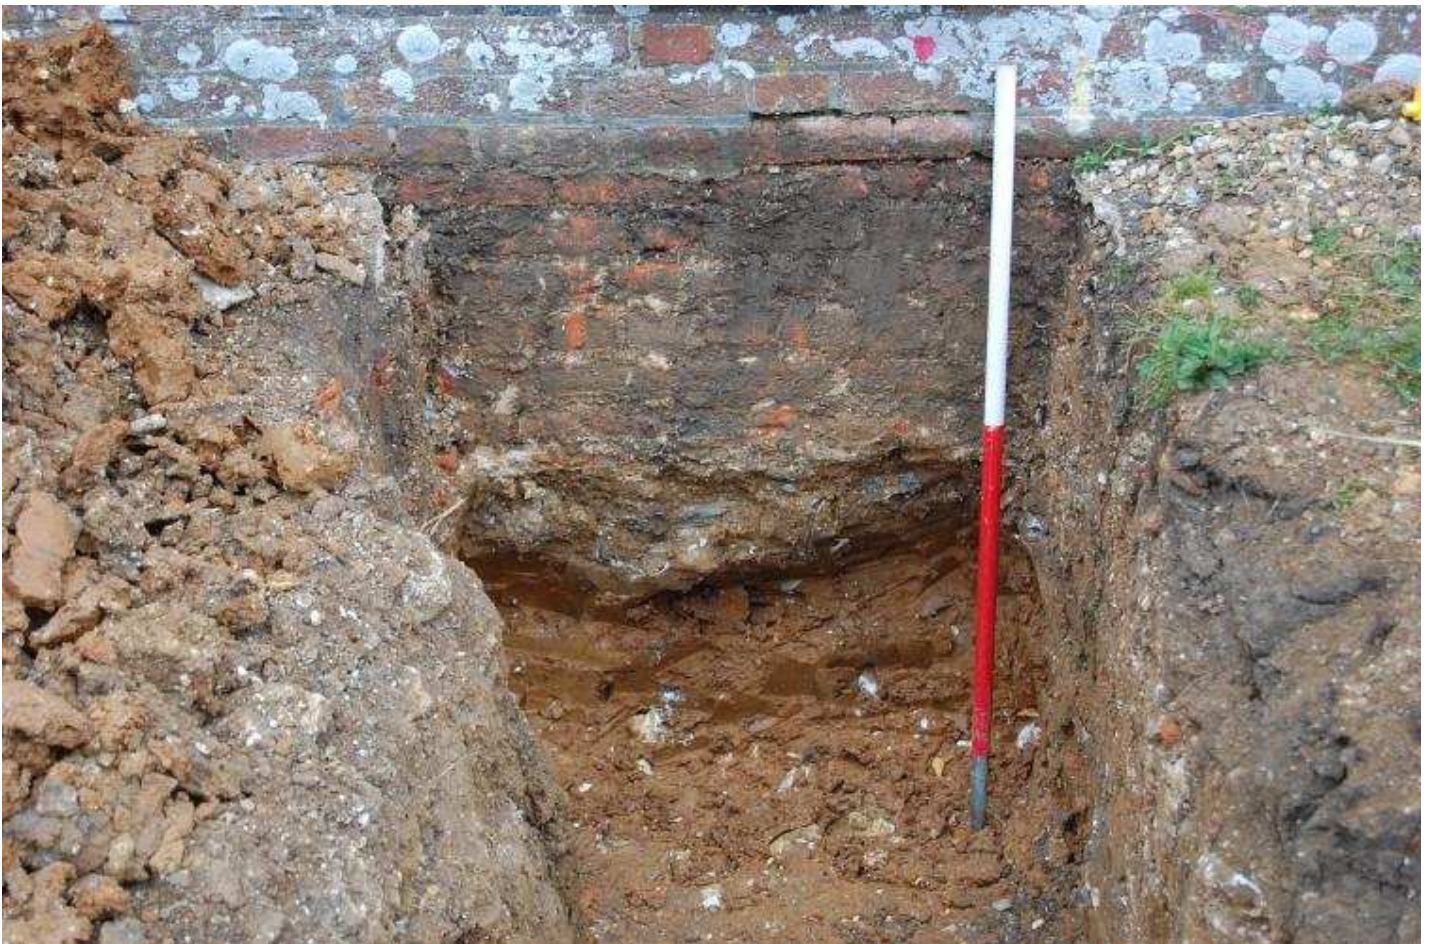
evidence for the foundations to the medieval church. A layer of flint and chalk rubble, context [102], was observed at a depth of 0.5m below the present ground level. It was sitting directly on the natural clay and below the later brickwork (Plate 6). The wall, which measured 0.20m in depth, was bonded with lime mortar. No evidence for a foundation trench was observed.

3.9 Further evidence for the earlier wall was observed in a footings trench for the new extension. This revealed flint and chalk rubble below the brick facing to the external elevation.

The early wall sat directly above the natural clay and was encountered at a depth of 0.5m below the present ground level. No evidence for a foundation cut was observed in the footings trench.

Plate 006 - Footings trench, showing earlier foundation [102], looking N
(c) The Heritage Network Ltd.

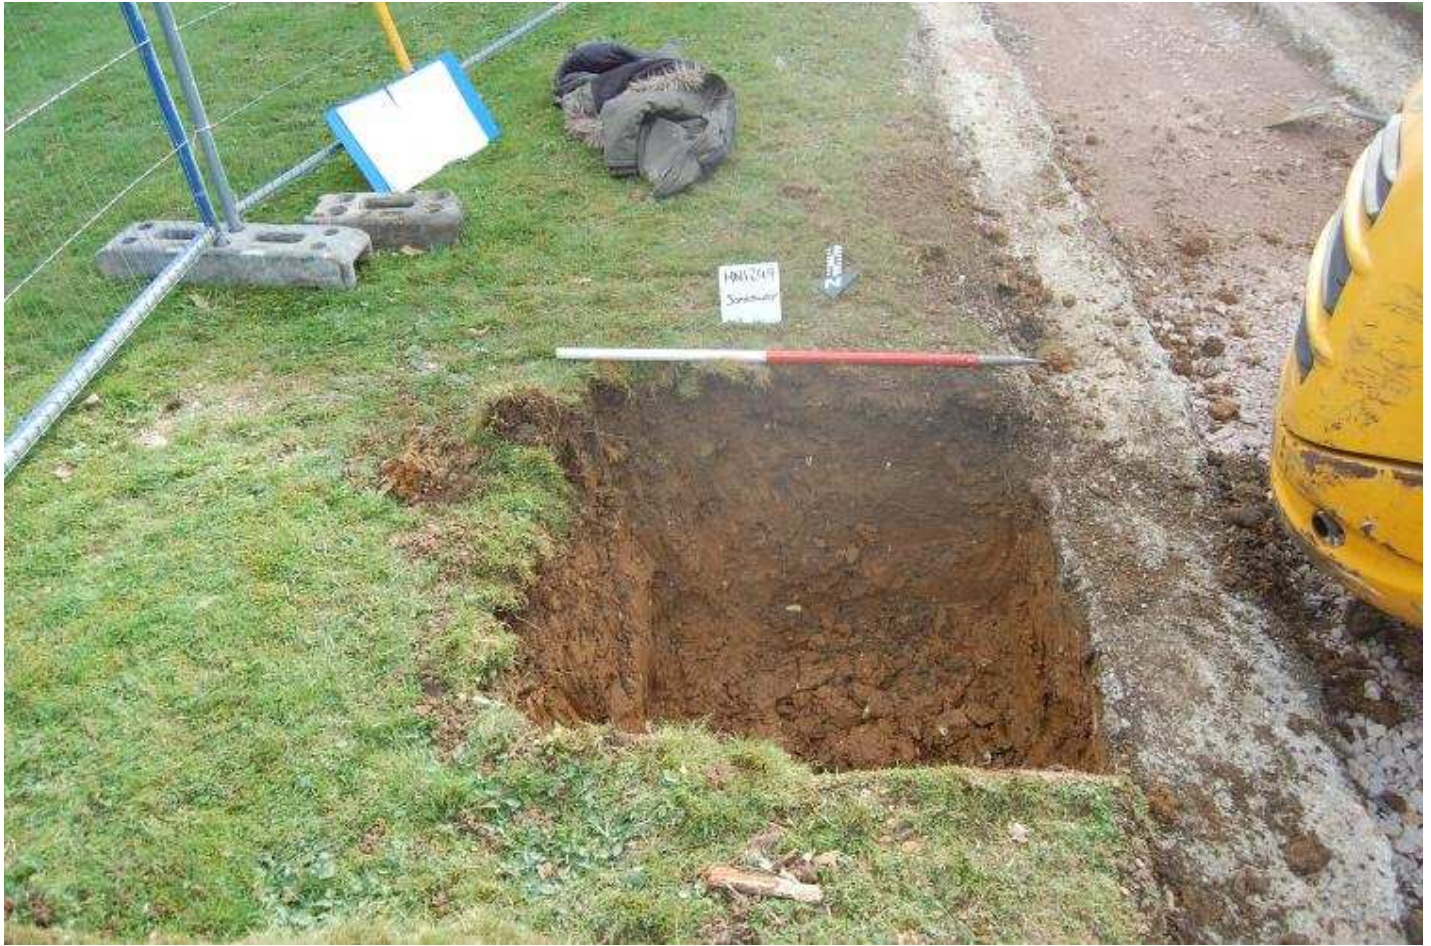
2.23 Two soakaways were excavated during the present project (Figure 2). Soakaway 1 was located to the north of the church, on the eastern side of the footpath. It measured 1m by 1m and was excavated to a depth of 1.2m. The stratigraphy exposed in the sections comprised dark grey sandy silty clay topsoil, 0.2m in depth, above pale brown silty sandy clay cemetery soil, over 1m in depth (Plate 7).

Plate 007 - Soakaway 1, looking S

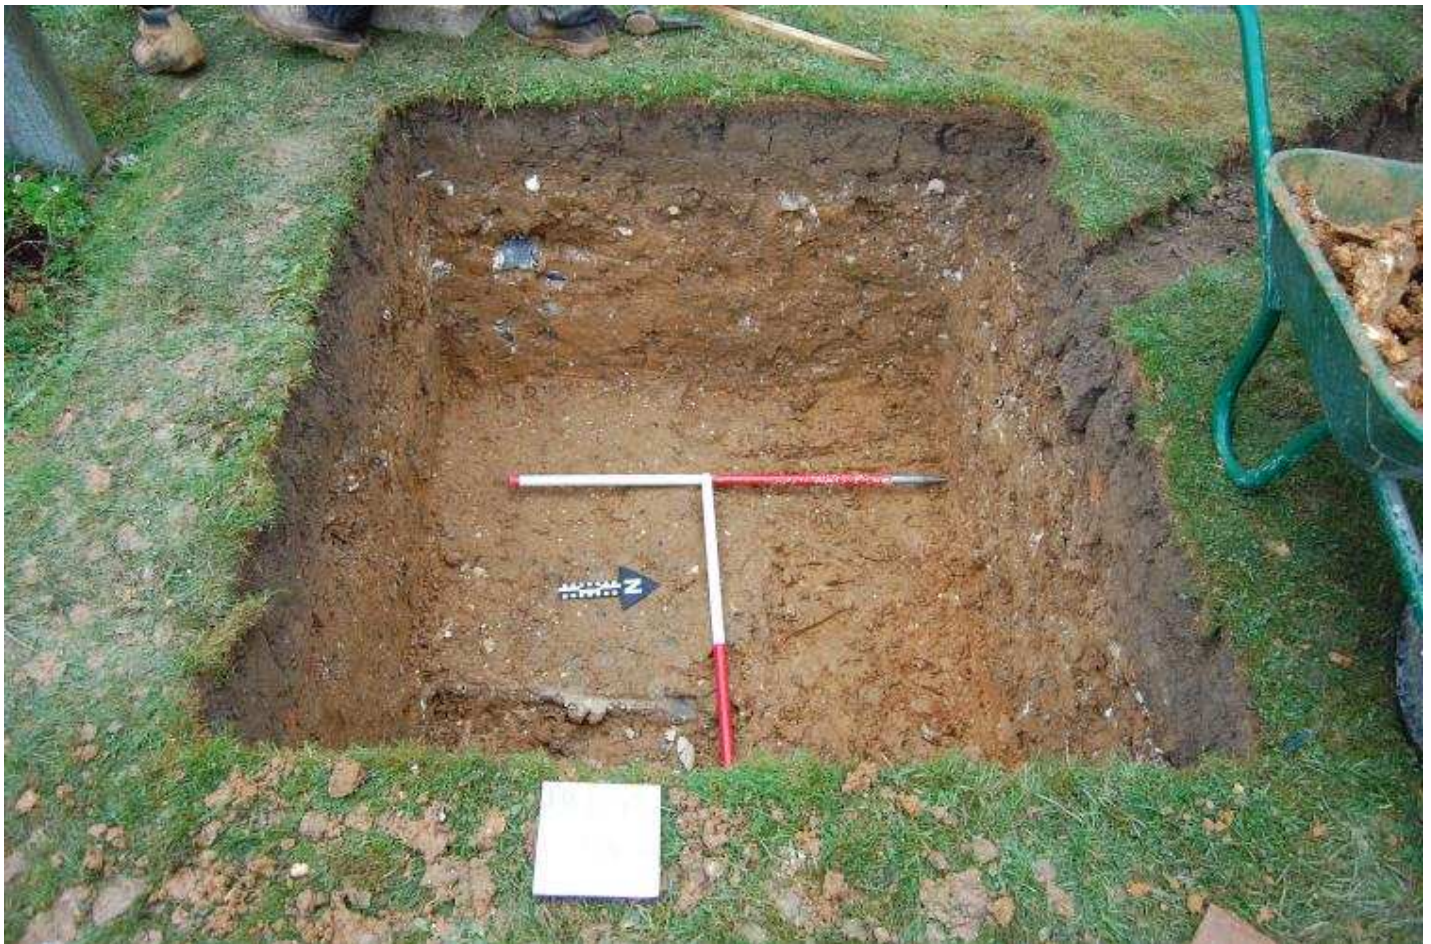
2.25 Soakaway 2 was located approximately 4.5m to the south of the church nave, in an small open space surrounded by a number of graves (Figure 2). It measured 1.6m by 1.4m and was excavated to a depth of 1m (Plate 8). The stratigraphy exposed in the sections was similar to that encountered in Soakaway 1.

Plate 008 - Soakaway 2, looking W
(c) The Heritage Network Ltd.

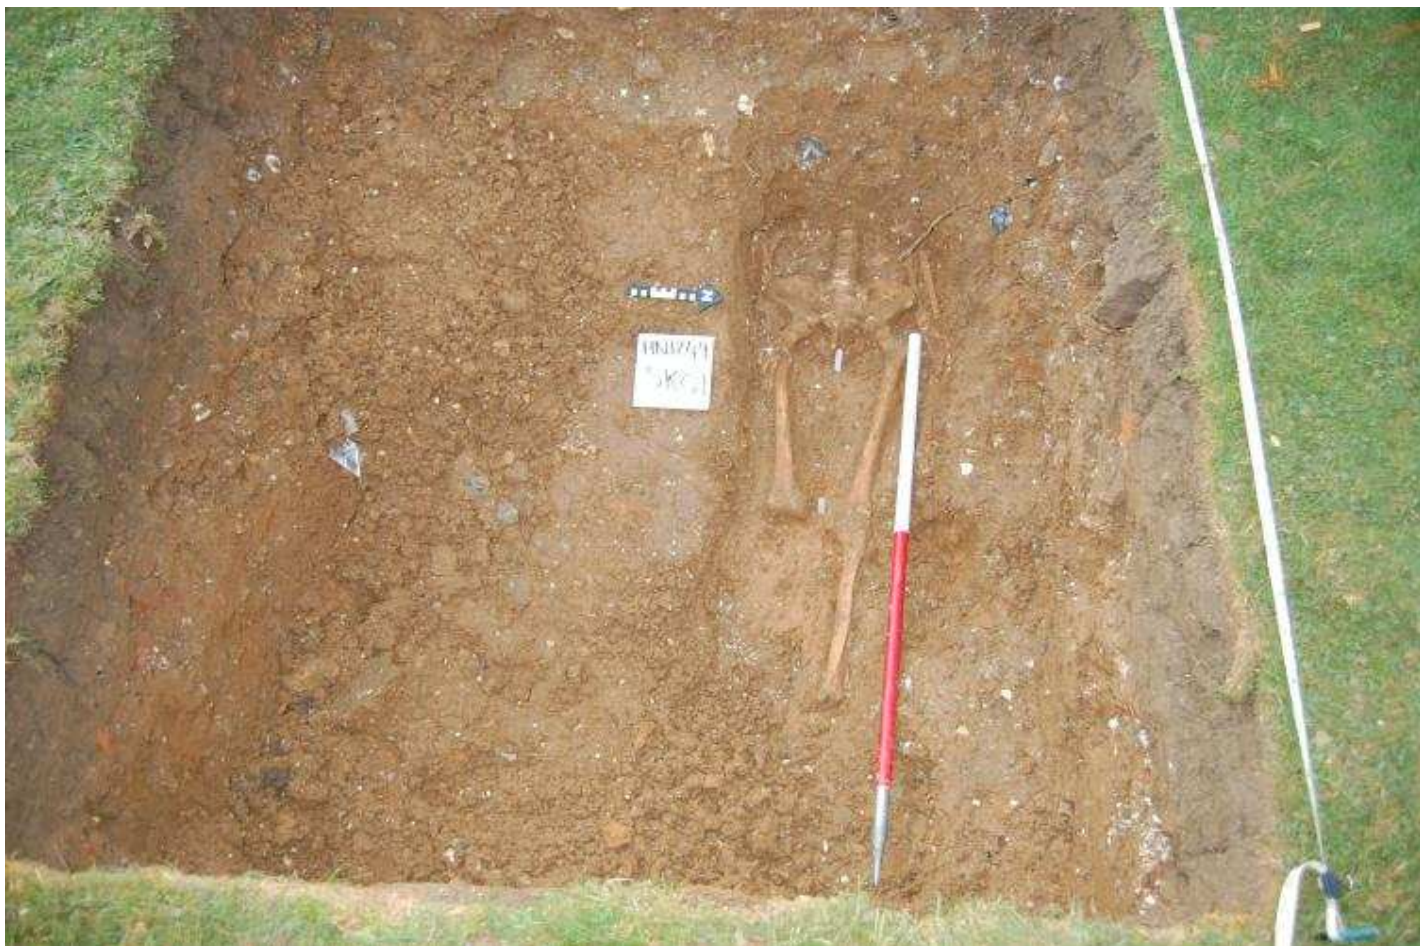
2.26 Part of an articulated inhumation was revealed in the northern half of the soakaway, at a depth of approximately 0.8m below the existing ground surface (Figure 4, Plate 9). The skeleton was aligned east - west and lay in a supine position. The lower half of the body, including feet, legs, pelvis, lumbar vertebrae, hands and lower arm bones, was exposed within the soakaway. The upper torso and head lay beneath the western baulk.

2.27 Examination of the bones showed that they were in good condition. The structure of the pelvis appeared to indicate a male, while wear in the vertebrae indicated an age range of between 20 and 40 years. The exposed bones were collected and handed to the vicar for reburial.

Plate 009 - Skeleton in Soakaway 2, looking W

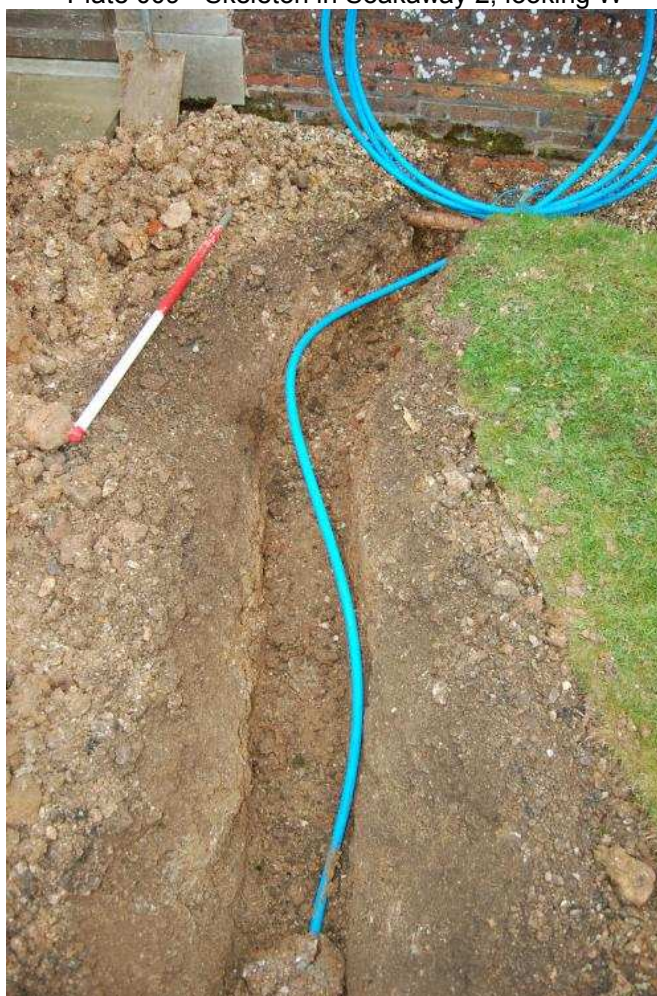
2.29 Soakaway 1 was served by a service trench (ST1) which ran north from the north doorway of the church and along the eastern edge of the area stripped for the new path (Figure 2). The trench measured approximately 1m in width, 0.5m in depth and 11m in length. The stratigraphy exposed in the trench sections was similar to that recorded elsewhere on the site and comprised loose dark grey sandy silty clay topsoil, 0.2m thick, over a pale brown silty sandy clay subsoil, >1m in depth (Figure 5, Plate 10).

Plate 010 - ST1, looking S
(c) The Heritage Network Ltd.

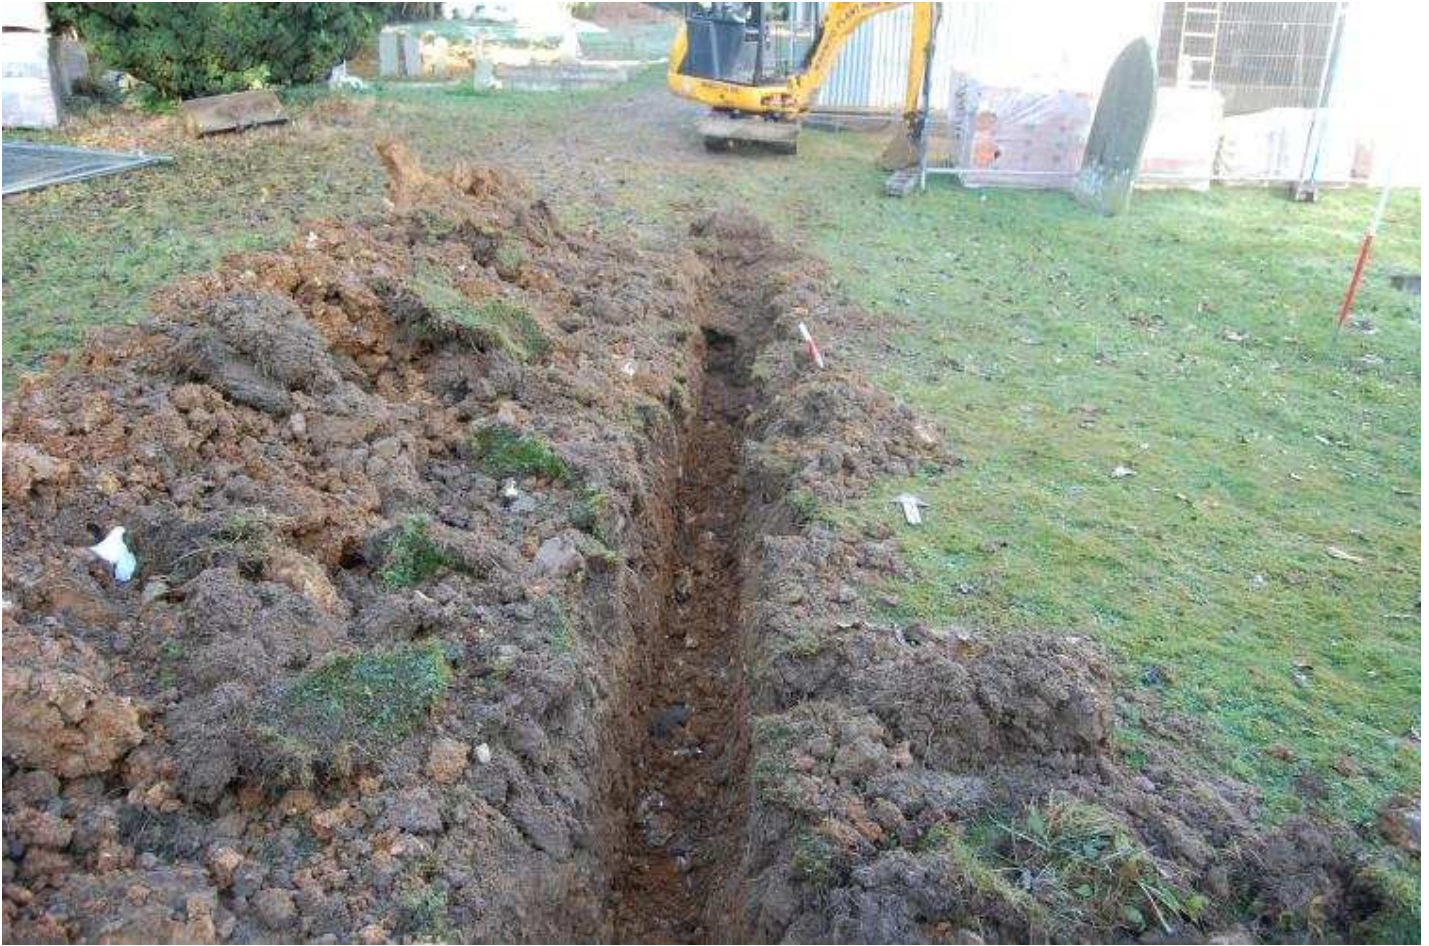
2.32 The trench sections revealed dark grey sandy silty clay topsoil, 0.2m in depth, over a pale brown sandy silty clay subsoil, >1.8m in depth (Figure 5, Plate 11). The underlying natural clay was not reached in this trench.

Plate 011 - ST2, looking N

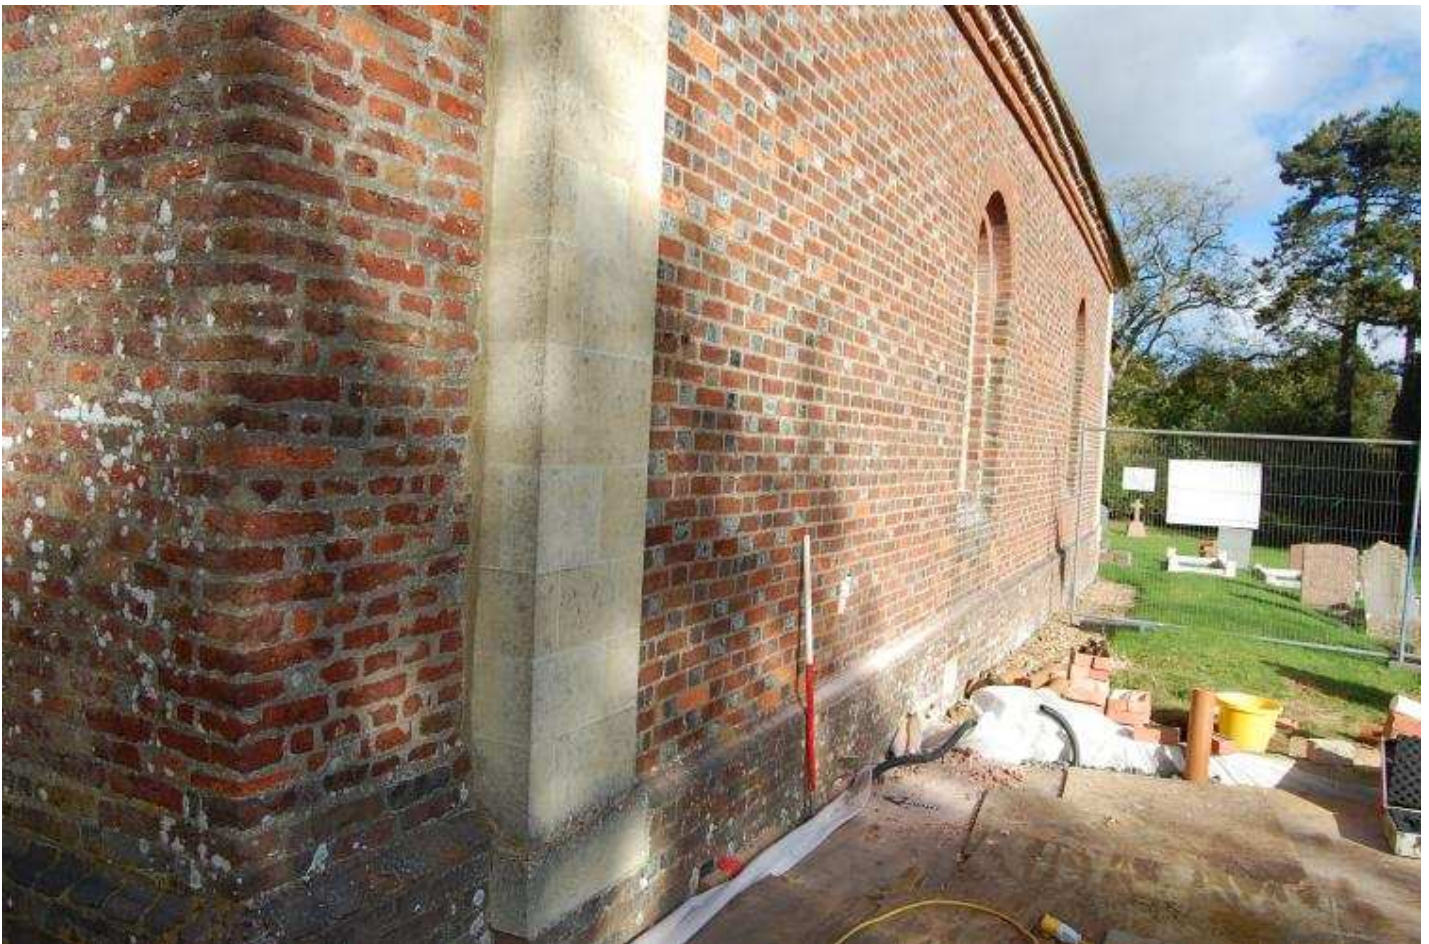
2.35 The exterior elevation of the south wall, [106], is constructed of red unfrosted bricks, laid in Flemish bond with lime mortar (Plate 12). The individual bricks measured 9" x 4" x 2½" (227mm x 101mm x 63mm). The measurements were taken in situ as no brick was available for collection.

Plate 012 - South wall of church, looking NE
(c) The Heritage Network Ltd.

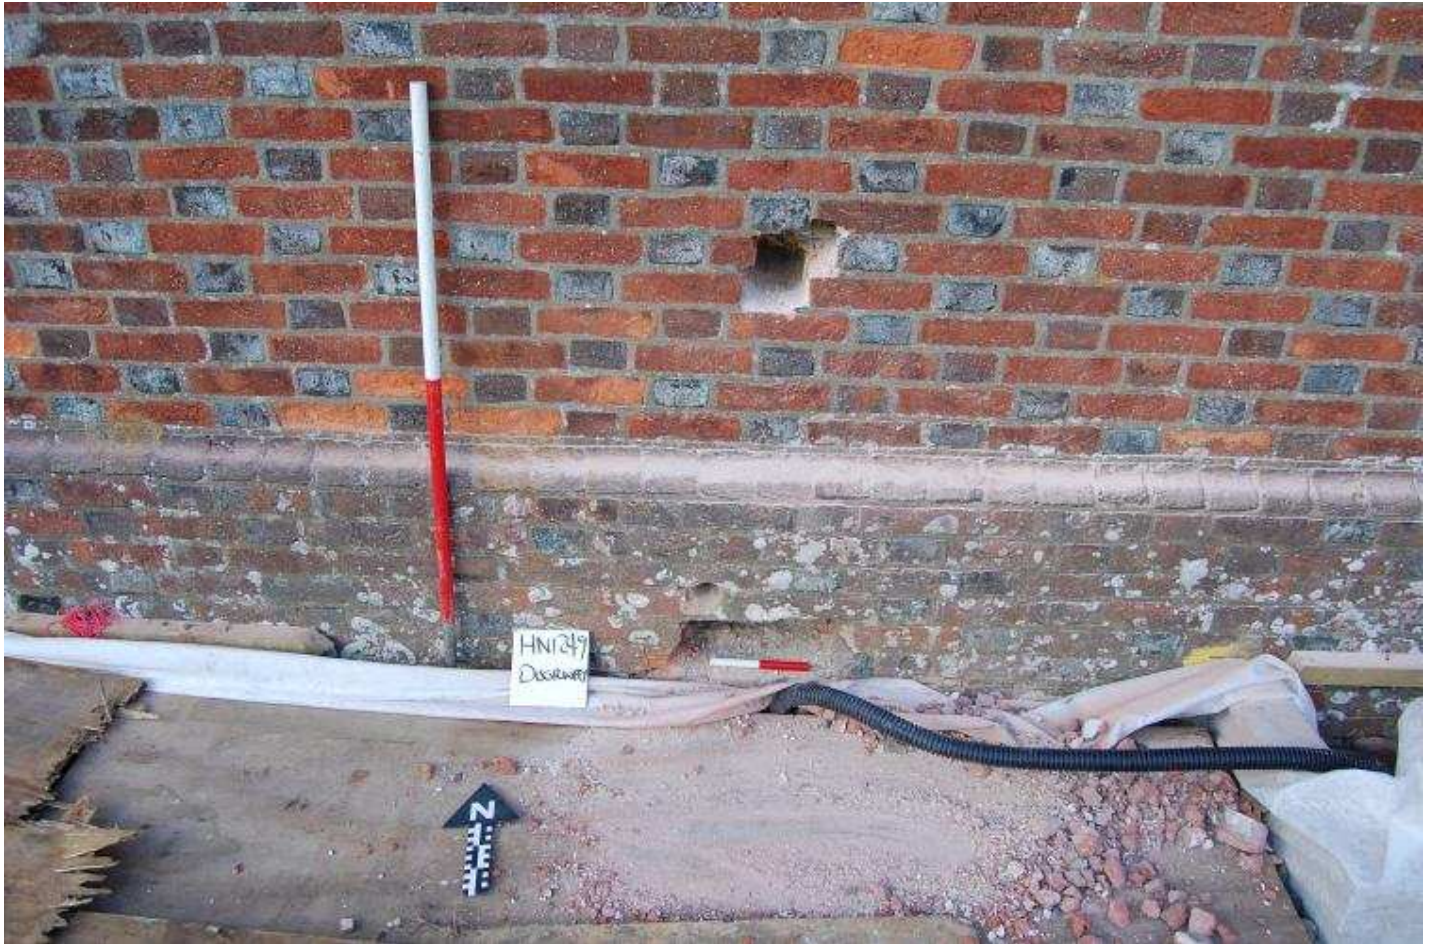
2.36 Two test holes were created at different heights in the exterior wall by the removal of two bricks, in order to inspect the wall structure and define a methodology for the cutting of the doorway (Plate 13). Inspection of the test holes demonstrated that the facing brickwork was a single skin thick, with headers bonded to the material behind. They also revealed the possible survival of an earlier wall behind the brick facing (Plate 14).

Plate 013 - Test holes for new doorway, looking N

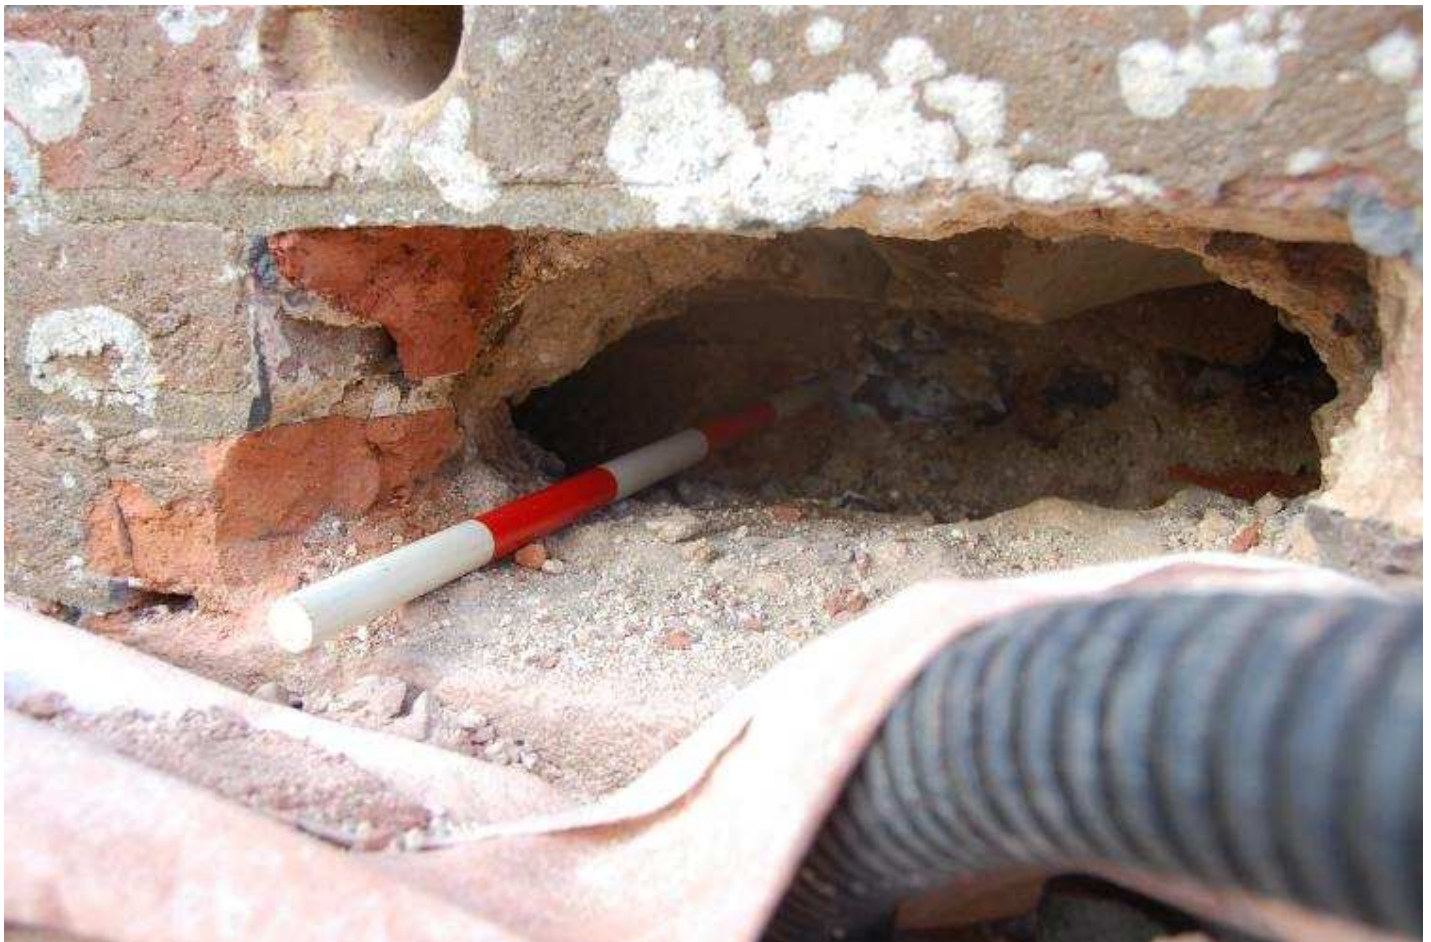
Plate 014 - Test hole, showing earlier wall, looking NW
(c) The Heritage Network Ltd.

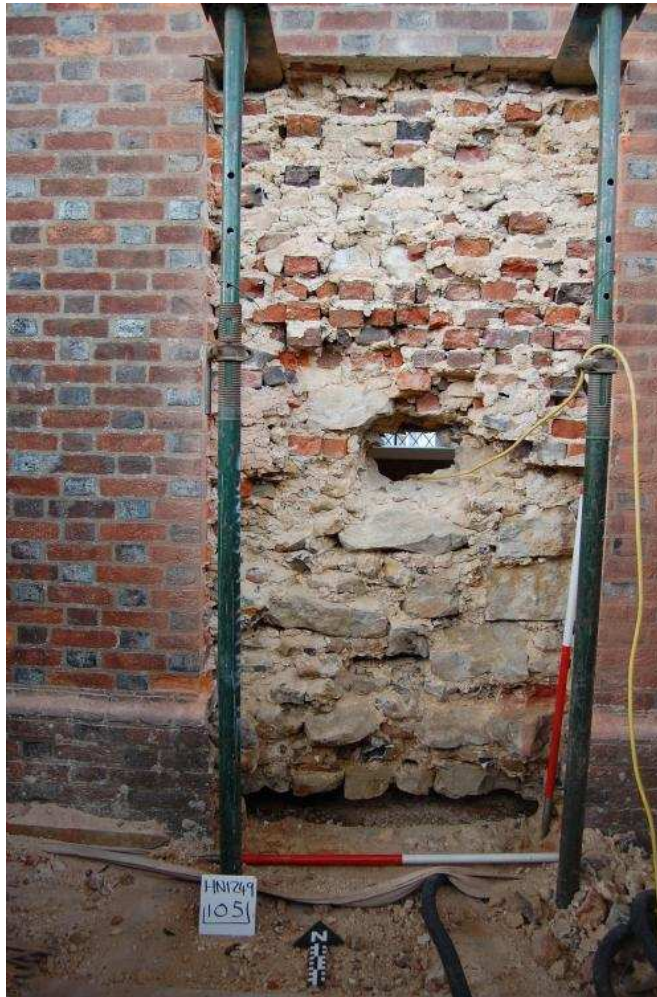
2.38 Above the stone and flint wall was a roughly coursed brick wall, [108], (see Plate 15). This consisted of 14 courses of headers, bonded with lime mortar. The individual bricks measured 8½" x 4" x 2½" (215mm x 101mm x 63mm). A small number of Totternhoe stone blocks were also incorporated into the wall.

Plate 015 - New doorway after removal of exterior brick facing

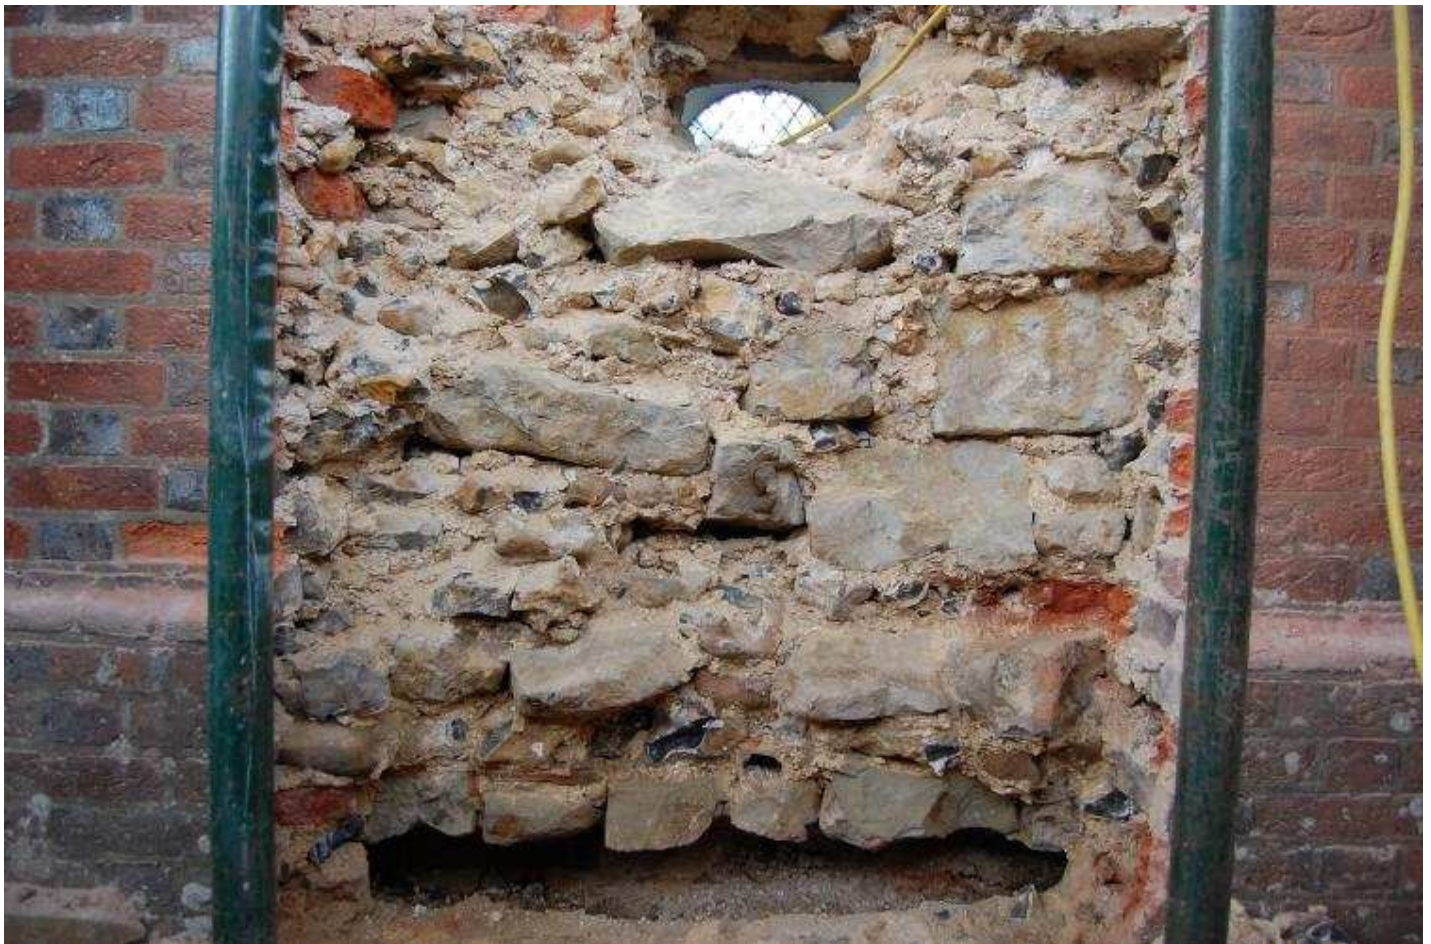
2.39 A void, 0.15m in height and extending across the width of the opening, was revealed at the base of wall [105] (see Plate 16). Fragments of heavily degraded wood were observed within this space, including a substantial piece which measured 0.5m in length and 0.06m in

depth. It is possible that this void represents the location of a sill beam, with fragments of wood surviving.

3.11 A void was observed below the external face of wall [105], but was not visible on the inner face. This contained degraded wood fragments which may represent the remains of a sill beam. It is possible that the sill beam originally extended the width of the wall, but later repairs have removed the evidence on the northern side.

3.16 It is possible that the medieval church had a sill beam. A void was encountered below the outer face of [105]. This contained a number of fragments of degraded wood.

Plate 016 - Detail of wall [105], looking N
(c) The Heritage Network Ltd.
