CHURCH OF ST MARY MAGDALENE Whippsnade, Beds

***ARCHAEOLOGICAL
MONITORING REPORT***

CHURCH OF ST MARY MAGDALENE Whipsnade, Bedfordshire

Archaeological Monitoring Report

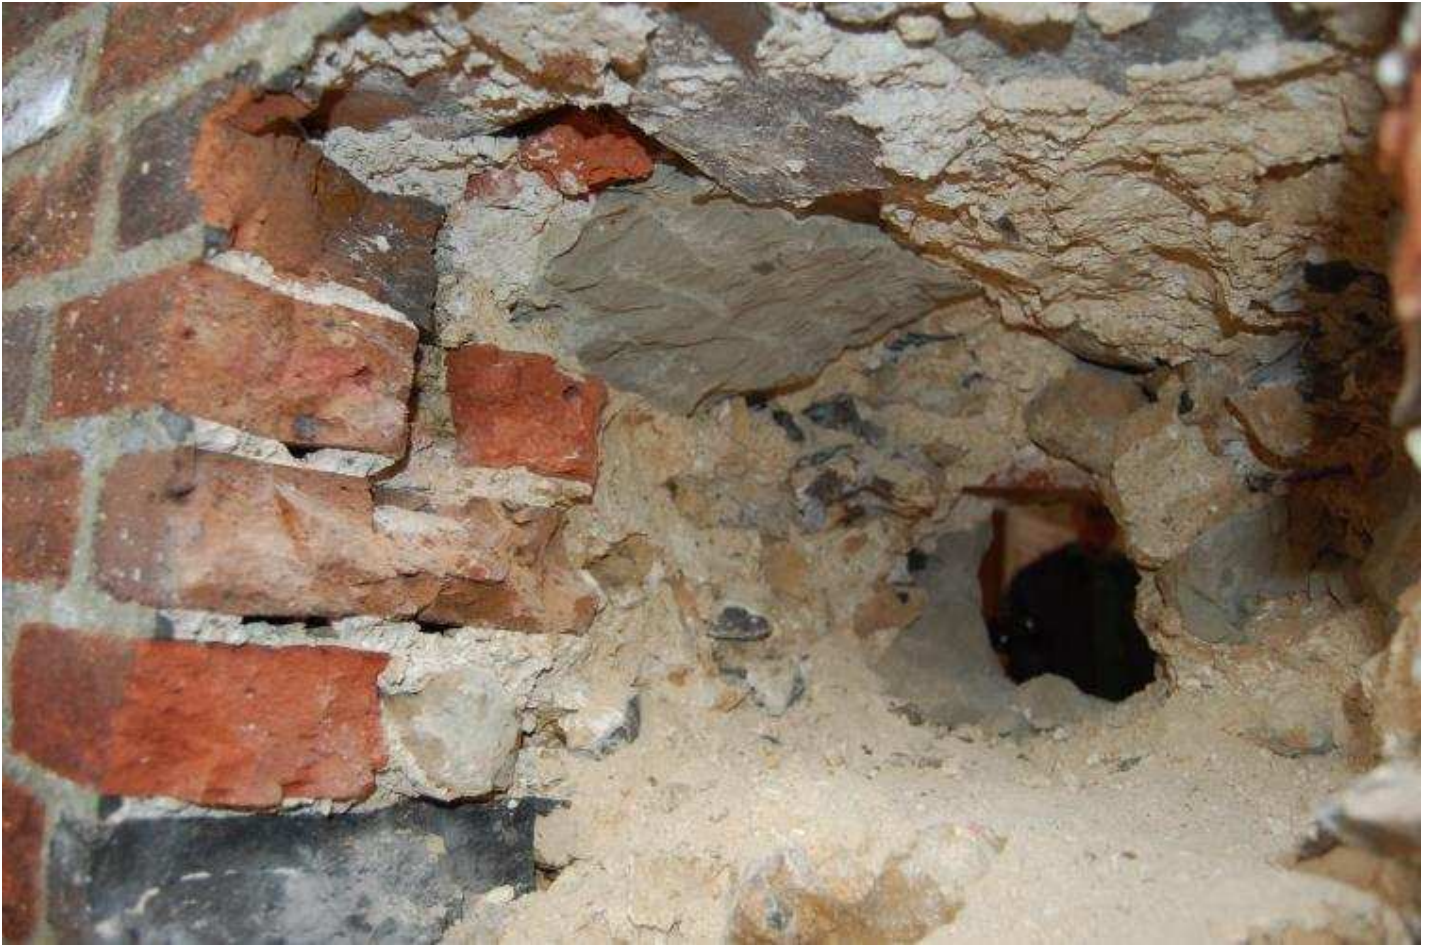
Plate 017 - Section through south wall of nave, looking N

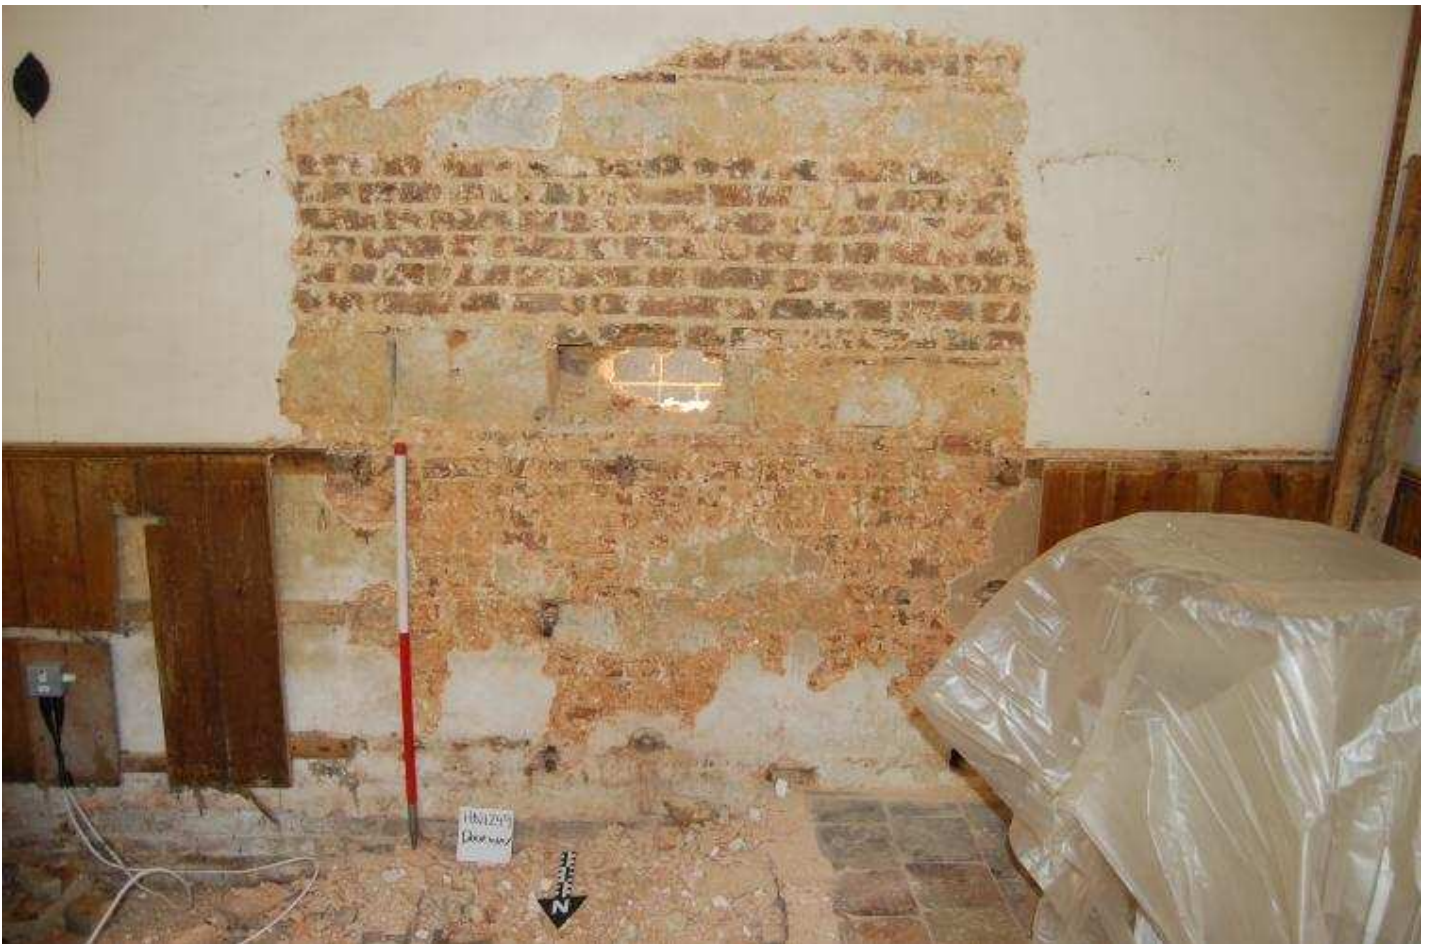
2.40 Removal of the wall plaster from the internal elevation of the nave, across an area measuring 2m in width by 2m in height, revealed brick wall [103], which contained two distinct courses of Totternhoe stone blocks [104] (Plate 18). The brickwork consisted of red unfrogged bricks, laid in Flemish Bond with a lime mortar. The individual bricks differed slightly in size from those on the exterior wall and measured 8½” x 4” x 2½” (215mm x 101mm x 63mm).

Plate 018 - S wall of nave after removal of plaster
(c) The Heritage Network Ltd.

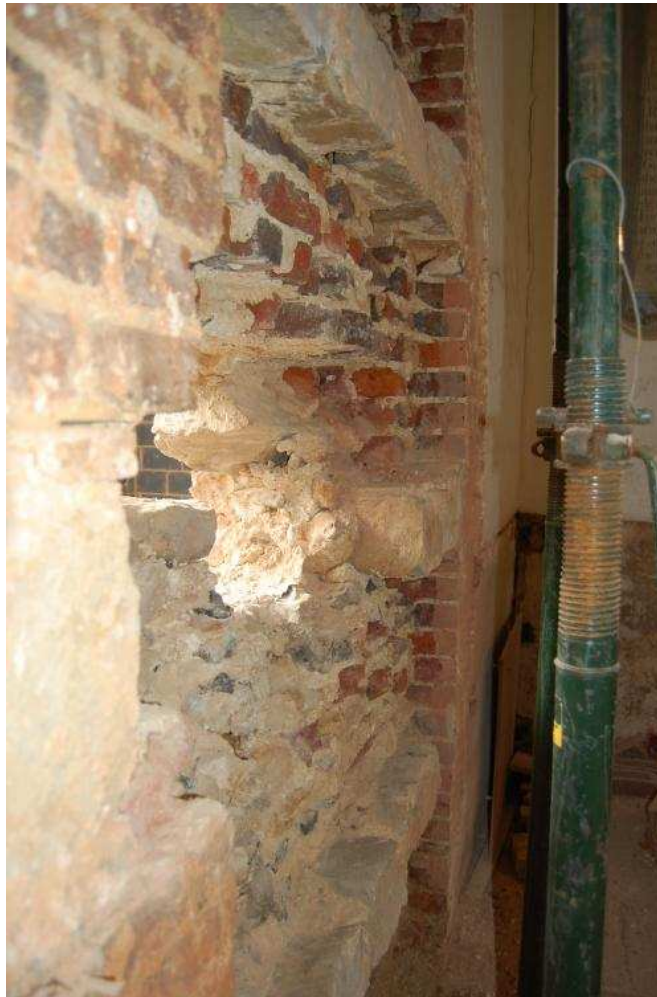
2.41 The courses of Totternhoe stone were a single block deep and bonded with lime mortar. The individual stones ranged in size between 0.15 - 0.2m in height, 0.2 - 0.4m in length and 0.2m in width (Plate 19). These are likely to represent re-used stone, with the lower course possibly laid as a base for the later brick wall above. These stone courses were not visible on the external face of the wall.

Plate 019 - Detail of stone coursing on internal elevation, looking W

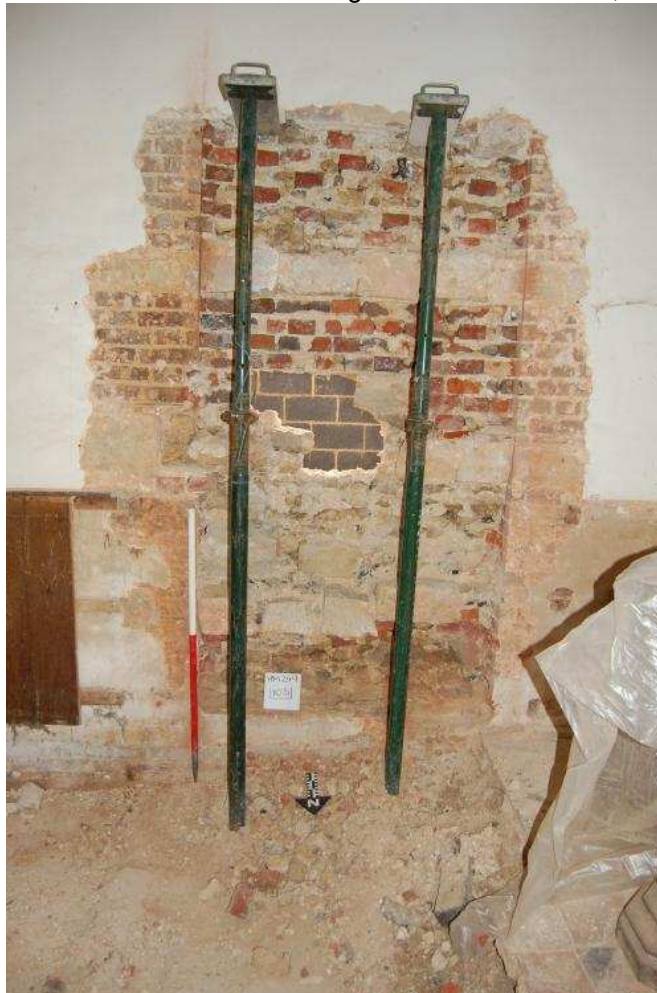
2.42 Removal of the brick facing behind the plaster revealed significant rebuilding or repair to the internal face of the core (Plate 20). The lower part of the wall consisted of brickwork to approximately 0.5m in height. This was largely hidden by a layer of mortar and plaster. Above this the wall, between c.0.5m and 1m from the ground, the wall was similar to that exposed on the exterior, being constructed of Totternhoe stone and flint in a lime mortar matrix. A course of stone blocks had been laid on top of the early core, which supported wall [108].

3.8 Removal of the plaster and brick facing to the internal elevation appeared to show that the inner face of the early core to the wall had been significantly repaired. Its lower part had been replaced by brickwork, covered with a layer of mortar and plaster. An area approximately 0.5m in height had survived above this, which supported a course of stone blocks, laid as a base for a later brick wall [108].

Plate 020 - New doorway after removal of interior brick facing
(c) The Heritage Network Ltd.
