**Churchyard Wall, All Saints Church  
Houghton Regis, Bedfordshire**

HN1295

Report No.1030

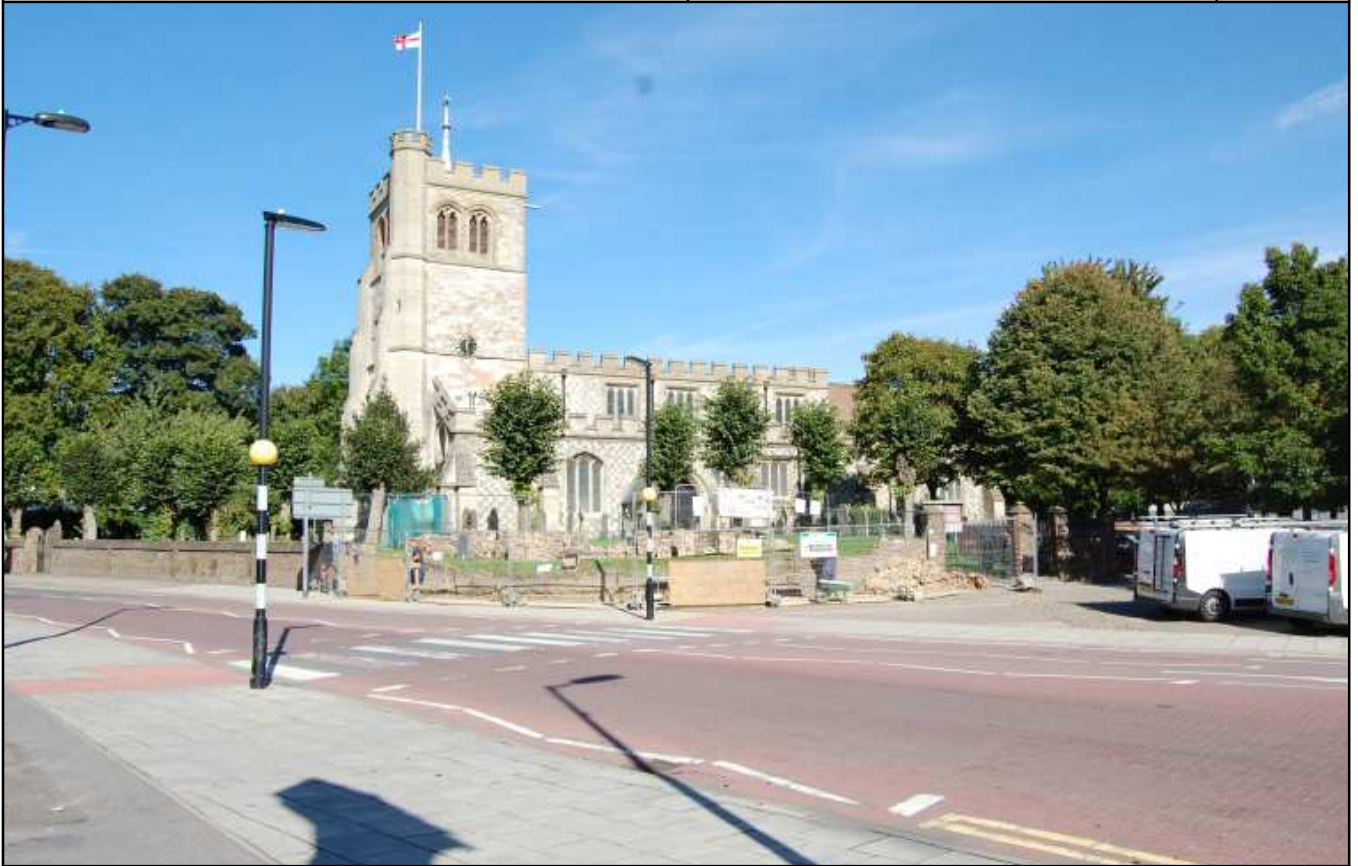
The south-western corner of the churchyard wall, adjacent to the main access gate, required attention due to health and safety concerns (Figure 2, Plate 1). This section of the wall had become bowed and there was a risk of collapse onto the public footpath.

Plate 1: All Saints Church, showing removal of graveyard wall in foreground, looking north-east

In order to make the wall safe, four sections of the wall, totalling 19m in length, were removed by hand. The subsequent works involved cutting back the soil behind the wall, the excavation of new footings and the rebuilding of the wall.

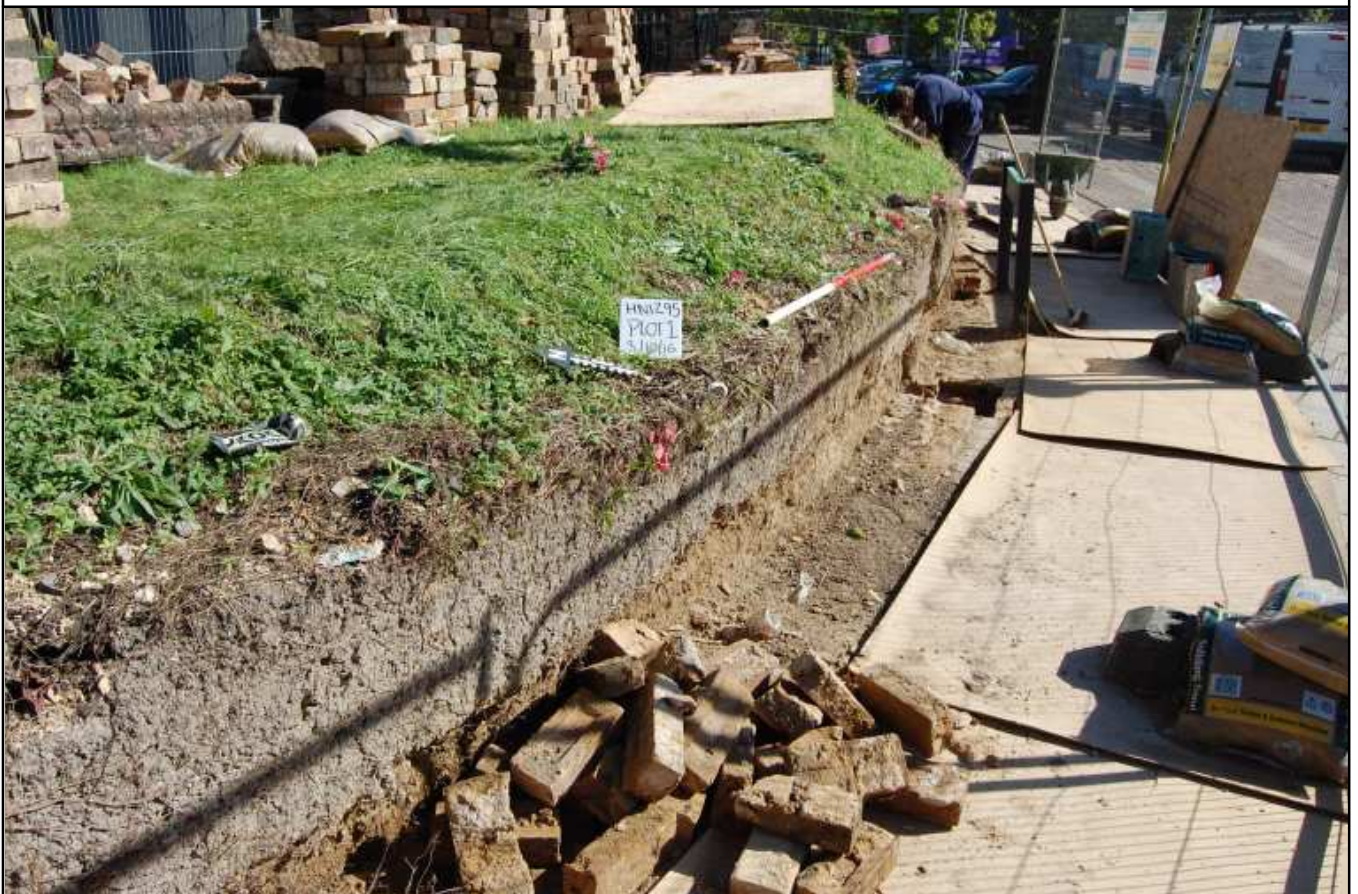
Removal of the wall exposed a stratigraphic sequence consisting of a friable dark brown (10YR 3/3) silty sandy clay topsoil, 0.1-0.2m thick above a friable dark yellowish brown (10YR 4/4) silty clay cemetery soil, 0.3-0.4m thick (Plates 2 & 3). The natural substrate of friable yellowish brown (10YR 5/8) silty clay, more than 0.3m thick, was observed below the cemetery soil (Plate 4). Inspection of the exposed section suggested that the soil behind the wall had slumped forwards, forcing the wall to bow outwards. As a result, the cemetery soil layer was extremely thin in places.

Plate 2: Soil face of graveyard after wall removal, looking east

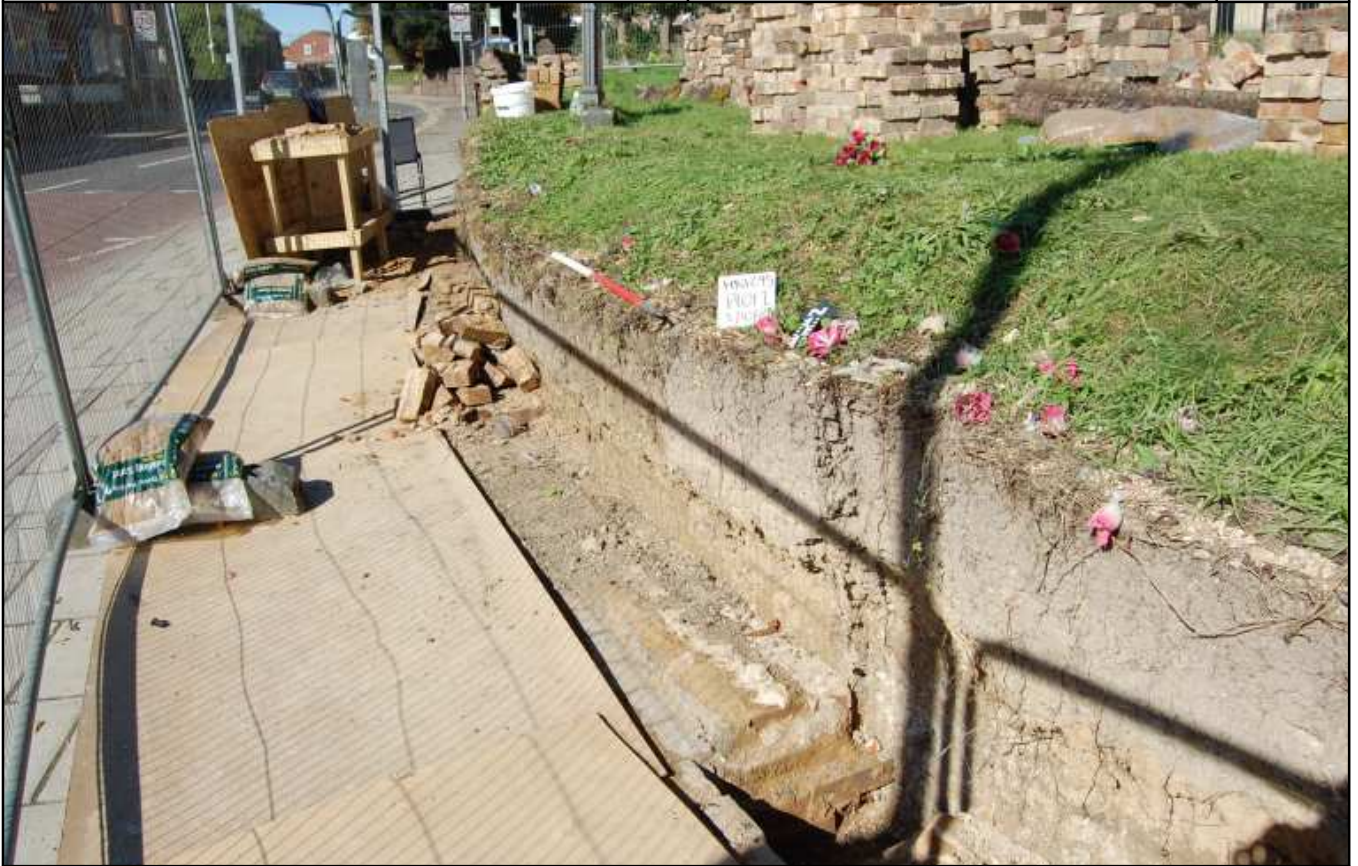
Plate 3: Soil face of graveyard after wall removal, looking north-west

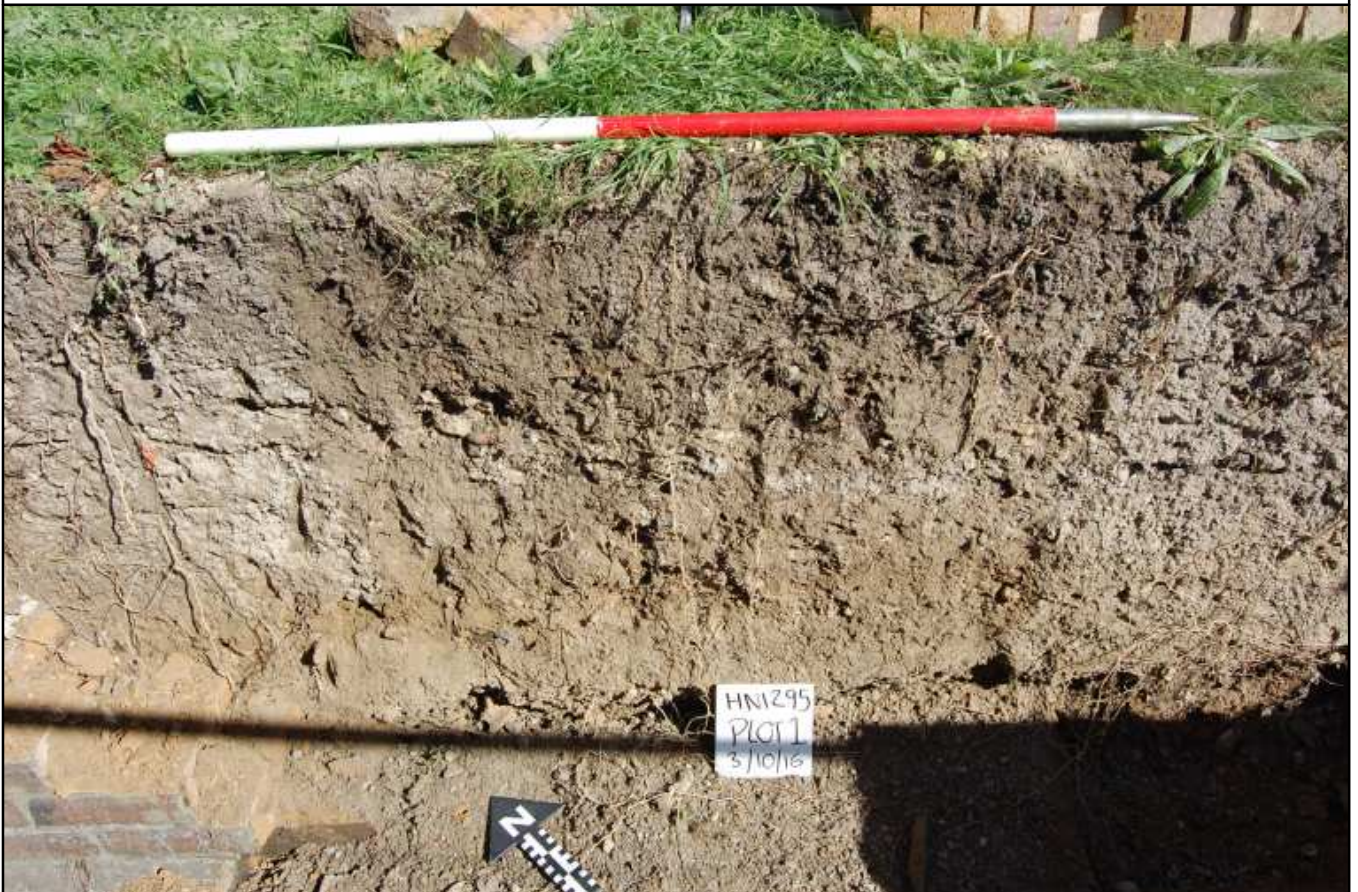
Plate 4: Section of soil face after wall removal, looking north-east

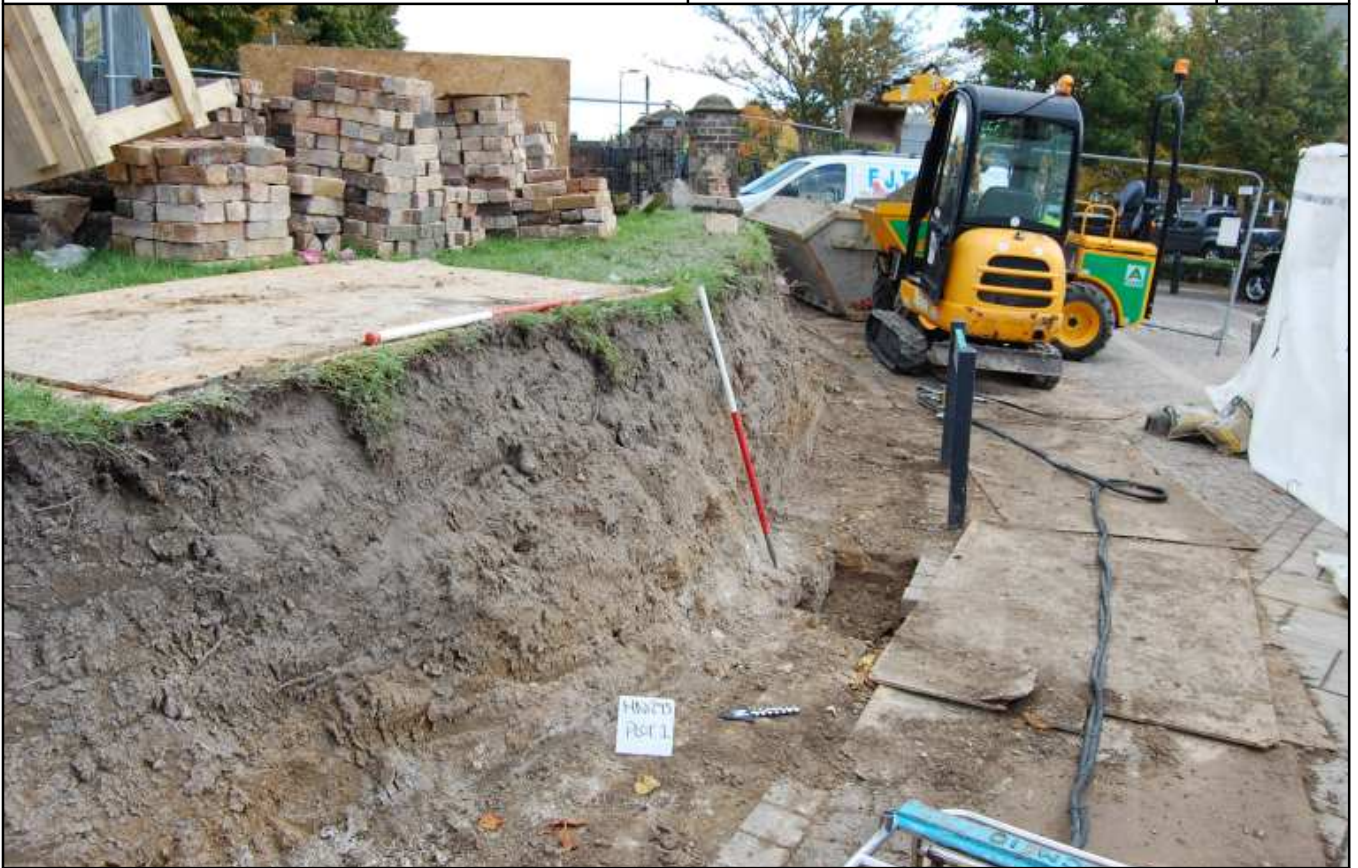
Monitoring of the cutting back of the soil bank revealed no changes in the stratigraphic sequence (Plate 5 & 6). A few fragments of disarticulated human bone were recovered but no articulated burials were revealed. The bone fragments were handed to the vicar for reburial,

Plate 5: Cutting back of graveyard soil face, looking east

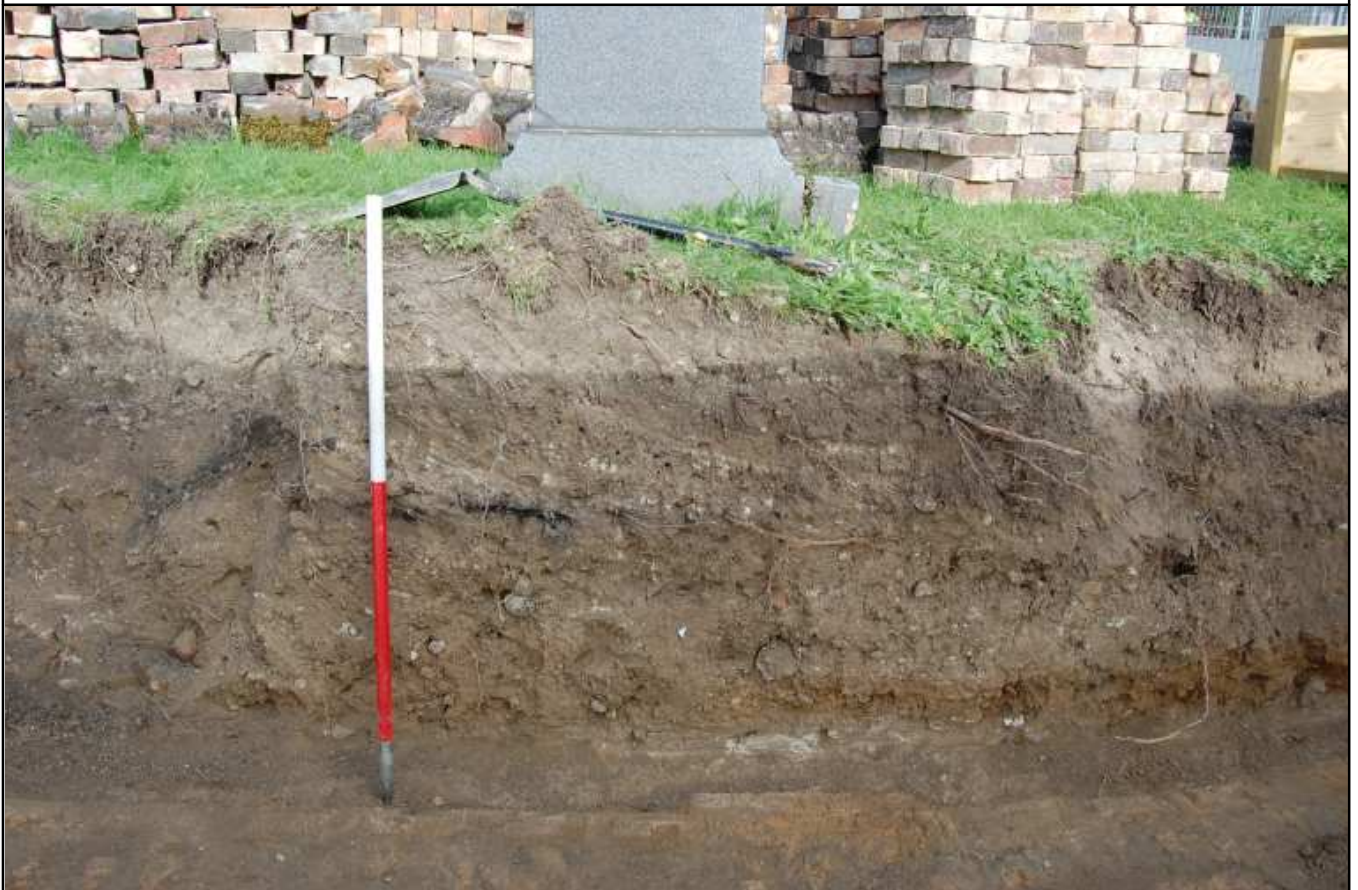
Plate 6: Section of graveyard soil face after having been cut back, looking north
