Church of St Mary the Virgin, Nevill Holt, Leicestershire

HN1261

Report No. 1040

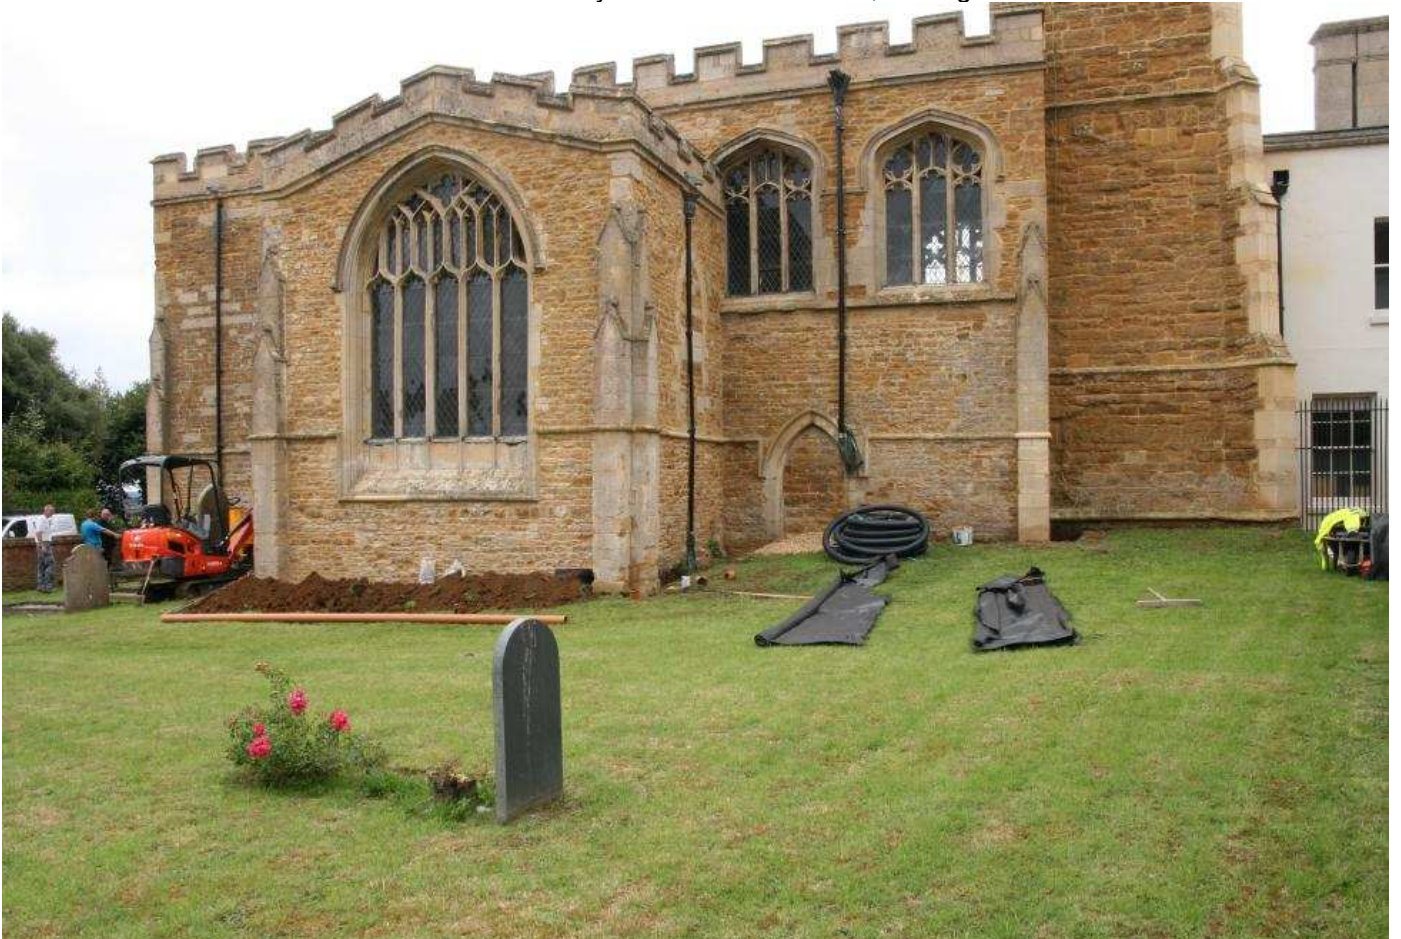
Plate 02 - St Mary's Church, N elevation
(c) The Heritage Network Ltd.

The works involved the monitoring of the excavation of a drainage trench and a soakaway on the north side of the church (Figure 2, Plate 2). A further trench on the southern side of the church, which was also to have been monitored, was excavated and backfilled by sub-contractors prior to the arrival on the site of the monitoring archaeologist. A proposal to re-open the trench, in order to meet the provisions set out in the approved *Project Design*, was turned down by the main contractors.

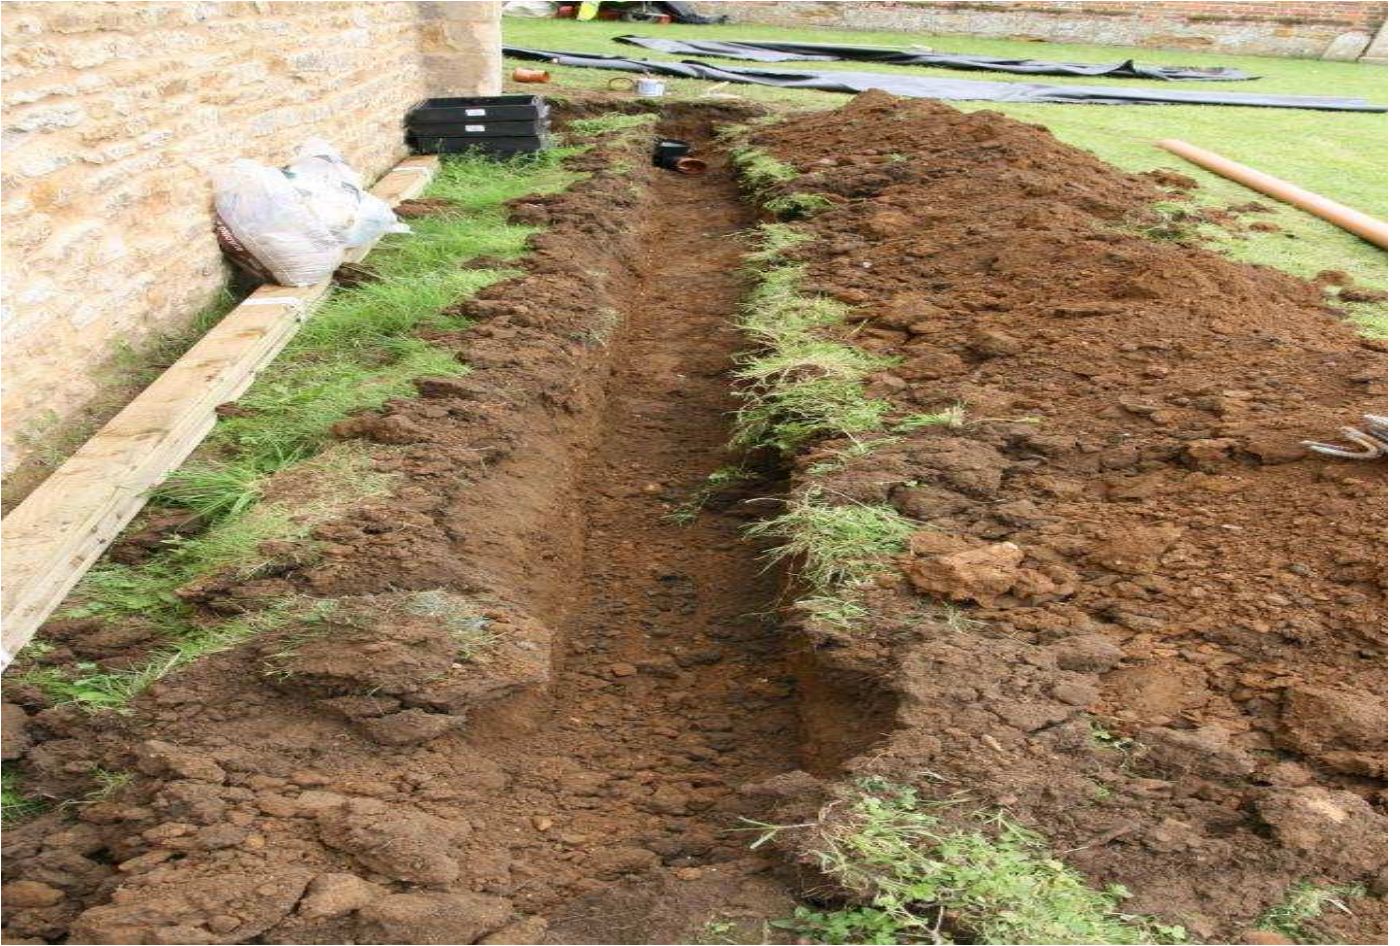
Plate 03 - Trench along E side of North Transept, looking N

The trench was excavated to a depth of 0.30m and revealed a mid-yellowish brown sandy silt, containing moderate stone and old mortar fragments derived from the earlier repointing of the walls (Plate 3). No grave cuts were encountered and no human bone, either articulated or disarticulated, was observed.

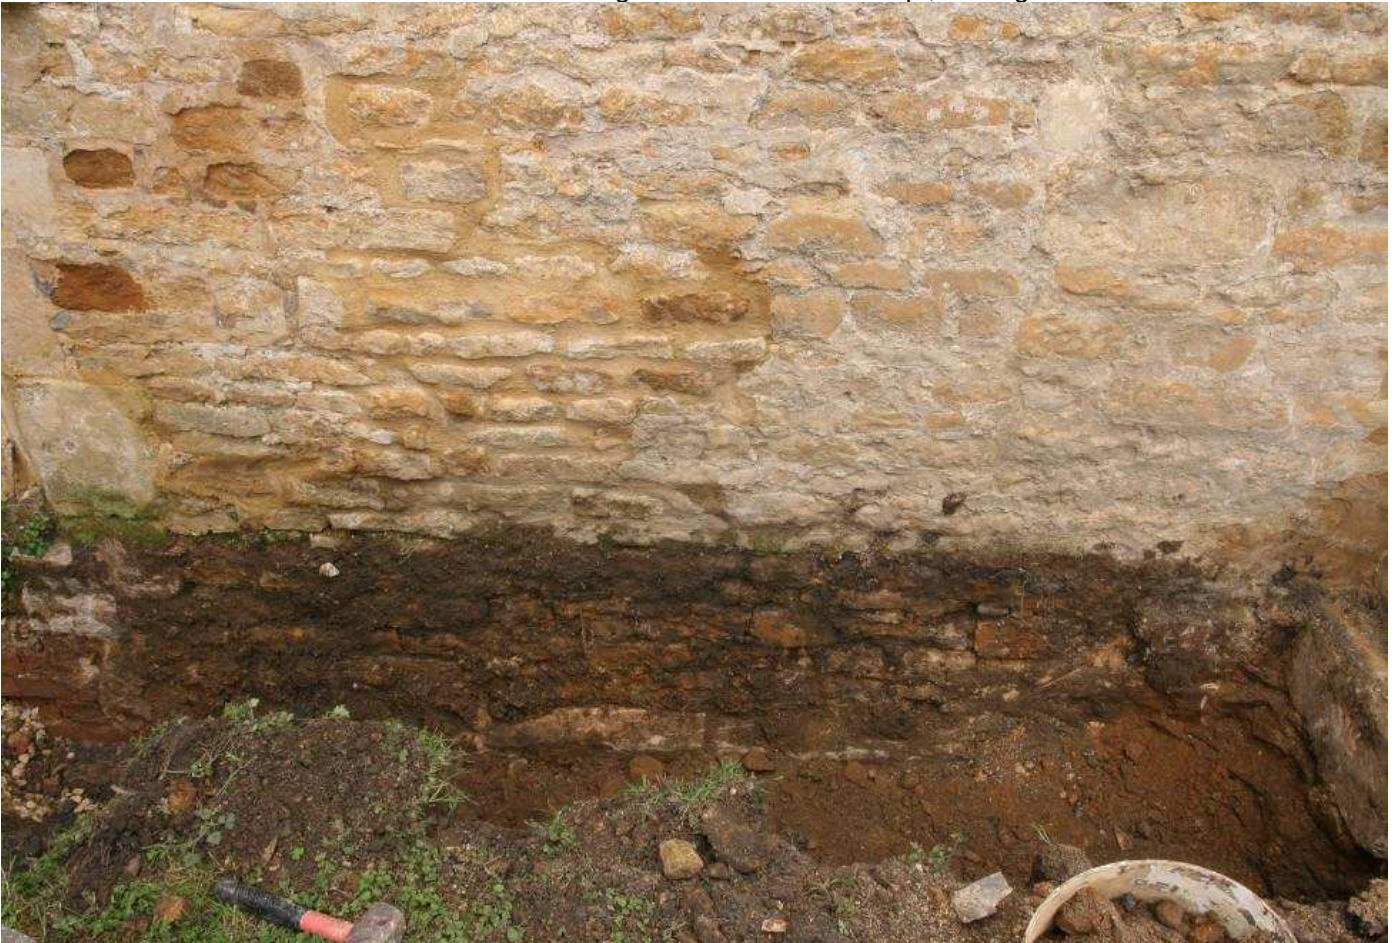
Plate 04 - Footings to N wall of church, looking S
(c) The Heritage Network Ltd.

The footings to the north wall of the nave and the west wall of the north transept were exposed, revealing coursed sandstone above larger stone blocks (Plate 4). These blocks were observed at the base of the trench only and were not fully exposed.

The present project involved monitoring the groundworks for new drainage, though only the works on the north side of the church were seen. These works revealed the foundations for the north wall of the nave, which consisted of roughly coursed sandstone, which appeared to sit on larger stone blocks. The observed stratigraphy consisted of a layer of topsoil sealing a cemetery soil over 1m in depth, but no grave cuts or other significant features were encountered. The works to the south of the church were carried out by the sub-contractors without the benefit of archaeological monitoring.

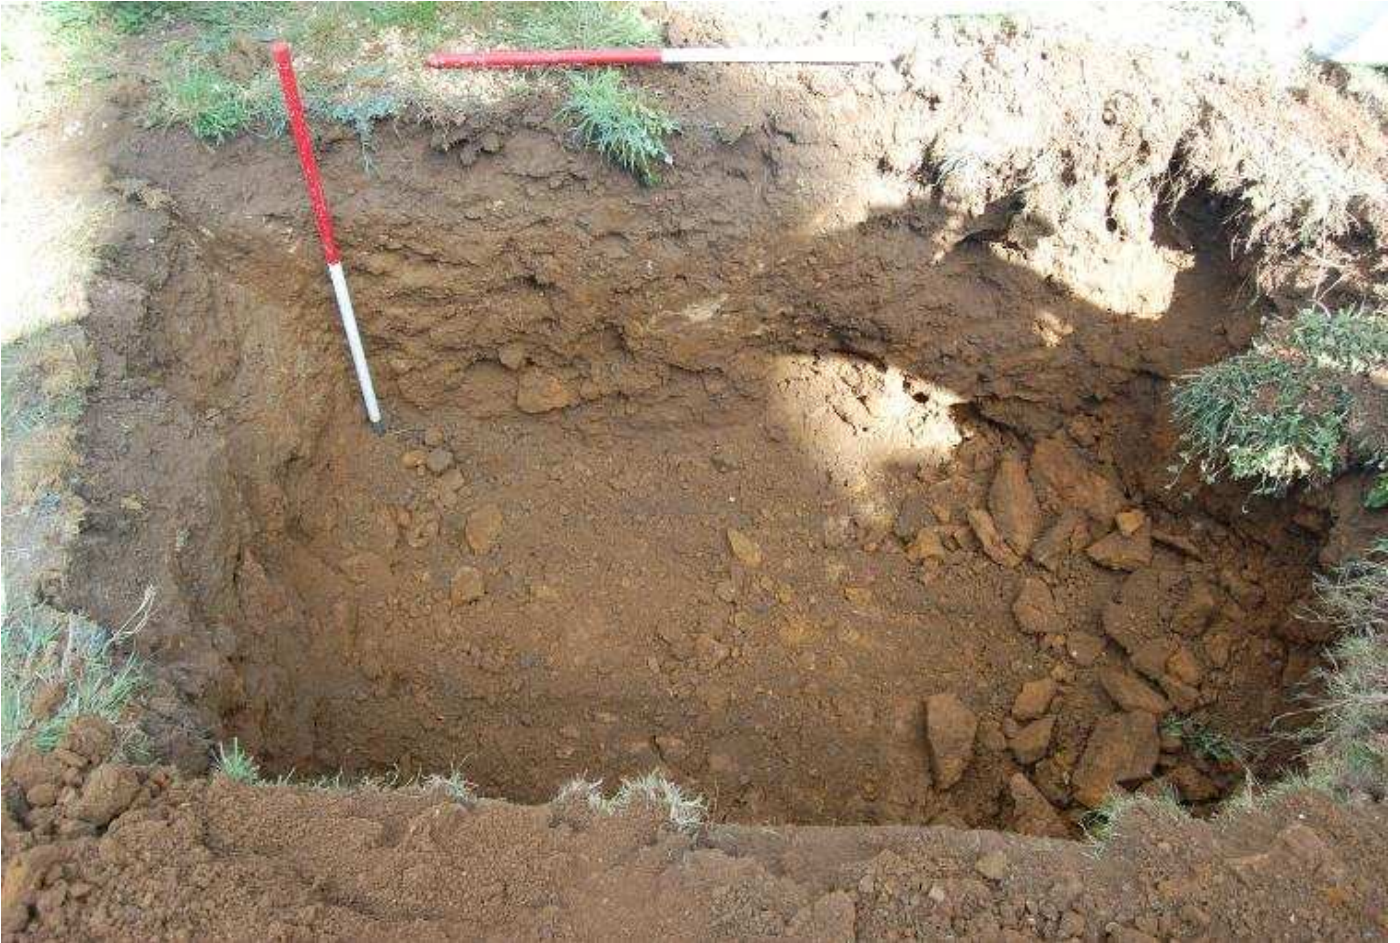
Plate 05 - Soakaway, looking W

A soakaway, measuring 1.90m in length, 1.30m in width and 1.35m in depth, was located approximately 1.60m to the north-east of the north transept. The exposed sections revealed a brown silty sandy clay topsoil layer, approximately 0.25m in depth, above a reddish yellow silty sandy clay cemetery soil, approximately 1.10m in depth, which contained frequent large fragments of sandstone (Plate 5). The natural substrate was not encountered in the soakaway.

Some fragments of disarticulated human bone were recovered from the cemetery soil, which were placed in the care of the sub-contractors for delivery to the Rector of the parish of Six Churches Circa Holt for re-interment. No other finds were recovered and no significant archaeological features or deposits were observed.

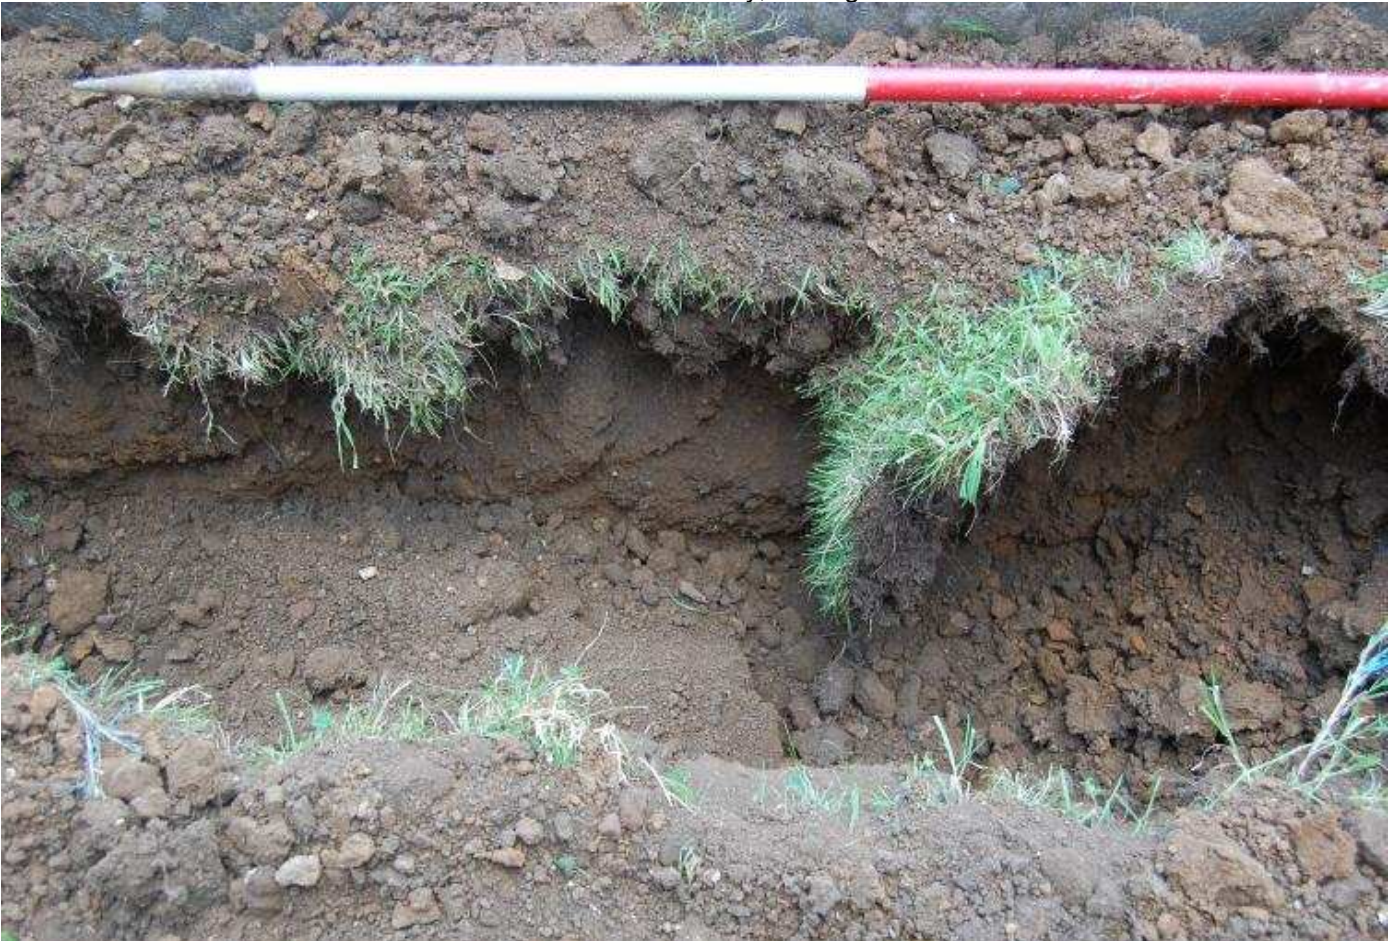
Plate 06 - Soakaway feeder trench, indicative section
(c) The Heritage Network Ltd.

The soakaway was served by a trench running south for approximately 1.50m before turning west for approximately 2m to join the trench excavated along the eastern side of the north transept. The trench, which measured 0.30m in width and 0.30m in depth, revealed only the topsoil layer (Plate 6). No finds were recovered and no significant archaeological features or deposits were observed.

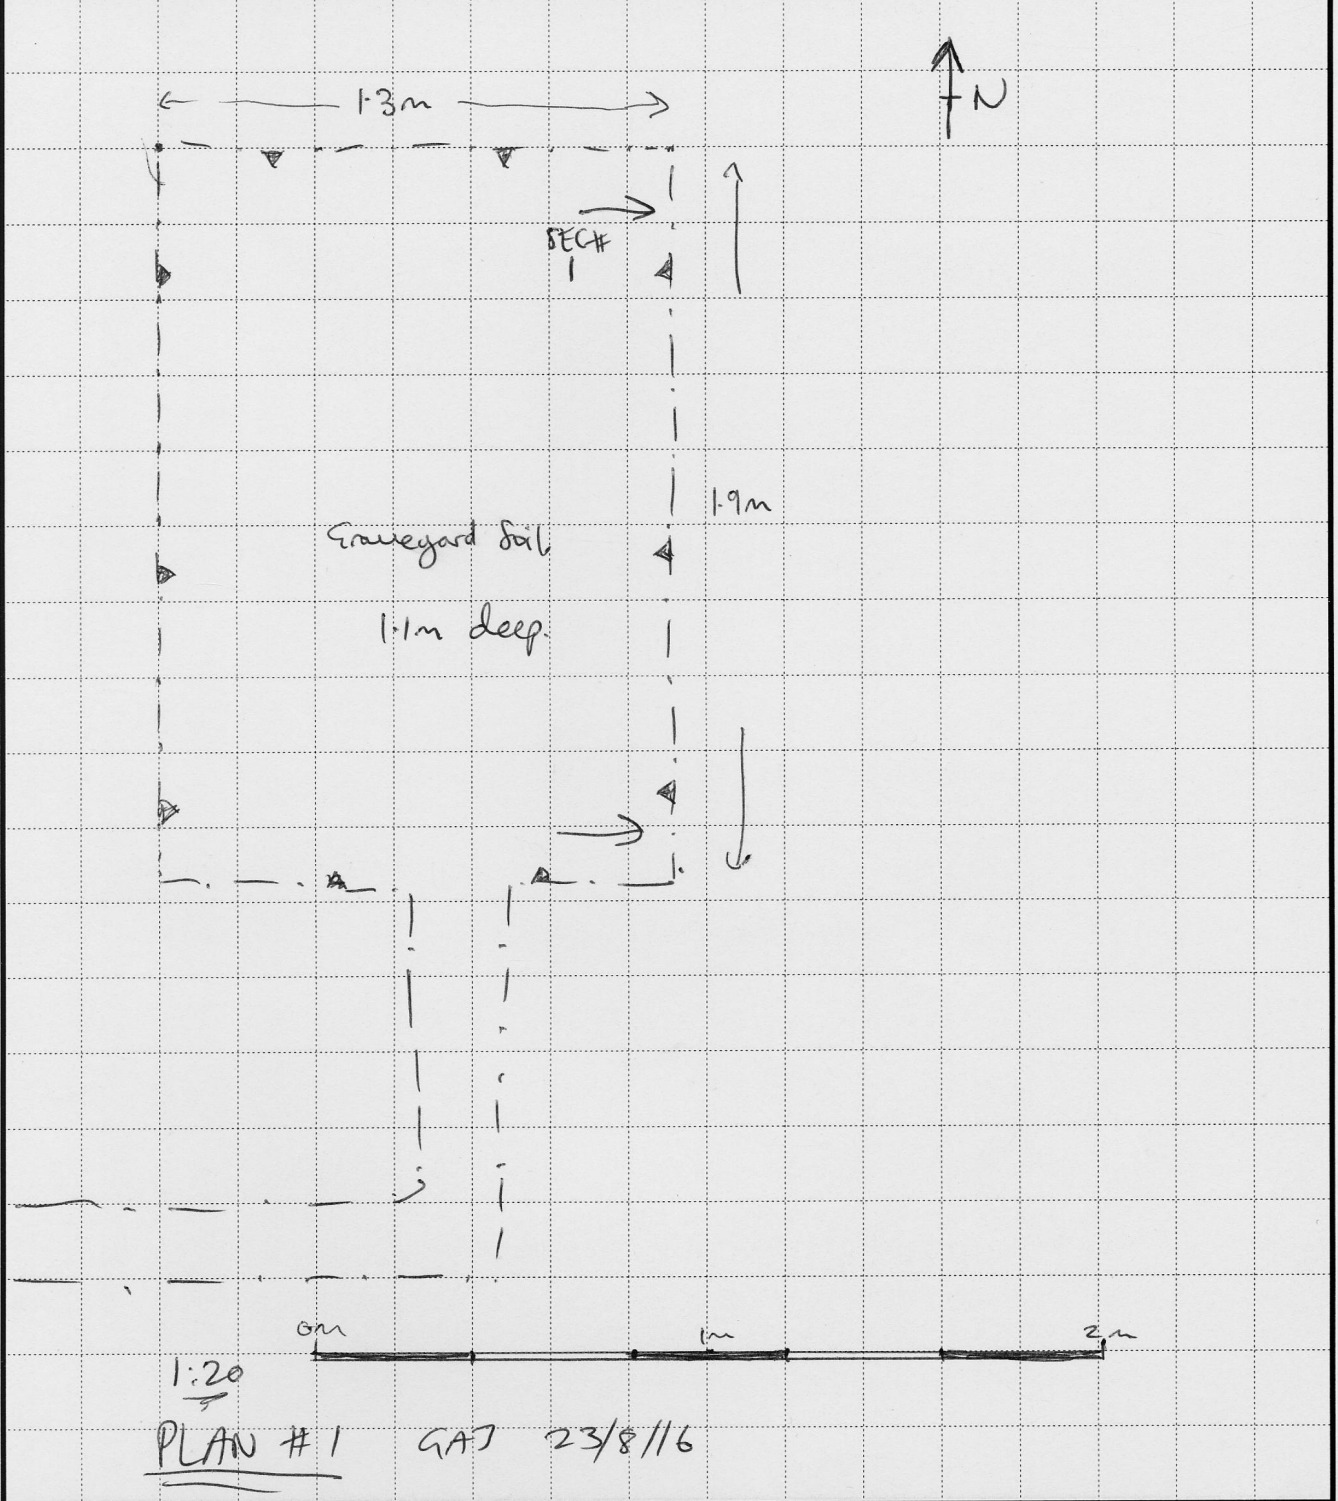
Plan of Soakaway. No archaeology other than scrap of human bone (disarticulated + abraded).		Scale	1:20
		Signature	GAJ
		Date	23/8/16
Sheet	2	of	4
		Checked

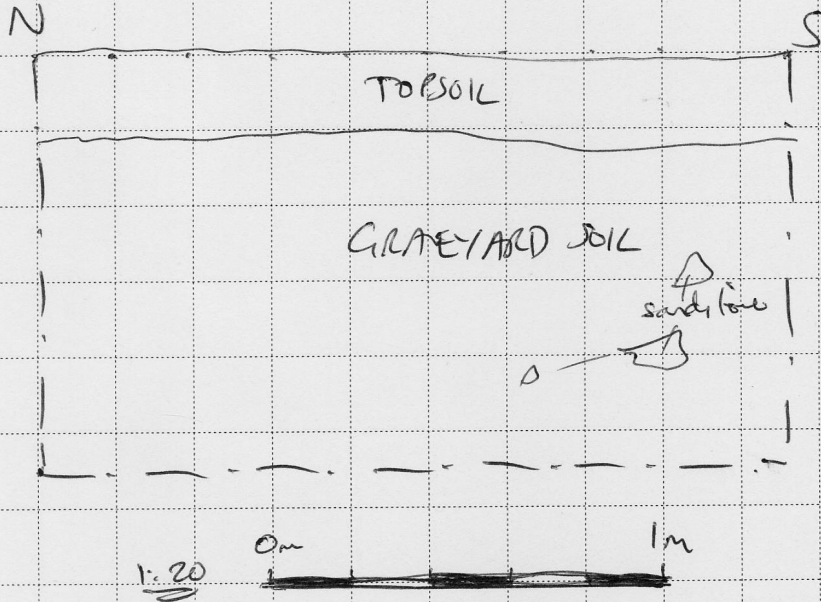
SECTION #1

section of soakaway.
