## **NORMANS FARM** **Willian, Herts.**

HN630

***Historic Building Record &  
Archaeological Monitoring Report***

Report no.403

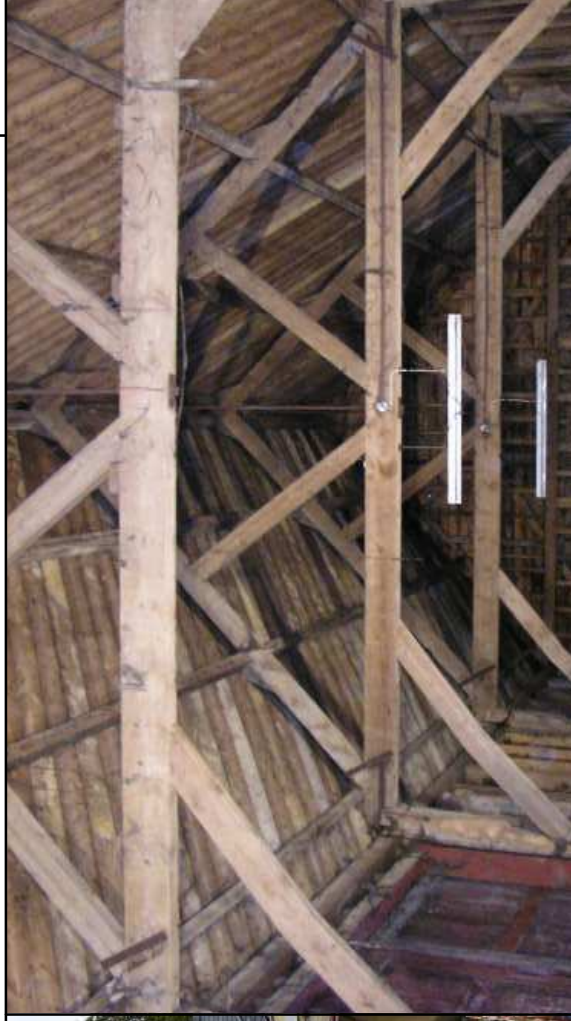
Plate 6: Barn 1 roof structure

**2.11** The roof structure consists of softwood trusses with raking queen struts and a central tie rod which splits at the top to brace the principal rafters (Plate 6). The trusses have iron bracing. There are four purlins supporting both slopes of the diagonally boarded, battened and slated roof, which has ridge tiles topped with a saw-tooth crest.

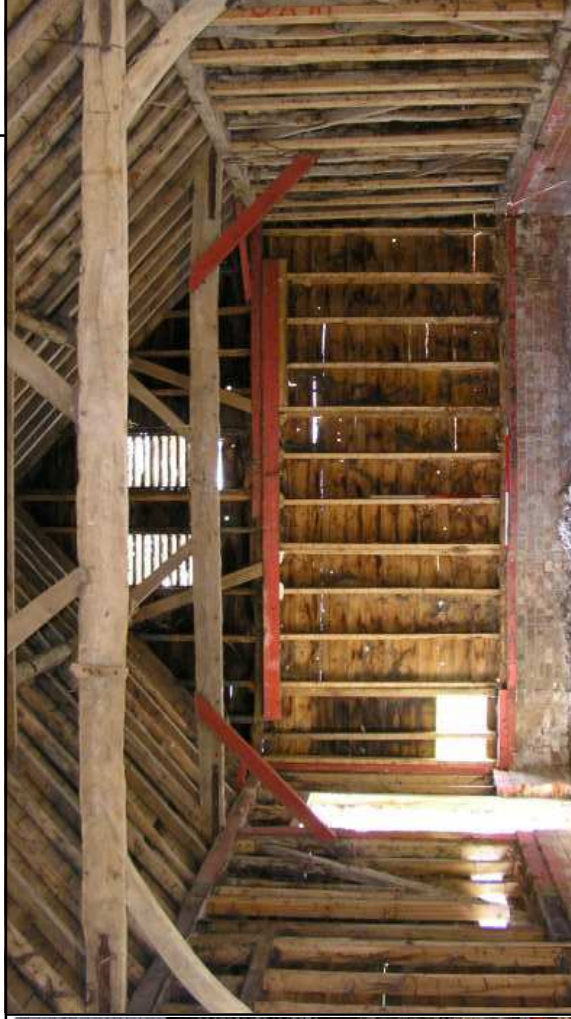
Plate 10: Barn 2, interior facing south

of the northern elevation. A pair of louvred openings have been inserted in the gable of the southern elevation (Plate 10).

**2.16** The surviving principal posts are reclaimed adzed timbers. The studwork is a mixture of reclaimed oak and softwoods, though the south elevation has been repaired using pre-fabricated panels (Plates 10 & 11).

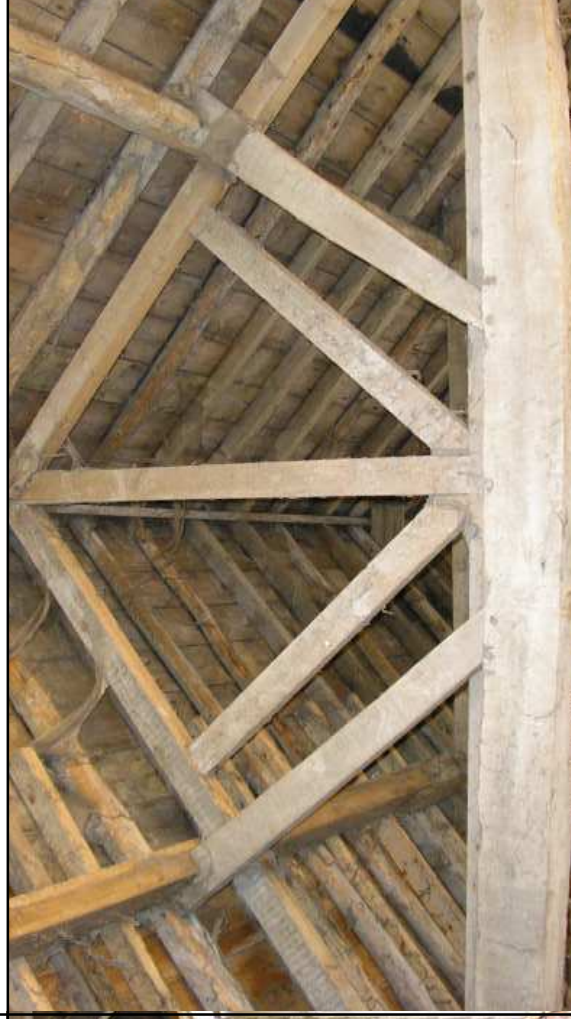
Plate 12: Barn 2, roof truss (detail)

**2.17** The roof trusses are oak with bark attached in places, and may also be reclaimed timber (Plate 12). There are raking softwood queen struts and curving braces in mixed woods. An additional truss doubles up the truss between Bays 1 and 2. The king post, which does not reach the apex of the roof, has raking struts in sawn softwood. The roof is slated with ridge tiles topped with a saw-tooth crest.

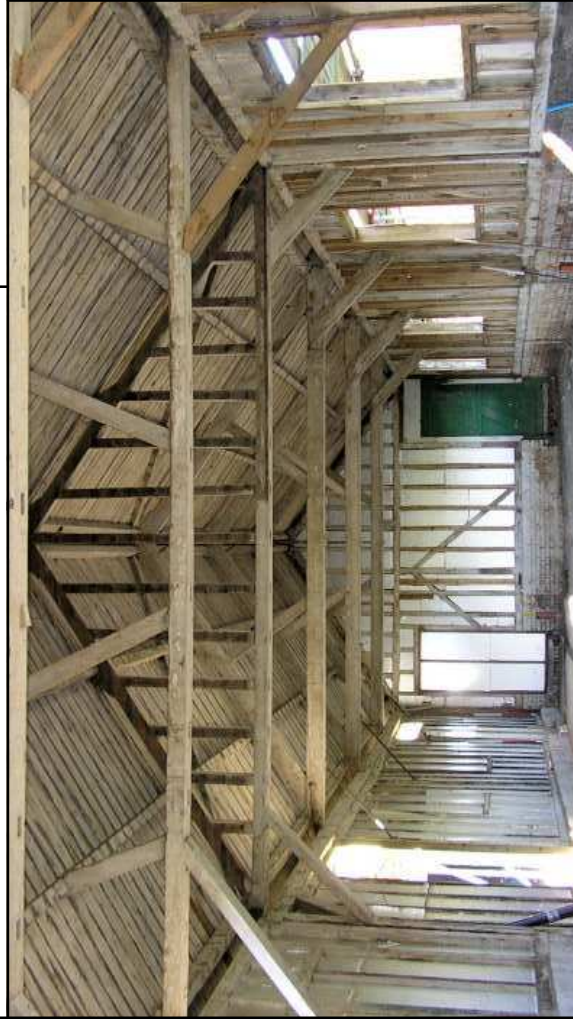
Plate 17: Barn 3, interior looking north

**2.19** Bays 1 to 4 appear originally to have been open to the west (Plate 17). The north and east elevations sit on a brick plinth, eight courses above the existing ground level, laid in Monk bond. Framing on the east elevation is formed of sawn softwood with diagonal bracing (Plate 18). Windows have been inserted into Bays 1, 2 and 4. The north elevation is similar in construction, but with two personnel doors to the adjacent barn to the north. The horn of the roof to this barn projects above the wall plate (Plate 17).

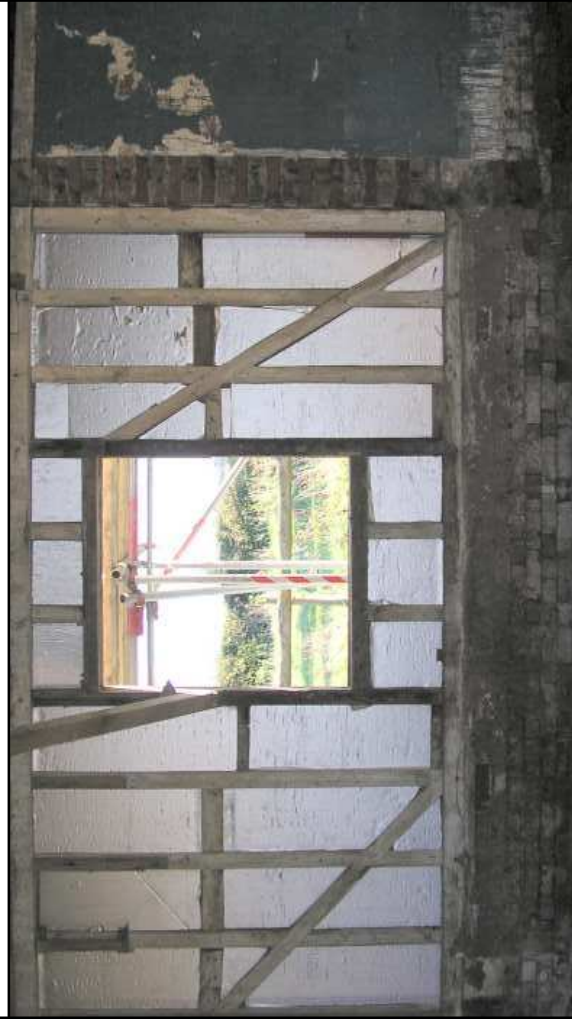
Plate 19: Barn 3, bay 7, east elevation

**2.25** The eastern elevation has window openings in Bays 5 and 7, which, on the basis of the diagonal bracing, may be original (Plate 19). The western elevation has blocked window openings in Bays 5 and 7, the sill having been chamfered to accommodate them (Plate 20), and a doorway in Bay 6, all of which are likely to be original. The southern elevation of this unit would have been formed of a solid brick wall, which had been demolished by the time the present record was made.

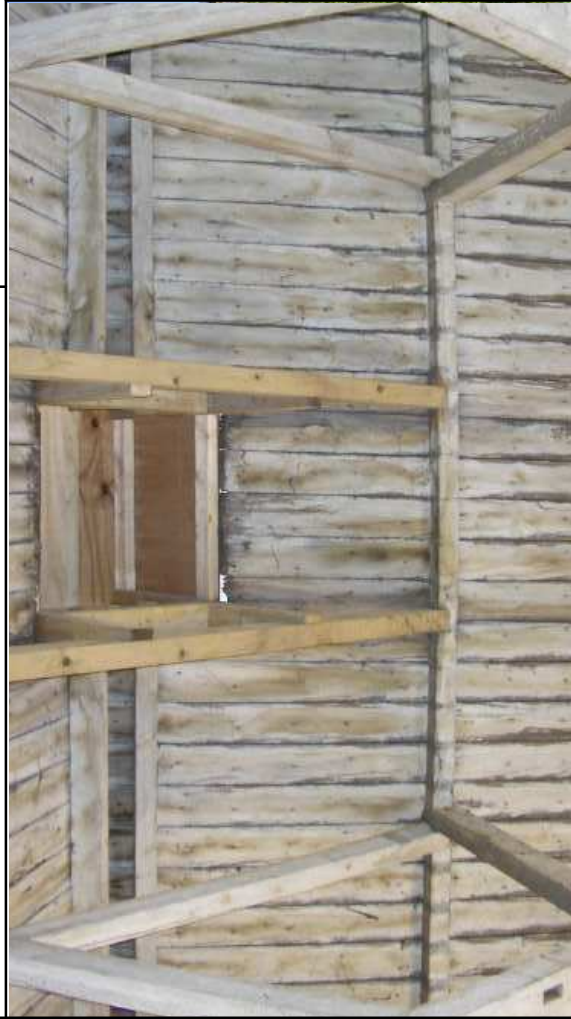
Plate 21: Barn 3, roof of bay 6 (detail)

**2.26** The trusses to Bays 5 to 7 are formed with two pairs of raking queen struts supporting a pair of purlins in each slope, and a collar. Mortice holes are visible in the bottom face of the tie-beams. A later projecting roof-vent or dove-cot has been inserted through the ridge in Bay 6 (Plate 21).

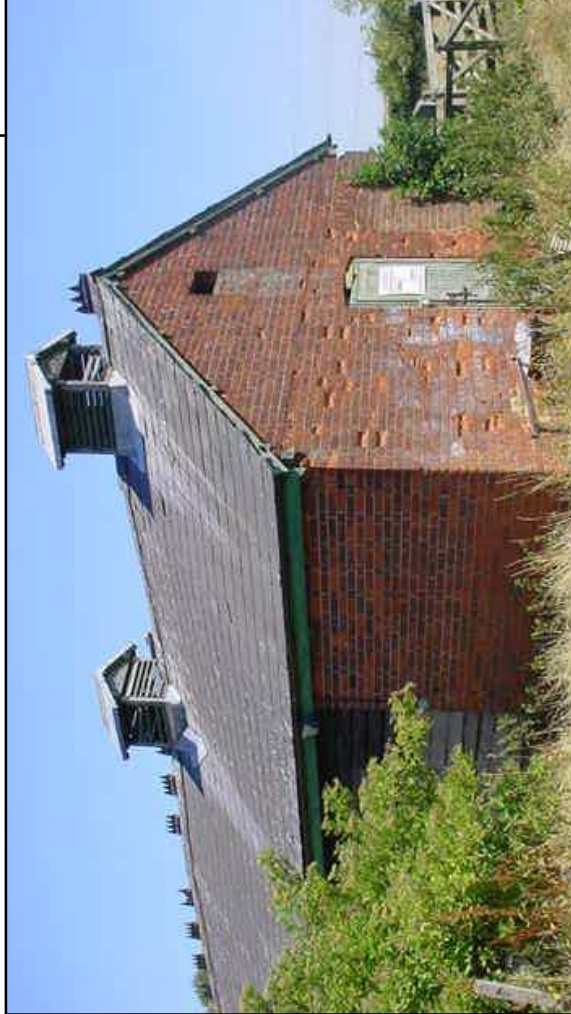
Plate 22: Barn 3, bay 8

**2.27** Bay 8 is entirely brick-built, in red brick laid in Monk bond (Plate 22). A door and high-level window are located in the southern elevation. A later projecting roof-vent or dove-cot has been inserted through the ridge.

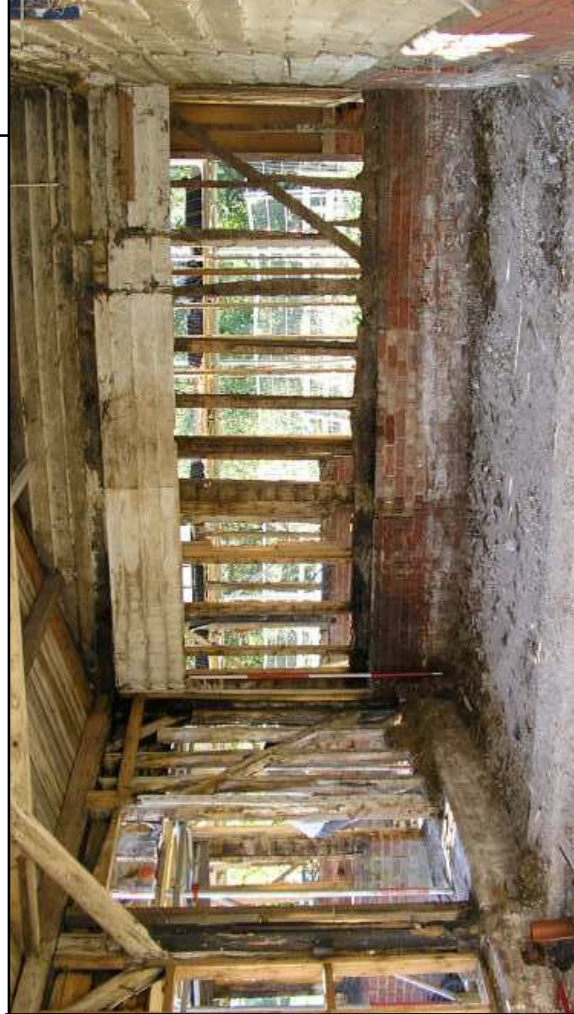
Plate 26: Lean-to, interior facing west

**2.29** The eastern plinth is original, rising five courses from the exterior ground level, and has a chamfered exterior top edge. The framing above is formed of sawn softwood with diagonal bracing to the north of an original personnel doorway (Plate 25). The western elevation has a central doorway blocked in Fletton brick, and the northern elevation has a blocked doorway into Barn 1, as previously noted (Plate 26).

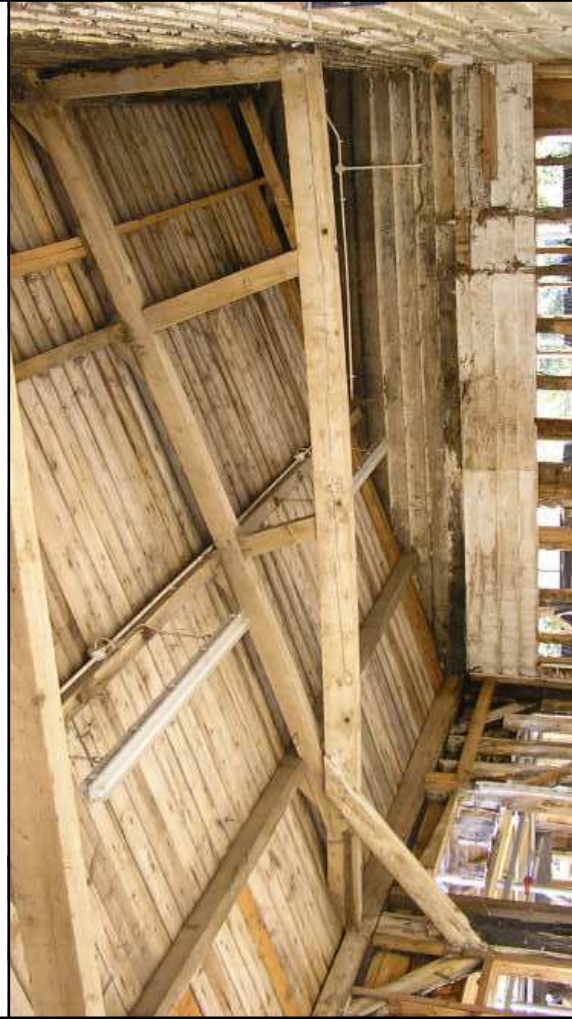
Plate 27: Lean-to, roof structure

**2.31** The roof structure is supported by half-trusses of sawn softwood with a pair of raking queen struts supporting purlins and a boarded and slated roof (Plate 27). The trusses are braced to the principal posts in the southern elevation, and are attached to the wall-plate of Barn 1 in the northern elevation.

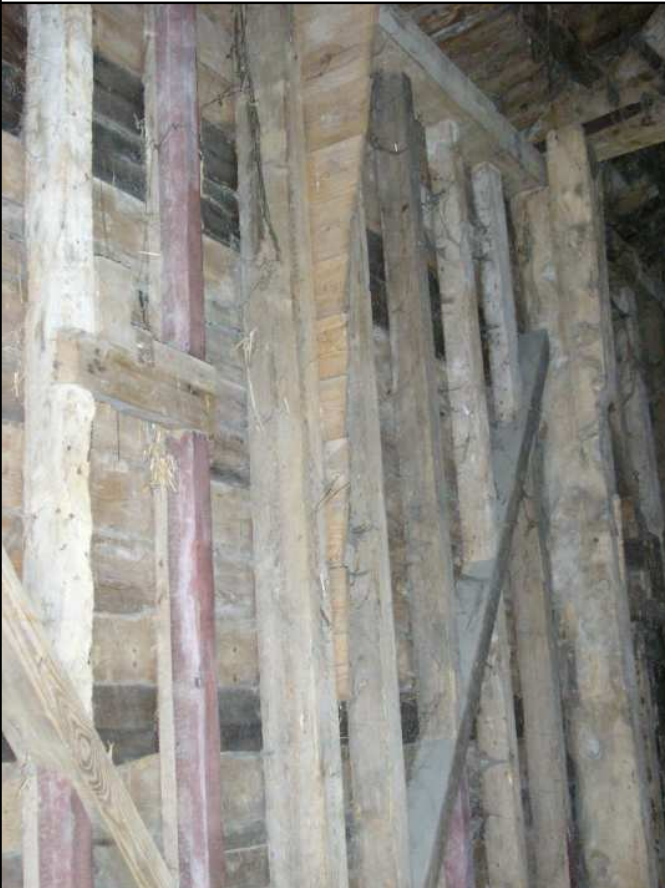
Plate 30: Barn 1, bay 2, partitioning (detail)

**2.13** The remnants of a tongue and groove partition is nailed to the mid-post of Bay 2 on the southern elevation (Plate 30) and two separate carpenter's marks were observed on a re-used stud at the western end of the southern elevation of Bay 4 (Plates 31 & 32).

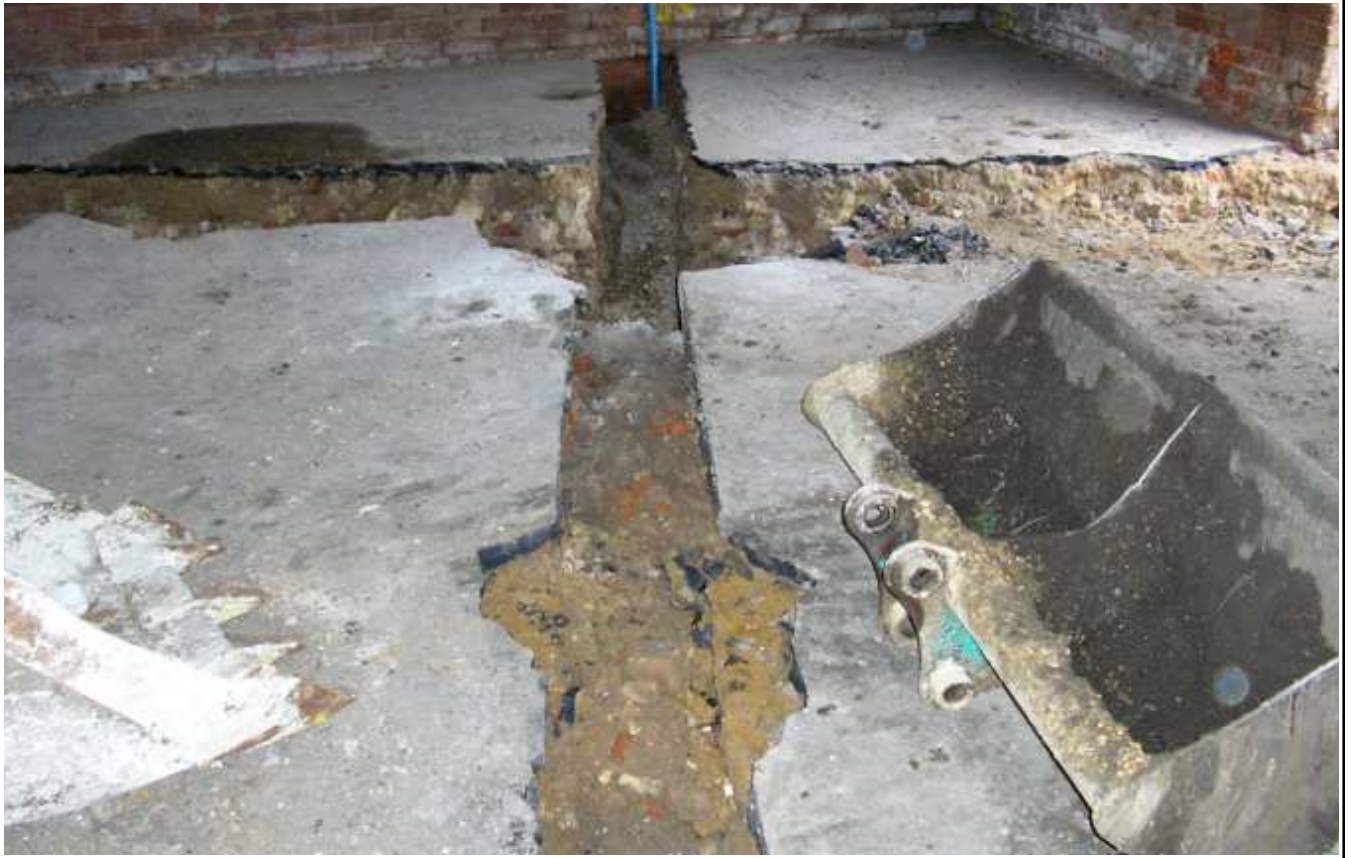
Plate 34: Trench 2 looking northeast

**2.34** In the northeast corner of Barn 1 a mortar layer was observed in the section of Trench 2, 0.3m below the existing floor level. This deposit may represent an earlier floor although it is at a lower level than that of the chalk layer outside Barn 1 (Plate 34).
