**CHURCH OF ST LAWRENCE**  
**Ardeley, Hertfordshire**

HN634

*Archaeological Monitoring Report*

Report No. 422

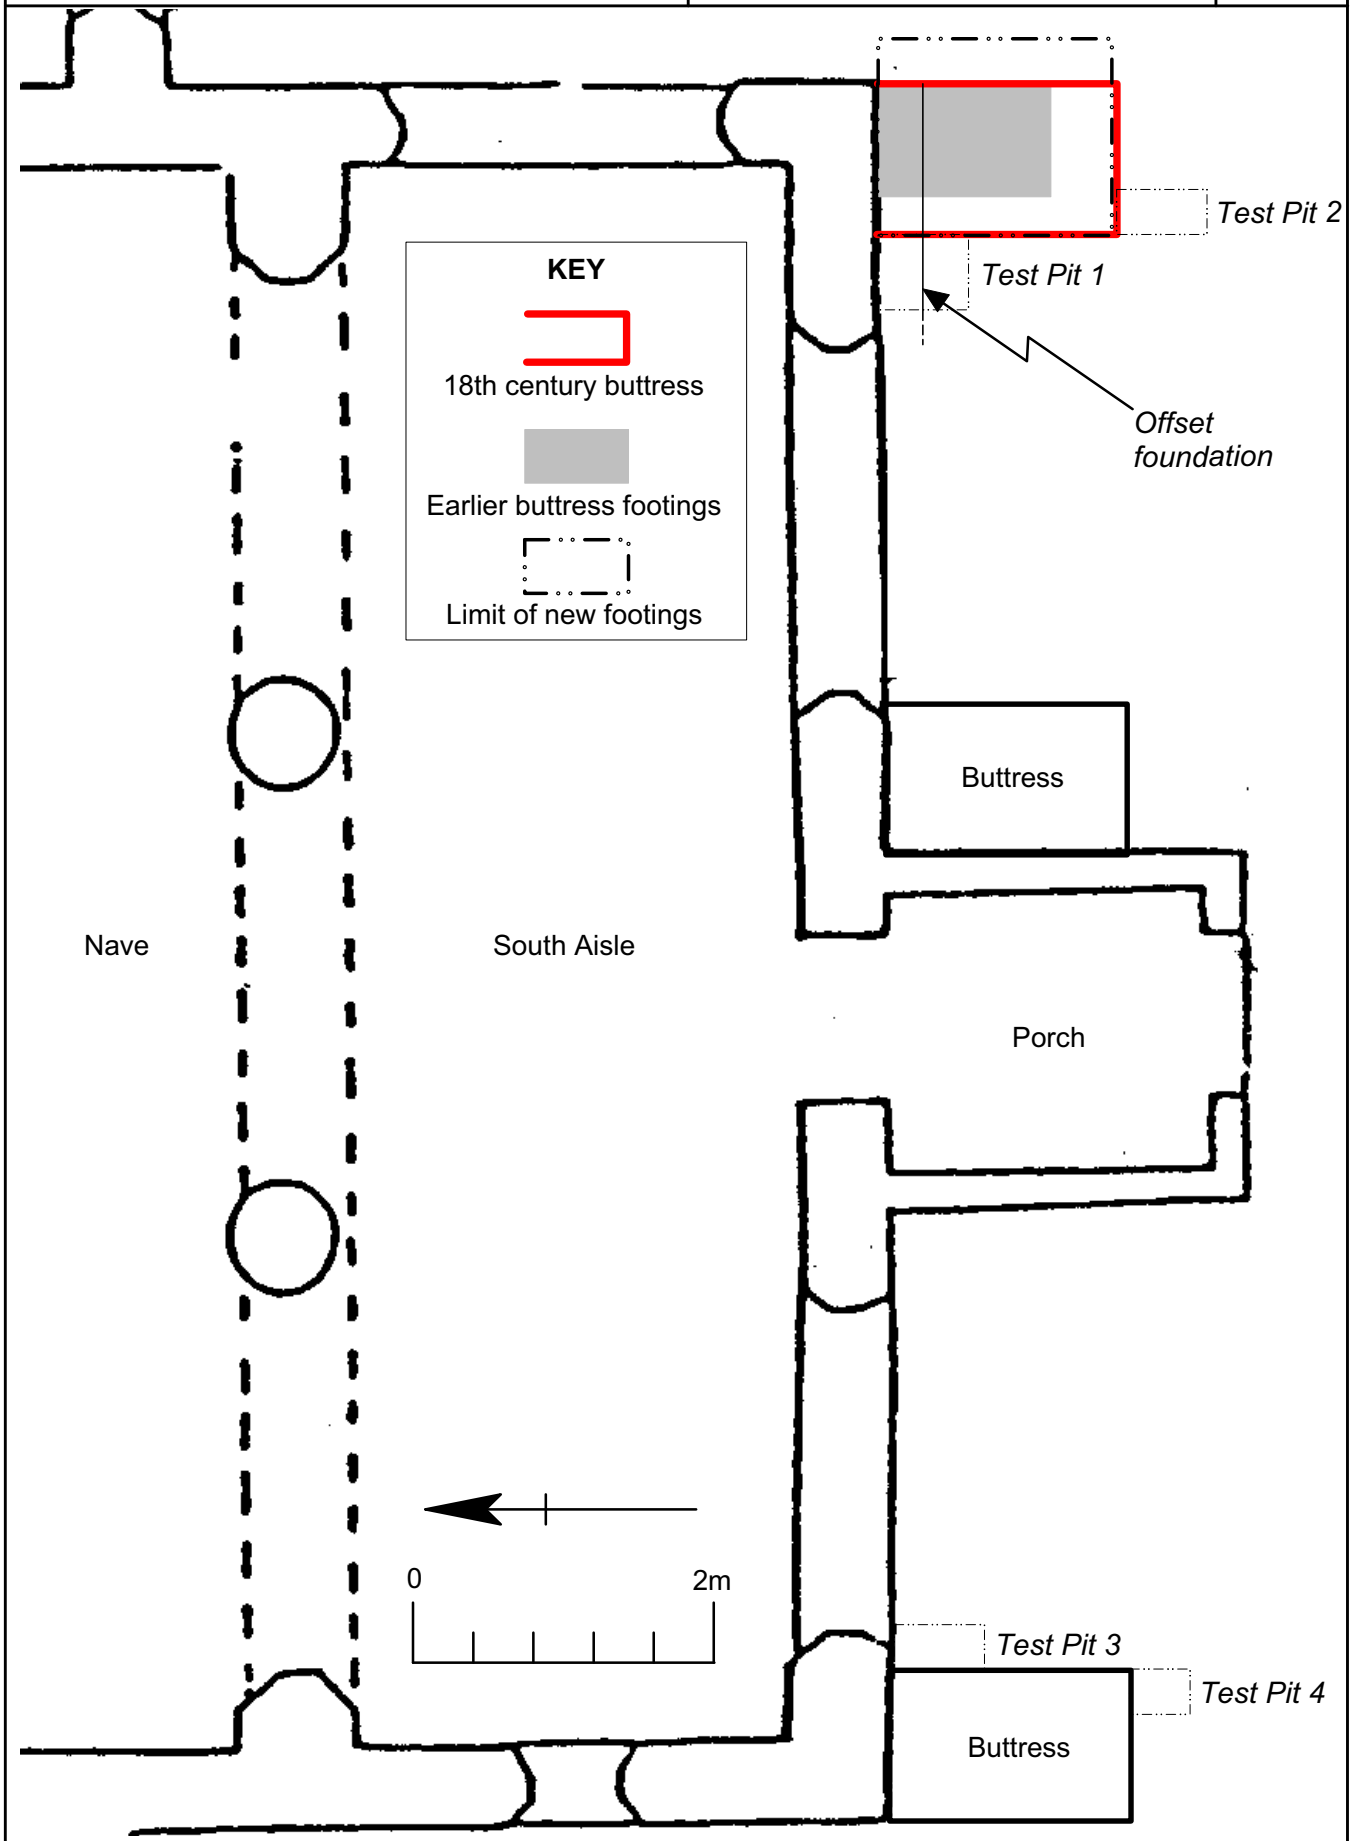
Figure 2

**2.7** The eastern buttress, which is constructed of flint, was observed to extend to a depth of c.0.2m below the existing ground level in Test Pits 1 and 2 (Figure 2; Plates 1a & b). No foundation was observed, the buttress appearing to rest on a layer of buried topsoil. The southern wall of the south aisle was observed in Test Pit 1 to rest on a footing constructed of flint and clunch, which extended to a depth of c.0.5m below the existing ground level, and stepped out by 0.3m. This footing was cut into the natural clay. The buttress appeared not to have been tied in to the aisle wall.

**2.8** The foundations of the western buttress and aisle wall were observed in Test Pits 3 and 4 (Figure 2; Plates 1c & 1d). Both were formed of flint and clunch, and included some re-used dressed stone. They were observed extending to a depth of c.0.4m below the existing ground level, and cutting into the natural clay. Once again, this buttress appears not to have been tied in to the aisle wall.

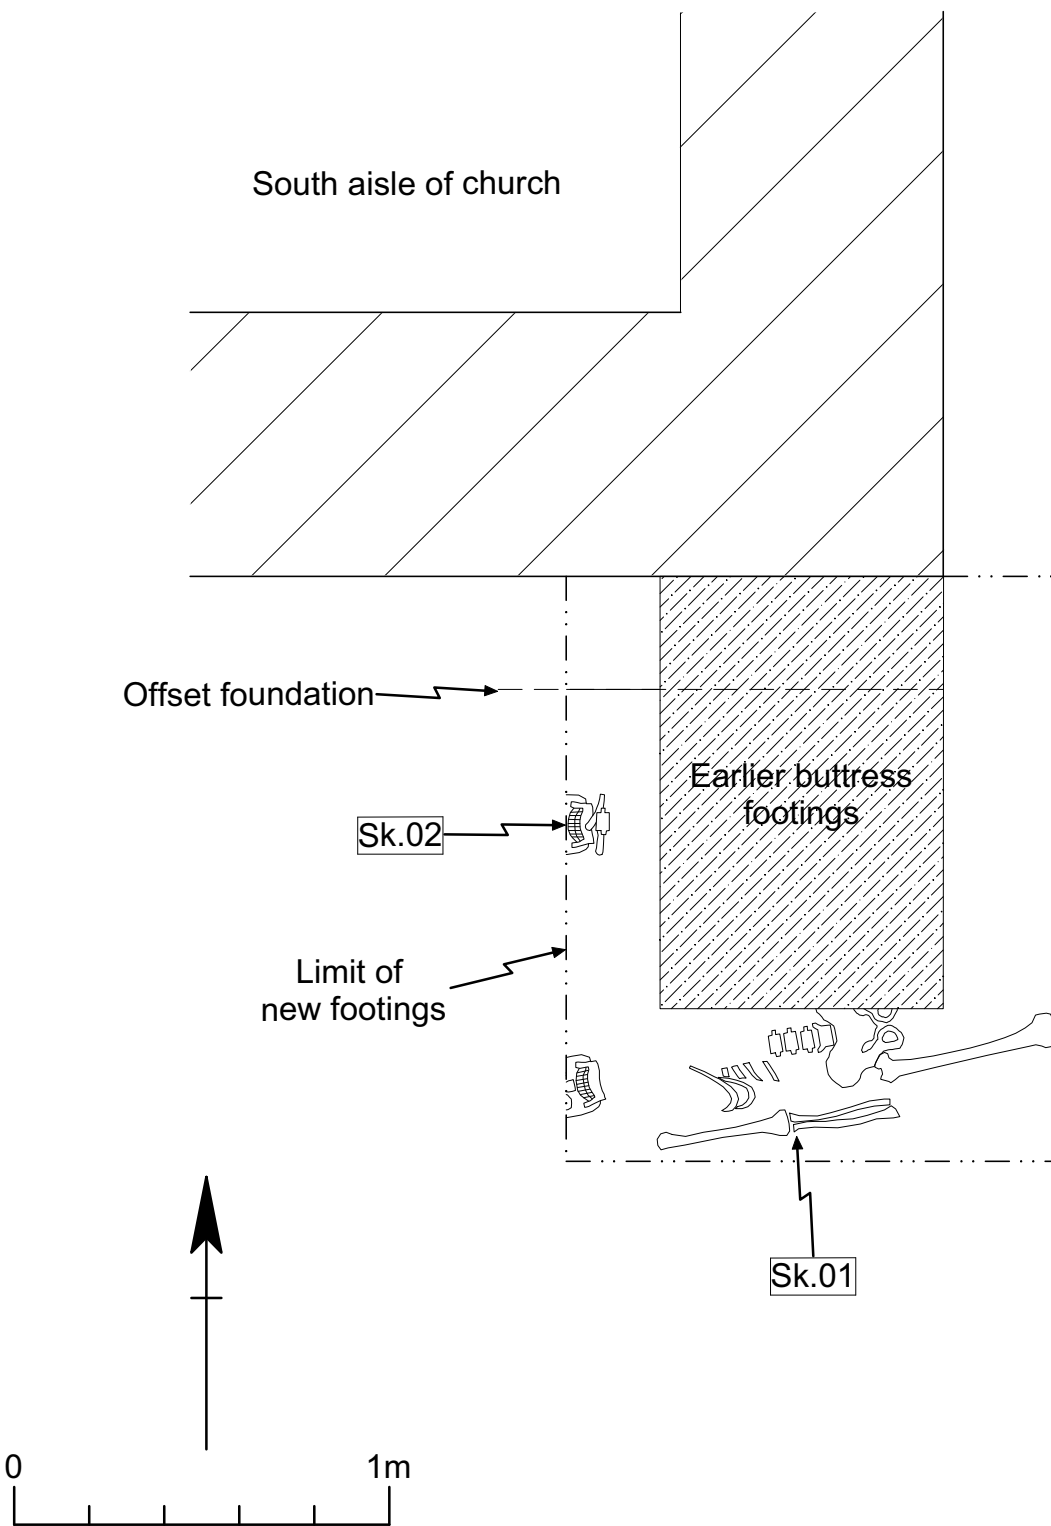
Figure 3

**2.14** The footings trench for the replacement buttress measured 1.55 by 1.30m and had a maximum depth of 0.9m below the existing ground surface (Figure 3). The stratigraphy consisted of a single layer of brown (10YR 4/3) silty clay to a depth of 0.8m. The footings for an earlier structure, probably another buttress, were observed within the trench on a smaller footprint than the demolished buttress. They measured 0.75 by 1.15m and extended from the south eastern corner of the south aisle wall with the northern edge lying flush against the south aisle wall overlying the wall's offset foundation course. The footings were of flint mixed with yellowish brown (10YR 5/8) sandy clay and extended to a depth of 0.8m. No dateable evidence was observed or recovered.

**2.15** Two burials were identified in the footings trench, both having been truncated by the previous building work (Figure 3; Plates 4a & b)). The affected skeletal material was cleaned, recorded and removed prior to being re-interred elsewhere in the churchyard. No dateable artefacts were observed or recovered in association with the burials.

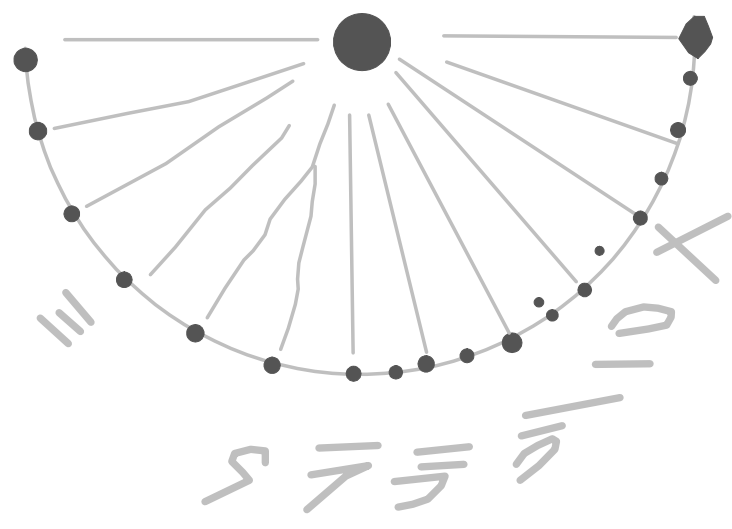
Top Dial

- The upper dial is located 1.32m (4'4") above the existing ground surface and is formed of an incised upright semi-circle, 0.18m (7") in diameter, with a central hole for a gnomon. Incised radii link the gnomon hole with pock marks and break the semi-circle into twelve sub-divisions. In the lower quadrant, additional intermediate pock marks have been added to each sub-division. Crudely carved Roman numerals are still just visible carved around the outside of the dial.

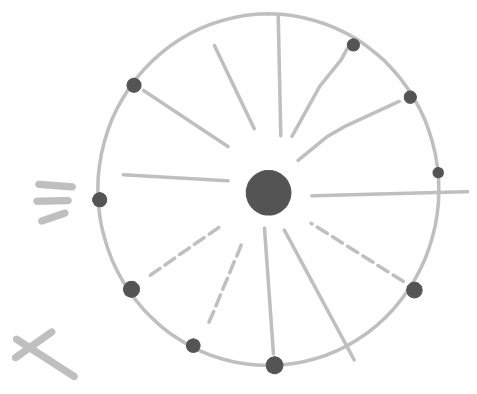
Middle Dial

- The middle dial is located 1.14m (3'9") above the existing ground surface and is smaller and simpler than the upper example. It is formed of an incised circle, 0.09m (3½") in diameter, with a central hole for a gnomon. Incised radii link the gnomon hole with indistinct pock marks and break the circle into twelve sub-divisions. Faint traces of crudely carved Roman numerals are just visible at the top of the dial.

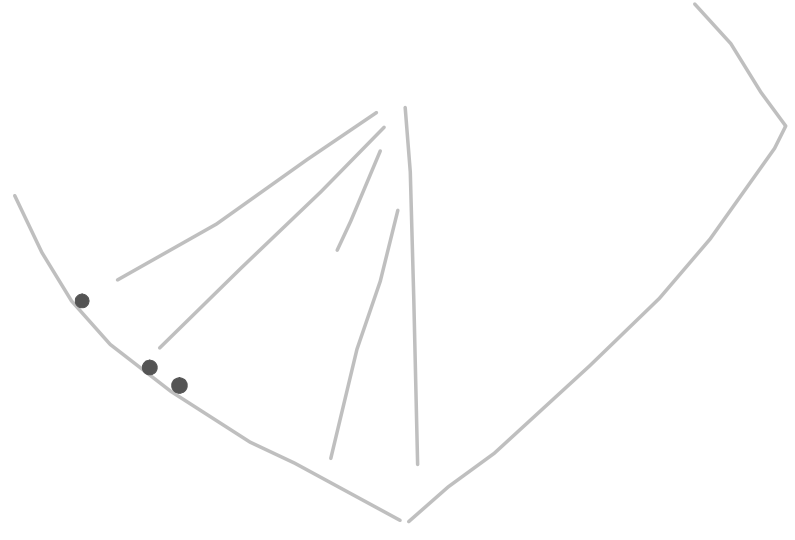
Bottom Dial

- The bottom dial is located 0.87m (34") above the existing ground surface and is very crudely rendered. It is formed of an incised upright sub semi-circle, 0.20m (8") in diameter, with faintly incised lines breaking the face into sub-divisions. The right-hand edge is weathered or broken and the full extent of the carving is uncertain. No gnomon hole is visible and it is unclear whether the radii were originally linked to pock marks. No numerals are apparent.

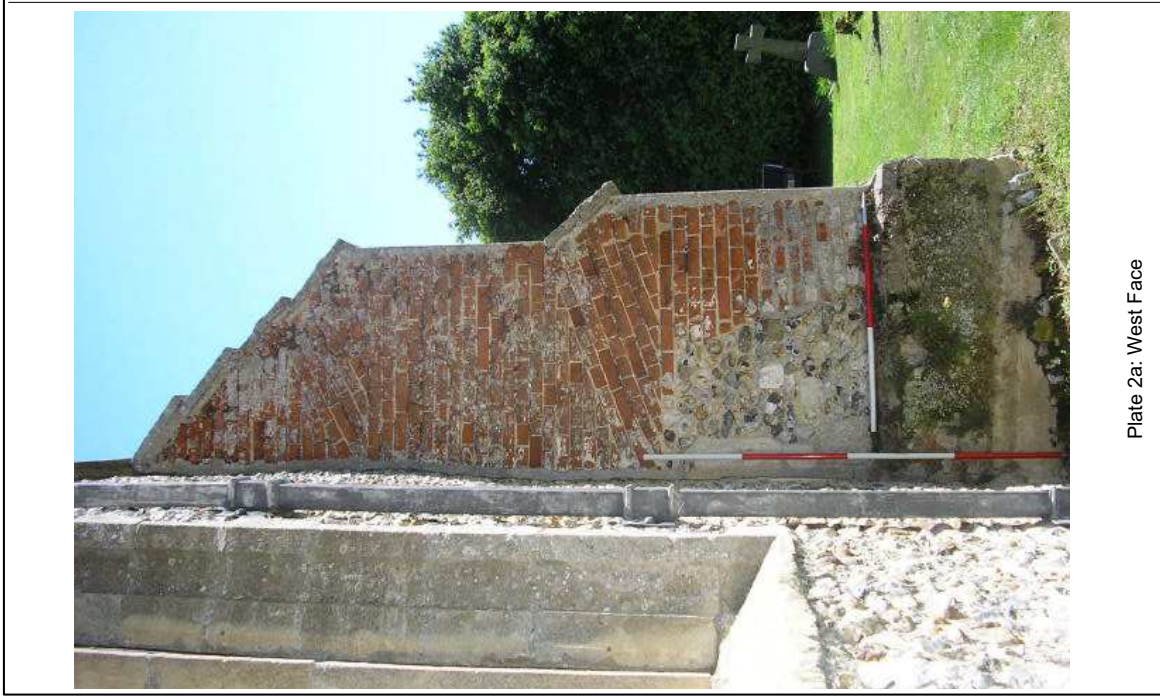
Plate 2a: West Face

2.11 The base of the buttress, measuring 0.91m wide and 1.51m deep, was constructed of rendered flint rising 0.68m from the existing ground level to a chamfered stone offset of 0.08m. Above this, the buttress reduced to 0.74m in width, and rose to a maximum height of 4.58m in two stages defined by weathering formed of limestone slabs (possibly reused gravestones).

2.12 The buttress was covered in a cement render on the south and east faces, with the exposed west face exhibiting a block of flint masonry adjacent to the aisle wall above the offset, measuring approximately 1.00m high and 0.75m wide, surrounded by a facing of tumbled red brick. As the buttress was demolished, the core was shown to be formed of loosely laid red brick. The flint masonry appears to form part of an earlier buttress, but, like the structure as a whole, it was not bonded to the aisle wall, and it overlay the aisle wall's offset foundation course. There was a gap between the buttress and the face of the south aisle which had been filled with a cement mortar.

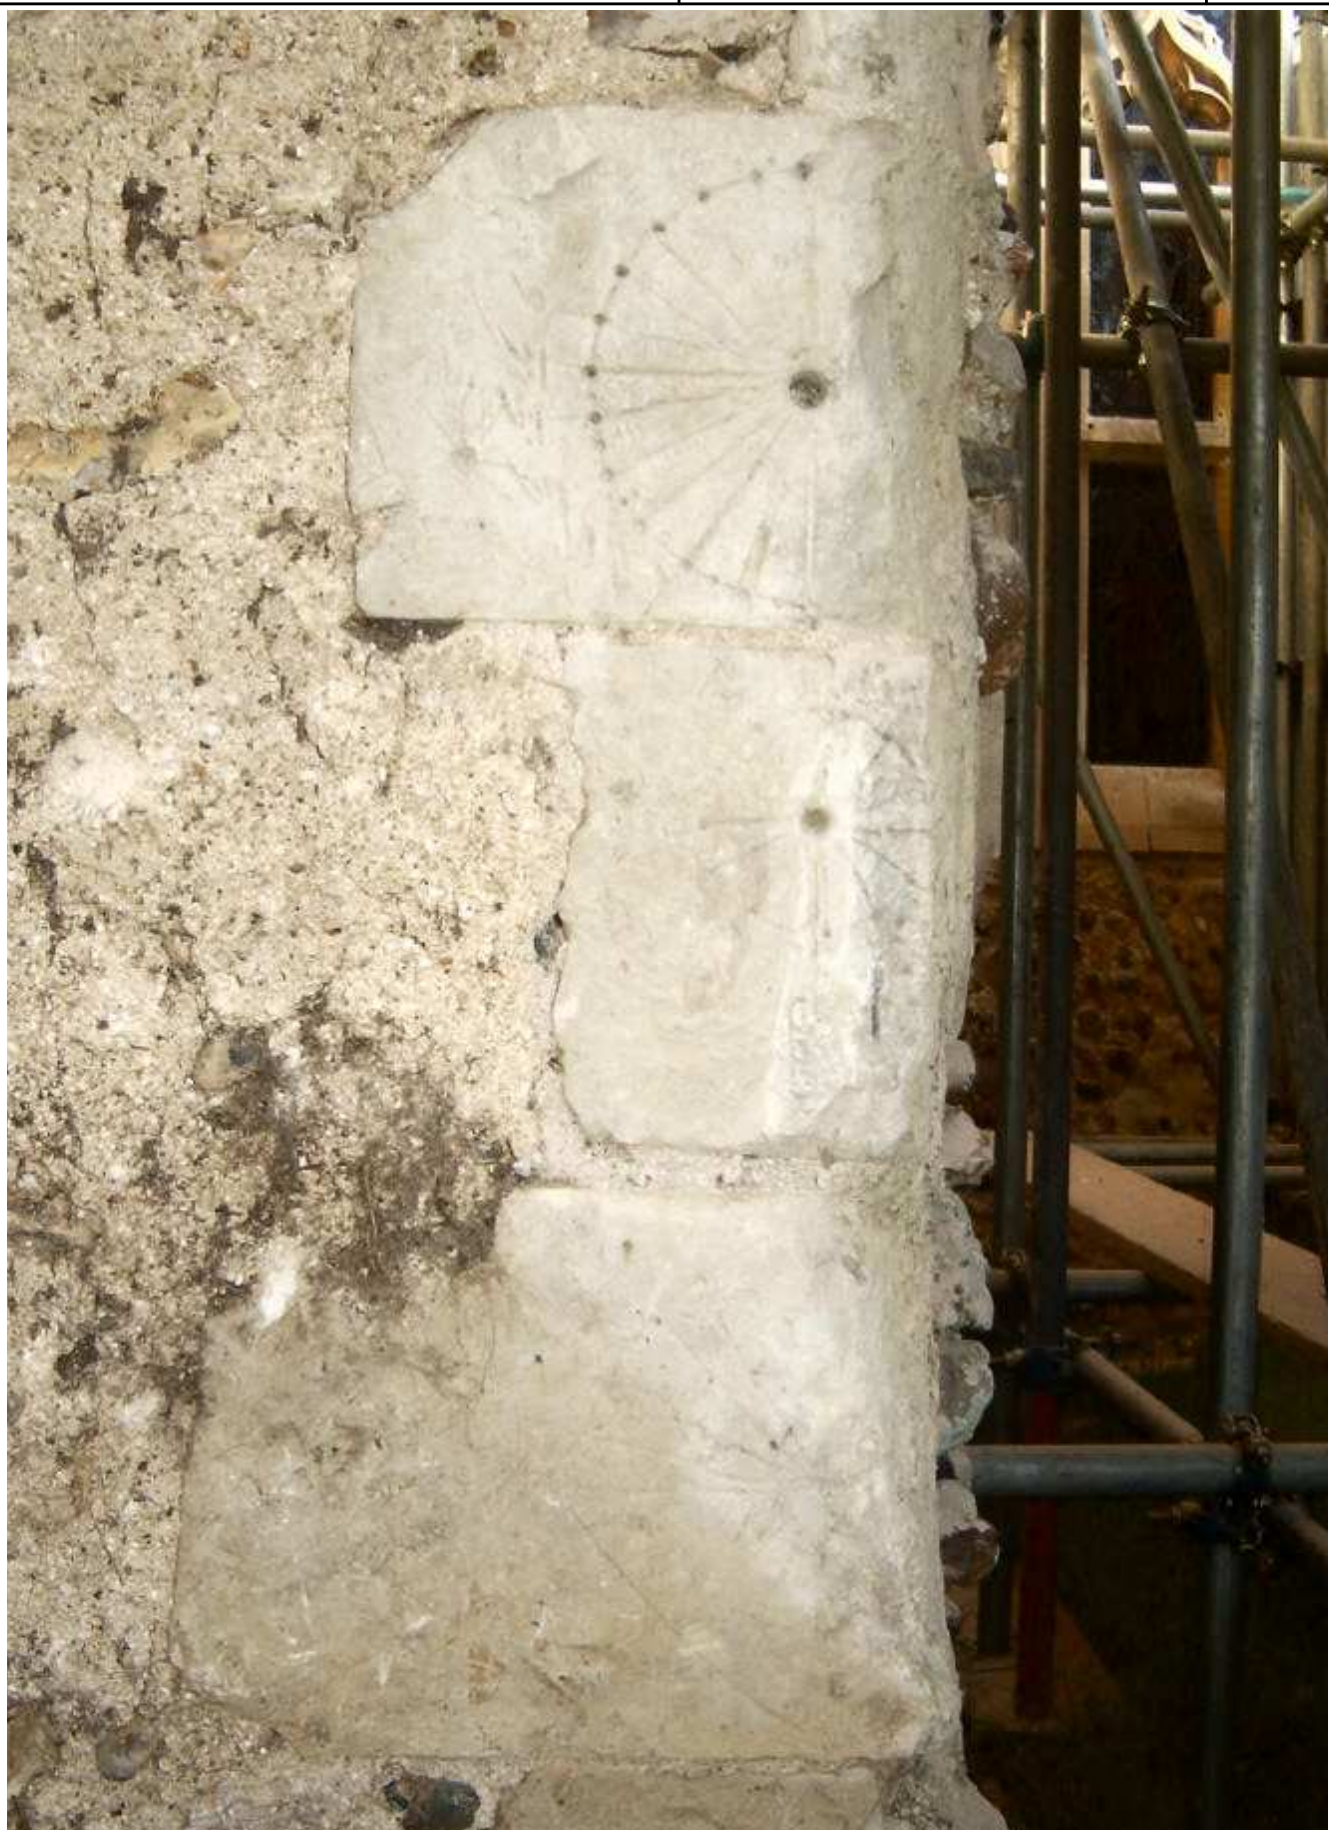
Plate 3

2.13 Once the buttress had been demolished, the clunch quoin stones of the south-east corner of the south aisle were revealed, as were traces of lime render adhering to the wall. The south face of three of the clunch quoin stones revealed incised mass-dials in different styles (Figure 4; Plate 3).

**3.5** The removal of the buttress revealed three mass-dials incised into the south face of three of the clunch quoin stones at the south-east corner of the south aisle. According to the British Sundial Society, which is compiling a gazetteer of such carvings, mass-dials (or scratch dials) are medieval in date and were usually located near to the main door or to the priest door of the church, at about chest height. Precise dating is difficult but, in general, the simpler the design, the earlier the dial. The presence of pock marks and numerals suggest a later date for the upper dial, possible 15<sup>th</sup> or 16<sup>th</sup> century. It is probable that these dials are not in their original locations, however. It is not uncommon for dials to have been repositioned in the course of rebuilding works and this would explain why the upper and lower dials appear to be positioned on their sides.

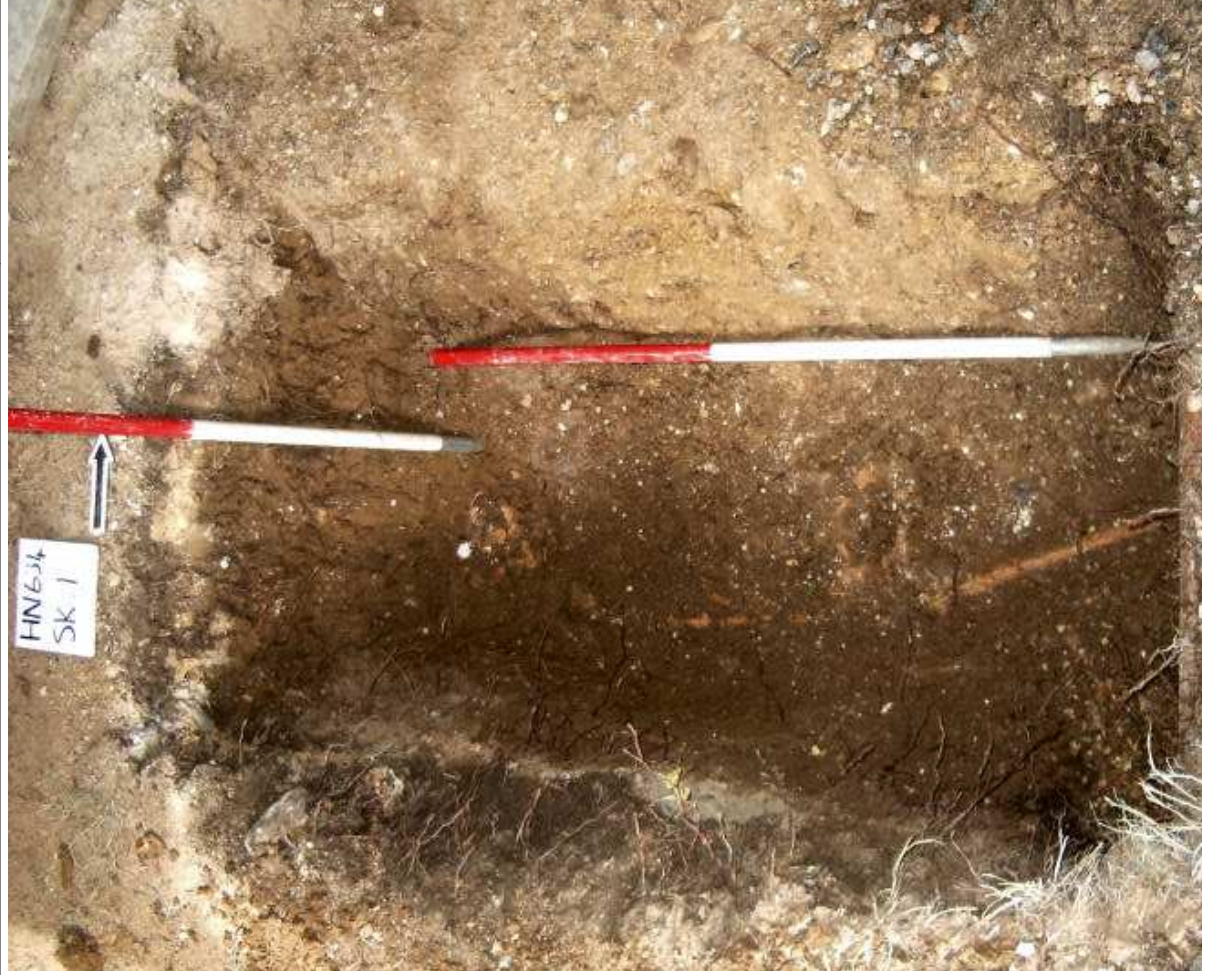
- Burial [01] was 0.8m below the existing ground surface and measured 1.35 by 0.4m. The skeleton was articulated and in a fair condition although most of the left hand side had been truncated by the earlier buttress footing. Fusion of the epiphyses had taken place in the observed long bones suggesting that the individual was an adult. The sex was indeterminate as both the pelvis and skull had sustained considerable damage. The skeleton was in a supine position and orientated east-west. No grave cut was visible within the trench.

Plate 4a: Skeleton [01] and early buttress footings

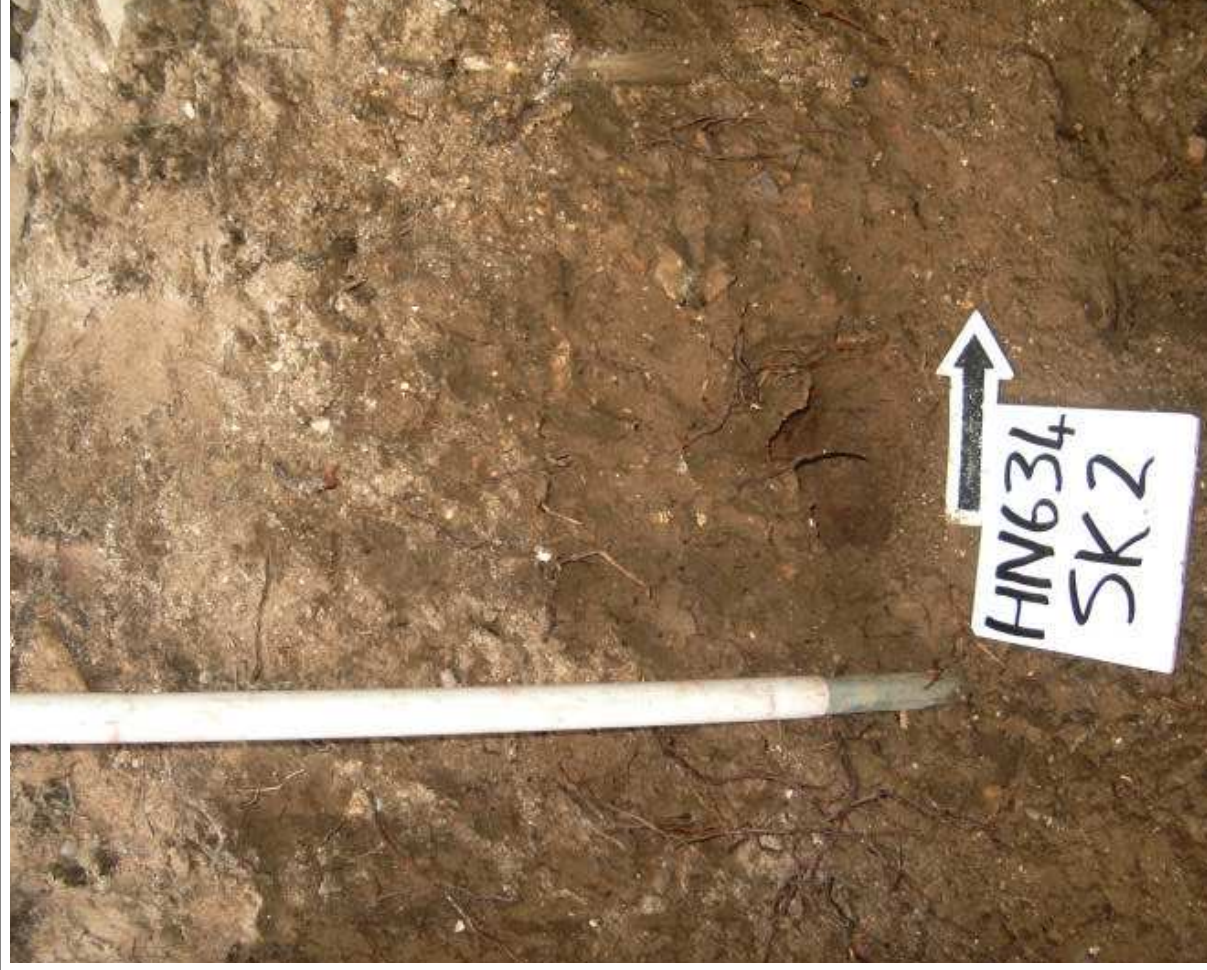
- Burial [02] was 0.6m below the existing ground surface and was largely disarticulated and fragmented, having been heavily truncated by the earlier buttress footing. Some of the bones are likely to have been redeposited. The bone was in fair condition and most probably adult. Due to the incompleteness of the burial, it was not possible to determine sex. There was no visible grave cut.

Plate 4b: Skull fragments from Skeleton [02]
