CHURCH OF ST NICHOLAS, NORTON, HERTS.

Report No. 440

At the request of the Norton Parochial Church Council, the Heritage Network was commissioned to monitor the excavation of a new drainage channel and soakaway at St Nicholas Church, Norton, Hertfordshire.

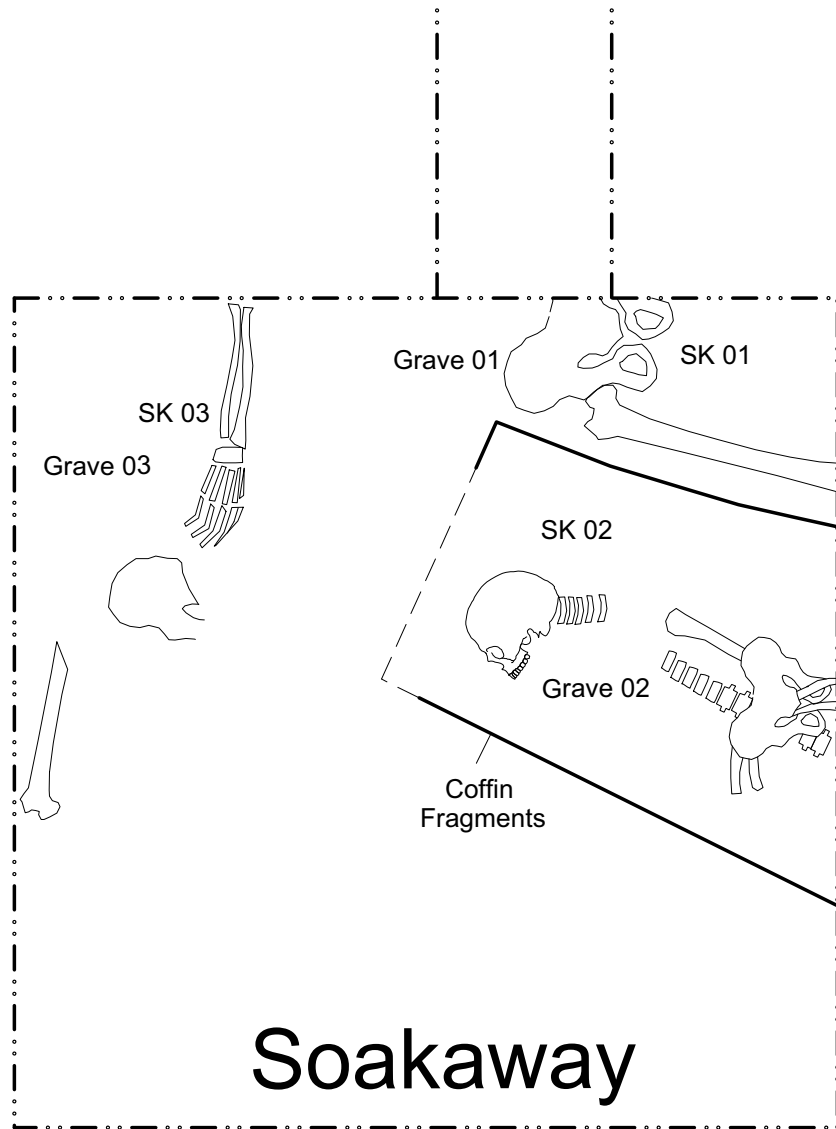
Three burials were encountered in the soakaway at the depth of 1m (Figure 3). The grave cuts could not be identified in the subsoil but the remains in Graves 1 and 2 were aligned NW-SE. Grave 3 was disturbed and

contained disarticulated remains broadly aligned N-S. Wooden coffin fragments were identified around Grave 2. The burials were recorded and, in keeping with current guidelines, the human remains were re-interred.

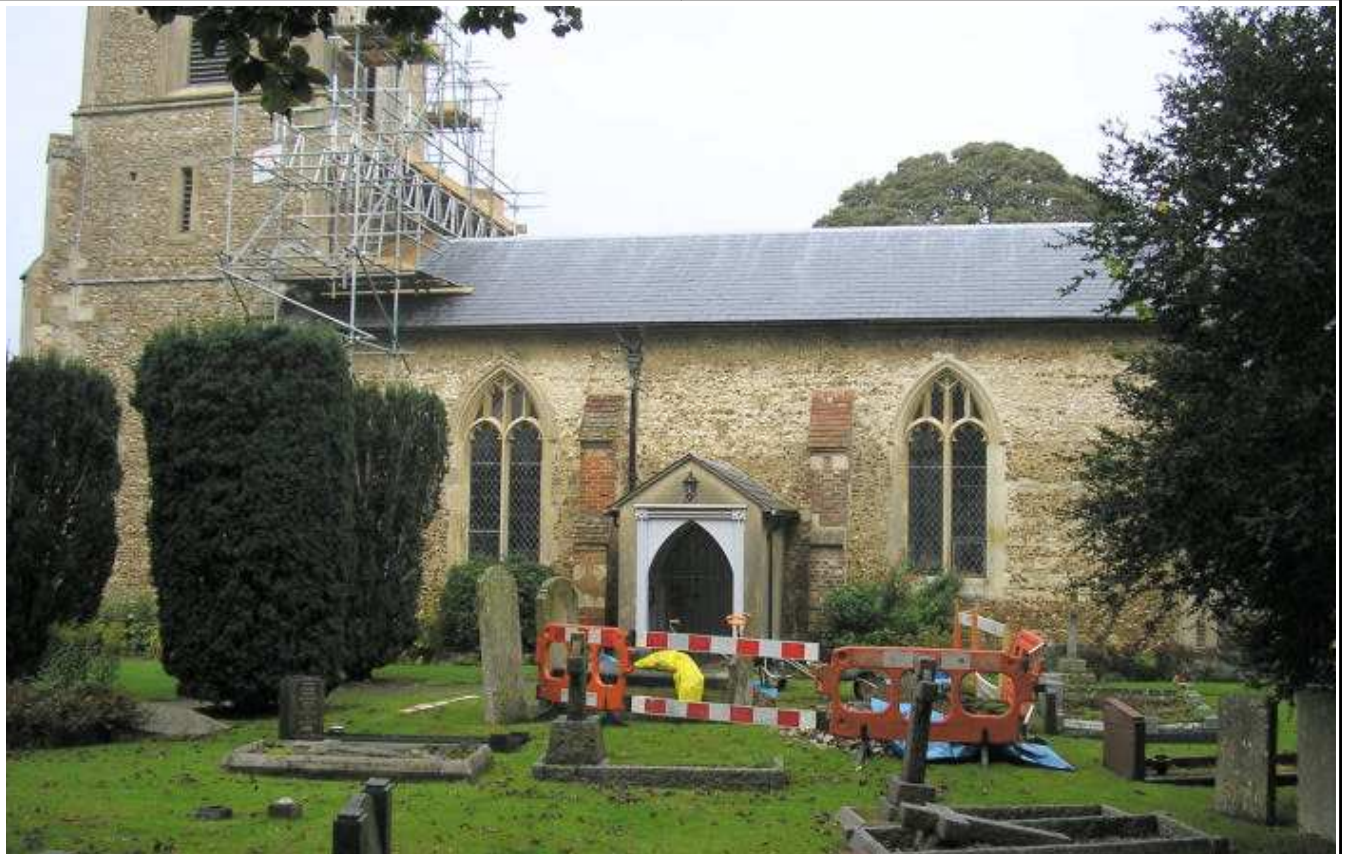
Plate 1: Study area, looking north

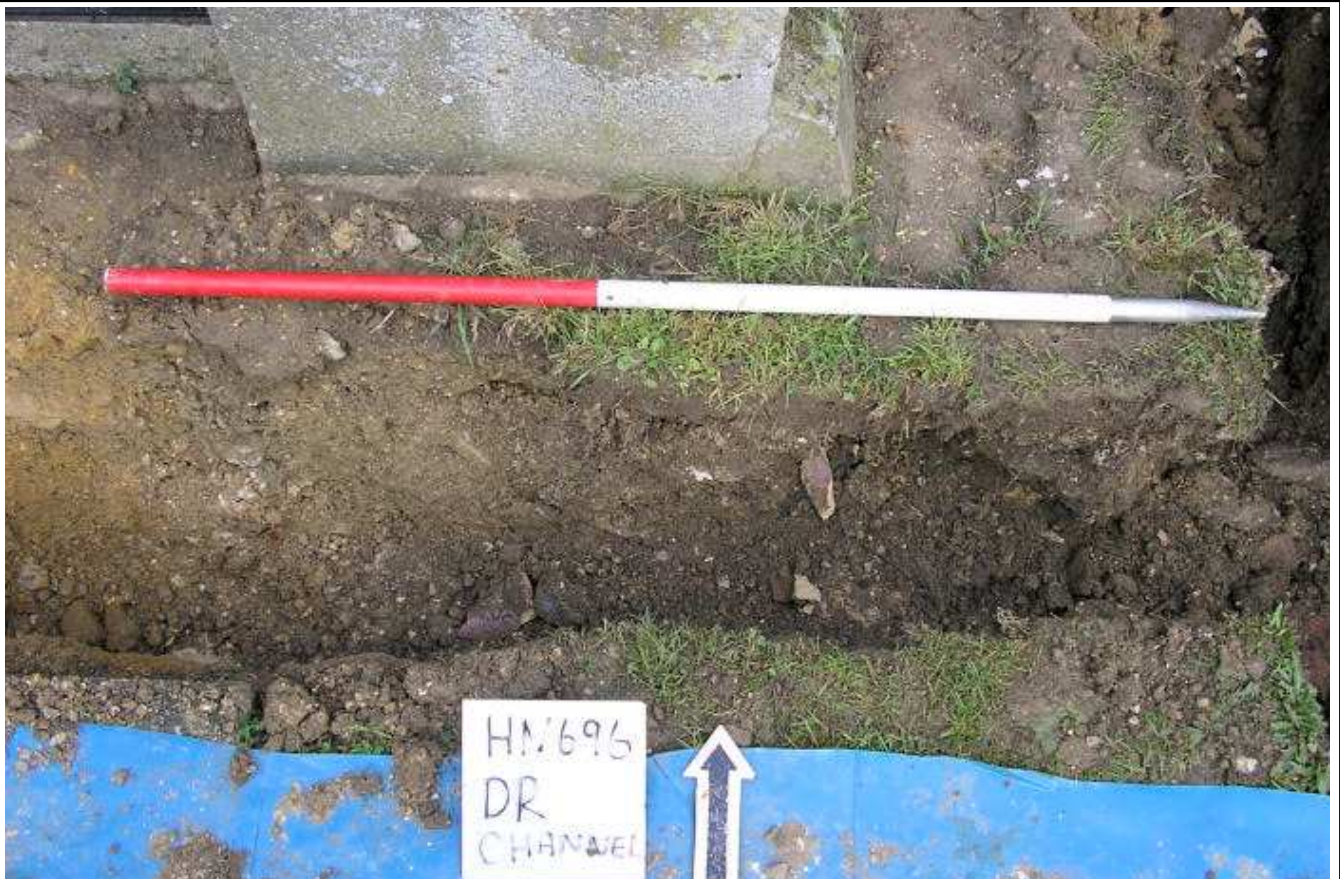
The drainage channel was excavated by hand and ran east-west around the front of the porch, and part way along its eastern and western elevations. It measured 5.75 m in length, had a maximum width of 0.38m and was 0.38m deep. A further length of drainage channel extended approximately 4m southwards from the south-eastern corner of the porch passing under the existing pathway. This section was 0.33m wide with a depth of 0.5m (Figure 2). The general stratigraphy of the drainage channel consisted of a layer of very dark grey (10YR 3/1) silt topsoil, 0.10m in depth, over dark brown (10YR 3/3) silty clay subsoil with occasional medium flints. The channel crossed a paved area directly in front of the porch entrance below which was a make-up layer of sand and shingle, 1.10m in length. Some modern brick rubble and CBM were observed within this layer but not collected.

Plate 2: Drainage trench at base of porch, looking north

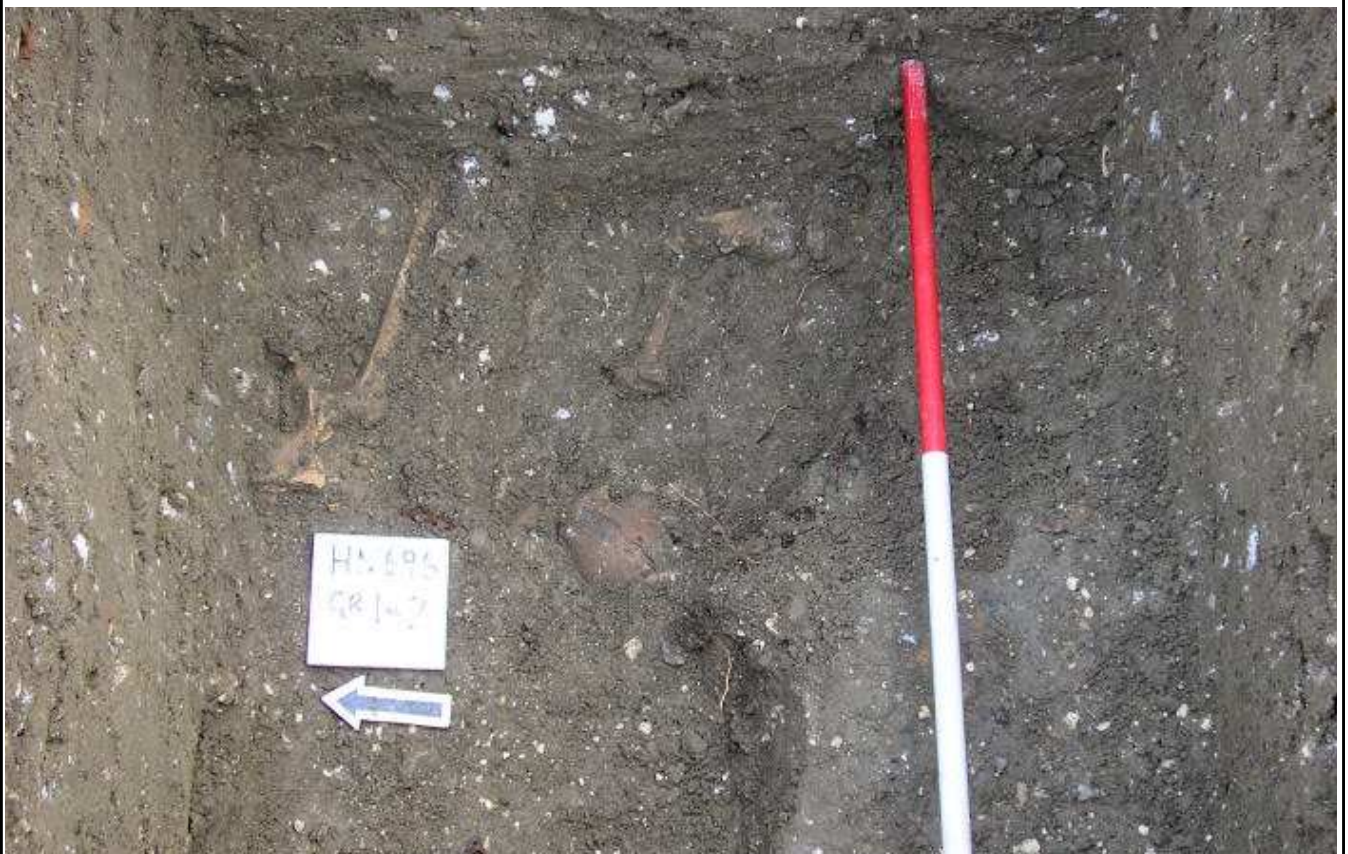
Plate 3: Graves 1 and 2, looking east

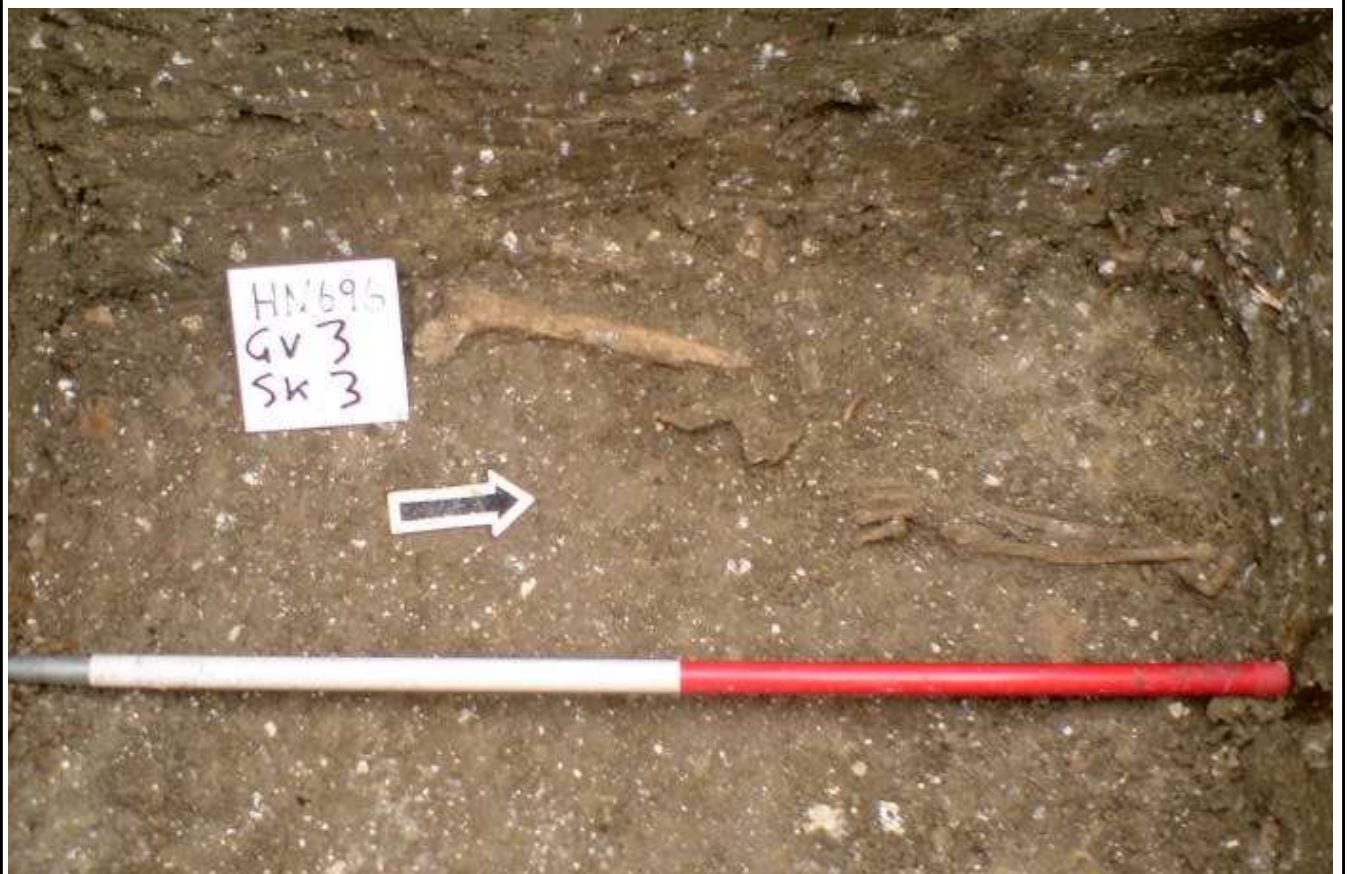
Plate 4: Grave 3, looking west
