## **CHURCH FARM HOUSE** **Clothall, Herts.**

***Historic Building Record  
& Archaeological Monitoring Report***

Report no. 454

*February 2008*

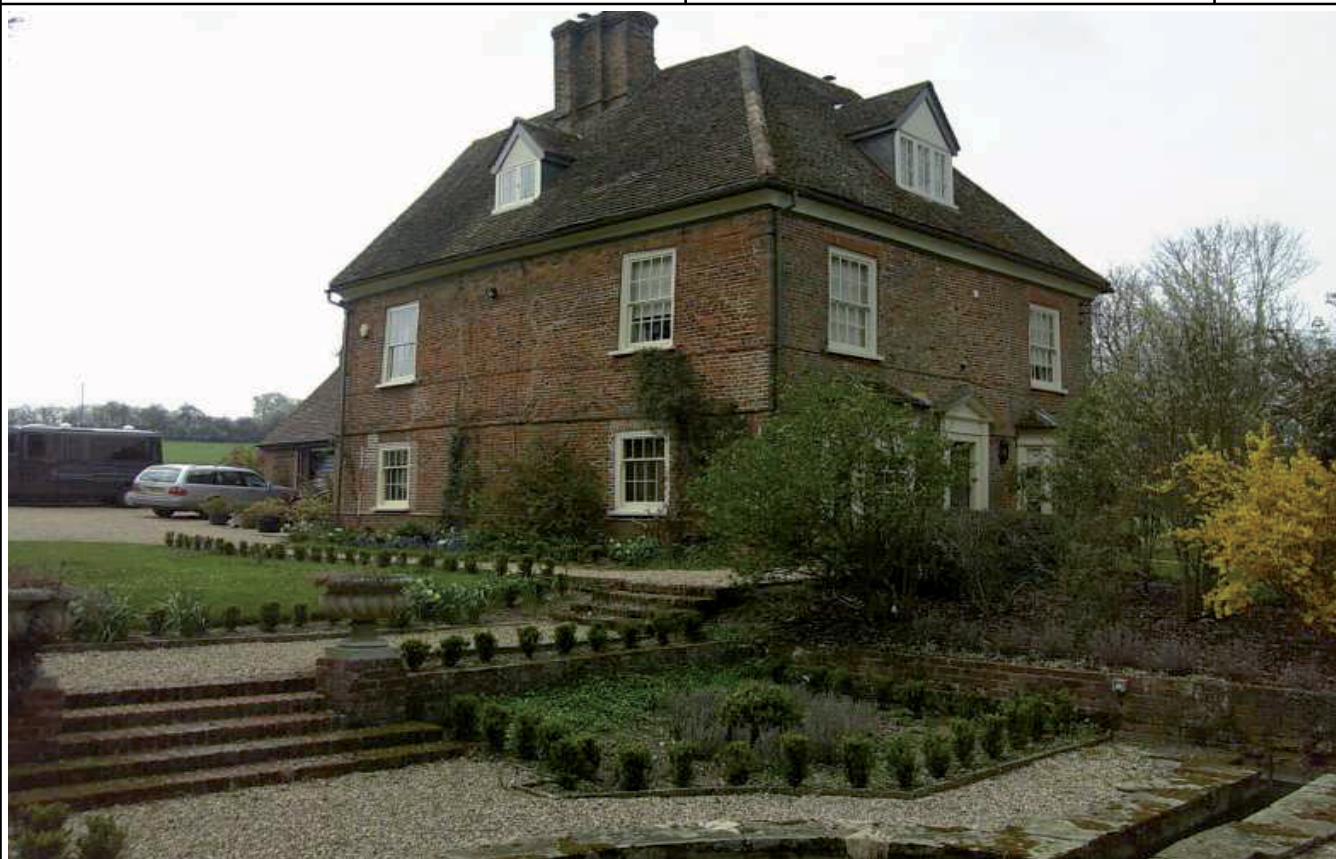
**2.12** The northern block to the main house is a Grade II listed building of two storeys and attics (IoE number: 162243) (Plate 1). It is described as being late 17<sup>th</sup> century in date, with a possibly earlier core, and some late 18<sup>th</sup> century details. It is timber-framed, with red brick casing and a hipped tile roof. The rear (south) elevation is plastered. The house is square in plan, with two rooms on either side of a central cross passage. The stairs rise from the western side of this passage, the chimney stack from the eastern side.

Plate 1: View of the main house, looking south-east

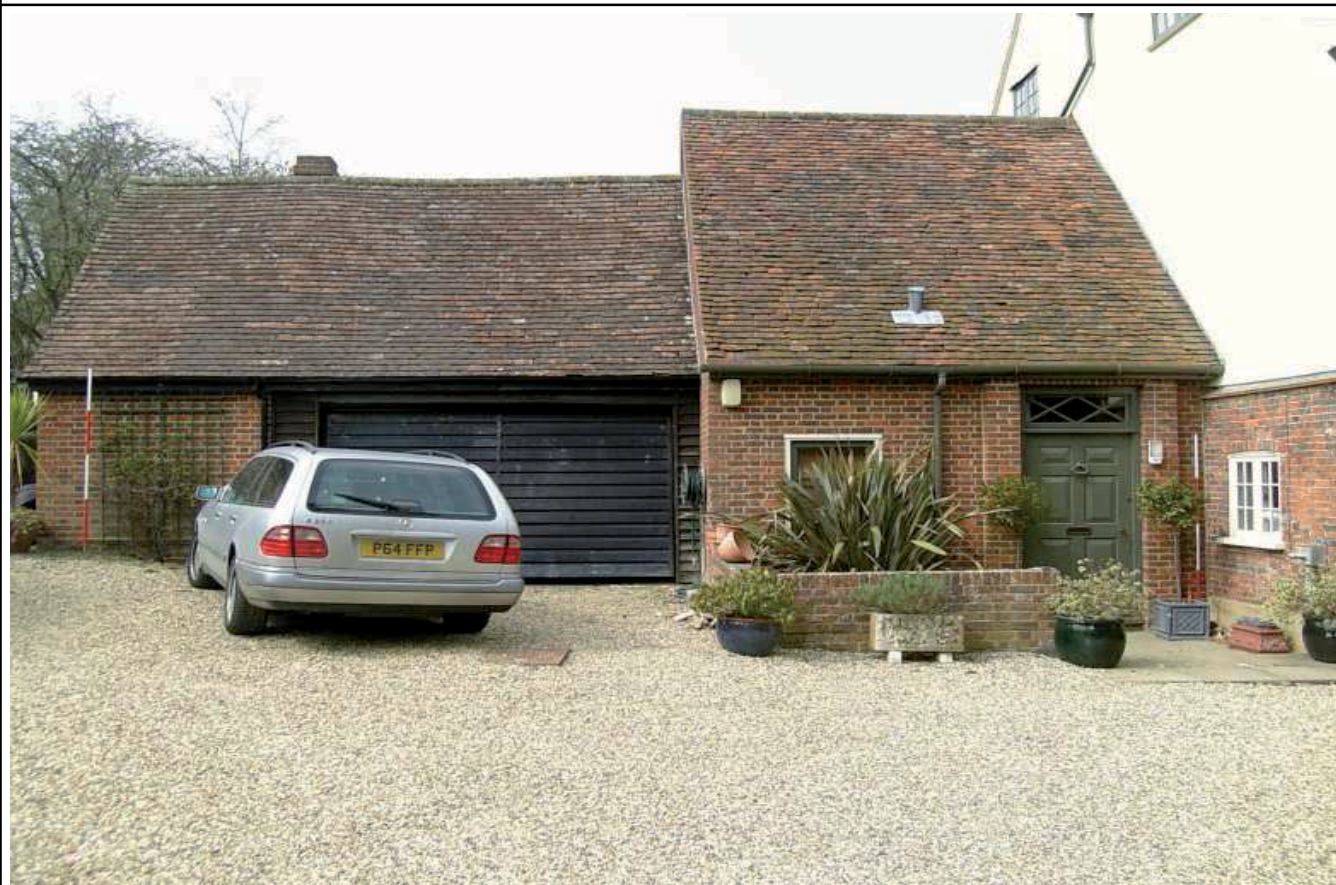
**2.15** The eastern elevation of the utility room has a doorway at the northern end with a window to the south. The brickwork in this area is laid in Flemish bond and appears to be modern, with modern pointing. The garage to the south has a double up-and-over door, set within wooden weather-boarded framing. To the south of the framing the upper brickwork is apparently modern, with modern pointing, but appears to be sitting on an earlier dwarf wall with surviving lime mortar (Plate 2).

Plate 2: Eastern exterior elevation, garage and utility room, looking east

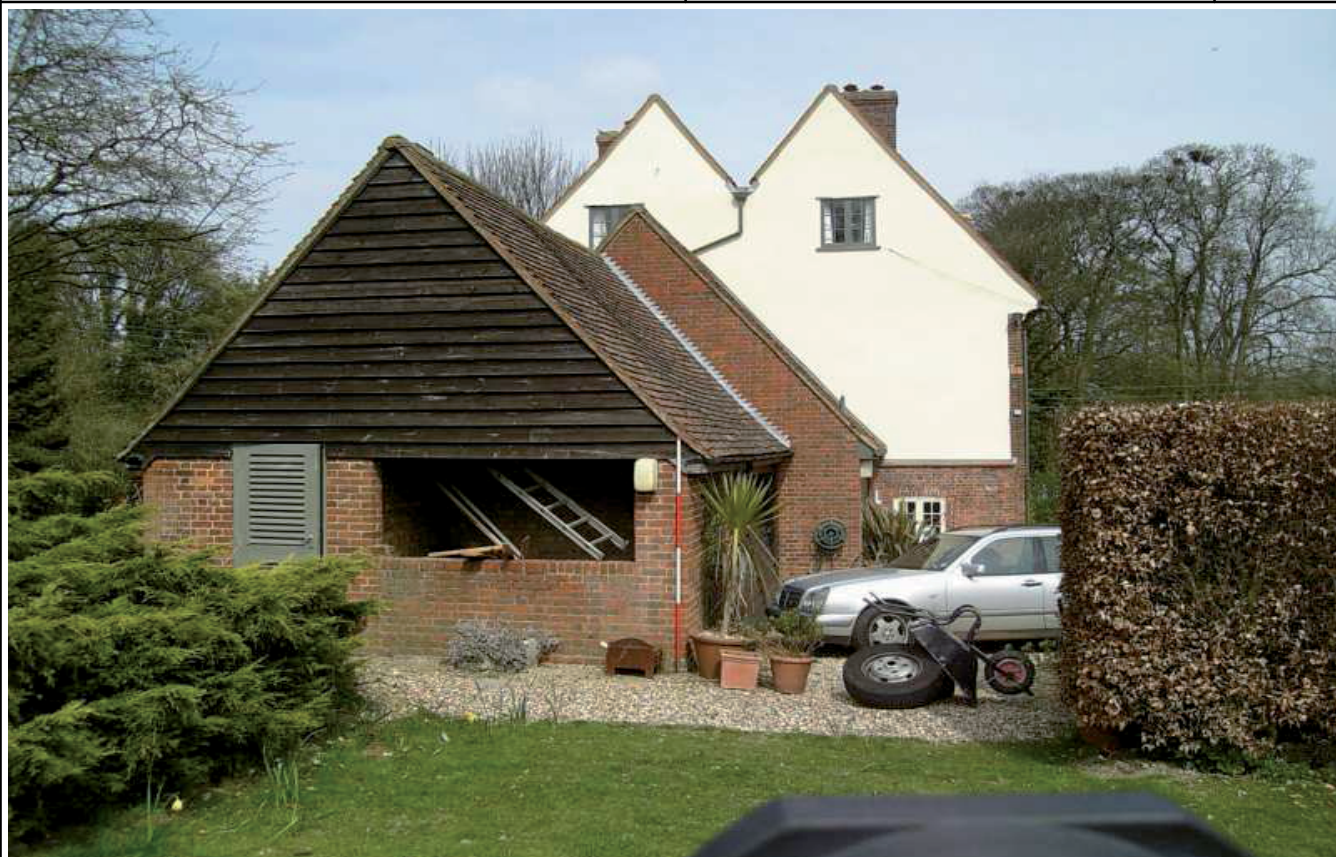
**2.16** The southern elevation has a door at the western side, with a former window opening, now blank, to the east. The brickwork is laid in stretcher bond and appears to have been extensively remodelled and re-pointed, but again appears to be sitting on earlier brickwork with surviving lime mortar. The gable is weather-boarded above door and window height (Plate 3).

Plate 3: Southern elevation, looking north

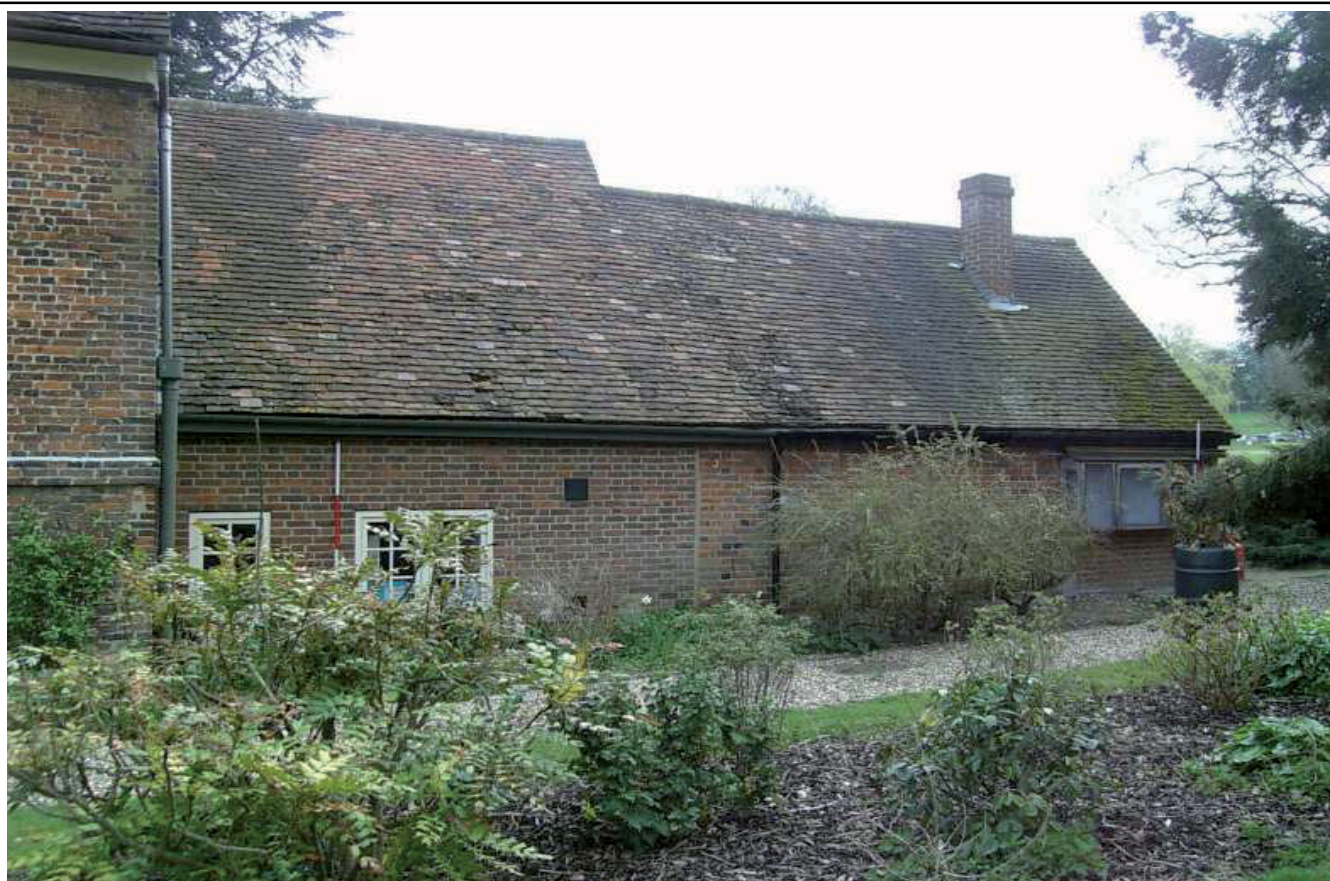
**2.18** The middle section forms part of the western wall of the garage and appears to be earlier than that to the north. Here the bricks are a mixture of burnt bricks and regular bricks, some of which are poorly weathered. It is bonded with poor quality coarse cement mortar, which may date to the late 19<sup>th</sup>/early 20<sup>th</sup> century. This section of wall terminates in a cement post or pillar, which may be a rendered over timber post or a replacement for an earlier timber post in this location.

Plate 4: Western elevation, looking south-west

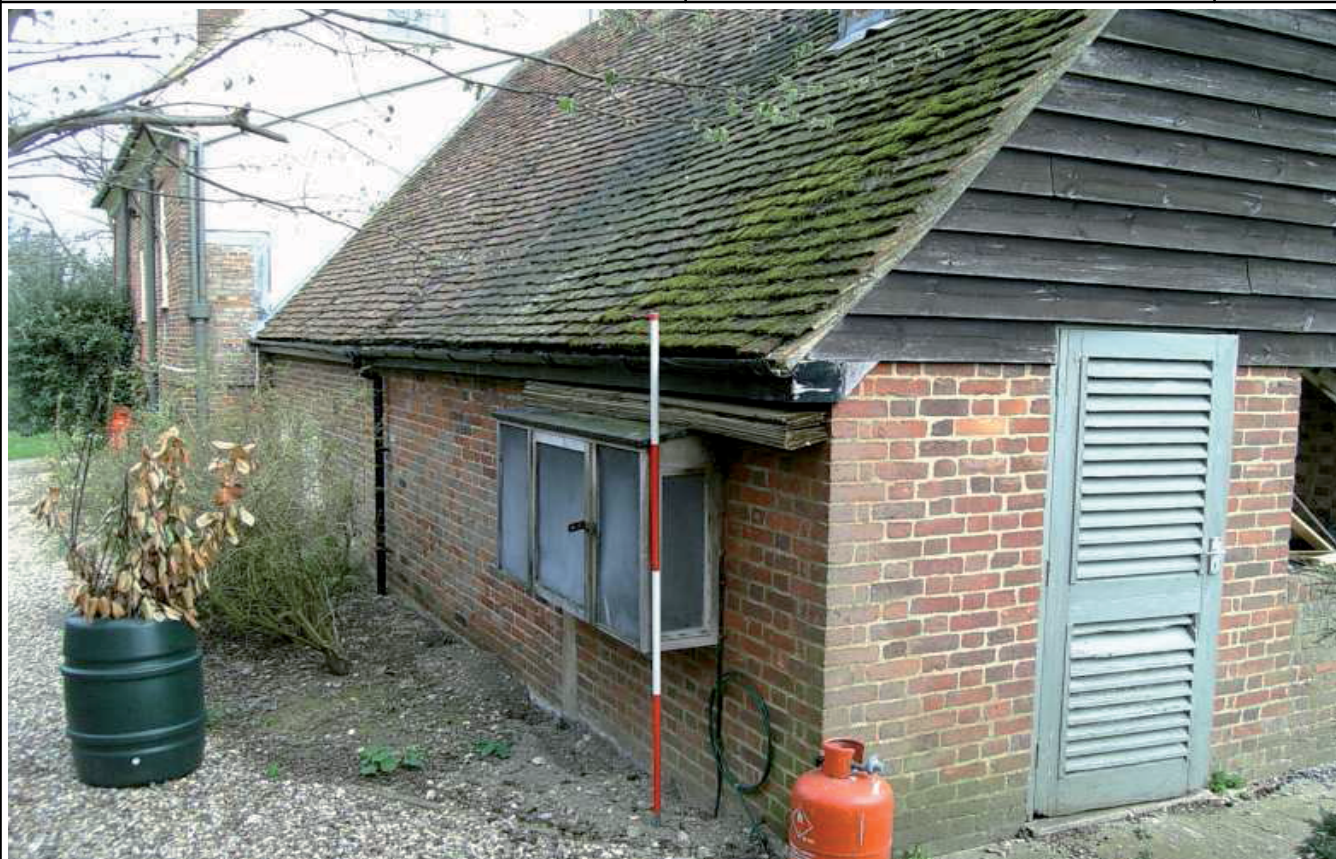
**2.19** The third section represents the continuation of the rear wall to the south-western corner of the building (Plate 5). The brickwork here has been extensively re-pointed and remodelled.

Plate 5: Western elevation, looking north

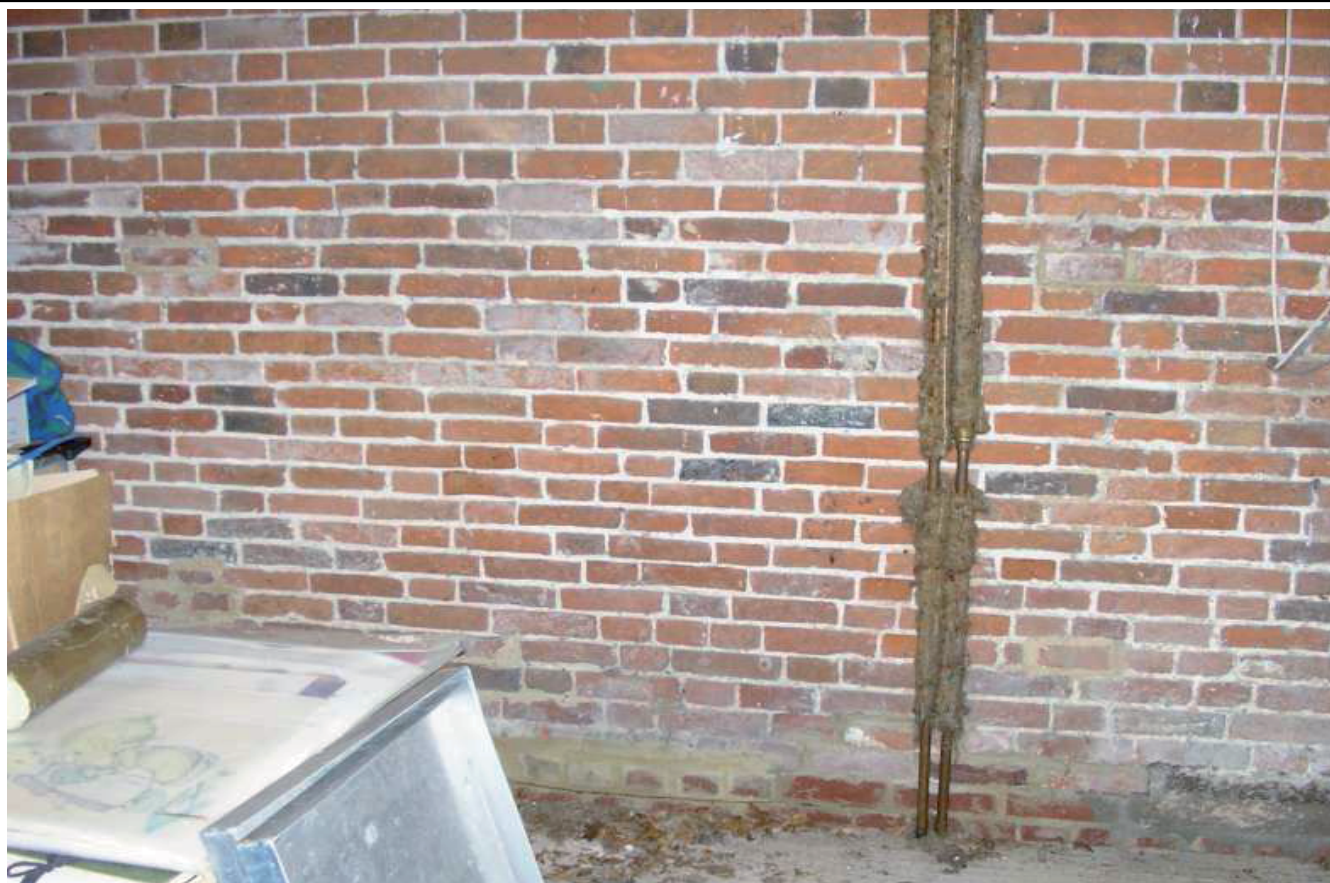
**2.21** The northern internal elevation of the garage is a one brick thick skin which appears to butt up to the wall of the adjacent utility room. The base of the wall has been underpinned with new red engineering bricks, set in a cement mortar, to a height of two courses above the concrete floor (Plate 6).

Plate 6: Garage: northern internal elevation, showing underpinning

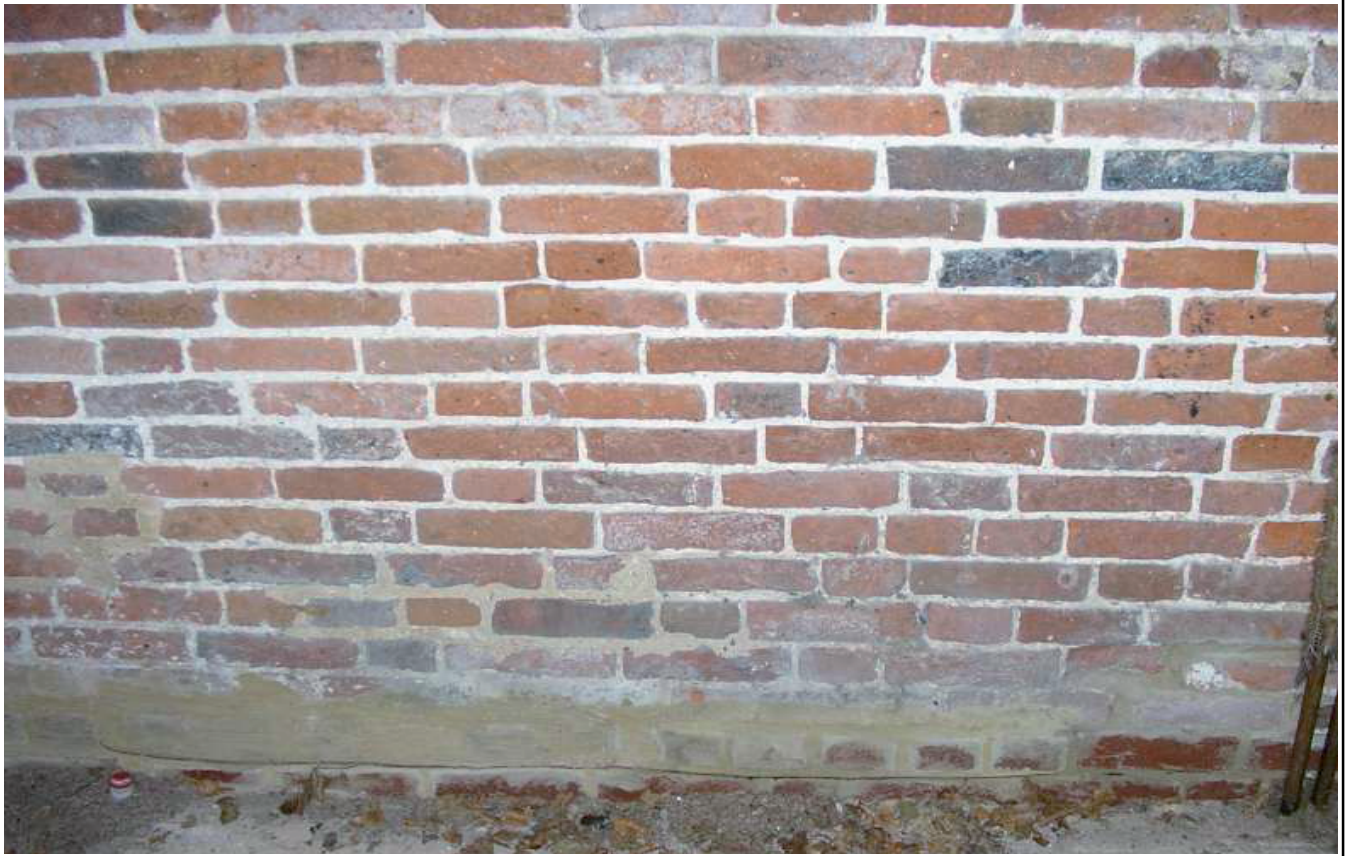
**2.22** Above this, to a height of 1.42m (20 courses), the wall consists of narrow red bricks, with an occasional burnt brick, of a similar size and quality to those which make up the main house (Plate 7). These measure 8" - 8½" by 2" - 2¼" and are handmade in coarse clay with frequent inclusions. They are laid in a rough stretcher bond and are set in a coarse lime mortar.

Plate 7: Older bricks in north wall of garage

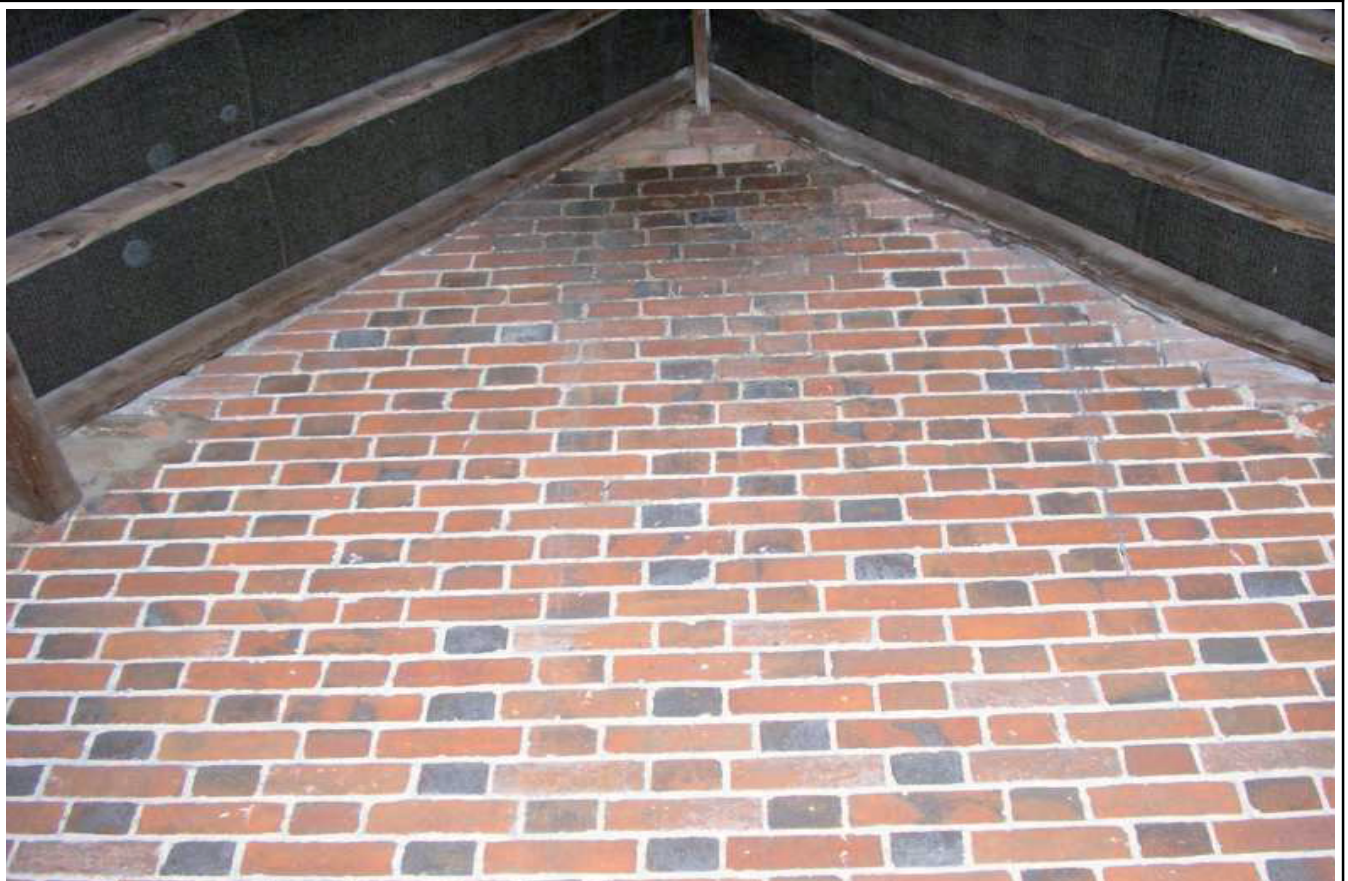
**2.23** A more regular layout of newer red bricks, laid in Flemish bond with a regular pattern of burnt headers, is located above this (Plate 8). These bricks are factory made and possibly date to the early 20<sup>th</sup> century. They measure 8" x 2½" x 4", and are set in a cement mortar with penny roll joints occasionally visible.

Plate 8: New bricks in upper north elevation

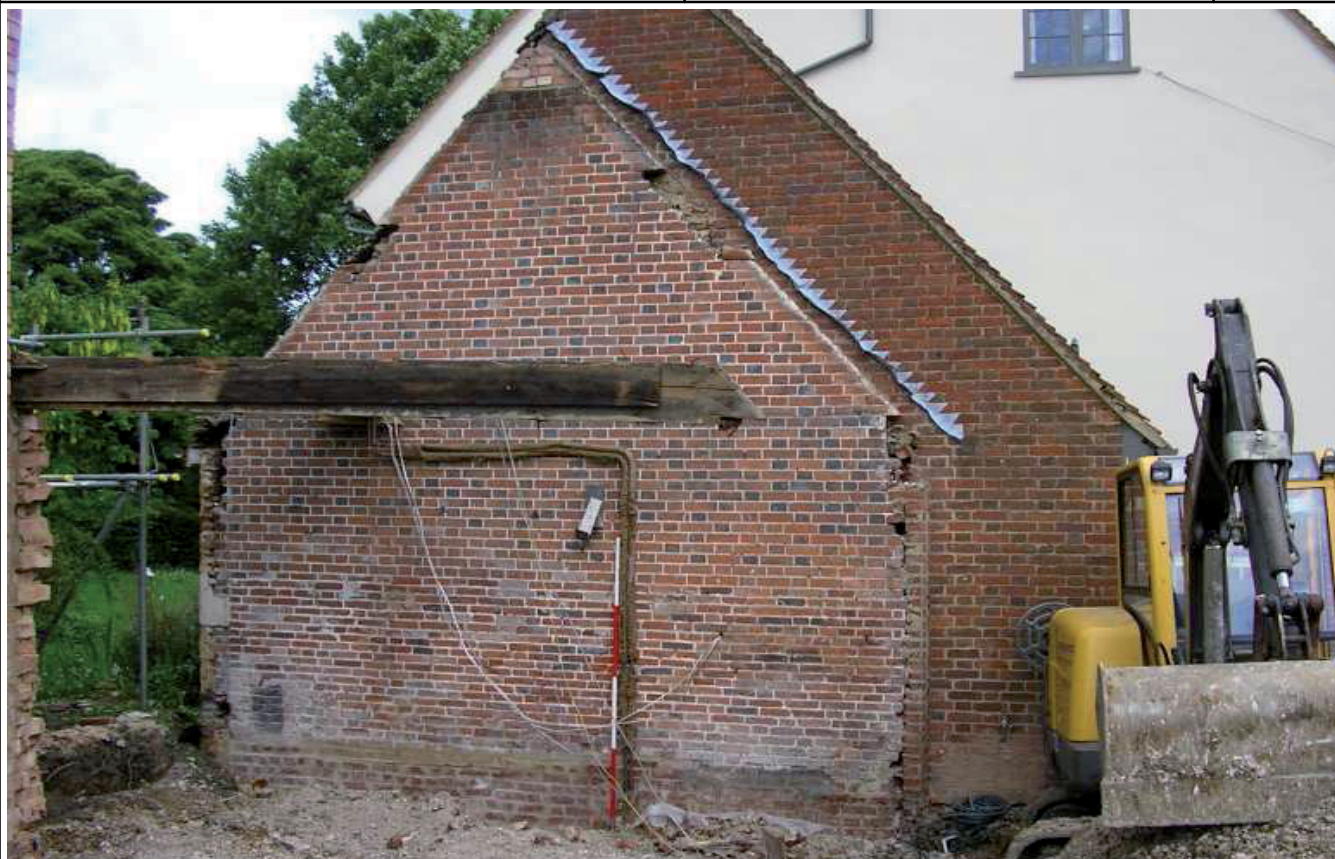
**2.24** The northern elevation was fully exposed following the demolition of the garage (Plate 9). An examination revealed that the west wall of the utility room to the north is a new build, possibly re-using early bricks but more likely using modern reproduction bricks. This has been butted up against the west end of the north wall of the garage. A shadow on the wall indicates that the former rear wall, the western elevation, was also butted up against the north wall.

Plate 9: North interior elevation of garage, after demolition

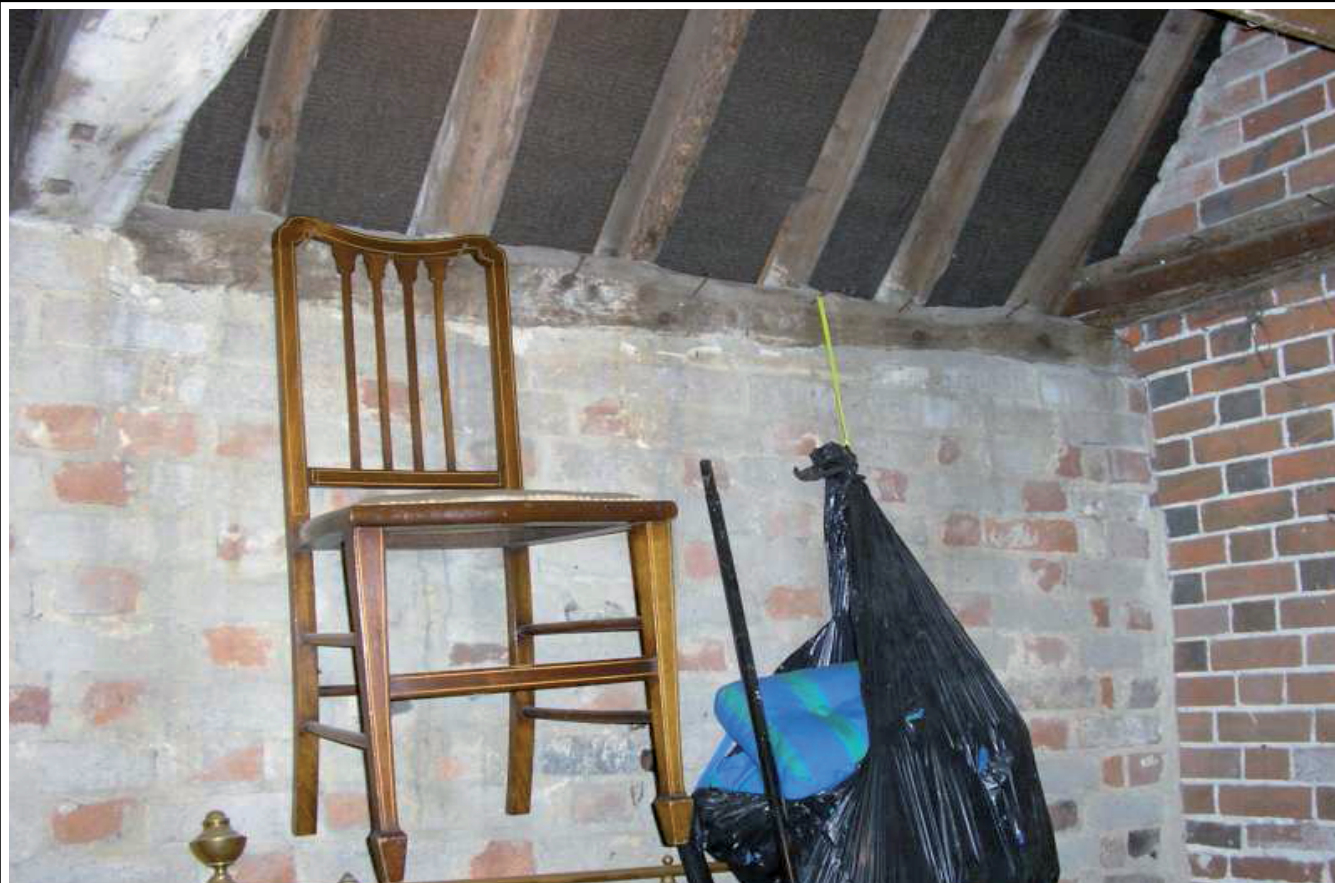
**2.25** The west elevation is built off a foundation of early bricks and appears to be a modern rebuild, using early 20<sup>th</sup> century bricks (Plate 10). These are laid in Flemish bond, set in a modern cement mortar. The wall supports a wall plate to the line of the truss, beyond which a concrete lintel has been used.

Plate 10: Garage, west interior elevation, showing wall plate

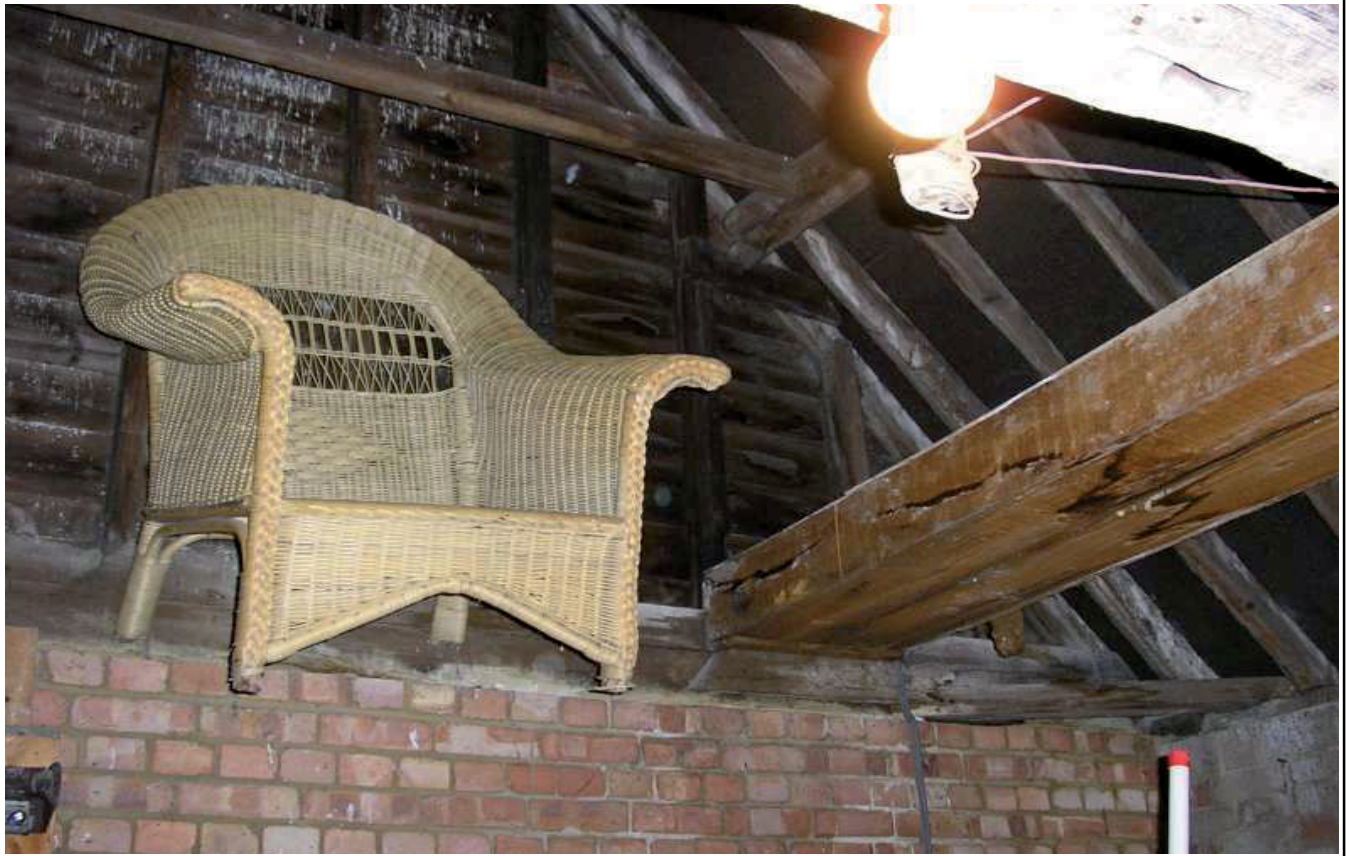
**2.26** The southern elevation is formed of modern fletton bricks, which sit on an earlier foundation. A tie beam sits on the bricks, surmounted by a studded and weatherboarded partition which marks the former limit of this structure (Plate 11).

Plate 11: Garage, south interior elevation

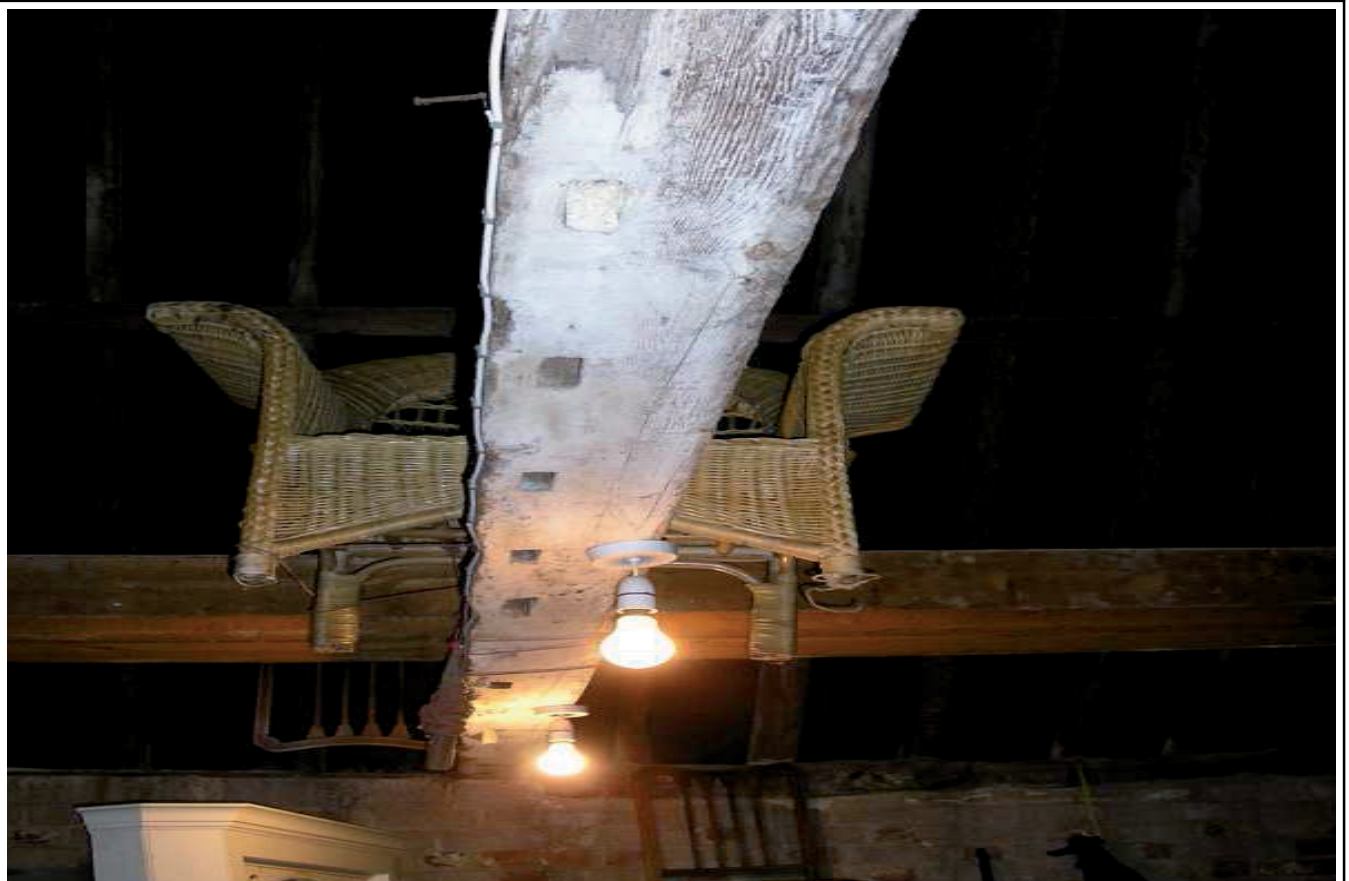
**2.28** The truss is a reused floor joist, with mortice holes still visible (Plate 12). Raking queen struts support a collar, which in turn supports the purlins. A further tie beam crosses the northern elevation.

Plate 12: Garage, detail of mortice holes in re-used roof truss

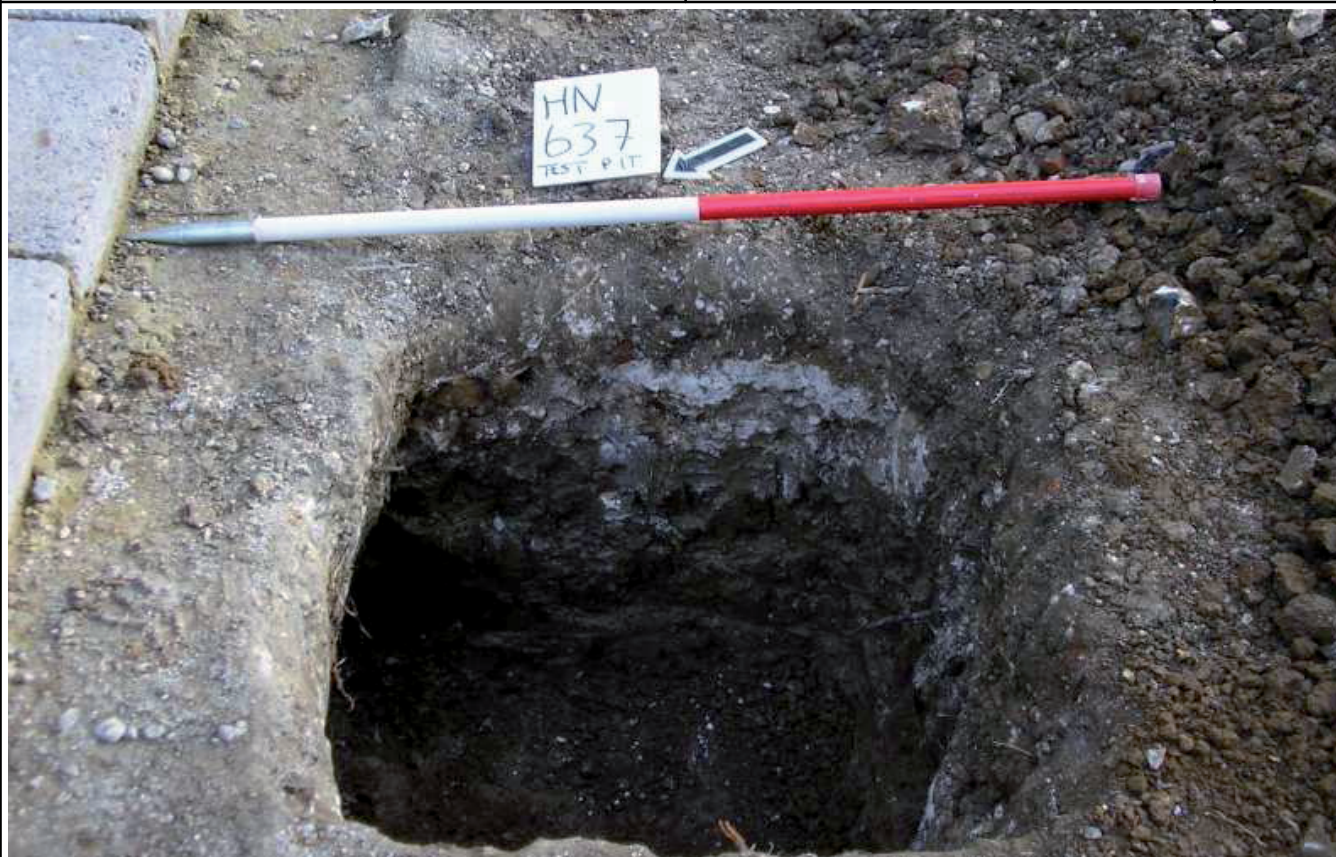
**2.30** The new garage is located approximately 20m to the east of the house and 14.5m to the south of the road (Figure 8). The test pit was located in its central bay and measured 1m square and 0.60m deep (Figure 9). The stratigraphy revealed in the sections comprised a layer of olive brown (2.5Y 4/4) clay, with frequent chalk lumps and occasional post-medieval tile fragments, approximately 0.10m in depth. Below this was a layer of compacted chalk with mortar, 0.15m in depth (Plate 13). This is likely to represent a former surface. The chalk surface sat on a layer of dark yellowish brown (10YR 3 / 4) redeposited clay, containing occasional charcoal flecks and late post-medieval tile and brick fragments.

Plate 13: Test pit in new garage

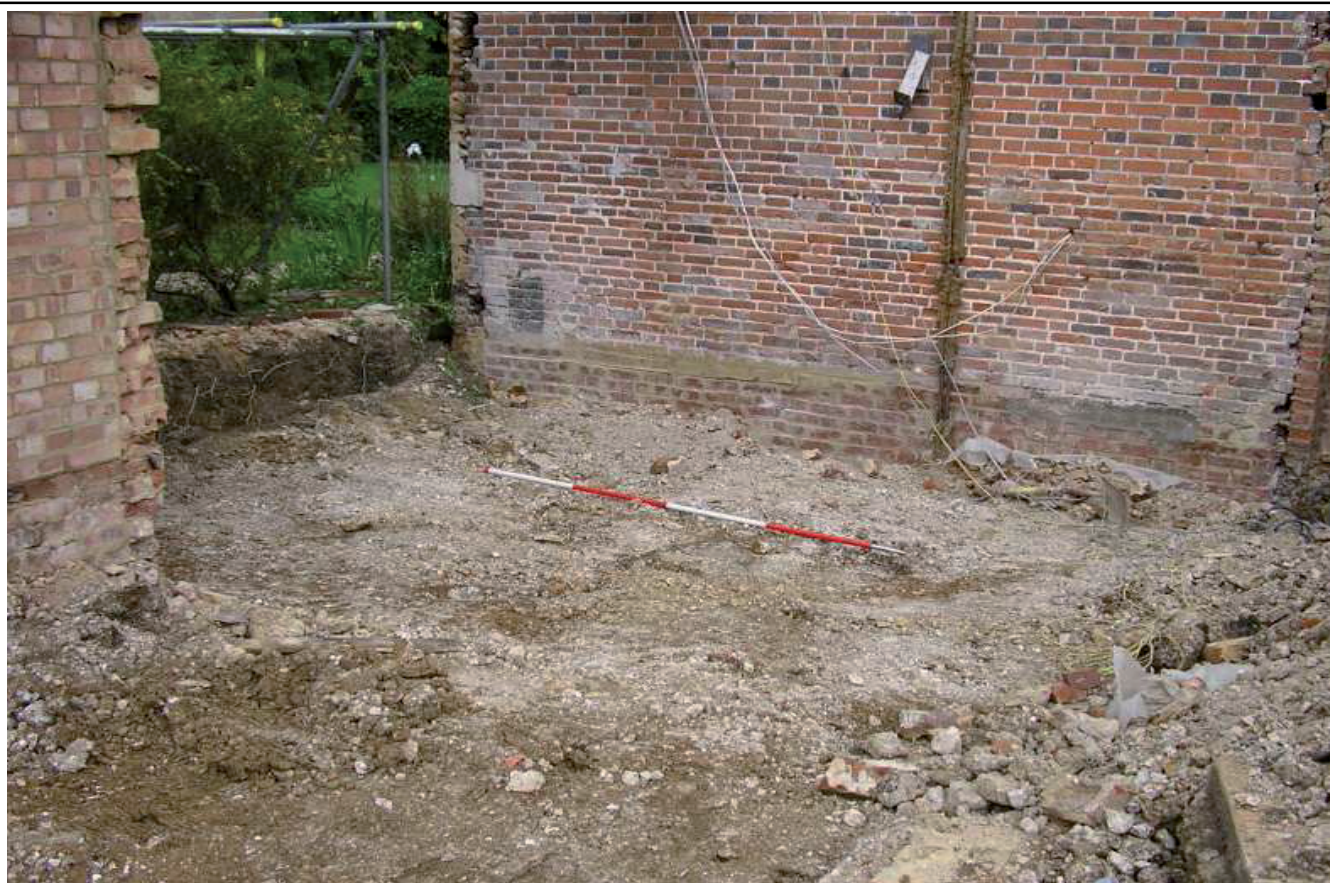
**2.34** A general spread of redeposited chalk was exposed on the western side of the footprint of the garage, at the interface with the clay natural (Plate 14). This is likely to represent an earlier floor surface, but was not clearly exposed. Observation of the ground reduction immediately to the west of the former garage suggests that the chalk surface extended beyond the limit of the building. It was located at a depth of 0.35m below ground surface and measured at least 0.20m in depth. The full extent was not recorded (Plate 15). The floor consisted of yellowish white redeposited chalk and light yellowish brown decayed chalk, with occasional brick flecks and fragments.

Plate 14: Chalk surface exposed in former garage footprint

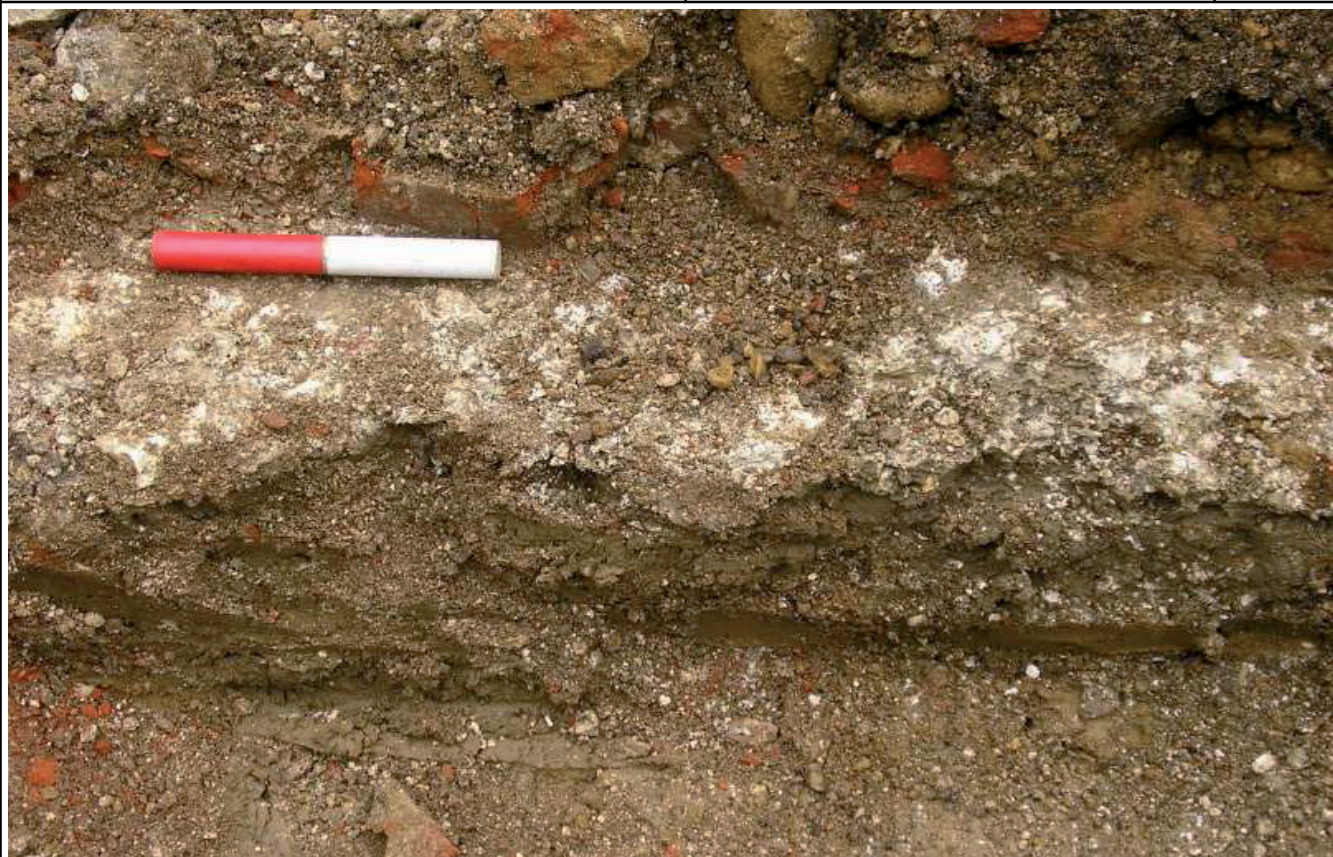
Plate 15: Section through chalk surface to west of former garage

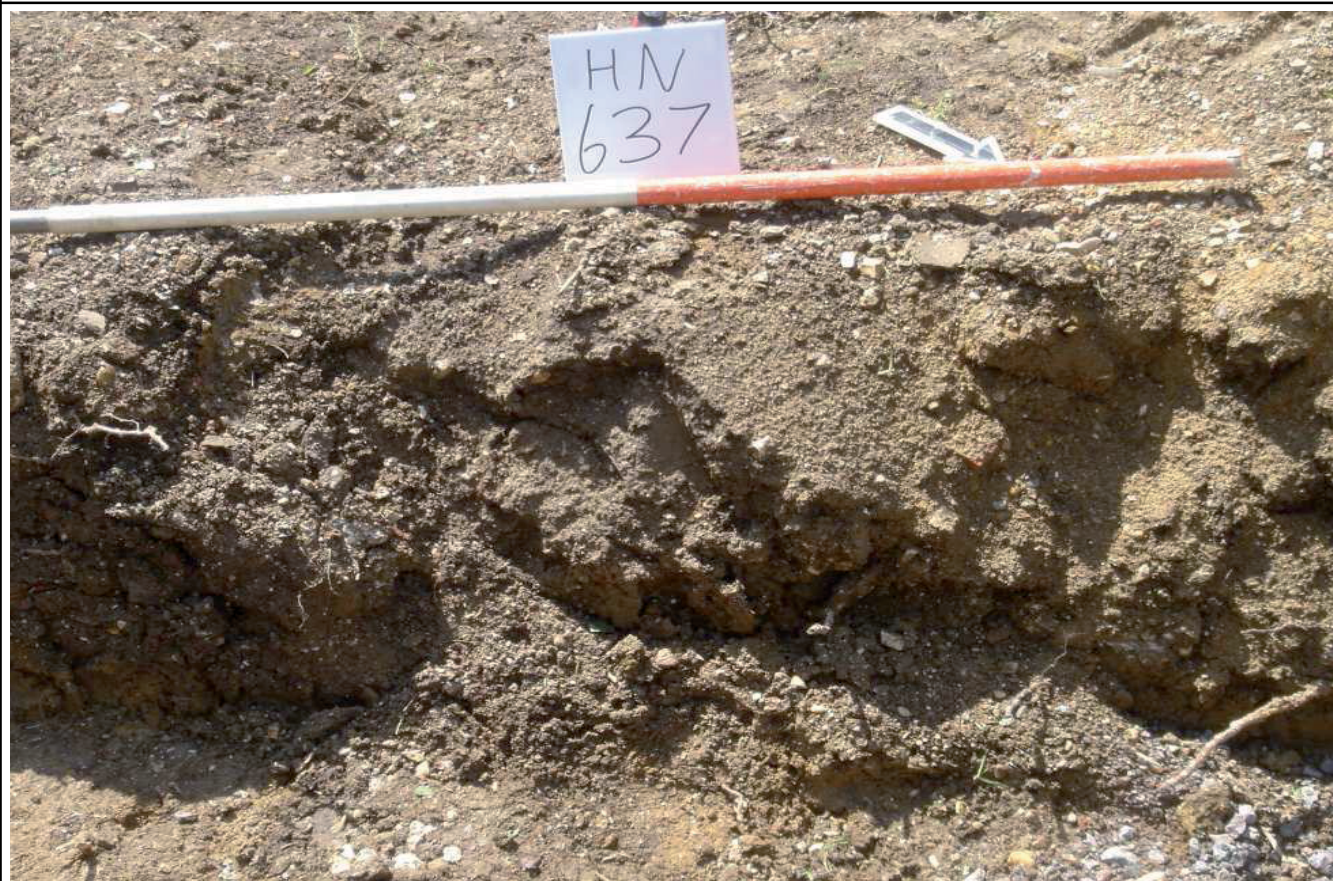
**2.36** An irregularly shaped area around the new extension was reduced by between 0.30 and 0.35m. The topsoil consisted of a very dark greyish brown (10YR 3/2) sandy clay, which overlay the natural clay (Plate 16). No archaeological cut features or deposits were observed, and no artefacts were recovered from the spoil.

Plate 16: Sample section, ground reduction to south of former garage
