**ASHDON HALL,
Ashdon, Essex**

HN679

*Historic Building Record
& Archaeological Monitoring Report*

Report no.457

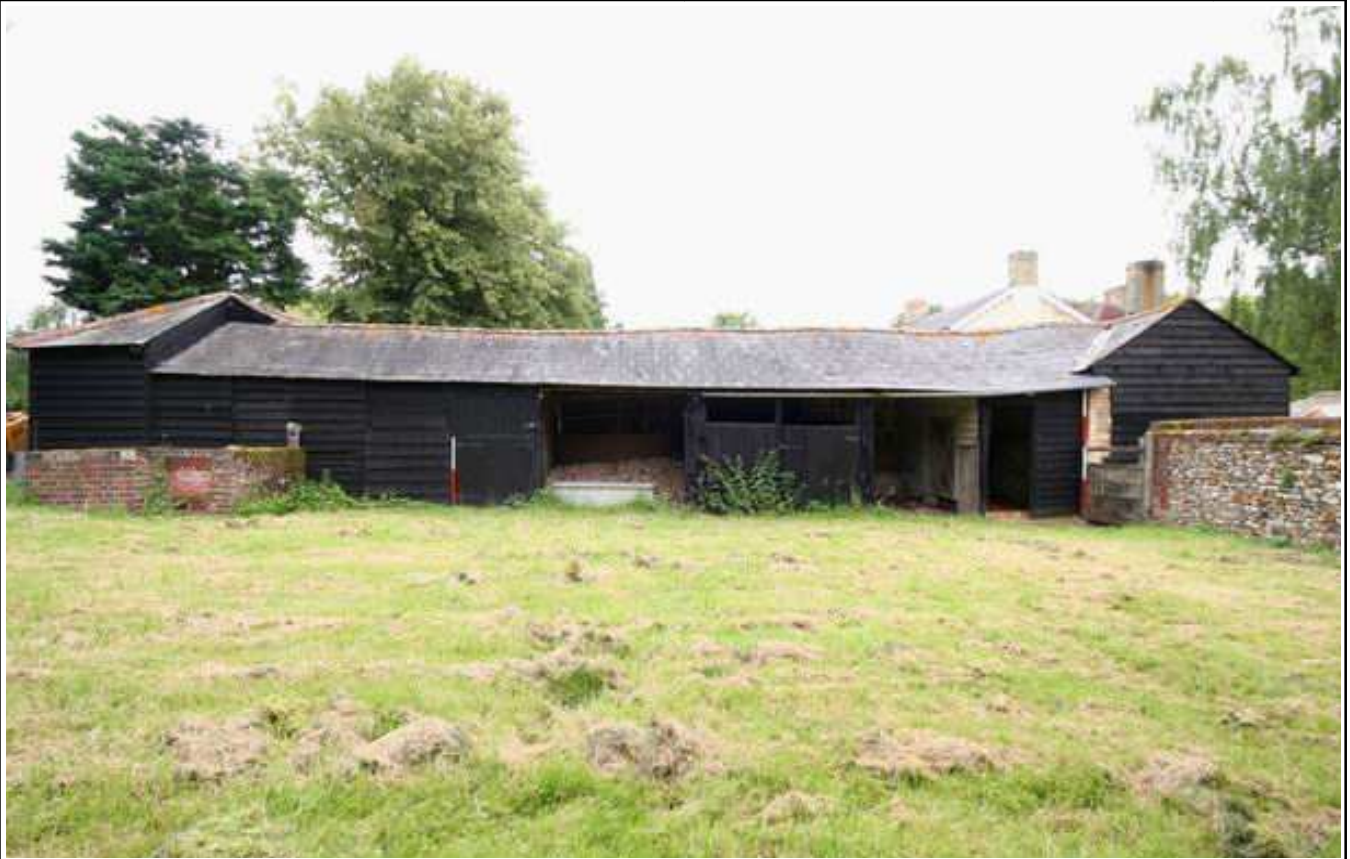
Plate 1: Barn 1, south elevation

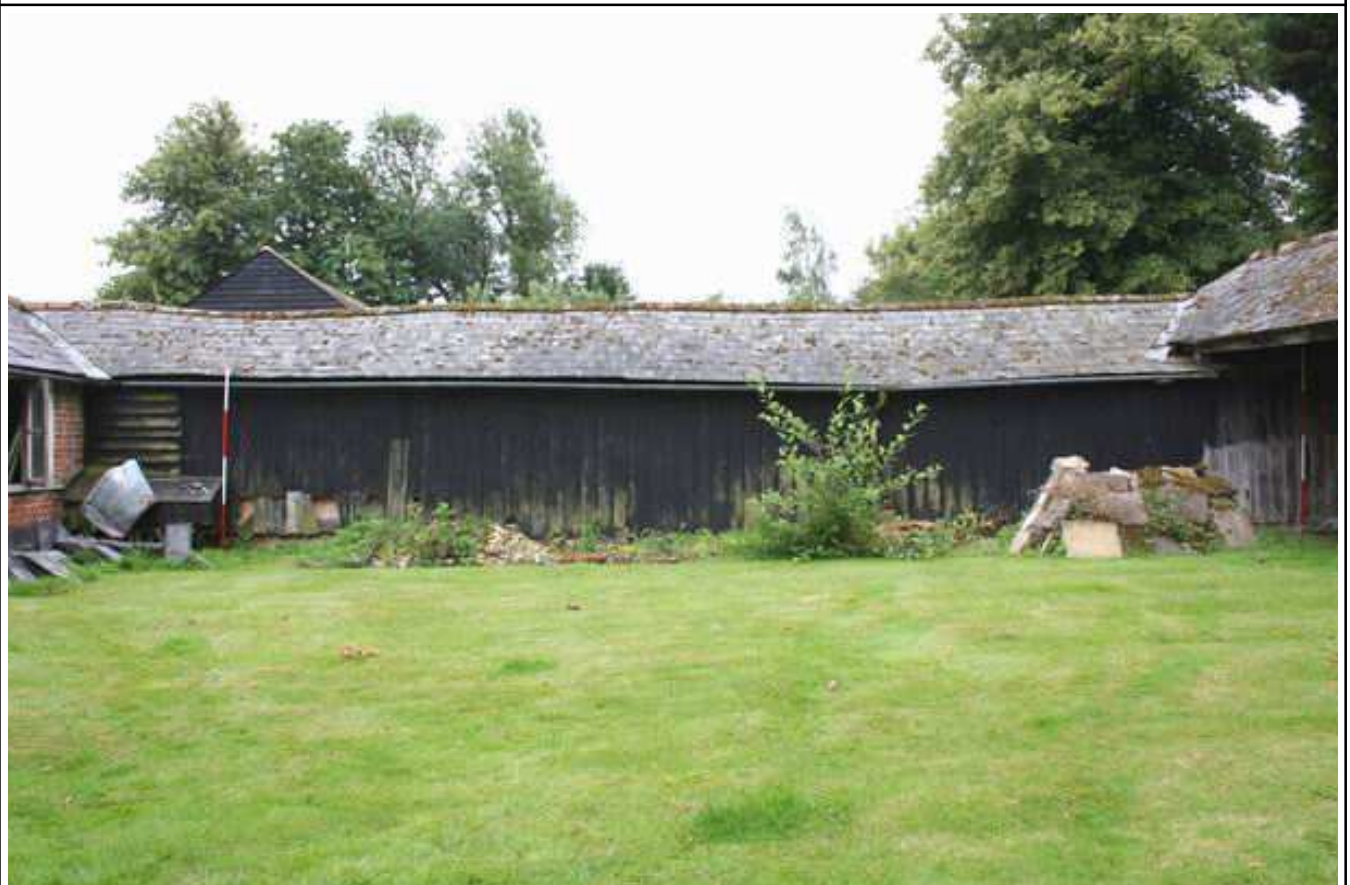
Plate 2: Barn 1, north elevation

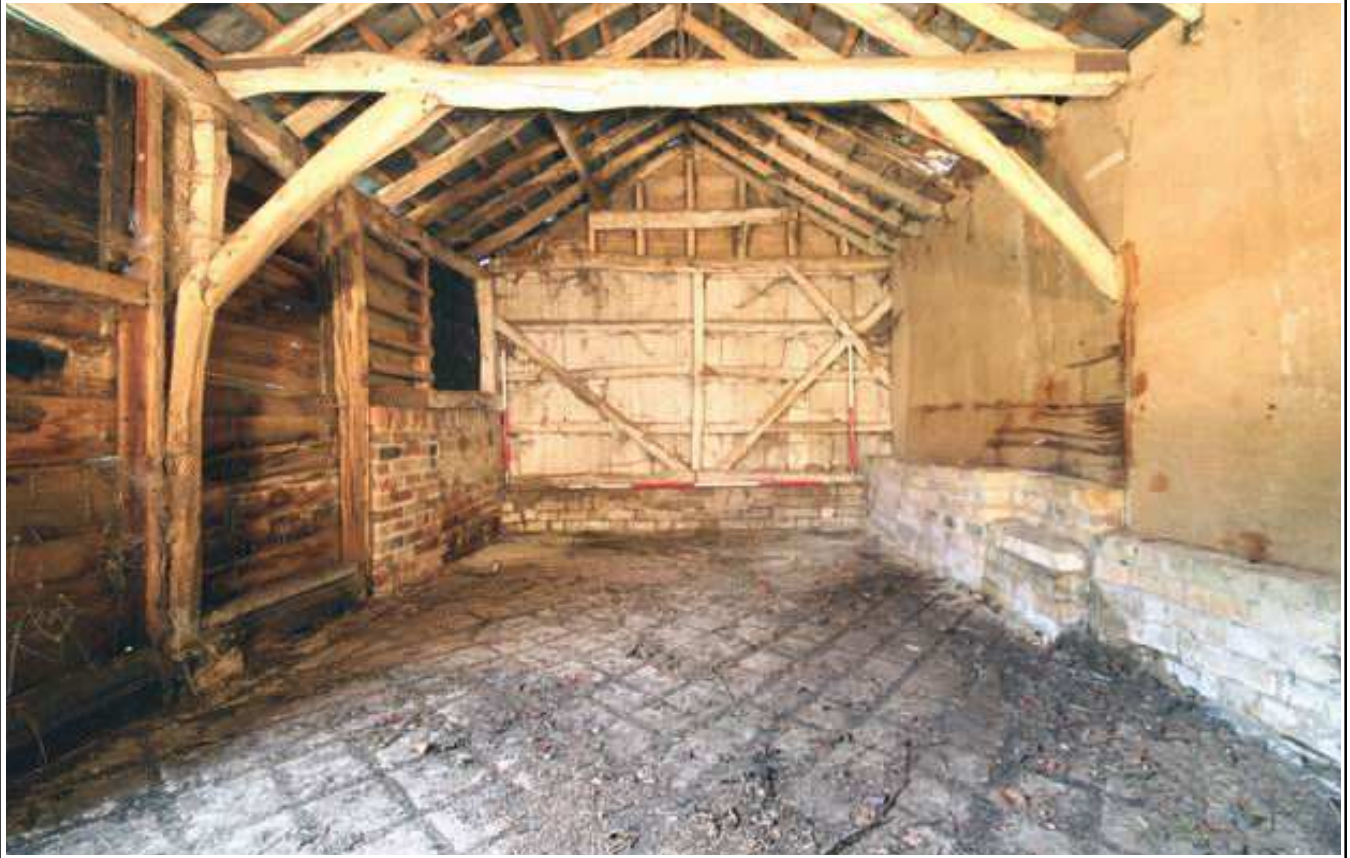
2.23 Bays 1 and 2 (numbering from the left) are enclosed, with a modern stable door at the eastern end and horizontal softwood weatherboarding (Plates 3 and 4). Bay 3 was open to the south at the time of recording and Bay 4 had $\frac{2}{3}$ height doors, open at the top. Bay 5 had been divided into two, with the eastern half partitioned off, apparently to form a chicken coop and run.

2.25 The western elevation has diagonal bracing in addition to battens supporting vertical boarding in hardwood, possibly elm (see Plate 3).

Plate 3: Barn 1, Bays 1 and 2, looking west

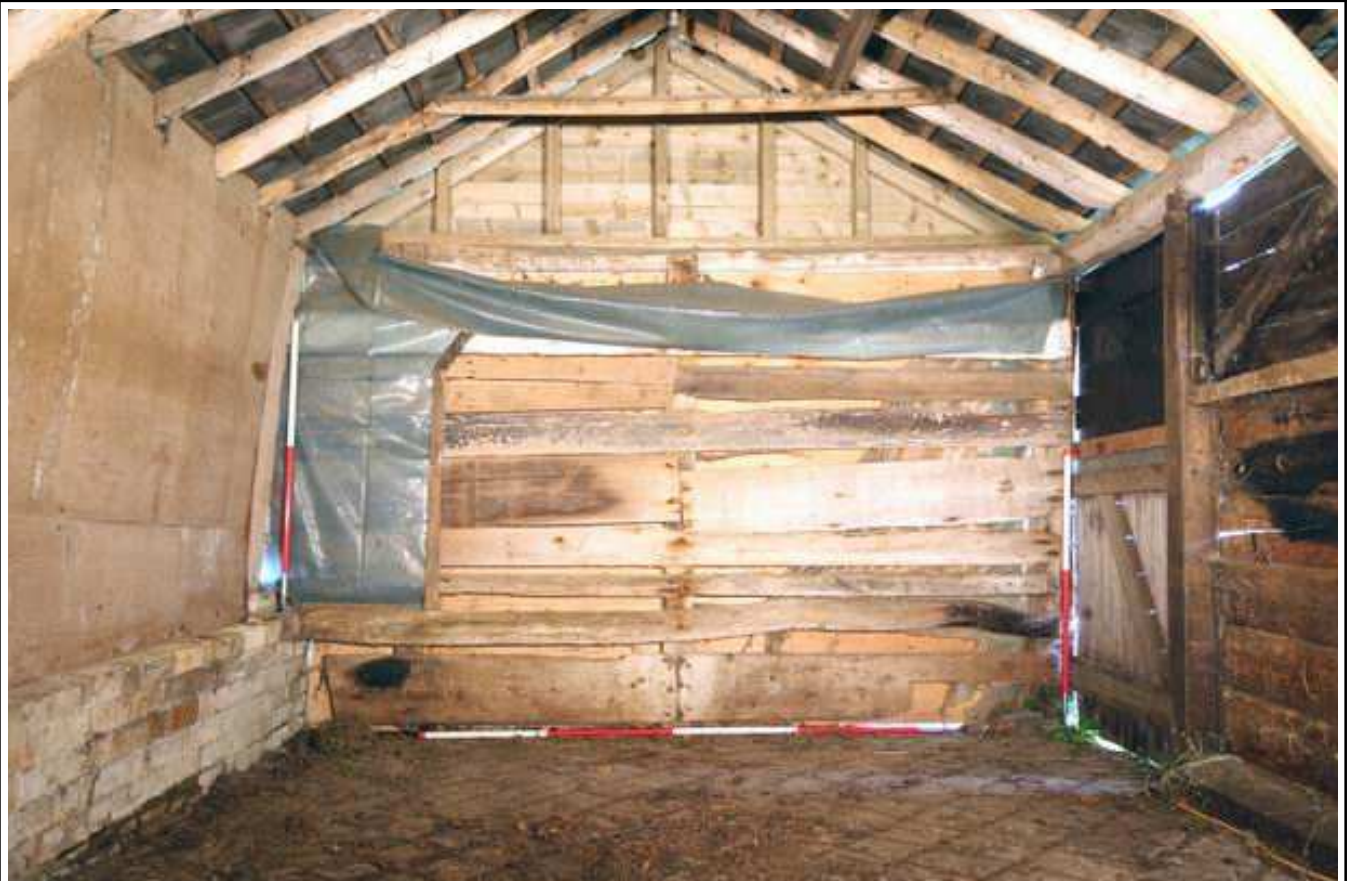
Plate 4: Barn 1, Bays 1 and 2, looking east

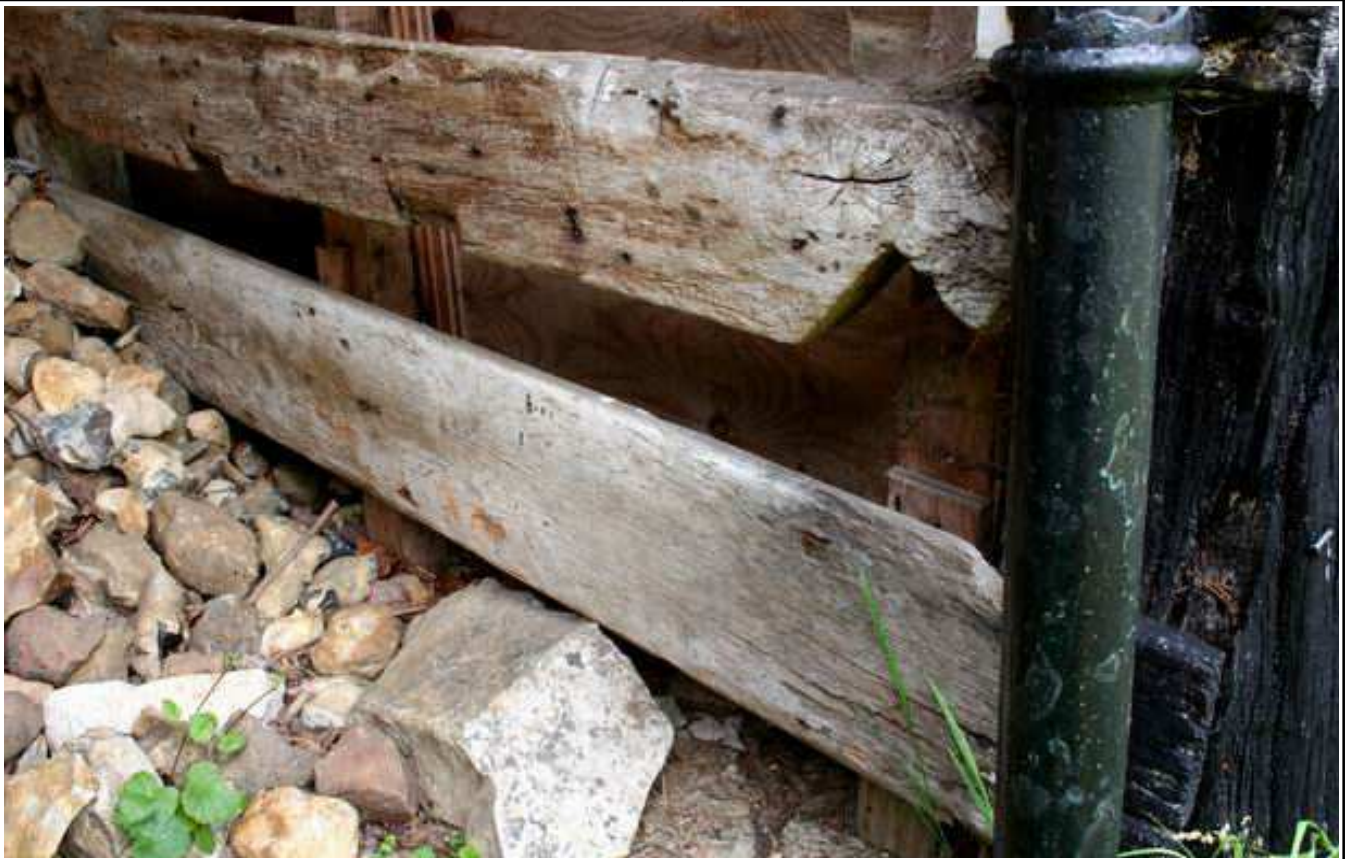
2.24 The southern (front) elevation is supported on heavy hardwood posts, reused from elsewhere and resting on short brick piers (Plate 5). The partitioning between the bays is haphazard and formed of various scraps of timber. The slate roof is supported on waney edged and poorly finished softwood rafters which clasp the ridge, some of which have been braced with collars. The beams in line with the principal posts are poorly finished softwood branches, with nailed diagonal boarding. The floors are of concrete.

Plate 5: Re-used timbers in Barn 1, detail

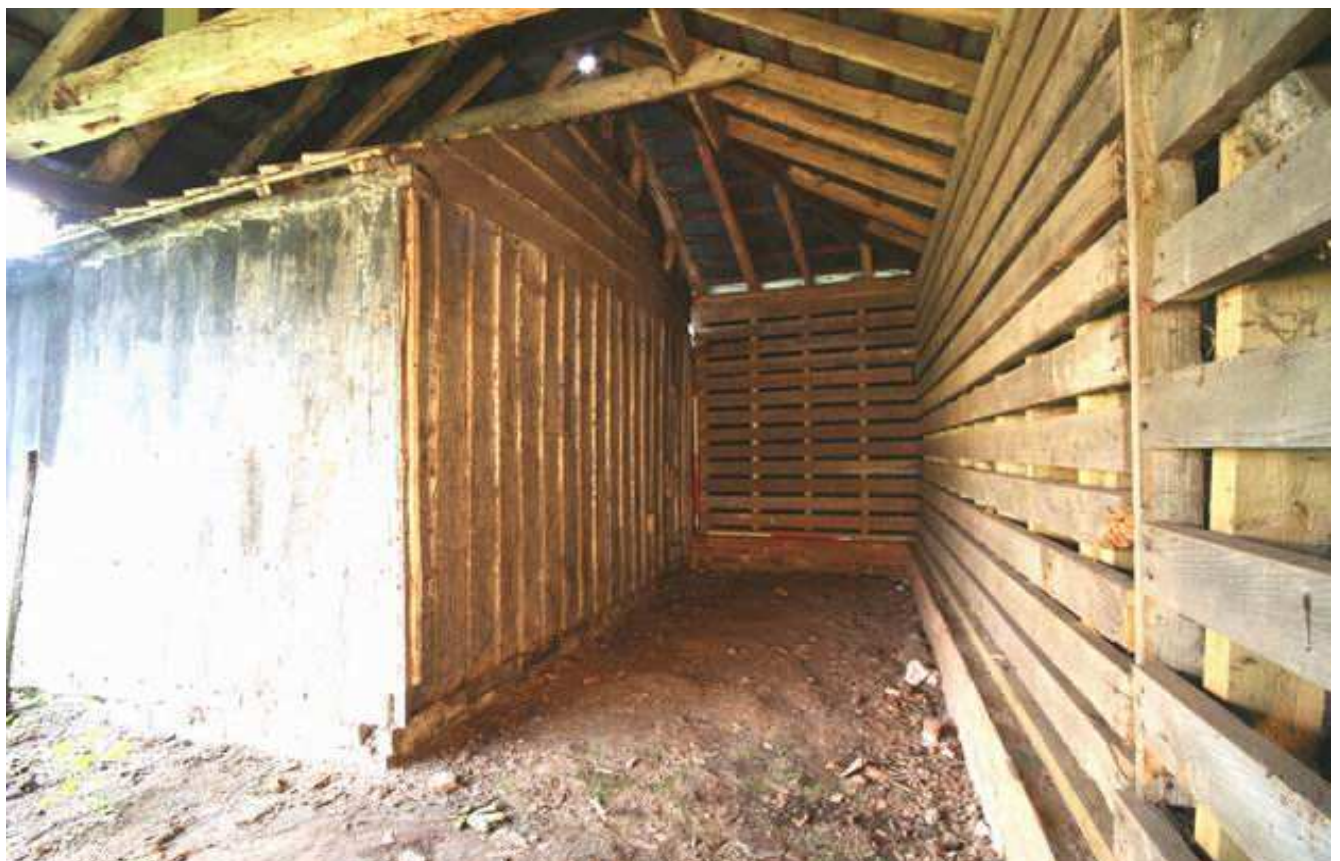
Plate 6: Junction between Barns 1 and 2, looking S

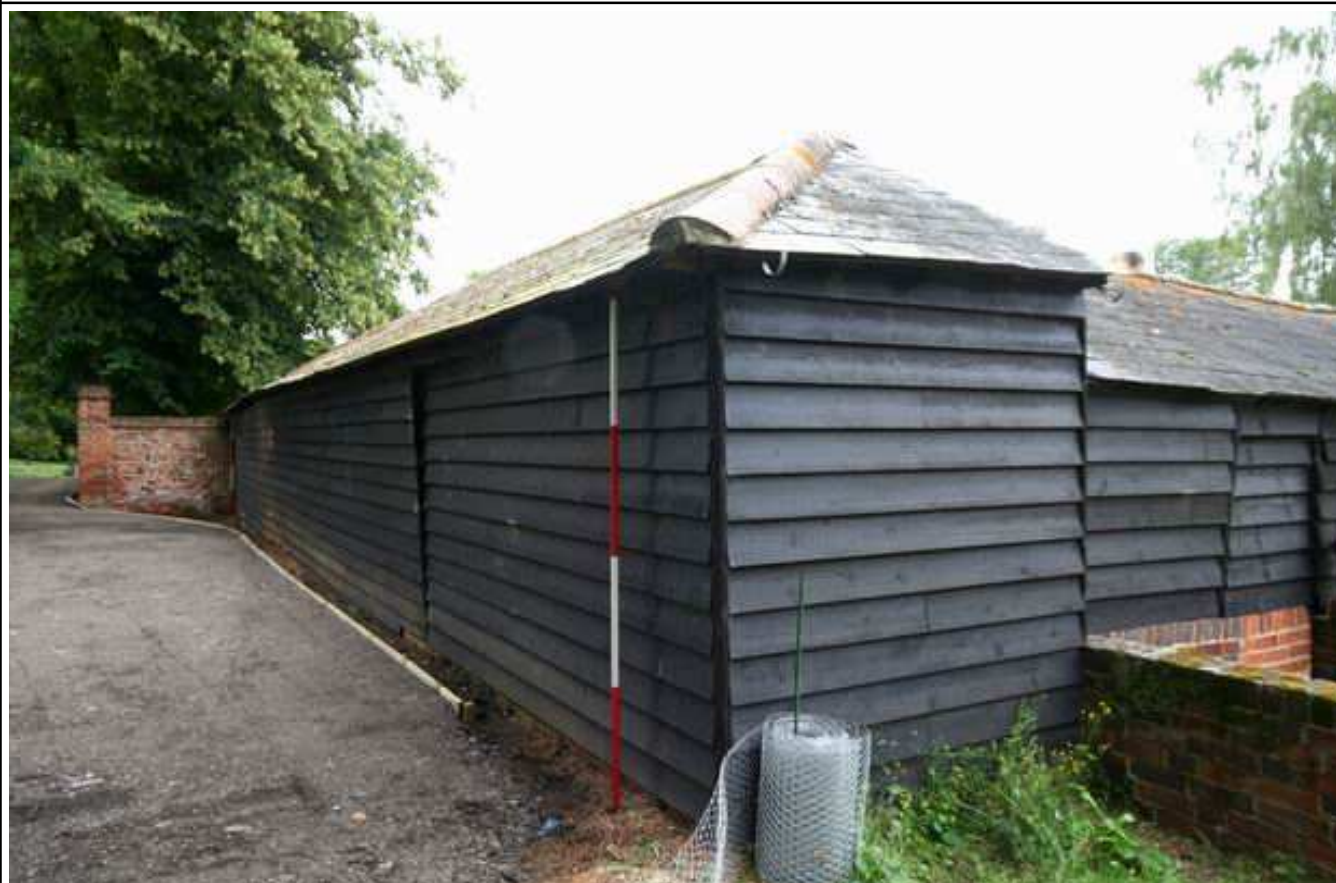
2.29 The west (rear) elevation is formed of diagonally braced studwork, with no apparent principal posts, covered with largely modern weatherboarding (Plate 8). The five beams are

formed of waney edged hardwood beams. These support modern queen posts supporting a single purlin in each slope, relieving an original line of collars.

Plate 8: Barn 2, south and west elevations looking NE

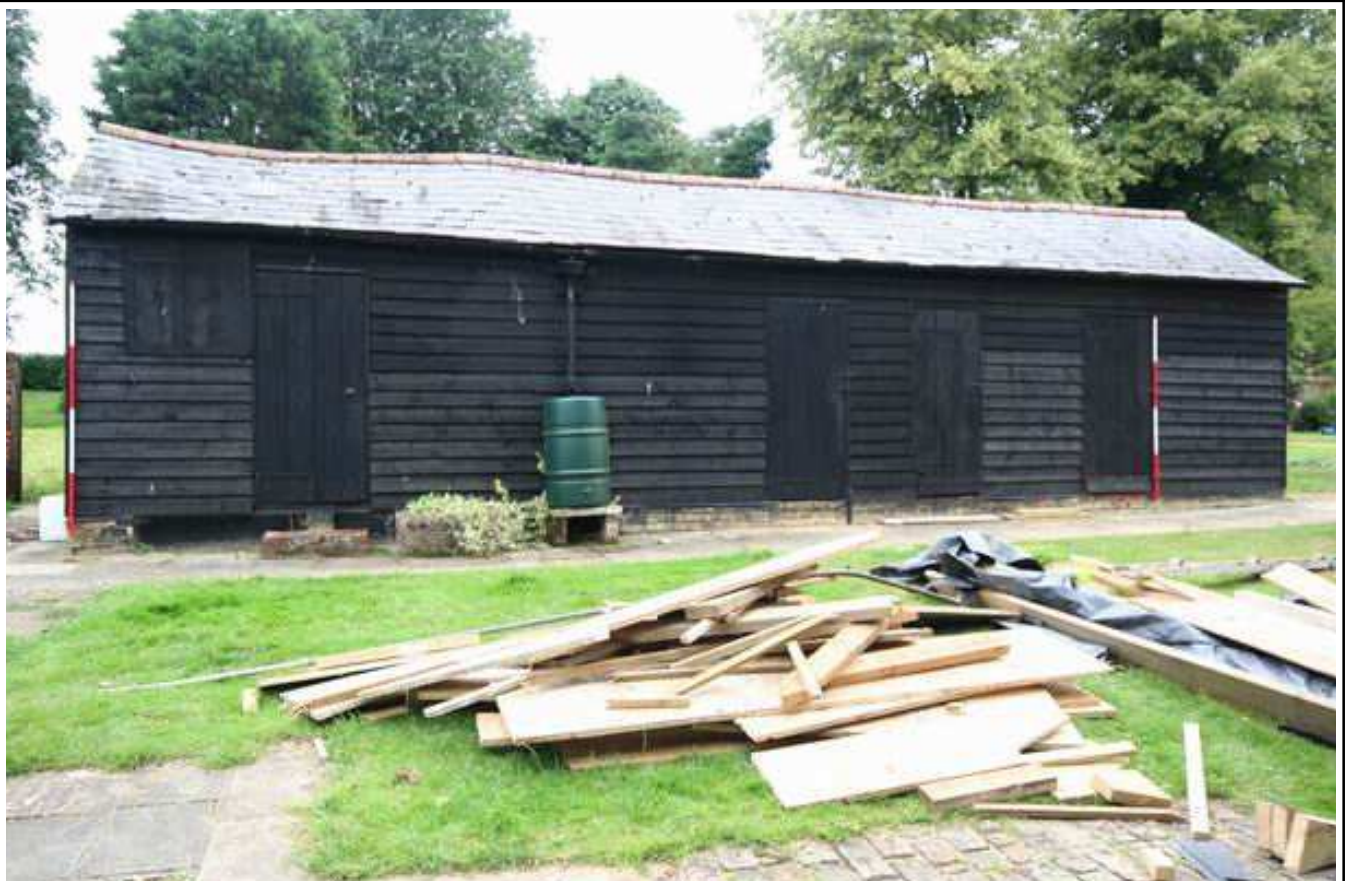
2.31 Barn 3 is a timber framed barn of 5 bays which forms the eastern range of the U-shaped group. It is likely to predate Barn 1 and its western elevation is formed of red bricks, laid in a rough English bond (Plate 9). Its eastern elevation is weatherboarded, with a line of stable doors (Plate 10).

Plate 10: Barn 3, eastern elevation, looking W

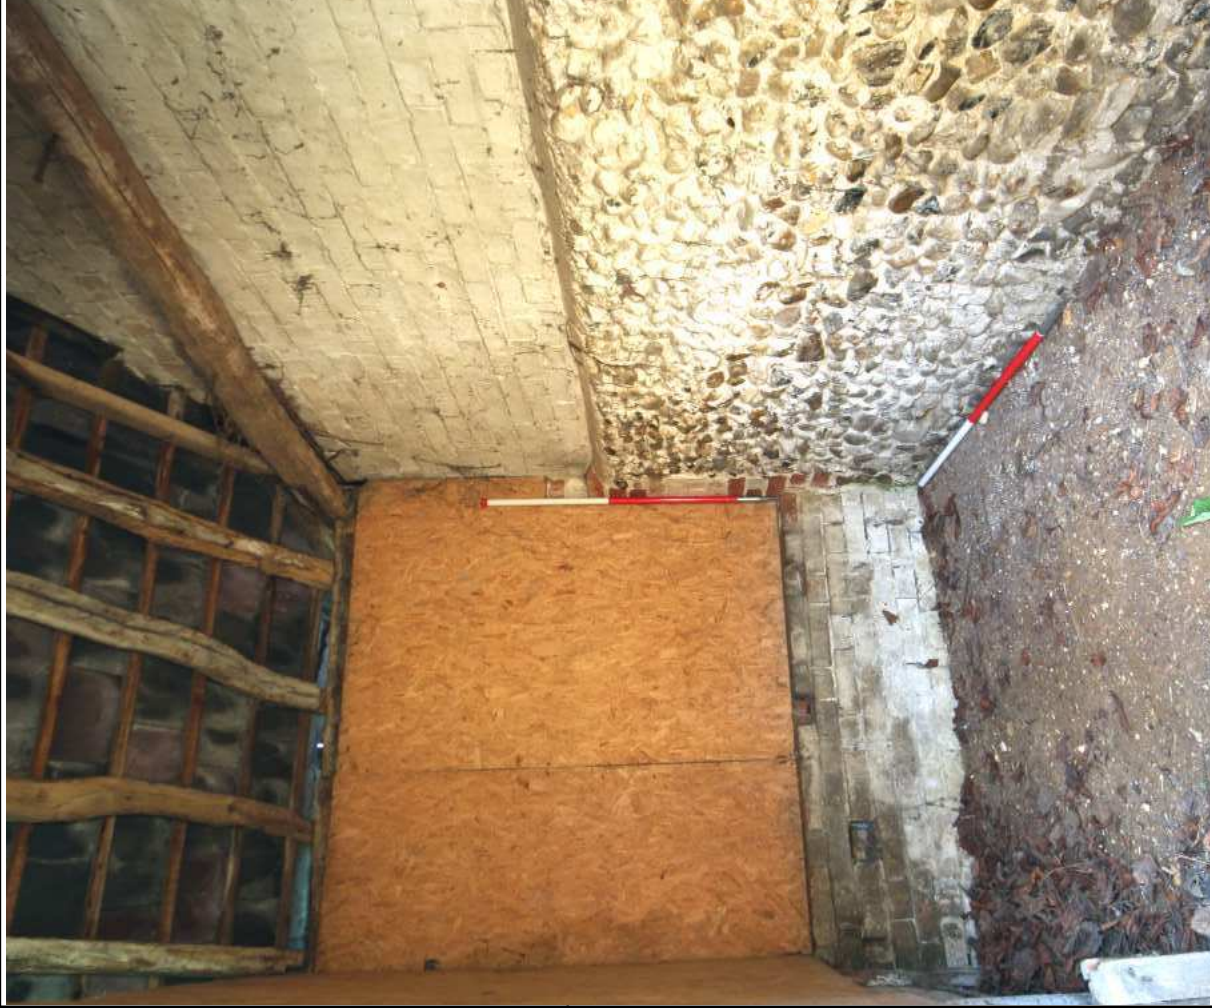
2.26 The eastern elevation is formed from a brick and flint wall, extending 1.30m above the existing ground level, and forming part of the existing boundary between the stable yard and the orchard (Plate 11). The lower part is in flint, with a whitewashed brick wall, laid in Flemish bond, above. A modern brick pen has been appended to Bay 1.

Plate 11: Barn 1, east elevation, showing wall between barn and orchard

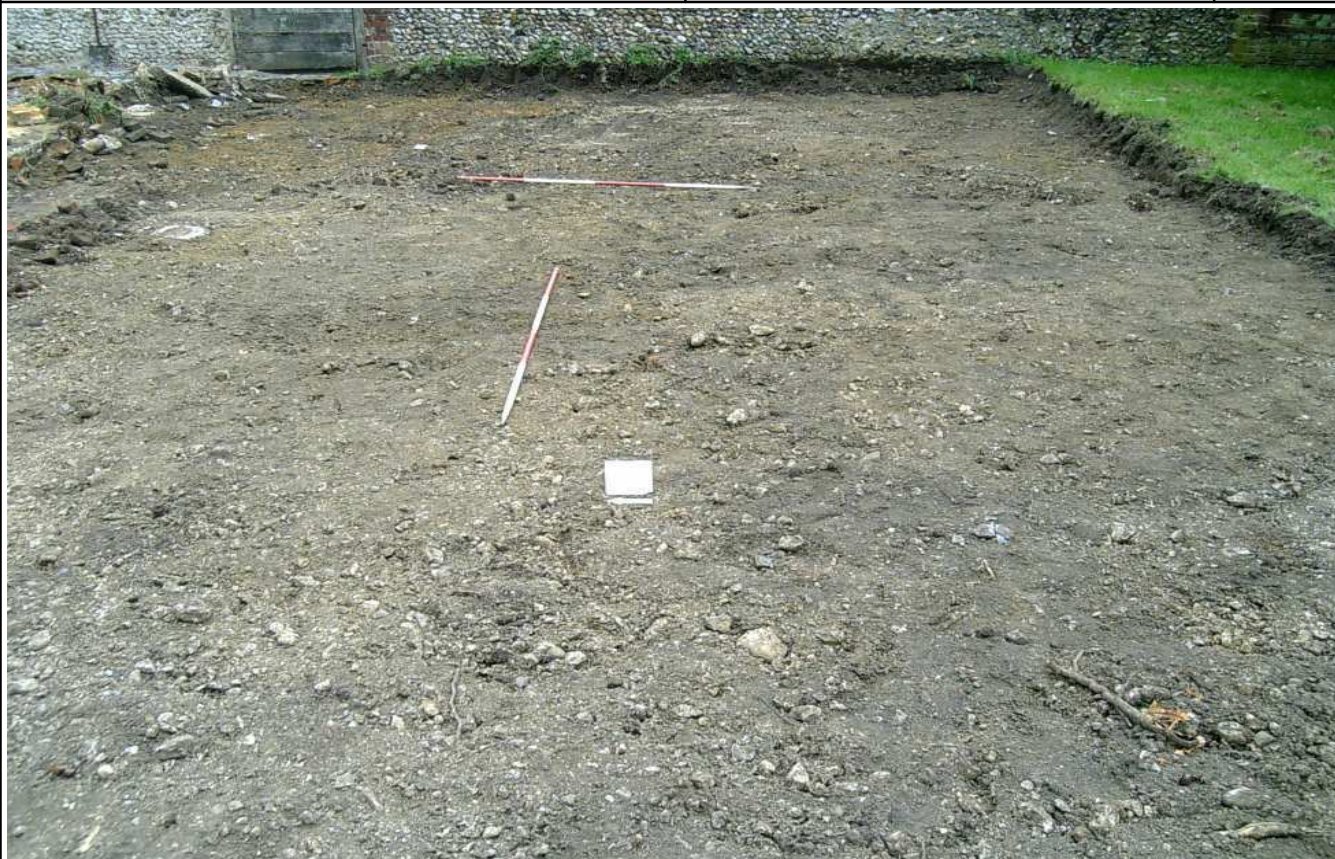
2.35 A gravel surface, possibly a former yard surface, was revealed below the topsoil (Plate 12). Large quantities of post-medieval brick, tile and pottery were present, but not collected. A piece of moulded cement or cast stone, post-1920 in date, and possibly used as a decorative string course, was recovered from the topsoil. This may have been imported on to the site as no evidence for such decoration was visible on any of the buildings in the study area.

Plate 12: Ground reduction to the south of Barn 1, looking E

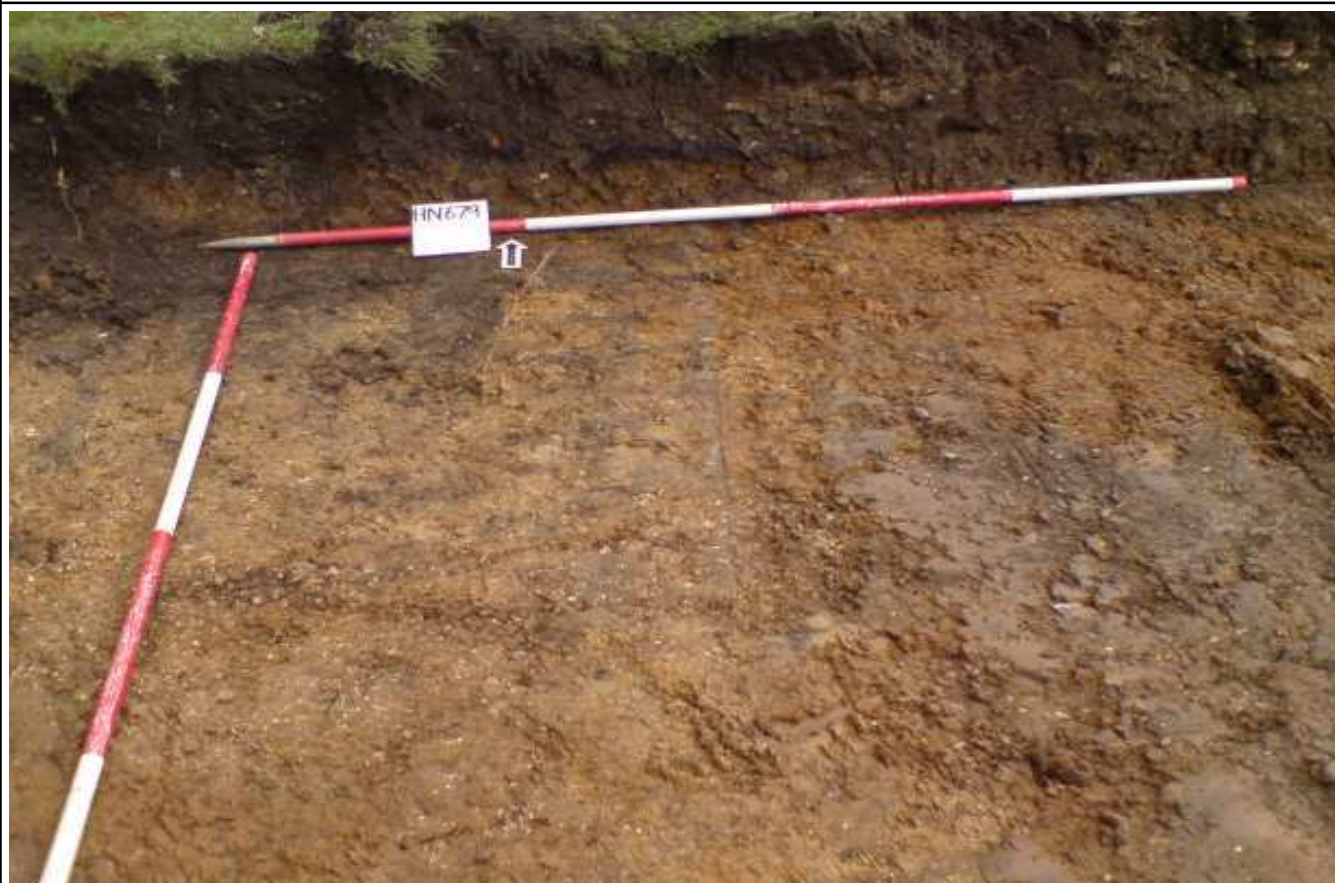
2.38 The topsoil at the western end of the new garage consisted of a friable dark greyish brown sandy clay. Below this was a thin layer of cinders, 0.05m in depth, which lay directly over the

natural clay and extended eastwards for 2.90m. The nature of the topsoil changed on the eastern side of the cinder layer, becoming a very dark greyish brown silty clay, which directly overlay the natural (Plate 13).

Plate 13: Ground reduction in the footprint of Barn 1, looking N

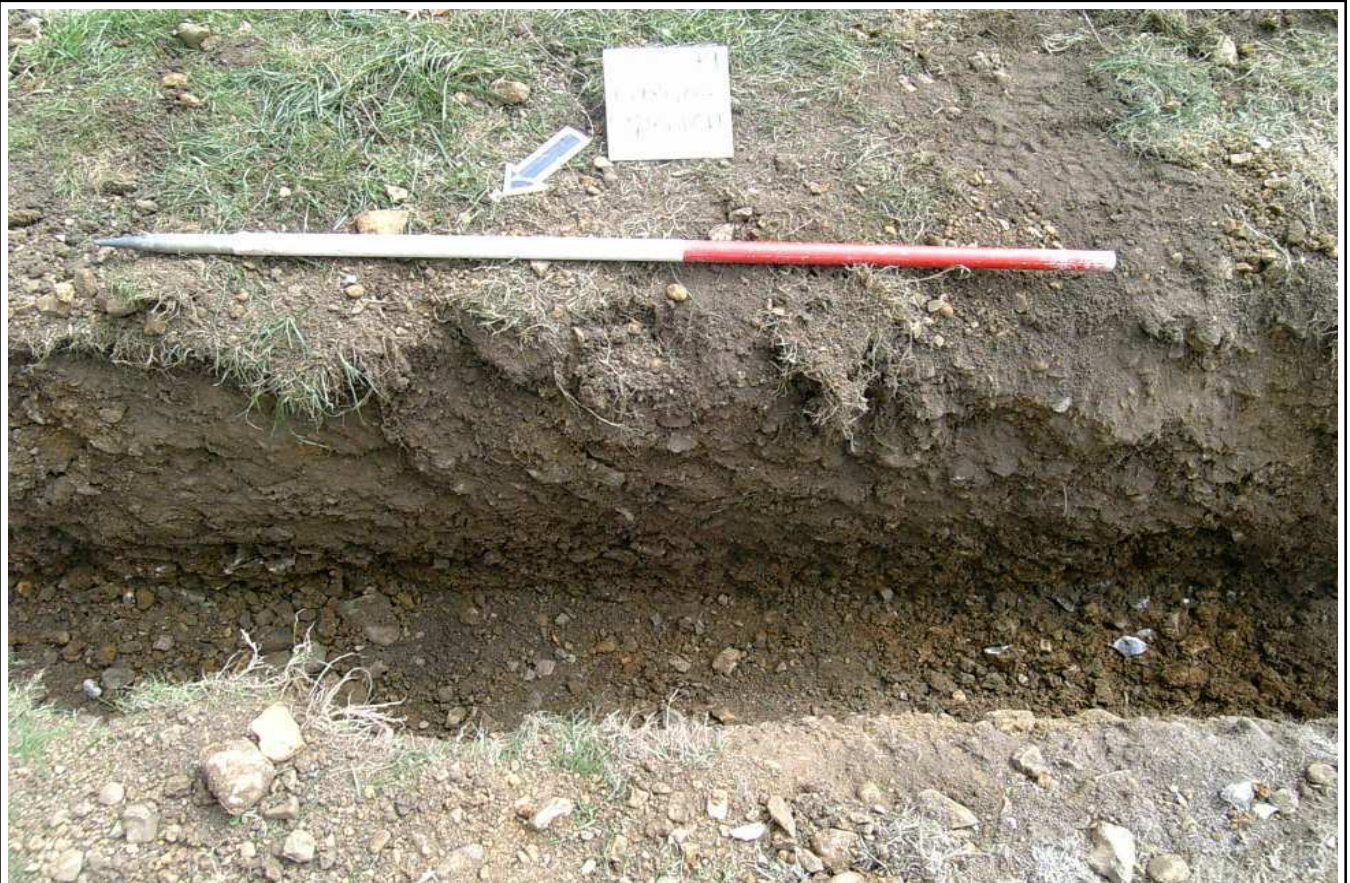
2.48 The trench was 0.40m in width and excavated to a maximum depth of 0.70m. The stratigraphy was uniform along its length, consisting of a layer of dark greyish brown firm sandy

clay, with frequent flints and stones, brick, tile and breeze block fragments and late 19th/20th century pottery (Plate 15). This lay directly over the natural sand and gravel.

Plate 15: Drainage trench, looking south
