72-74 SOUTH ROAD Baldock, Hertfordshire

HN709

***Archaeological Evaluation &
Historic Building Impact Assessment Report***

Archaeological Evaluation
&
Historic Building Impact Assessment

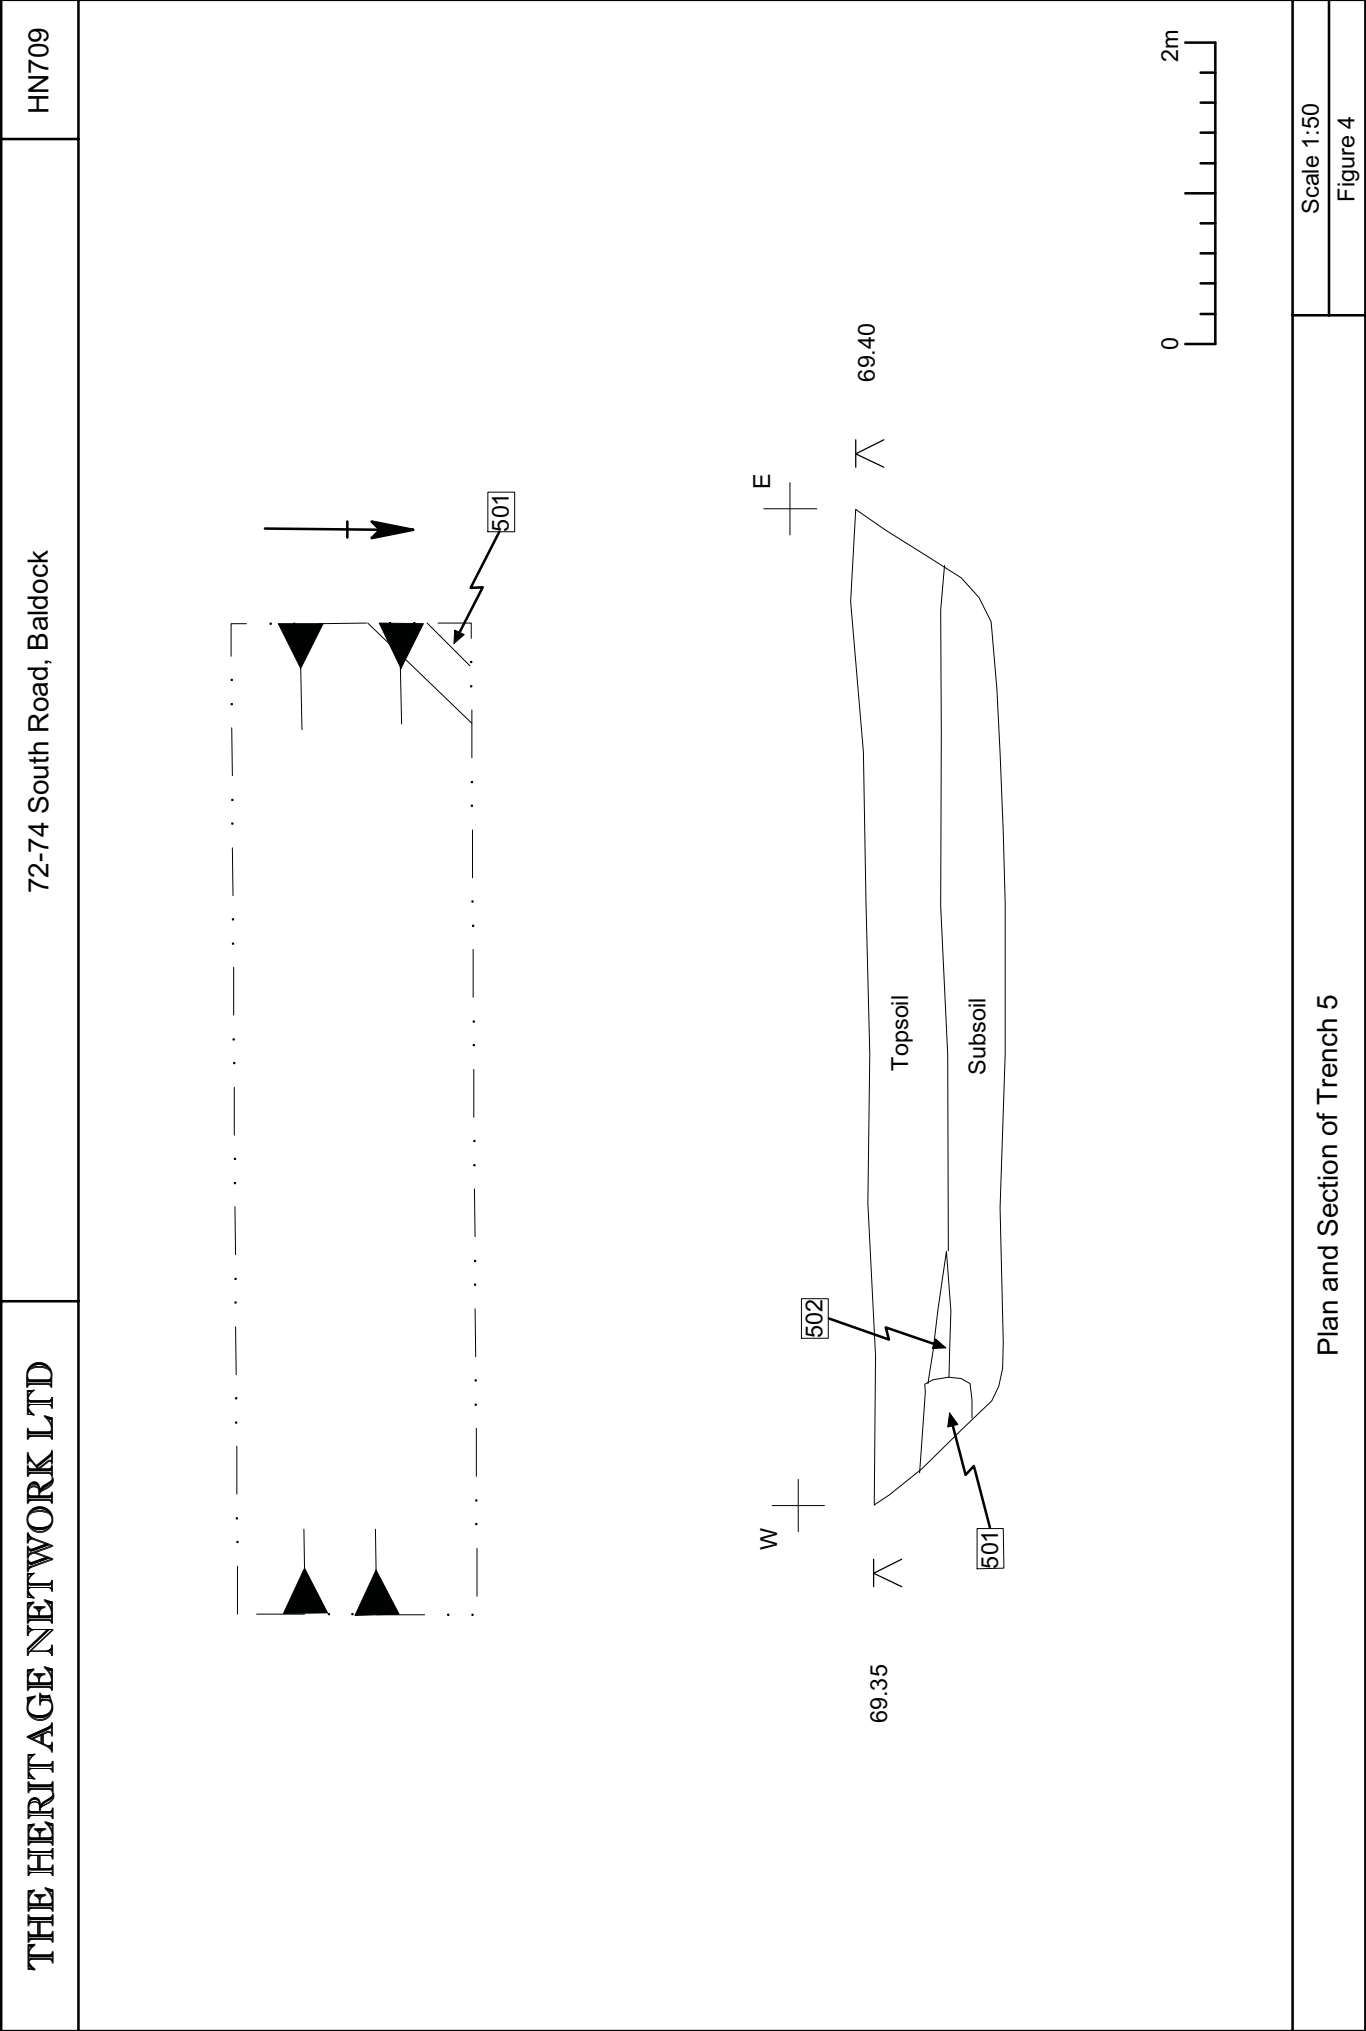
Figure 4

2.3 Trench 5 (Figure 4) contained wall [501]. This was formed from red bricks and was laid in the subsoil. It may represent the remains of a 19th century farm building which can be seen is shown on the Ordnance Survey map of 1898 (Figure 7). Layer (502) was observed between the topsoil and subsoil. Its location abutting wall [501] suggests it is a make up layer deposited to raise the ground level on the eastern side of the wall.

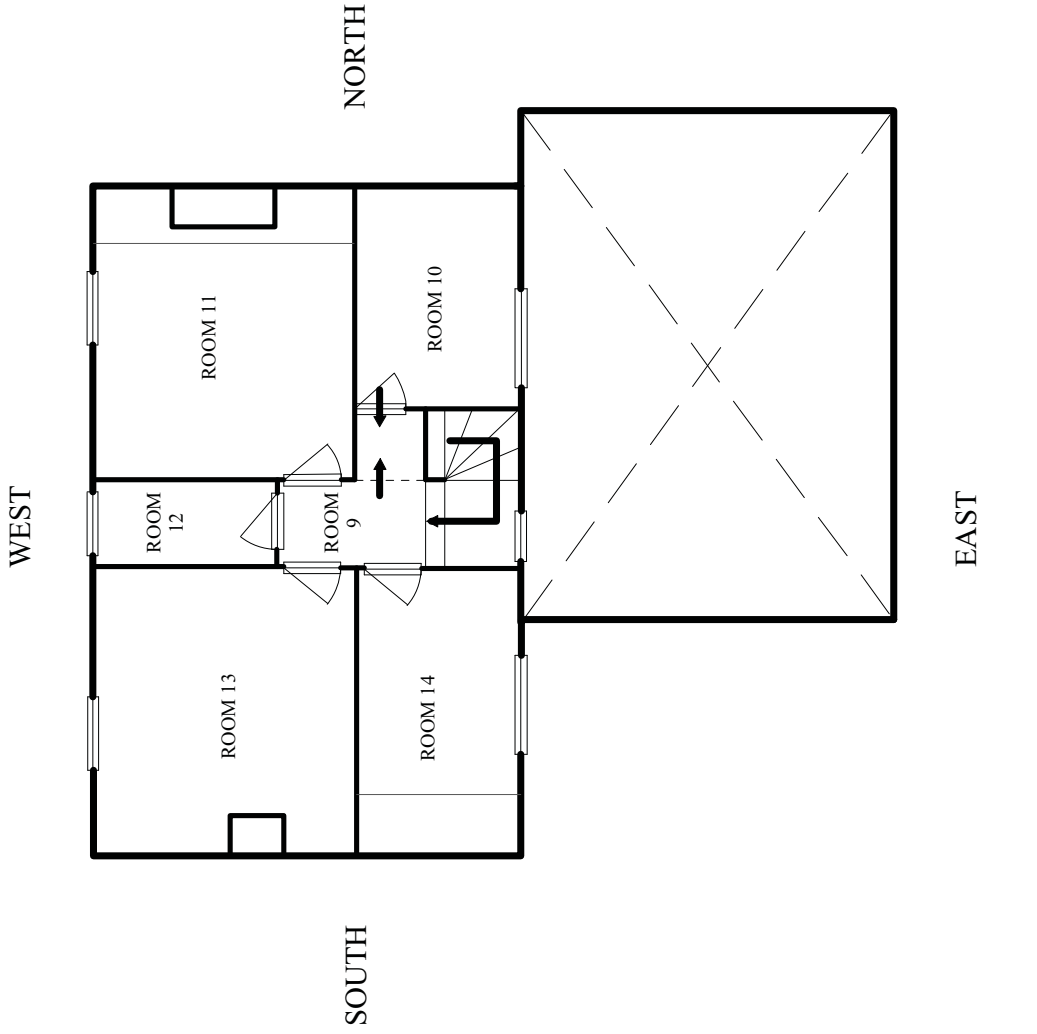
Figure 9

3.13 Room 9: landing and hall. Continues from the staircase on the ground floor (room 5). Landing turns a hundred and eighty degrees then up two steps onto the first floor hallway running from east to west. Original newel post and curved hand rail with plain square balusters along the landing by the steps up to (and adjoining) a modern newel post, hand rail and balusters that run northward over the staircase towards room 10 (contemporary with the inserted step at the approach). Narrow multi-paned window to the stair landing on the east elevation. Original plain skirting board to the hallway. Five doorways, one to each room; four with original four-panel doors with spring latches and chamfered and stopped door frames. Modern door to room 10.

3.14 Room 10: bathroom. Former rear bedroom (north side). Original plain skirting boards to all. Modern door leading to the hall and landing (room 9). Casement mullion window with frosted glass (probably replaced).

3.15 Room 11: bedroom (front north side). Original plain skirting boards to all. Original four-panel door with spring latch and chamfered and stopped door frame. Original 2-over-2 sash window with horns and vertical side glazing bars (secondary glazing). Built-in modern wardrobe to the north elevation over a central projecting chimney breast with an external brick hearth (former open fireplace now blocked).

3.16 Room 12: cloakroom. Original plain skirting boards to all. Original four-panel door with spring latch and moulded frame. In-filled fanlight window above. Original 2-over-2 sash window with horns and vertical side glazing bars.

3.17 Room 13: bedroom (front south side). Original plain skirting boards to all. Original four-panel door with spring latch and chamfered and stopped door frame. Original 2-over-2 sash window with horns and vertical side glazing bars (secondary glazing). Narrow chimney breast to the south elevation (never operated as a fireplace).

3.18 Room 14: bedroom (rear south side). Original plain skirting boards to all. Original four-panel door with spring latch and chamfered and stopped door frame. Casement mullion window (probably replaced). Series of four timber boarded in-built cupboards to the south elevation.

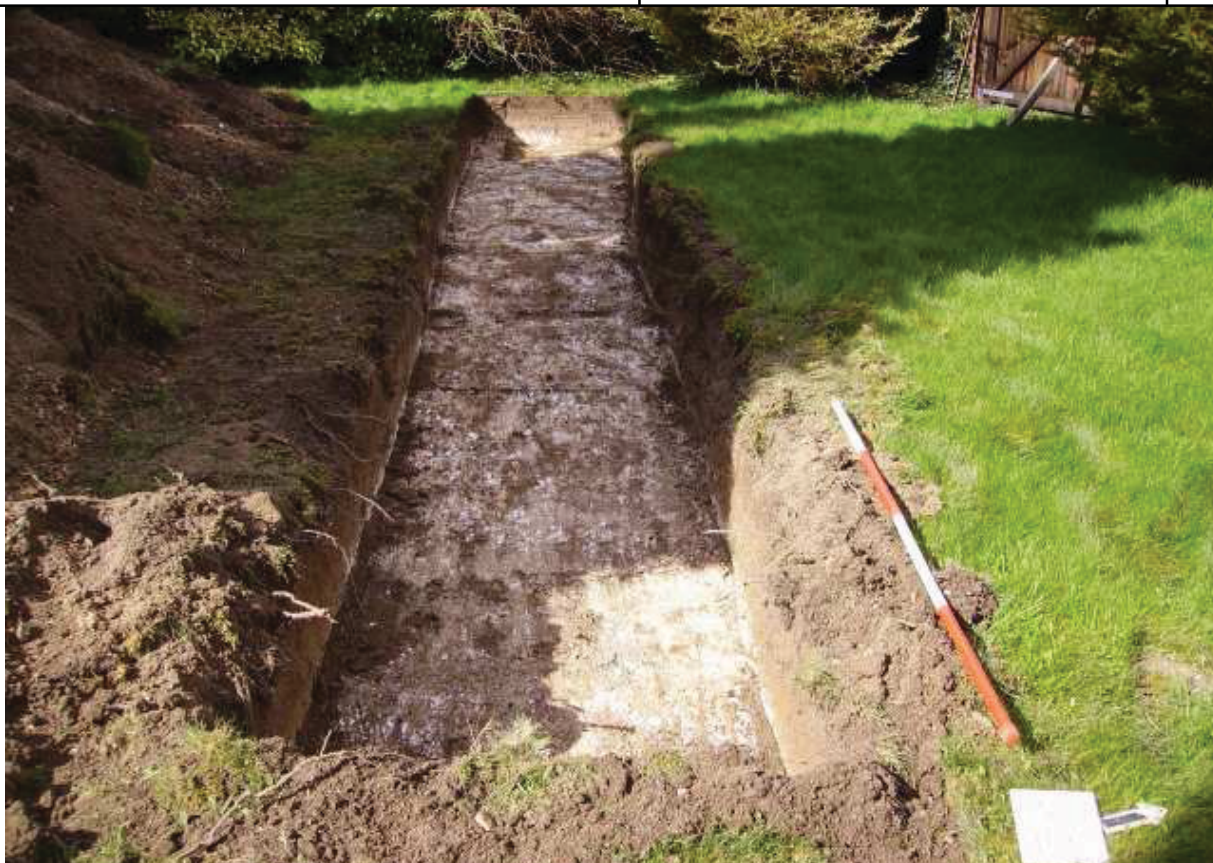
Plate 1: Trench 1, looking west

2.7 Trench 1 was located in the western corner of the site (Figure 2). It measured 12.20m in length, 1.6m in width, and 0.70m in depth (Plate 1).

2.9 Trench 1 contained no archaeological features or deposits.

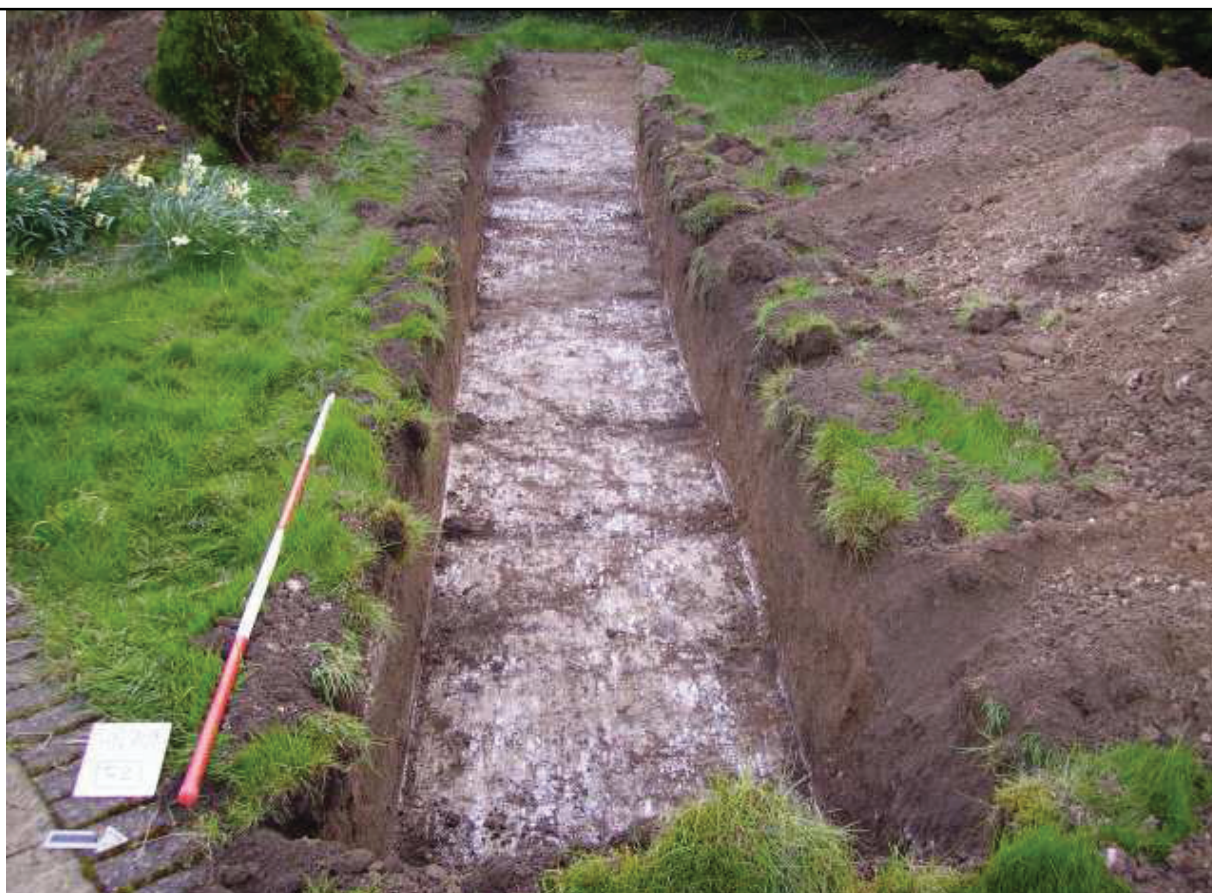
Plate 2: Trench 2, looking west

2.10 Trench 2 was located in the front garden of no. 72 South Road (Figure 2). It measured 13.20m in length, 1.60m in width, and 0.70m in depth (Plate 2).

2.12 Trench 2 was crossed by a gully feature [201] which ran in a northwest-southeast direction (Figure 3). The feature measured 1.40m+ in length by 0.72m in width by 0.15m in depth and contained a yellowish brown (10YR 5/4), firm, clayey silt fill with frequent fine chalk, occasional small sub angular flint, and very occasional small chalk inclusions together with CBM and shell.

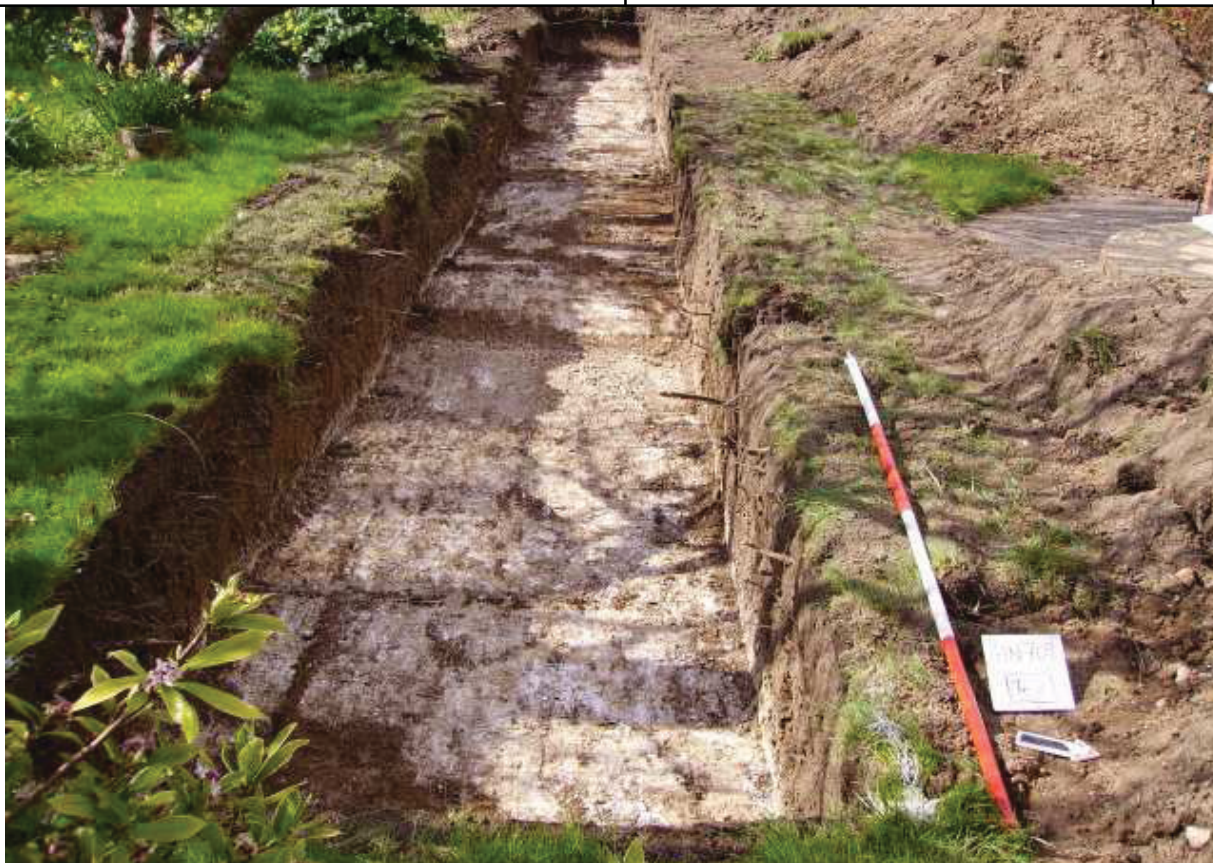
Plate 3: Trench 3, looking southwest

2.13 Trench 3 was located to the rear of 72 South Road (Figure 2). It measured 15.10m in length, 1.60m in width, and 0.58m in depth (Plate 3).

2.15 Trench 3 contained no archaeological features or deposits.

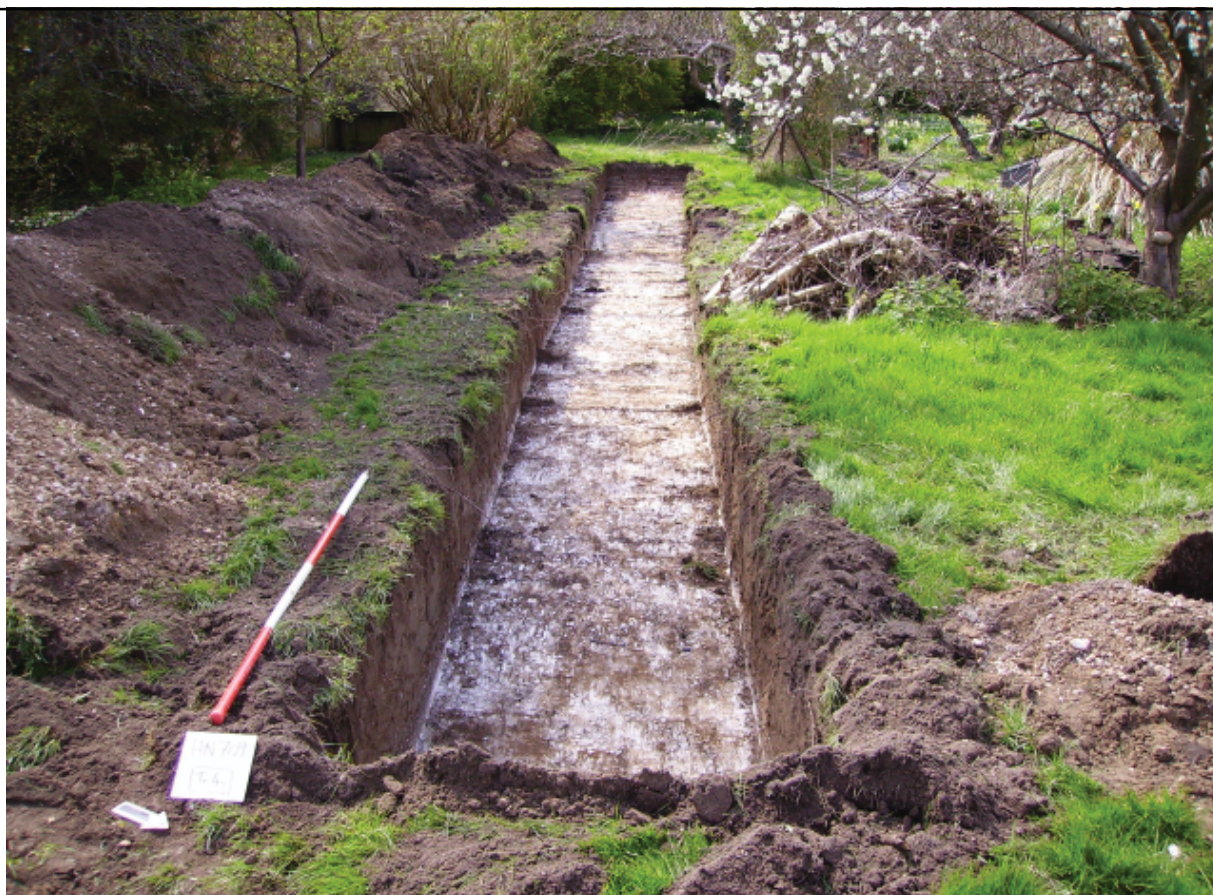
Plate 4: Trench 4, looking southwest

2.16 Trench 4 was located on the eastern side of the site (Figure 2). It measured 19.90m in length, 1.6m in width, and up to 0.80m in depth (Plate 4).

2.18 Trench 4 contained no archaeological features or deposits (Figure 6).

2.4 During the evaluation it was noted that there was a slightly greater level of build up at the north-eastern end of the site. This was most noticeable in Trench 4 and may be the result of levelling this area after removal of the 19th century farm buildings.

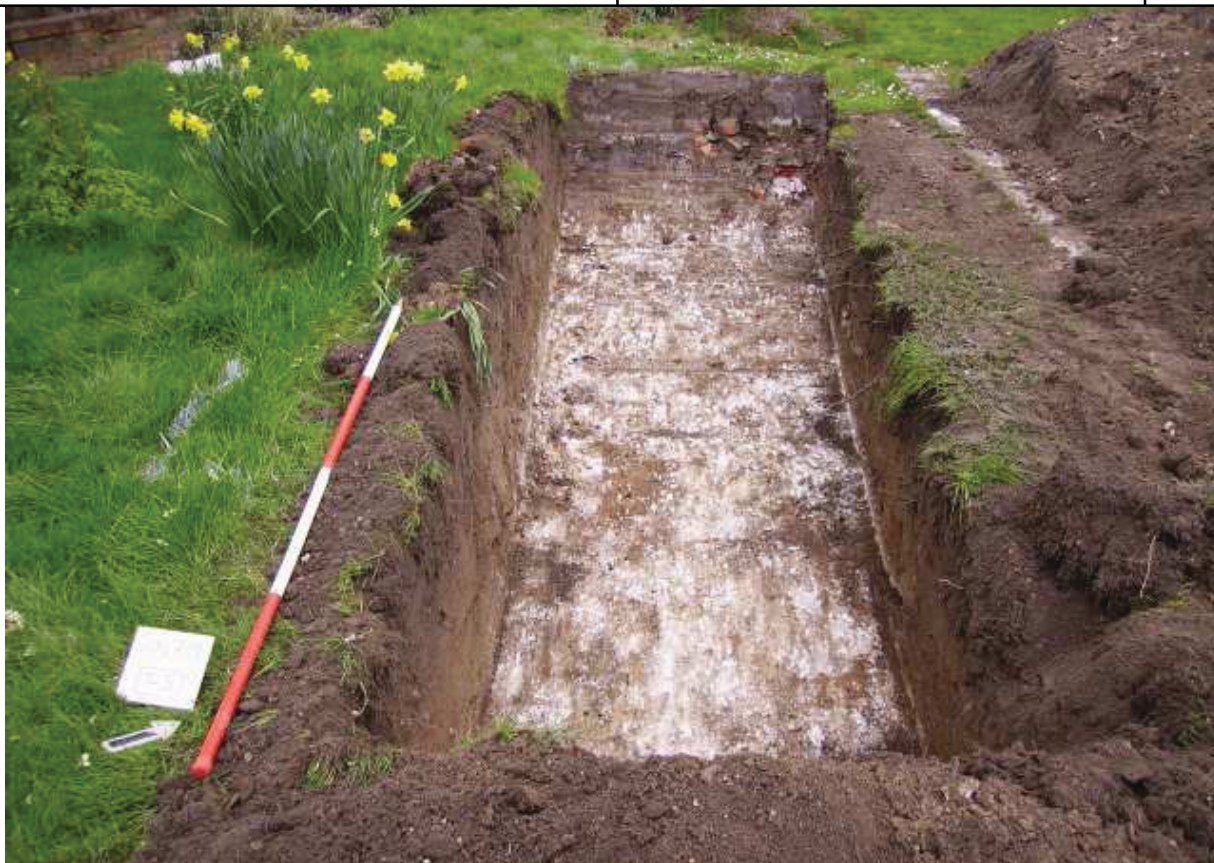
Plate 5: Trench 5, looking west

2.19 Trench 5 was located on the eastern side of the site (Figure 2). It measured 6.60m in length, 1.60m in width, and 0.90m in depth (Plate 5).

2.21 Trench 5 contained brick wall [501], formed of red bricks with a concrete mortar (Figure 5). This survived to a height of 5 courses and was two bricks wide. The wall appeared to be set in the subsoil. An additional makeup layer (502) was a very dark greyish brown (10YR 3/2) loose silty clay which measured 0.22m deep by 1.10m wide.

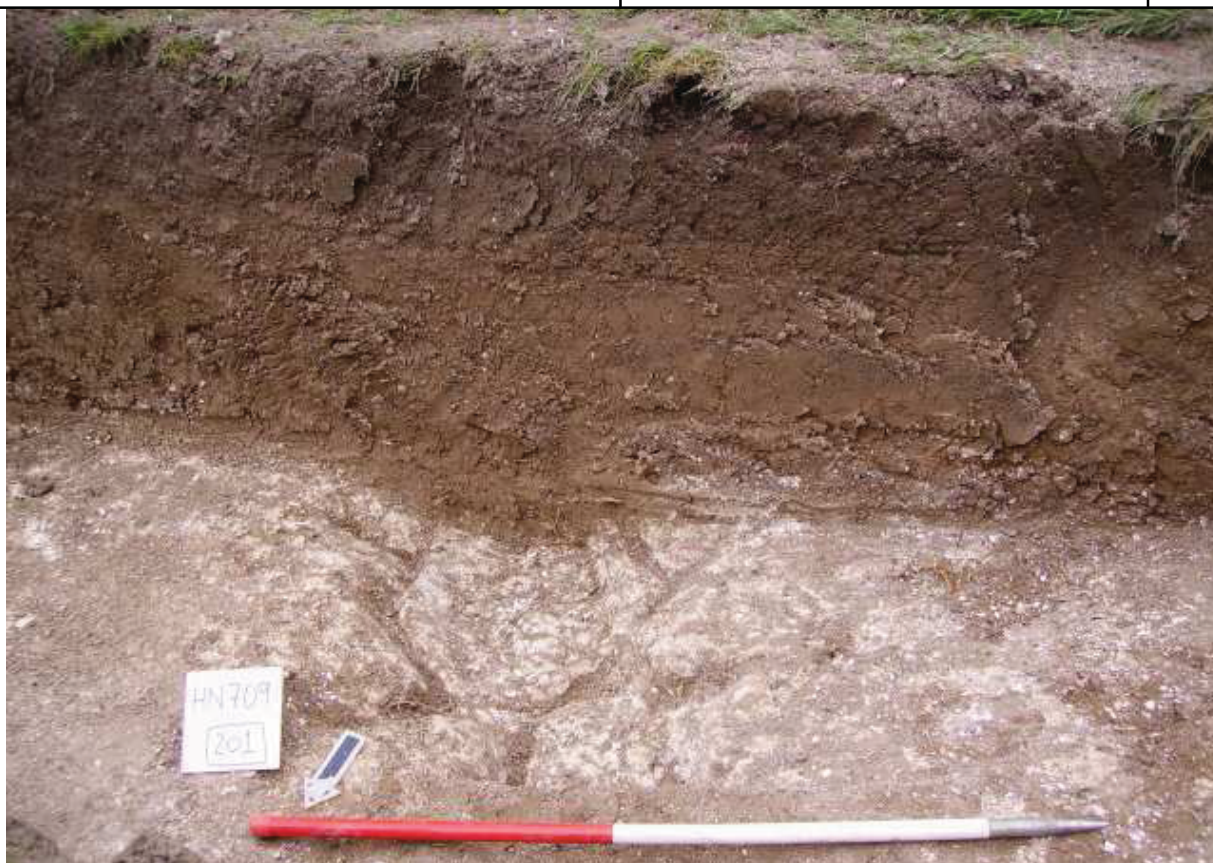
2.2 Trench 2 (Figure 3) contained a small gully feature [201] which was aligned northwest-southeast. This contained a small amount of CBM, some snail and oyster shell, charcoal and a single piece of flint. The feature contained only one fill which could not be distinguished from the subsoil. This may represent part of a post-medieval field system and may be a drainage channel.

Plate 7: Gully [201]

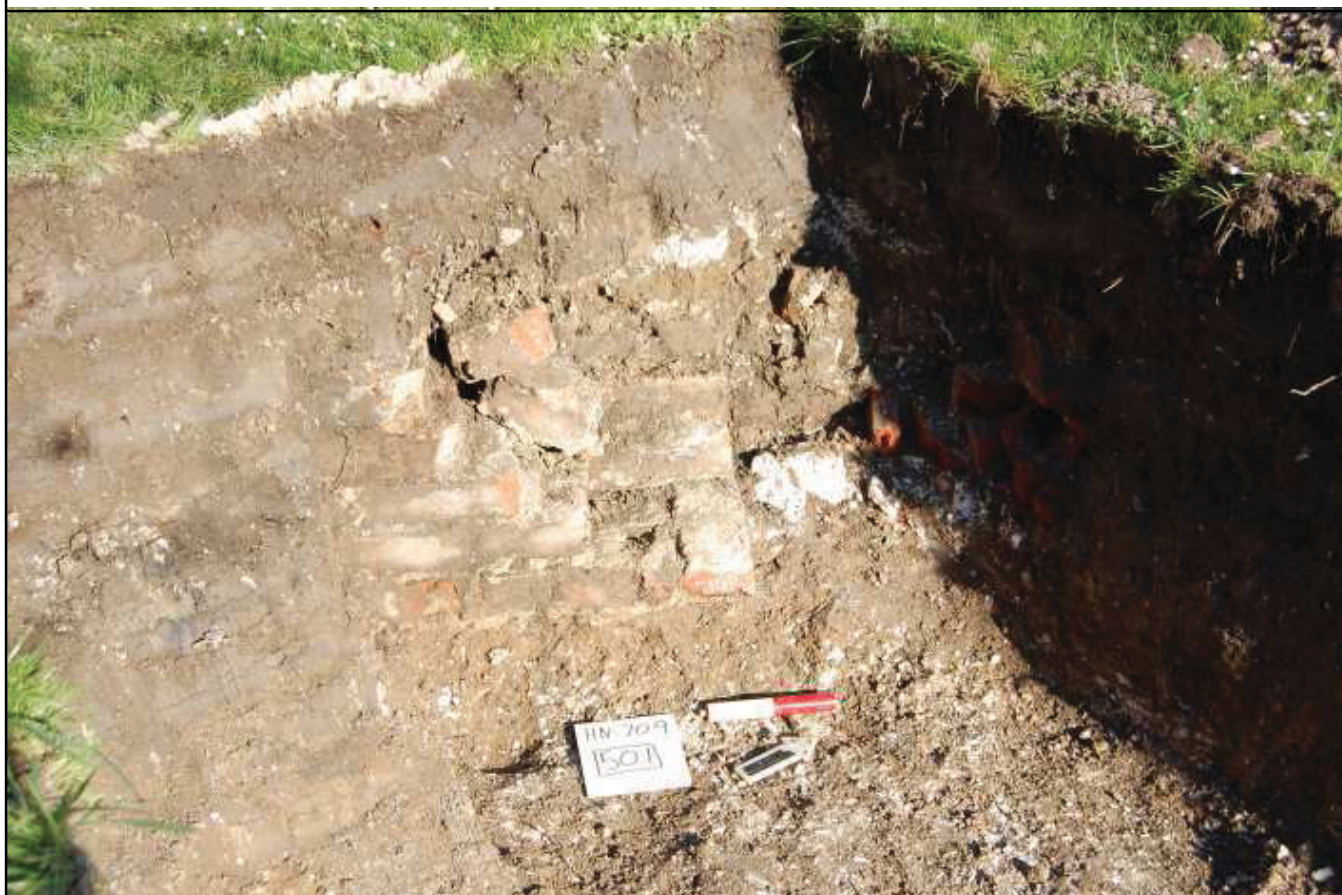
Plate 8: Wall [501]

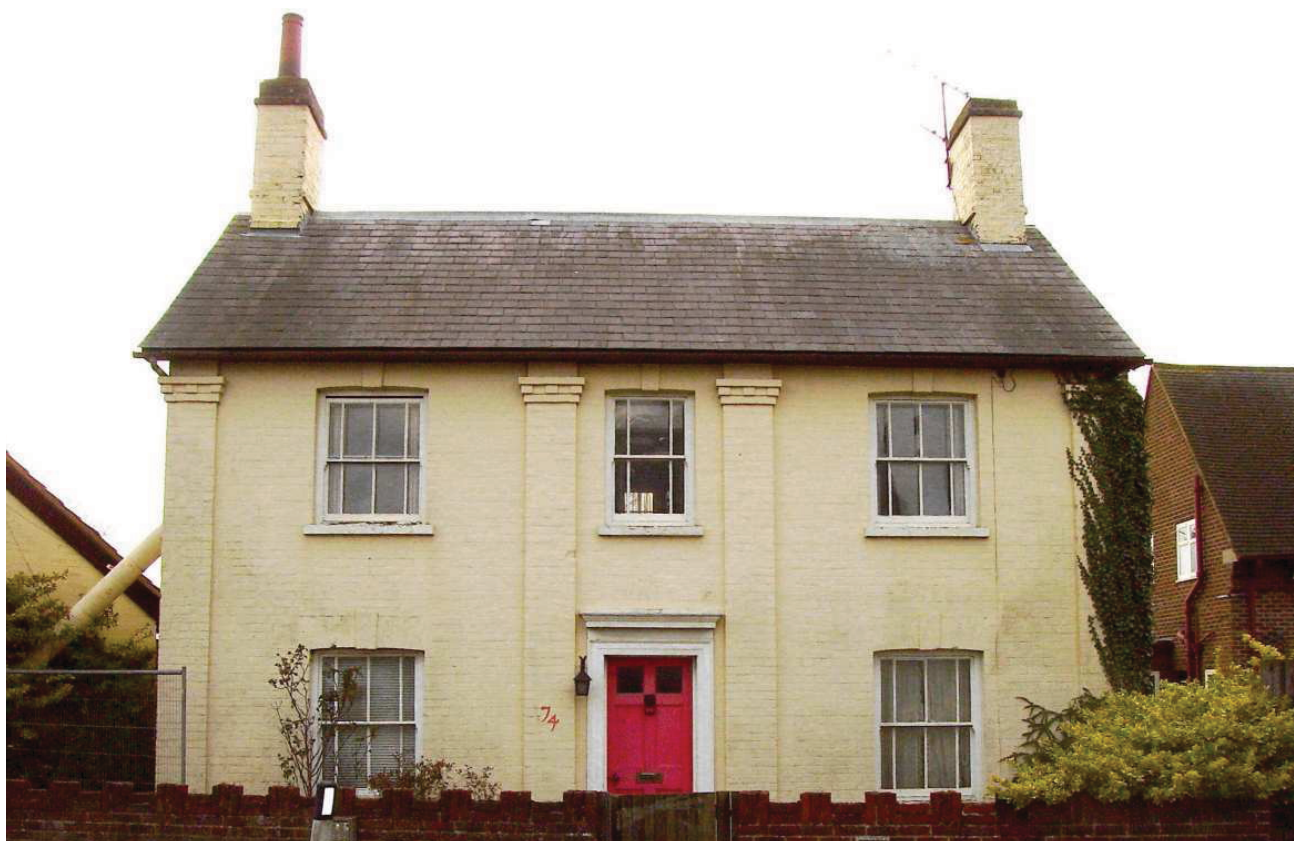
3.2 West elevation: symmetrical front with central doorway comprising a moulded doorcase surround and plain panelled reveals with a plain frieze above and cornice hood over (probably early 20th century and contemporary with the panelled door). The lower part of the surround is missing. Six-panel replacement door with glazing to the upper panels. Four brick pilasters each with brick cornice and dentil under the eaves; one to each end of the front elevation and two at the centre, one either side of the doorway. Two deeply recessed ground floor windows and three deeply recessed first floor windows, all original and most have original glass. All five windows have segmental brick headers and brick keystone in relief, and projecting stone sills. Four windows have 2-over-2 sashes with horns and vertical side glazing bars. The central first floor window is slightly smaller but similarly styled; 1-over-1 sash with horns and vertical side glazing bars.

Plate 9: Exterior. Building 1, west elevation

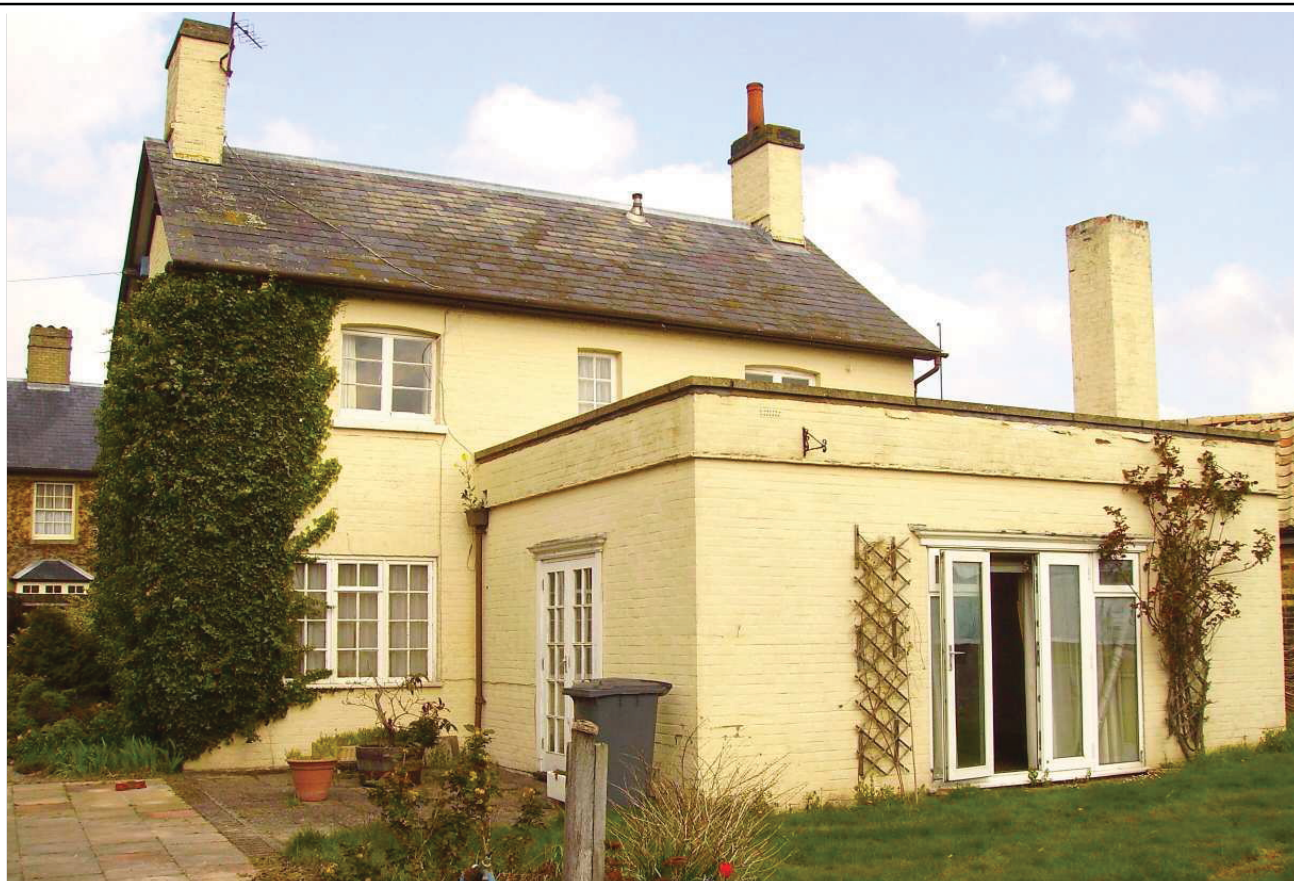
3.4 East elevation: four windows along the east elevation of the main house; three to the first floor and one to the ground floor. Three deeply recessed first floor windows with segmental brick headers and brick keystone, and projecting stone sills. Two casement mullion windows, one with frosted glass (both probably replaced) located either side of an original, narrow, multi-paned fixed window. On the ground floor to the south end is an inserted modern multi-paned casement window (replacing an earlier smaller opening). Modern double doors and full length side windows to the east elevation of the rear extension.

Plate 10: Exterior. Building 1, east elevation

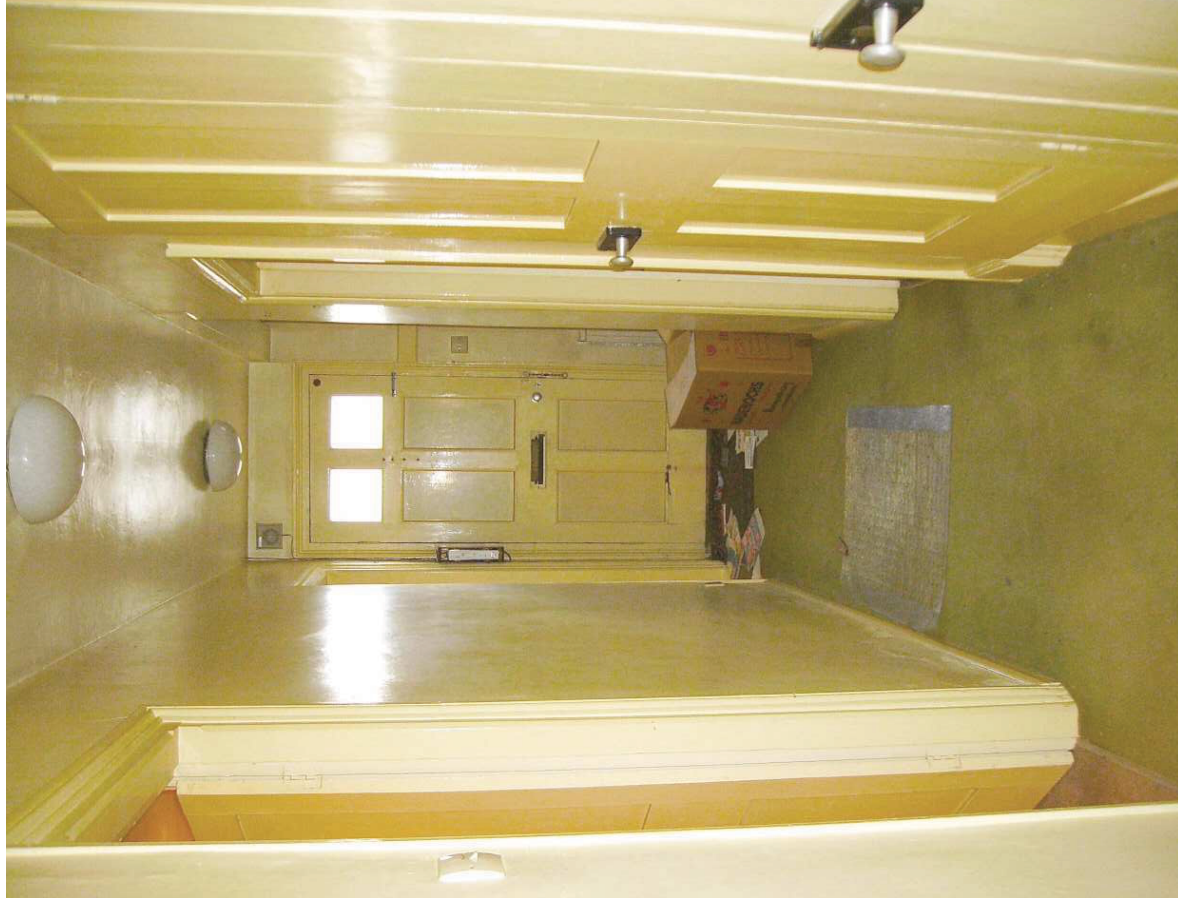
3.6 Room 1: hall. Formerly a front to back corridor with up to eight doorways, now open to the northwest leading into the ante room (room 2). Modern chamfered skirting board to all (small part of original 19th century skirting board survives). Six doorways; three have original four-panel doors with chamfered and stopped doorframes (rooms 4 & 8), original four-panel door to the stairs with a plain door frame (room 5), an original tongue and groove door to the cupboard under the stairs (room 6), and the six-panel replacement front door with glazing to the upper panels.

Plate 11: Interior. Building 1, room 1, hall facing west

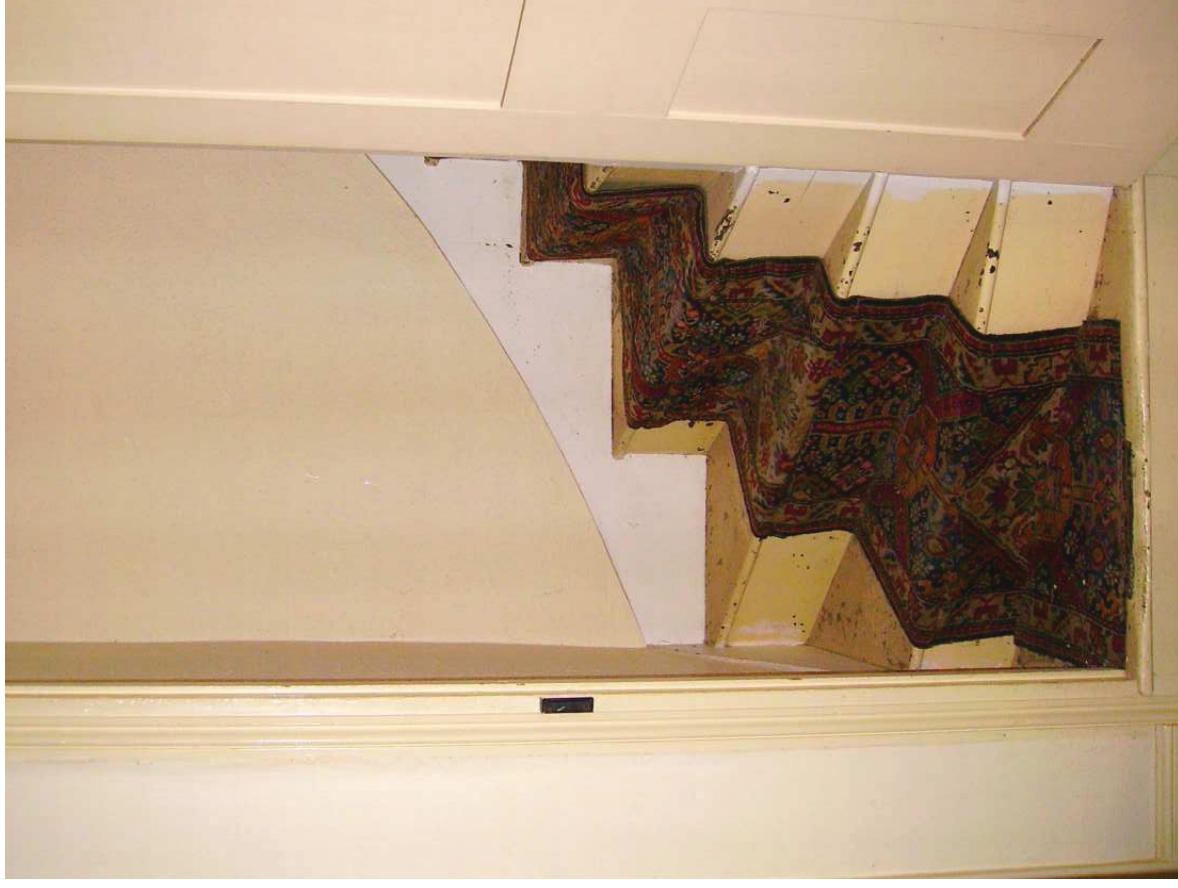
3.10 Room 5 & 6: staircase with cupboard under. Original four-panel door with a plain door frame leading onto the timber staircase that turns ninety degrees from the southeast corner of the doorframe up to a landing (room 9). Partly carpeted with nosing to the treads and deep wall string. Tongue and groove door to the cupboard. Original position and form to both.

Plate 12: Interior. Building 1, room 5, staircase facing north

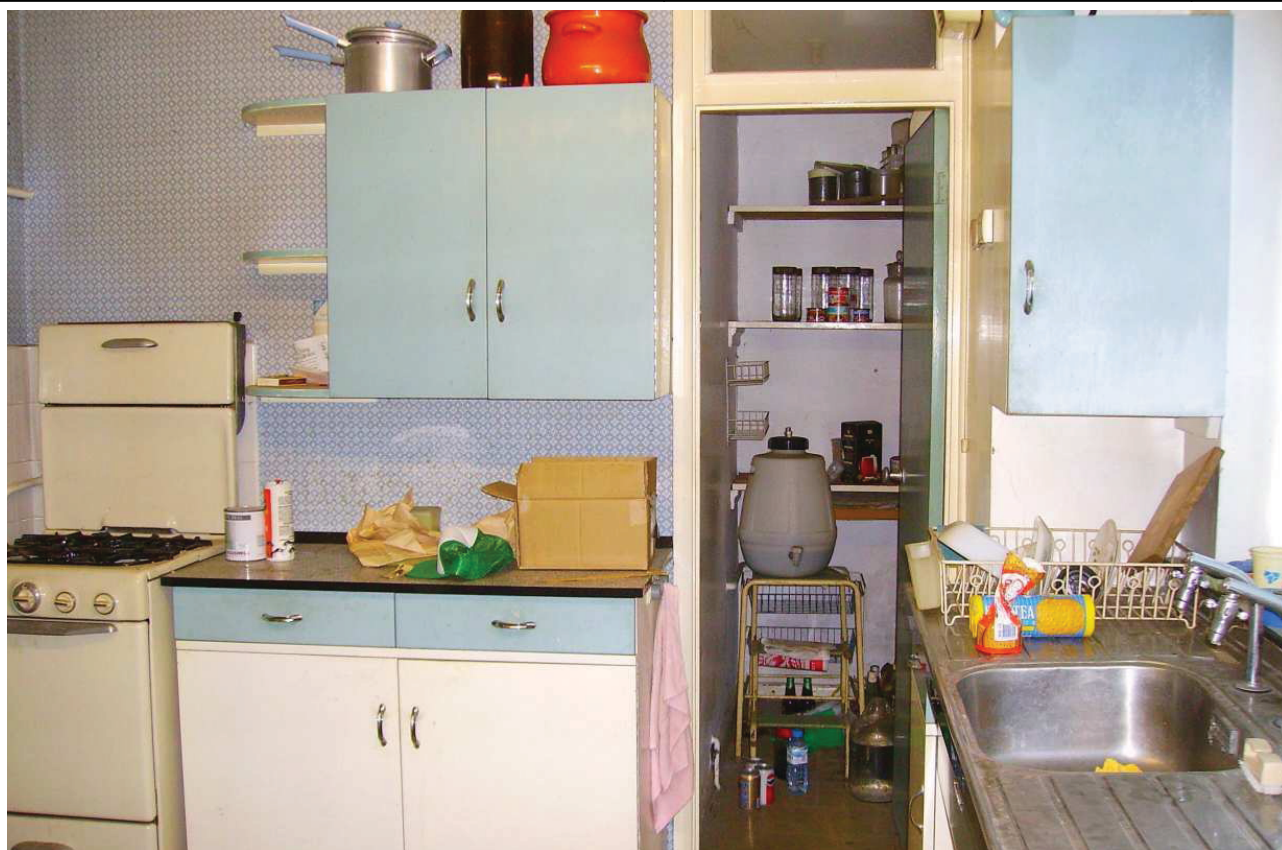
3.9 Room 4: kitchen and pantry. Formerly part of the front room (north side) and the original kitchen to the rear. Modern chamfered skirting board to all. Three doorways; original four-panel door to the south leading into the hall, modern door into the pantry, and an inserted modern part glazed multi-paned door to the north elevation leading into the yard. Inserted modern multi-paned casement window next to this exterior door. To the north elevation, partly in the pantry and partly in the kitchen is a projecting chimney breast (blocked fireplace, now only the flue is used by the coke / coal boiler / furnace located inside Building 2).

Plate 13: Interior. Building 1, room 4, kitchen, north elevation

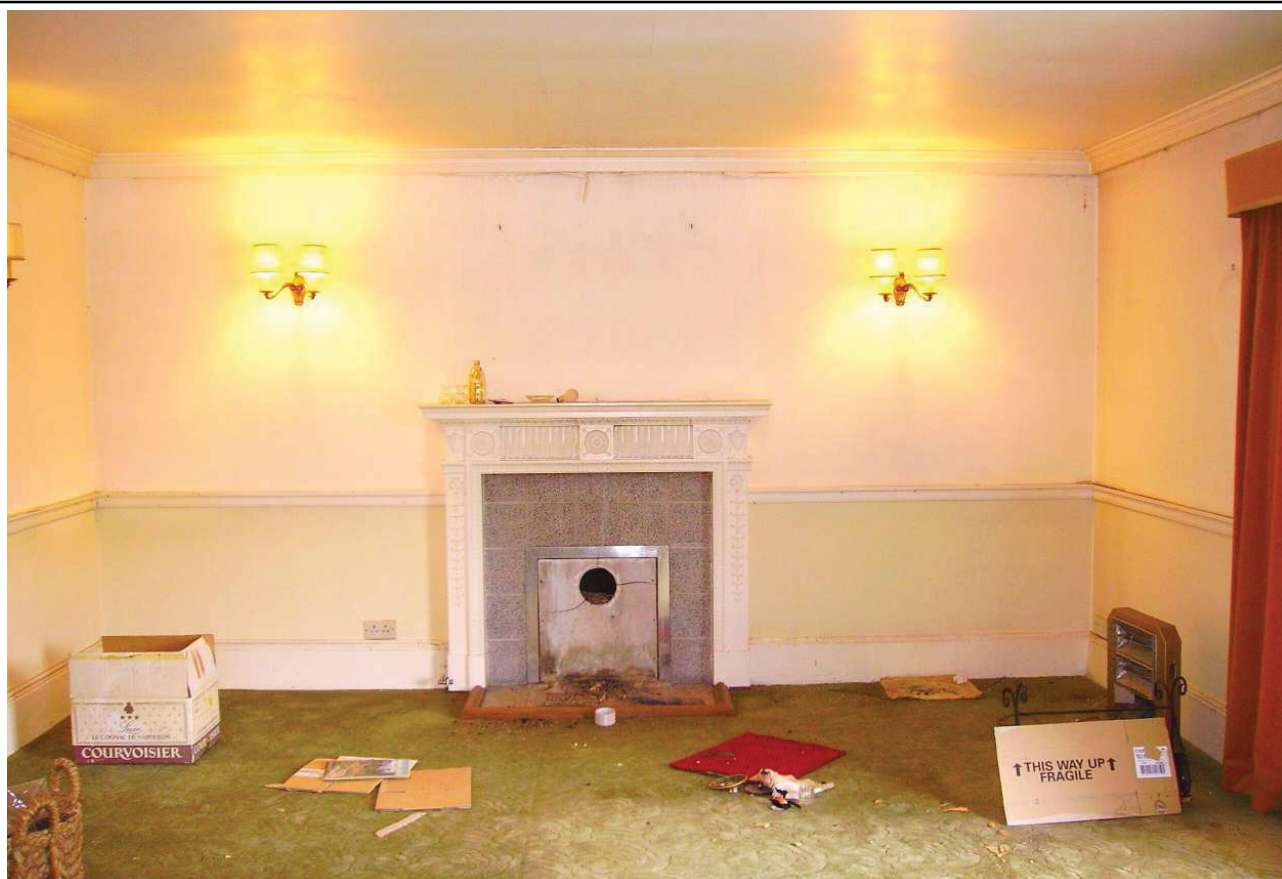
3.11 Room 7: living room. Large single room in the 1960s extension with modern deep skirting board, moulded dado rail and coving. Three doorways, two leading outside; one modern double door to the east elevation with full length side windows and one modern multi-paned double door to the south elevation. Modern internal multi-paned door to the west elevation leading into the hall (probably occupying the position of the former back door).

Plate 14: Interior. Building 1, room 7, living room facing north

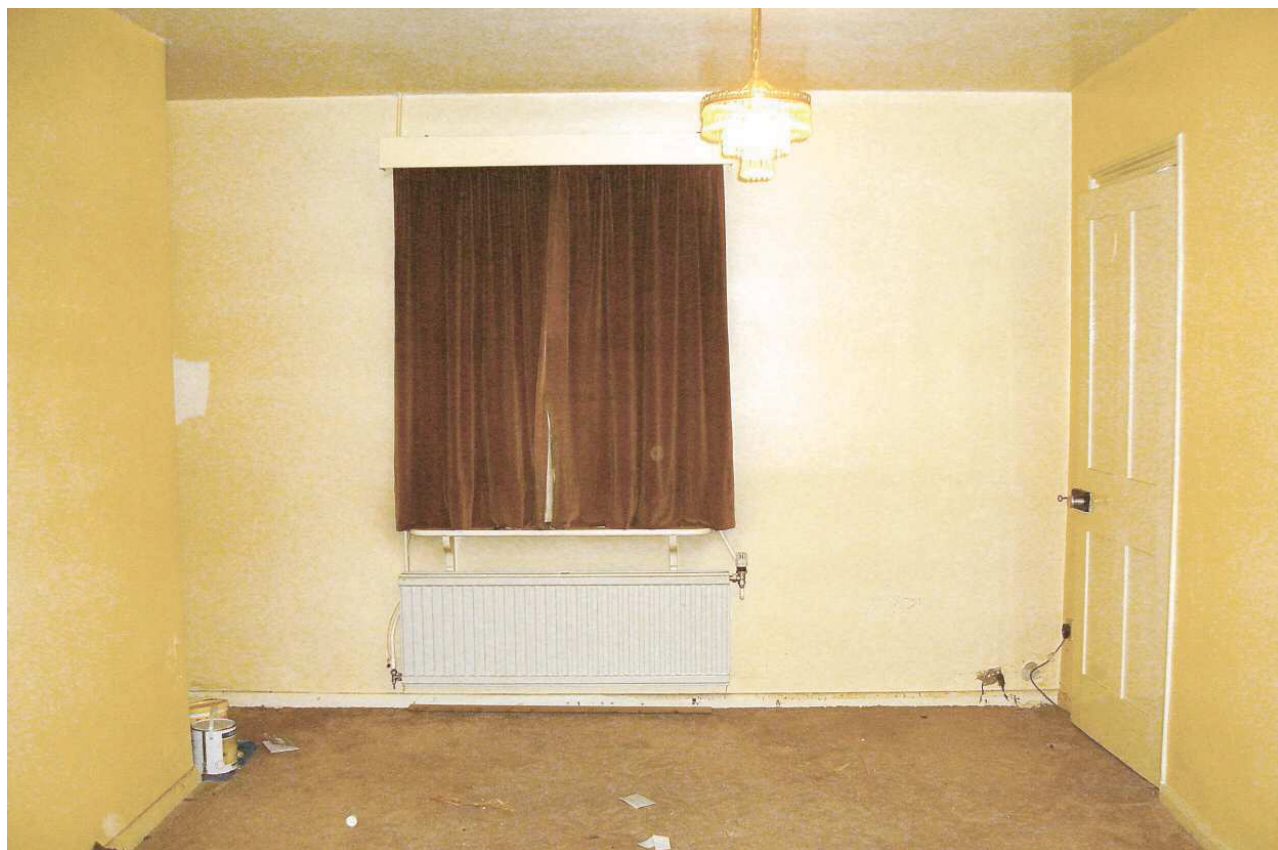
3.12 Room 8: sitting room. Formerly two separate rooms, the front room (south side) and rear parlour. Modern chamfered skirting board to all. Two doorways; original four-panel doors with chamfered and stopped doorframes to the north elevation. Dual aspect with two windows; to the west is an original 2-over-2 sash window with horns and vertical side glazing bars, and a projecting sill on brackets below. Modern multi-paned casement window to the east elevation (replacing an earlier smaller opening).

Plate 15: Interior. Building 1, room 8, sitting room, facing west

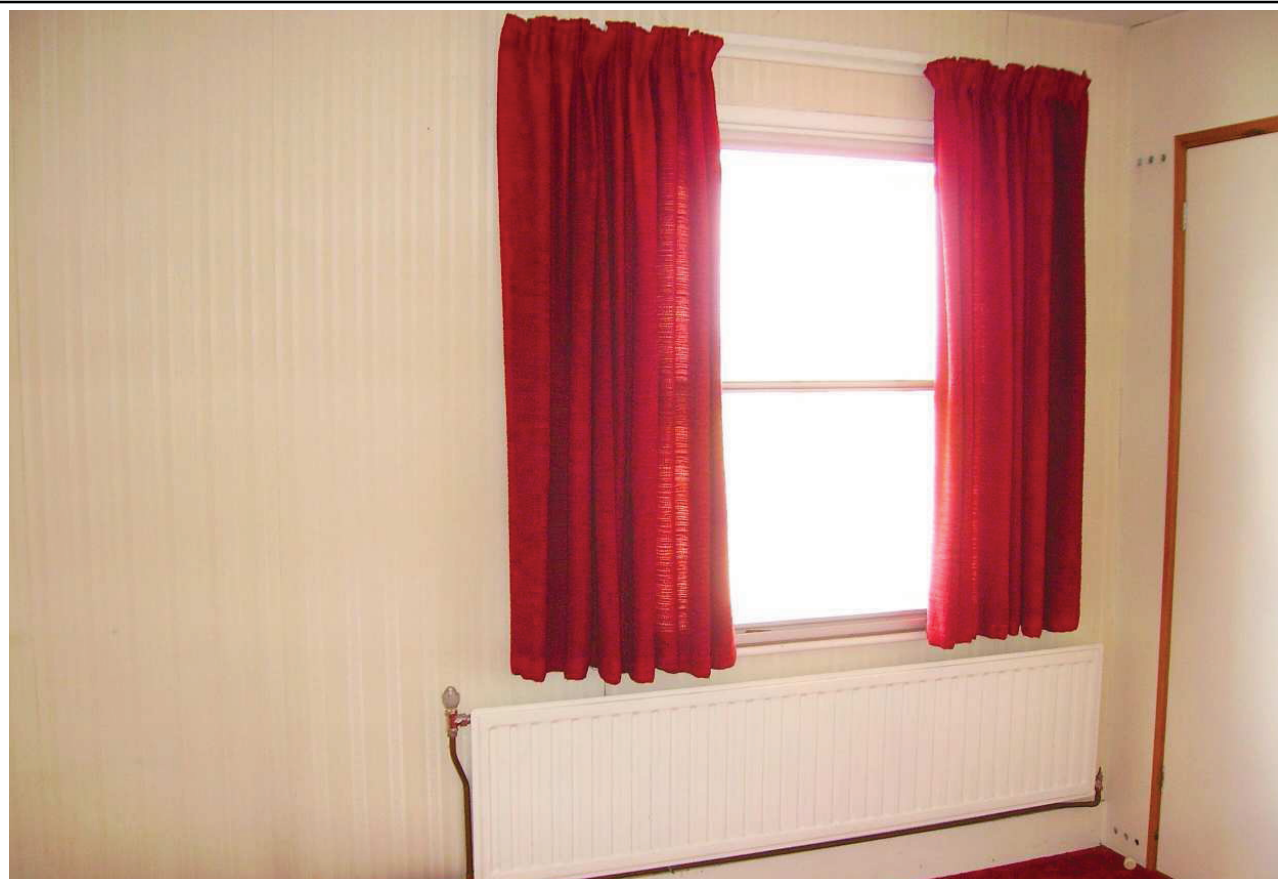
Plate 16: Interior. Building 1, room 11, bedroom west elevation
