72-74 SOUTH ROAD Baldock, Hertfordshire

HN709

***Archaeological Evaluation &
Historic Building Impact Assessment Report***

Archaeological Evaluation
&
Historic Building Impact Assessment

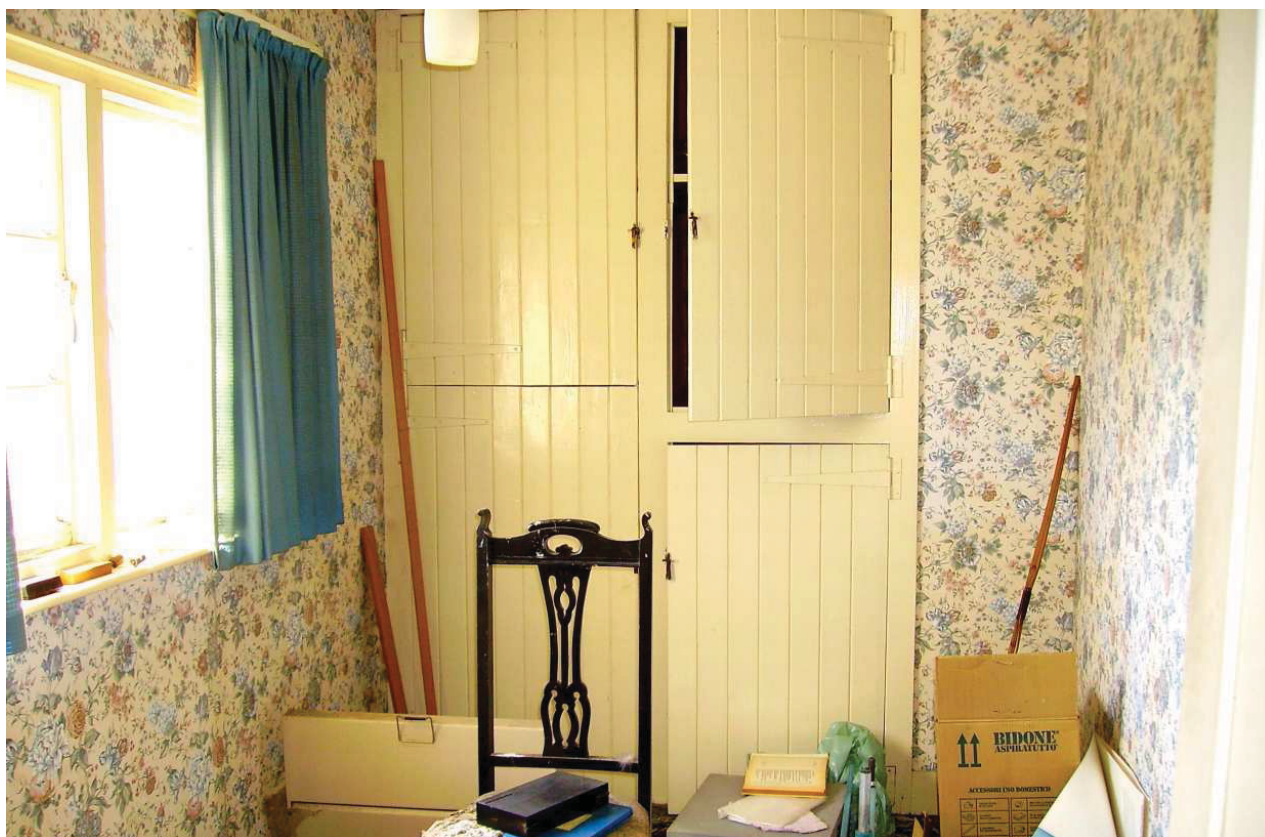
3.18 Room 14: bedroom (rear south side). Original plain skirting boards to all. Original four-panel door with spring latch and chamfered and stopped door frame. Casement mullion window (probably replaced). Series of four timber boarded in-built cupboards to the south elevation.

Plate 21: Interior. Building 1, room 14, bedroom east elevation

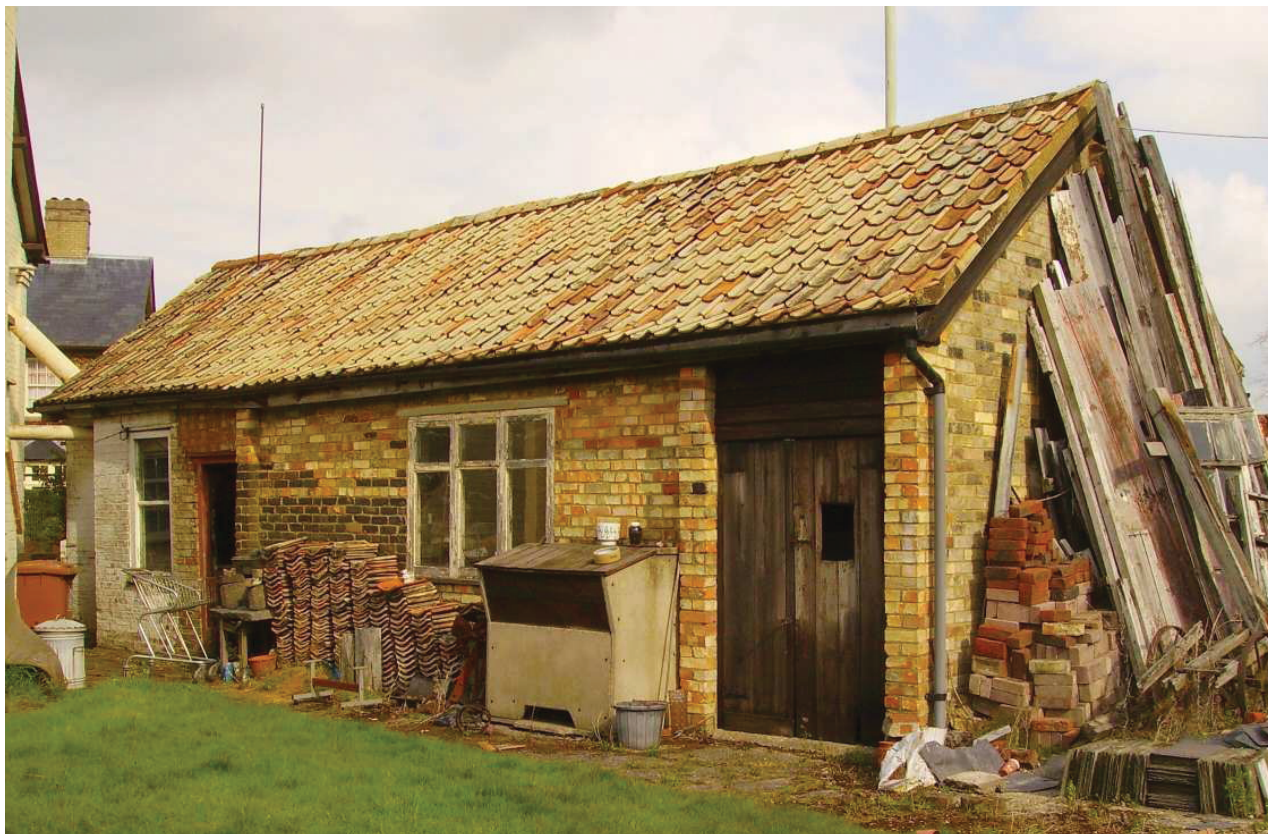
3.24 The materials used in its construction varies from yellow brick that is comparable with that recorded in Buildings 1 and 3, to modern fletton bricks, yellow and orange ‘reclaimed’ brick and a number of heavily burnt hand-made older bricks. The yellow brick is used mostly on the west elevation of the building where it is laid in Flemish bond with some also found at the west end of the north and south elevations.

Plate 23: Exterior. Building 2, south elevation
