**OLD BOWLING FORGE COTTAGE**  
**Cottered, Herts.**

*Archaeological Monitoring Report*

HN374

Report No.178

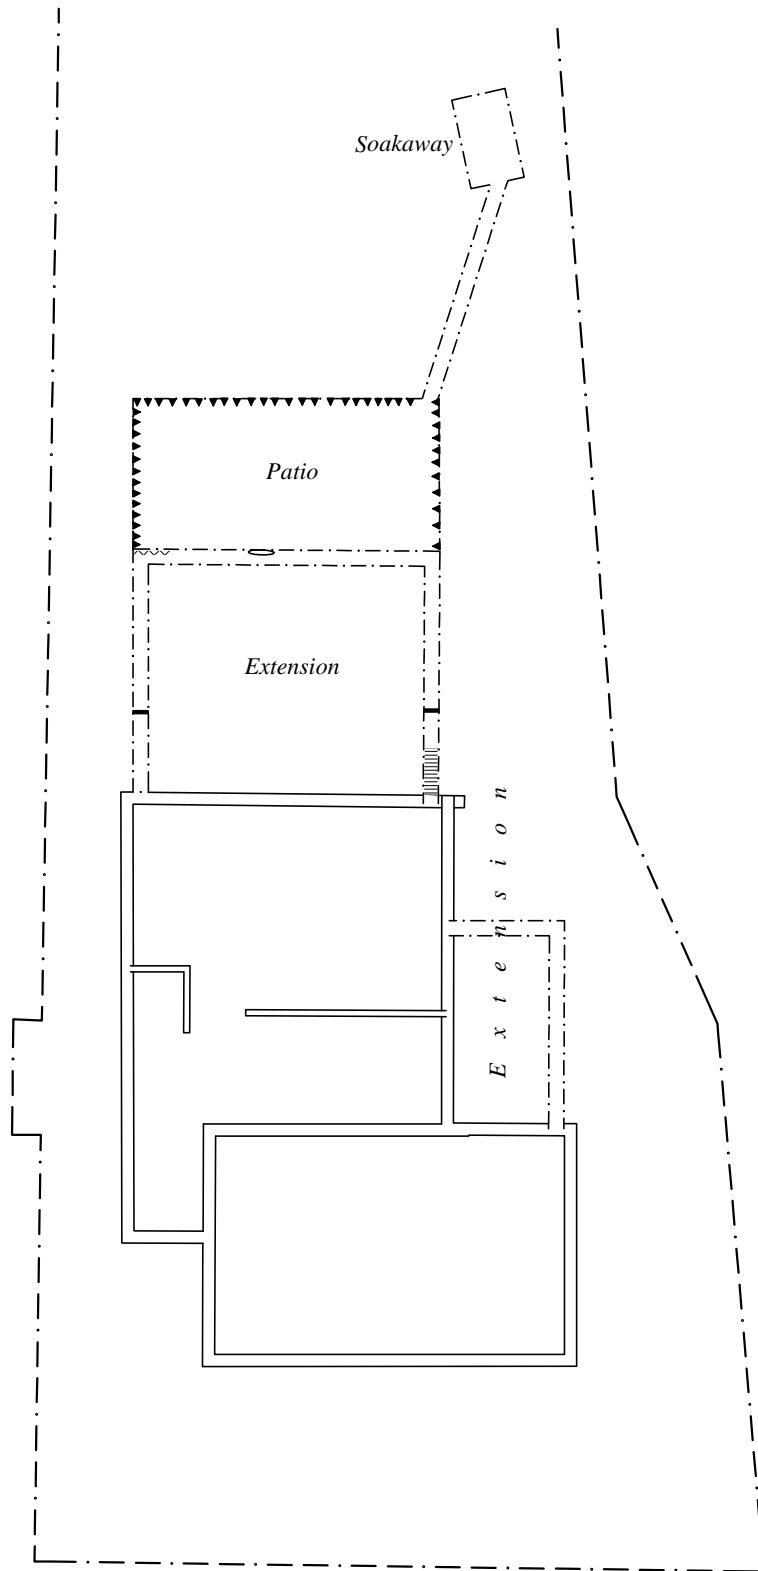
Figure 2

**2.10** The rear extension also revealed evidence for underpinning in the western trench. This measured 0.80m in length and reached a depth of approximately 0.27m. The fill consisted of very dark grey (7.5YR 3/1) soft silty clay.

**2.11** A modern land drain ran across the site and was revealed in the eastern and western trenches, approximately 1.30m south of the building.

**2.12** A chalk layer measuring greater than 0.63m in length, greater than 0.11m in width and approximately 0.10m in depth was visible in the south-east corner of the footings trenches approximately 0.90m below the ground surface.

**2.13** A sub-circular area packed with a stone resembling Reigate Firestone was revealed in the southern trench, 1.90m west of the south-east corner. This area measured 0.43m in length, 0.20m in depth and lay 0.80m below the ground surface, which had been reduced by c.0.60m at this point.
