BULIMERS FARM Writtle, Essex

WRBF09
HN811

***HISTORIC BUILDING
RECORD***

Historic Building Record

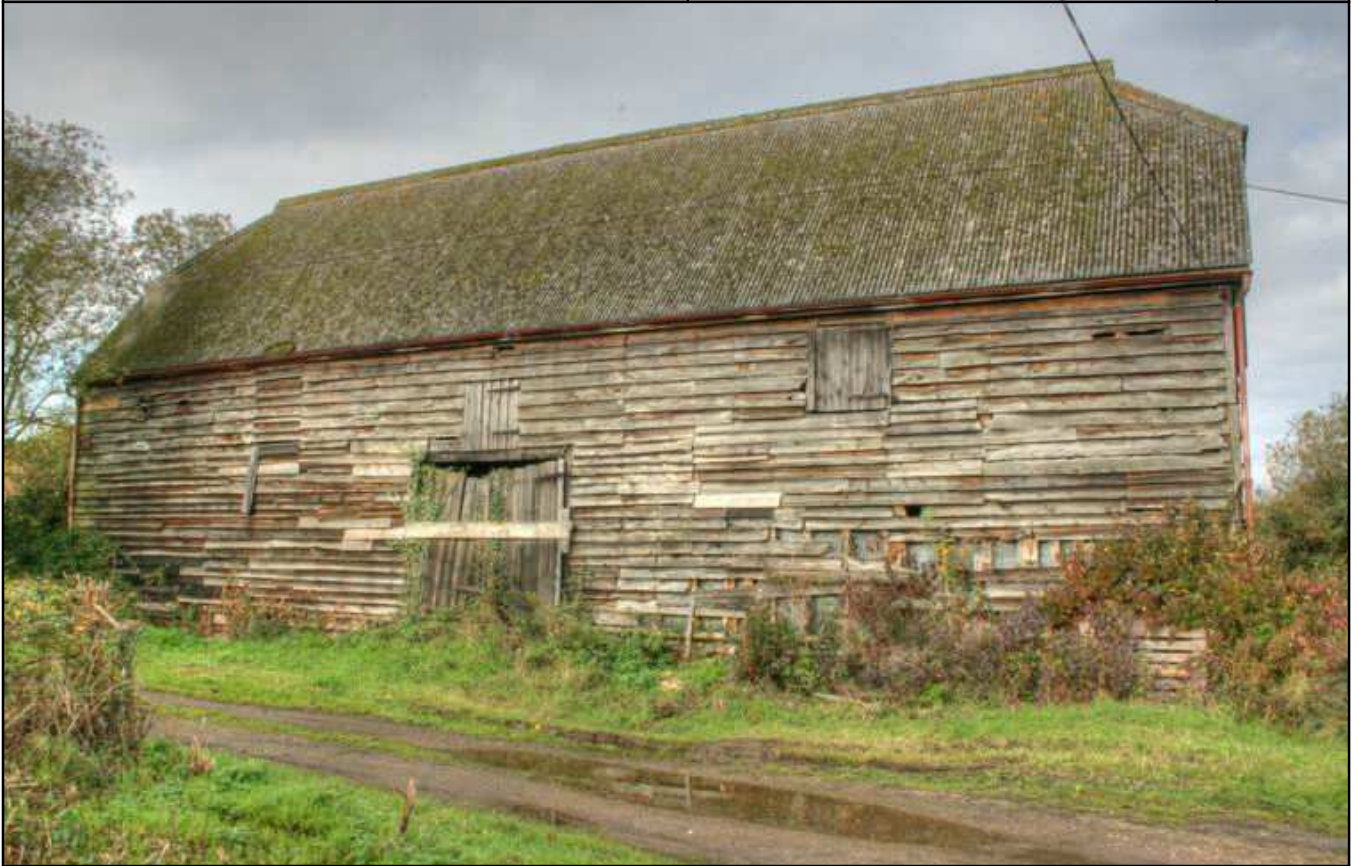
Plate 1: South exterior elevation, looking north

3.5 The elevation facing the road, which is the southern elevation, has a centrally placed pair of doors (Plate 1). A pitching door is located above this, with another pitching door to the east. An area of infilled weatherboarding beneath the eaves to the west indicates a further blocked opening. The timber framing rests on a brick plinth formed of red bricks laid in alternate layers of headers and stretchers (English Bond). The plinth appears formerly to have had a bitumen coating, although this has largely weathered off. The brickwork is bonded with a lime mortar.

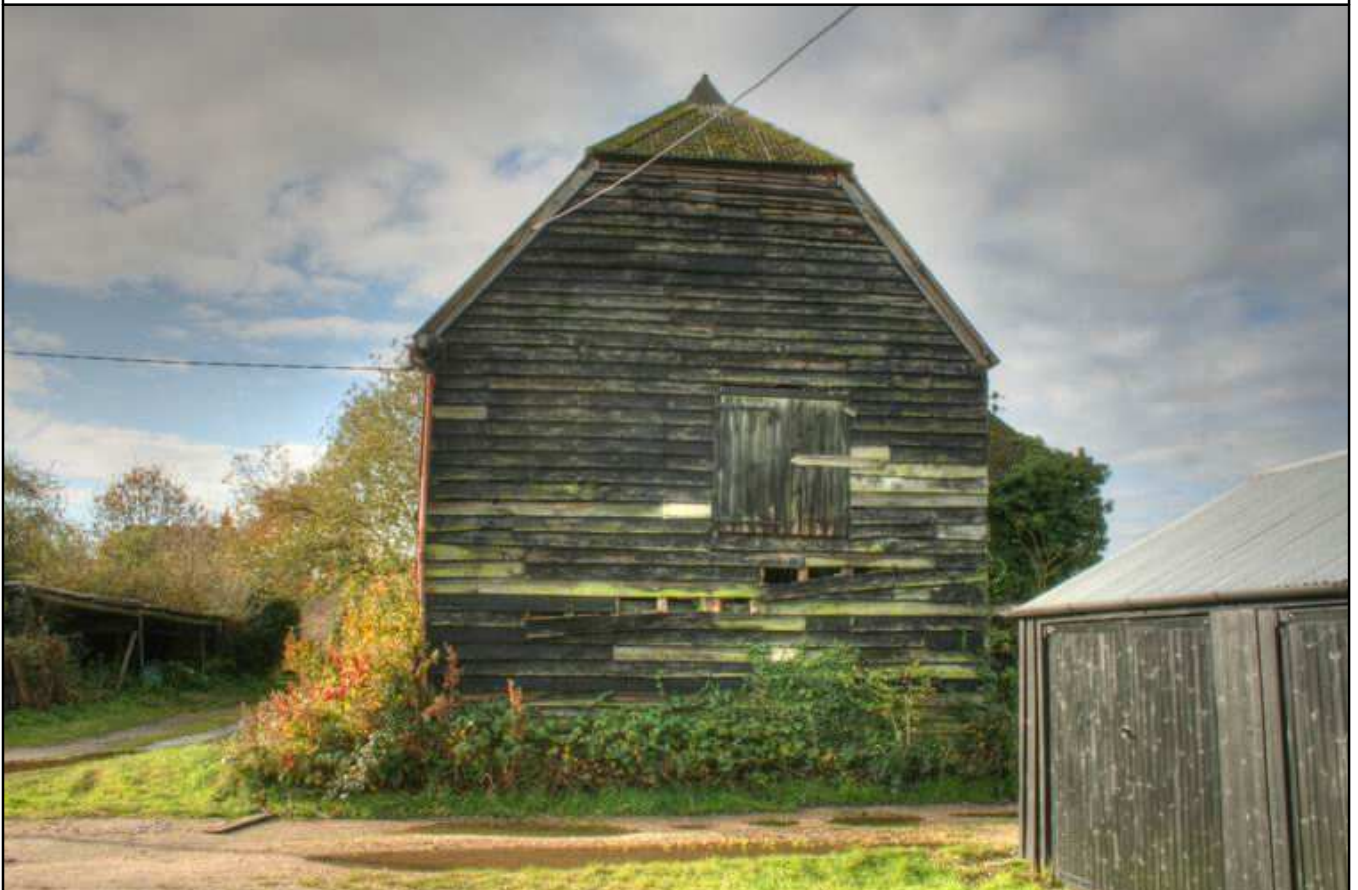
Plate 2: East exterior elevation, looking west

3.6 The east elevation has a pitching door located just below the level of the eaves and offset to the north (Plate 2). The weatherboarding, which has also been coated in bitumen, may be of elm.

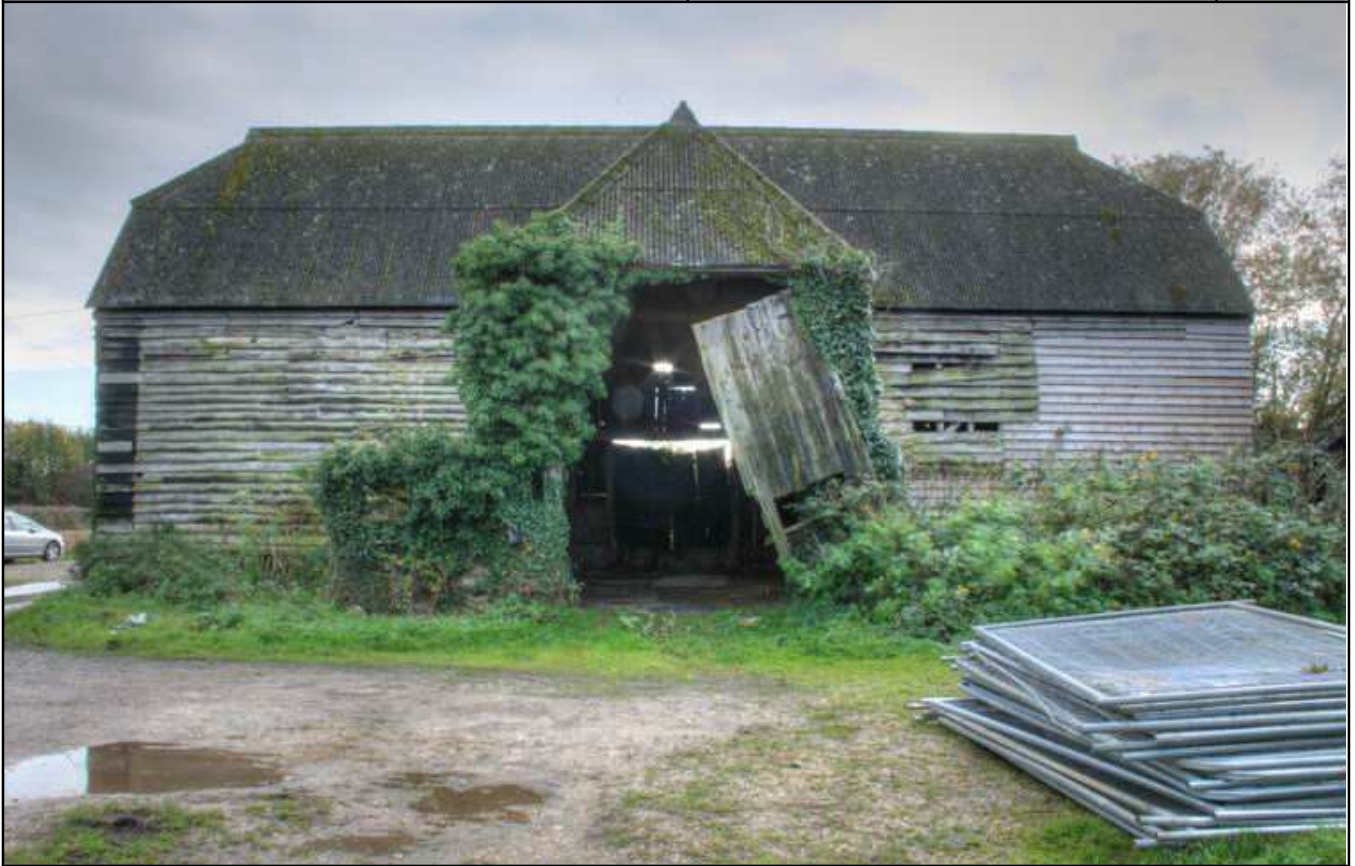
Plate 3: North exterior elevation, looking south

3.7 The northern elevation has a centrally placed porch with a hipped roof, also covered in corrugated concrete asbestos (Plate 3). The remains of one boarded, ledged and braced door hangs on the western doorpost; the eastern having been removed. To the east of the porch, there is evidence of a former lean-to, which has now been removed. The weatherboarding on this elevation shows a line in the bitumen where the lean-to once stood, and in the eastern elevation of the porch, the roof-line can be made out. A door from the porch leads into this area. One tie-beam survives, which appears to be of machined softwood, suggesting that this lean-to was a later addition. The area to the west of the porch is heavily overgrown with brambles, but may also have been the location of a lean-to. A timber remains attached to the west elevation of the porch, at a pitch suggestive of a roof. The north elevation of the barn, to

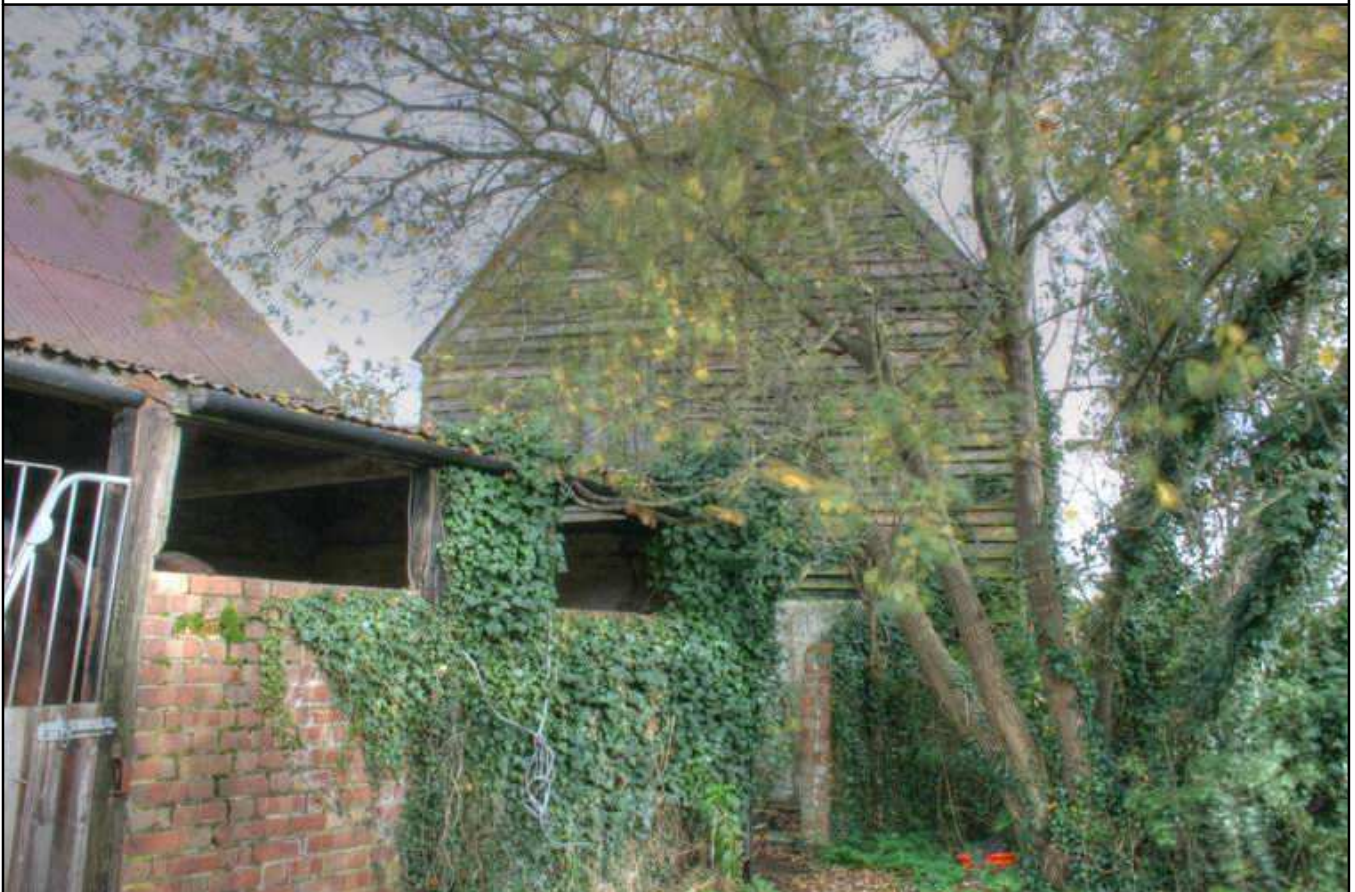
Plate 4: West exterior elevation, looking east

3.8 The western elevation of the barn is also weatherboarded, mostly in softwood, and evidence for bitumen coating can be seen (Plate 4). A pitching door is located just below the level of the eaves, and offset to the north. It is apparent that a shed or outhouse was formerly built up against this elevation, and a cement rendered facing survives. It may have been a modern stable, which has since been demolished.

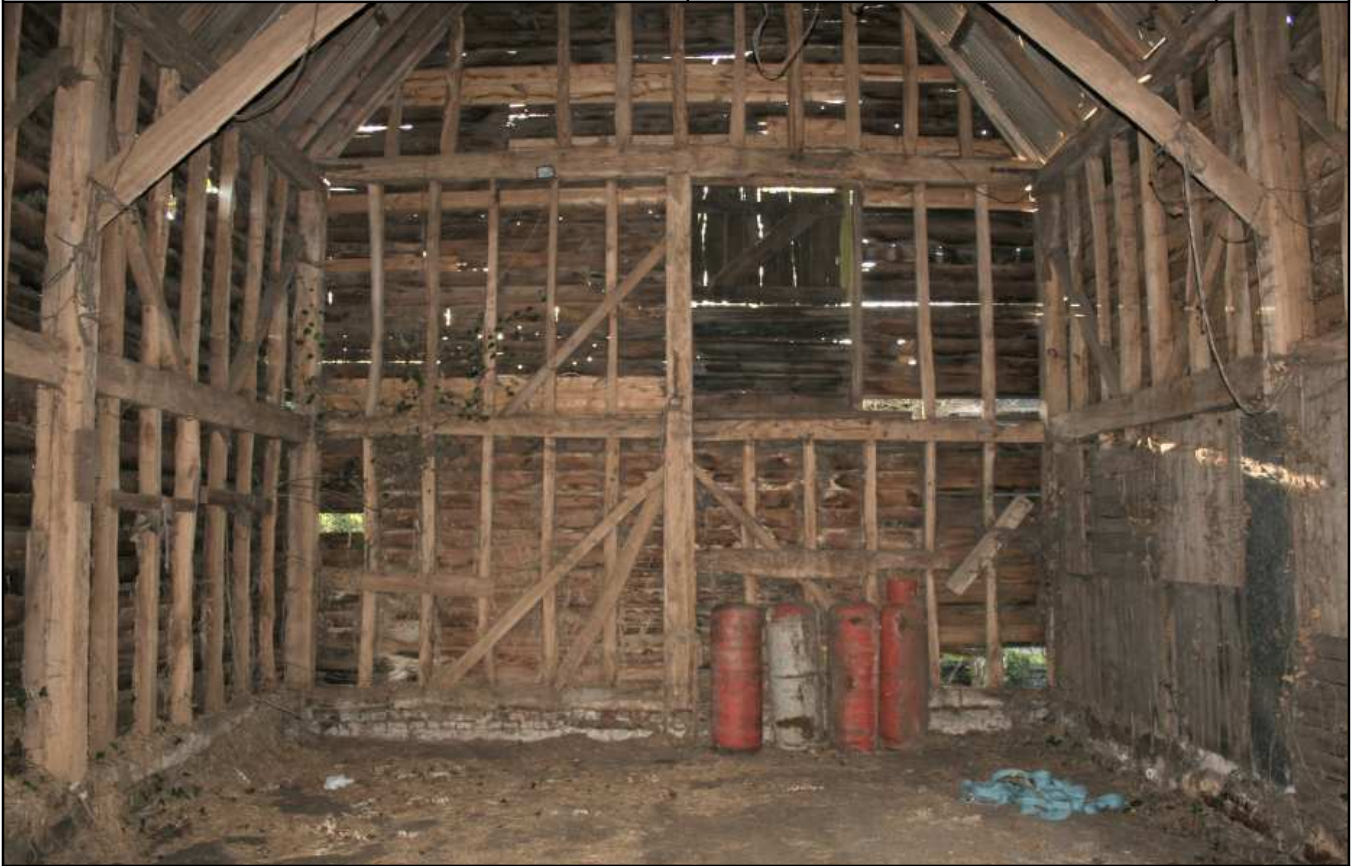
Plate 5: West interior elevation, looking west

3.10 The western elevation rests on a brick plinth, which shows signs of having been limewashed, and has a central principal post bisecting the elevation (Figure 9, Plate 5). To either side there are five studs with a primary brace coming down from the top of the central post to a mid-rail, and a further brace below this descending to the sole-plate. Above the wall-plate eleven studs rise to the collar, above which is the hip of the roof. To the north of the central post, above the mid-rail, there is a pitching door; a blockage below this suggests that the opening originally occupied the full height between the mid-rail and wall plate. Only the upper door survives, if this was the case.

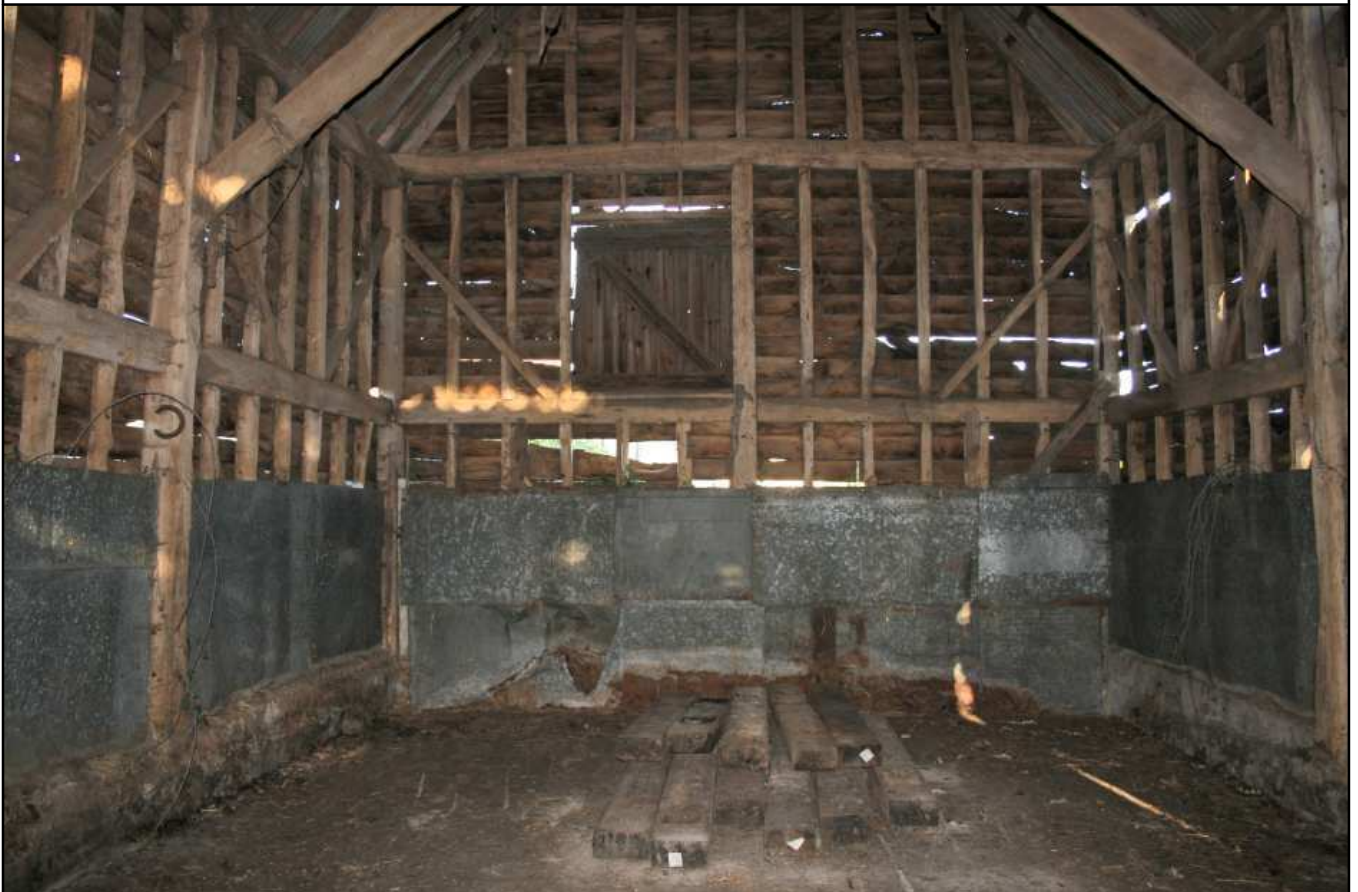
Plate 6: East interior elevation, looking east

3.11 The eastern elevation is similarly laid out with a pitching door in a similar location occupying most of the space between the mid-rail and the wall-plate (Figure 9). In this elevation the primary braces descend from the corner posts to the mid-rail. Below the mid-rail, the elevation is largely obscured by galvanised metal facing the studs (Plate 6).

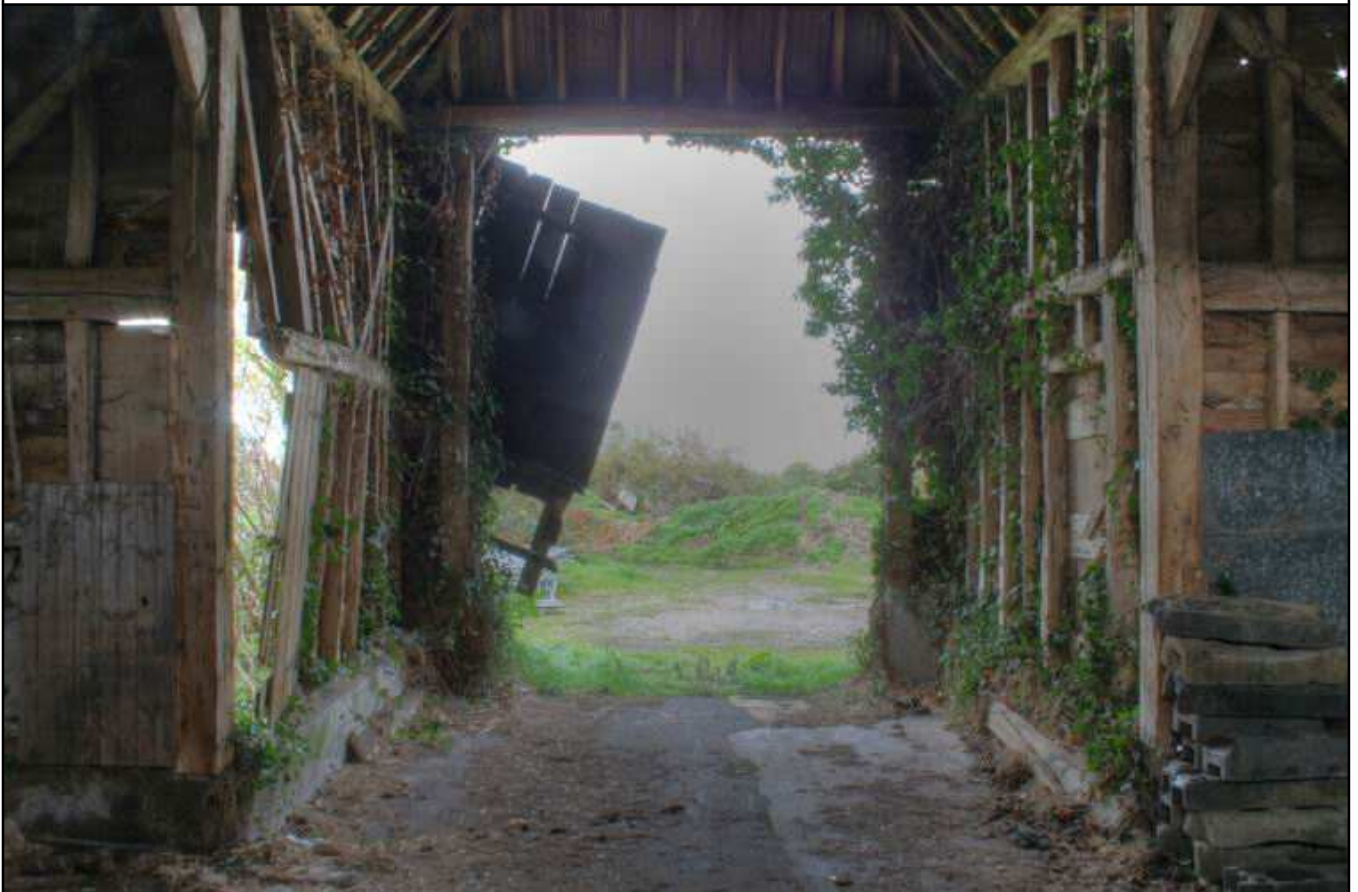
Plate 10: North interior elevation, looking north through porch

3.13 The northern elevation, to the east and west of the porch, mirrors the layout of the southern elevation, having galvanised metal in the lower half of the bay to the east of the porch, but to the west, old pallets have been used to protect the studs (Figure 9, Plate 10).

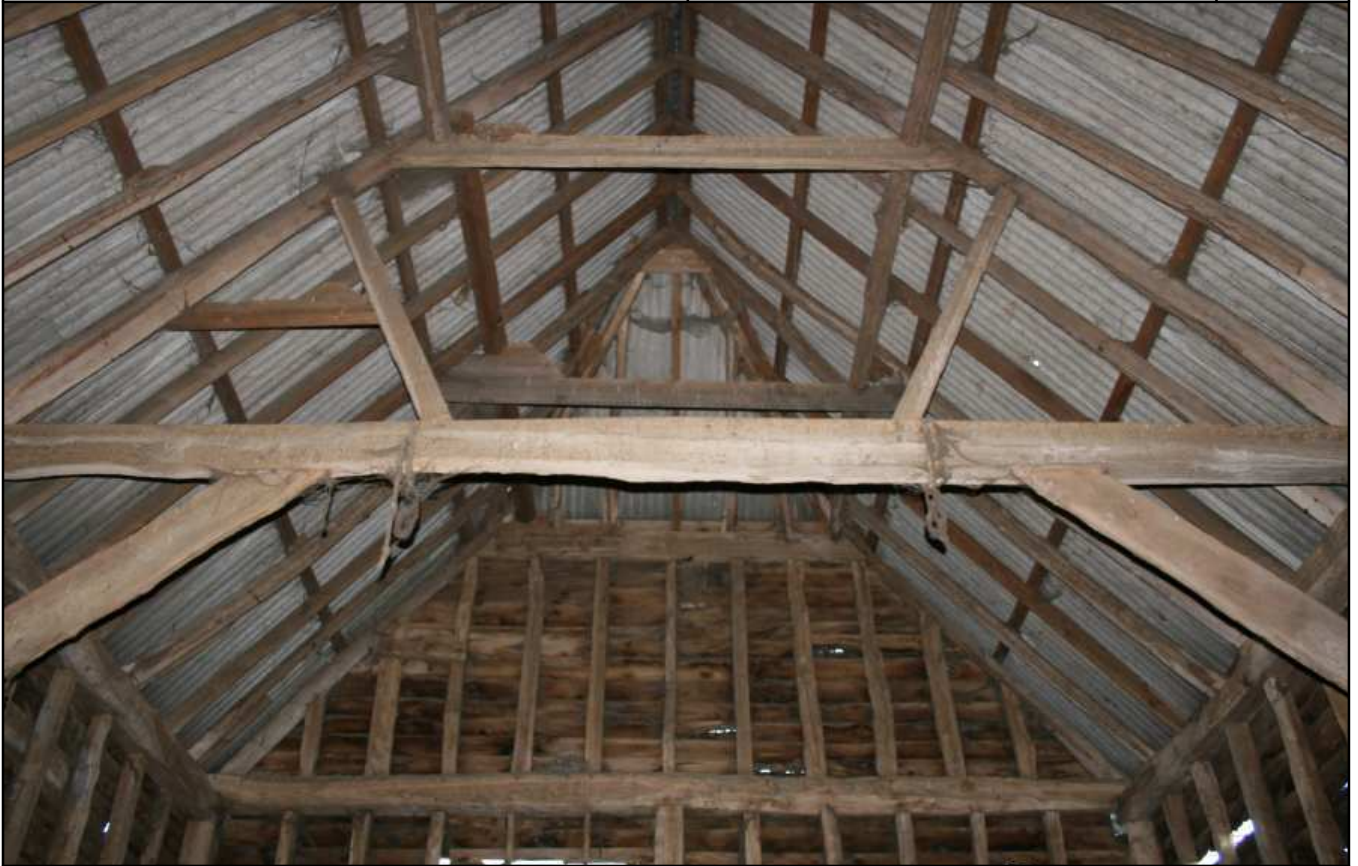
Plate 13: Roof structure, looking east

3.15 The roof structure is supported on tie-beams running from the top of the wall-plate and braced to the principal posts with diagonal braces (Figure 9, Plate 13). Raking queen-struts brace the principal rafters, and collars support a single purlin in each slope, slightly above the queen-struts. There appears to be a mixture of original rafters and replacement softwood rafters, all of which meet each other at the apex of the roof. The roof of the porch has a single purlin in each slope, supported by collars.

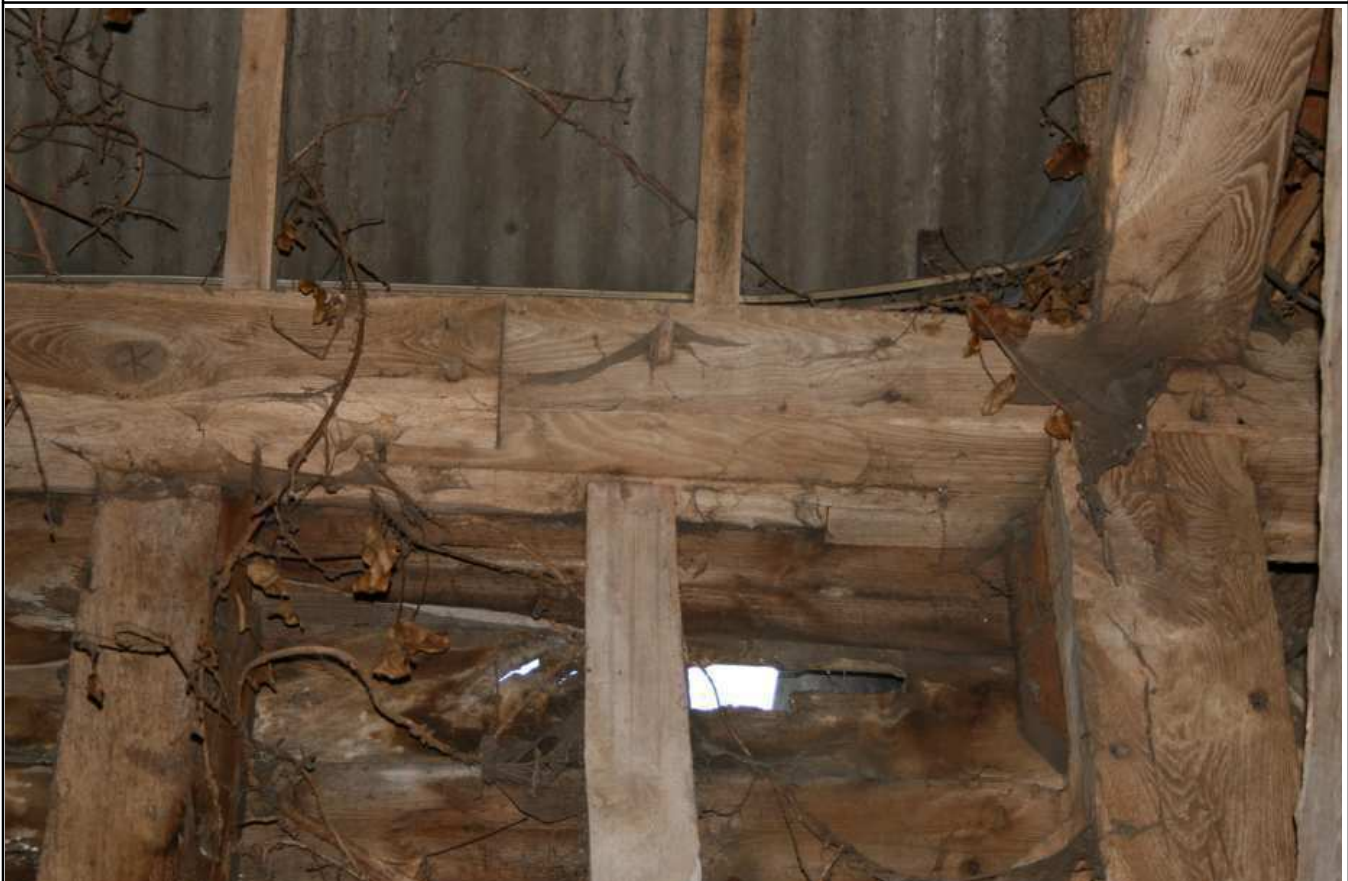
Plate 14: Sample scarf joint in wall plate

4.3 An examination of the barn shows that it is a 5-bayed structure of frame construction. The framing and studwork throughout the barn appears largely to be original, and in good condition. The exception to this is the sole-plate, where it is visible, which shows signs of weathering and decay. Carpenter's marks are visible on the diagonal braces to the tie-beams. Face-halved and bladed scarf joints are visible in the wall-plate, dividing the plate into three sections in both north and south elevations (Plate 14). In both elevations, the joints are located just to the east and just to the west of the middle bay.
