CROWN COTTAGE. Kelshall, Herts.

HN818

*Historic Building Record
& Archaeological Monitoring Report*

Report no.612

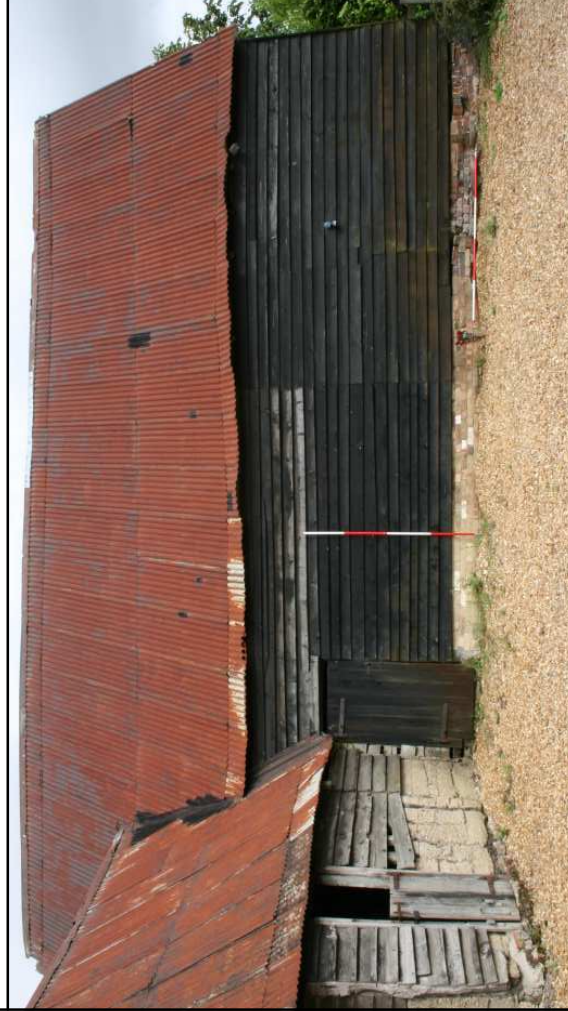
Plate 3: North Barn, S exterior elevation, looking N

3.6 The south elevation has a repaired brick plinth with modern weatherboarding above and a corrugated iron roof (Plate 3). A personnel door has been inserted adjacent to the junction with the Link Building.

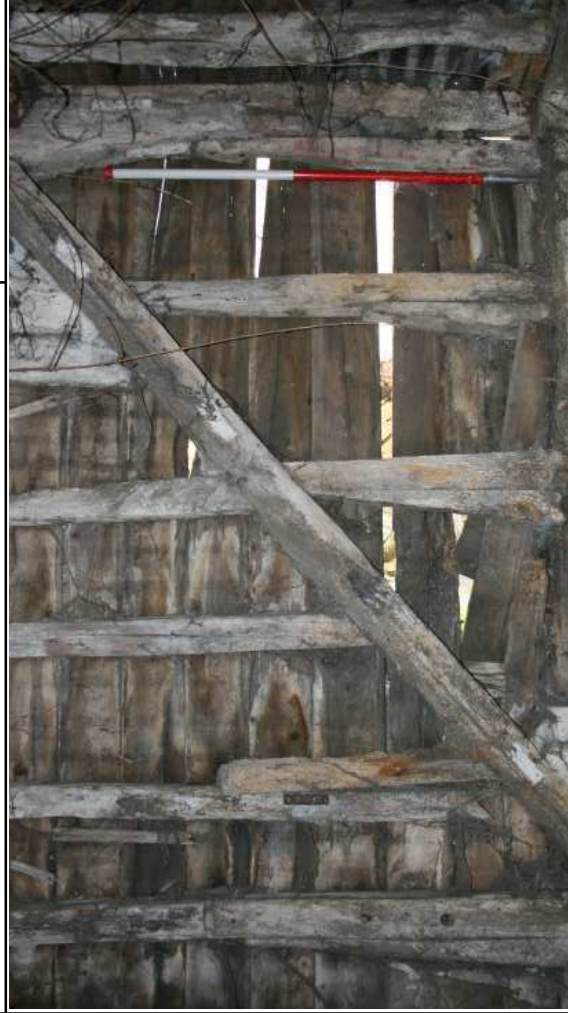
Plate 37: Block 4, Bay 2, detail of re-used brace in S elevation

3.43 The southern elevation has an irregular tie beam with heavily weathered studs and a diagonal brace reused from elsewhere (Plate 37). Four mortice holes have been cut into the front face of the tie beam. A decayed sill beam sits on a crumbling brick plinth. A boarded and ledged door has been inserted into the east end of the elevation (Plate 34).

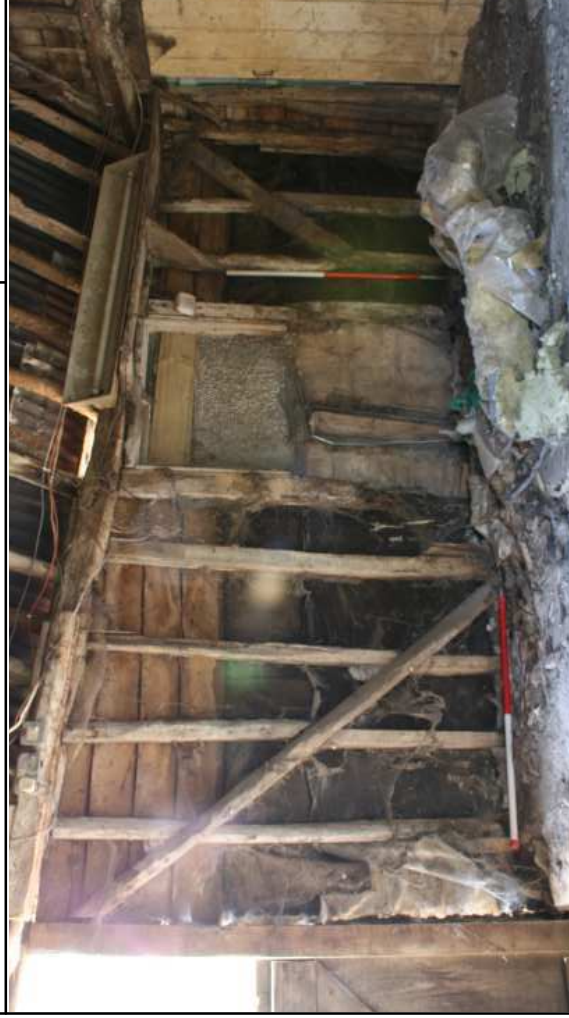
Plate 41: Block 4, Bay 2 W interior elevation, looking SW

3.46 Most of the studs in Bay 2 appear to be part of the original construction (Plate 41). Elsewhere they have been replaced (Plate 42).

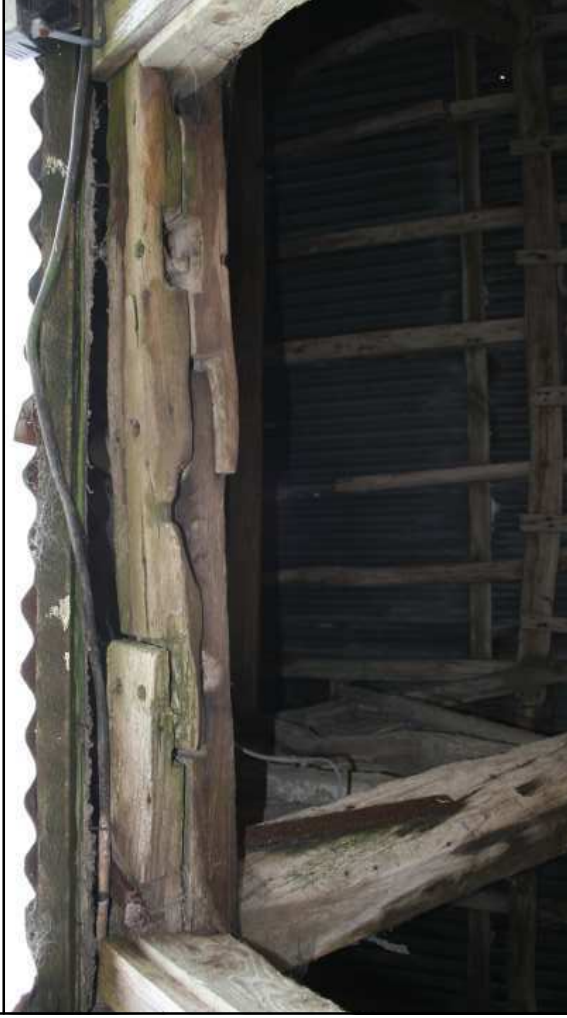
Plate 43: Block 4, detail of joint in the east wall plate

3.47 In the eastern elevation the wall plate is in two sections, joined just to the north of the middle truss above the existing doorway with a face-halved and bladed scarf joint (Plate 43). The sill plate is largely obscured. The studwork has been largely replaced and a window has been blocked in Bay 2 (Plate 35). The shutter hinge hooks survive in the northern stud (Plate 36).

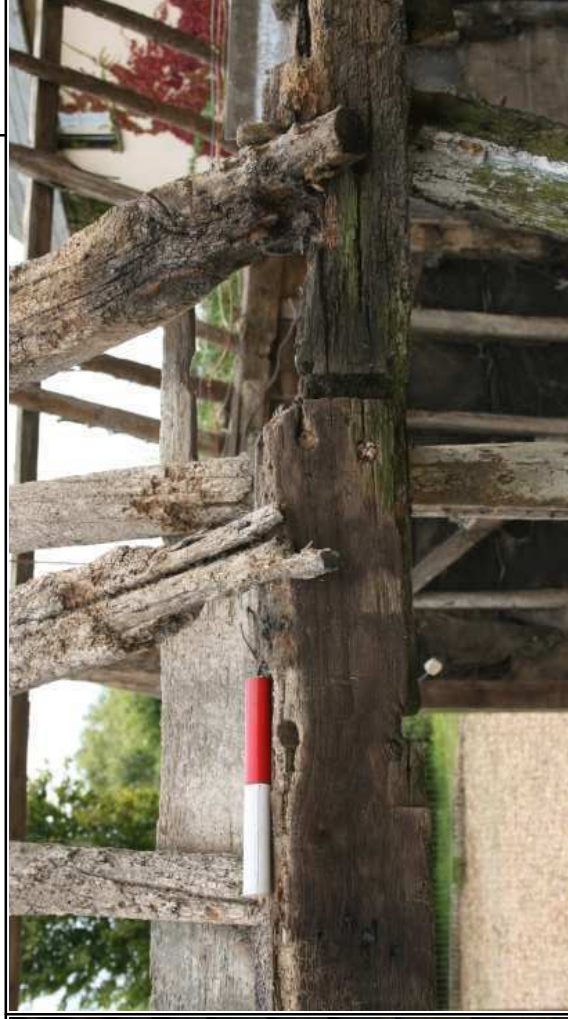
Plate 46: Block 4, detail of W wall plate, visible after removal of cladding

4.6 A visit was made to inspect the Link Building following the removal of the cladding, which exposed the framing (Plate 45). A joint in the wall plate of the western elevation of Block 4, between Bays 1 and 2, was noted (Plate 46). This had not previously been visible.

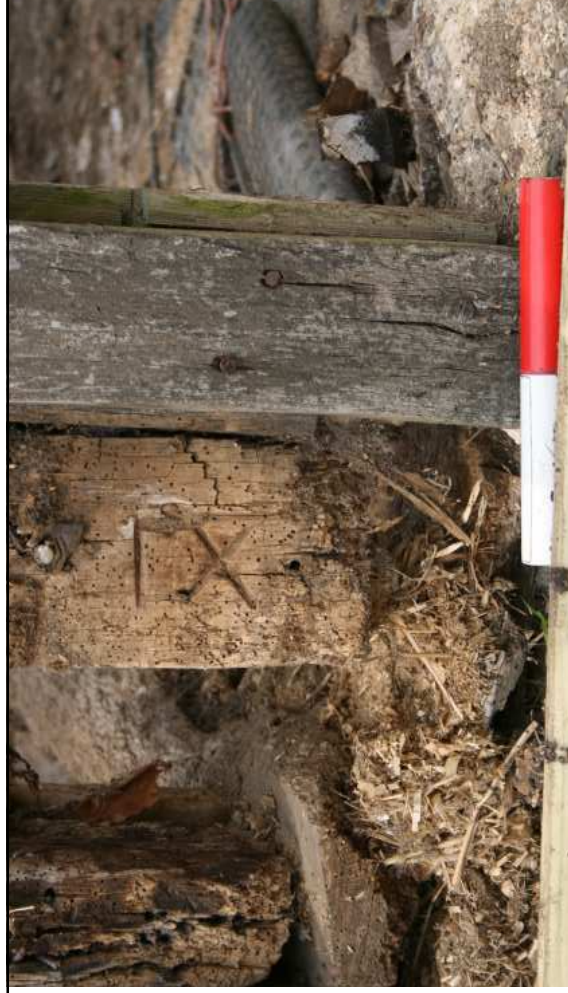
Plate 47: Block 4, detail of carpenter's mark, base of SE corner post

4.7 The work also revealed a series of carpenter's marks. One was observed close to the base of the south-eastern corner post in Block 4 (Plate 47), another on the north door jamb on the eastern side of Block 1 (Plate 48).

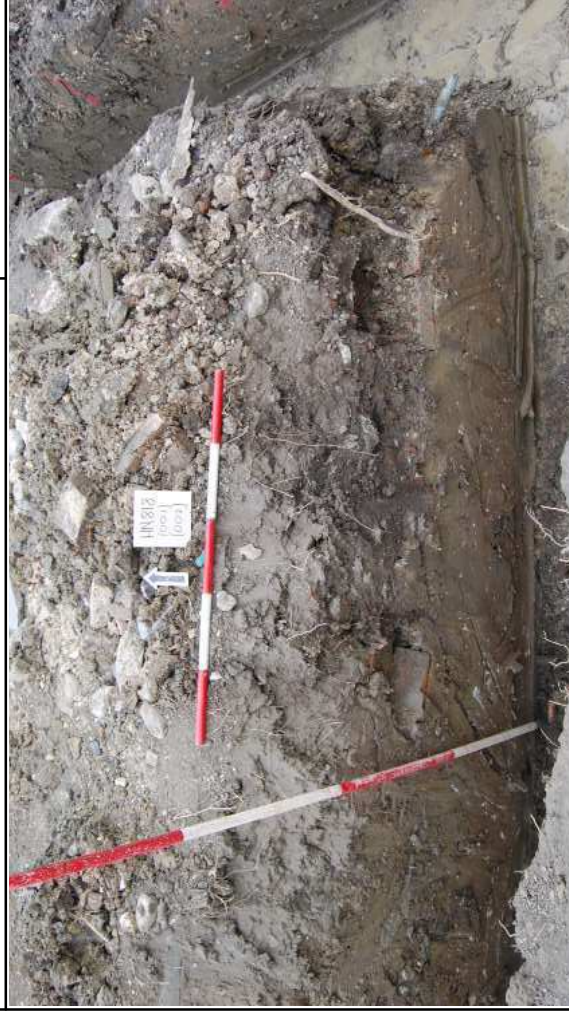
Plate 49: Contexts (001) and [002], looking N

4.9 A cut line, [002], was noted 2m to the west of the footings (Figure 15). This defined the limit of a mixed deposit, (001), comprising dirty clay with brick and tile fragments and general debris, approximately 0.75m in depth, which was also observed in the western trenches (Plate 49). It represents the backfilled terracing of the natural slope to accommodate the link building. Sherds of brown glazed pottery of 18th-19th century date were recovered from this deposit, along with a modern handmade ash tray, in thick white clay with a skull in the centre. This is likely to have been made by a child at school and is marked on the base with an indistinct stamp, which may read 'L. Smith'.

5.3 Monitoring of the groundworks associated with the new Link Range revealed a number of deposits and features. A cut line, context [002], was observed approximately 2m to the west of the barns. This marks the western limit of context (001), a mixed deposit approximately 0.75m in depth, which represents the backfilling of the natural slope to accommodate the original barns.

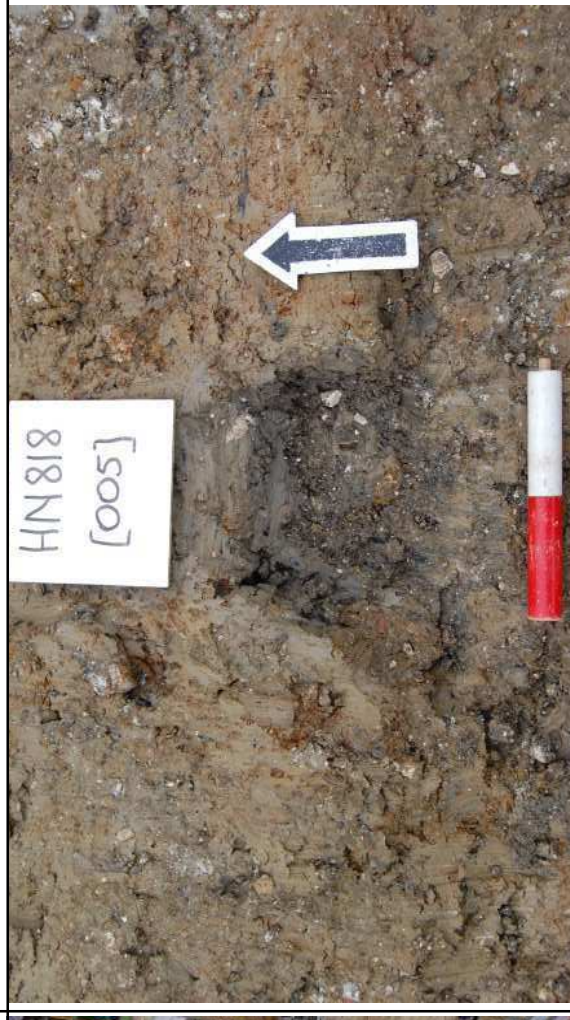
Plate 52: Posthole [005], looking N

4.17 A number of features were observed at the natural horizon (Figure 16). These comprised three square post holes, each aligned north to south and measuring 0.15m square (contexts [005], [007] and [008]) (Plates 52 – 54). Cuts [005] and [007] contained a similar fill, comprising a dark greyish brown damp clay, with frequent charcoal flecks and were relatively shallow, extending to 0.07 below the natural horizon; cut [008] was filled with redeposited chalk and was over 0.15m in depth.

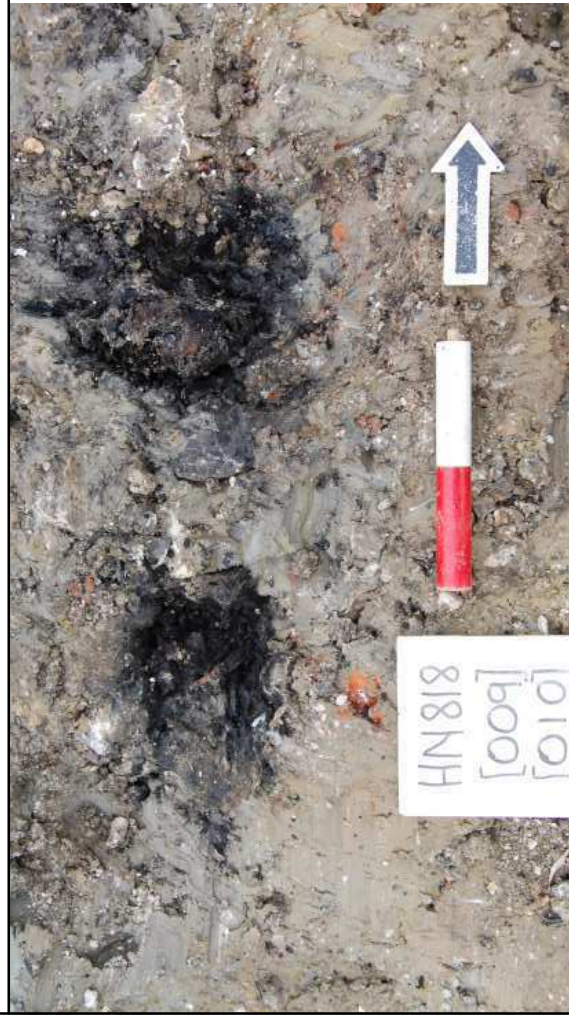
Plate 55: Stakeholes [009] & [010], looking W

4.19 No dating material was recovered from any of the features, though brick fragments were observed in the vicinity of posts [009] and [010]. It is likely that these features are associated with a structure pre-dating the link building, though still of post-medieval date.
