## **HEADSTONE MANOR Pinner View, LB Harrow**

HN572 / HN774

*Archaeological Report*

*February 2010*

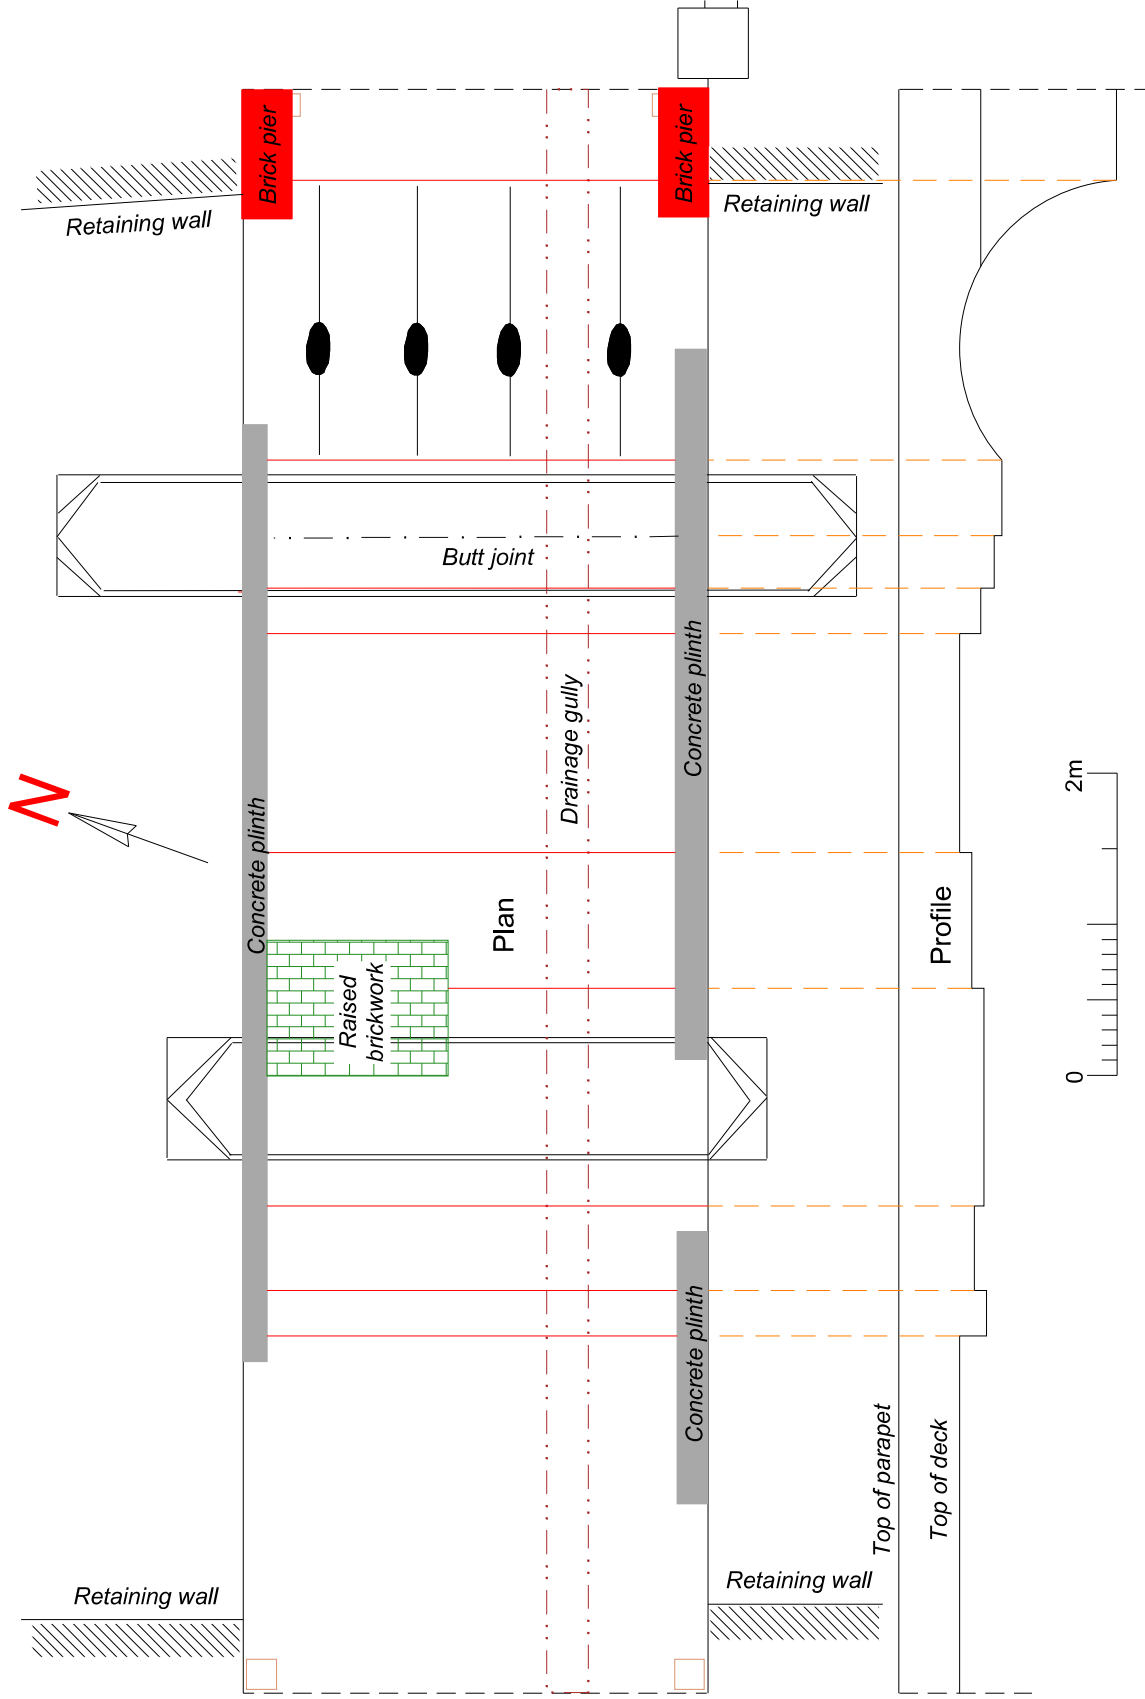
**3.10** The subsequent removal of the entire existing bridge deck allowed a clear view of the upper surfaces of the arches (Figure 5). It showed that the western and central arches were of solid spandrel construction with the deck carried on the resulting flat top, while the eastern arch was of filled spandrel construction relying on fill material above the extrados to support the deck (Plate 12). A distinct joint was observed in the brickwork between the central arch and the eastern arch. Evidence for modern work was also revealed, including concrete footings for the balustrades on either side of the bridge and a modern drainage channel, which had been cut through the brickwork along the full length of the bridge.

Plan and profile of bridge deck after removal of surfacing materials  
Base plan courtesy Hockley & Dawson Consulting Engineers

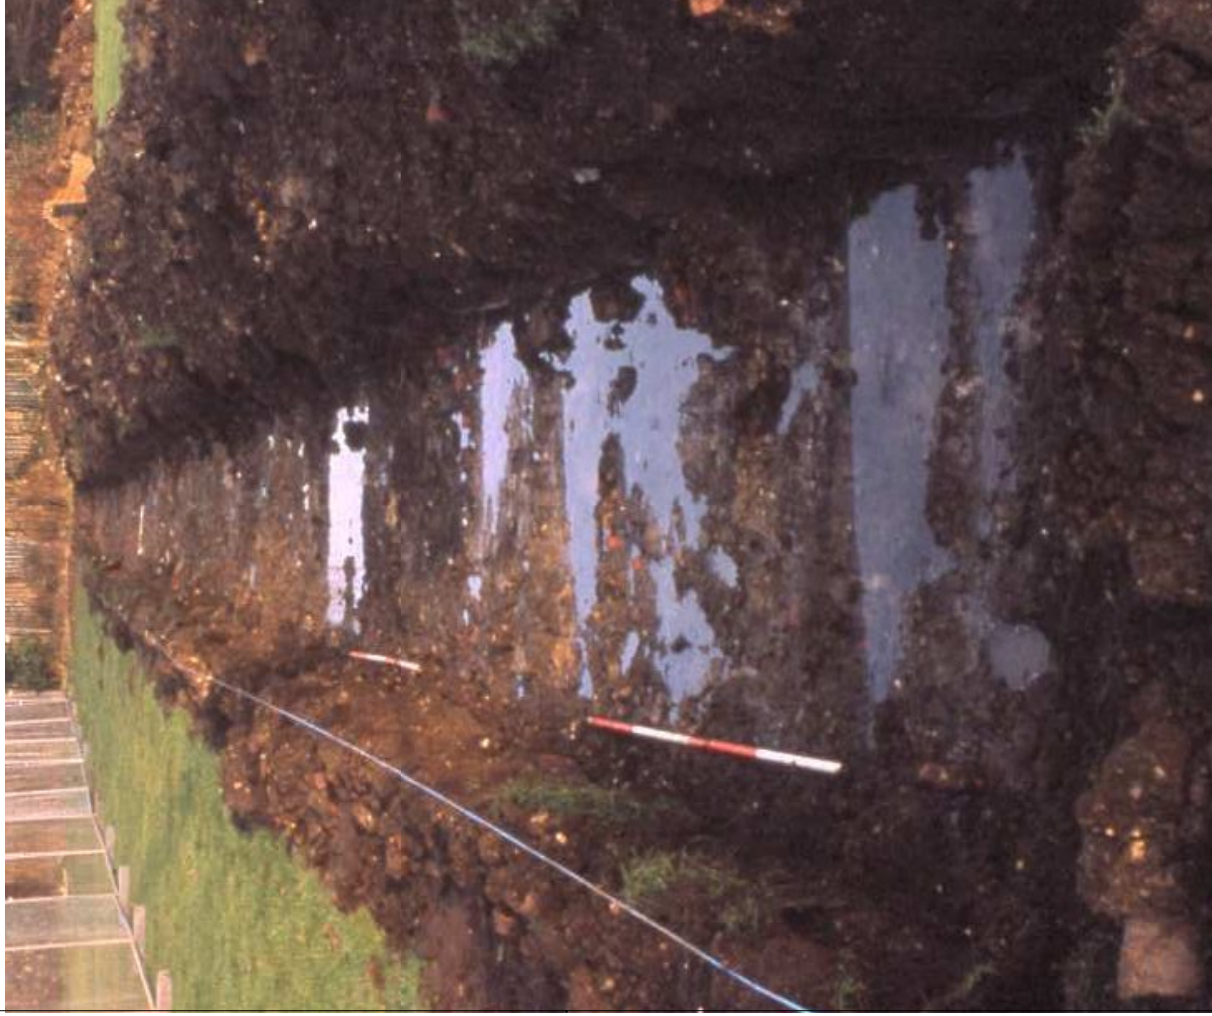
**2.7** The excavation was undertaken entirely within made ground (Plates 1 & 2). No archaeological cut features were observed and no artefacts recovered within the test strip. On this basis, it was considered unnecessary to continue the monitoring of the stripping operation.

Plate 1: Storage lagoon, test strip, NW arm looking NE

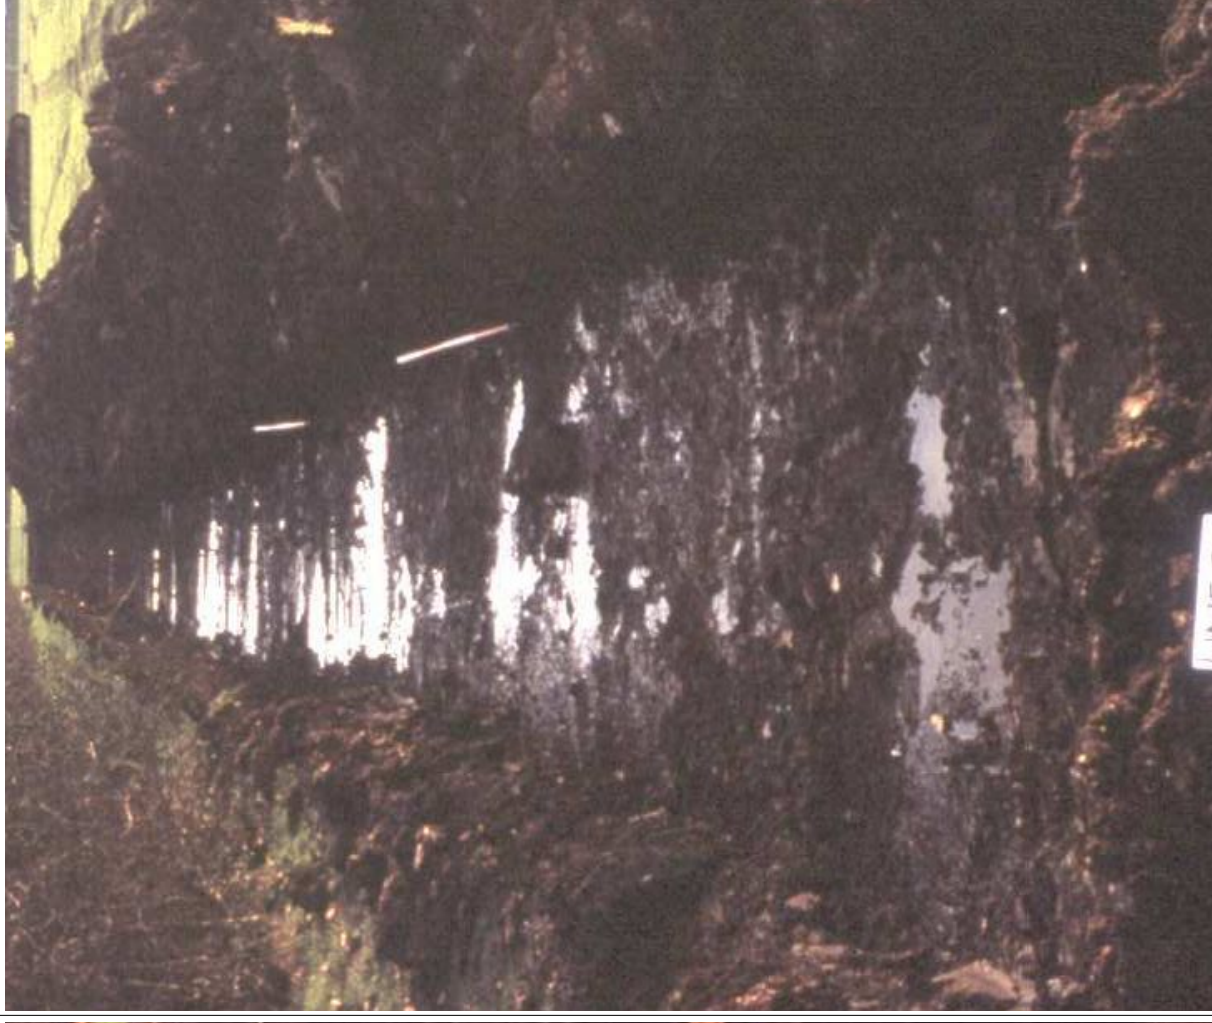
Plate 2: Storage lagoon, test strip, NE arm looking SE

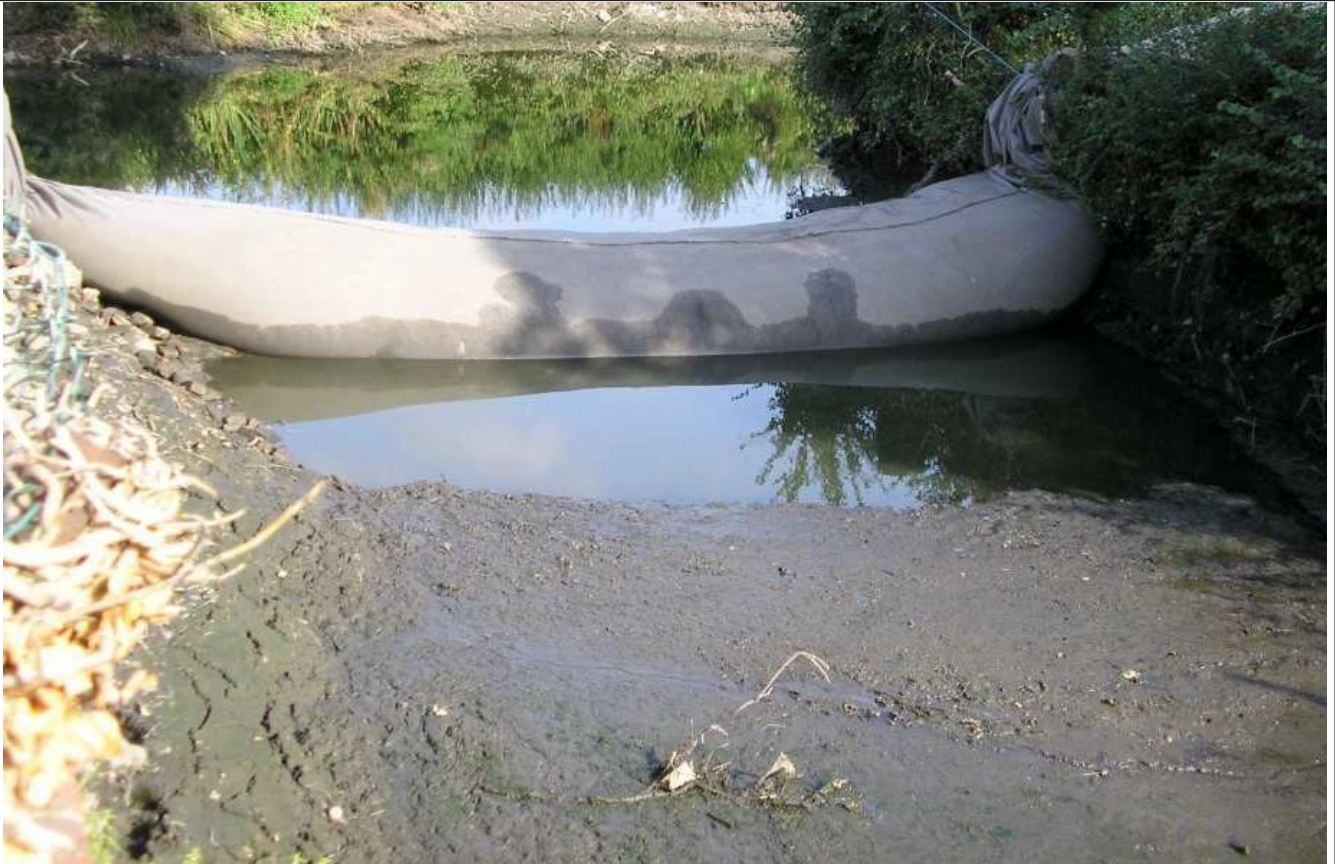
**2.14** Because the barrages were not adequately water-tight, this stage of work was abandoned before the moat lining was exposed and the silts entirely cleared. Of the artefacts retrieved, all were of modern origins.

Plate 5: Water-filled barrage at NW end of SW arm of the moat

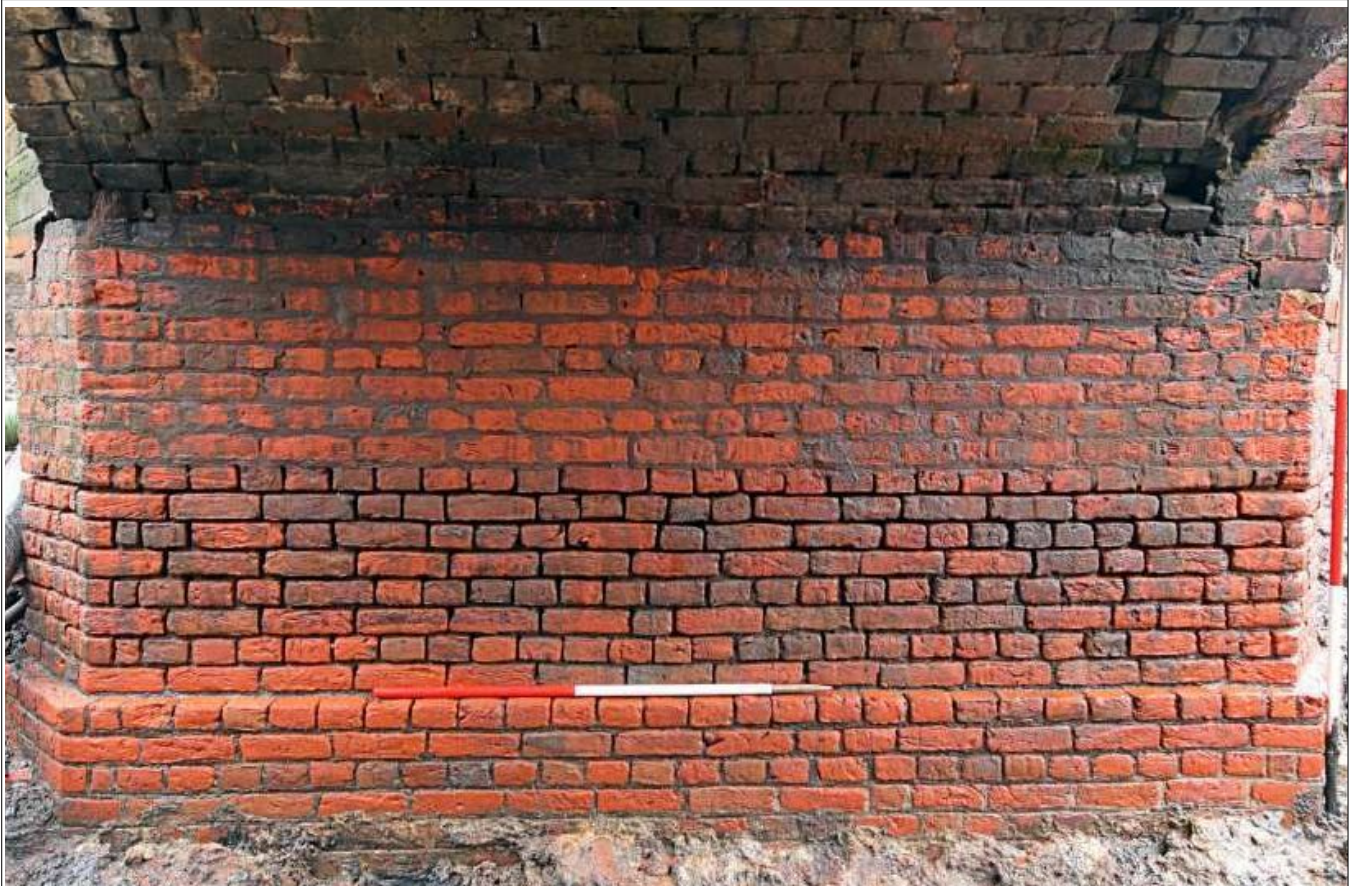
**3.7** The bricks which form the piers measure  $8\frac{3}{4}'' \times 4'' \times 2\frac{1}{2}''$  (22cms x 10cms x 6cms) (Plates 10 & 11). They are hand-made and bonded with a mortar formed of lime and sand, and have been dated to the mid-17<sup>th</sup> century. The cut-waters on either end of the pier on the island side have shorter and blunter points measuring 0.28m long. The cut-waters on the land side pier are longer and sharper, measuring 0.39m long. The bricks at the corners of the cut-waters, which were hand thrown into a mould, appear to have been made especially for these structures. Each brick has an angle of 135° and measures 7'' (17cms) above the angle and 2'' (5cms) below. The original mortar has survived well, particularly below the waterline. Above this is a band where the mortar has been exposed and subject to some frost damage (Plates 10 & 11). The bricks in the applied buttresses above the piers date to the 1950s or 1960s and are bonded with a cement based mortar. Poor modern re-pointing, probably contemporary with these buttresses, is visible at the top of the piers.

**3.8** The bricks which form the two landward arches measure  $8\frac{1}{2}'' \times 4\frac{1}{4}'' \times 2\frac{1}{2}''$  (21.5 x 10.5 x 6cms) (Plates 10 & 11). They have been dated to the mid-19<sup>th</sup> century.

Plate 10: Western pier, E elevation, detail of brickwork

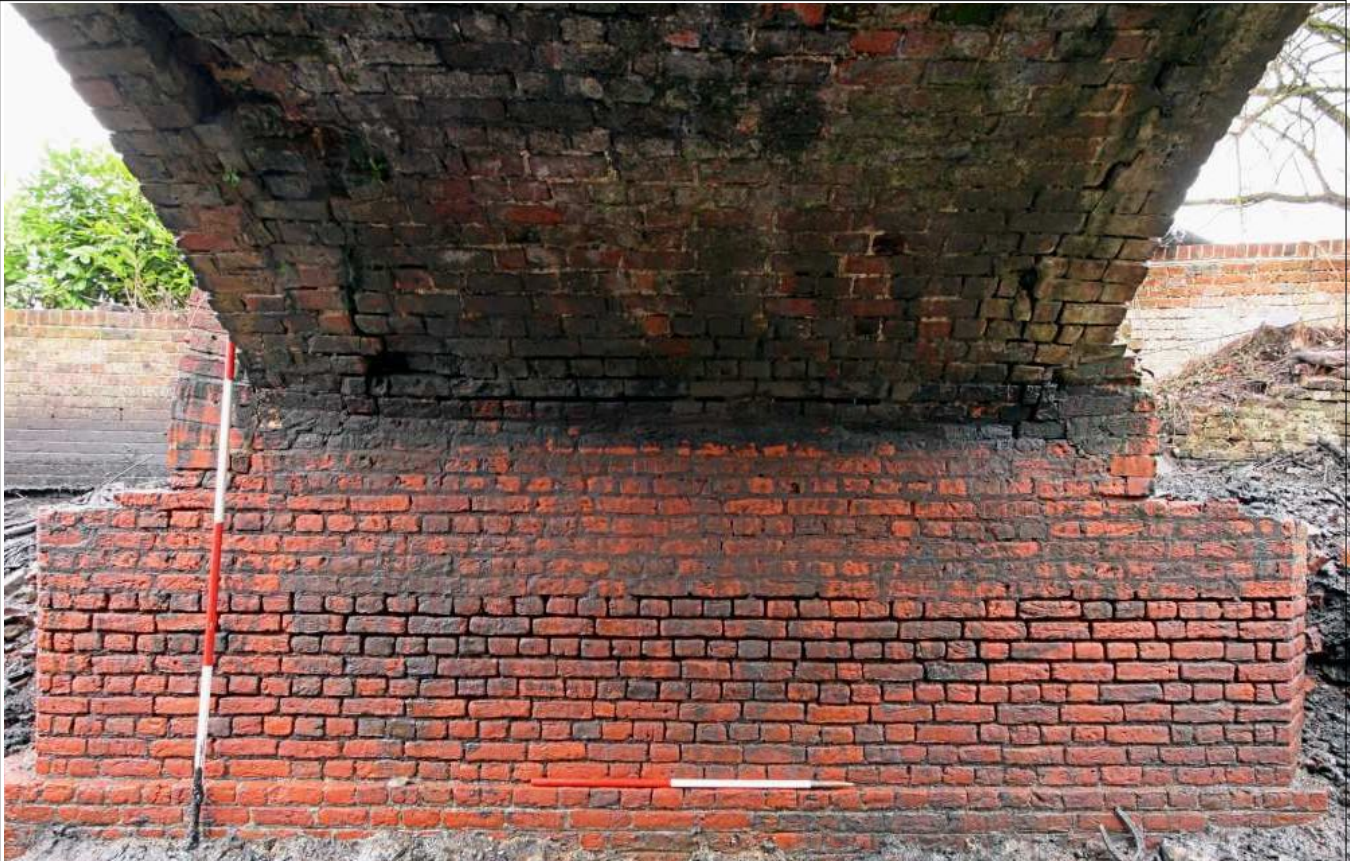
Plate 11: Eastern pier, W elevation, detail of brickwork

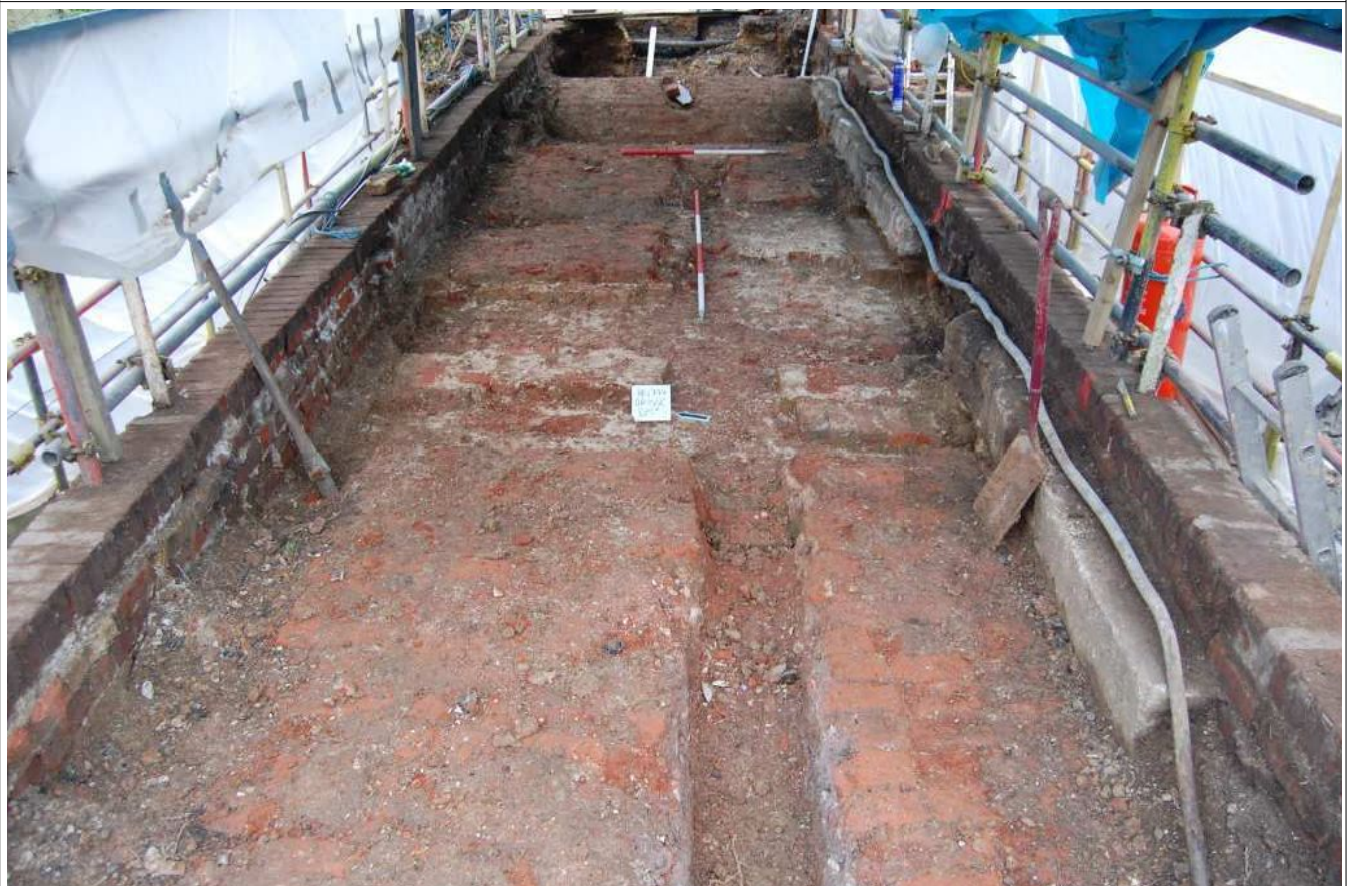
Plate 12: bridge deck following the removal of the surfacing materials, looking NE

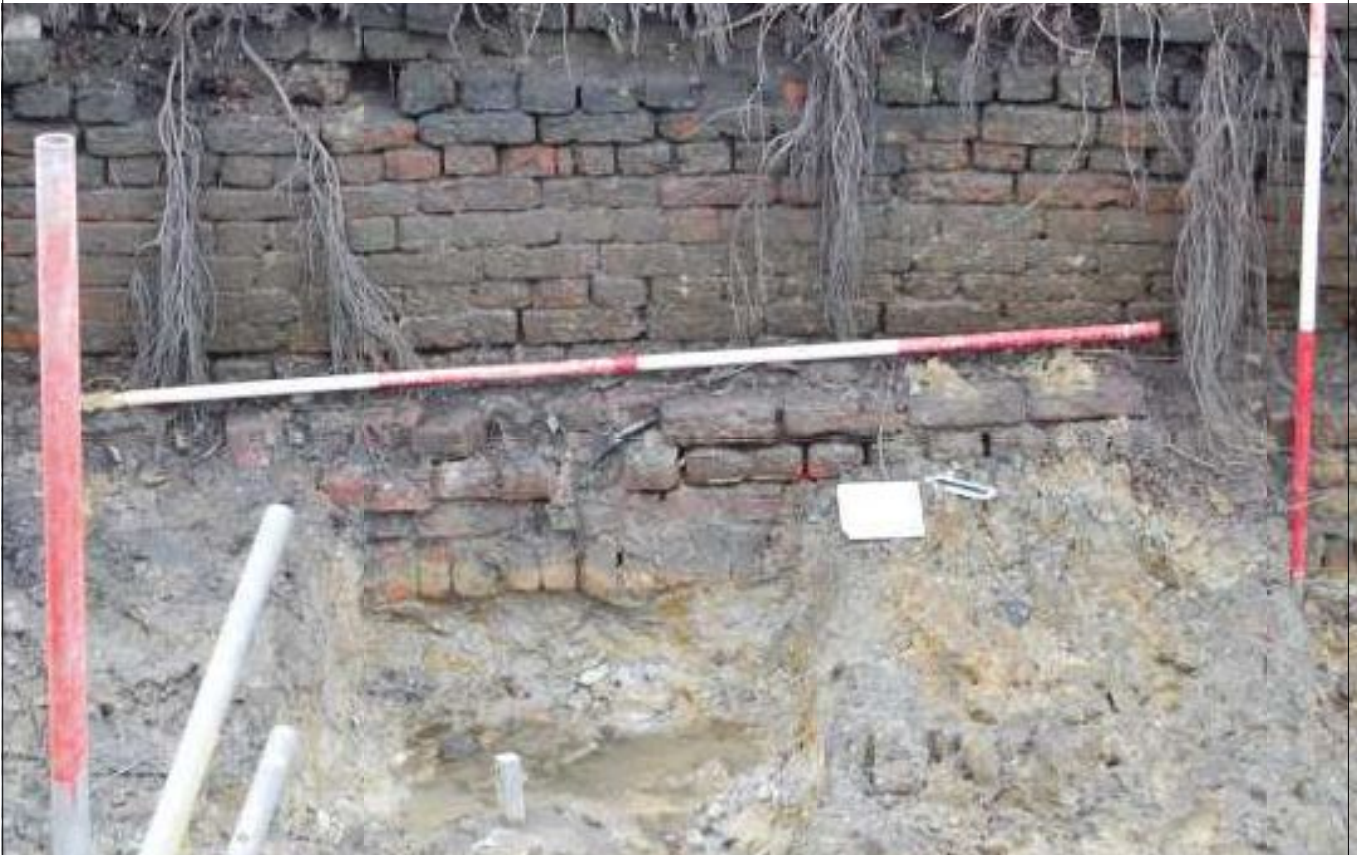
**3.12** The south-western arm of the moat had retaining walls on either bank. To the south of the bridge, on the island side, the wall was constructed of bricks dating to the 1880s-1890s, built on top of an earlier wall, revealed after the draining of the moat (Plate 13). This rests on the clay bed of the moat and is in poor condition. It comprises a row of side-laid headers below three courses laid in English bond (0.35m in height); above a 0.21m wide offset are nine further courses, also laid in English bond. The lower wall is constructed using un-frogged red bricks, which date to the 1820s-1830s, measuring  $8\frac{1}{2}'' \times 4'' \times 2\frac{1}{4}''$  (21cms x 10cms x 6cms).

Plate 13: Earlier wall footings below late 19th century retaining wall to island side

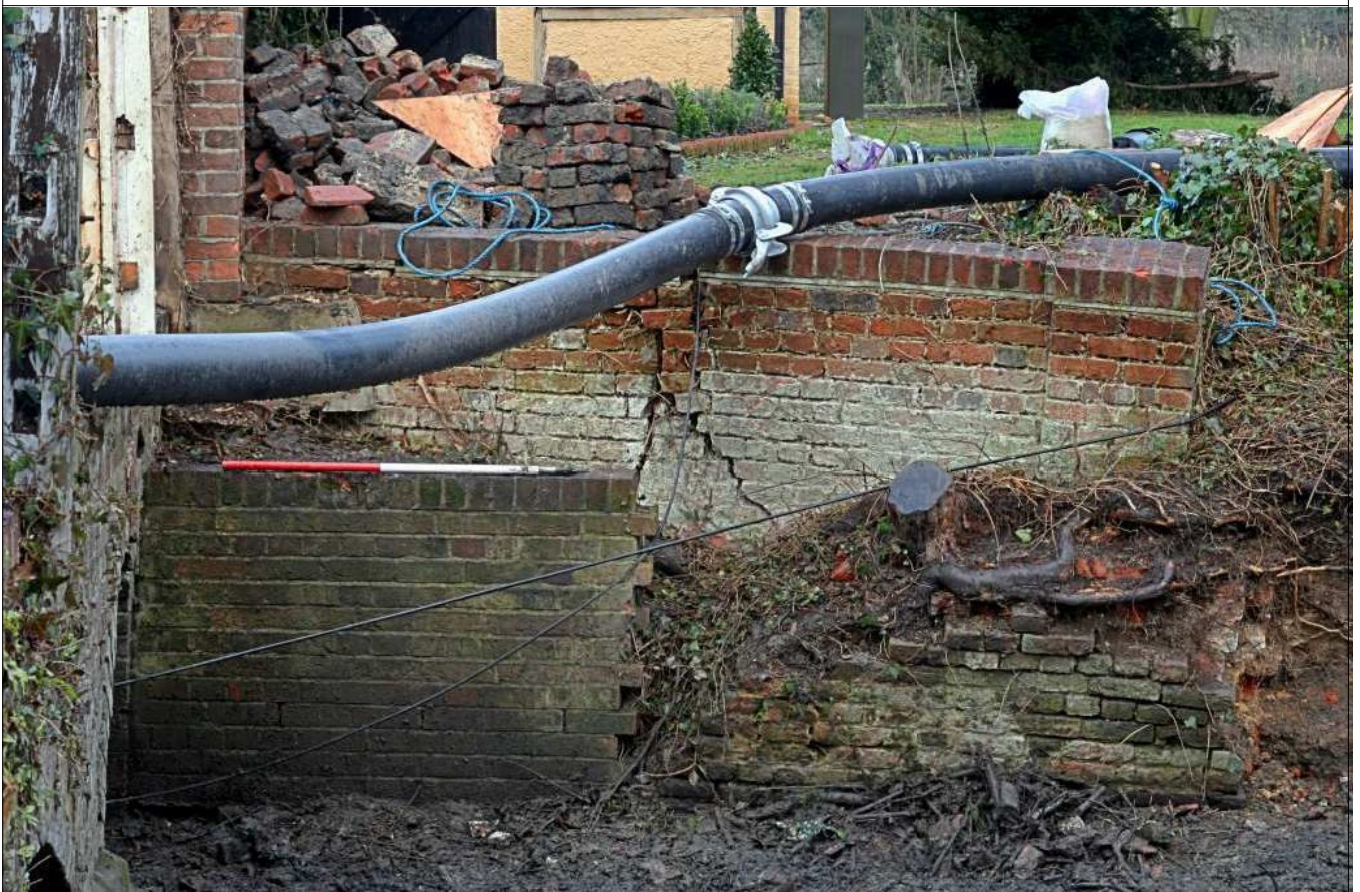
**3.13** To the north of the bridge, on the island side, the retaining wall also appears to have undergone a series of repairs and rebuilds. The wall immediately adjacent to the bridge dates to the 1930s-1940s. This was built in front of a wall dating to the 1880s-1890s, which was also built on top of an earlier wall, dating to the 1820s-1830s (Plate 14).

Plate 14: Retaining wall to N of bridge on island side

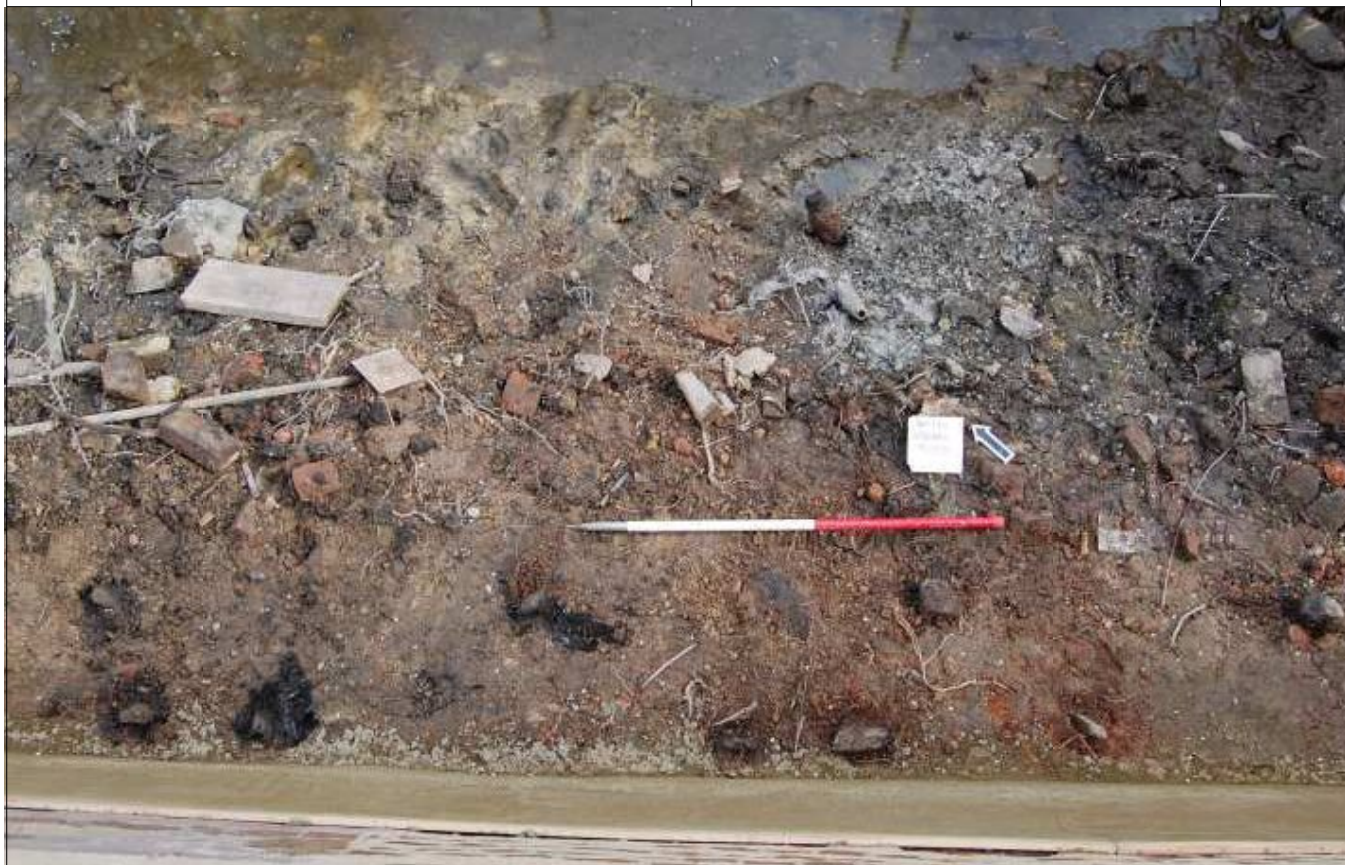
**3.17** These posts are unlikely to form part of an earlier bridge, but instead appear to form part of the construction for the brick retaining walls which support the landward bank of the moat. It seems likely that any earlier bridge on the site actually followed the same alignment as the existing structure, with its remains either concealed by the clay lining to the moat, or destroyed by the later brick piers.

Plate 15: timber posts at the base of the retaining wall on the landward side to N of bridge

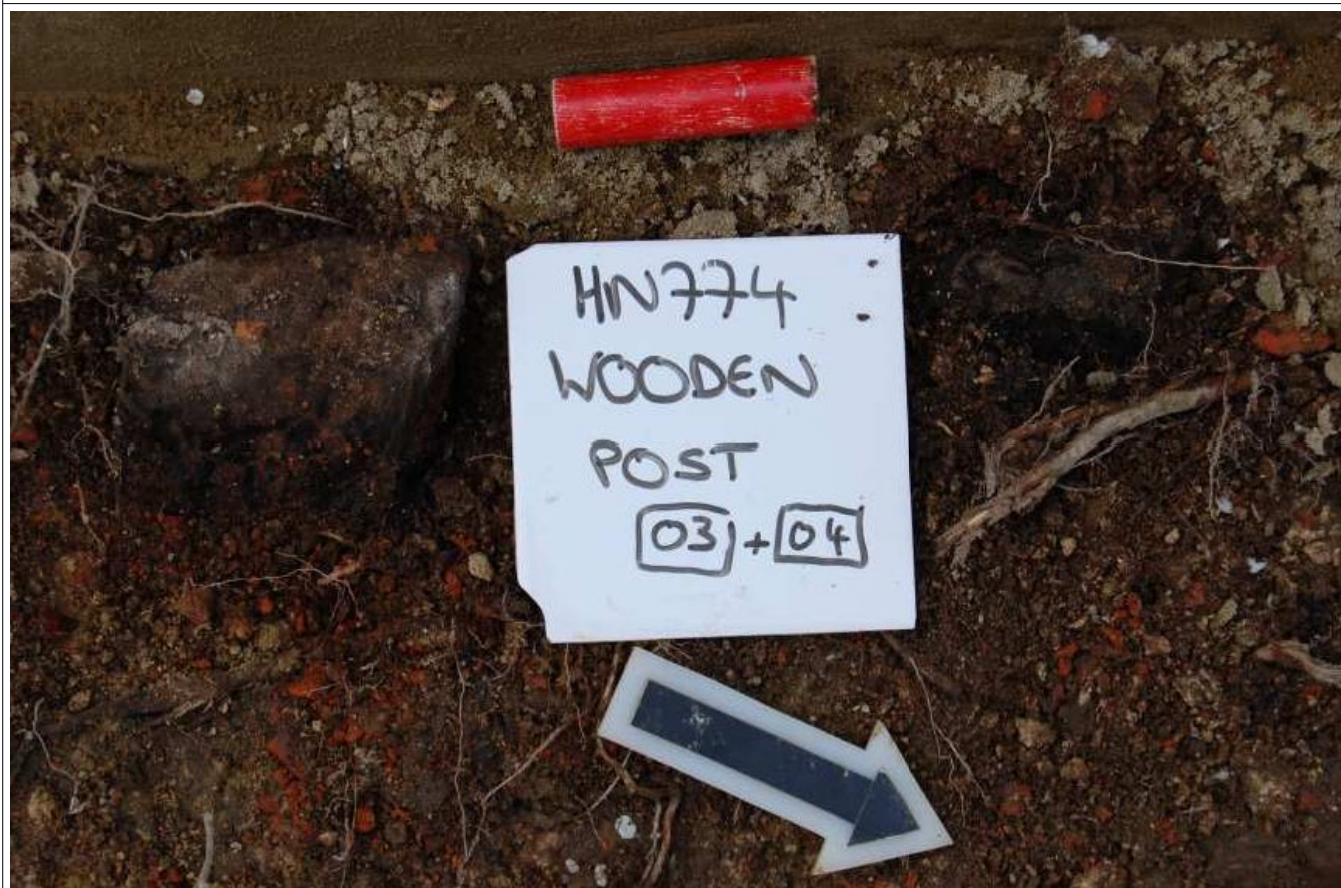
Plate 16: Detail of posts [03] and [04]

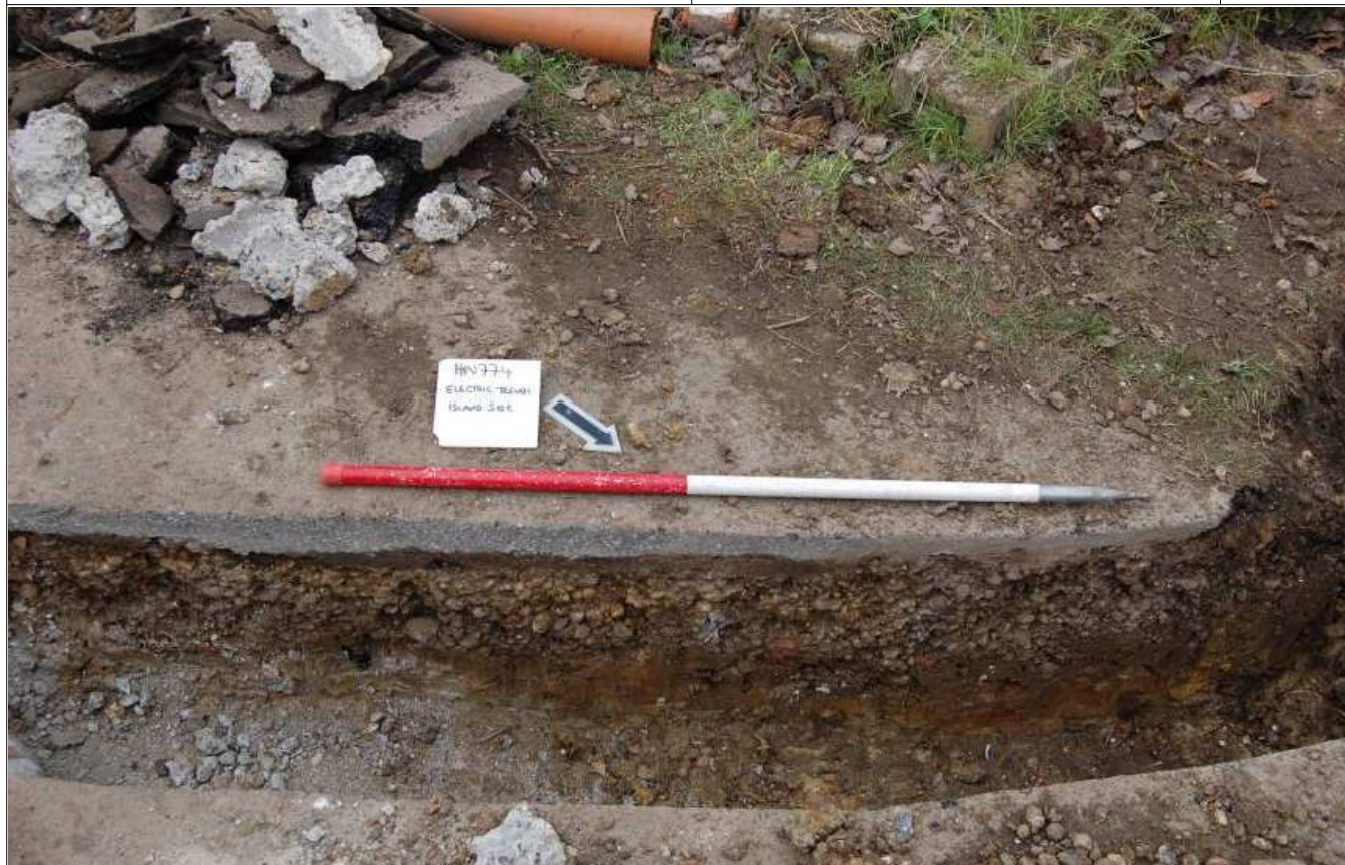
**3.18** Two small curving service trenches were excavated through the tarmac path on either side of the bridge (Figure 5; Plate 17). Both were 0.41m in width and were dug to a maximum depth of 0.46m. The stratigraphy revealed in their sections was uniform, consisting of a layer of tarmac, 0.06m deep, above a bedding layer of yellowish brown aggregate, 0.09m deep. Below this was a layer of dark brown (10YR 3/3) sandy clay made ground which overlay the natural yellowish brown (10YR 5/8) slightly sandy clay. No archaeological features, deposits or finds were encountered during these works.

Plate 17: Island side service trench, looking SW

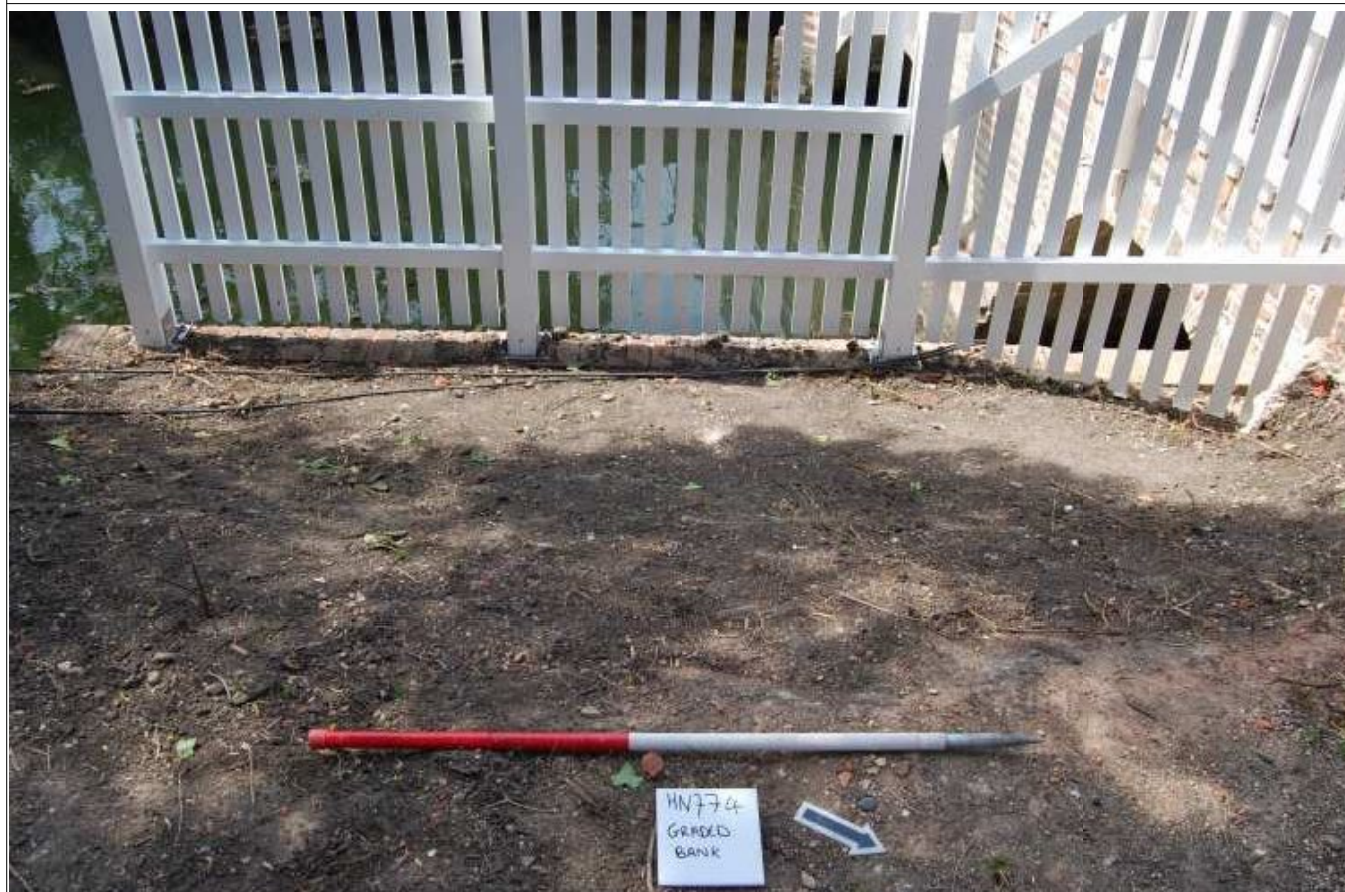
**3.19** The grading of the bank above the new retaining wall to the south of the bridge on the island side was monitored. The bank was removed to a depth of 0.75m and a distance of 2.20m from the wall face (Figure 5; Plate 18). All the excavation was through topsoil, consisting of dark greyish brown friable clayey sandy silt containing frequent roots, moderate amounts of sub-rounded pebbles and occasional small brick or tile fragments of post-medieval date. The unusual depth of the topsoil suggests that the bank may have been built up, though no dating evidence was retrieved to indicate when this may have occurred. No archaeological features, deposits or finds were encountered.

Plate 18: Graded bank to S of bridge on the island side, looking SW
