**STAMFORD YARD,
Kneesworth Street,
Royston, Herts.**

***Historic Building Record &
Archaeological Monitoring Report***

Report No. 194

June 2003

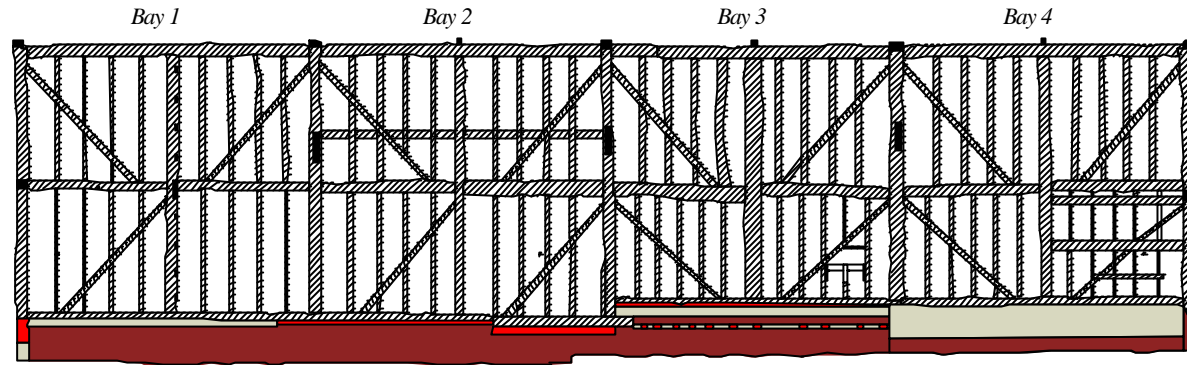
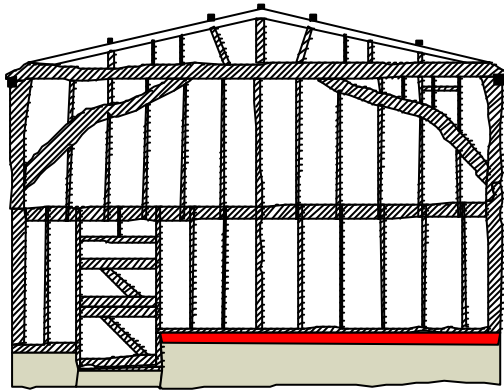
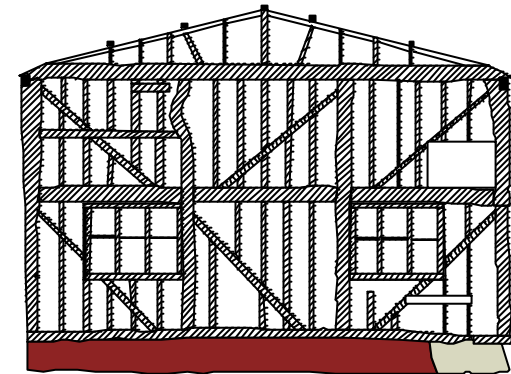
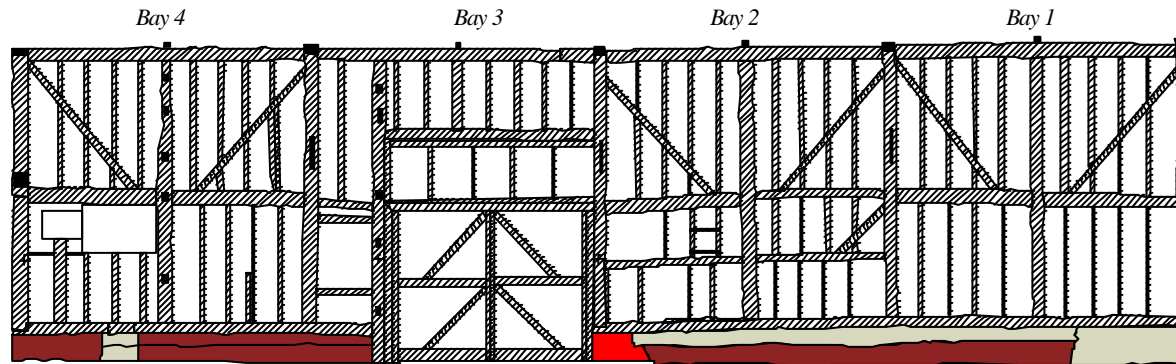
Figure 5

2.2 Further analysis of the barn reveals that it is of typical post-medieval construction, whereby oak has been used for the sill beams, whilst the cross frames are constructed from elm and the studs of pine. The elevations are also indicative of a post-medieval date, in that they consist of primary bracing, which suggests an early 17th century date (Fig.5).

2.4 On the whole, the studs above the middle rail are original. However, wholesale replacement can be seen below the middle rail, where the studs are machine cut and of uniform scantling. The west elevation appears to have undergone major rebuilding in recent years. The modern appearance of the timber work is further substantiated by the use of Fletton brick in the supporting dwarf wall. Some replacement has also taken place of the sill beam, as is evident in the north elevation of Bays 3 and 4.

2.12 All four elevations have areas rebuilt in Cambridge Yellow brick. Those available for close inspection, showed that they were of an early date, c.1880, as they were not frogged and had been finished with a striker. The brickwork in the east and south elevations is consistently of English bond, whilst that in the north elevation of Bay 4 is a combination of Flemish Bond and an approximation of English Bond. The bricks are bonded with a lime mortar in all but the west elevation, where a cement mortar has been used.

2.13 The most recent type of brick used in the barn is Fletton Brick from the London Brick Company of Peterborough. This was commonly used after the second world war. It can be seen in the upper courses of the north elevation of Bays 2 and 3, the west elevation and immediately west of the barn door. The correlation between the use of Fletton brick in the upper three courses in the west elevation and the modern appearance of the timber work in the same elevation has been mentioned above. It would appear that this elevation was largely rebuilt some time in the 1950s or 1960s.

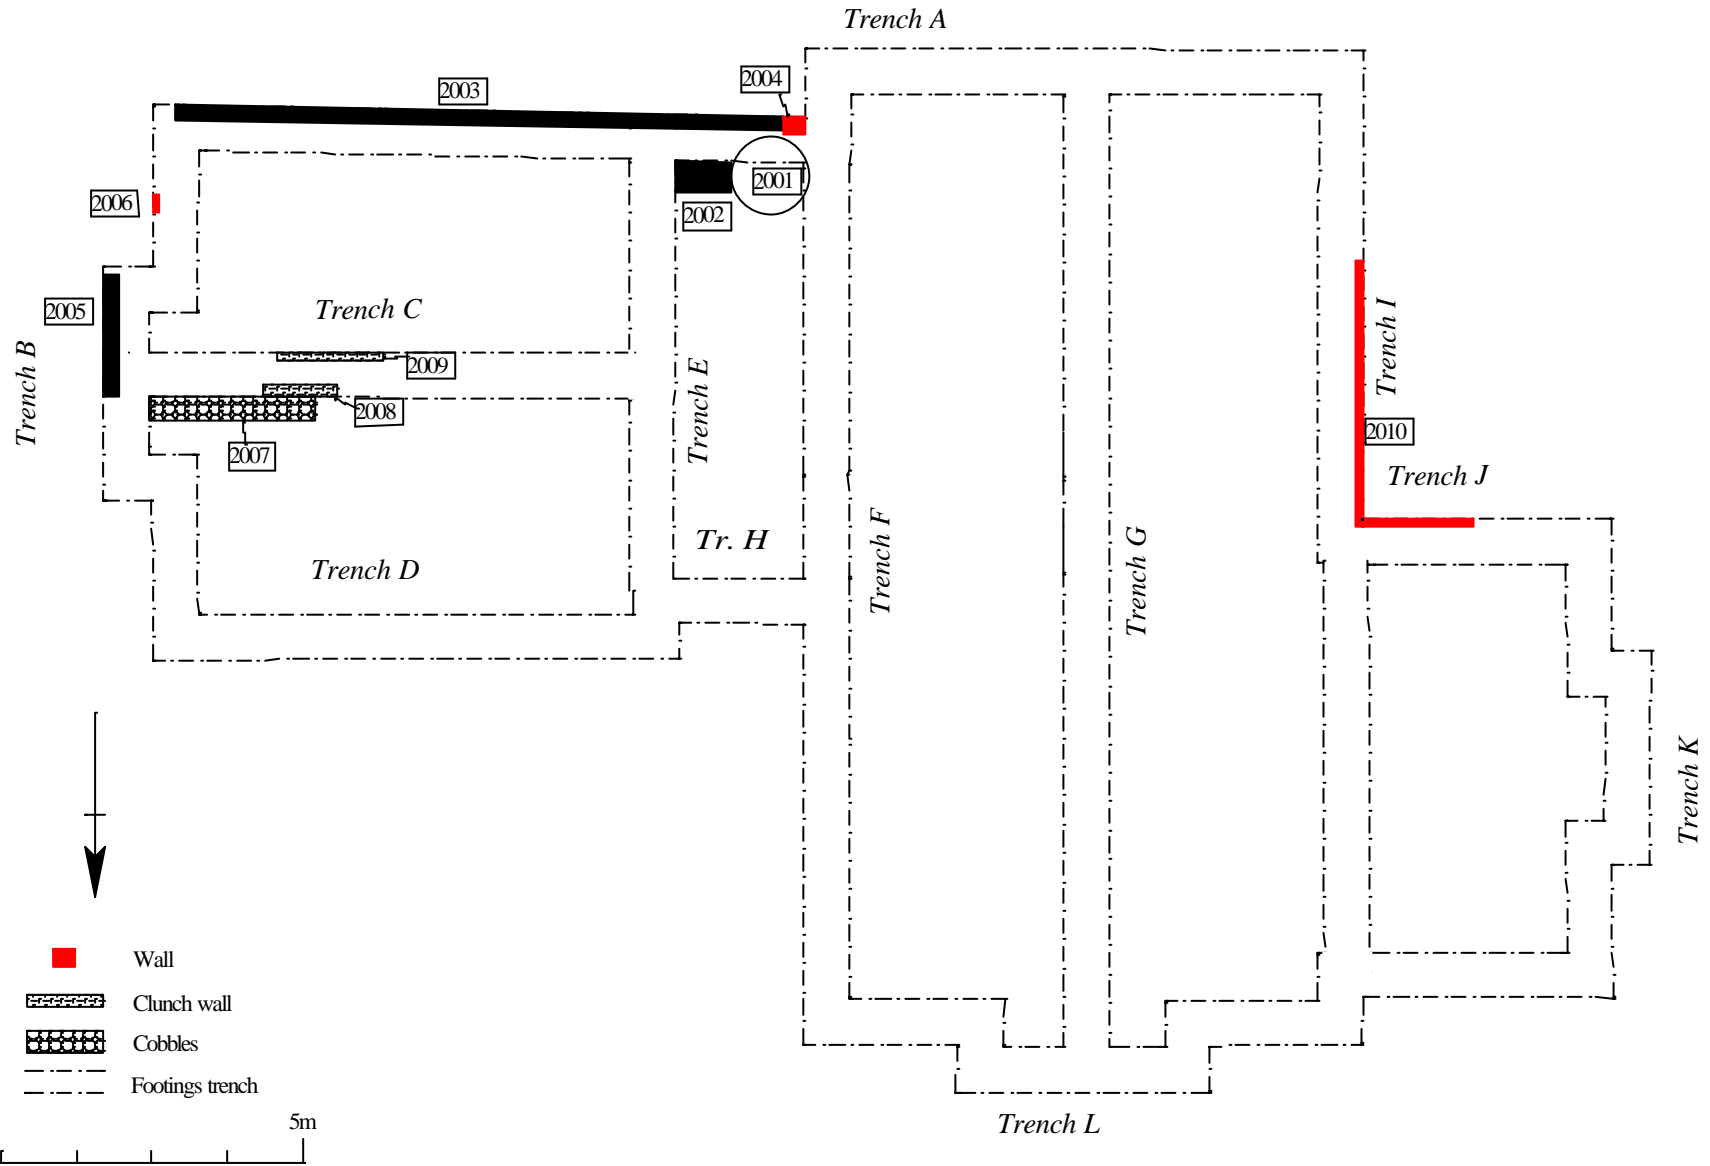
Figure 8

3.7 The footings trenches for the block of flats on the south side of the site measured 0.70m in width and between 1.0m and 1.20m in depth (Figs.7&8).

3.8 A well or cess-pit [2001] measuring 1.60m in diameter and 2.0m in depth containing late 19th/early 20th ceramics, glass and slate was revealed at the junction of Trenches A and F.

3.9 To the east of this was a pit [2002], which measured 1.10m north-south, 1.26m east-west and 1.0m deep. The fill was very dark brown (10YR 2/2) with a high organic content including decayed wood. The finds were of a similar date and composition to those in [2001].

3.10 A large, flat-bottomed pit [2003], measuring 5.05m in length and approximately 1.60m deep was revealed 0.30m west of the junction of Trenches A and B. The fill contained modern material. Immediately to the west of this pit were the remains of a brick wall [2004].

3.11 A pit [2005] measuring approximately 1.60m in length and 0.76m (max) in depth was revealed 0.20m below the ground surface approximately 1.40m north of the junction of Trenches A and B in the west facing section of Trench B. The fill consisted of a mid-grey clayey silt (5Y 4/2) mixed with chalk, with no datable artefacts. It was unclear whether this was a single pit with a stepped base, or two adjoining pits.

3.12 Masonry remains [2006] were present 0.60m north of the junction between Trenches A & B. These measured 0.43m in height and 0.23m in width.

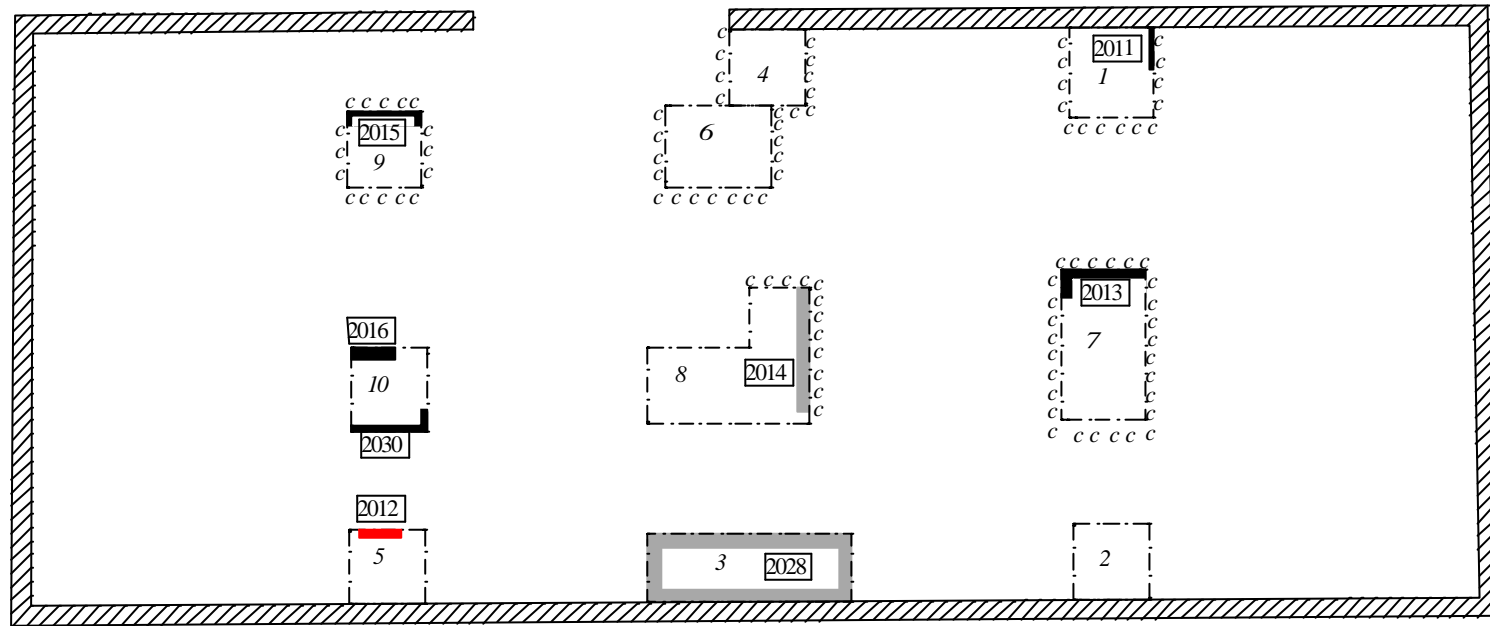
Figure 9

3.17 Ten foundation pads were excavated within the barn, two of which (Pads 3 and 8) were dug as one (Figs.7&9). They varied in size from 1.0 x 1.0 x 0.85 to 0.90 x 2.70 x 1.10m.

3.18 The recorded stratigraphy fell into two basic categories. In the southern two-thirds of the barn, there was a cinder layer between the existing concrete floor and the underlying chalk. This was absent in the northernmost series of pads, Pad 10 and the northern and eastern part of Pad 8. A double layer of concrete was apparent in some of the pads, such as Pads 3 and 5.

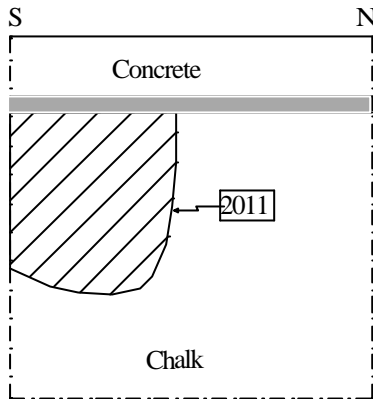
East facing section of Pad 1

3.19 Seven possible pits were observed and recorded. Pit [2011] was revealed in the southern end of the east facing section of Pad 1. It lay below a 0.05m layer of cinders, which in turn was below a layer of concrete approximately 0.20m deep. The pit measured 0.55m in length and 0.58m in depth. The fill consisted of burnt chalk mixed with soil with occasional brick/tile fragments. The fragments recovered appeared to be of the locally made brick used to construct the barn.

4.18 This could tie in with the burnt chalk found in pit [2011] in Pad 1, which also contained fragments of early post-medieval brick and tile. This pit was cut by the south wall of the barn, which indicated that it pre-dated the barn. This must also have been the case for pit [2028] in Pad 3, which was cut by the north wall, and possibly pits [2013] in Pad 7 and [2014] in Pad 8.

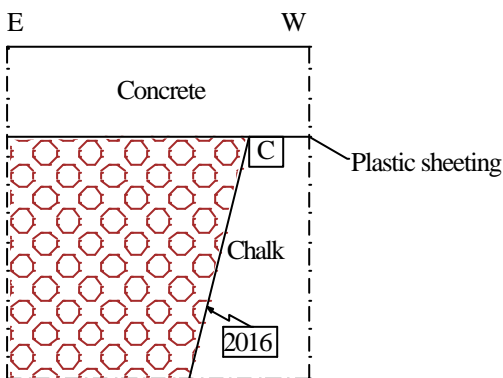
North facing section of Pad

3.23 Pad 9 revealed a pit [2015] in the north facing section which extended 0.20m northwards in the east facing section and 0.18m in the west facing section. The fill consisted of a yellowish brown (10YR 5/4) soft silty clay with chalk inclusions, a locally made early post-medieval brick fragment and a considerable quantity of charcoal in the eastern end. This was overlain by a layer of cinders, above which was the modern ground surface.

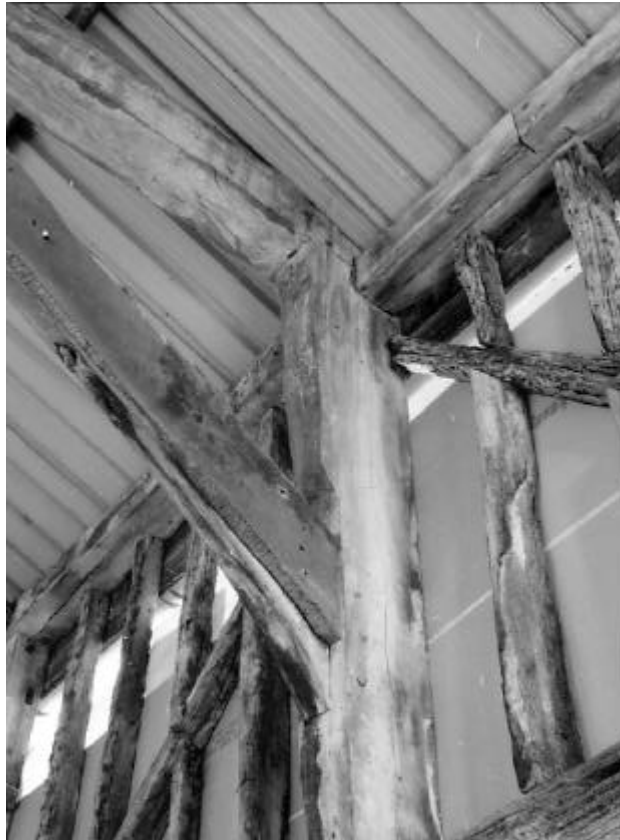
Plate 1a

2.5 Two scarf joints worthy of note are present in the wall plates of the north and south elevations of Bay 3. That on the south elevation is an edge-halved and bridle-butted joint, which was in use from the 15th/16th century until the early 17th century (Plate 1a). On the opposing elevation is a face-halved and counterbladed scarf joint (Plate 1b), described by Hewitt as "...the ultimate contraction of the ultimate form of joint.." (1980:269). This was also in use from the late 16th century.

Bay 3, south elevation: edge-halved & bridle-butted scarf joint

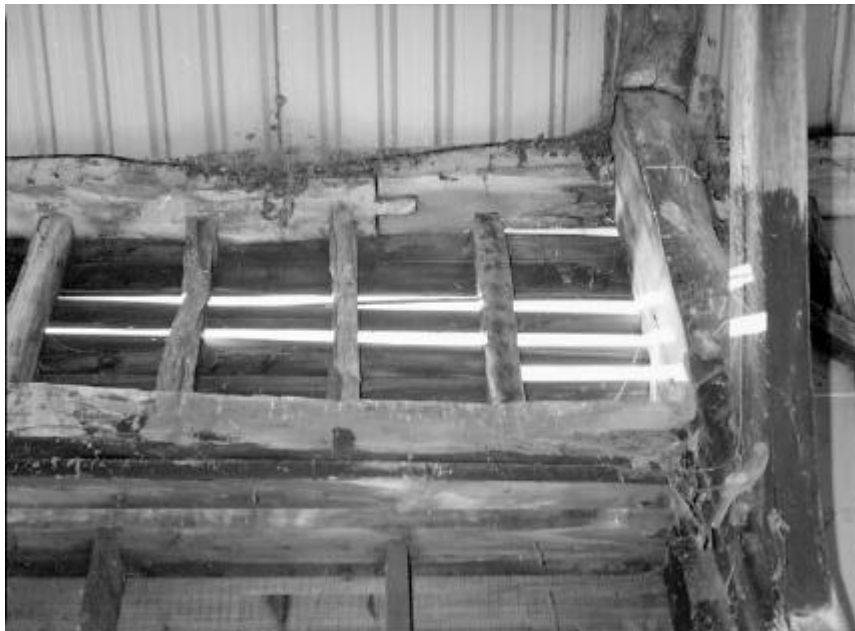
Plate 1b

Bay 3, north elevation: face-halved & counterbladed scarf joint

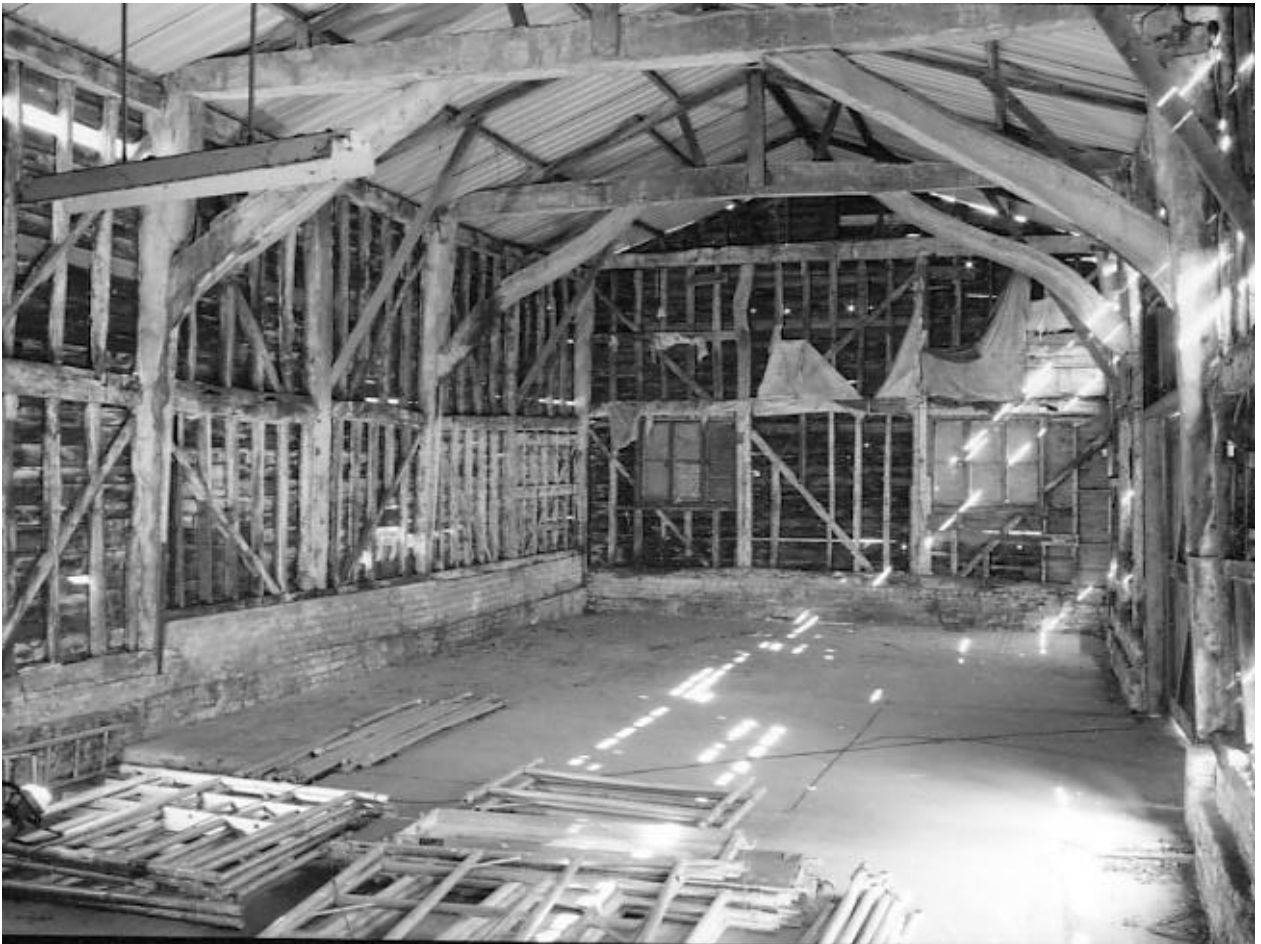
2.7 The roof construction is of straight tie beams and rudimentary king posts with raking struts supporting the rafters (Plate 3). There are two purlins supported by cleats in each roof pitch. The use of cleats is indicative of a late 19th/early 20th century date. The roof pitch is shallow, which indicates that it was tiled before the present corrugated roof was added.

2.16 Although the cross frames are original, the use of cleats with the purlins indicates a re-roofing exercise in the late 19th or early twentieth century. This may well be of the same period of repair and renovation as the use of Cambridge Yellow bricks. The style of these bricks and the fact that lime mortar was predominantly used suggests that a 19th century date is the most likely. Some of the timbers, such as those immediately to the east of the barn door, and the weatherboarding, may also have been replaced at this time.

Interior view looking northeast showing the king post roof
