## **COTTERED SERVICE STATION** **Baldock Road, Cottered,** **Hertfordshire**

HN916

## ***ARCHAEOLOGICAL MONITORING REPORT***

### *Archaeological Monitoring and Recording*

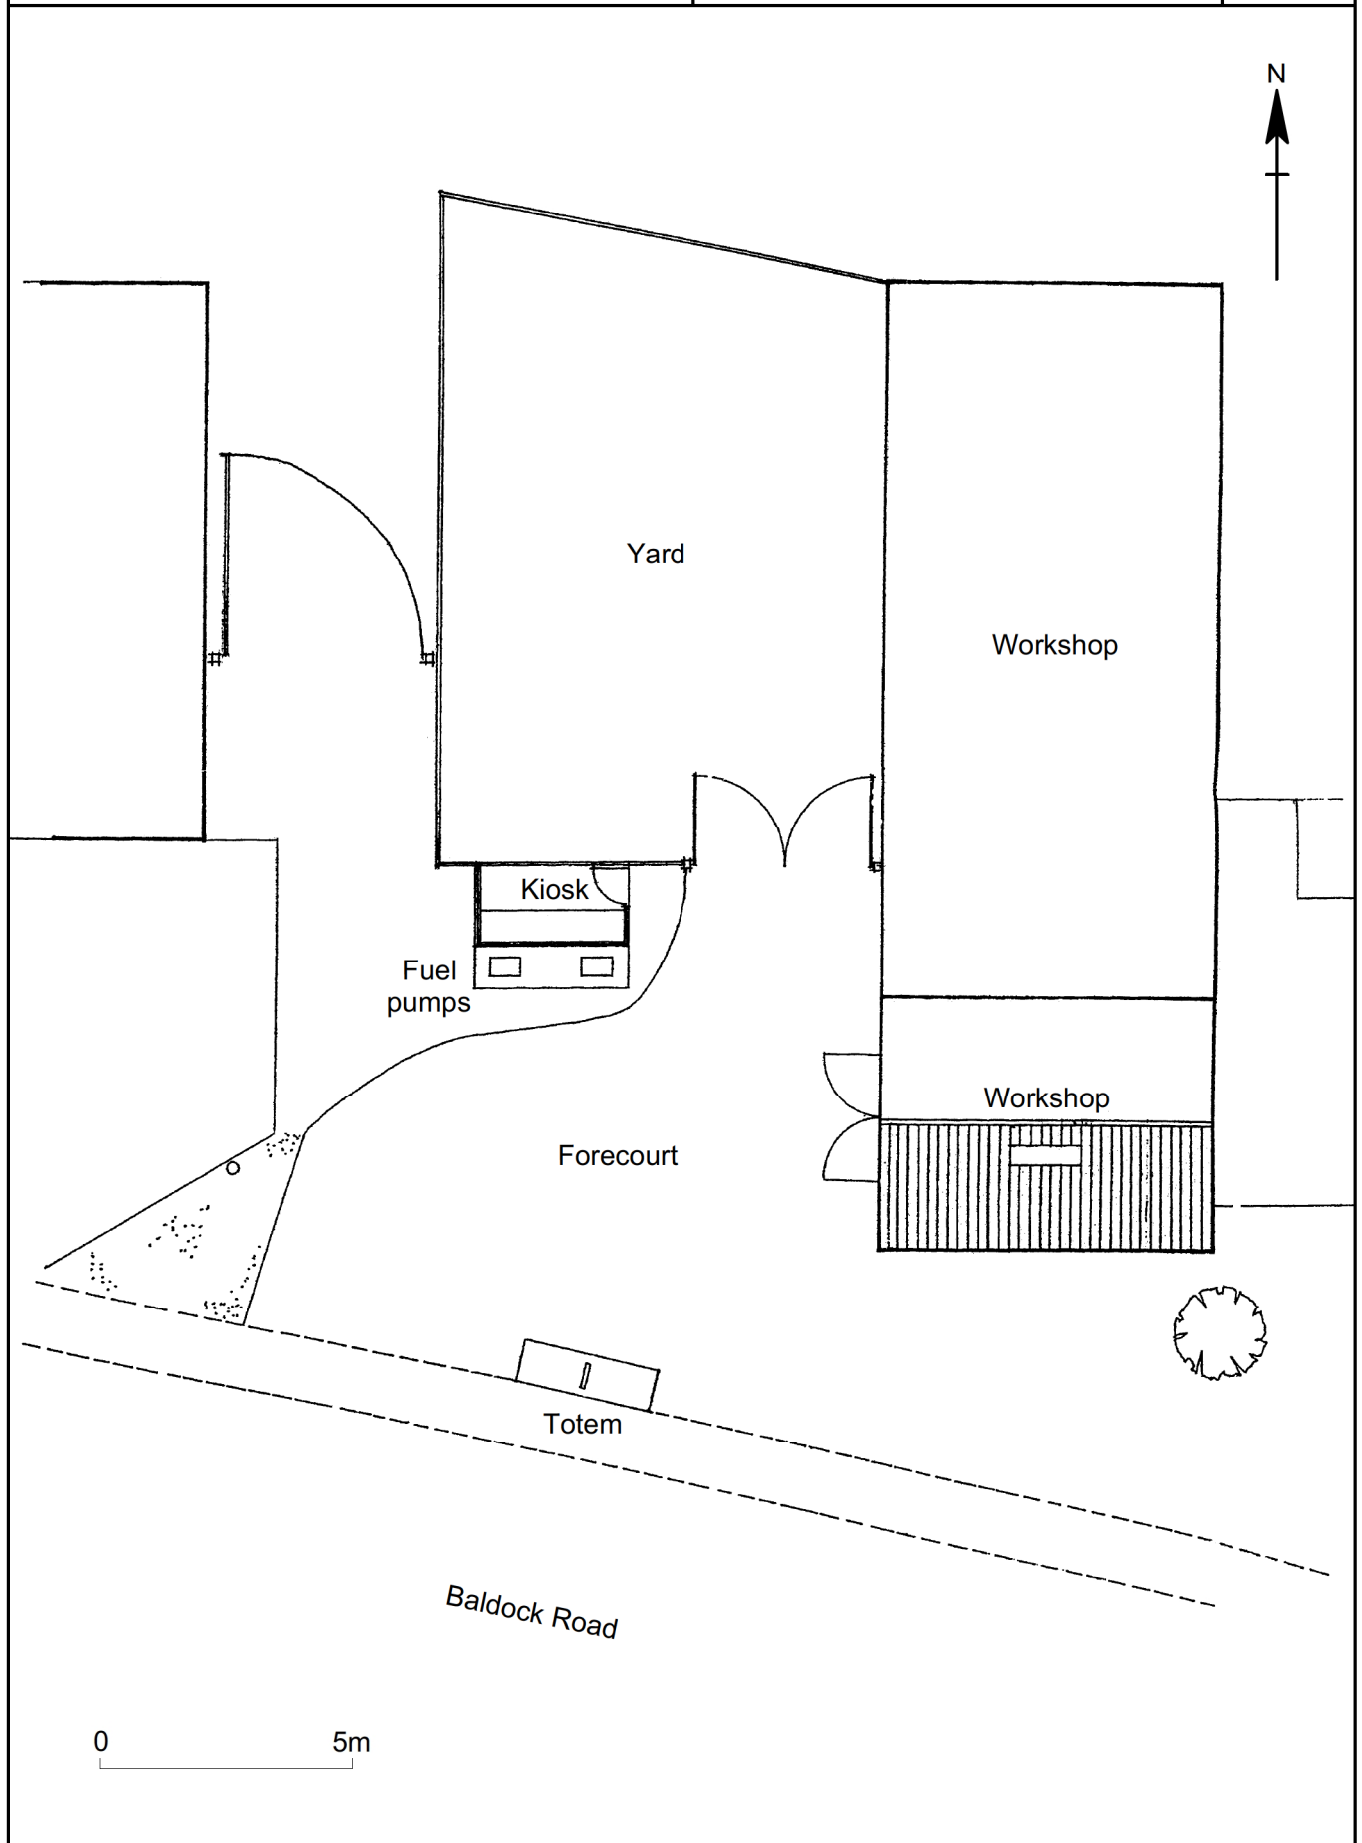
Figure 2

**2.7** Cottered Service station was located on the north side of Baldock Road. Prior to demolition it comprised of a totem, forecourt, fuel pumps, kiosk, yard and two workshops (Figure 2).

**2.12** The yard was a sub-rectangular area defined by the workshops on the east and narrow brick walls to the north, west and south (Figure 2; Plate 5). Access to the yard was through a blue painted double gate in the southeast corner. The yard contained a number of temporary structures including a grounded truck body (Plate 6).

**2.13** A single storey rectangular range, comprising two connected workshops, occupied the eastern side of the yard and forecourt (Figure 2). Its southern end adjoined Green View Cottage to the east (Plates 2, 3 & 5). The south elevation was composed of machine made brick in stretcher bond with cement mortar. There were two white painted casement windows, each of two lights and 6 panes, in the elevation. The roof was in red pantiles, with a corrugated plastic skylight.

Former Site Layout (Courtesy of Attfield and Jones Architects)

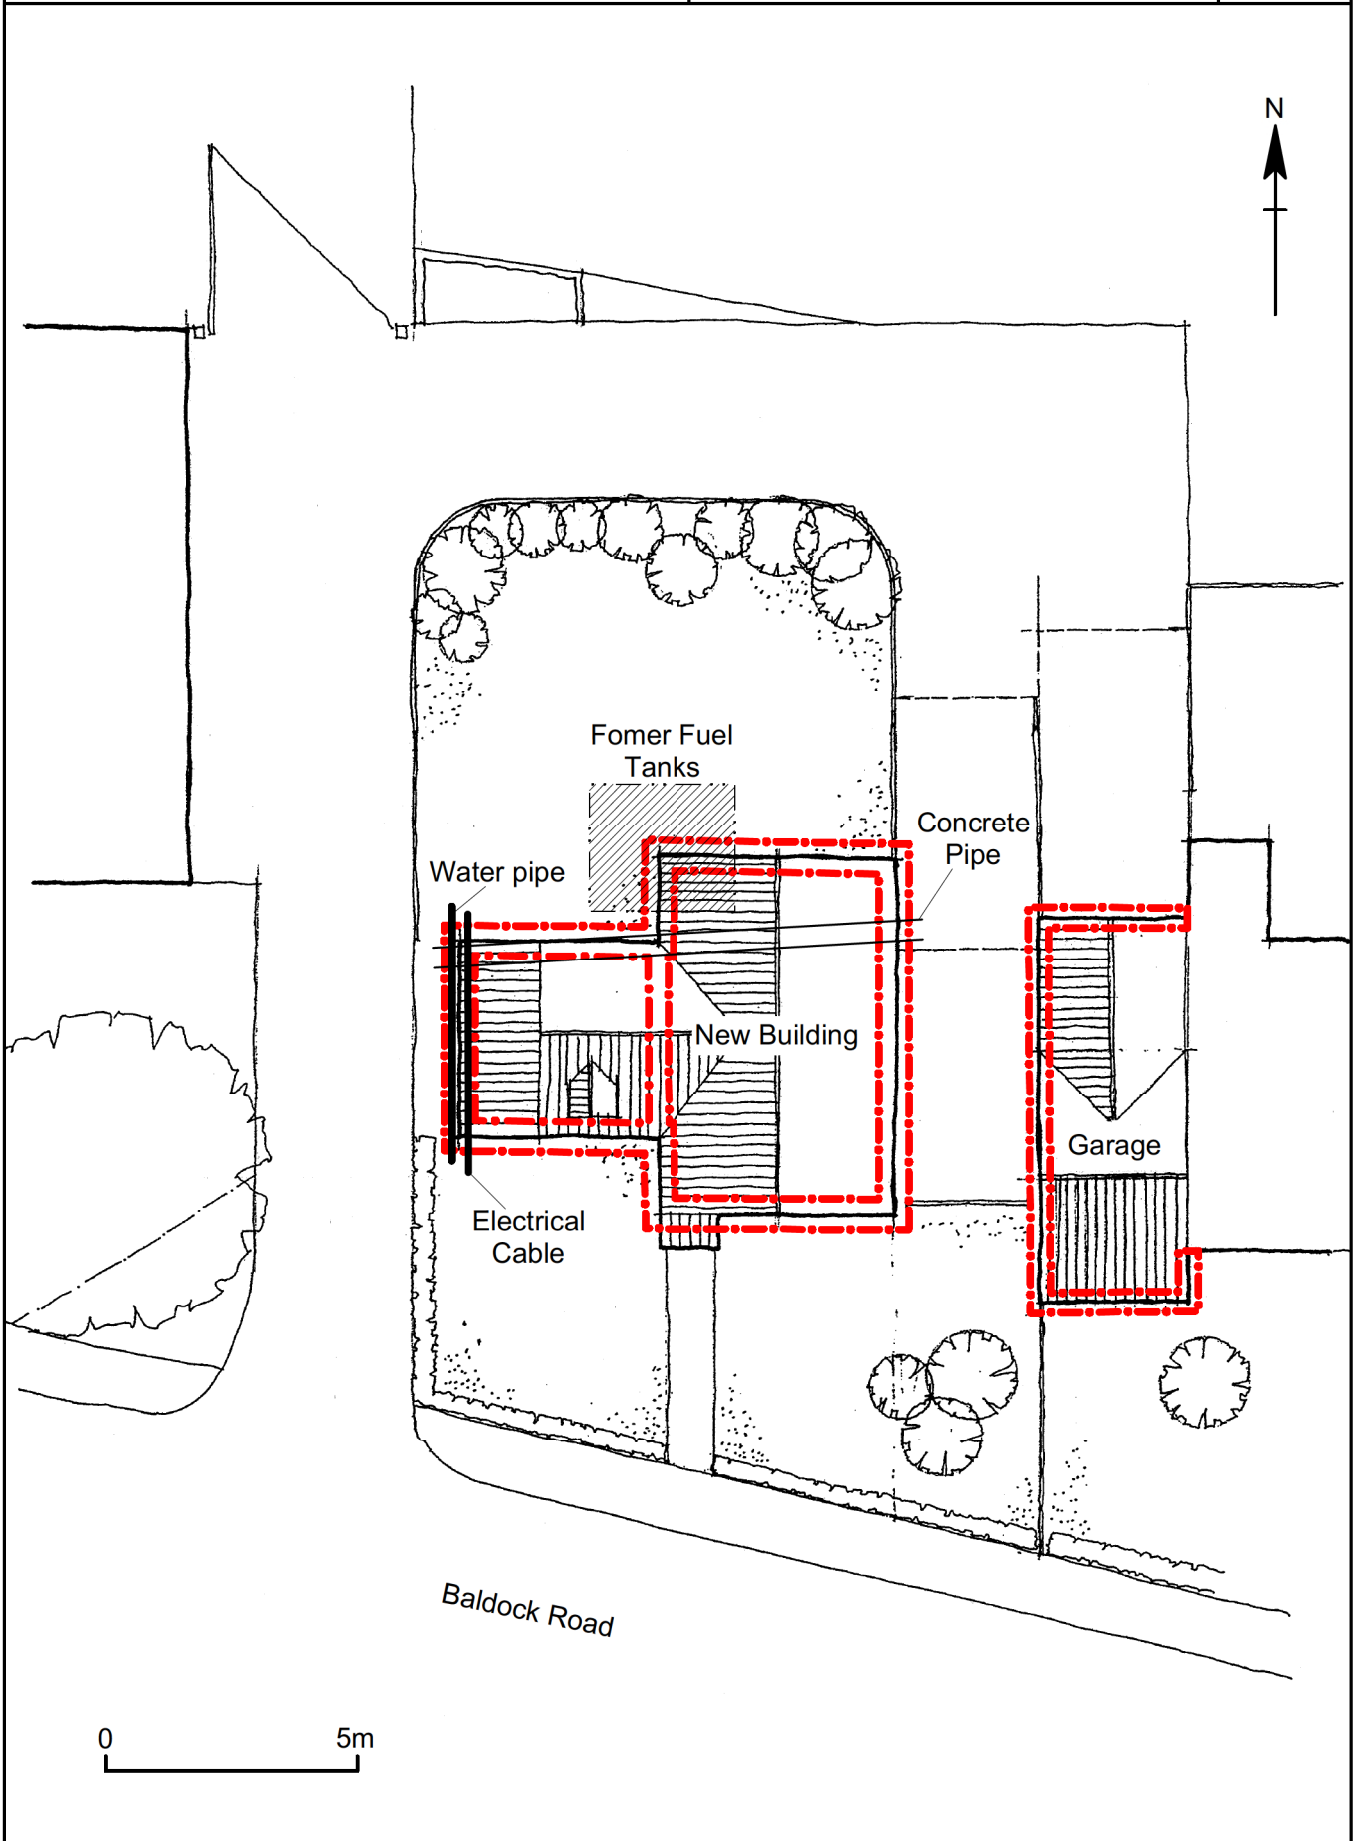
Figure 3

**2.16** The excavation of the footings trenches for the new dwelling was monitored. The trenches measured 0.60m in width and were excavated to depths of between 1.10m and 1.20m (Figure 3).

**2.18** A number of modern service trenches were encountered during the course of the groundworks (Figure 3). These included a water pipe and electric cable which ran north – south along the eastern footings trench. A concrete drain was also present, which ran east – west across the site. The ground in the northwestern corner of the new dwelling had been disturbed by the removal of underground fuel storage tanks.

Site Layout (Courtesy of Atfield and Jones Architects)

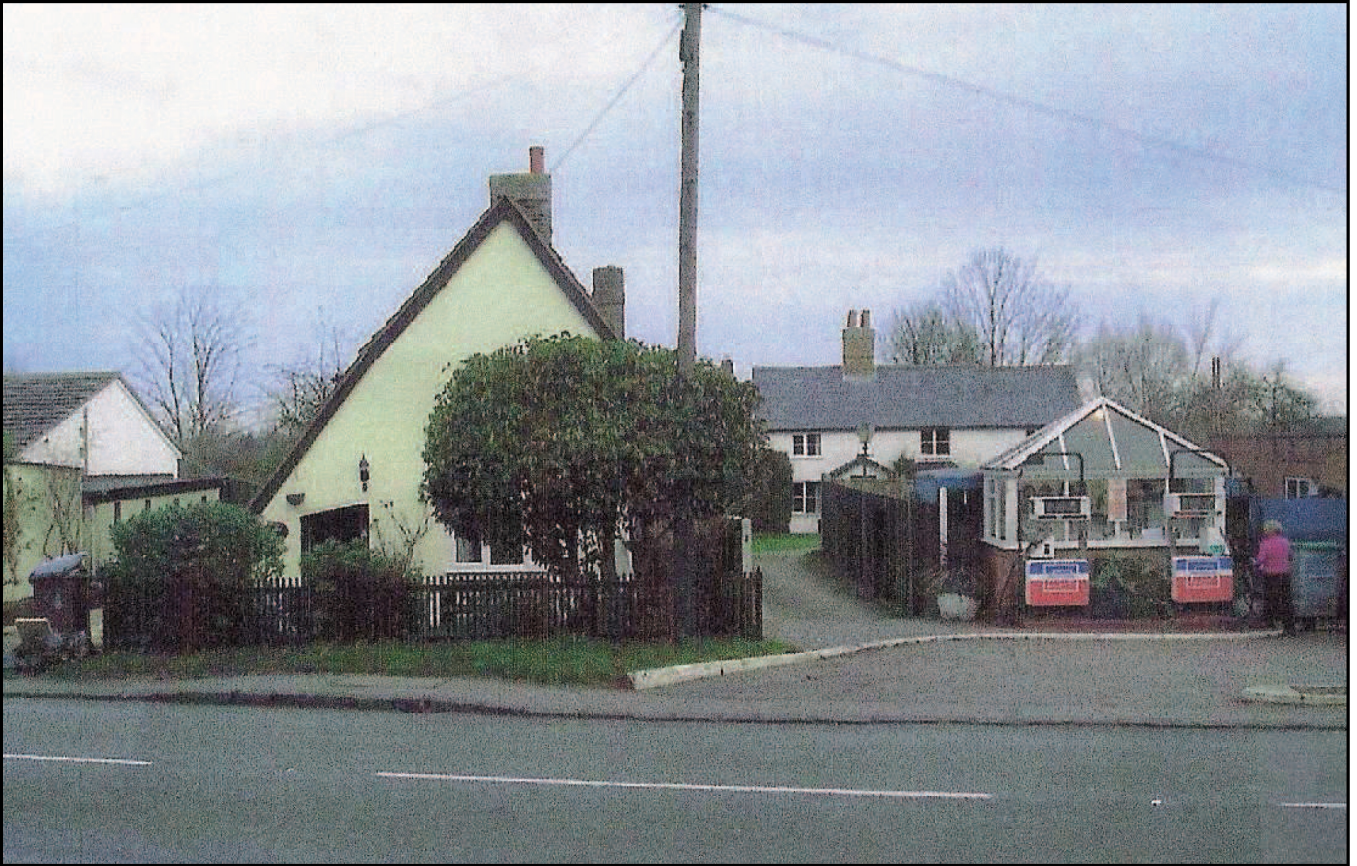
**2.9** The forecourt was surfaced in a mixture of tarmac and brick paving. The western and northern limits of the forecourt were defined by white painted concrete kerbs (Plates 1 & 2).

**2.10** At the north side of the forecourt was a low concrete plinth supporting two electric petrol pumps (Plates 1 & 4). The pumps were metric, indicating that they were not original, and displayed the Proteus logo.

**2.11** Immediately to the north of the patrol pumps was a small kiosk (Plates 1 & 4). This comprised a full wall on the north side, with dwarf walls to the east, south and west. Above the dwarf walls were glazed panels with white frames, supporting a pyramidal glazed roof. The kiosk had a single door in the east elevation.

Plate 1: Forecourt and kiosk, prior to demolition, looking north.  
(Courtesy of Attfield and Jones Architects)

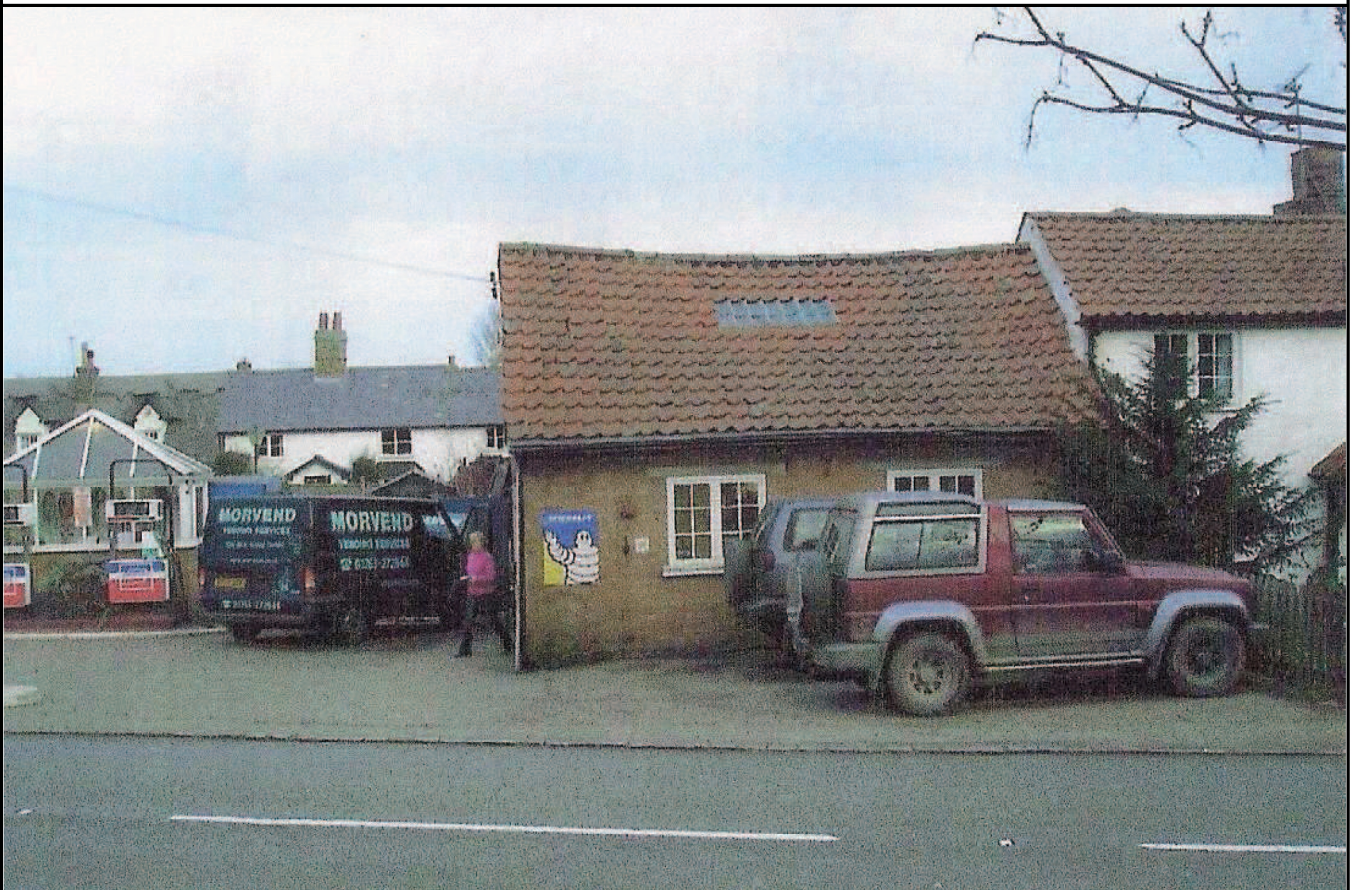
Plate 2: Forecourt, kiosk and workshop, prior to demolition, looking north.  
(Courtesy of Attfield and Jones Architects)

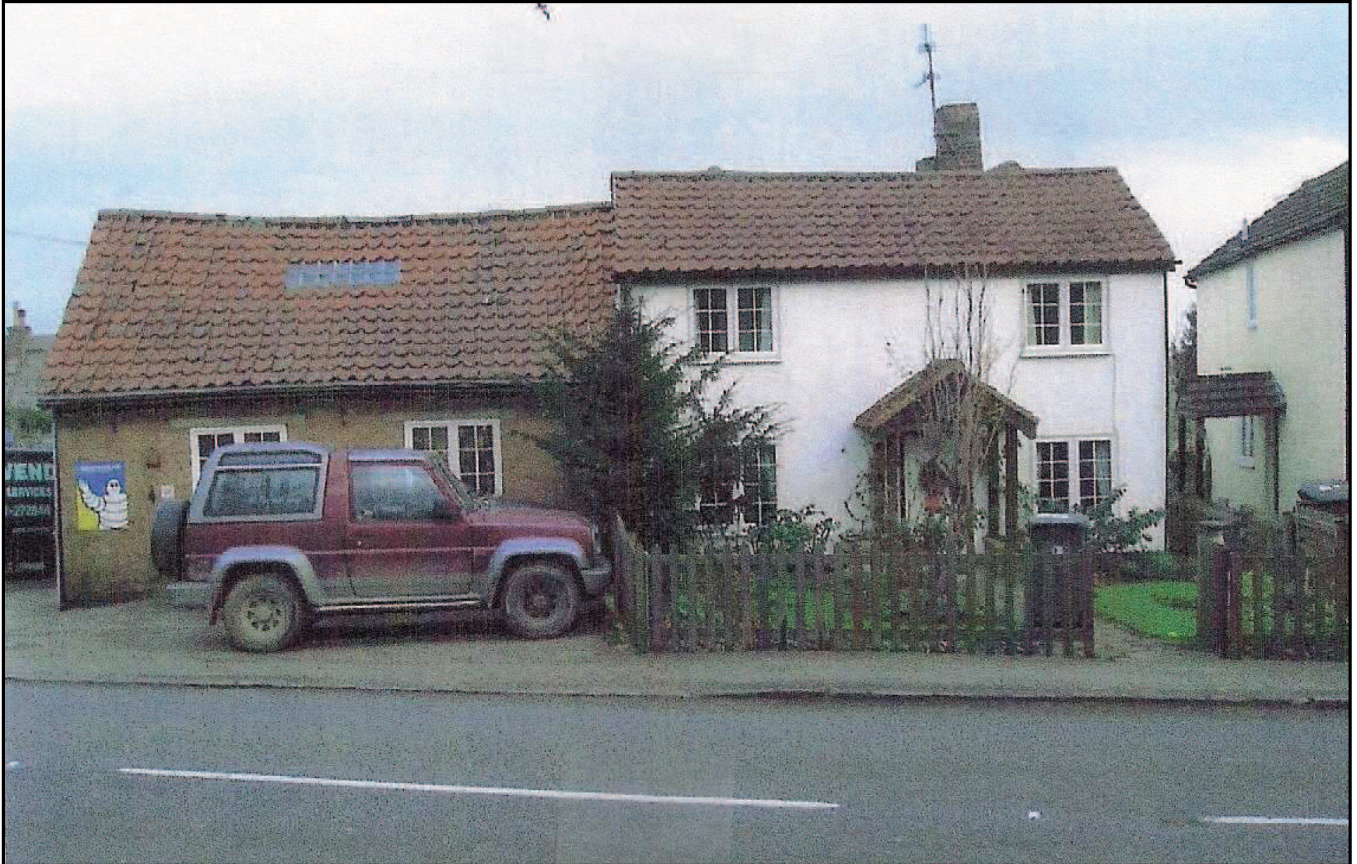
Plate 3: Workshop, prior to demolition, and Green View Cottage, looking north.  
(Courtesy of Attfield and Jones Architects)

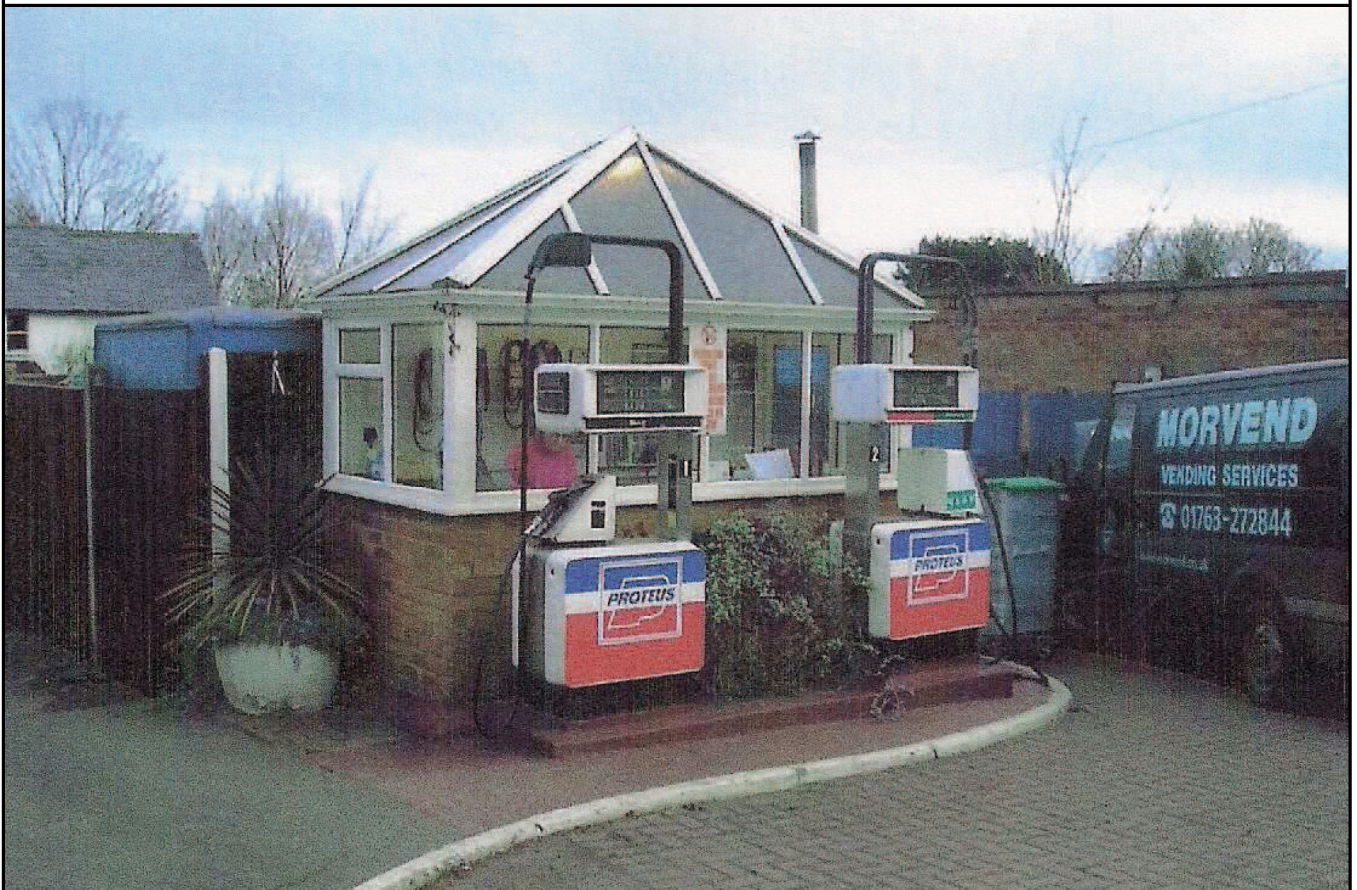
Plate 4: Kiosk and petrol pumps, prior to demolition, looking northeast.  
(Courtesy of Attfield and Jones Architects)

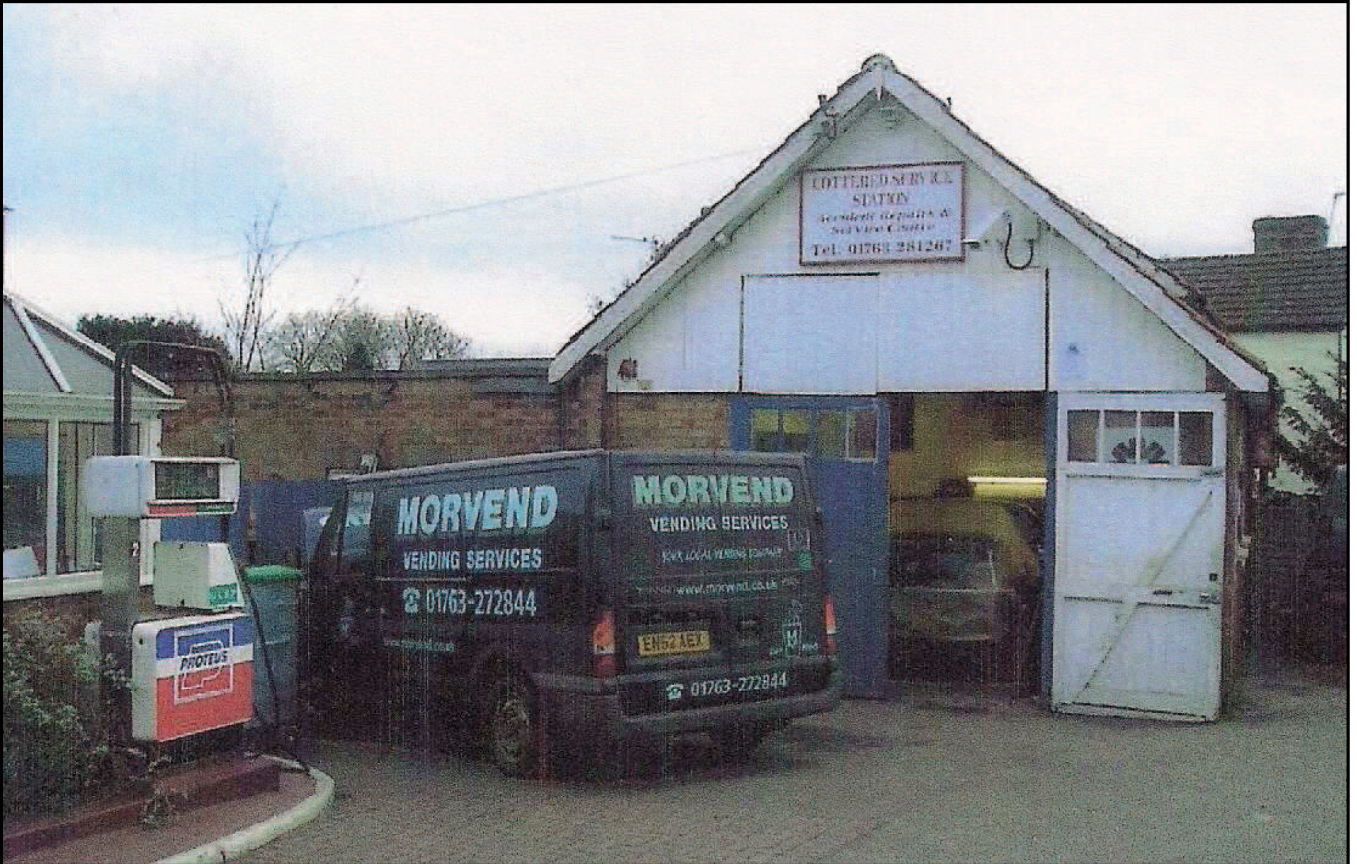
**2.14** The western elevation contained double doors of plank and brace construction, glazed at the top (Plate 5). Above the doors the gable was timber clad and white painted. Two short wooden doors had been inserted into the gable to allow entry to high sided vehicles. A sign was mounted on the gable end which read; "COTTERED SERVICE STATION Accident Repairs & Service Centre".

Plate 5: Forecourt and workshop, prior to demolition, looking east.  
(Courtesy of Atfield and Jones Architects)

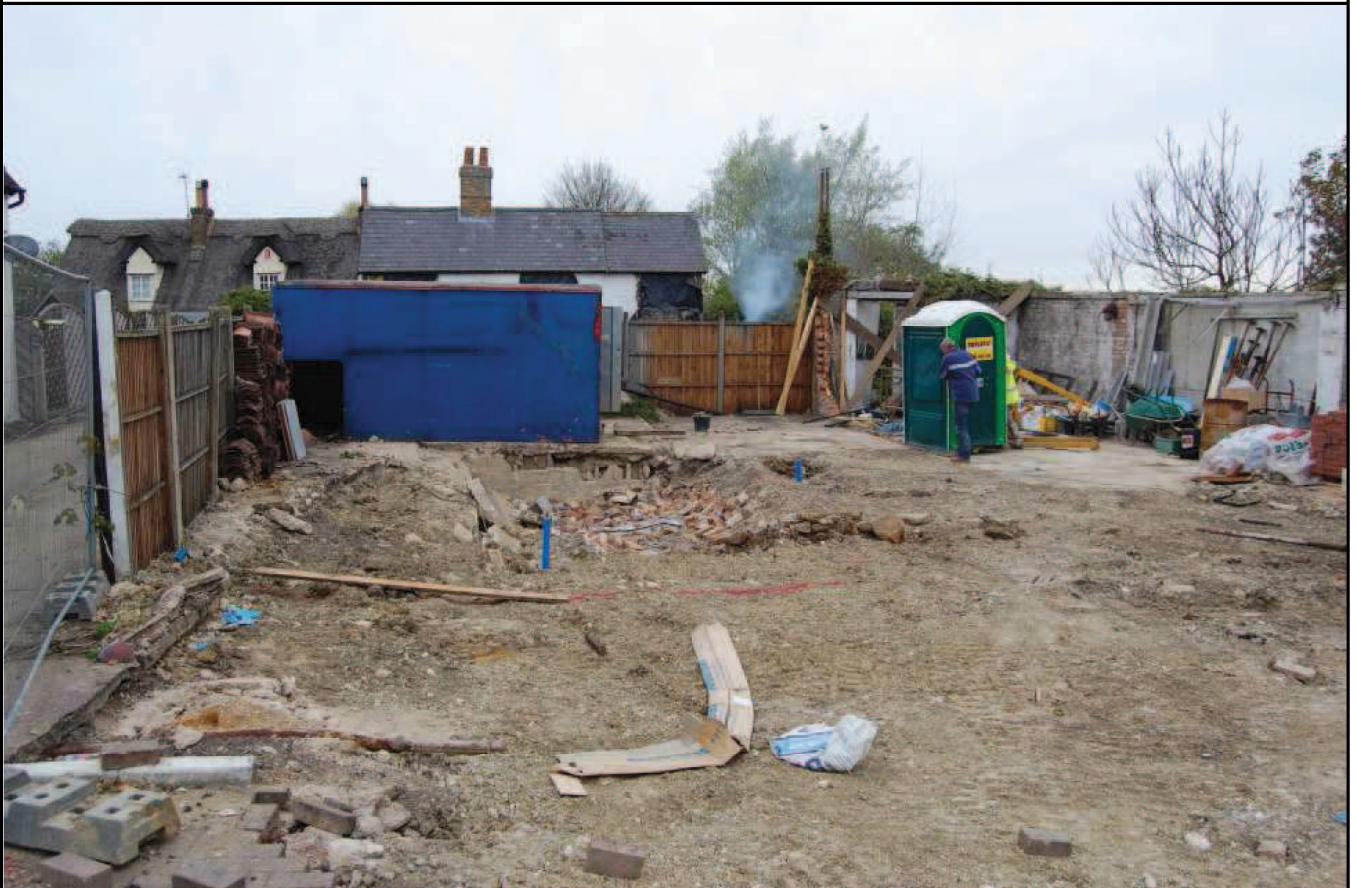
Plate 6: General view of development site, looking north.

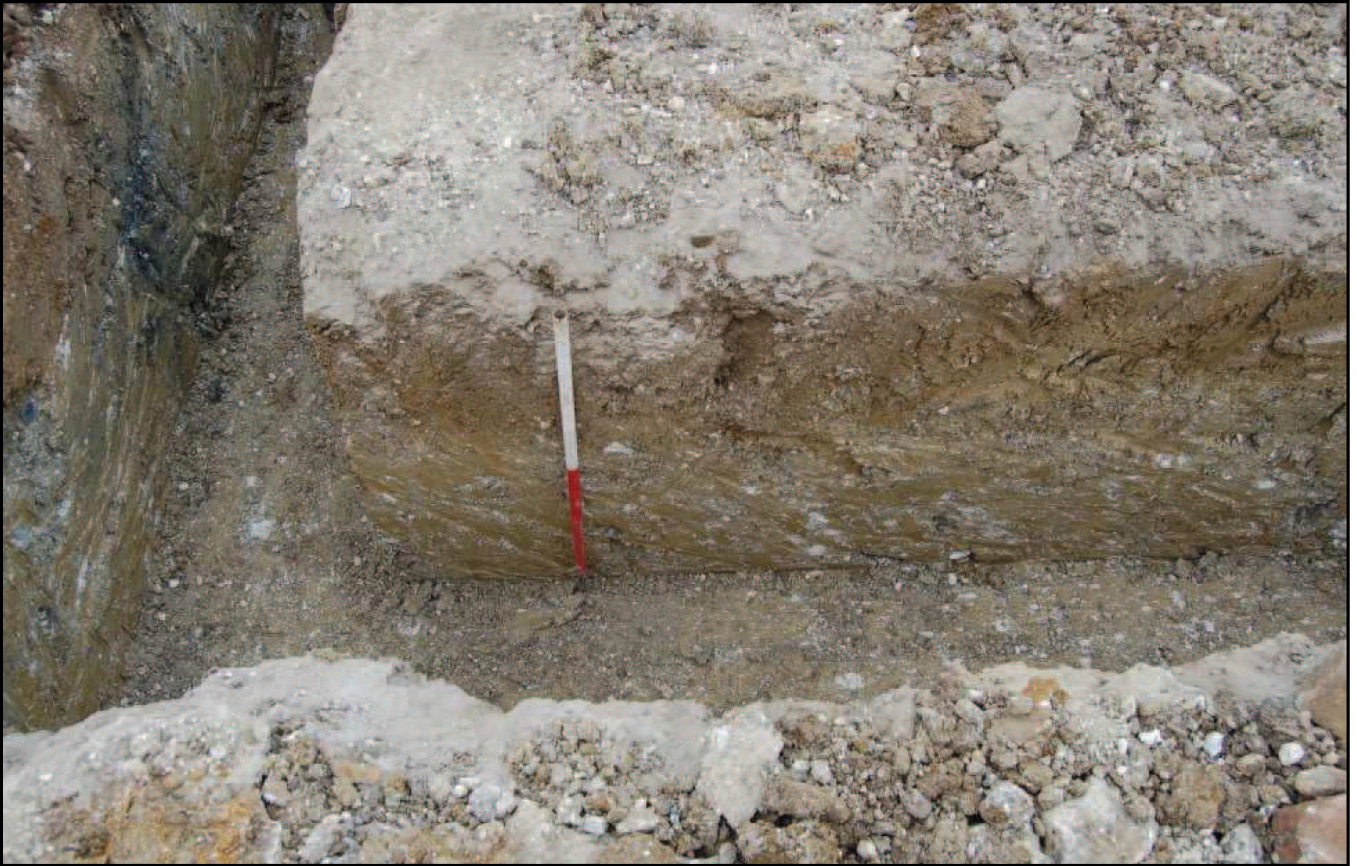
**2.17** The stratigraphy exposed in the trench sections consisted of more than 0.5m of stiff pale yellowish brown natural clay with frequent flint fragments, which in the southern half of the site was overlain by up to 0.60m of mid brown sandy clay subsoil (Plate 7). The site was covered with a levelling deposit of modern demolition rubble that was thinnest at the southern end of the site and became thick towards the north, finally achieving a thickness of 0.60m.

Plate 7: Typical section showing stratigraphy, looking west.

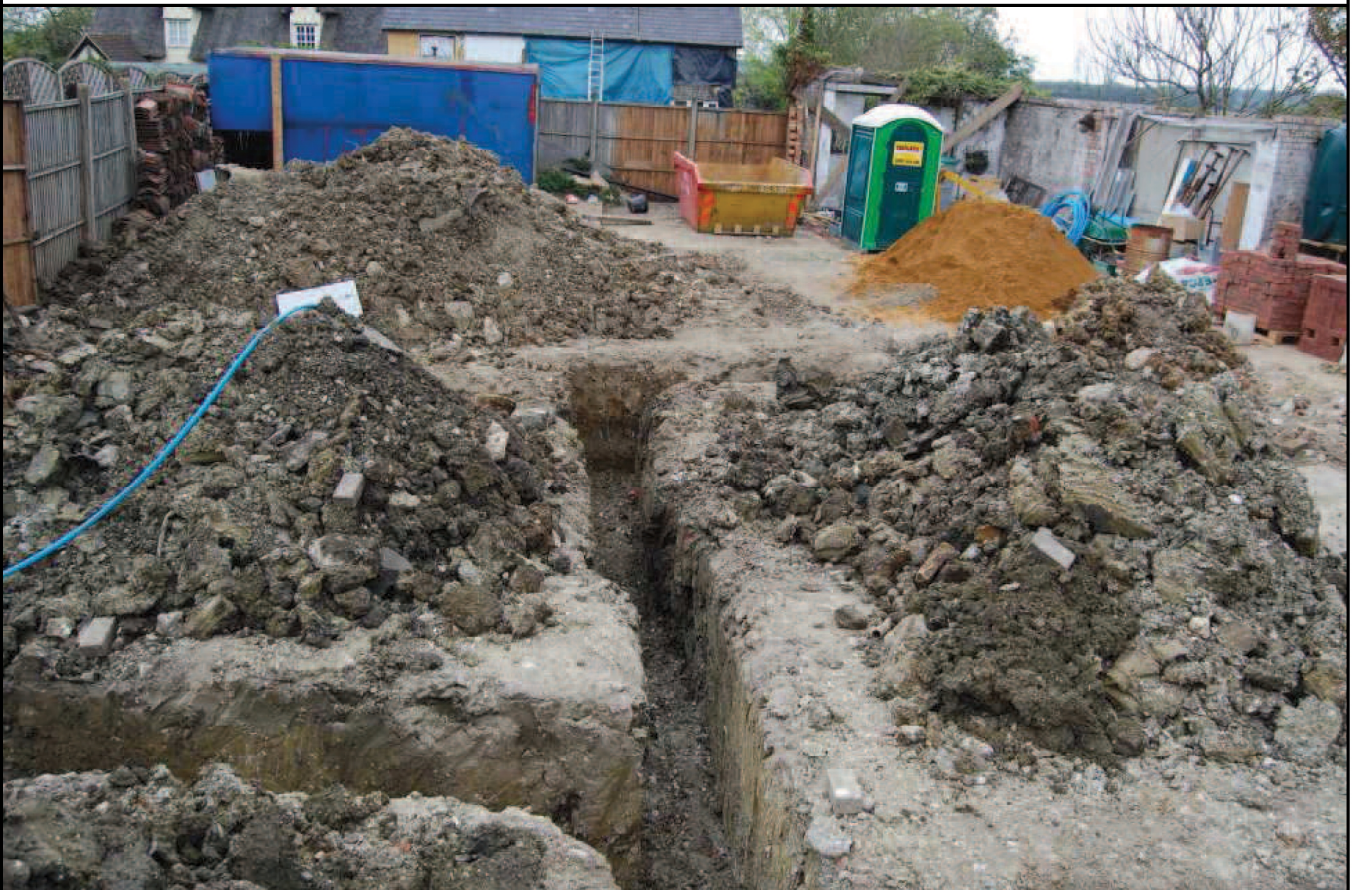
Plate 8: General site view showing groundworks, looking north.
