# OAKHAY BARTON, STOKE CANON, DEVON

Results of historic building recording

East Devon District Council planning reference  
15/0799/FUL, condition 12

Document No: ACD1645/2/0

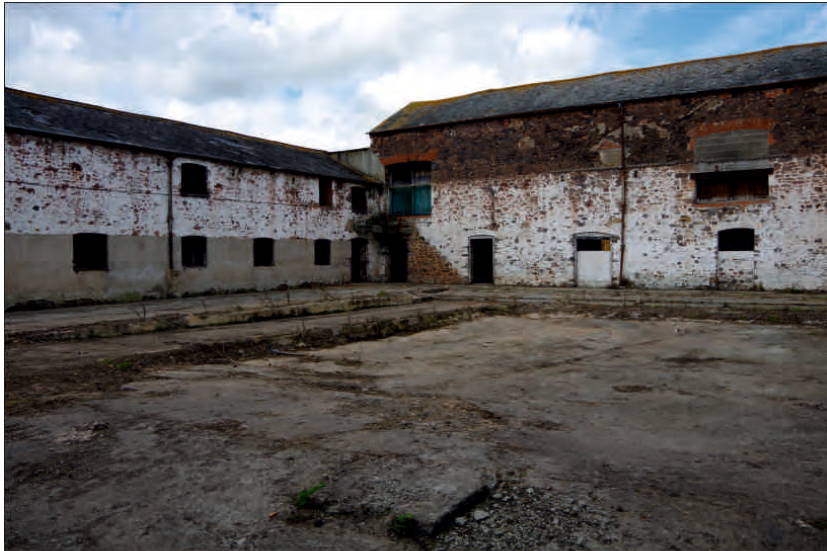
5.2 The central courtyard in the quadrangle is accessed through double doors in a covered passage between the east and south barns and through a gap between the west and south barns. The courtyard has a concrete surface along with an area of brick forming a walkway. There were previously structures within the quadrangle, and scars of walls, a first floor, and roofs of these demolished structures are visible on the courtyard surface and elevations of the north and west barns. The ground level in the courtyard is stepped, being higher to the north and west in the area of the former structures, and lower to the southeast. This lower area was probably used as a covered yard (Plate 1). To the north and west of the barns, on the exterior of the ranges, are a series of lean-to structures (Plate 2).

Plate 1: General view of central courtyard, looking northwest towards the north and west barns

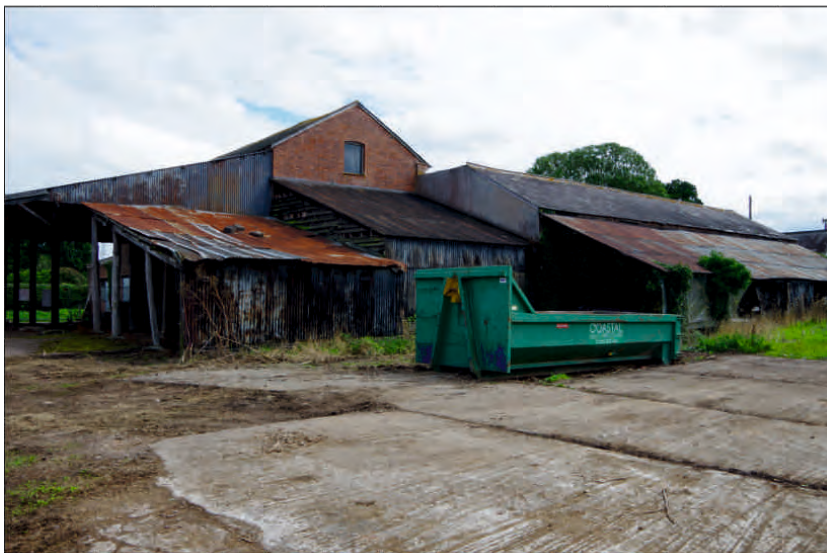
Plate 2: General view of lean-to structures, looking southeast

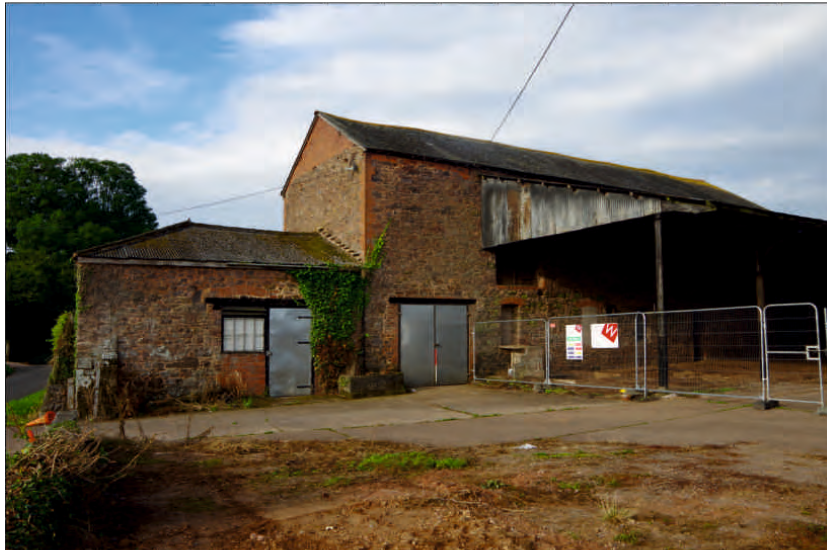
- 5.8** In the western two-storey section of the north elevation there are six openings on the ground floor (Plates 5 and 6). The central four openings were originally windows with brick-arched heads. Two of these openings have been filled with concrete blocks, with the western window converted into a door; this has brick jambs to the enlarged opening. The other window retains its original peg-jointed timber frame which displays sockets for now-removed security bars. The other two doorways are inserted and have brick jambs. The west opening has a wooden lintel and is fitted with wooden double doors, whilst the east opening is later and has a metal lintel and is fitted with metal double doors.

Plate 5: East end of north elevation of north barn, looking southwest (1m scale)

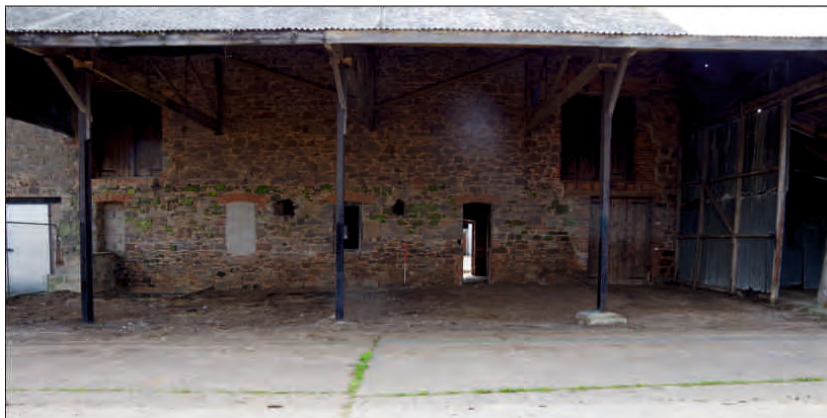
Plate 6: West end of north elevation of north barn, looking south (1m scale)

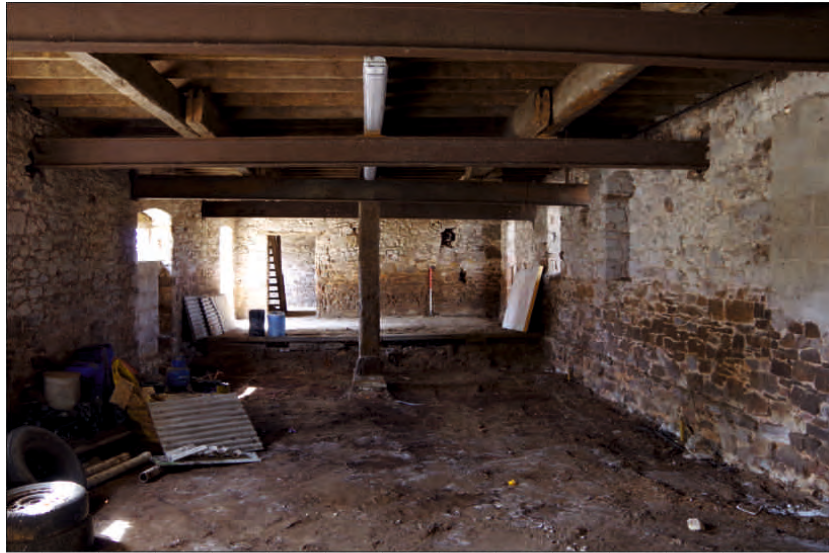
- 5.12** The central room is currently on two levels with the higher level being to the west and the original floor level having been reduced slightly to the east (Plate 7). There are two central posts supporting the first floor. The base of one has been exposed, and is a tapering block of volcanic trap supported with recently added concrete. The first-floor joists are supported on slender beams aligned east to west. These must have originally been supported on additional north-south aligned beams that have been replaced with four rolled steel joists. The central posts support the present lower wooden beams. The surviving floor at the west end of the room is a brick surface, which appears latterly to have lined a passage.

Plate 7: General view of central room on the ground floor of the north barn, looking west (1m scale)

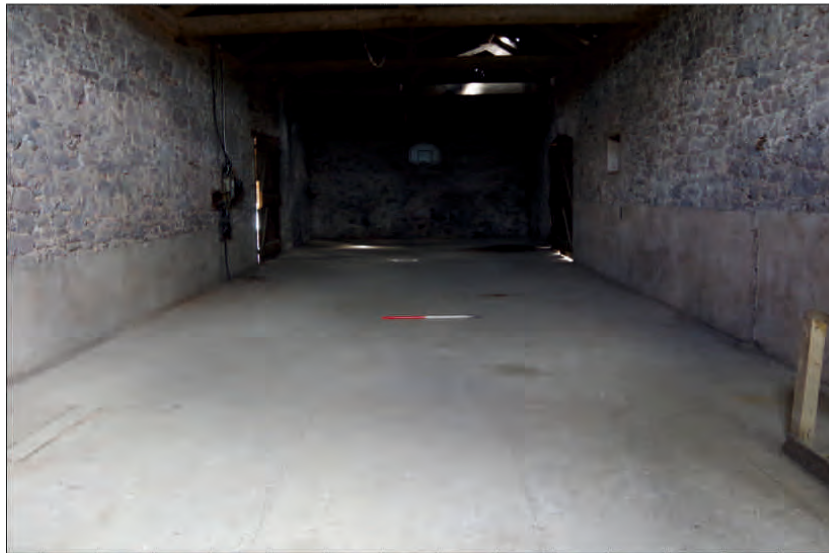
- 5.14** The first floor is a single open room with a chipboard floor replacing the original boards (Plate 8). The lower parts of the walls have been finished with concrete render. The roof comprises five king post trusses with back purlins resting on cleats that support the rafters, battens and slates.

Plate 8: General view of first floor of the north barn, looking east (1m scale)

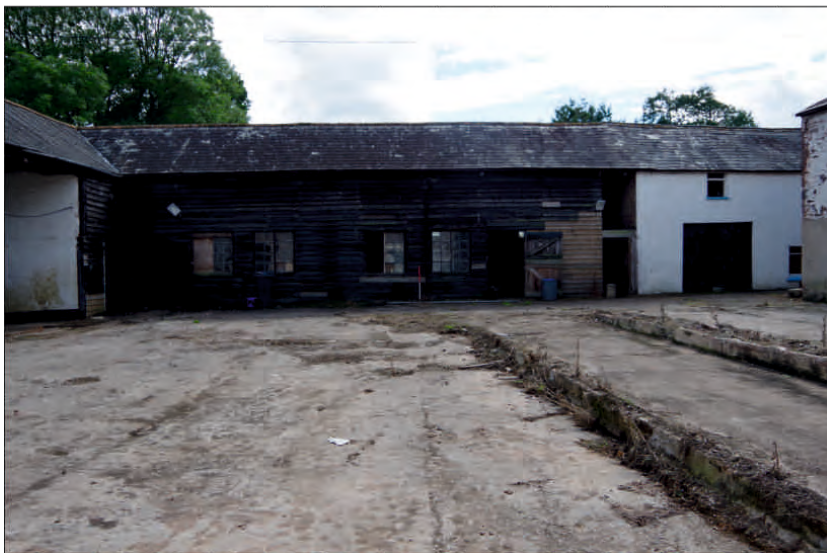
- 5.17** The west section of the north elevation is covered with white painted concrete render, with the remainder finished in timber cladding that continues around the east end of the barn (Plate 11). On the ground floor of the west section are a set of double wooden doors with round-ended strap hinges (one of which has been replaced with a plain strap) and a modern fixed window. On the first floor are two windows; the west window is a modern fixed casement, and the other is of three lights, each of three panes. The central light is hinged with small L-shaped strap hinges which is possibly a 19th- or early 20th-century replacement (Plate 12). In the east section, on the ground floor there are two wooden doors – one of which is a stable door – along with four horizontal sliding 16-pane windows. However, two are missing half of their windows. On the first floor there is a doorway above the corridor. The barn returns slightly to the north at its east end. Here there is a ground-floor wooden door.

Plate 11: North elevation of south barn, looking north (1m scale)

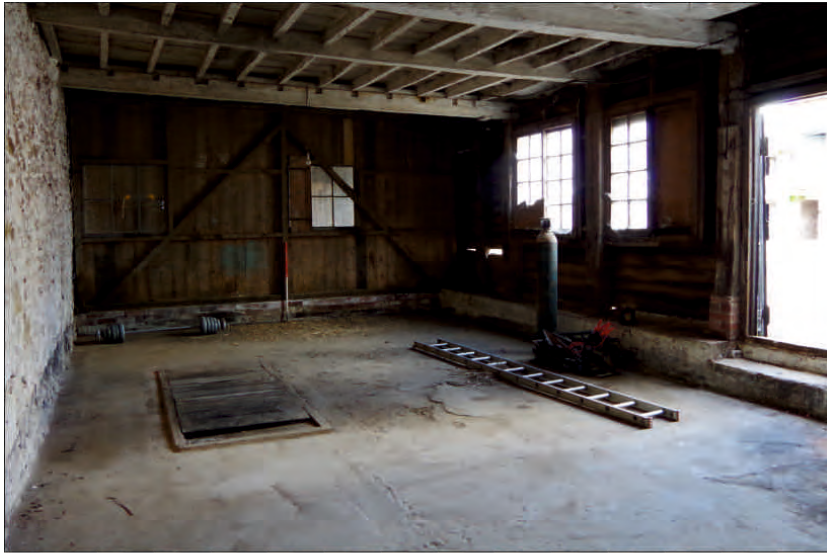
- 5.19** The east room has a concrete floor. At its east end is an inserted ceiling associated with a complete replacement first-floor structure. This is at a higher level than the original first floor. The original bridging beams survive and display unused sockets for the primary joists. There is a timber plank partition between this room and the stables to the west which is constructed onto a low brick plinth and contains two six-pane metal-framed windows. The original function of this room is unclear but was probably used to house animals, and may have been an open-fronted linhay. It last functioned as a garage and has an inspection pit in the floor (Plate 13).

Plate 13: General view of east room on the ground floor of the south barn, looking northwest (1m scale)

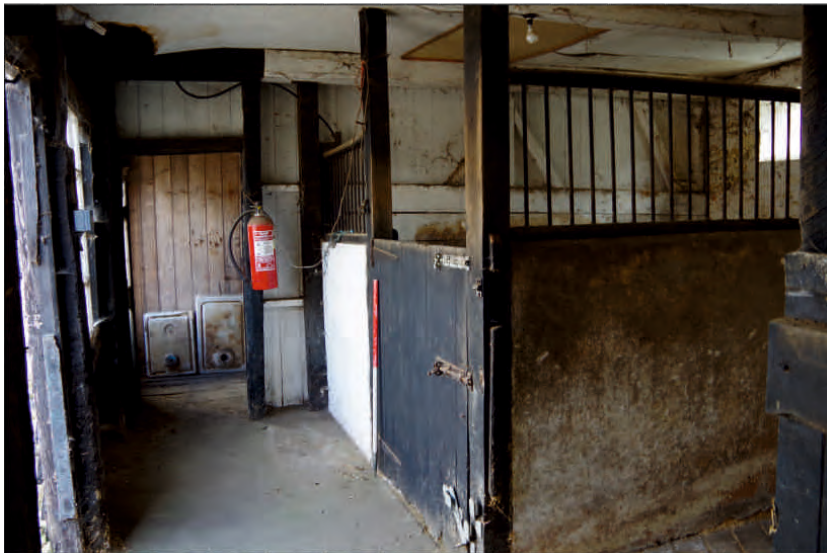
- 5.20** The central stable contains two stalls with a central concrete partition between, and with concrete floors to all elements (Plate 14). To the west is a tack room with a wooden floor. The partition wall between the tack room and stable is of timber planks and rendered blockwork, and the partition between the stable and the corridor to the west is also of timber planks and brickwork. There are concrete feeding troughs in each stable, with one having had a Belfast sink added on top. The room has a lower, inserted ceiling.

Plate 14: General view of stables on the ground floor of the south barn, looking east (1m scale)

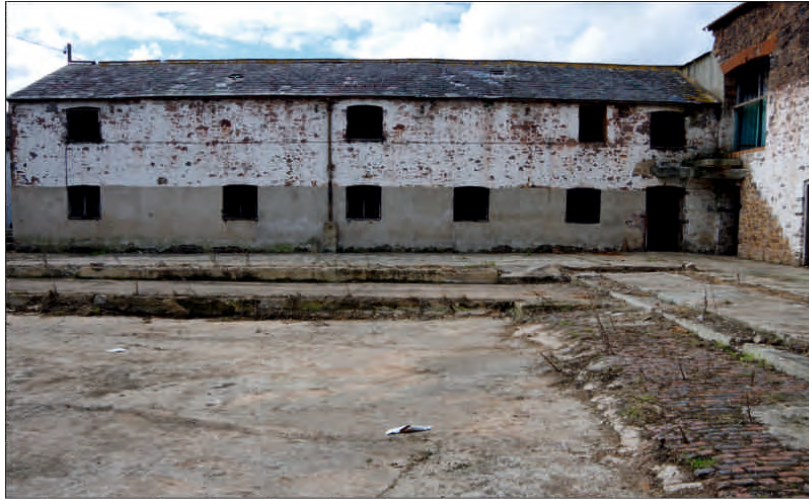
- 5.26** In the east elevation there are five windows and a door on the ground floor and four windows on the first floor (Plate 16). All but one of the openings on the first floor have brick arches above them. The window without an arch has been inserted and has brickwork around its opening. All of the original openings have peg-jointed timber frames. on the ground floor all of the windows retain their interior wooden shutters and iron security bars with two of the three windows on the first floor also retaining their shutters (Plate 17). The lower half of the elevation is covered with cement render with the remainder painted white. This reflects the two floors of the adjacent removed structures in the courtyard. Just below the eaves level is a row of inserted (and sawn-off) rolled steel joists associated with the roof of this demolished structure.

Plate 16: East elevation of west barn, looking west (1m scale)

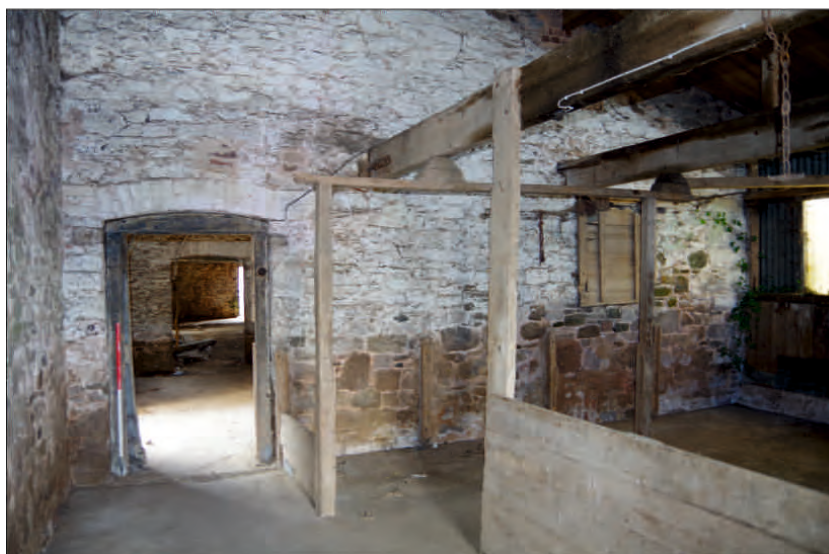
- 5.27** In the north elevation there are openings only on the ground floor (Plate 18). To the east is a doorway under a brick-arched head, retaining its peg-jointed timber frame. To the west is a hole in the stonework, with wooden lintels, that has been covered with planks. This may have been created to allow the insertion of a threshing machine driveshaft.

Plate 18: North elevation of west barn, looking southwest (1m scale)

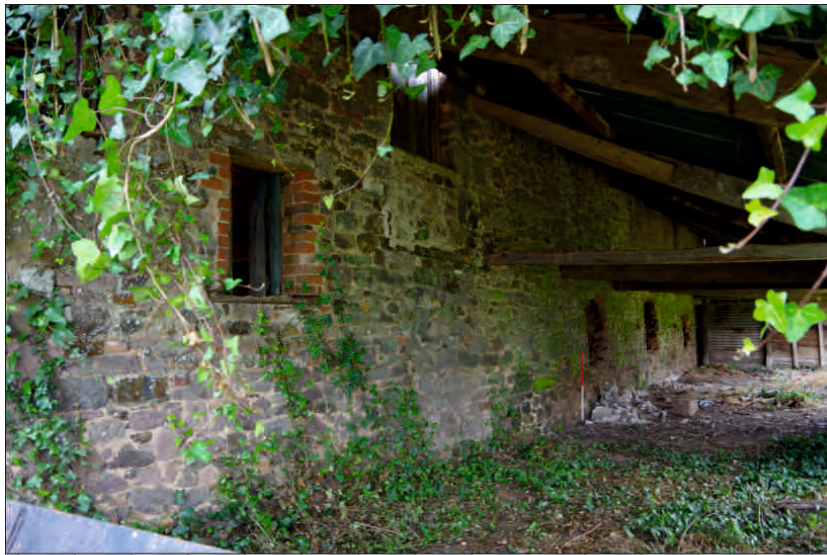
- 5.28** In the west elevation on the ground floor there is an inserted window at the north end, and to the south three holes have recently been knocked through the wall (Plate 19). The window has a wooden lintel and brick jambs, along with internal wooden shutters. On the first floor, at the north end of the elevation there is a door and loading hatch, both of which have peg-jointed timber frames and wooden plank doors. Brickwork has been inserted beneath the door opening and between the door and loading hatch.

Plate 19: West elevation of west barn, looking southeast (1m scale)

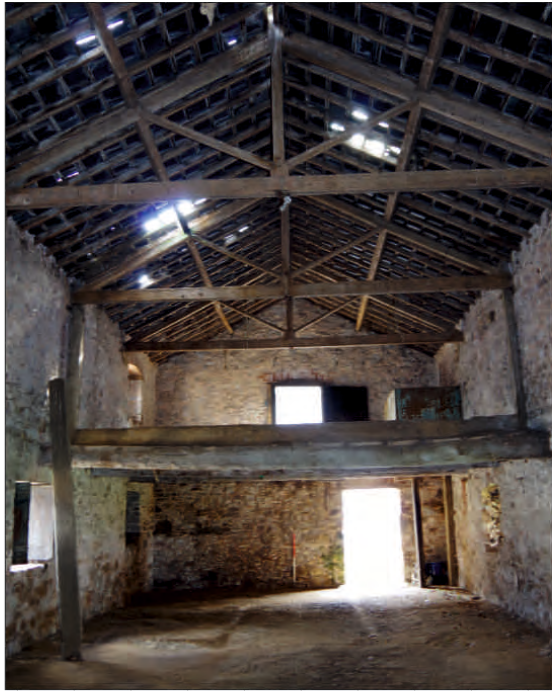
- 5.31** The north room has a part first floor with a central gap on the west side, which appears to have been utilised for the transfer of power to a threshing machine. The south room only retains its first floor at the south end. The rest has been removed with the sockets for the beams visible in the walls. The roof is supported on five king post trusses, with back purlins in turn supporting the rafters and batons (Plate 22).

Plate 22: General view of south room of the west barn, looking south (1m scale)

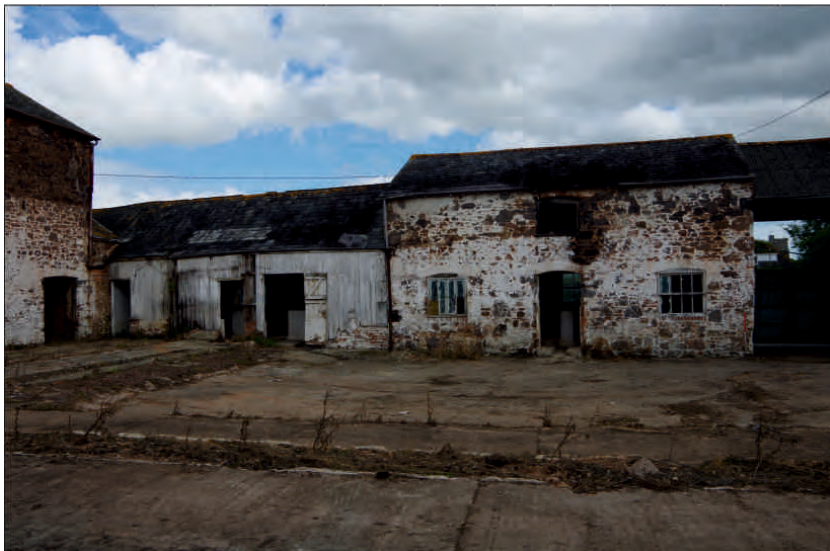
- 5.34** In the south part of the west elevation there are two windows and a door on the ground floor (Plate 24). The windows retain their peg-jointed timber frames, but the glazing is modern. The door has some brickwork repair to the side of its peg-jointed timber frame. All of the openings have brick arched heads. There are the cross ends of structural tie rods above these openings. There are some patches of brick repair to the corners of this part of the elevation. The north part of the elevation has timber cladding above a low brick wall incorporating three doors.

Plate 24: West elevation of east barn, looking east (1m scale)

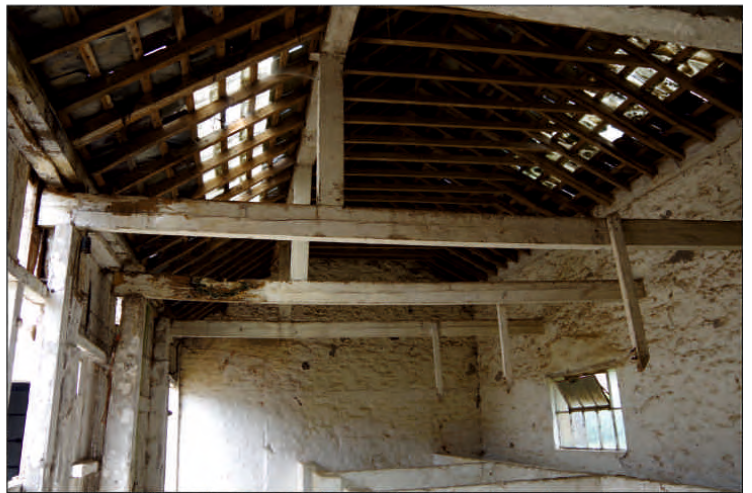
tie beams are offset king posts that support a north-south aligned horizontal beam. These timbers appear to represent part of an early queen post roof structure, that has been partially replaced (Plate 26). The current roof above these timbers is modern and is formed of rafters with trench jointed collars and back purlins. The slate roof incorporates long skylights in each pitch, both of which have been covered over with slates.

Plate 26: Roof structure in north end of ground floor of east barn, looking north (1m scale)
