Byre at Low Shipley Farm Eggleston County Durham

archaeological building recording

report 4236 August 2016

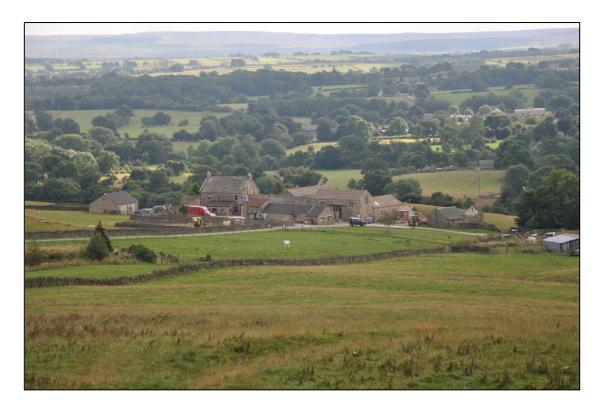
3.2 The building stands at an elevation of about 215m OD on the north-west side of the Low Shipley farmstead (Photographs 1 and 2). The land falls from north-east to south-west across the farm, with a steep drop immediately south-west of the yard

Photograph 1: Low Shipley Farm seen from the north-east. The byre is the partly-roofed building at the right-hand end of the steading

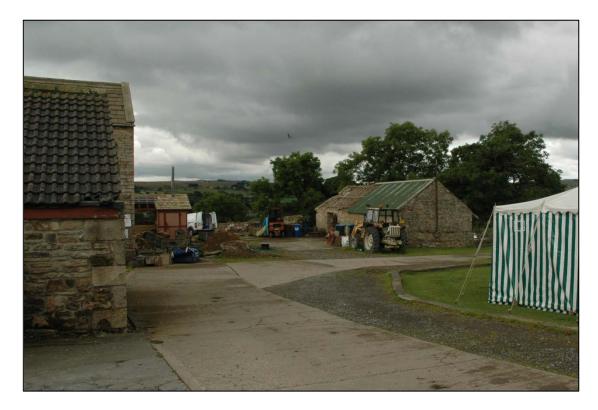
Photograph 2: The byre seen from the east. The concrete yard in the centre of the picture was formerly divided into two animal pens

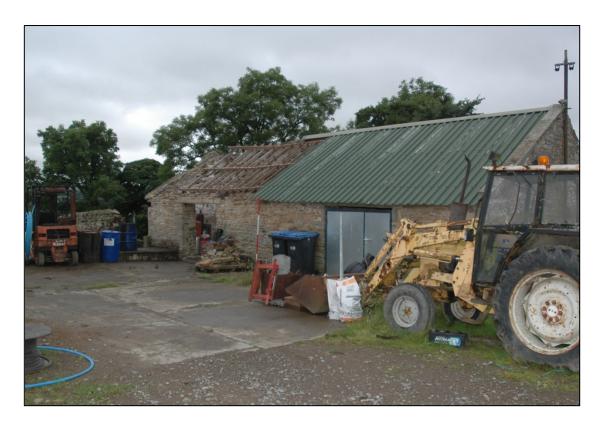
- 5.1 The building is a single-storey byre with a gabled roof, its long axis running northeast south-west, beside a concrete-surfaced yard (Photograph 3). The stumps of several steel posts in the yard mark the position of the latest version of the stock pens beside the byre (Photograph 4). The remains of a narrower concrete path run along the north-west face of the building and a concrete track passes the north-east gable towards a caravan site to the west of the farmstead. The old masonry of the byre is sandstone rubble laid in thin courses with projecting through stones in the gable ends and the internal wall. There are a few hammer-dressed squared stones at the angles and at the foot of the gable slopes. Because the building is at the lip of a steep slope, the south-west wall is much taller than the others.

Photograph 3: The yard and the south-east face of the building. Stubs of steel posts for the enclosures can be seen in places in the concrete yard

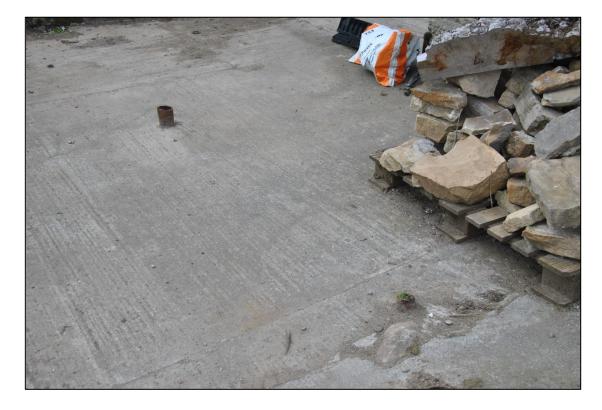
Photograph 4: Detail of two of the cut-off steel fence posts seen near the far door in the picture above

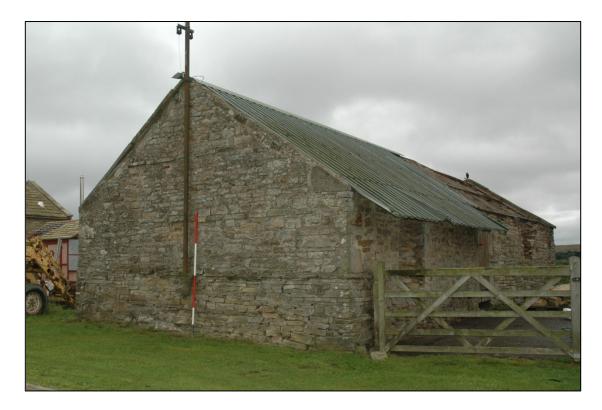
- The blind north-east end (Photograph 5) has three rows of through stones, projecting courses of large slabs that serve to bind the inner and outer faces of the wall together. These are a common feature of vernacular buildings in the region and are also often seen in dry-stone field walls. The roof has been slightly raised by the addition of a course of sloping masonry on the gable; the coping slabs have been replaced on the south-east side. There is a mass of concrete at the foot of the wall near the middle of this elevation, under a wooden pole for an electricity cable (Photograph 6). The foot of this pole is encased in concrete about 1m above the ground. This suggests that there was once a low structure, such as a stand for milk churns, against the middle of the wall here.

Photograph 5: The north-east end of the building with the attached electricity supply pole. Note the additional course of stones on each slope of the gable

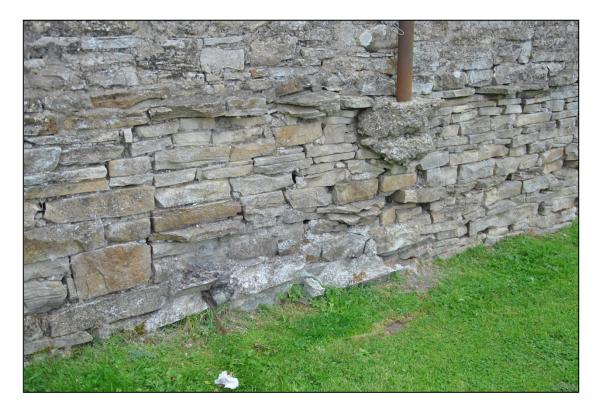
Photograph 6: Detail of the foot of the north-east wall. Note the concrete at ground level and around the bottom of the timber pole

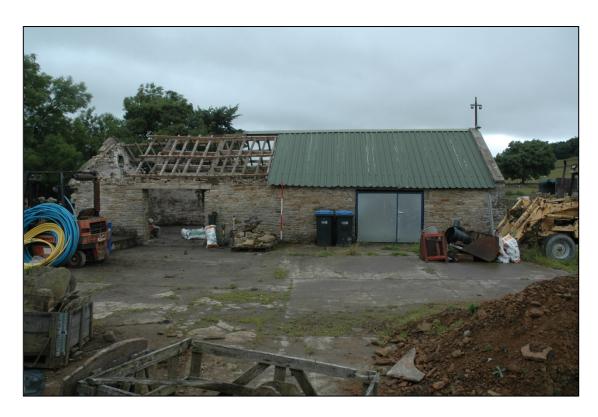
- 5.3 The south-east wall has two wide doors (Photographs 3 and 7). These are modern insertions with long sandstone lintels (Photographs 8 and 9). Most of the wall has been refaced at either side of these doors (Photograph 10). At the south end there is an old gate to the field below the farmyard, and a concrete plinth for the small building shown on the 1977 map (4.2, above). This was used as a fuel and oil store. The sandstone gateposts have been cut off at yard level to make a wider opening (Photograph 11).

Photograph 7: The south-east face, with the two large modern doors

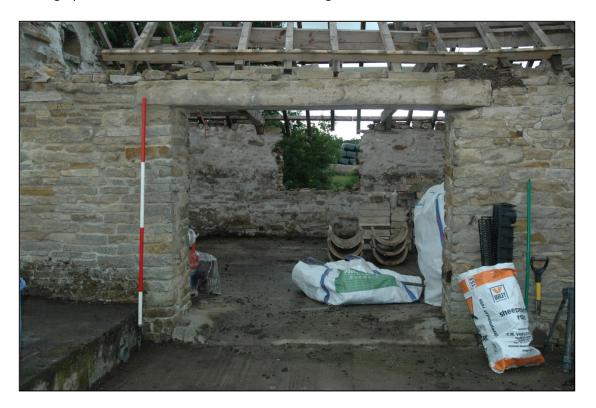
Photograph 8: The south door in the south-east wall. The masonry to the left of the door has been rebuilt relatively recently

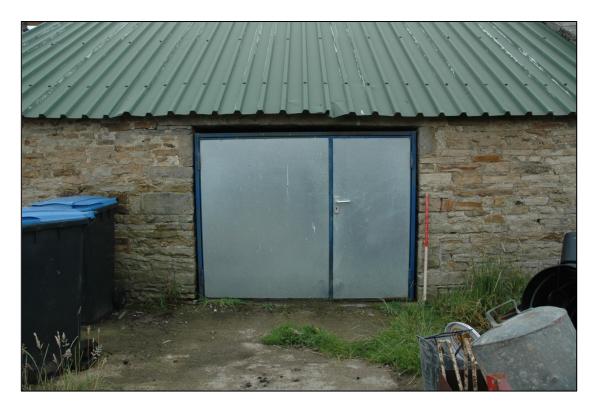
Photograph 9: The north door is also a recent insertion

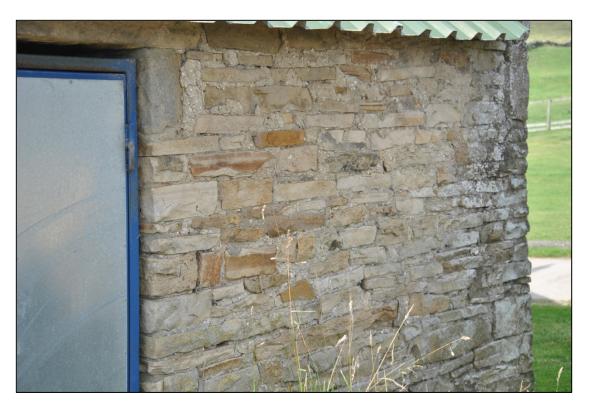
Photograph 10: The modern masonry beside the door is a good match for the greyer old stonework at the corner of the wall

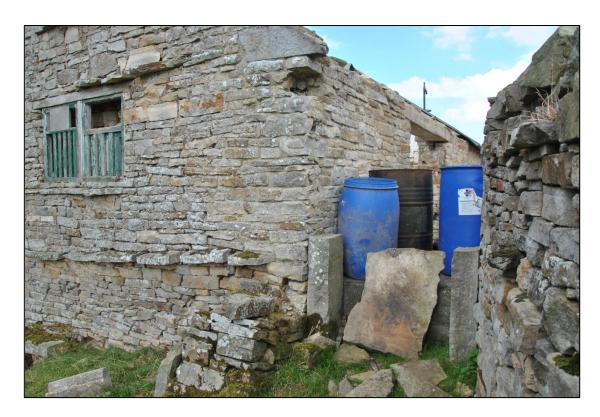
Photograph 11: The south corner of the building. This is another area of recent rebuilding. Note the cut-down gateposts at the right, beside the former fuel store

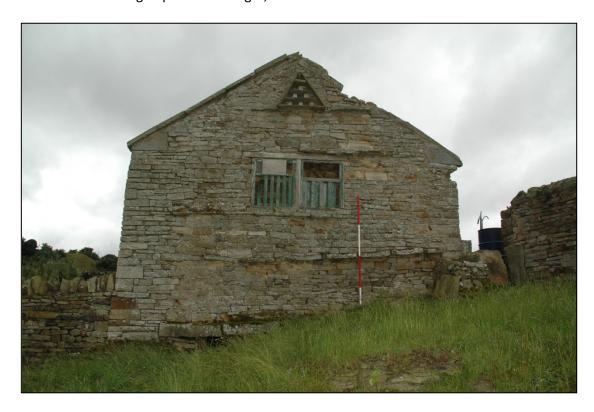
- 5.4 Most of the tall south-west end of the byre is old masonry, with four through courses (Photograph 12). The whole of the north-west side of this face has been refaced, as has part of the south-east angle (Photograph 13). As at the north end, the roof level has been raised in recent times. The additional course laid on the south-east slope of the gable includes two concrete blocks; there are old coping slabs on the north-west slope. In the gable, a triangle of thin slabs surrounds ten pigeon holes and three stone shelves. Below this, two old timber windows from farm buildings have been inserted into a hole cut into the outer skin of the wall (Photograph 14). The marks of the disc-cutter used to make the opening can still be seen. At the foot of the wall, well below the level of the yard, there is a low opening that reveals a small space under the floor (Photograph 15). This is largely filled with rubbish and its entrance is partly blocked, so it was not possible to examine it thoroughly. The space appears to be partly natural, with a stone outcrop on the north-west side near the entrance. It is L-shaped in plan, with a rear wall of rubblestone and big sandstone lintels to carry the floor above (Photographs 16 and 17). The original function of this small room is unknown; it might simply have been a midden.

Photograph 12: The tall south-west end wall. The window is a recent insertion

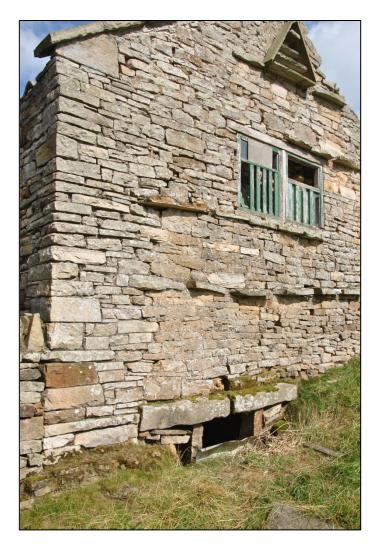
Photograph 13 (left): Detail of the south-west end, showing the courses of through stones, the pigeon holes above the recent window, and a large area of rebuilt masonry at the left-hand corner

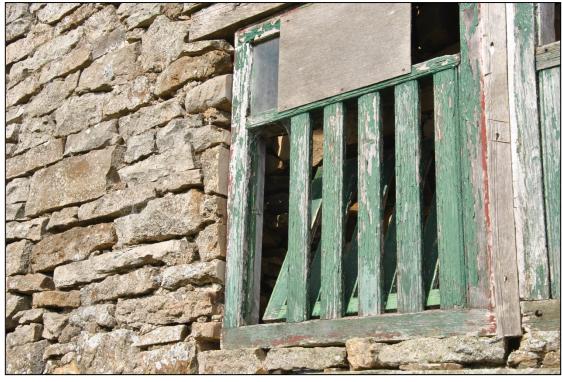
Photograph 14 (below): Detail of the inserted window, with saw-cut stones against the wooden frame

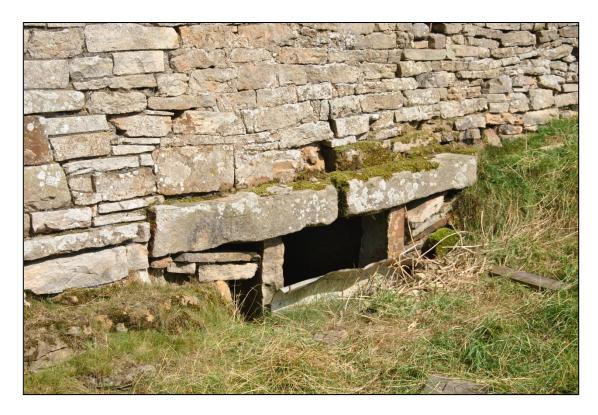
Photograph 15: The opening to the under-floor room, at the foot of the south-west wall

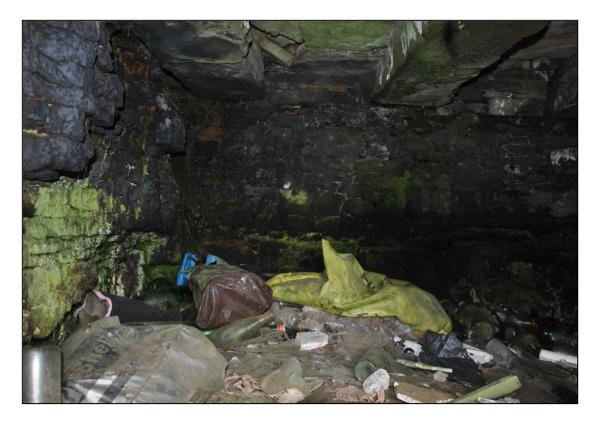
Photograph 16: The interior of the under-floor room, with what appears to be a natural stone outcrop on the left. A view looking north-east

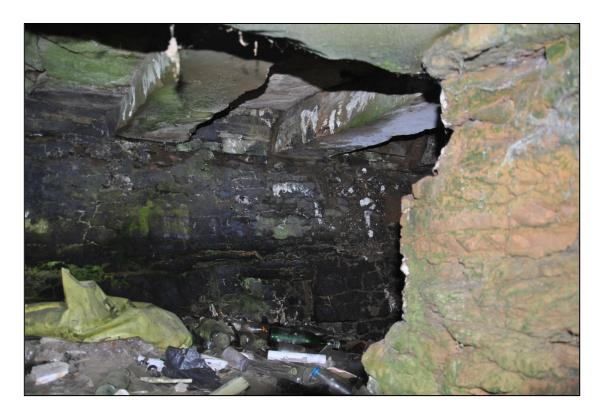
Photograph 17: Looking around the corner from the entrance of the under-floor room. Note the heavy stone lintels in the ceiling

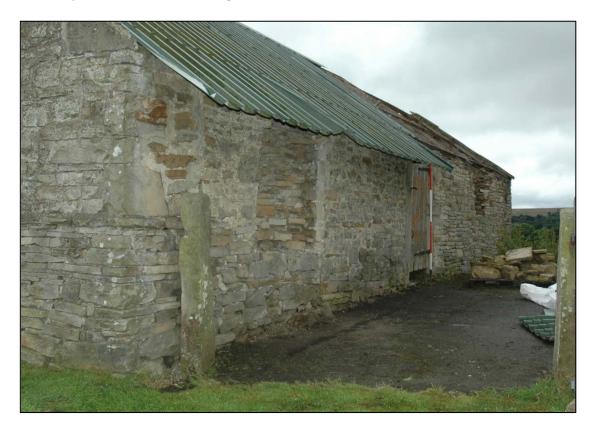
- 5.5 The north-west face (Photograph 18) has the only original opening that survives in the byre. This is a door, just north of centre, with dressed sandstone lintel and

Photograph 18: The north-west face. Note the central door beside the scale and the recent window in the foreground

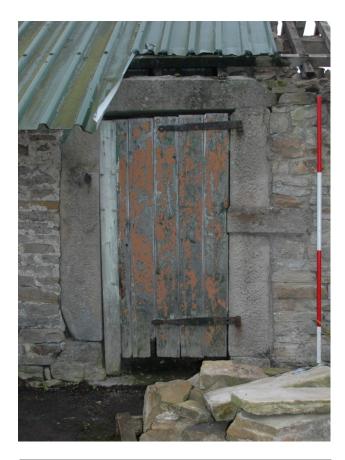
jambs. The old plank door has long iron T-hinges hung on external pintles (Photograph 19). South of this door the whole of the wall has been refaced (Photograph 20). There is a ragged gap for a window near the middle of the south room. Work on a similar window has been started in the old masonry to the north of the central door. As with the window in the south-west gable, the outer skin of stone has been cut out but the opening has not been completed (Photograph 21).

Photograph 19: Detail of the door near the middle of the north-west face

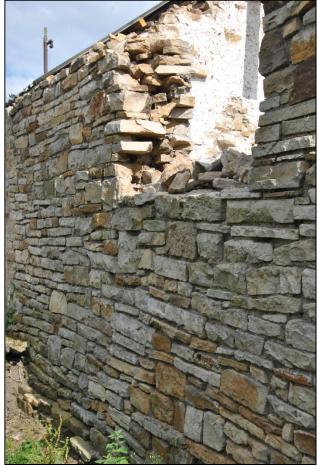
Photograph 20: The north-west face. A detail of the re-faced wall and the ragged window opening south of the door

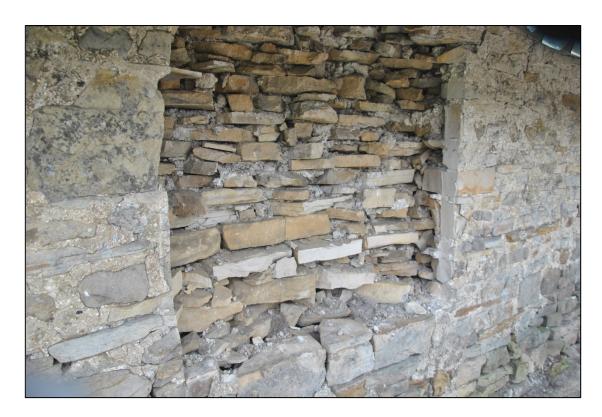
Photograph 21: The incomplete modern window opening at the north end of the north-west face

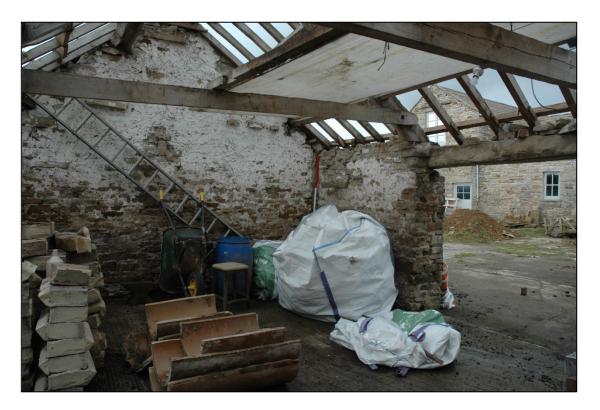
The interior of the building is two large rooms, open to the roof, with concrete floors. When the building was examined the south room (Photographs 22 and 23) was partly stripped and the north was in use as a store for farm equipment (Photograph 24). Both rooms have had modern drinking troughs along their northeast walls. These troughs are made from concrete blocks and sections of cut-down ceramic drain pipes. The one in the south room had recently been dismantled, revealing two long iron staples fixed to the walls (Photograph 25). These are common features of old byres; the halters of cattle would be tied to them while the animals were in their stalls. The trough is the only feature to be seen in the north room and the walls are bare stone. In the south room the walls are whitewashed, apart from in the rebuilt section south of the door. The pigeon holes in the south gable can be seen behind a square recess, and there are two rough holes in the wall slightly lower down (Photograph 26). The roof is supported by four common rafter trusses, all of modern machined timber.

Photograph 22: Looking east in the south room. The half-pipes in the foreground formed a feeding trough against the far wall

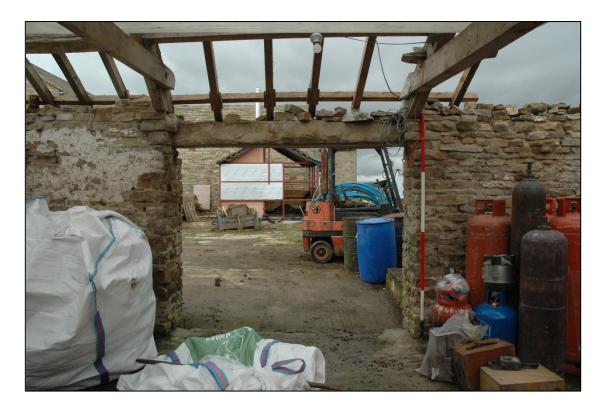
Photograph 23: The door of the south room. The rebuilt wall at the right has been slightly thickened at its head to support the roof truss.

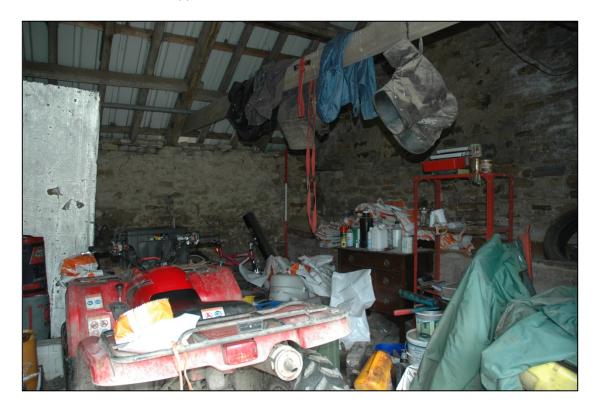
Photograph 24: Inside the north room. The feeding trough can just be seen to the left of the chest of drawers

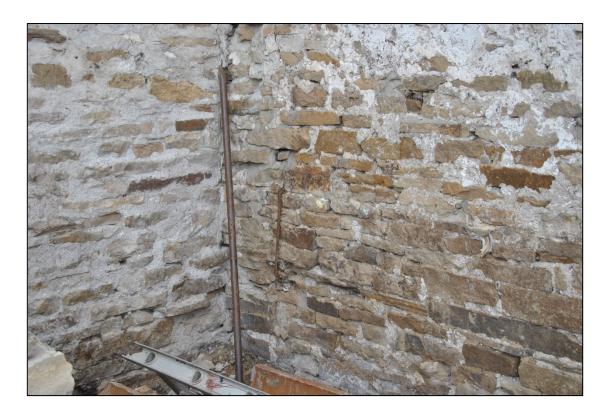
Photograph 25: An iron tethering staple (centre) attached to the internal wall, near the north corner of the southern room

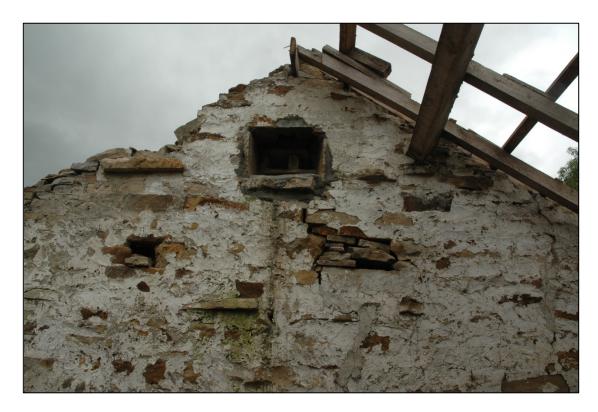
Photograph 26: The pigeon holes seen from inside the south room, with two rough recesses below
