ARCHAEOLOGICAL
SERVICES
DURHAM UNIVERSITY

Field barn at Stoop Hill
Greenrigg Lane
Mickleton
County Durham

archaeological building recording

report 4398
March 2017

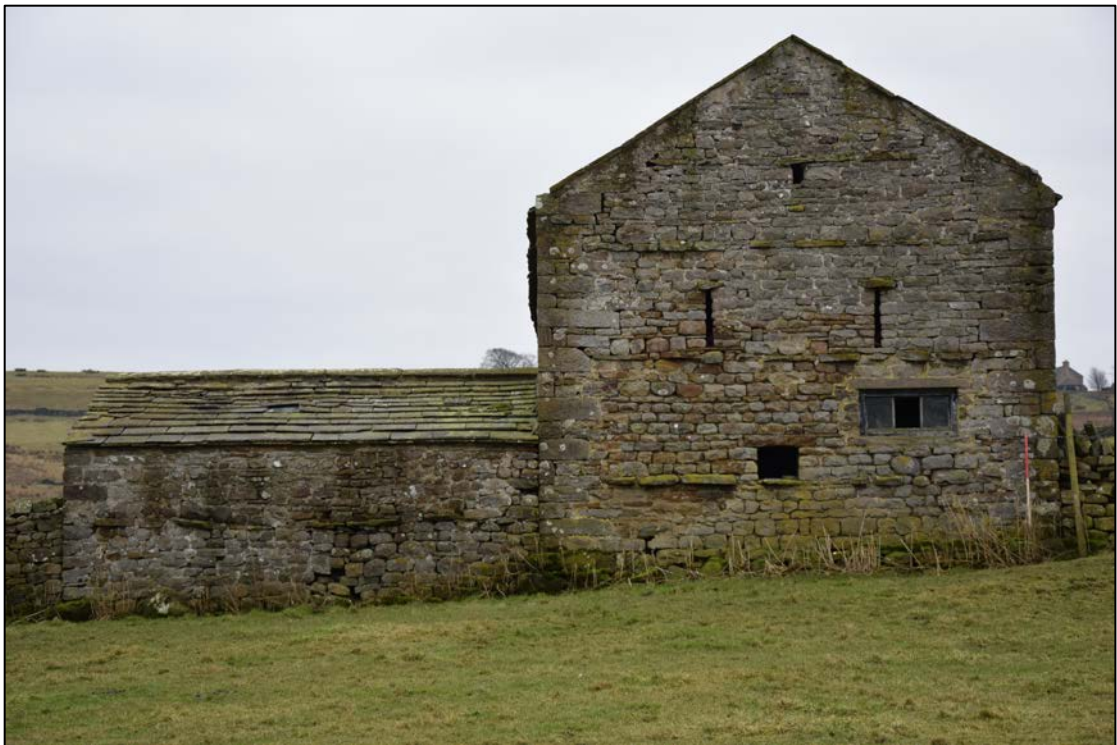
Photograph 4: The north face of the building. Note the large unshaped field stones in the lowest courses

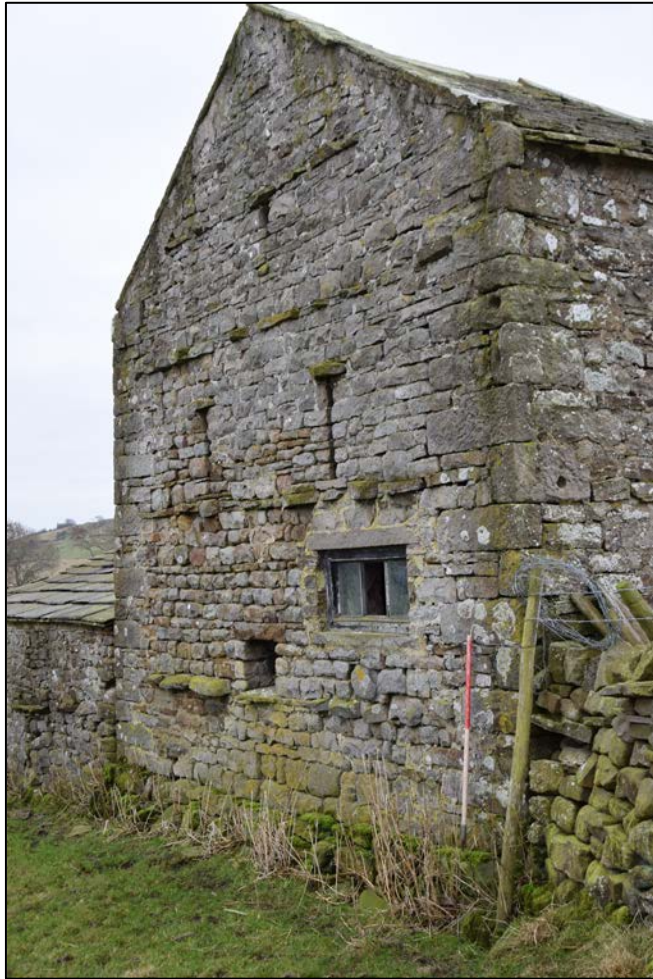
- 5.2 The north end of the barn has four courses of through stones (Photograph 5). Between these, in the upper part of the wall, there are three breather slits providing ventilation to the hay store. At ground floor level there is one old opening, a squarish unglazed window at the middle of the wall. At the west end there is a later window, wide and shallow with three panes of glass.

Photograph 5 (left): The north end of the barn, showing the courses of through stones. There is cement mortar around the later window near the scale

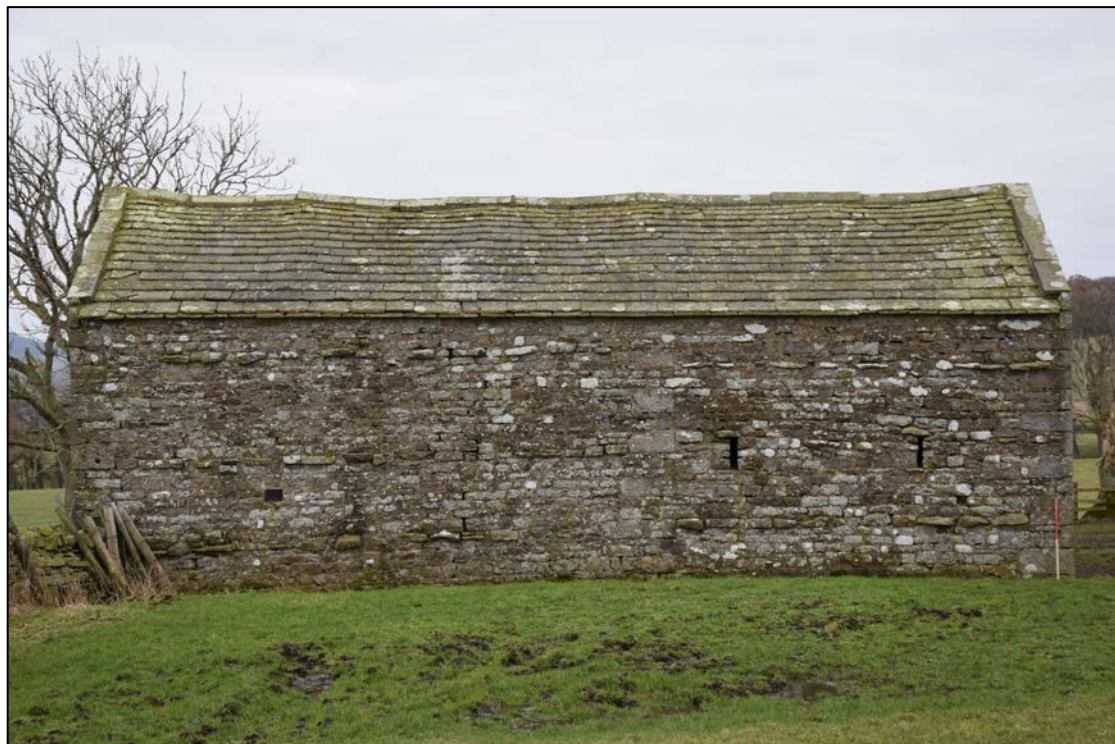
Photograph 6 (below): The west face. The row of large quoins, right of centre, shows where the south end of the building was before the extension was added

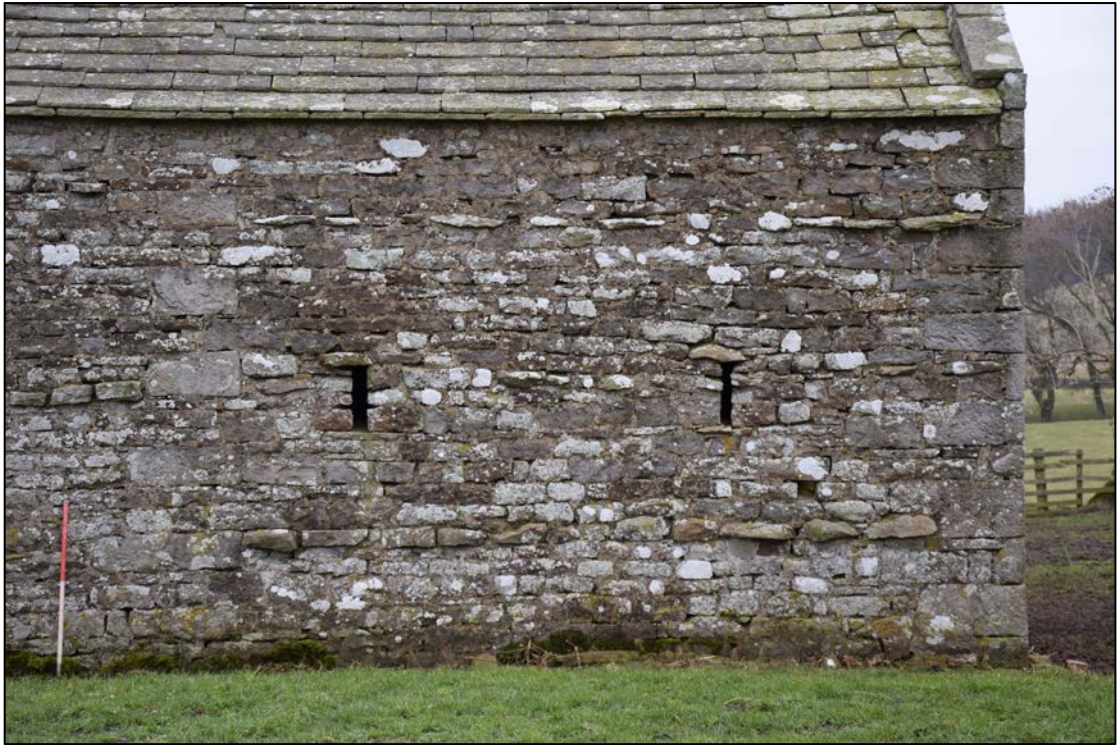
Photograph 7: Detail of the west wall of the extension, with large quoins marking the existing and former south-west corner. Note the disparity between the height of the through courses

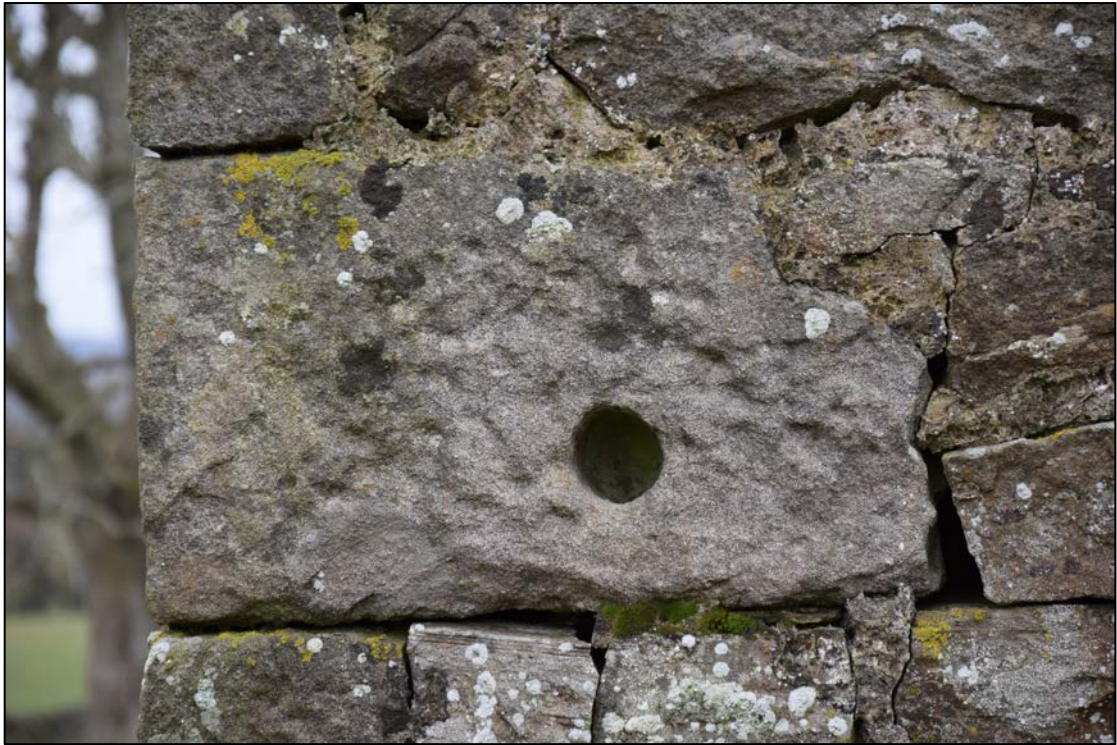
Photograph 9: A drilled quoin at the north-west corner of the barn, extreme left in Photo 6

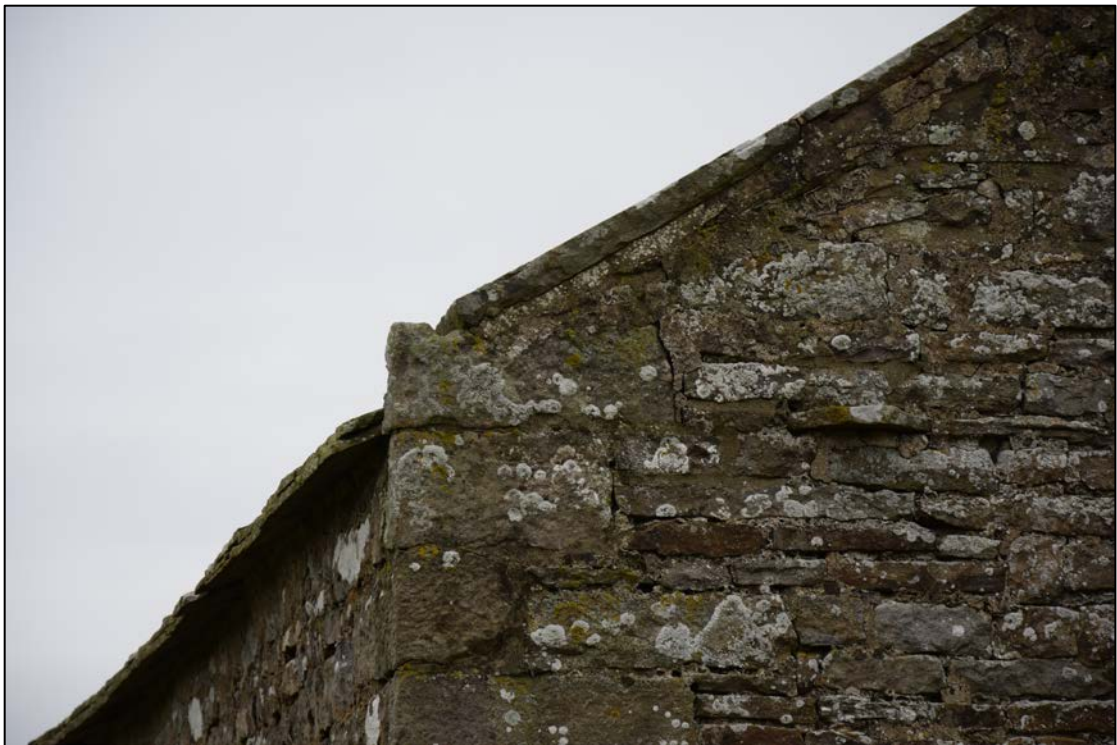
Photograph 10: A notched quoin supports the coping stones of the south gable

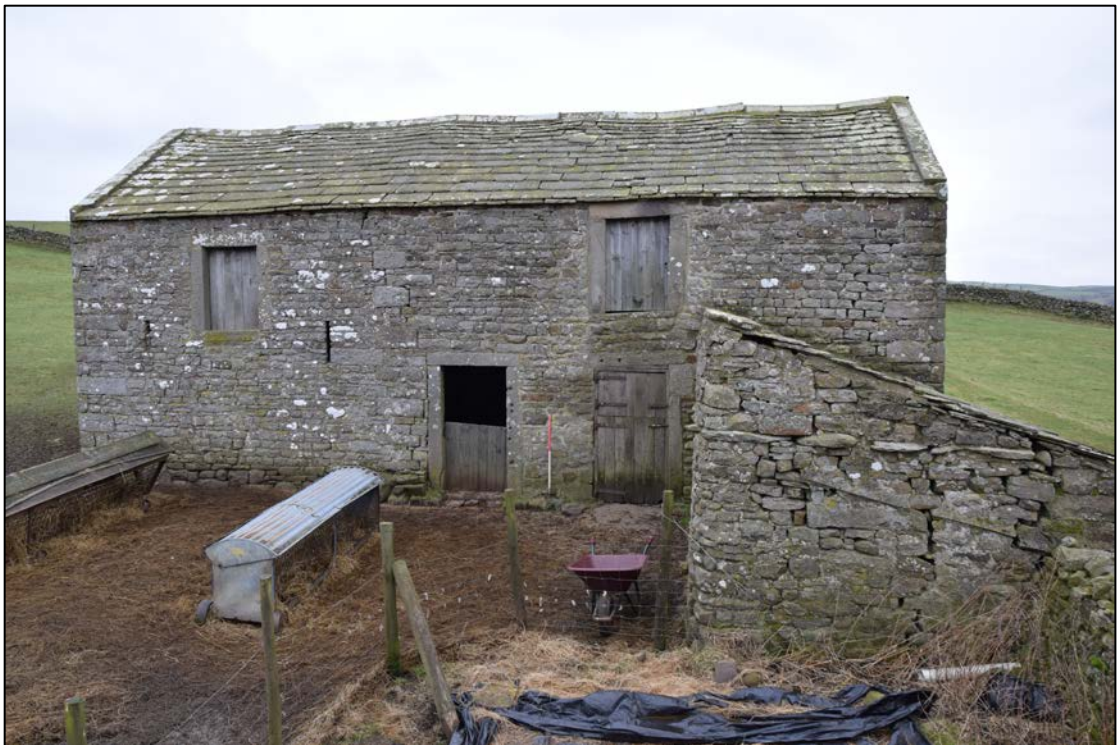
Photograph 12: The west face of the barn has a row of old quoins, left of the open door. Note the absence of through courses, and the difference between the two upper pitching doors

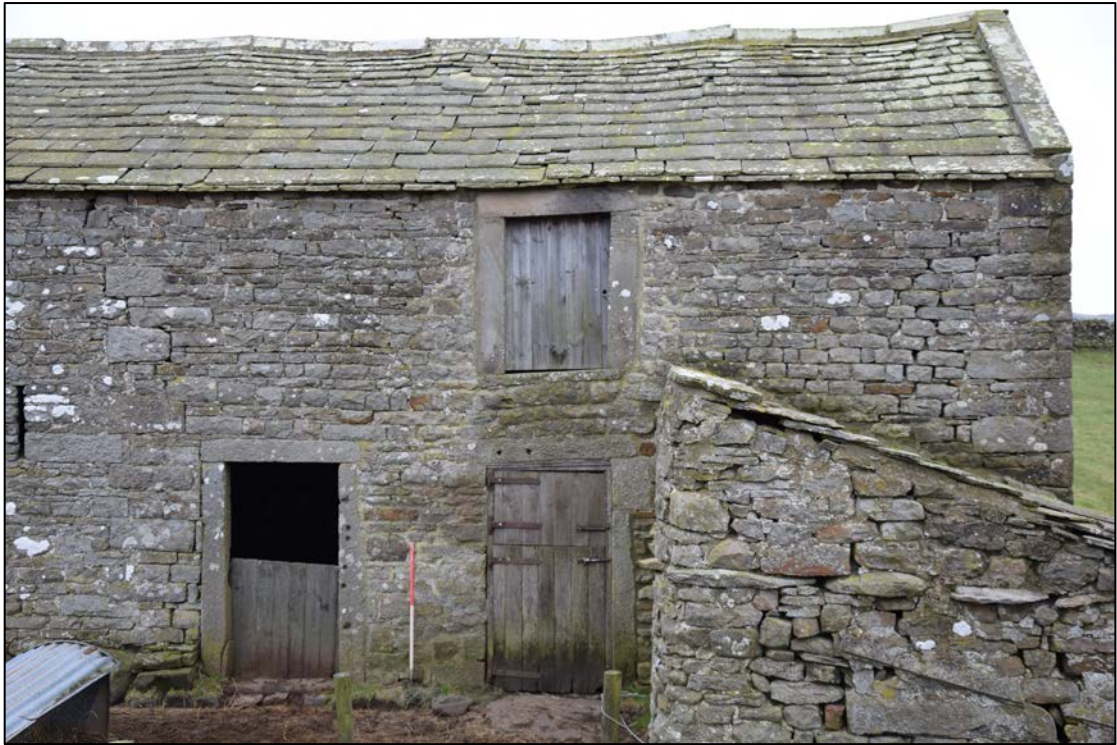
Photograph 13: The west face of the old part of the barn. Note the renewed masonry and pointing around the upper door. There are numerous drilled holes like the one shown in Photograph 9 in the jambs of the left-hand door

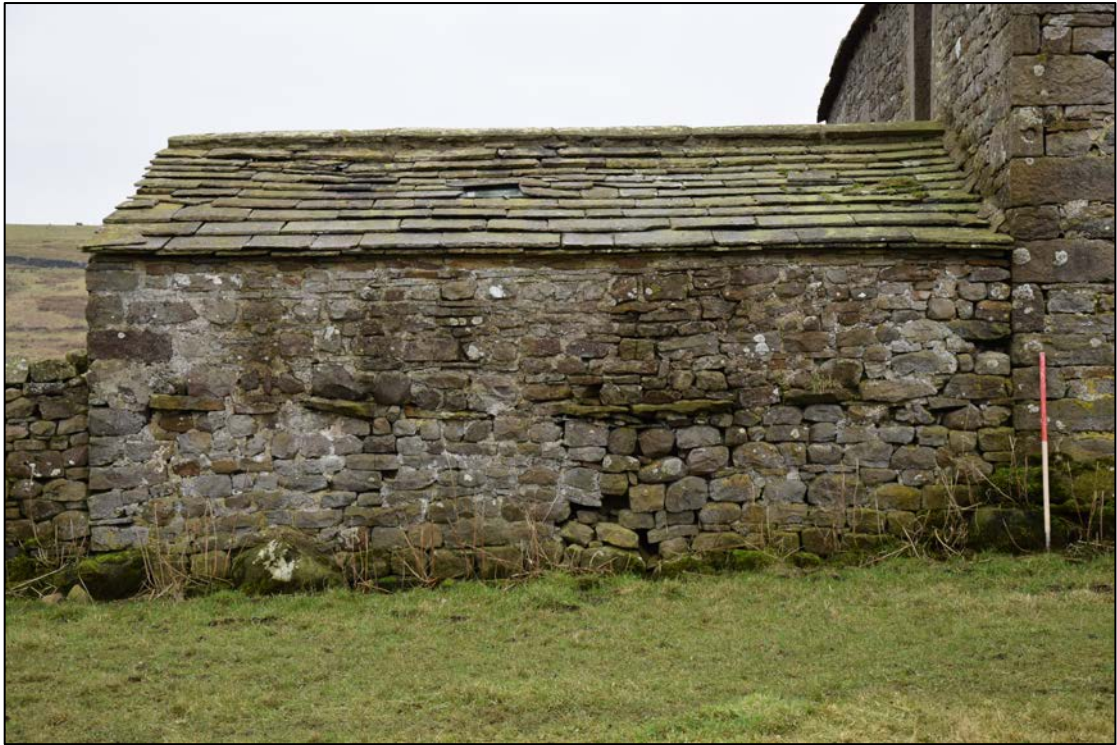
- 5.5 The construction of the smaller building matches that of the barn. There are large unshaped field stones in the footing of the north wall (Photograph 15); near the middle of this face, the drain outlet has partly collapsed. The single door is in the south face (Photograph 16). In the east end there is a small blocked window below the line of a vanished sloping roof (Photograph 17).

Photograph 15: The north face of the shed. The loose stone, low centre, marks the outlet of the manure drain

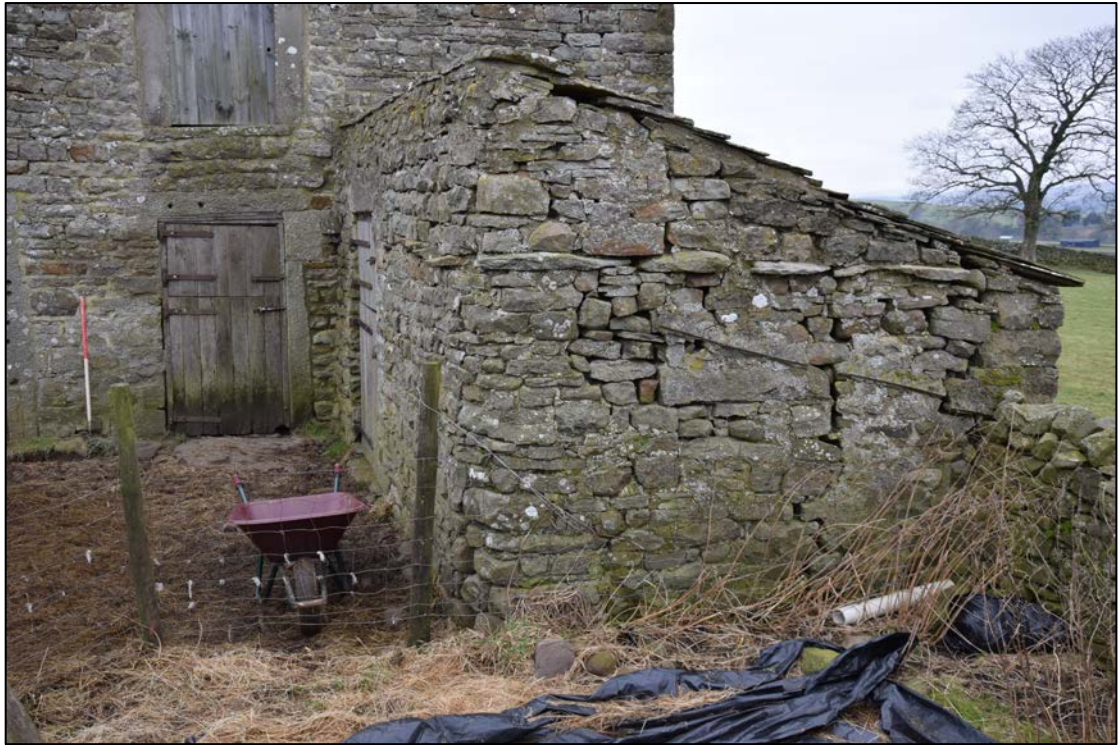
Photograph 17: A blocked low window can be seen below the sloping cement roof line on the east end of the shed

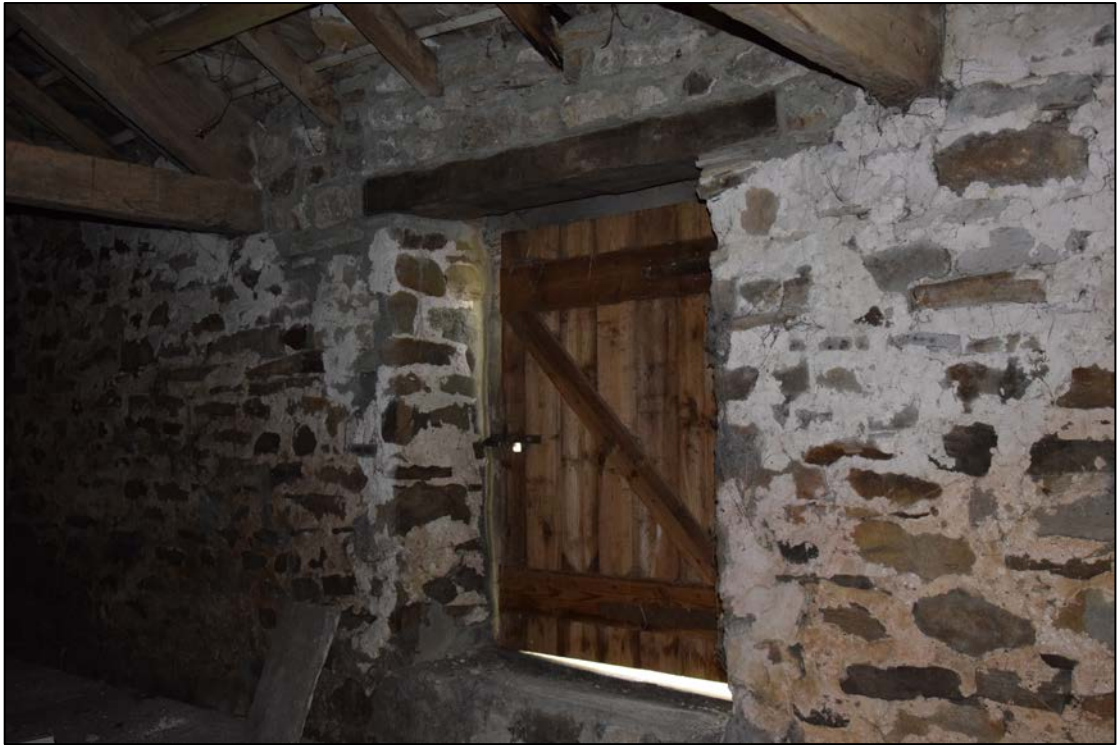
Photograph 23: The rebuilt pitching door on the east side of the hay loft

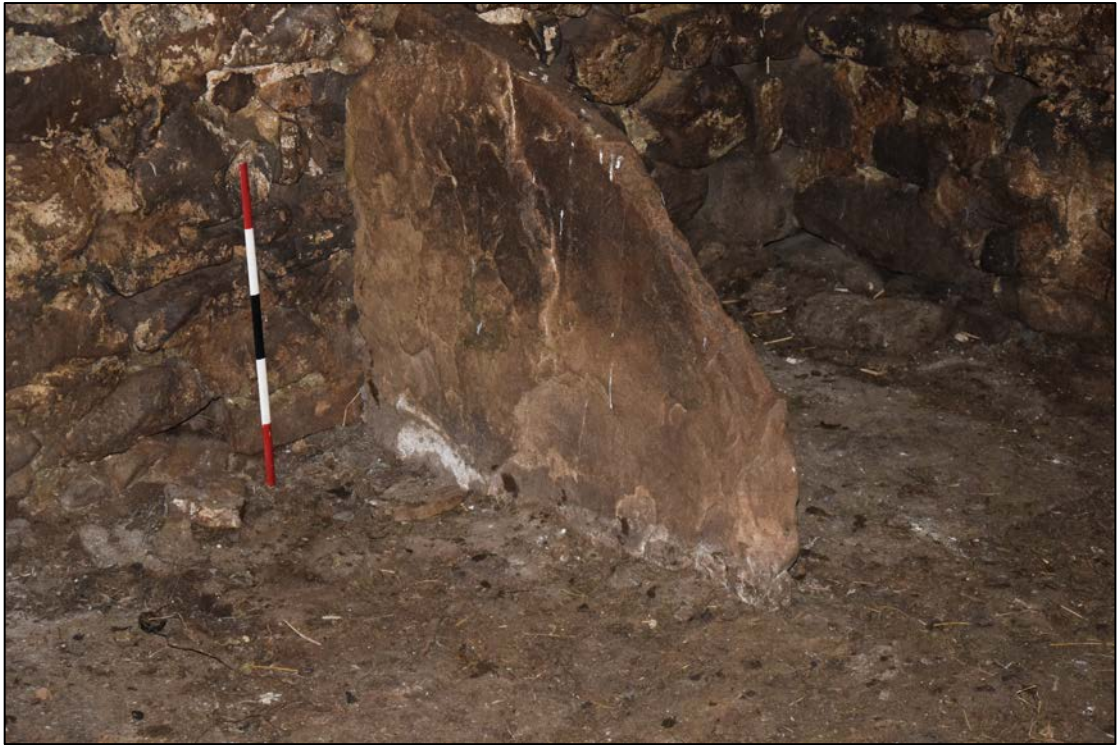
Photograph 29: Detail of the sandstone slab partition between the two stalls shown in the previous photograph

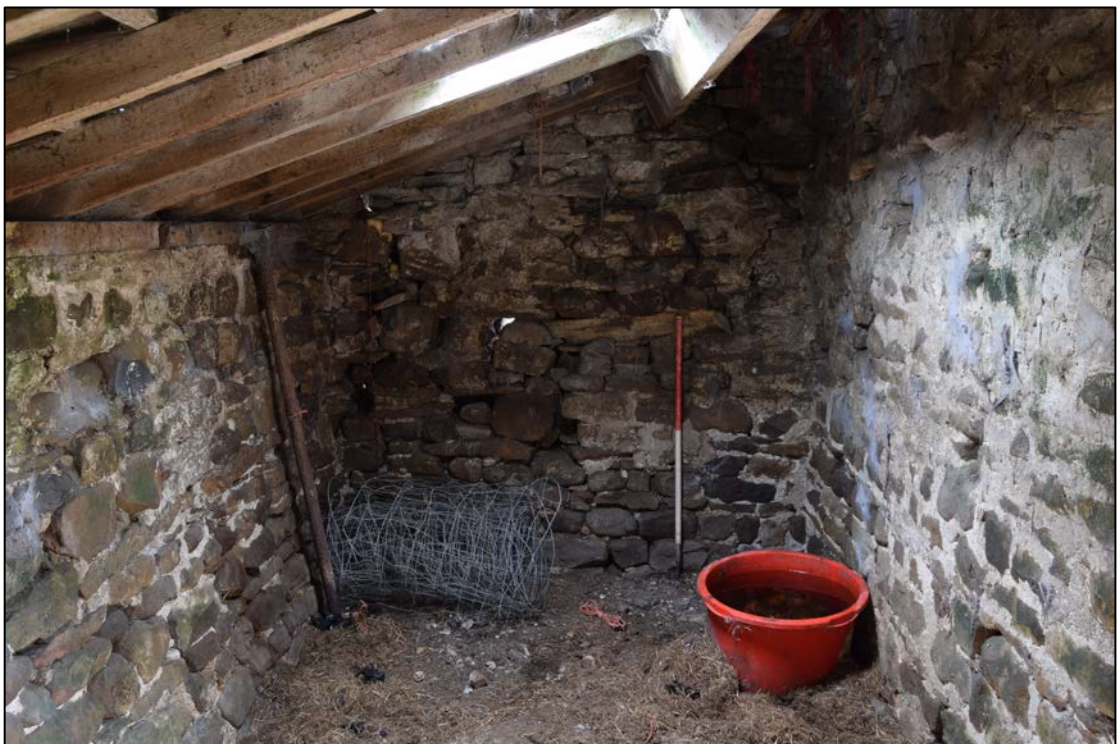
Photograph 30: Looking east inside the shed. The timber lintel for the blocked window is at the top of the scale. The steel tube attached to the wall plate was the tying post for the cow that was housed here
