ARCHAEOLOGICAL
SERVICES
DURHAM UNIVERSITY

Bedford Lodge
Bishop Auckland
County Durham

archaeological assessment and
building recording

report 4400
March 2017

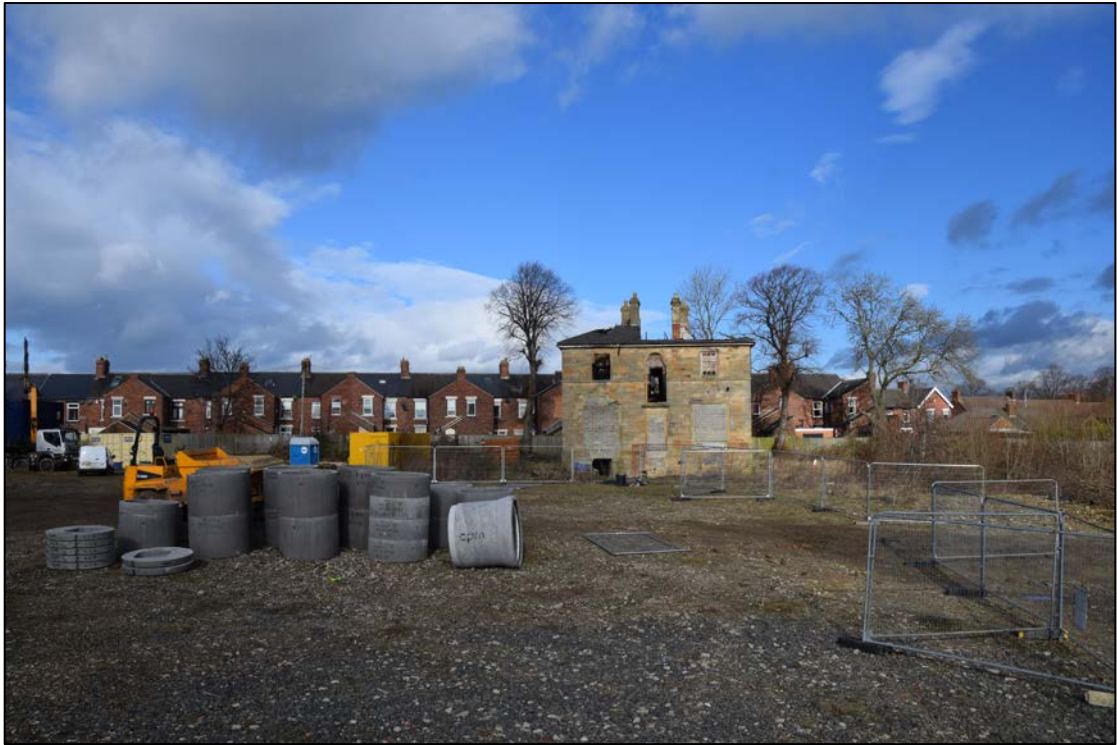
- 3.1 The disused building stands in an open area formerly occupied by a factory (Photographs 1 & 2). The site was levelled after the industrial buildings were removed and until recently it was overgrown.

Photograph 1: Bedford Lodge seen from the south. The house is isolated on a cleared site, with the backs of the houses on Salisbury Place beyond it

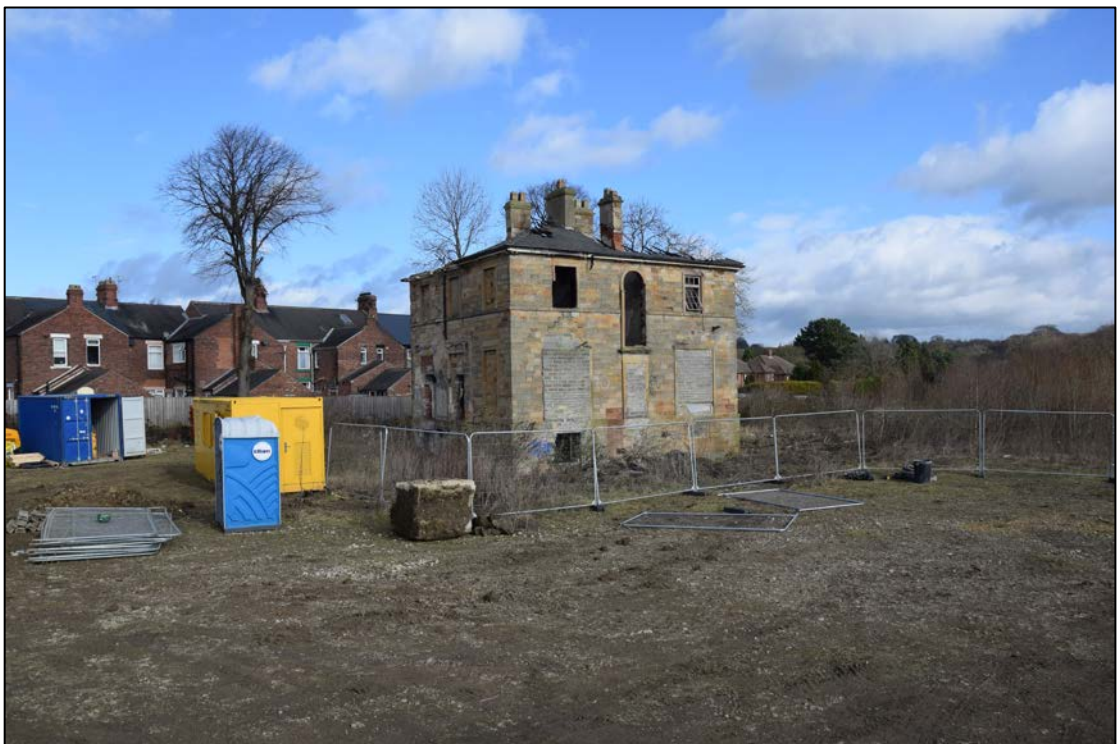
Photograph 2: The house from the south-west. The ground level seen here is well above the former garden, which was below the lowest point visible on the south wall of the building.

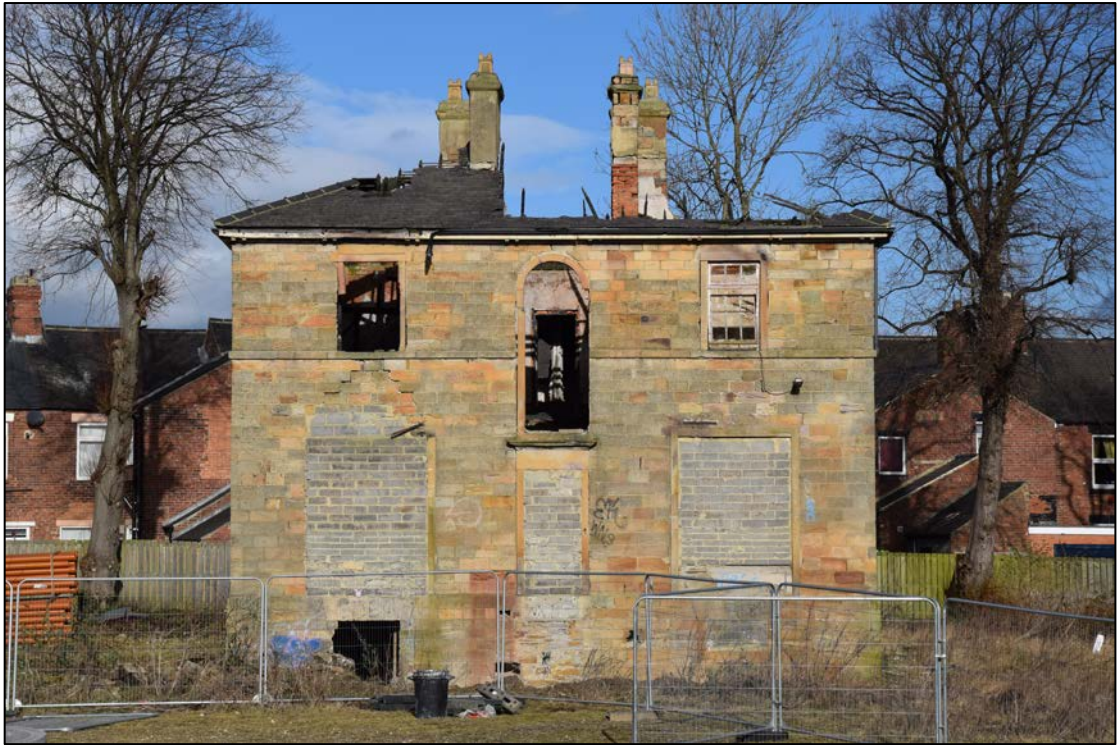
- 5.2 The south face is the tallest of the four elevations (Figure 3c; Photograph 3). It has wide windows at ground-floor level, both now blocked up. Between these is a central door that once led to the garden by way of a flight of steps. The scar of this can be seen in the masonry, within the dotted outline in Figure 3c. Above the door is a tall arched staircase window (Photograph 4). There is a shallow basement window at the right of this face. The matching window at the left has been enlarged to make a door. Both have deep wedge lintels that are also seen on other faces at this level.

Photograph 3: The south or garden front. Note the wide ground-floor windows and the scar of the steps below the central door

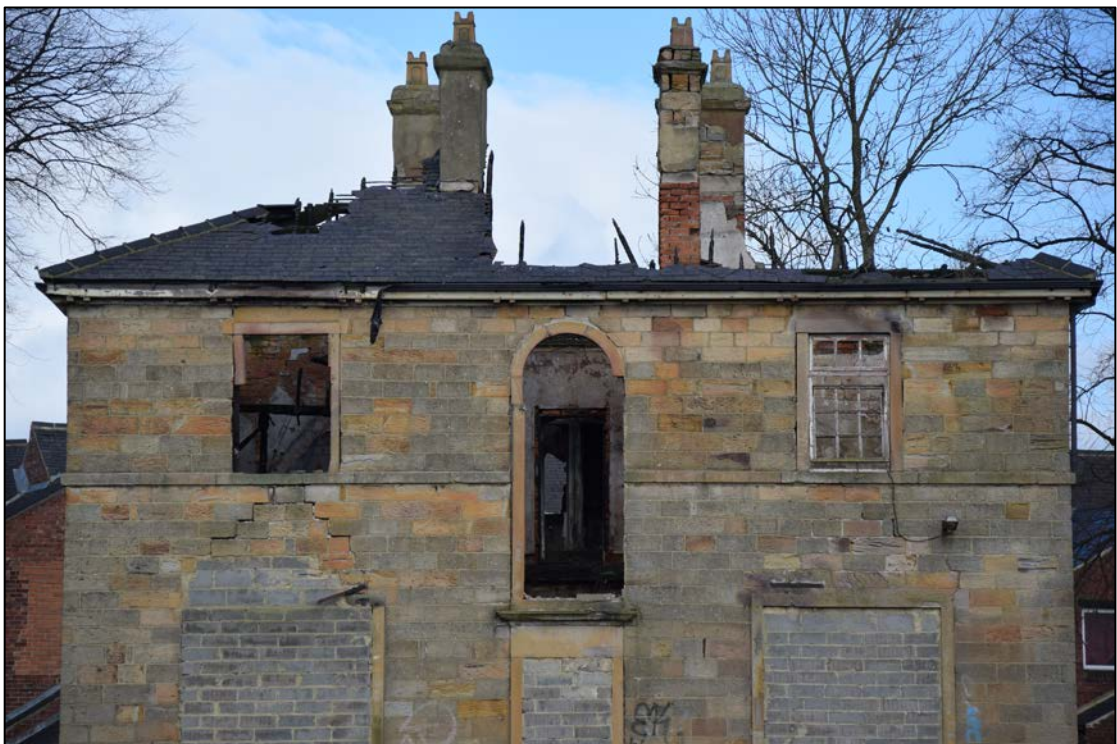
Photograph 4: The upper floor and the stair window on the south face. Paired timber gutter brackets can just be seen. Note the settlement cracks between the left-hand windows

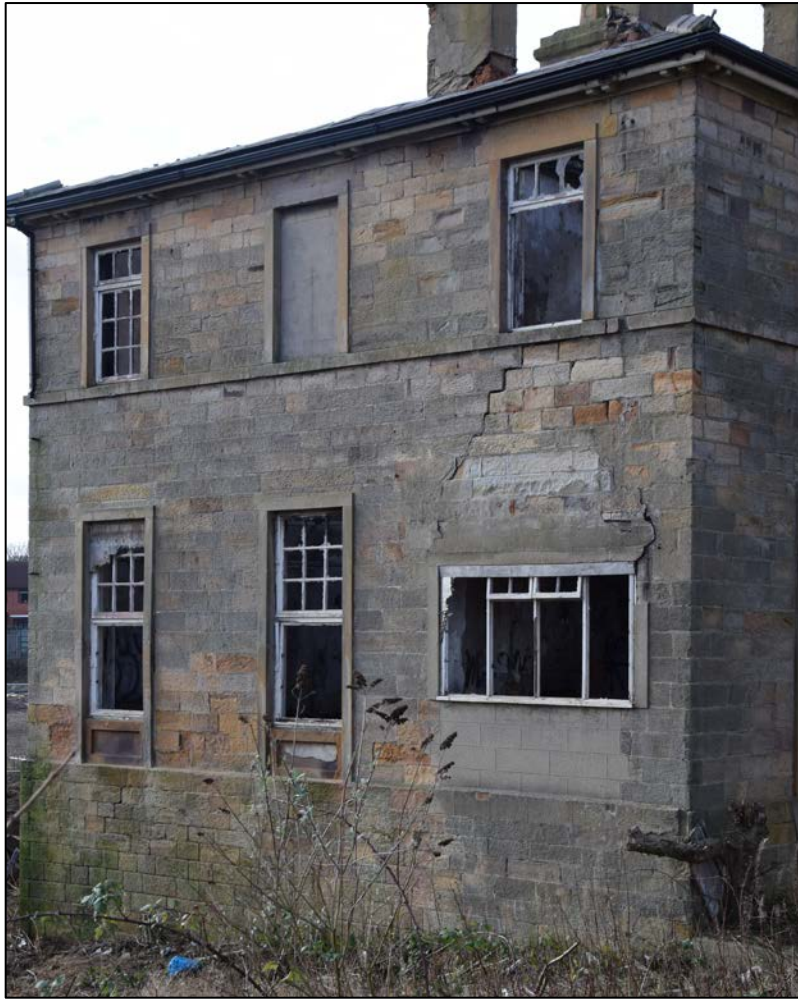
- 5.4 This east face contains the largest single alteration in the building. The right-hand window on the ground floor has been replaced with a lower and wider opening under a timber lintel. The infill above and below is finished with cement mortar, crudely marked to reflect the original ashlar. The stonework in the plinth below this ugly insertion is a different colour from that in the rest of the face. A row of holes for

an injected damp-proof course run across the face from the south corner, but stop short of the greyer stone below the new window.

Photograph 5 (left): The east face, showing the large alteration to the ground-floor window at the north-east corner

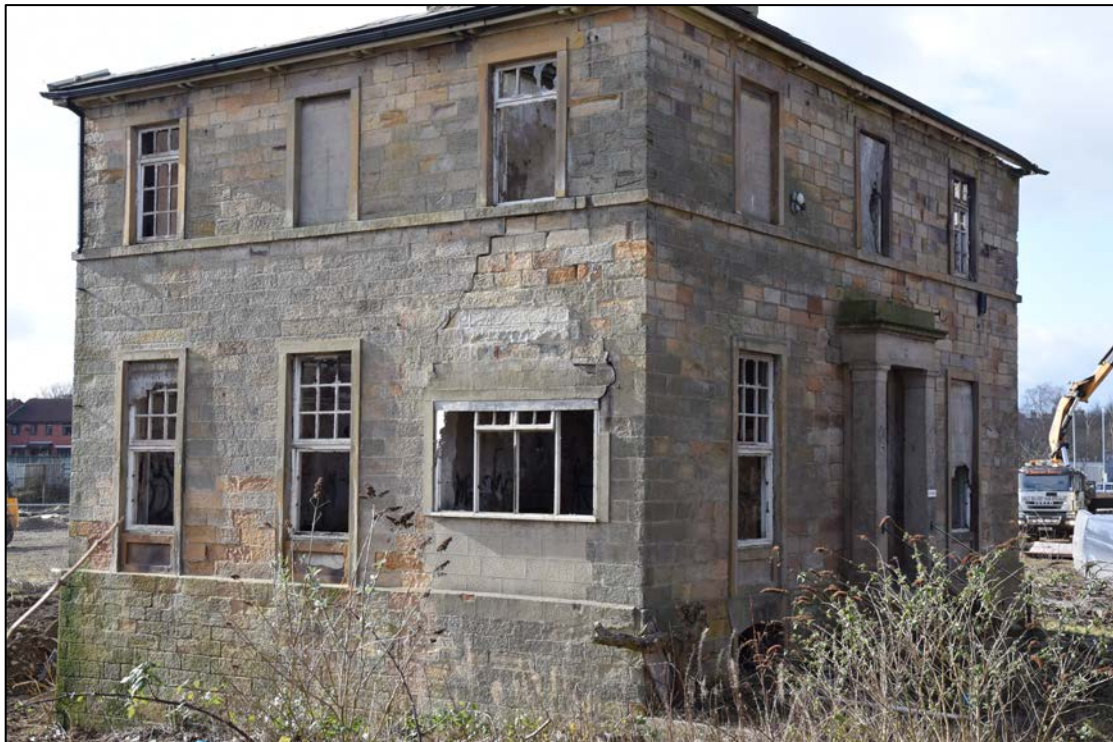
- 5.5 The principal entrance was at the centre of the north face (Figure 3a; Photographs 6 & 7). The door is approached by a short flight of stone steps with plain 20th-century iron railings. There is a shallow porch with plain square columns under an unadorned frieze and cornice. Below, the shallow basement windows have deep wedge lintels and segmental heads.
- 5.6 The west face has been much altered by the attachment of the later factory building, the outline of which can be seen on the masonry (Figure 3b; Photographs 7 & 8). The middle and south ground floor windows have been altered to make doors between the two structures. At basement level, there are three openings to the former service quarters; all have deep wedge lintels. The central opening is smaller and lower than the other two.

Photograph 6 (below): The house seen from the north-east, showing the rather plain portico

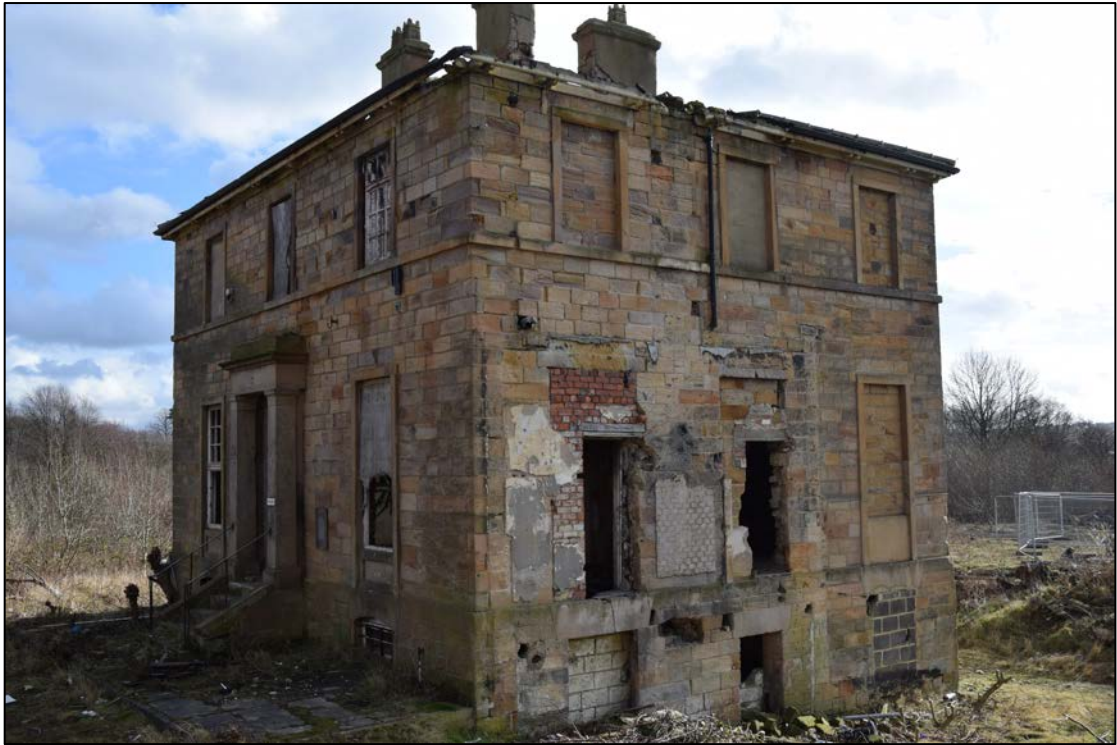
Photograph 7: The house from the north-west, showing the paved area at the front

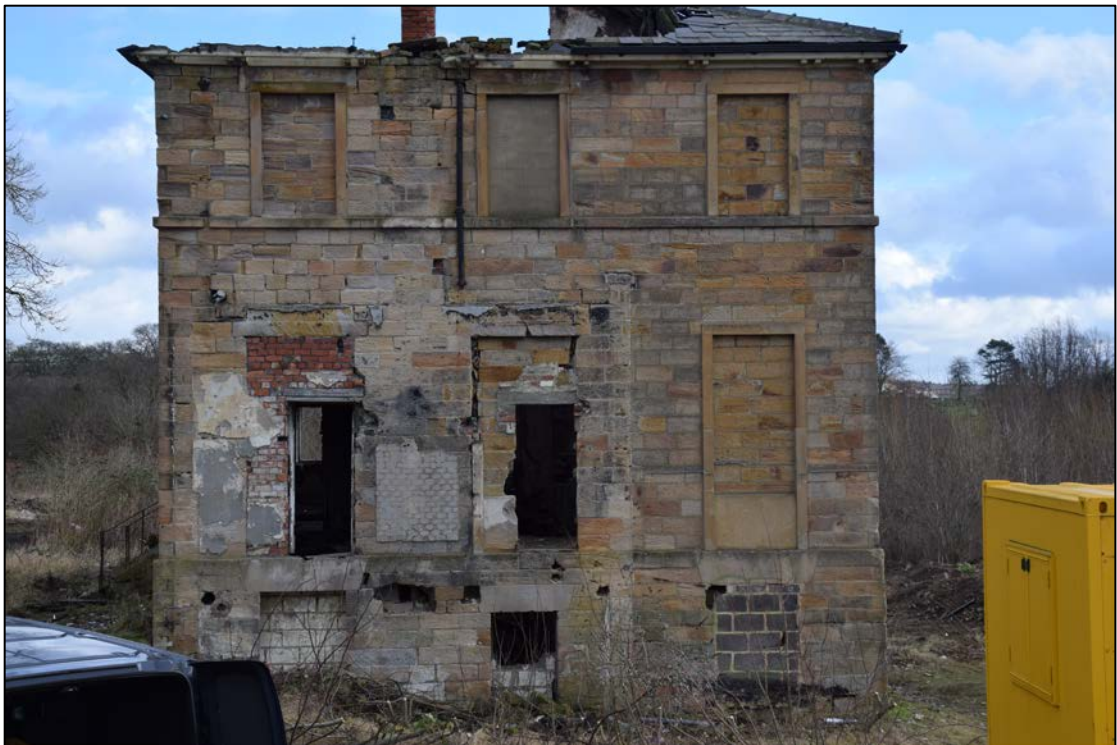
Photograph 8: The east face shows the marks of its connection with the 20th-century factory building that abutted it

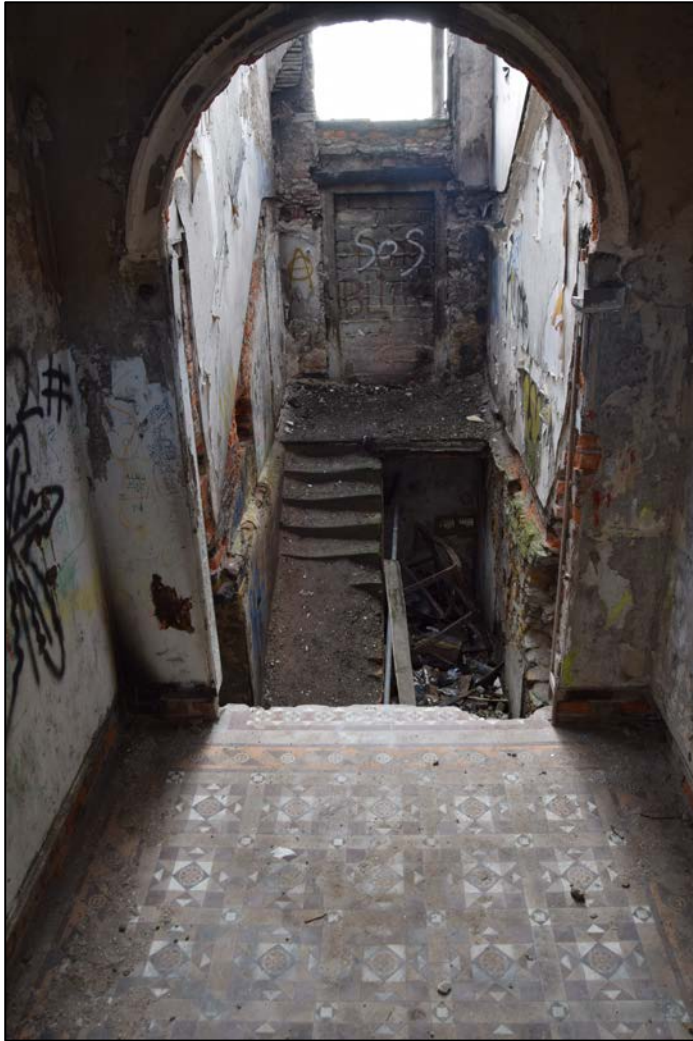
Photograph 9 (left): The staircase hall seen from the fanlight of the north door. The worn stone steps rise from the service quarters in the basement. Marks in the plaster of the side walls show the position of the lost stone staircase mentioned in the listing description. Note the remaining decoration of the arch from the lobby

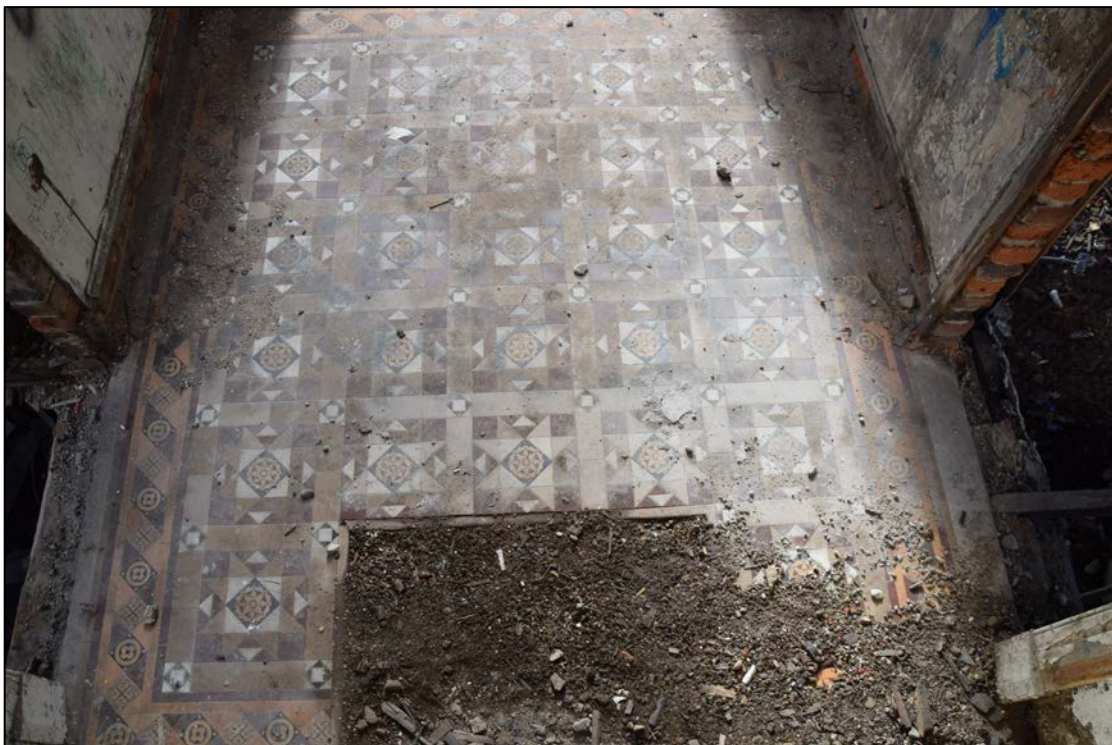
Photograph 10 (below): The encaustic tile floor of the entrance lobby

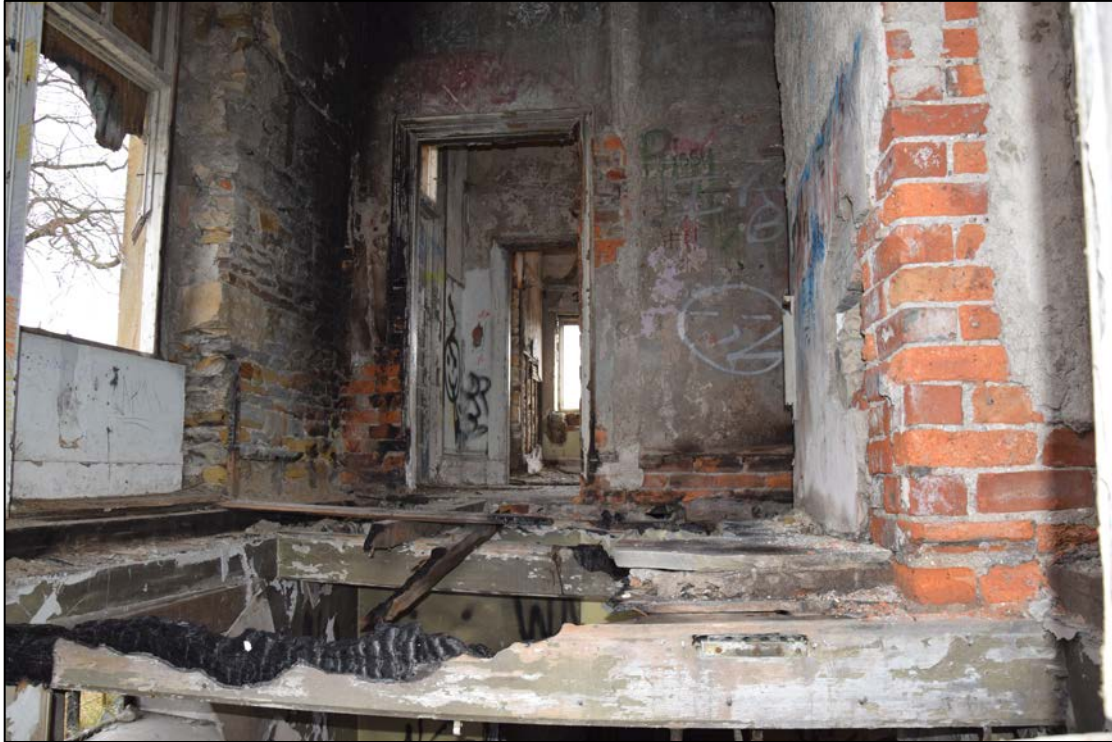
Photograph 11 (above): Looking through the ground floor rooms on the north side of the house. The window at the left is shown in Photograph 18, below

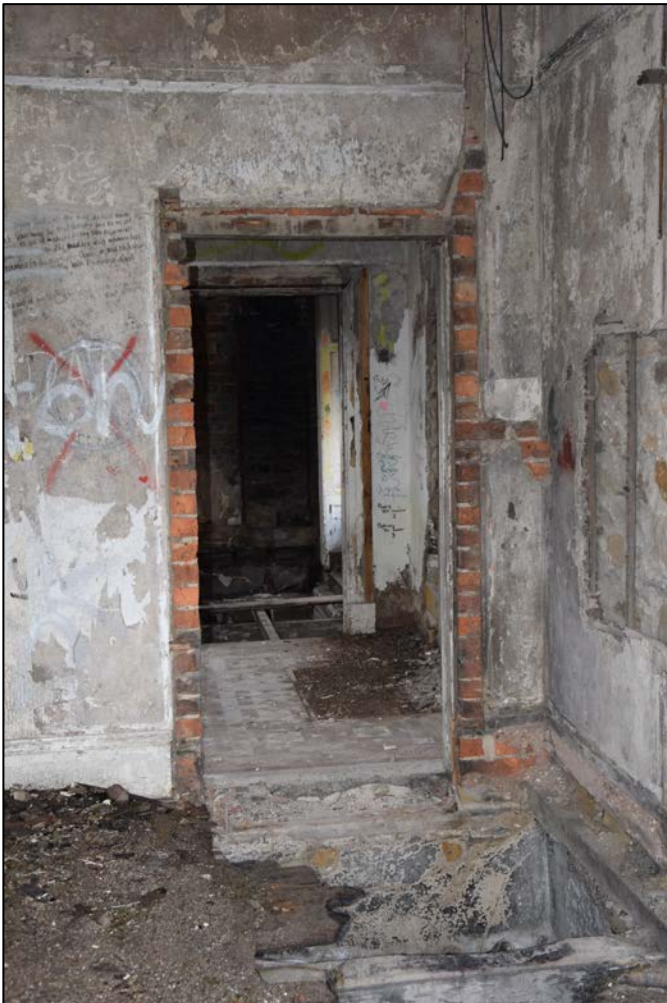
Photograph 12 (left): The same view from the east side of the house

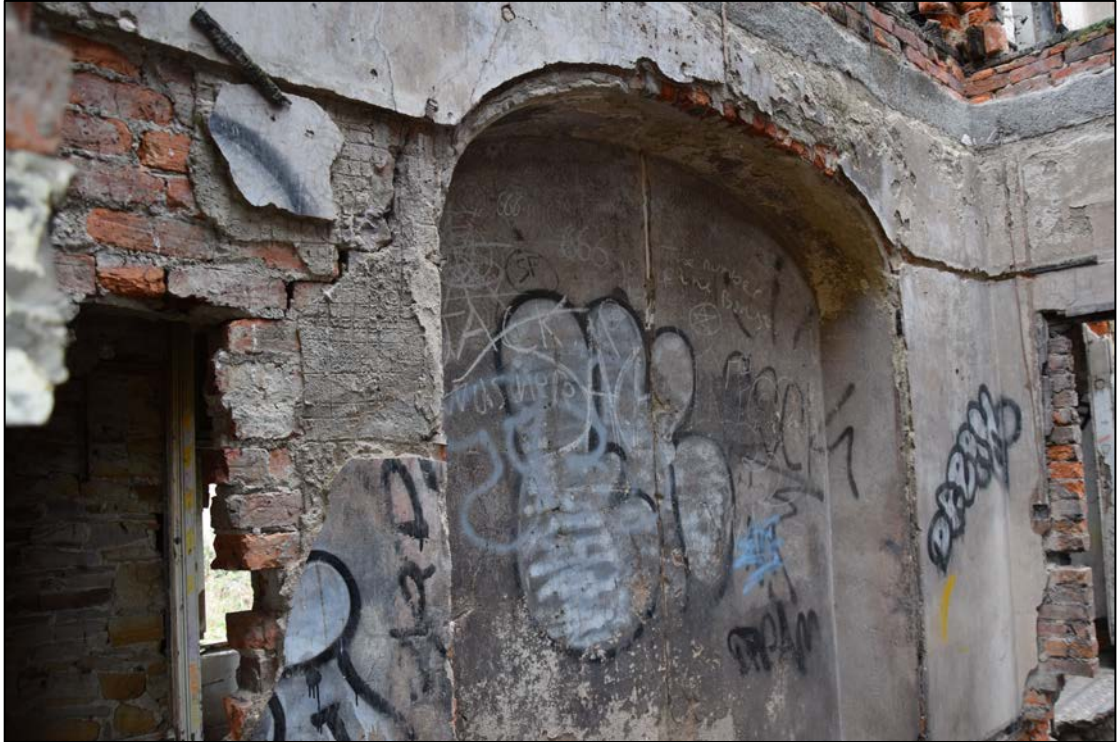
Photograph 13: Recess in the north wall of the large south-west reception room

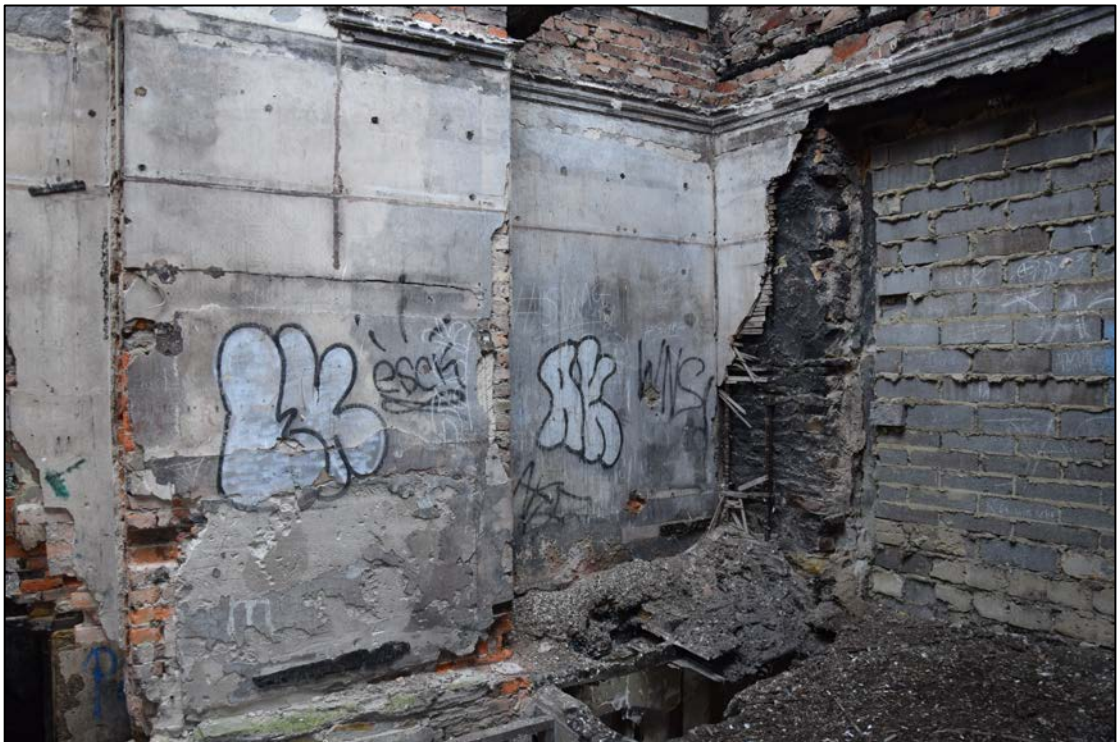
Photograph 14: The south and east wall of the room shown above. The blocked window fills most of the wall on the garden side

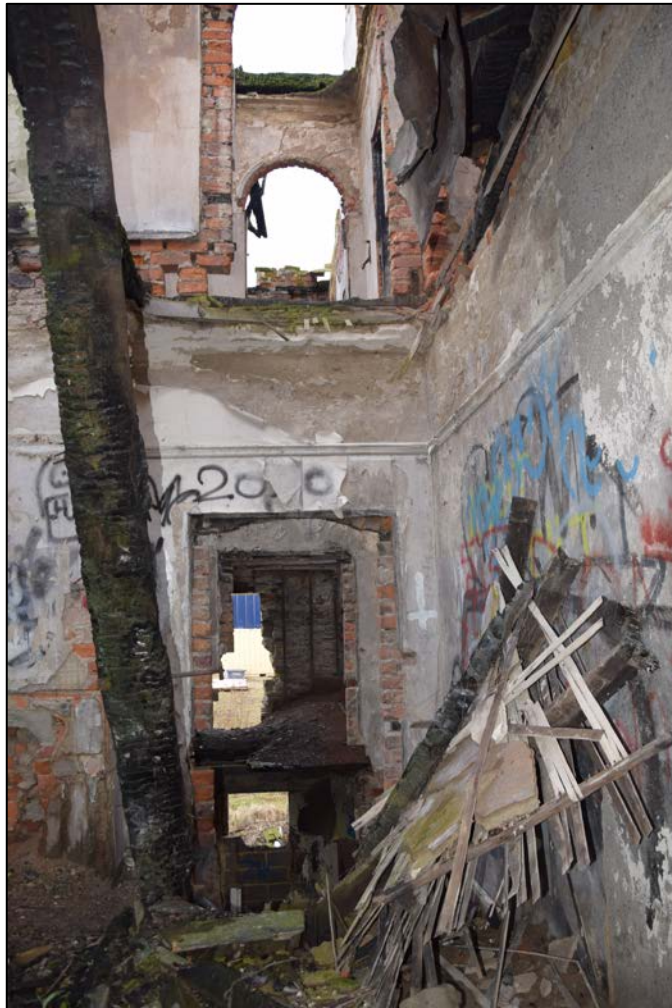
- 5.9 The floor is more complete in the south-east ground-floor room, but the ceiling has almost entirely collapsed (Photograph 15); only some parts of the picture rail remain. A back boiler is all that remains of the fireplace in the north wall (Photograph 16). The staircase hall is entirely gutted and the service rooms in the basement can be seen (Photographs 9 & 17). In the north-west room, the north window retains part of its panelled opening (Photograph 18). This is the only original woodwork that was seen in the course of this survey.

Photograph 15 (left): Looking west through the middle of the house at ground-floor level

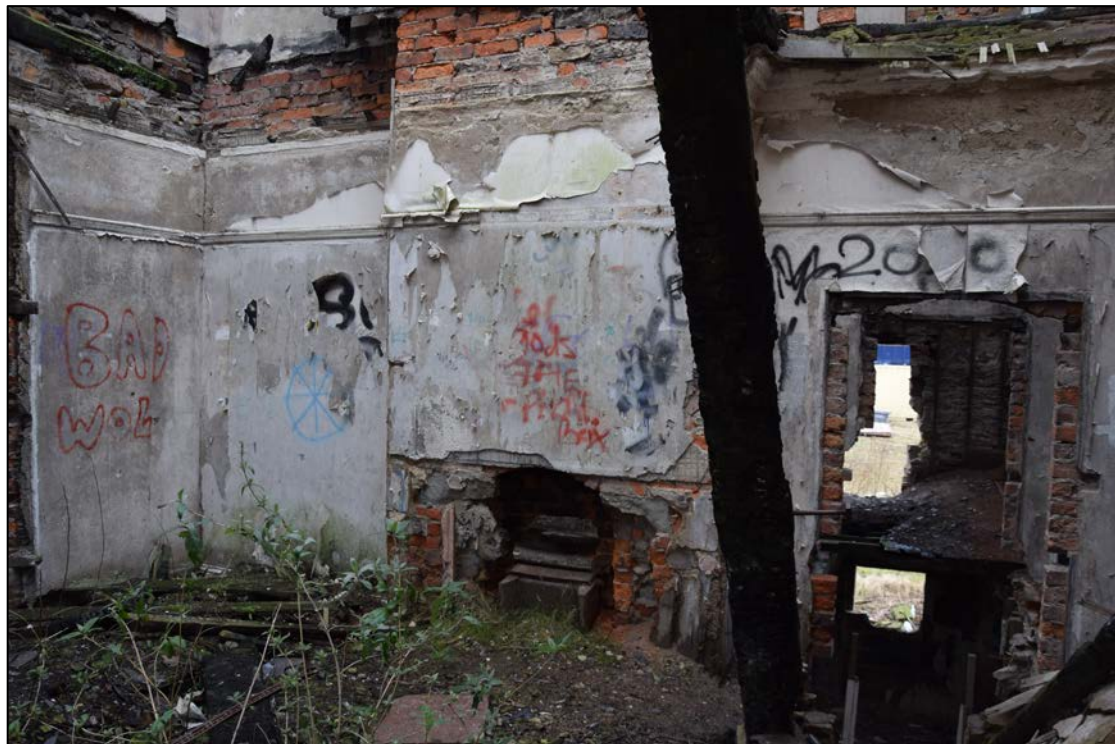
Photograph 16 (below): Chimney breast in the north wall of the south-east reception room

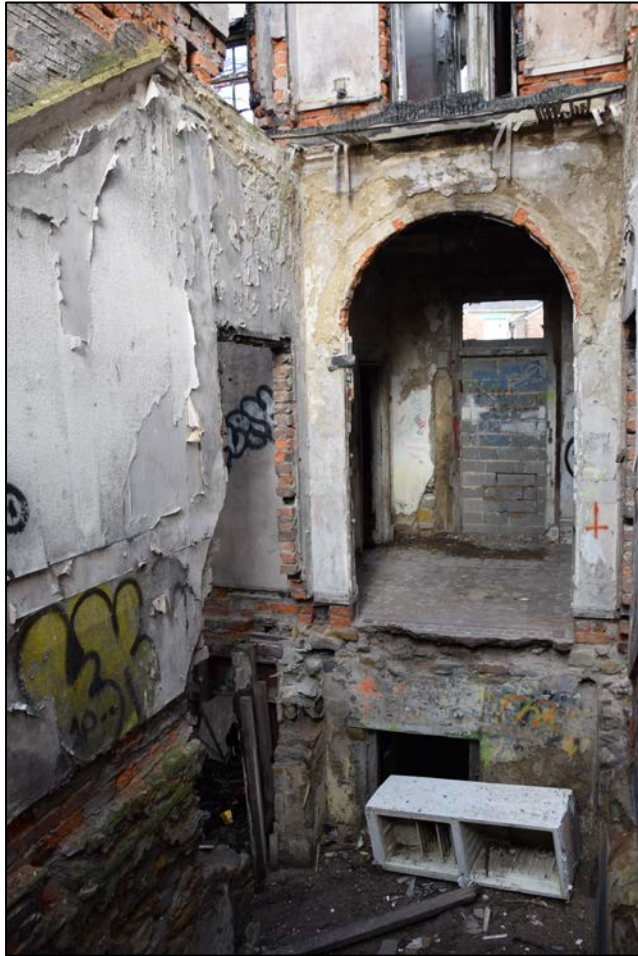
Photograph 17 (left): The staircase hall seen from the south-east. The service rooms in the basement are choked with rubbish and debris

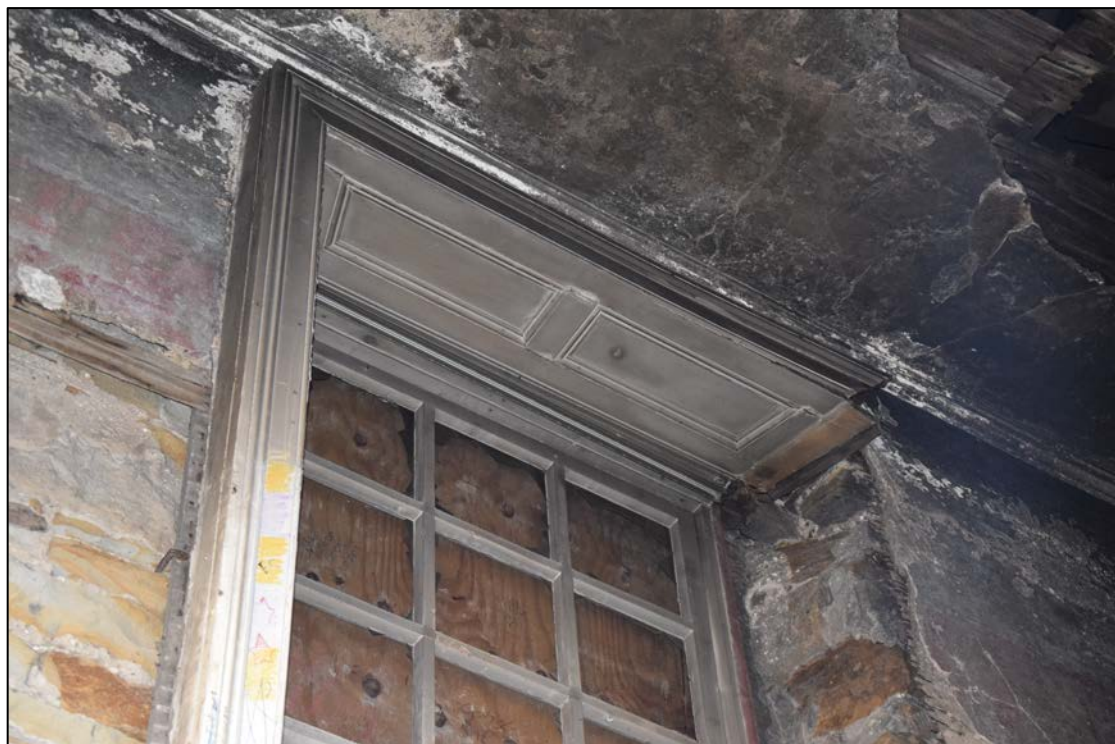
Photograph 18 (below): The surviving woodwork of a window in the north-west room on the ground floor

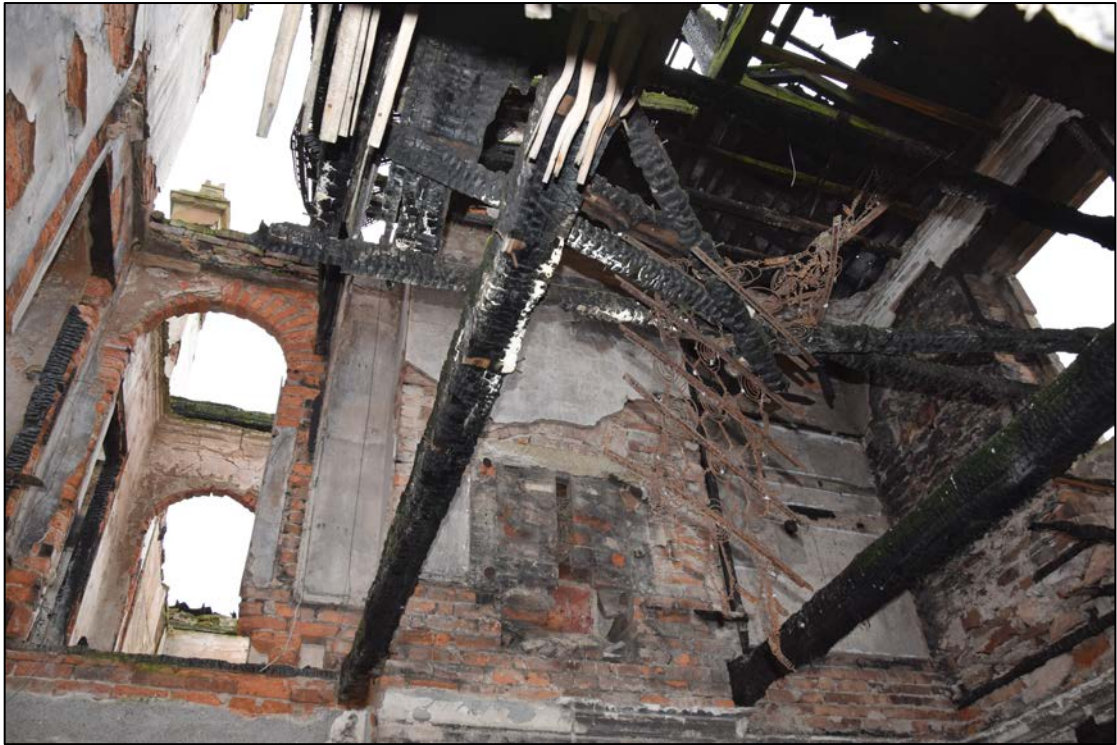
- 5.10 The loss of the floors and internal partition walls in the first-floor rooms means that there is little detail to be seen. The south-west room is now open to the landing that ran across the whole width of the house, to the room below and to the roof space (Photograph 19). Fragments of cornice are all that remains of its former decorations. The landing passed a door to a central room on the north side, which was divided by a timber partition; it is likely that this was a bathroom (Photograph 20). The south-

Photograph 19 (above): The south-west bedroom, seen from the floor below. A stud partition separated this room from the landing, which ran through the brick arches on either side of the staircase (left)

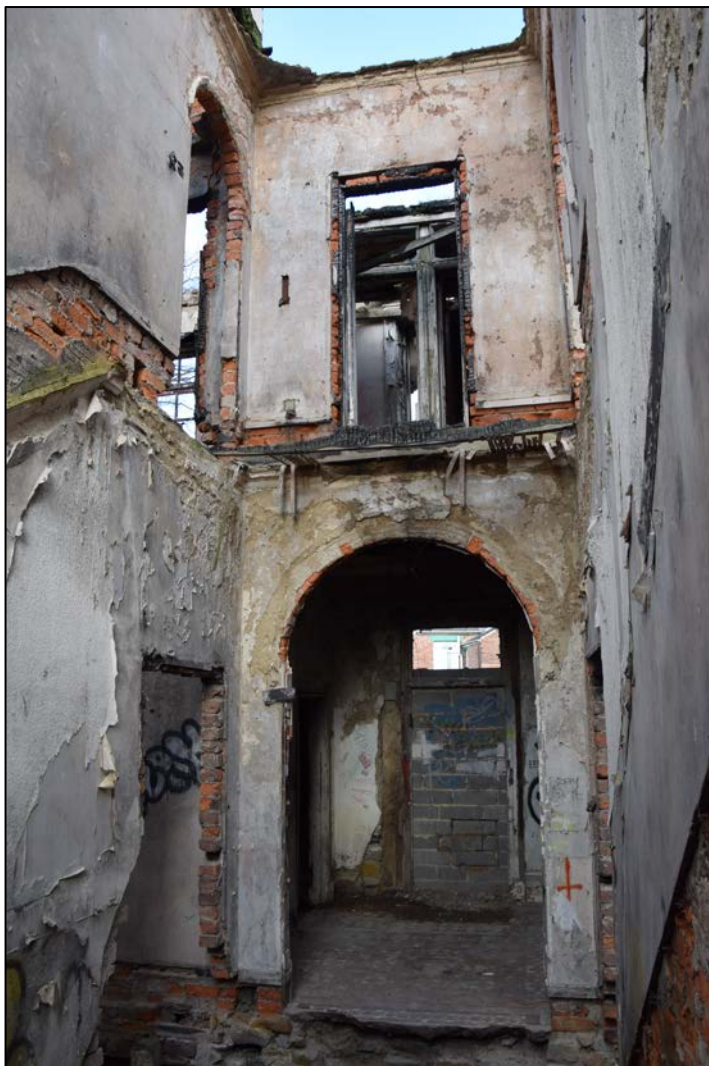
Photograph 20 (left): Looking up to the landing from the south-east of the staircase. Note the remains of a timber partition in the room beyond the upper door

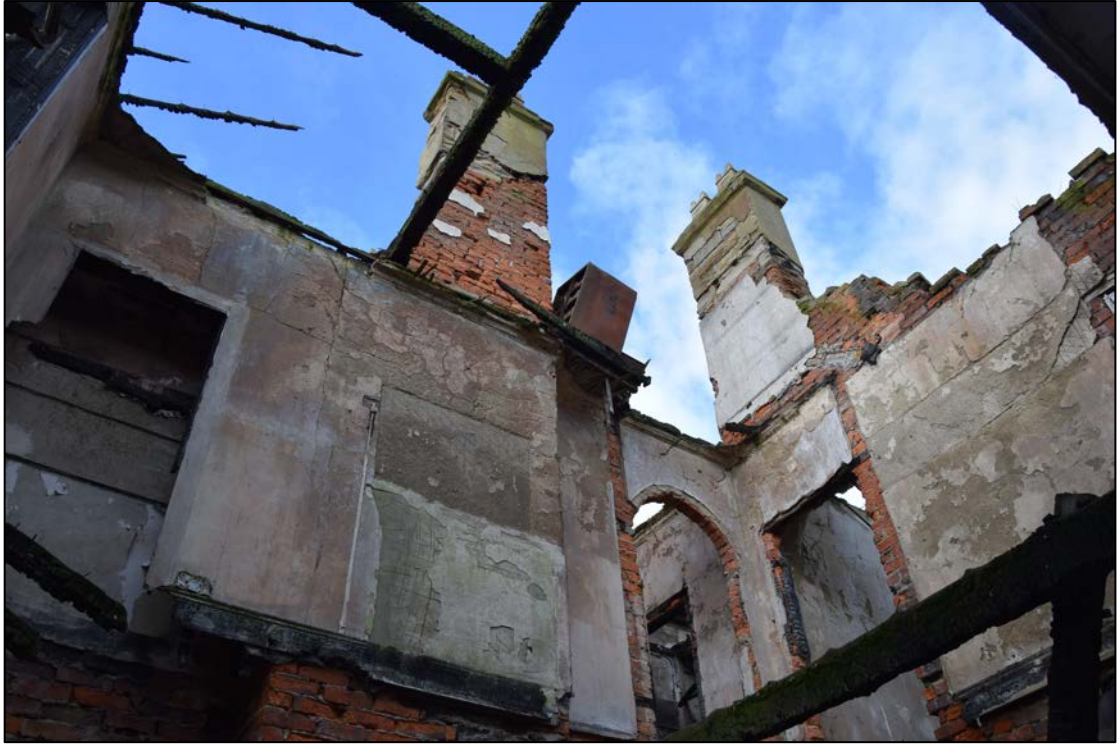
east room is possibly the most bare in the whole house (Photograph 21), but traces of a cornice can be seen here and in the adjoining landing. There was a cupboard in the recess south of the chimney breast in this room.

Photograph 21: The south-east room on the first floor. The mark of the partition wall can be seen at the left of the arched brick doorway on the former landing
