Buildings at Southside Farm
Westerton
County Durham

archaeological building recording

report 4434
April 2017

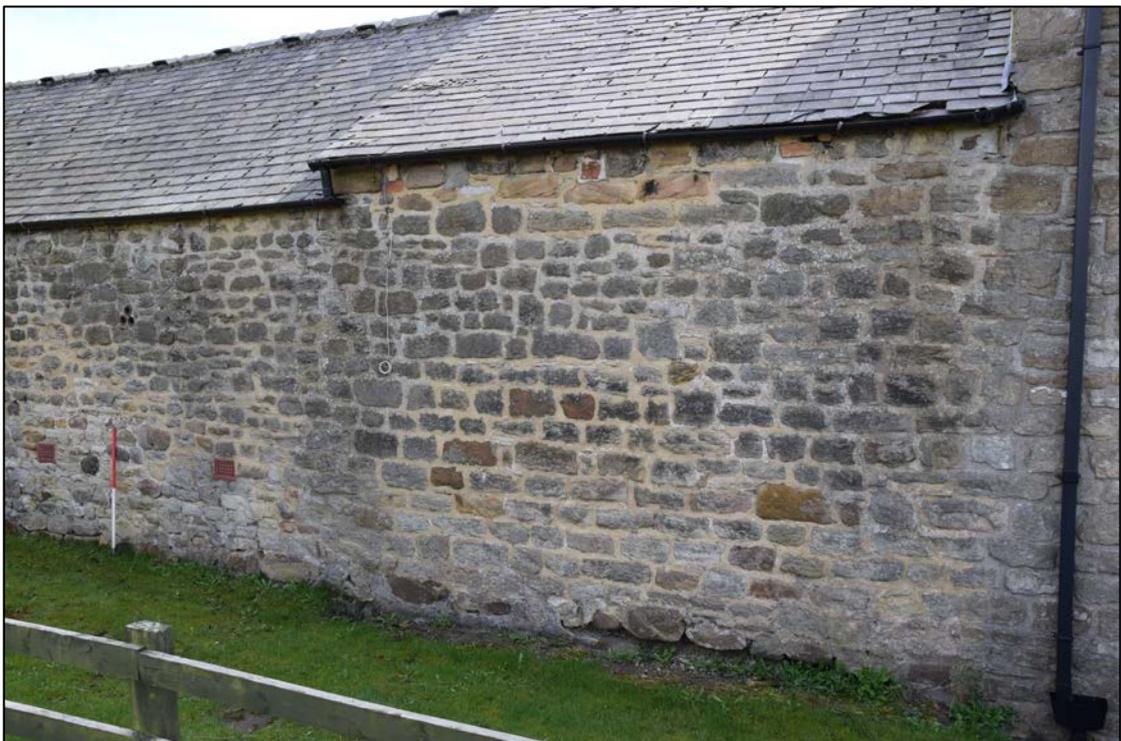
Photograph 8: The north wall of building 1. The masonry is slightly different from that in building 2/3 to the left

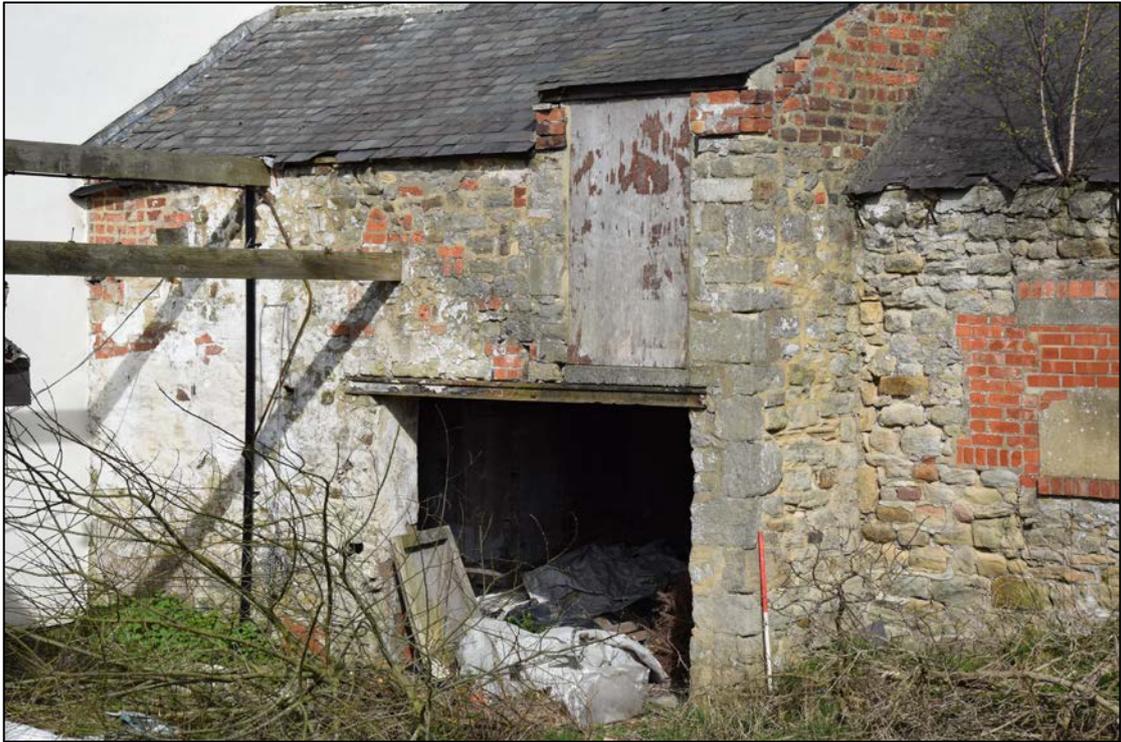
Photograph 9: The south face of building 1. Later brickwork, top right, accommodates the lower-pitched roof above an inserted loading door. The large horizontal timbers are the purlins of the vanished building 4

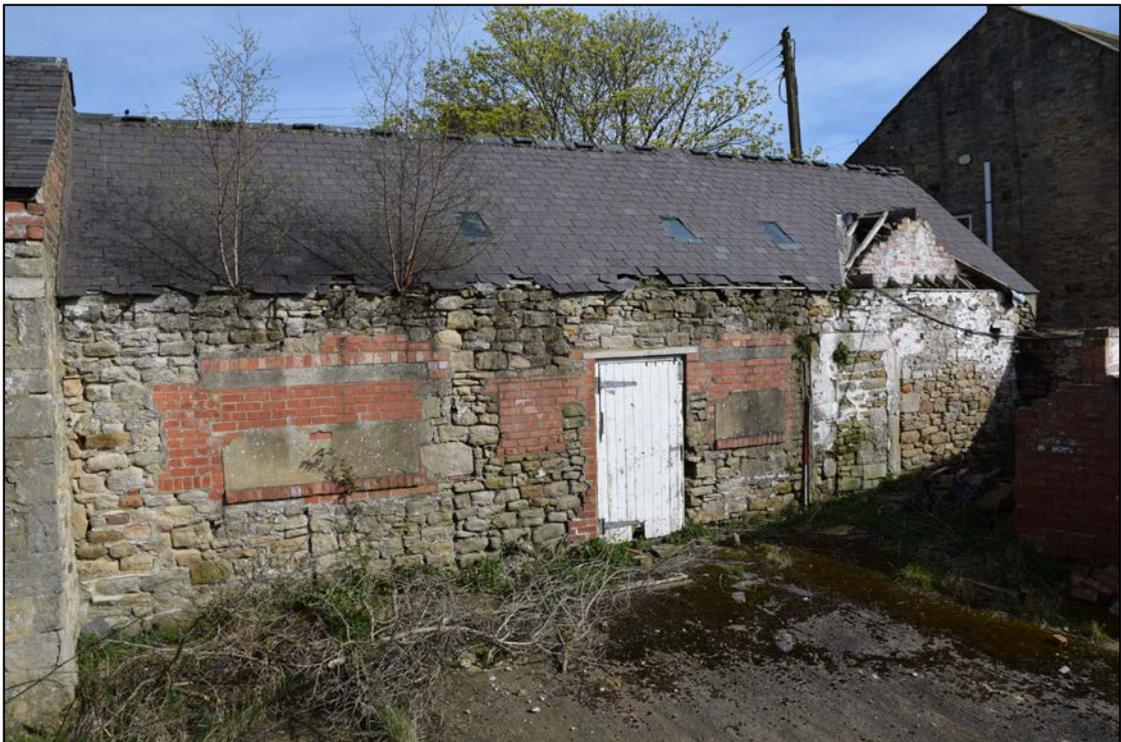
Photograph 14: The south face of building 2/3. Straight joints for a western door can be seen under the brick blocking of the left-hand window; its position mirrors that of a complete blocked door under the small gable at the right

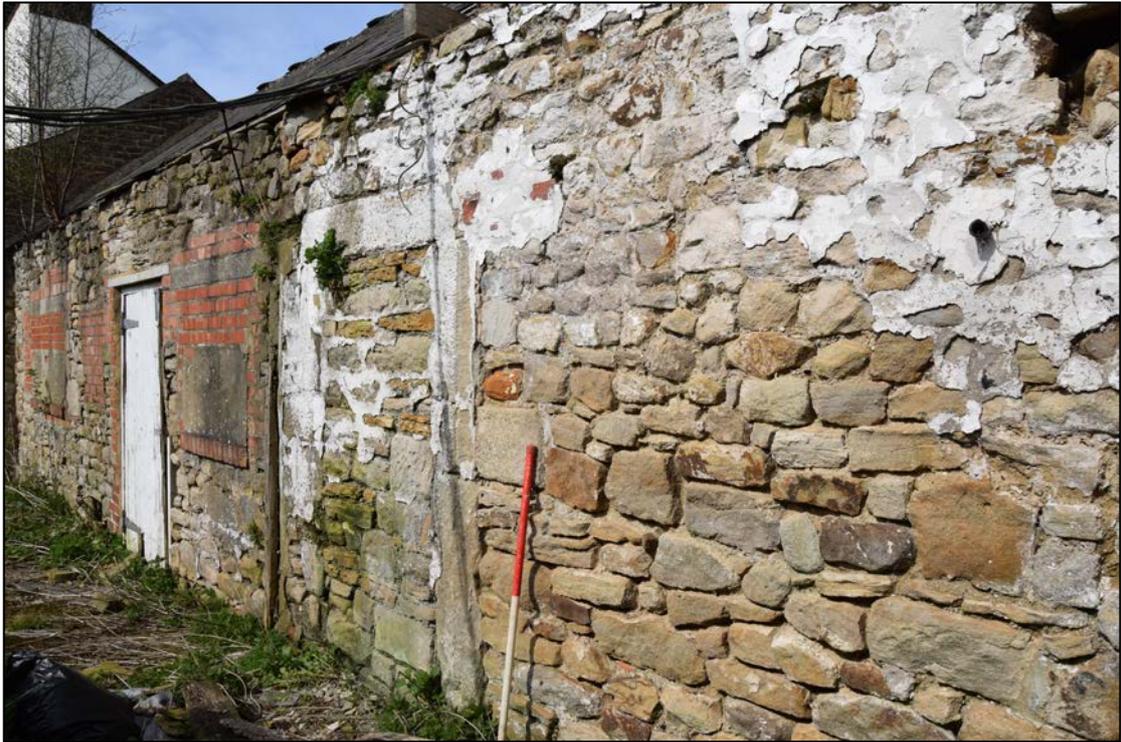
Photograph 15: The eastern blocked door in building 2/3

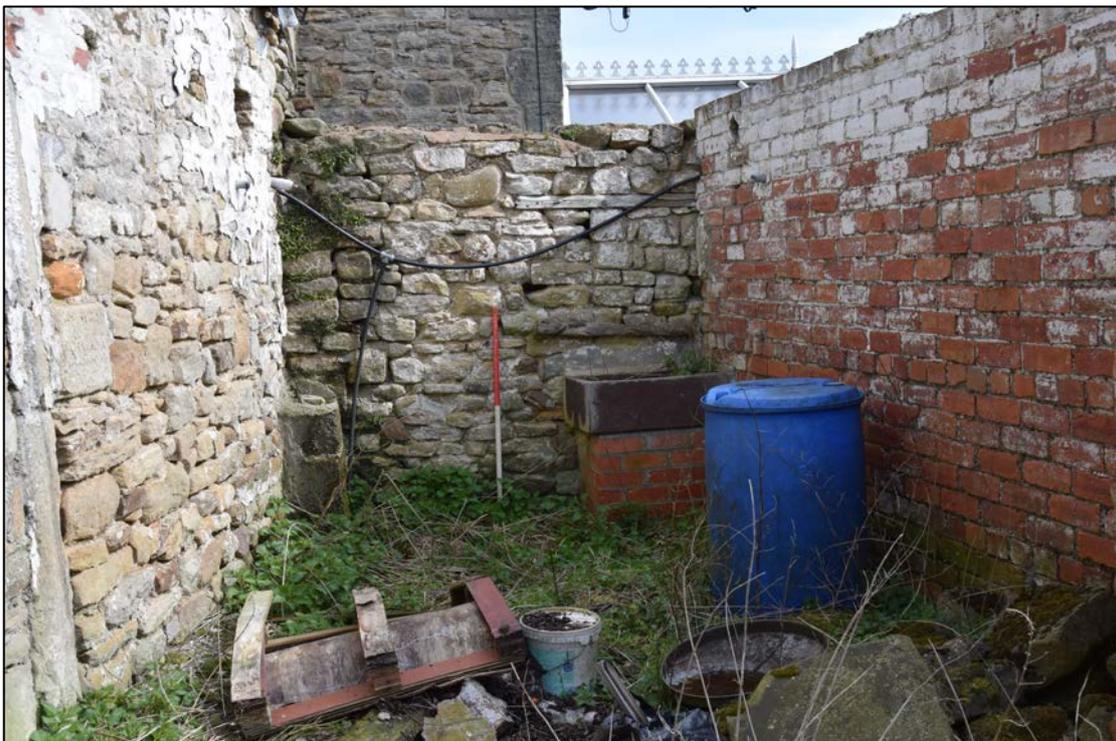
Photograph 22: The stone wall at the back of building 8 is part of an older shed. A blocked window can be seen above the brown ceramic trough

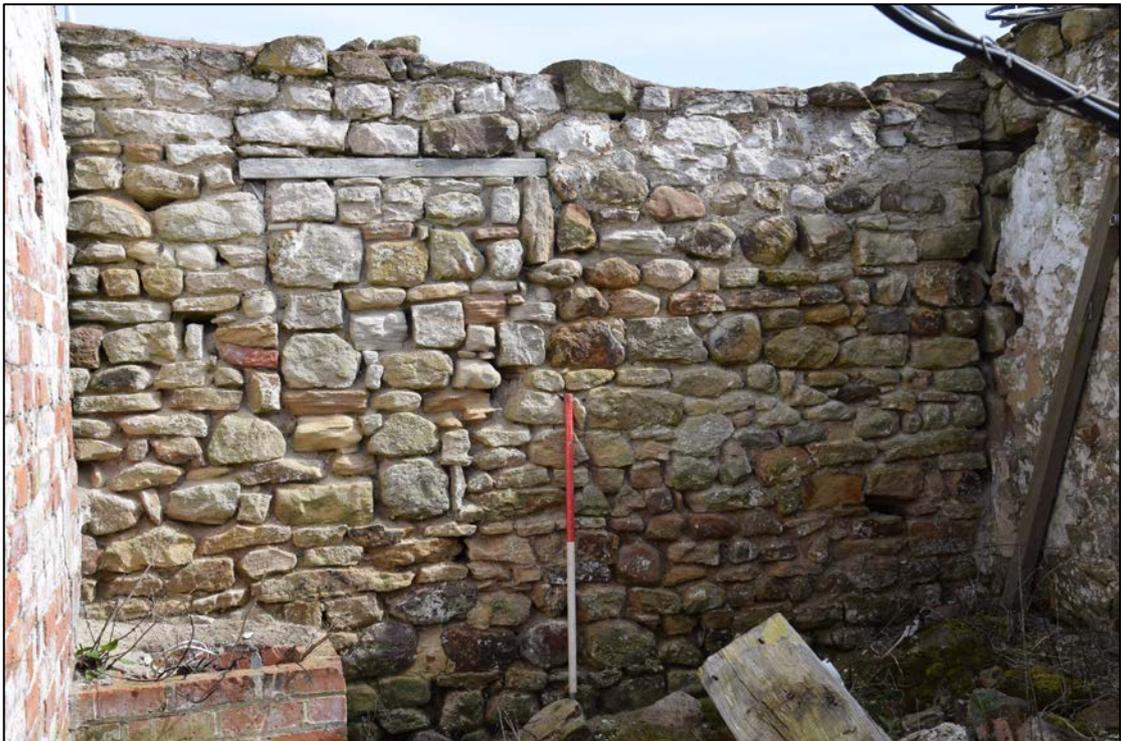
Photograph 24: Another blocked window in the back wall of building 10

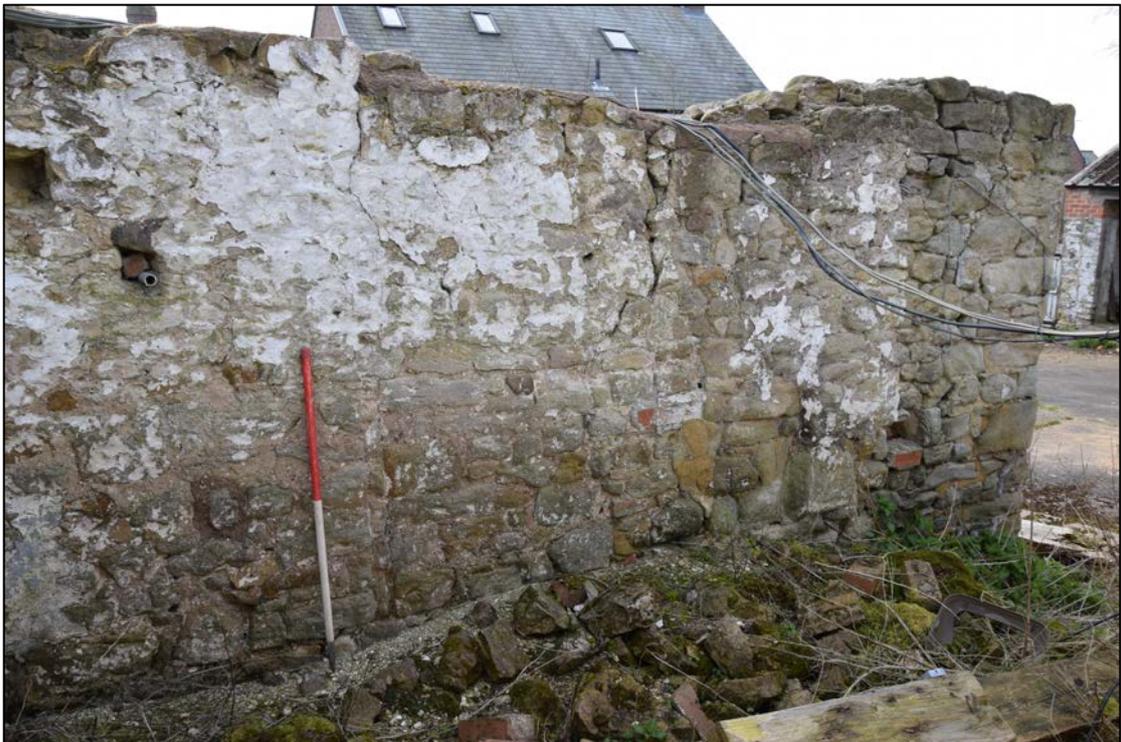
Photograph 26: The north end of building 11 seen from building 10. A blocked opening can be seen beside the scale

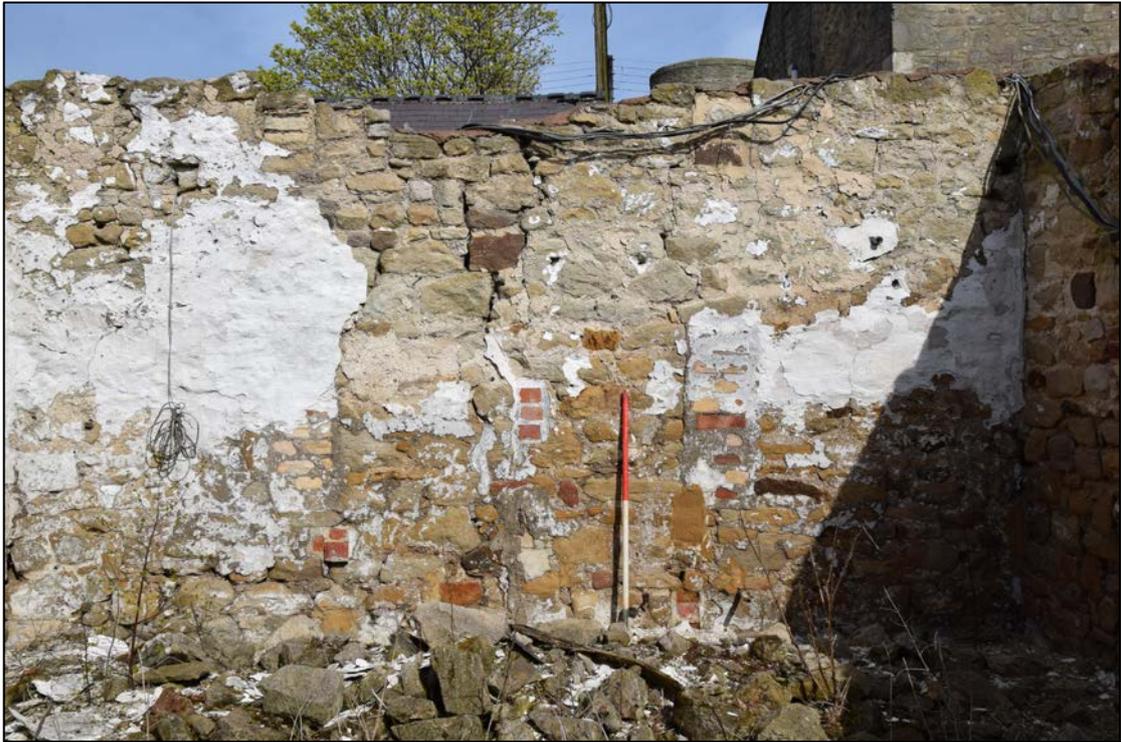
Photograph 29: The north wall in building 11, showing blocked openings

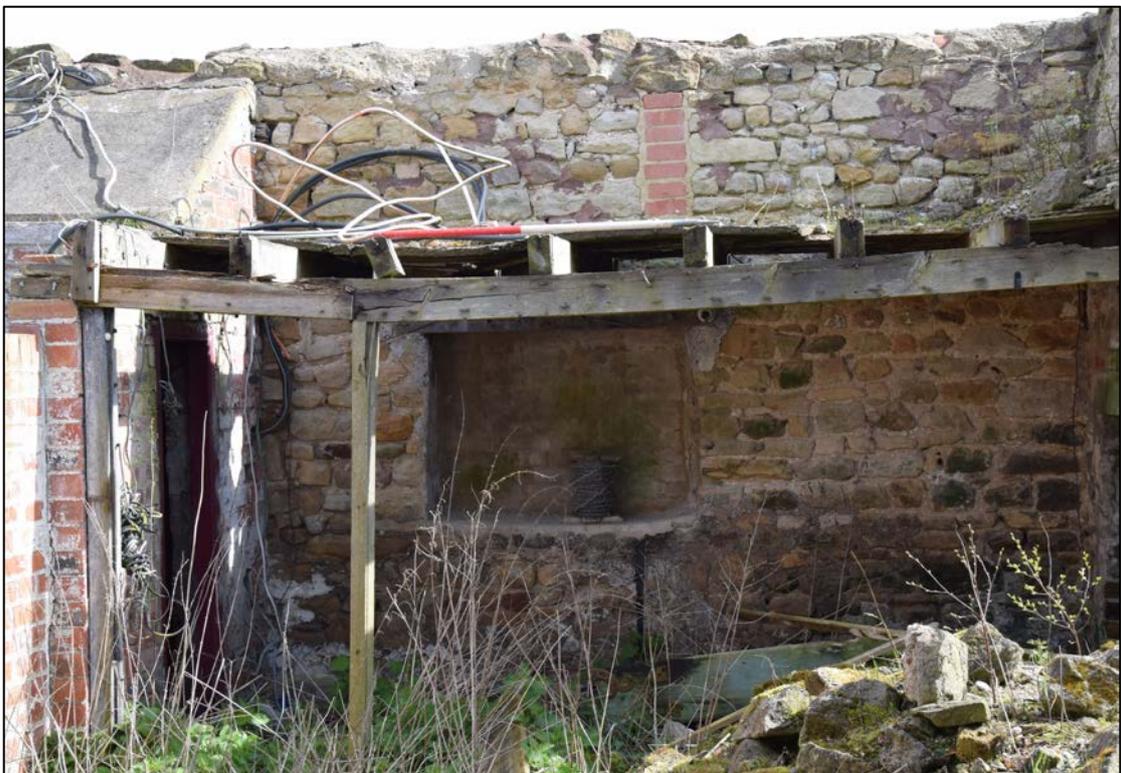
Photograph 32: The back wall of building 13, showing the door to the shed 12, a blocked window and a breather slit, and the remains of the low floor

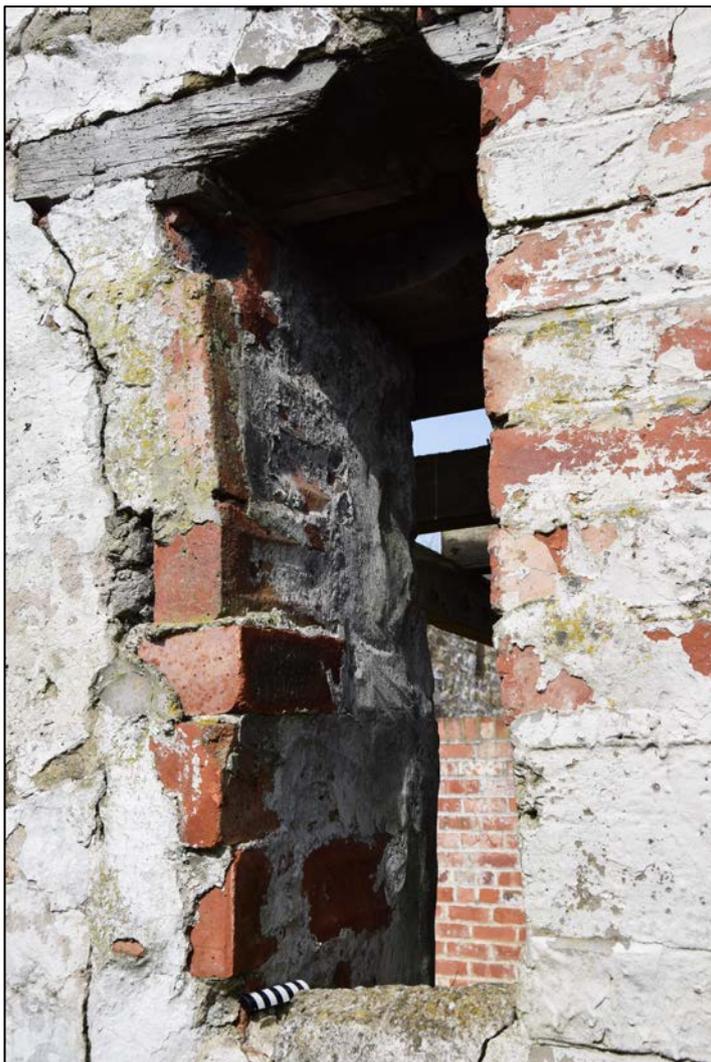
map (Figure 3). There is a smaller late door east of this, near the corner of the old barn, and beside that is a vertical slot for a drive belt (Photograph 33). The slot is lined with brick and has wear marks from the belt on its sides; the timber lintel has been cut away to provide clearance (Photographs 34 & 35).

Photograph 34 (left): Detail of the slot in the south wall of 13. Wear marks can be seen as oblique lines in the mortar, just right of the large dark brick. The scale is 10cm long

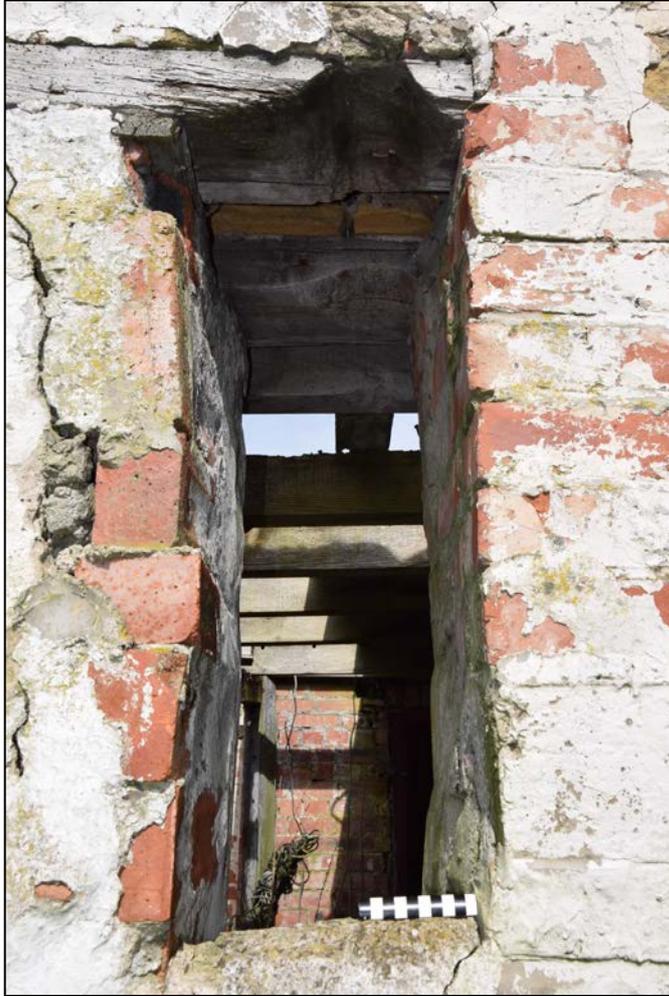
Photograph 35 (left): The timbers at the head of the belt slot have been cut away to increase clearance. A view looking north

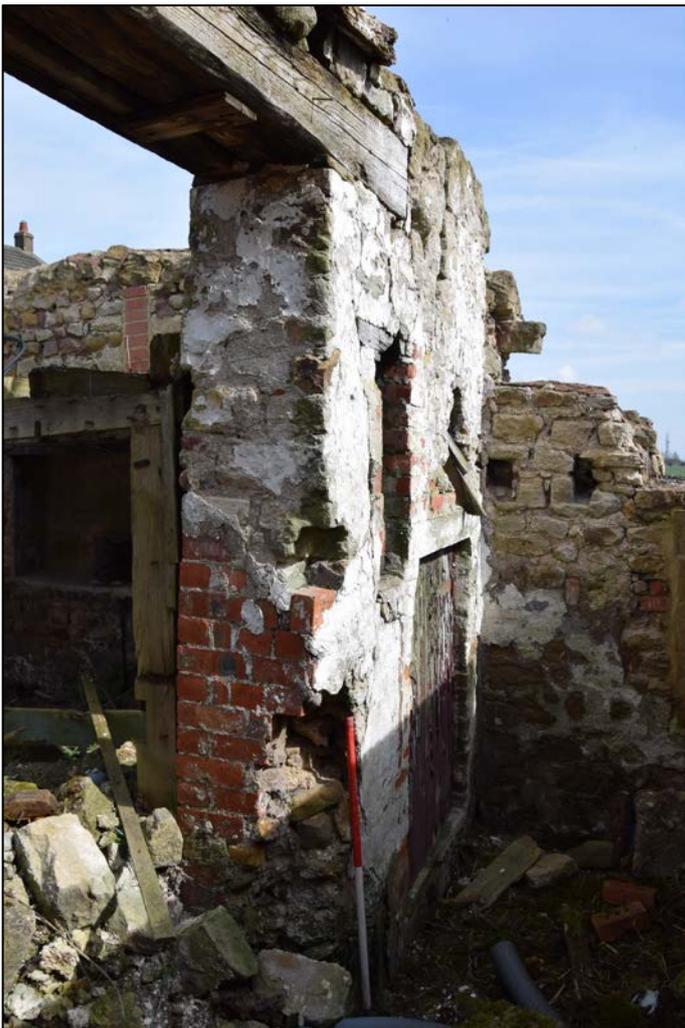
- 59 The brick wall that divides the floor continues into the external extension. This shows that the building was split before 1920, when the porch first appears on the map. The division incorporates the side of an old large barn door, as can be seen from the presence of dressed stone quoins (Photograph 36). The presence of the shed 12 and the belt drive slot suggests that the old horse-powered threshing machine in the stone barn was replaced by a mechanically powered thresher in the vanished south building. It is likely that the south end of the old barn (13) housed the motor that drove a belt running through the slot in the south wall. The upward slope of the wear marks seen in Photograph 34 are consistent with a thresher on the first floor. This was a common arrangement, allowing grain to be fed by chutes to sacks on the ground floor, and the threshed stalks to fall into the straw barn. Only a small section of the original masonry remains at the south-west corner of the old barn, suggesting that substantial alterations were made in this modernisation; the south side of the old door has been removed (Photograph 37). The outer face of the south wall also shows significant patching and alteration in brickwork (Photograph 38).

Photograph 38 (left): The patched and altered south wall of building 13, with the east side of the large door into a vanished larger barn

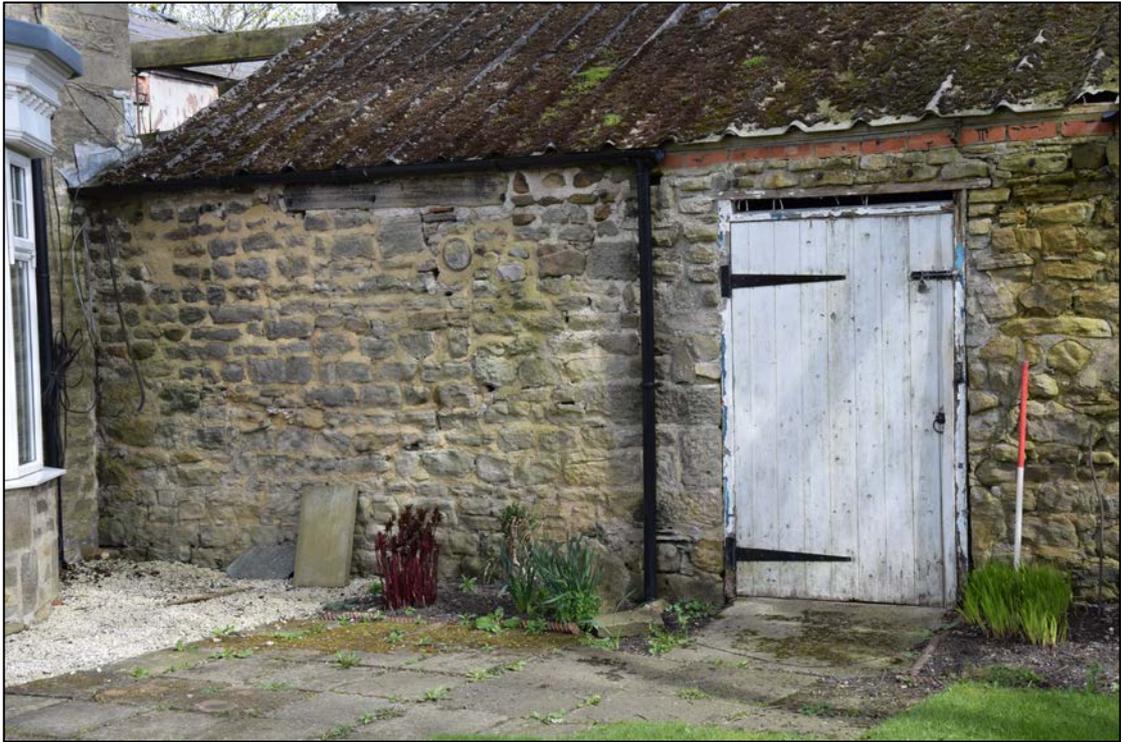
Photograph 43: Coursed rubble, a blocked window and a pipe ventilator in the west face of building 5. Note the difference between the stonework on either side of the door to building 6

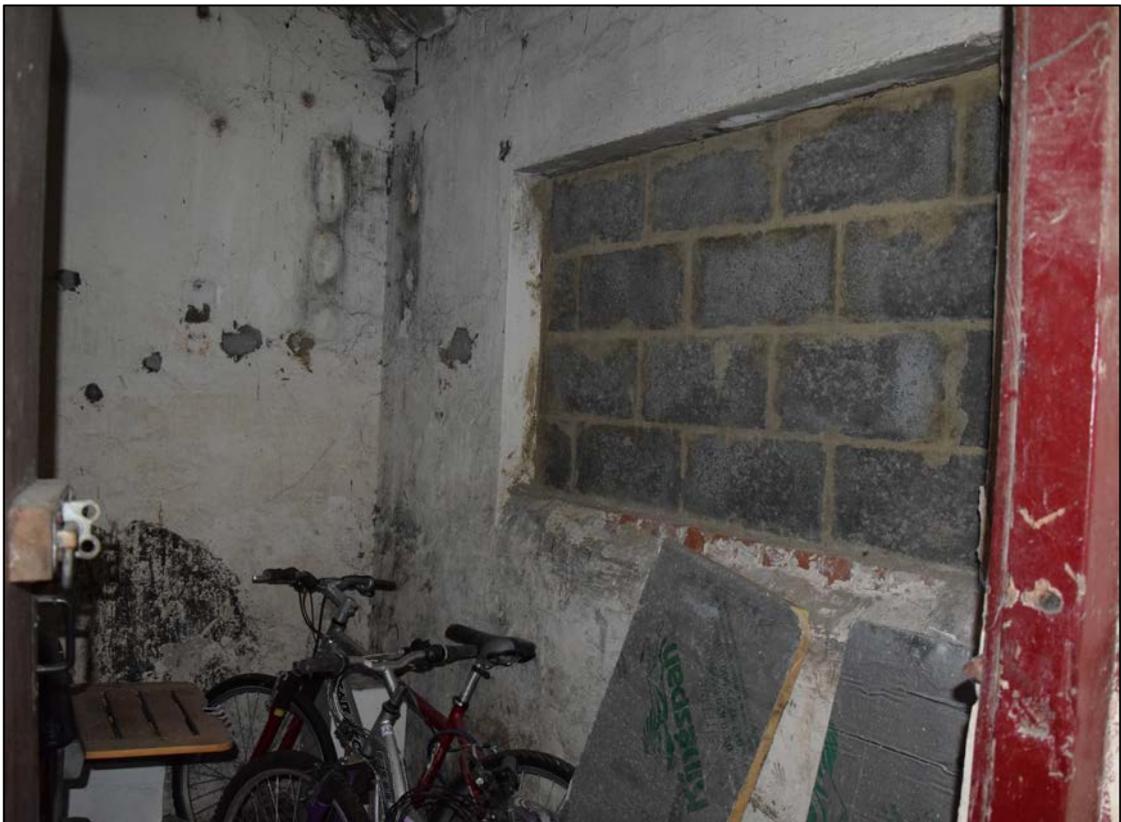
- 5.11 Building 5 was in use as a store room when the survey was made; no trace of blocked windows in the north and west faces was seen (Photograph 45), though the concrete blocks in the east window are obvious (Photograph 46).

Photograph 46: The large blocked window at the east end of building 5

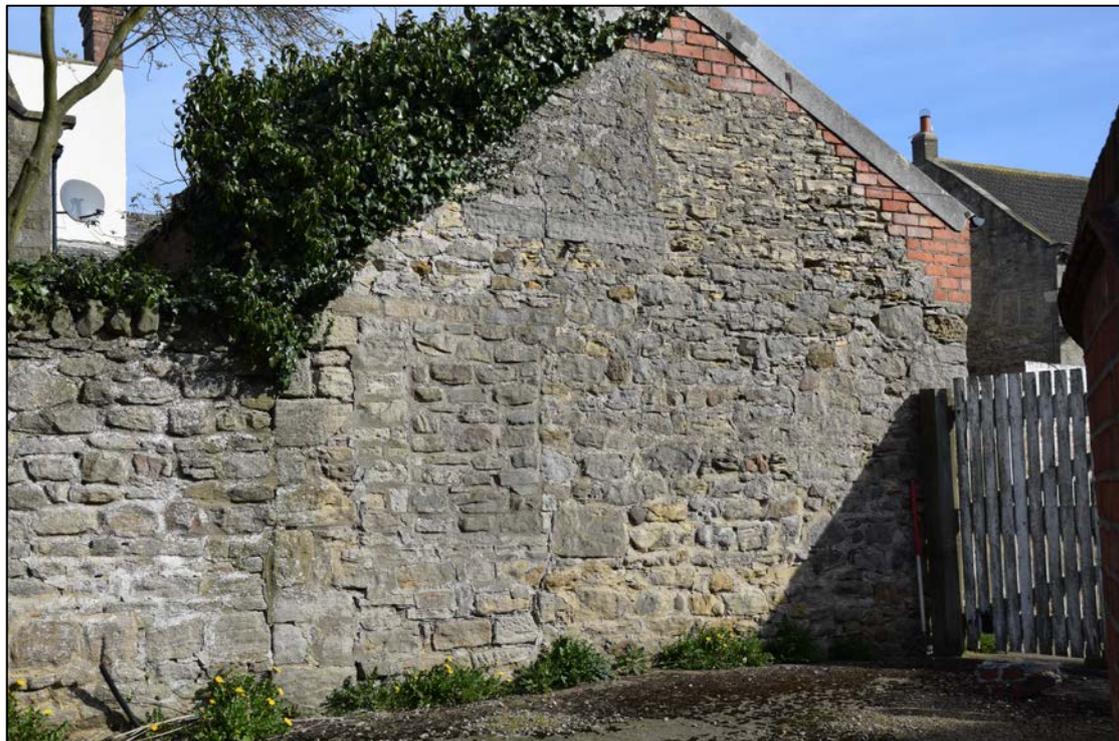
Photograph 50 (below): The south end of building 7 has blocked windows at two levels, left of centre. The roof line appears to have been raised at the east side, where brickwork has been added

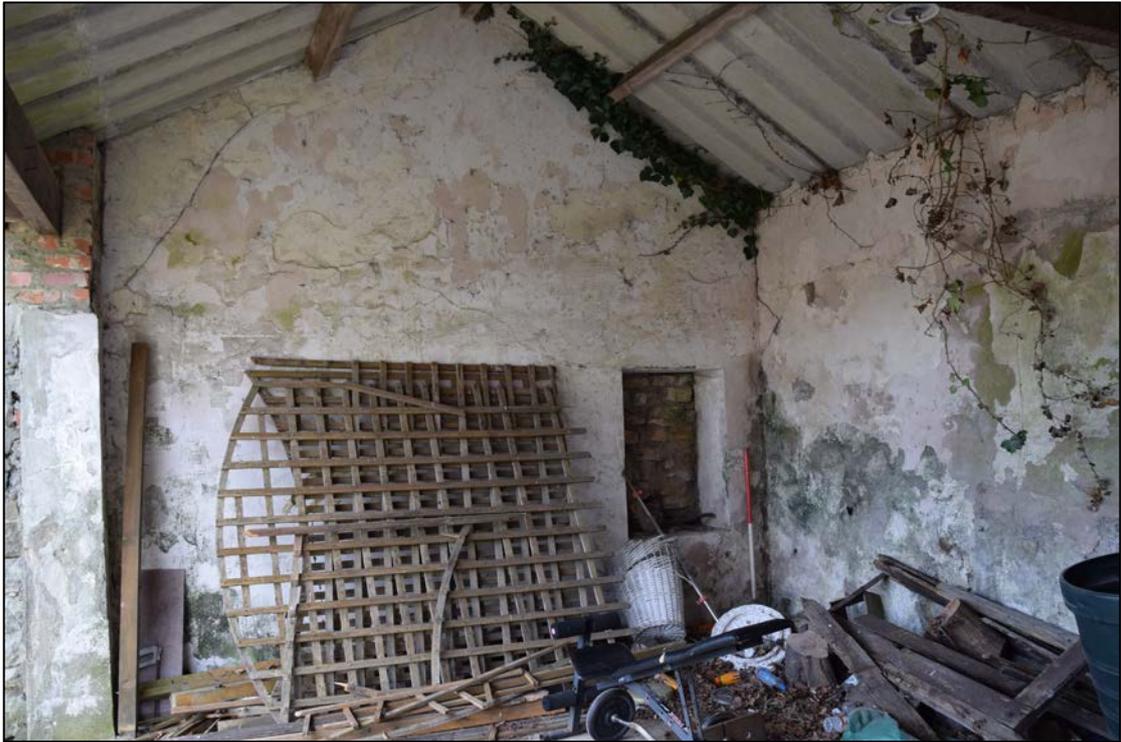
Photograph 51: The south end of building 7, showing the lower of the two blocked windows seen in the previous picture
