17 South Bailey Durham Co Durham

archaeological building recording

report 4643 December 2017

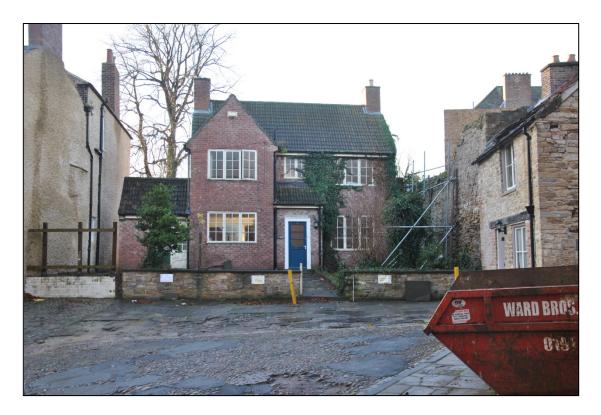
- 5.1 No. 17 South Bailey is a detached brick house set near the middle of the plot (Figure 2: Photograph 1). It is close to the retaining wall on the north side of the site and set well back from street (Photograph 2). It has two storeys and three bays, with a small shed attached at the left (south) side. The left bay breaks forward under a gable and there is a lean-to porch for the central door. The house is built of brick, in stretcher bond, with built-up red tile kneelers at the gables; the roof is covered with concrete tiles. There are brick gable chimneys and the openings have soldier courses covering steel lintels. At the front, the casement windows have timber frames (Photograph 3).

Photograph 1: The house seen from the east side of South Bailey, with the remains of the old rectory, now the college Music Room, at the right and the later Rectory house at the left

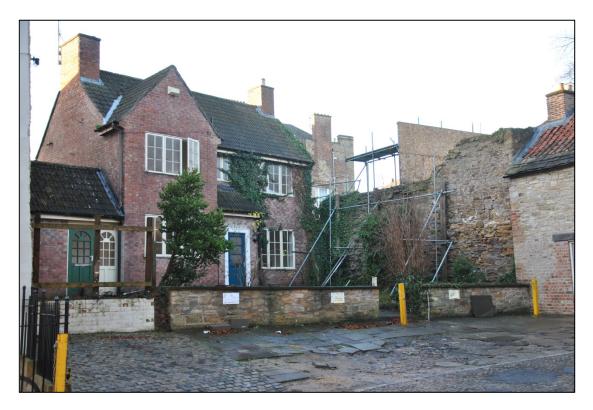
Photograph 2: A view from the south-east, showing the old retaining wall / gable end of the earlier rectory supported by scaffolding

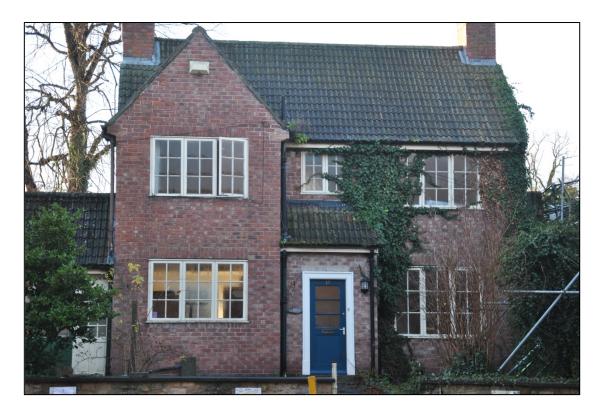
Photograph 3: The east face of no. 17. The porch is a slightly later addition

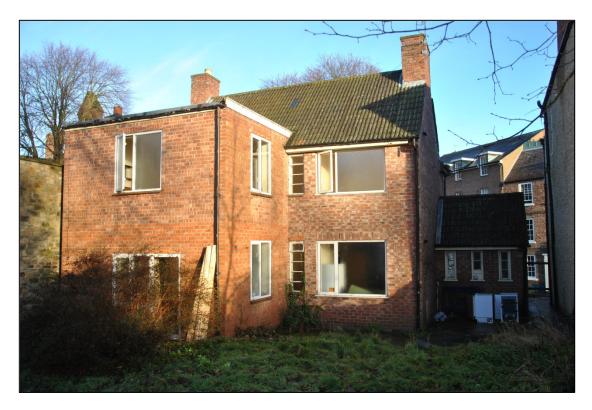
- 5.2 From the rear, the small size of the south shed is apparent (Photograph 4). The original windows in this face have been replaced with double-glazed uPVC units. The west side of the house is dominated by a large extension at the north-west corner. The construction of this entailed the remodelling of the central windows. The extension is a utilitarian flat-roofed structure with a patio door on its west side (Photograph 5). The northern retaining wall beside the extension is a modern construction (Photograph 6). Oddly, it does not run as far east as the old wall on the same line.

Photograph 4: The rear of the house, showing (at the right) the south shed running close to the wall of no. 16

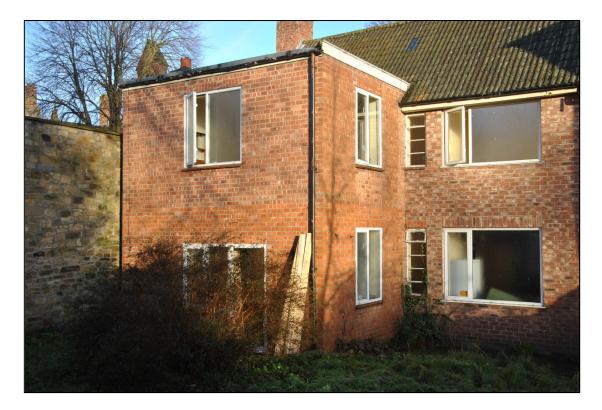
Photograph 5: The large rear extension and the altered windows beside it. A view looking north-east

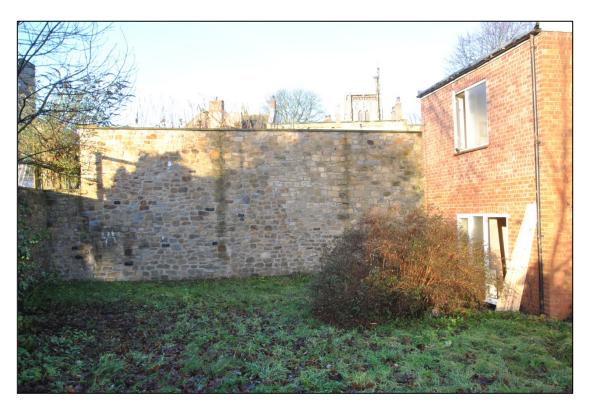
Photograph 6: The modern retaining wall at the north side of the site

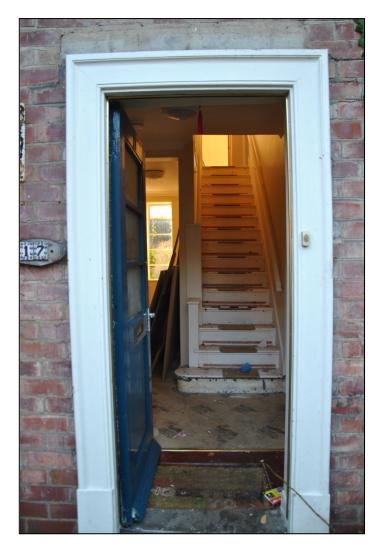
Photograph 7 (left): The staircase and hall seen from the front door

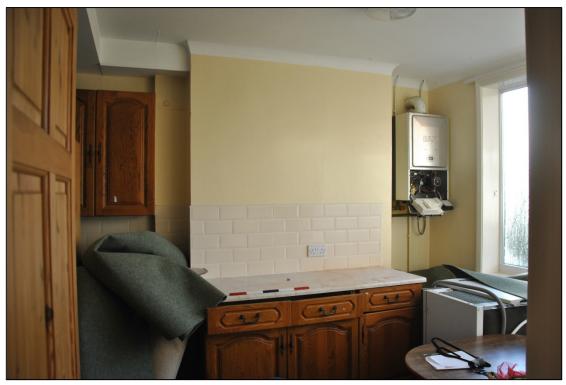
Photograph 8 (below): Looking south into the kitchen [4]. Note the blind chimney breast

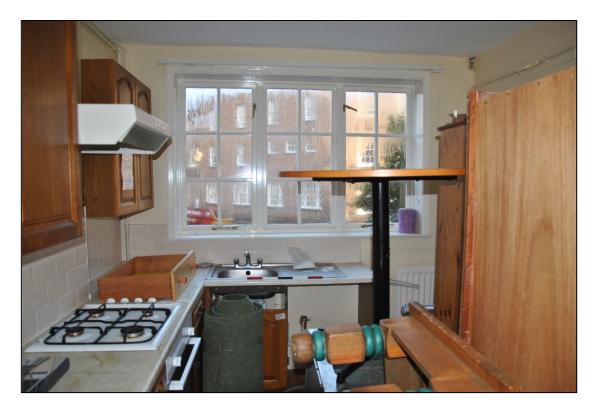
Photograph 9 (above): Looking east in the kitchen. The stacked furniture conceals the doors to rooms 1, 2 and 3

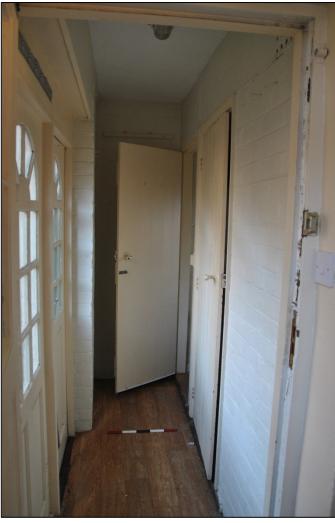
Photograph 10 (left): Looking south at the doors to rooms 1 and 2. Note the short brick wall at the far left, and the modern doors nearer to the camera

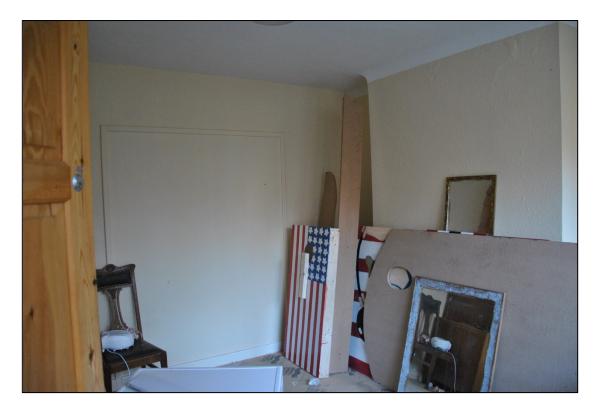
- 5.4 On the north side of the hall, a former reception room [6] has been reduced in size by the insertion of a thin partition at the west end (Photograph 11). The large common room at the rear [7] occupies the whole footprint of the extension as well as a shallow bay at the west end of room 6 (Photograph 12).

Photograph 11: The north-eastern reception room 6. The far wall is a recent insertion that reduces the size of the room

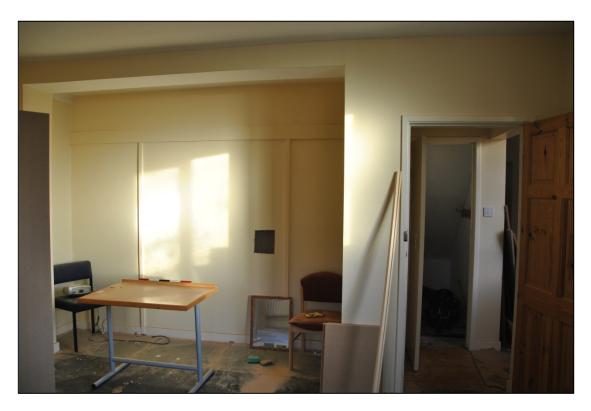
Photograph 12: The same inserted wall, seen from the south-west in the common room 7. The door at the right looks into the hall and the under-stair cupboard

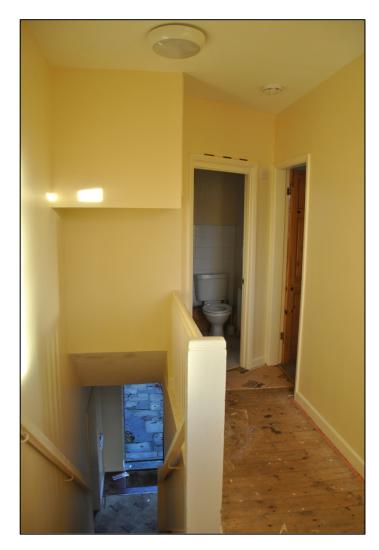
Photograph 13 (left): The landing [8] seen from the west. Before the insertion of the bathroom, the landing ran left beyond the stairs to the northern bedroom

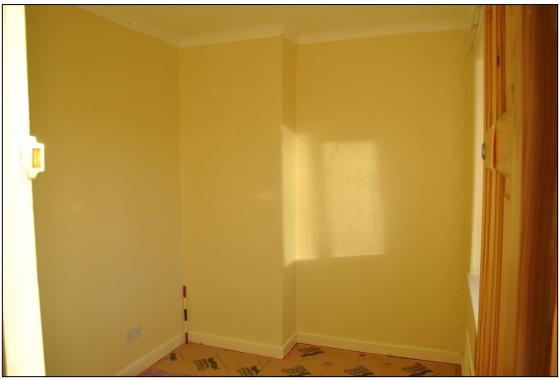
Photograph 14 (below): Looking south-east into bedroom 9. At the far corner is part of the chimney breast of the original large room

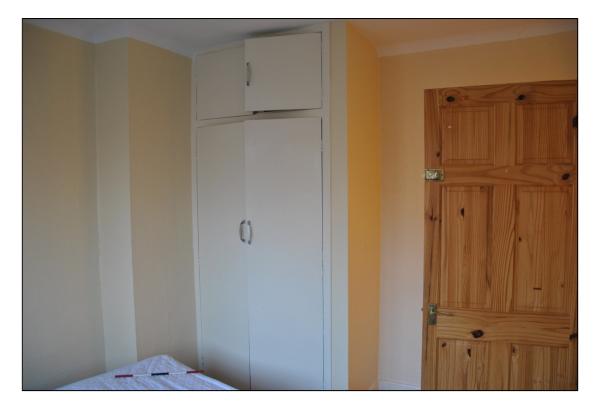
Photograph 15 (above): The other side of the old chimney breast, at the south-west corner of bedroom 10

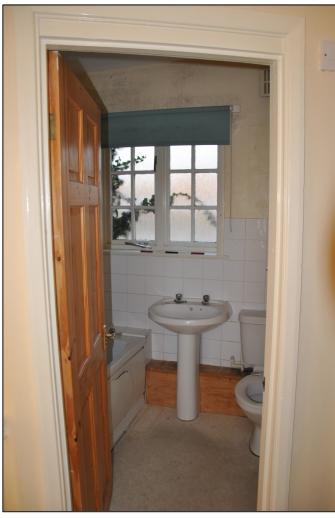
Photograph 16 (left): The bathroom, room 11

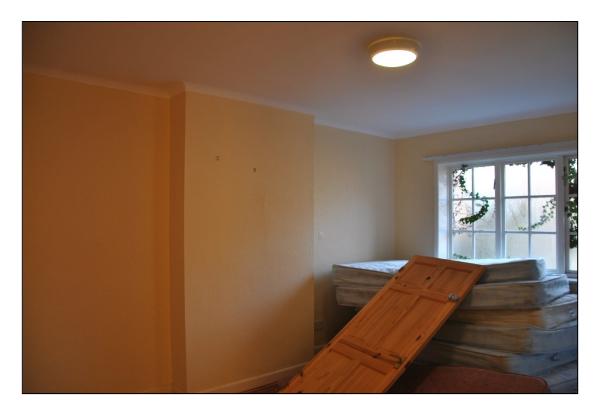
Photograph 17: Bedroom 12, seen from the south-west

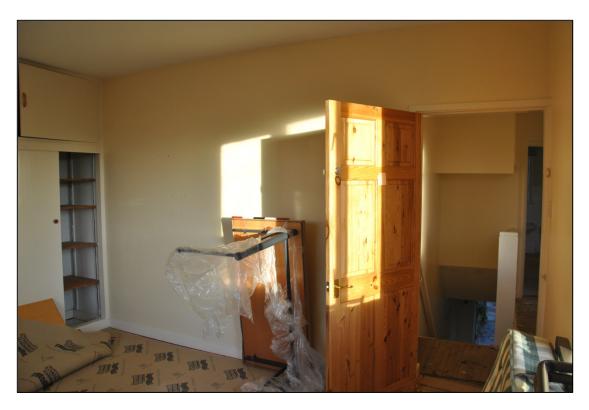
Photograph 18: The large room 13 in the extension. A view looking north-east
