ARCHAEOLOGICAL
SERVICES
DURHAM UNIVERSITY

Stag House Farm
Darlington

archaeological building recording

report 4804
June 2018

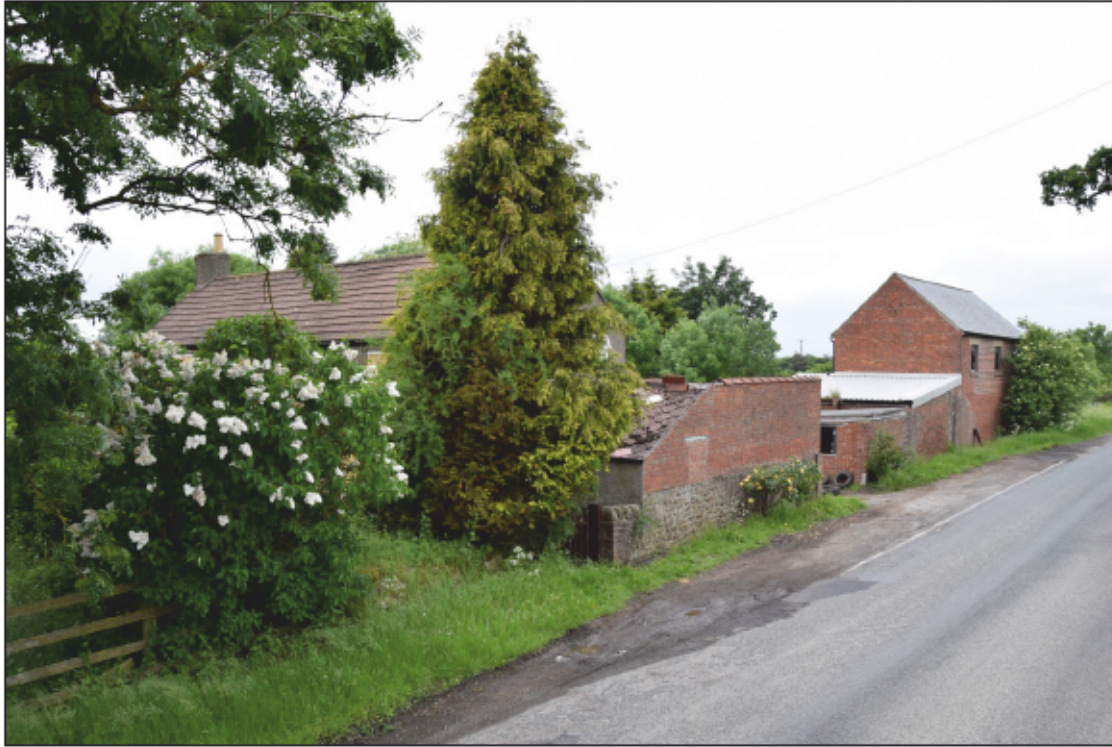
Photograph 1: The steading seen from the east, across Newton Lane. The concrete tile roof at the right is the farmhouse

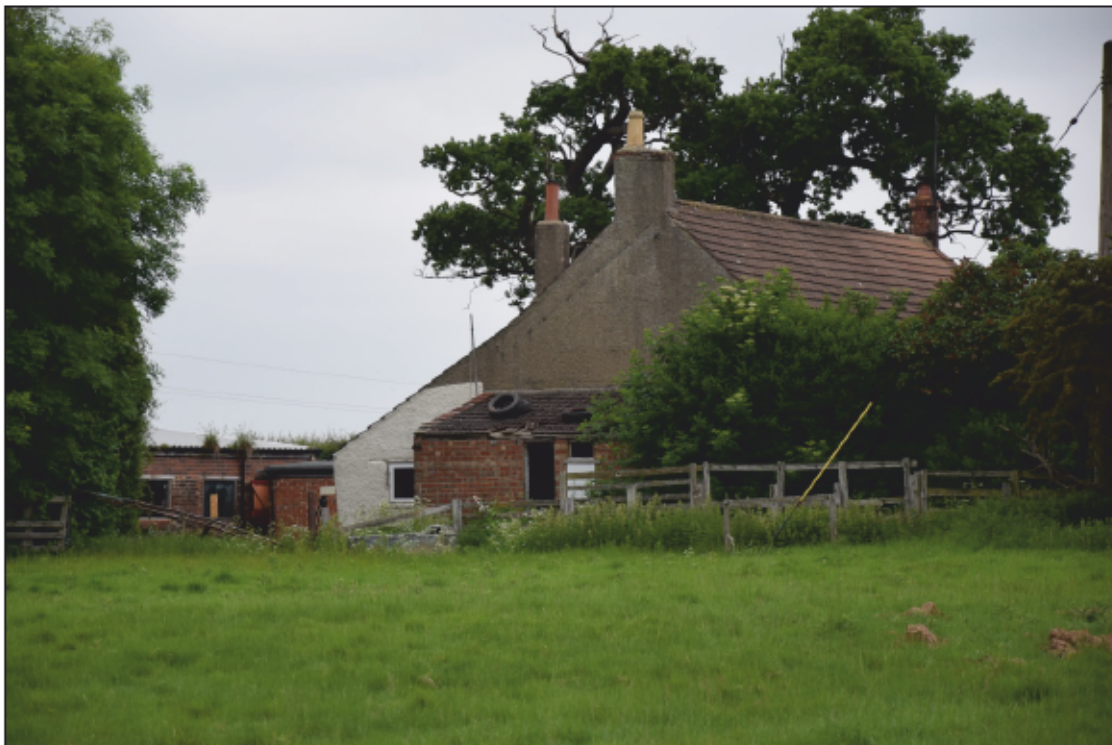
Photograph 2: The farm seen from the south

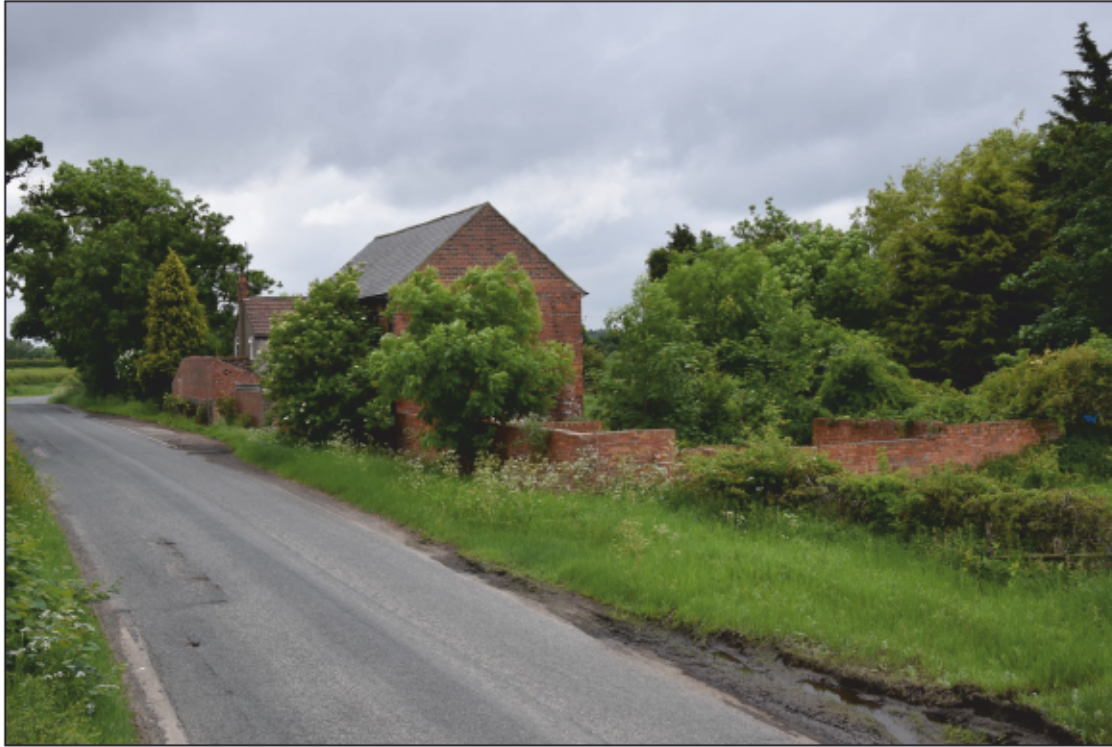
Photograph 3: The view from the north-west, with low brick pens at the north end of the site

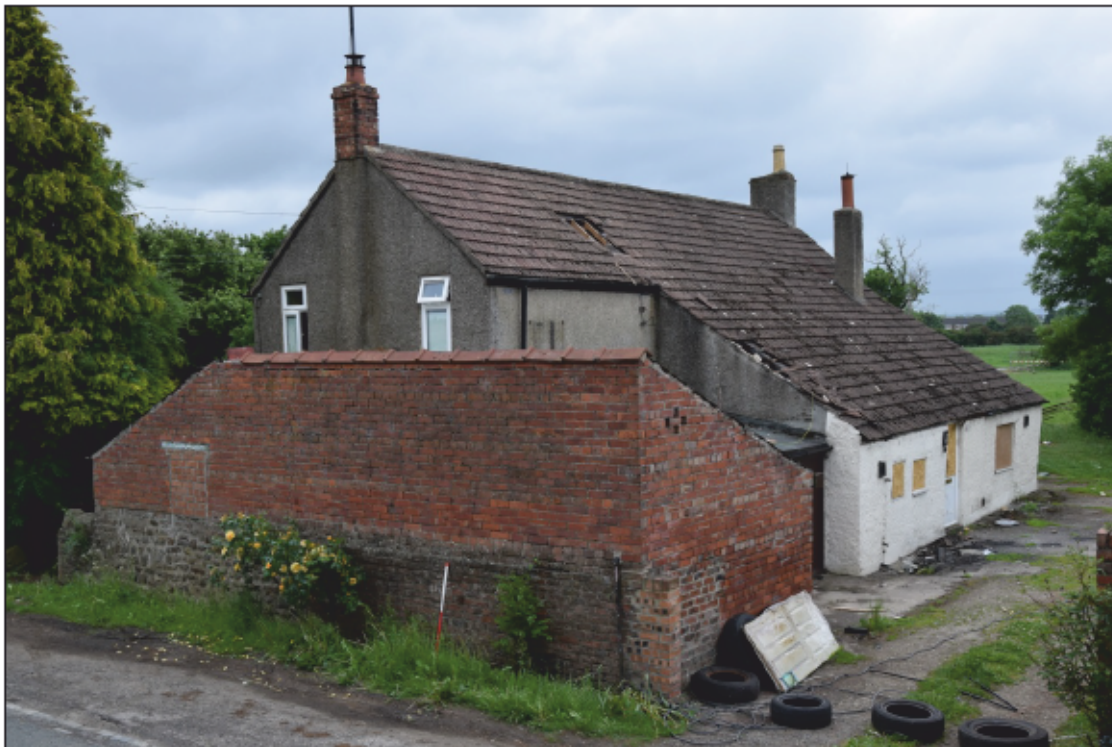
Photograph 4: The house seen from Newton Lane. A view looking south

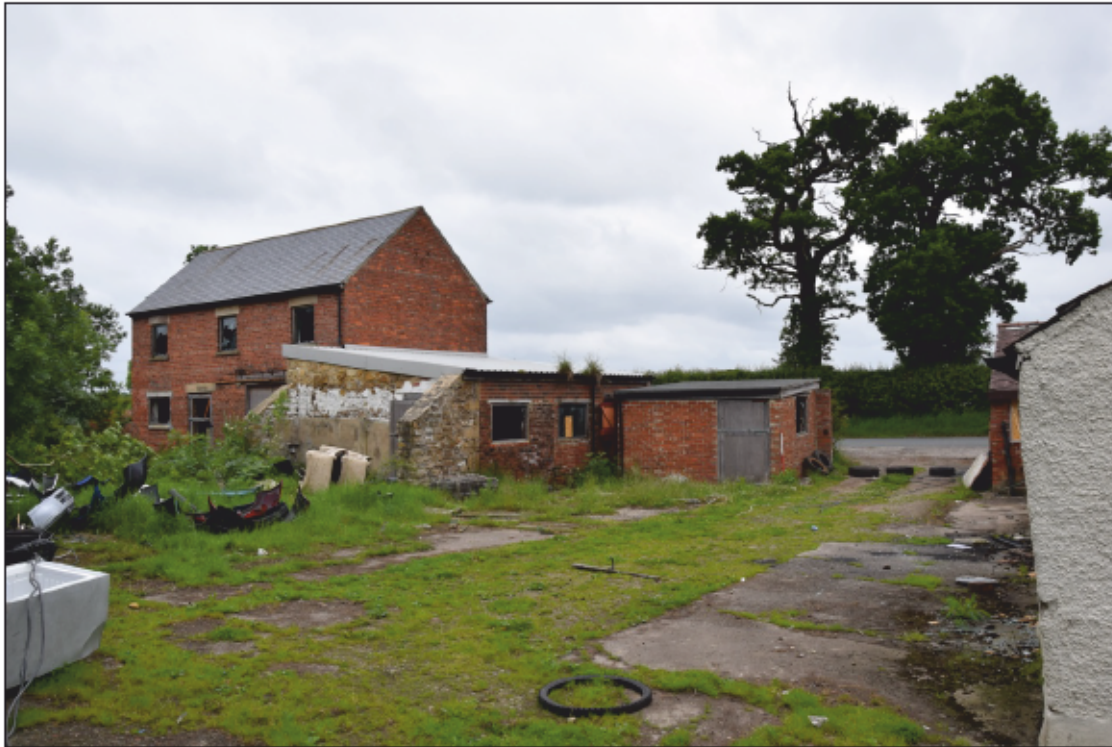
Photograph 5: A view looking north across the yard, with the house at the right

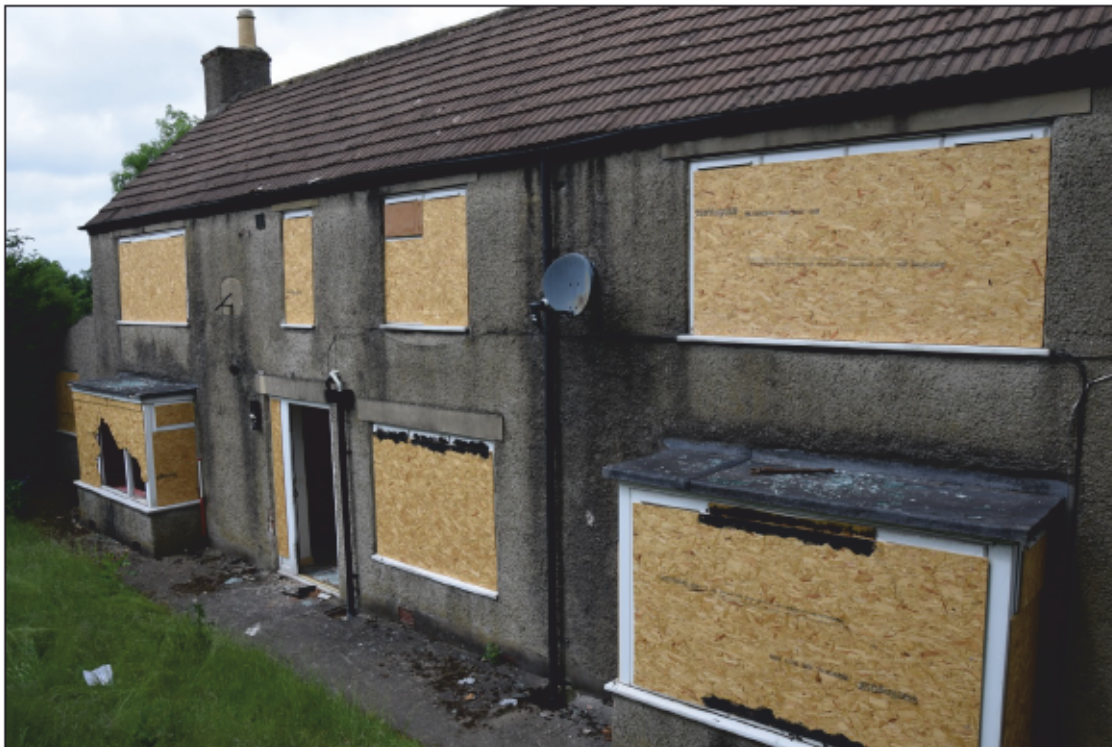
- 5.3 This is a two-storey four-bay building covered with unpainted roughcast render and roofed with modern concrete tiles (Photograph 6). Where the old fabric could be seen, the older part is stone and there are many alterations in later brick. Two modern bay windows have been added to the front of the house; in these and all of the other windows the glazing is modern. Recent concrete lintels span the uPVC front door and the window to its north-east (Photograph 7). There is a sundial at first-floor level near the original centre of the south-east wall. This is inscribed "John & Eliz: Ward 1763" (Photographs 8, 9). From the rear, the width of the original house can be seen in the outshut (Photograph 10). At the south-west end is a brick garage, shown on the 1955 map (Photograph 11). The chimneys at this end of the old house are covered with roughcast. At the other end there are brick sheds and a recent addition made of concrete blocks (Photograph 12).

Photograph 6: The front of the farmhouse

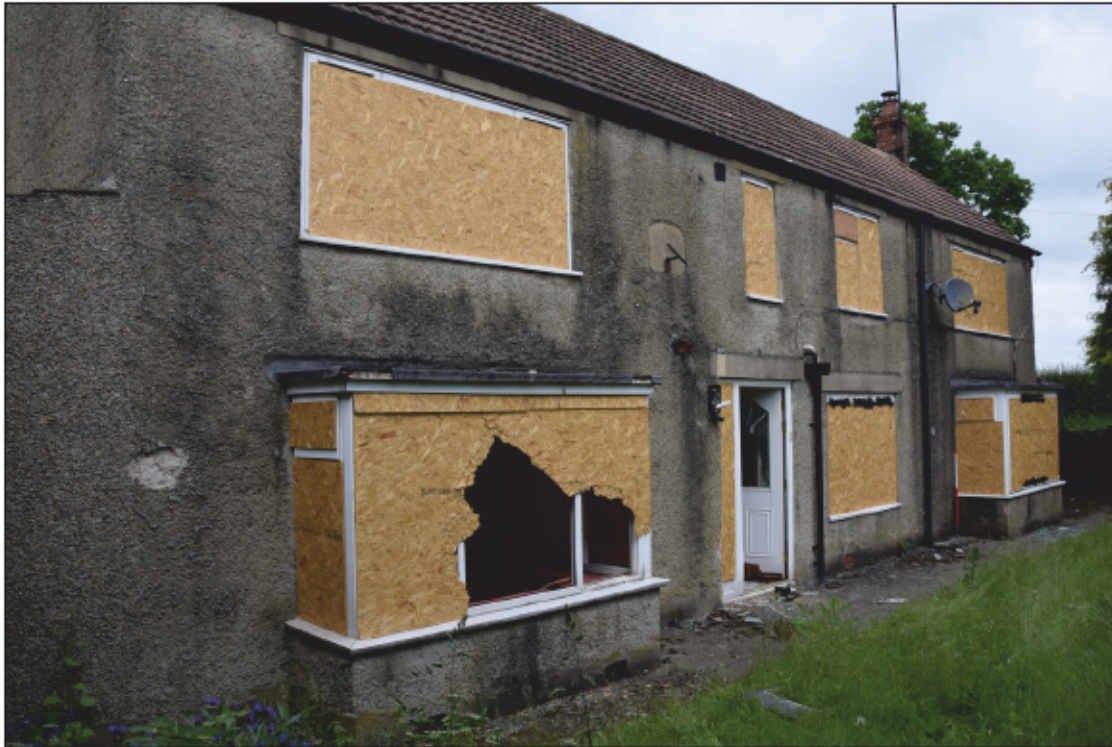
Photograph 7: The house seen from the south corner of the garden

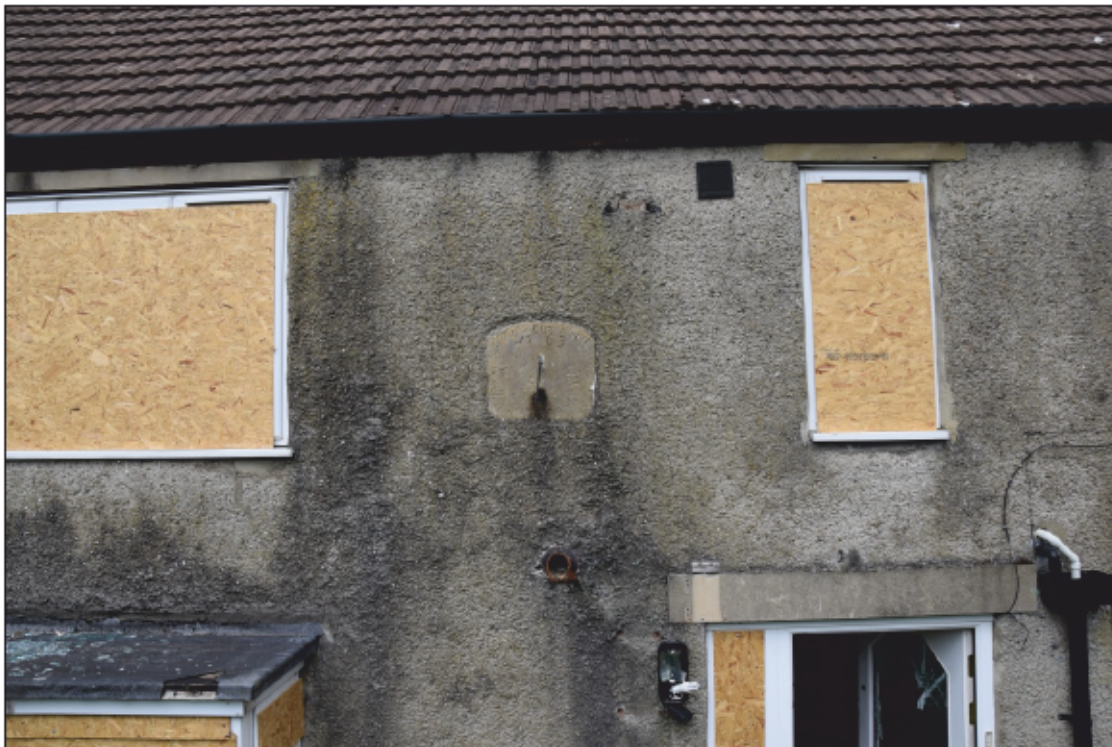
Photograph 8: The sundial above the altered front door

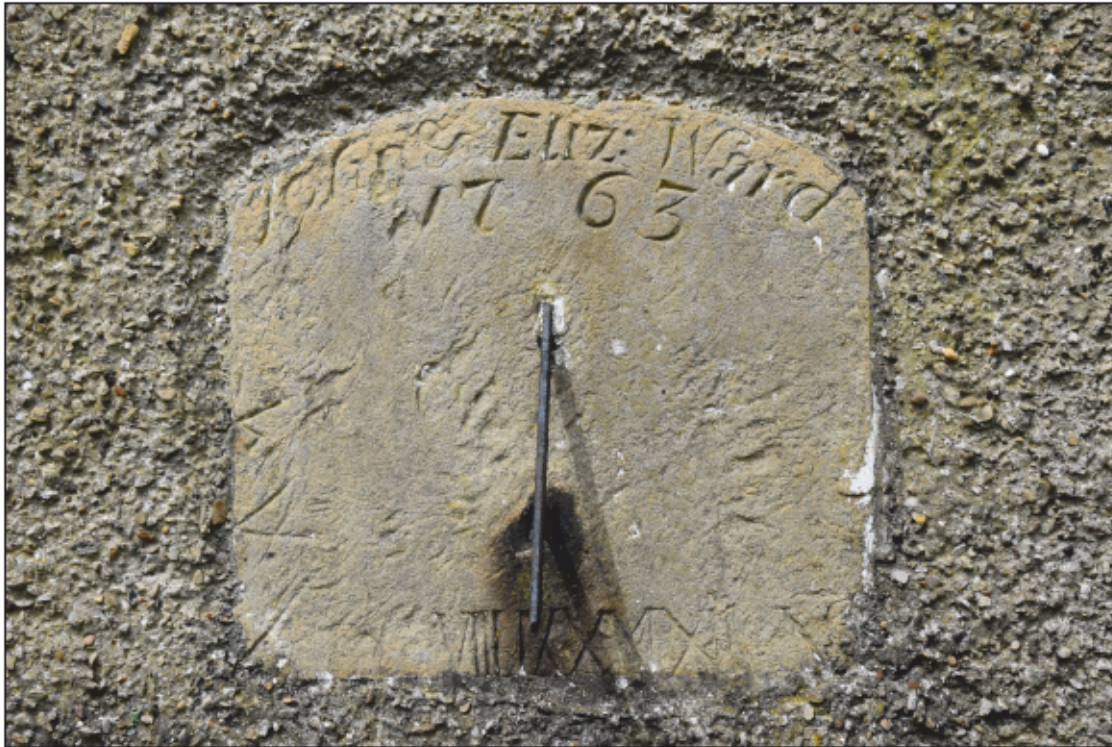
Photograph 9: Detail of the sundial with the inscription John & Eliz: Ward 1763

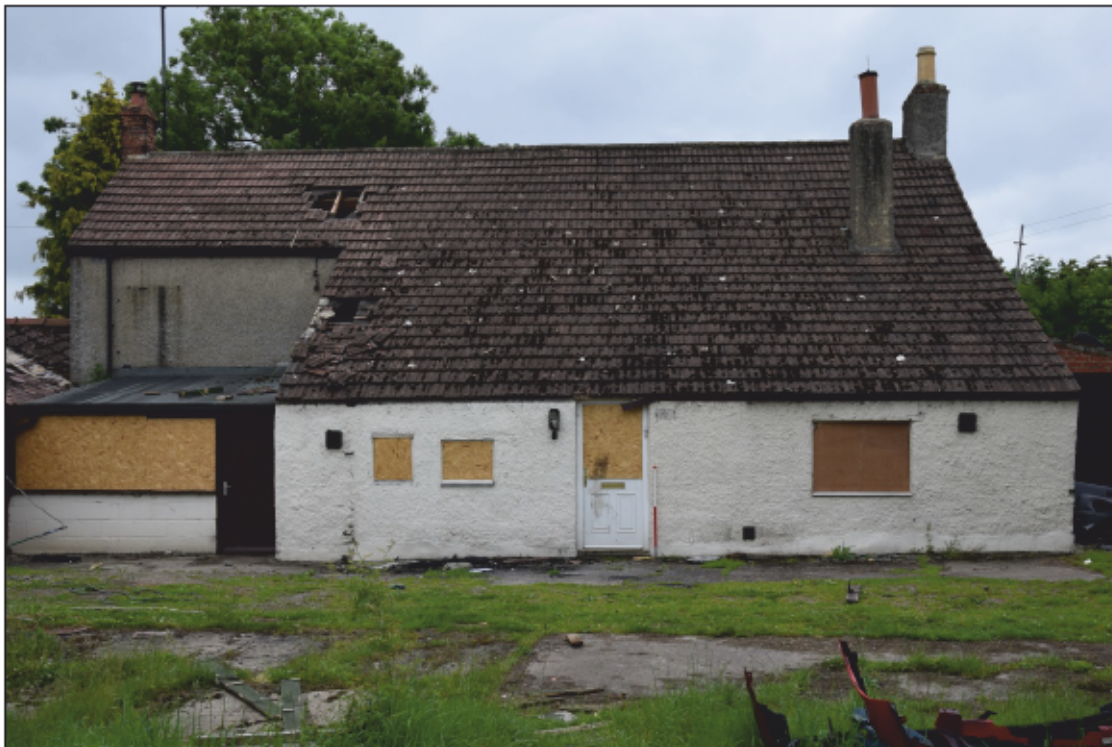
Photograph 10: The rear of the house, with the later extension visible as the grey wall at the left

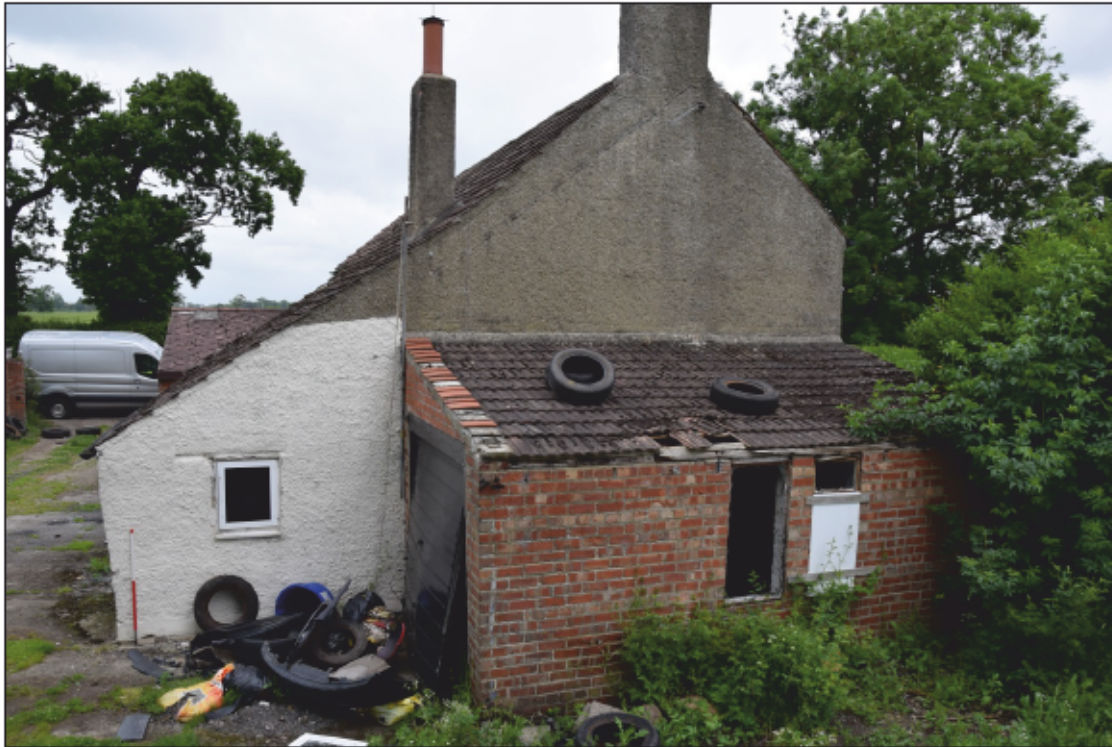
Photograph 11: The south-west end and the brick garage. What appears to be an old roof line is the mark of a later fixture on the gable

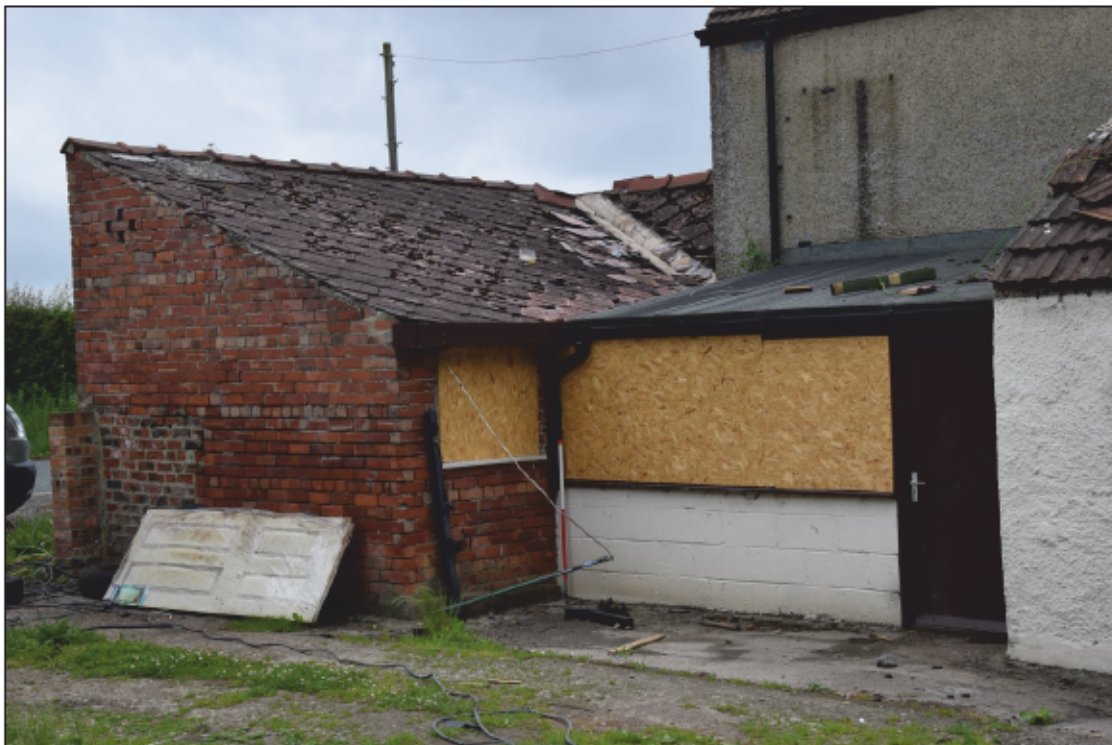
Photograph 12: The sheds at the north-east end of the house

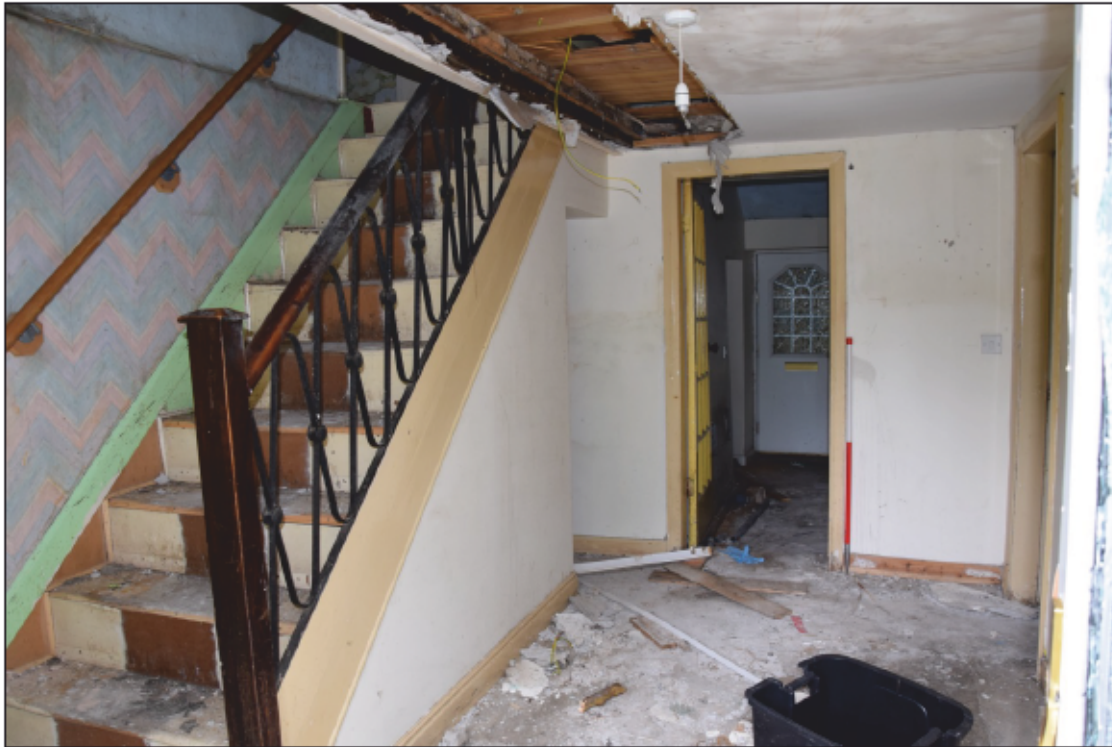
Photograph 13: The hall and staircase

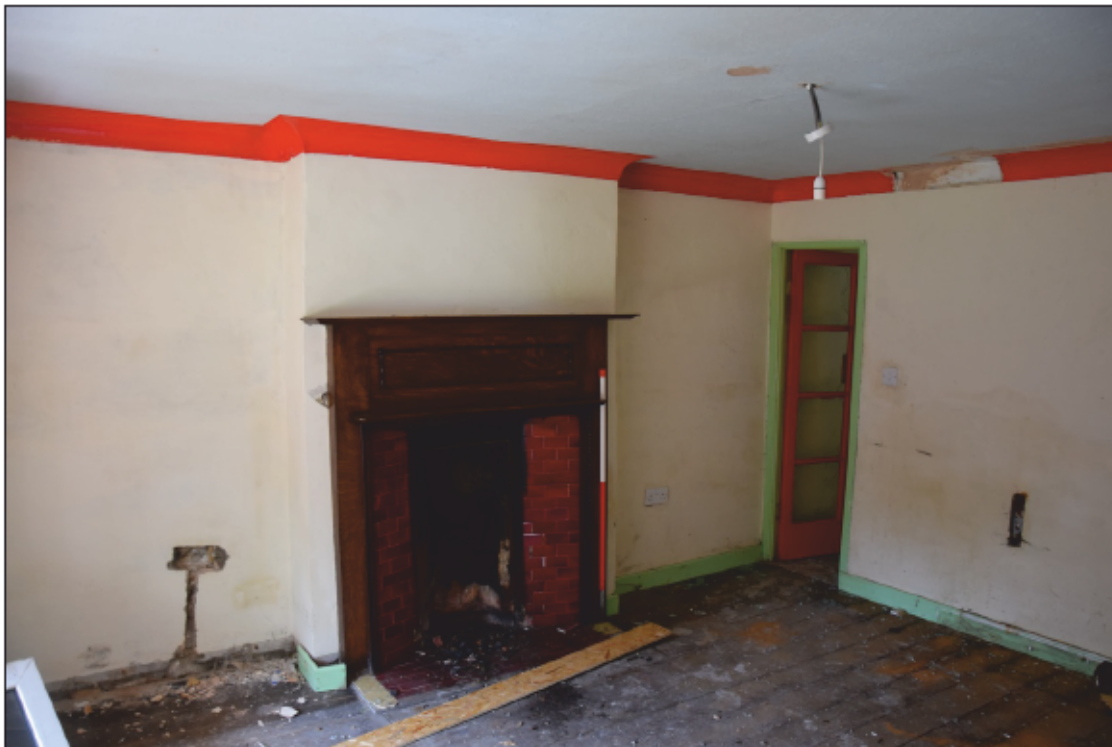
Photograph 14: The dining room, with the surviving fireplace and the narrow door to the kitchen

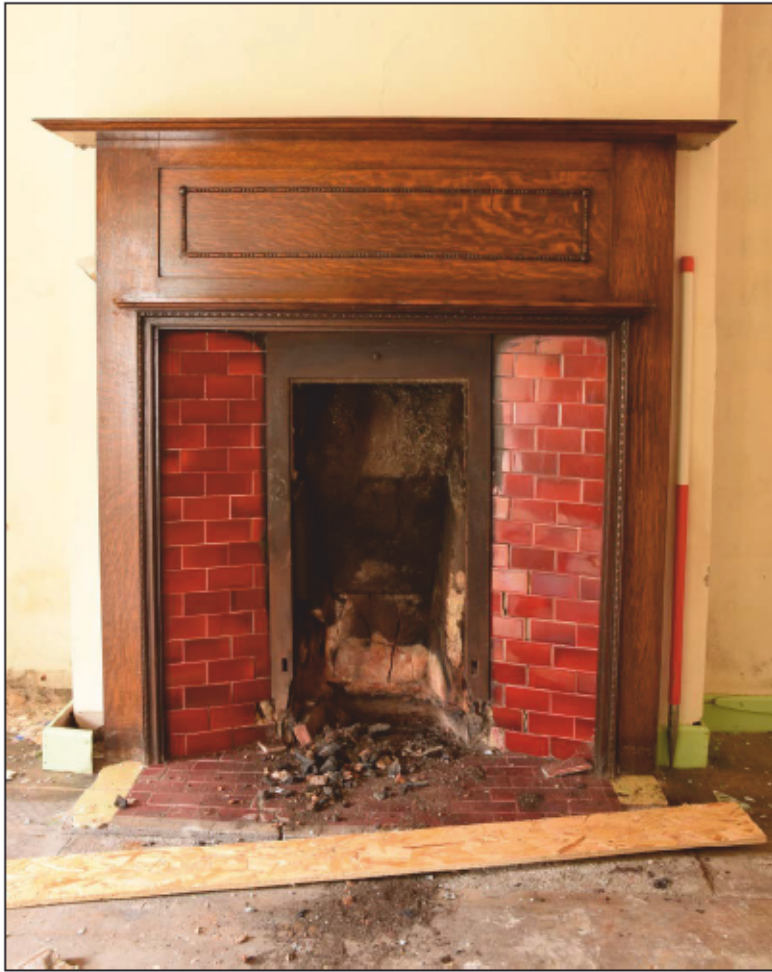
Photograph 15 (left):
Detail of the dining room
fireplace

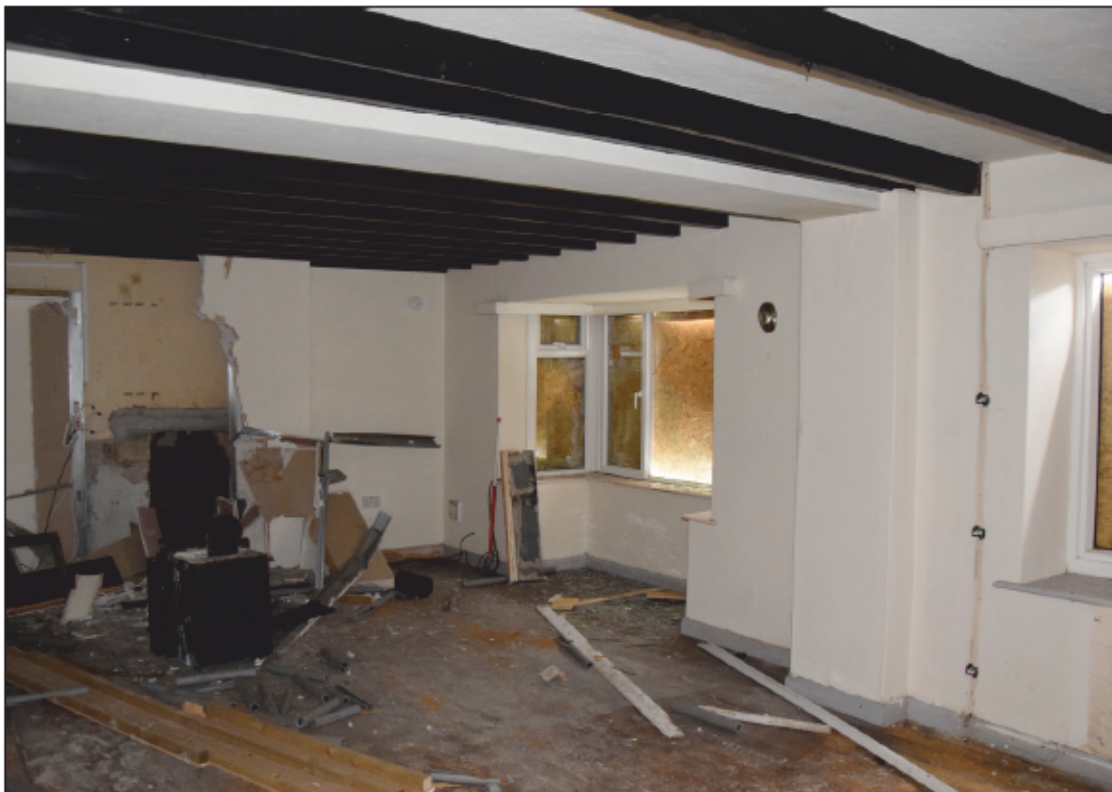
Photograph 16 (below):
The living room, seen
from the hall door. The
thick wall stubs mark the
end of the house before
the extension was added

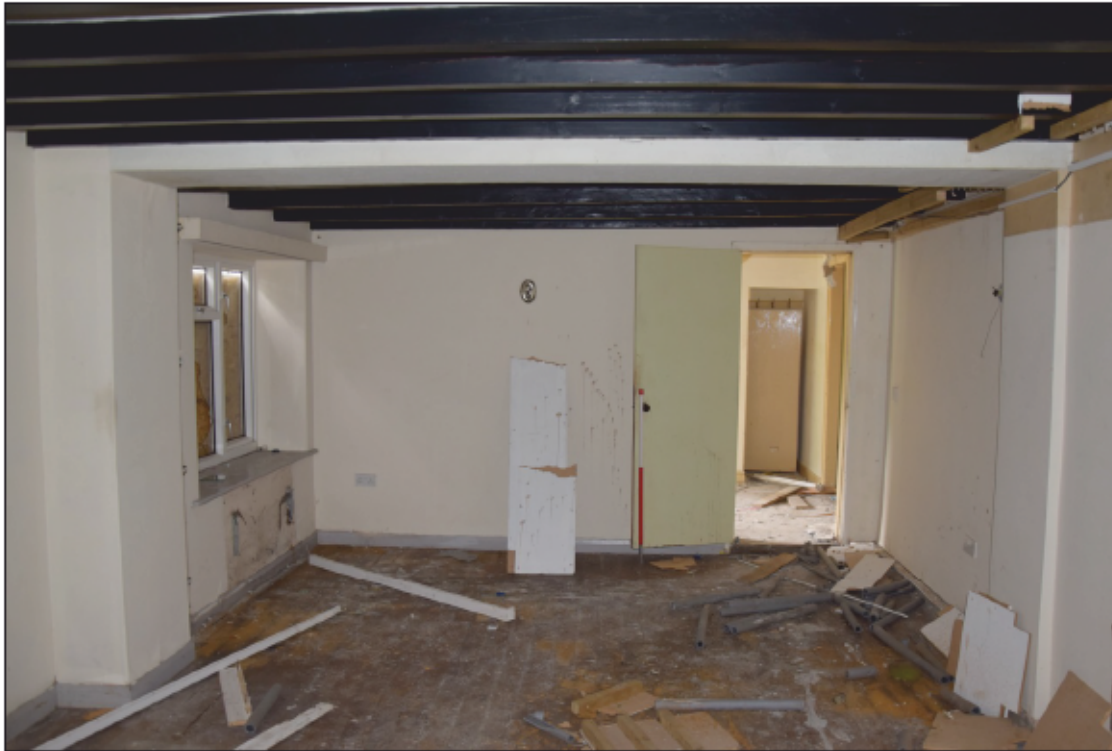
Photograph 17: The sitting room seen from the north-west end

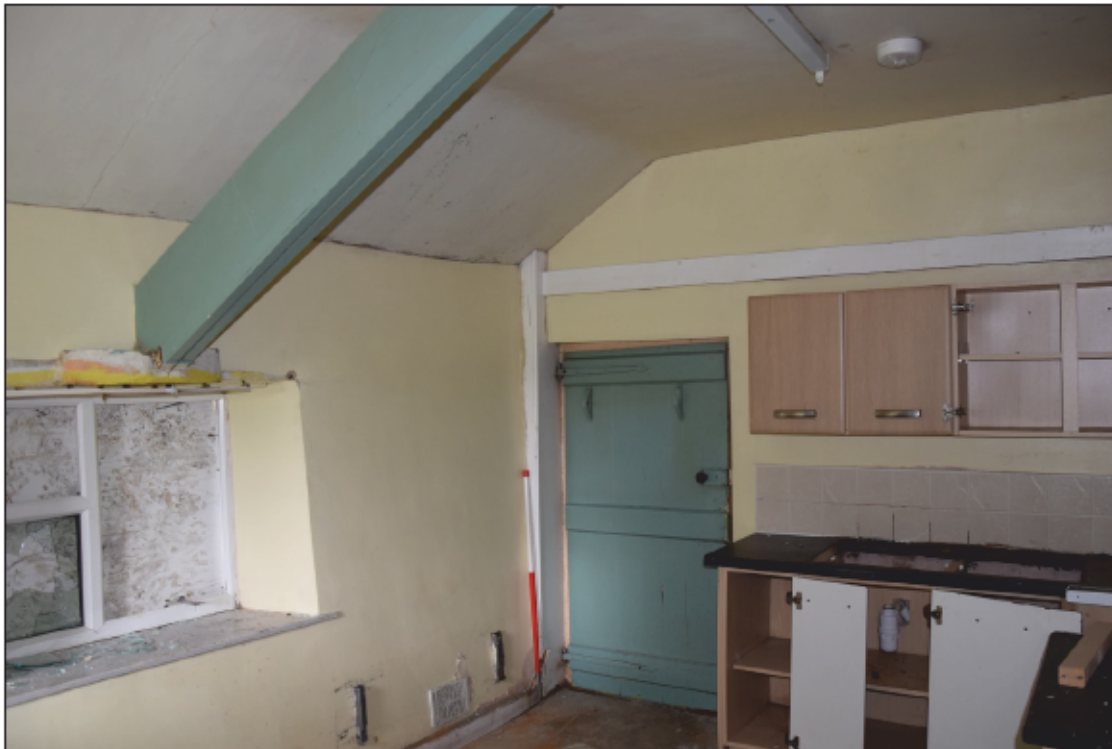
Photograph 18: The outshut kitchen, with the exposed roof truss carried on a projecting slab above the window

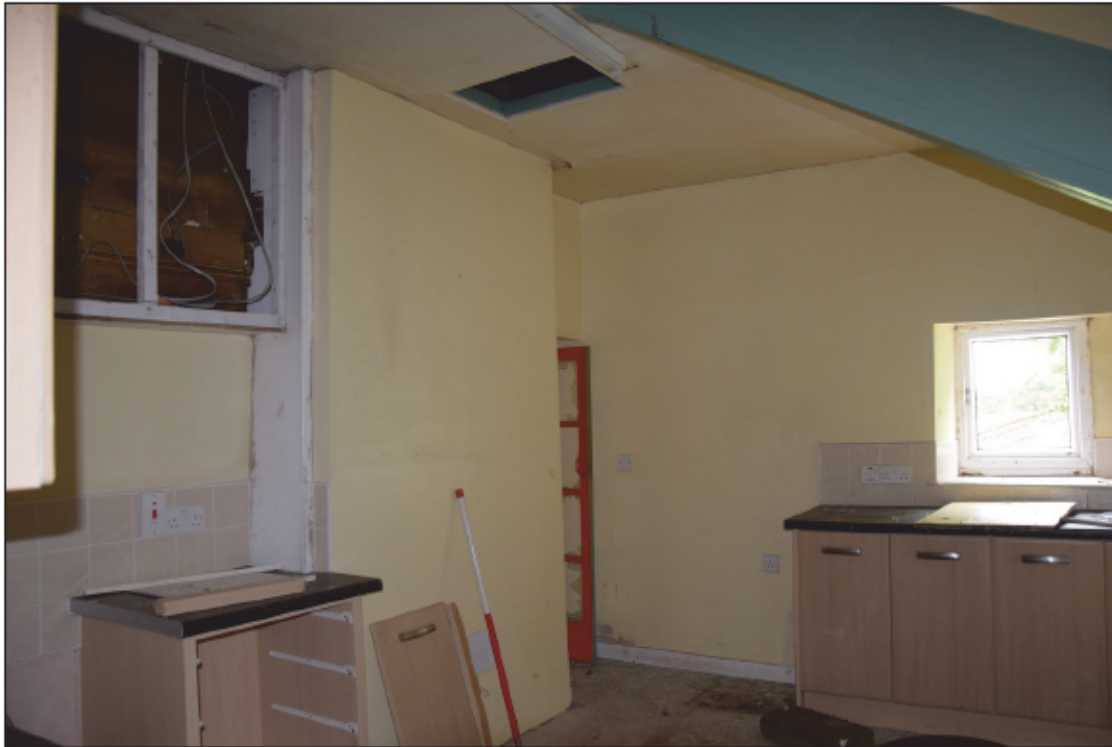
Photograph 19 (above): The blind chimney breast in the kitchen. A view looking south

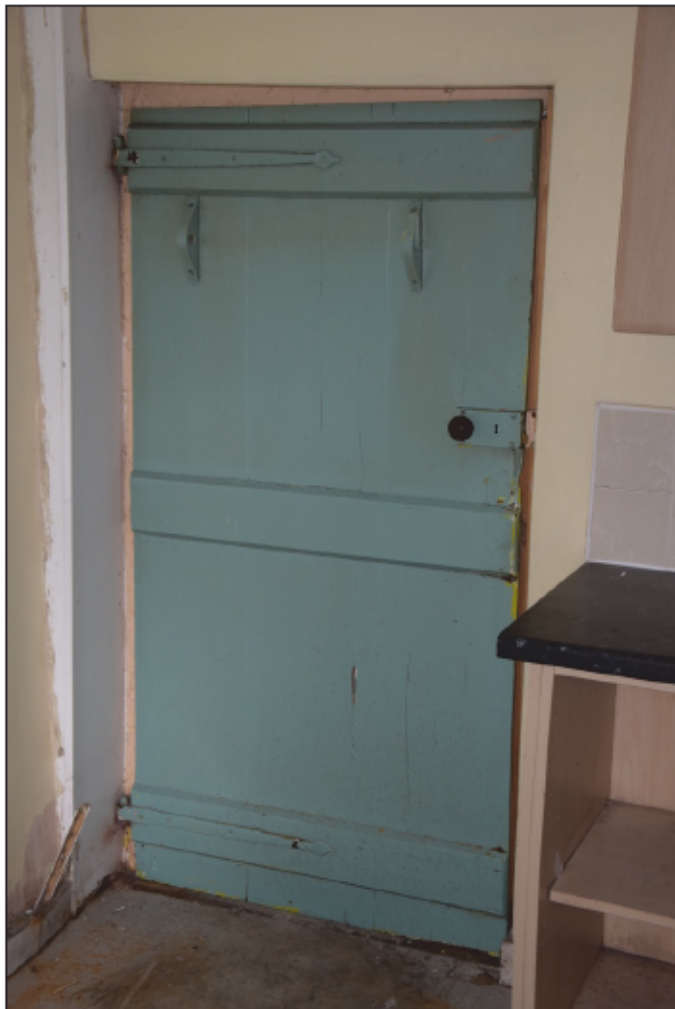
Photograph 20 (left): The old plank door in the kitchen

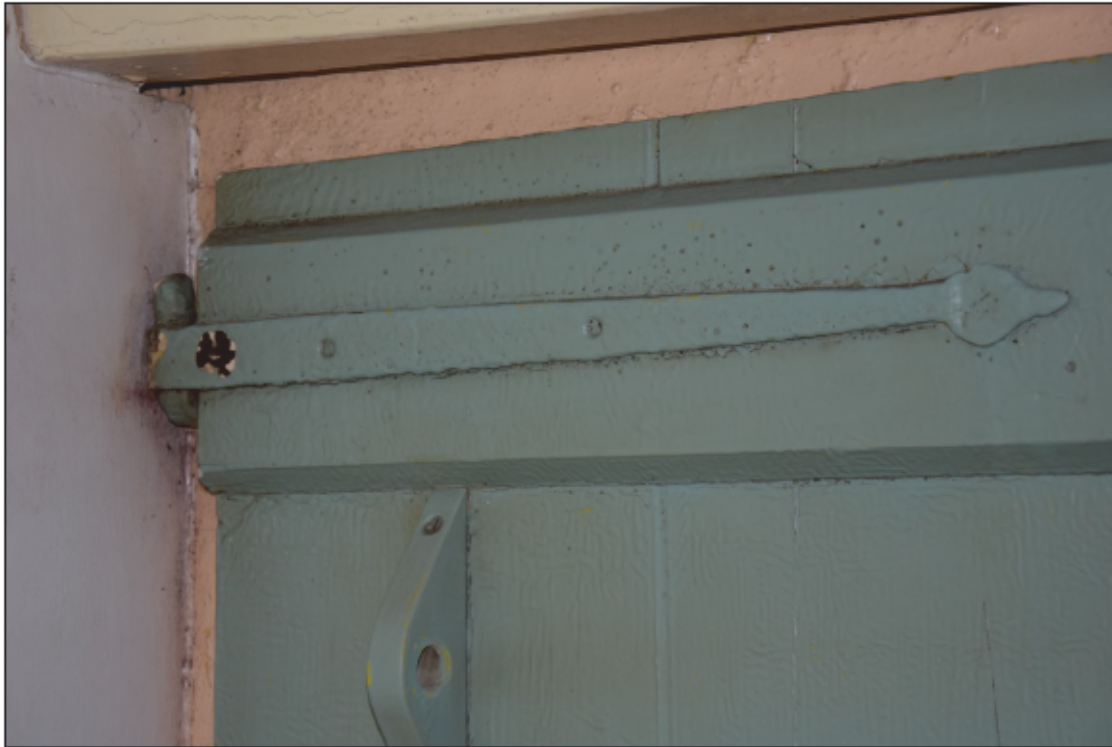
Photograph 21: Detail of the strap hinge and pintles of the kitchen door

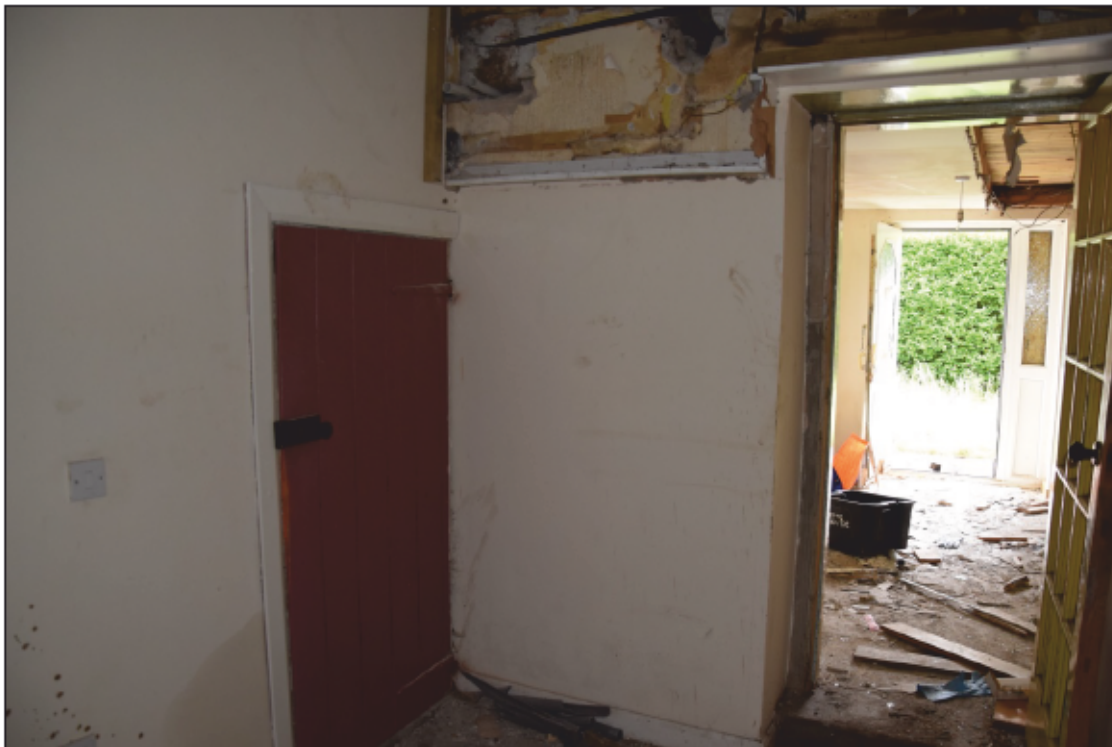
Photograph 22: The lobby and hall, with the old door to the passage

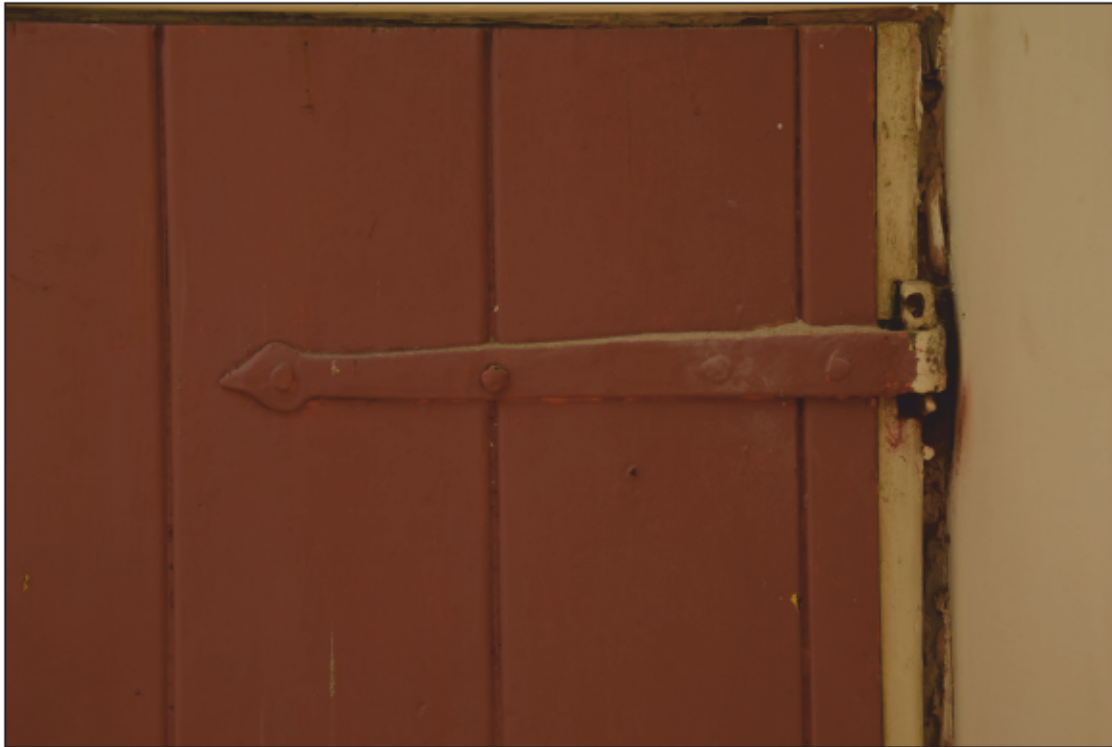
Photograph 23 (above): Detail of another old strap hinge on the lobby door

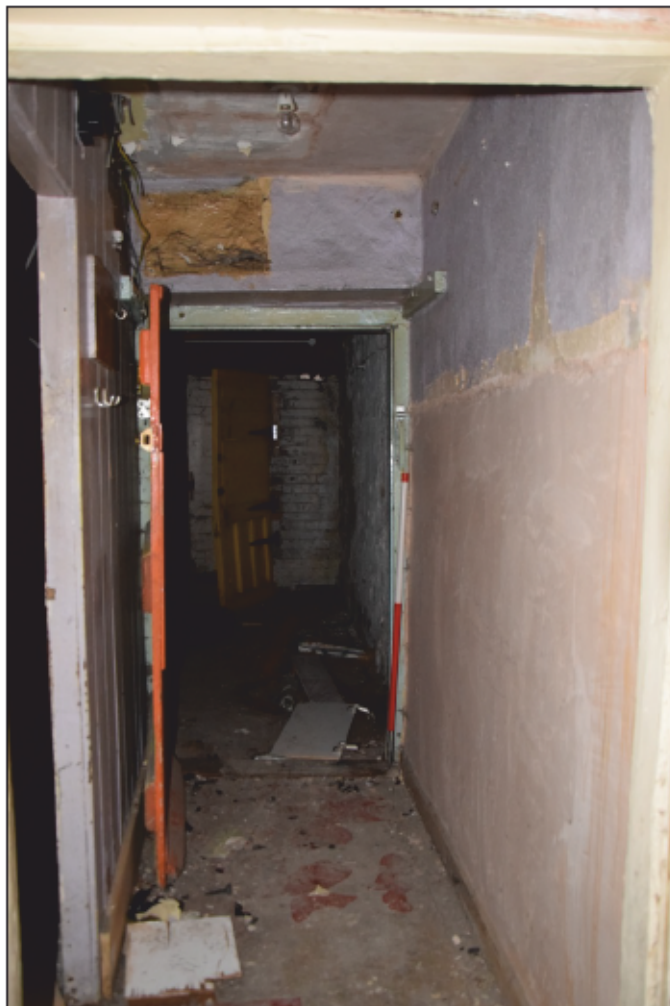
Photograph 24 (left): The passage at the back of the house. A view looking north-east

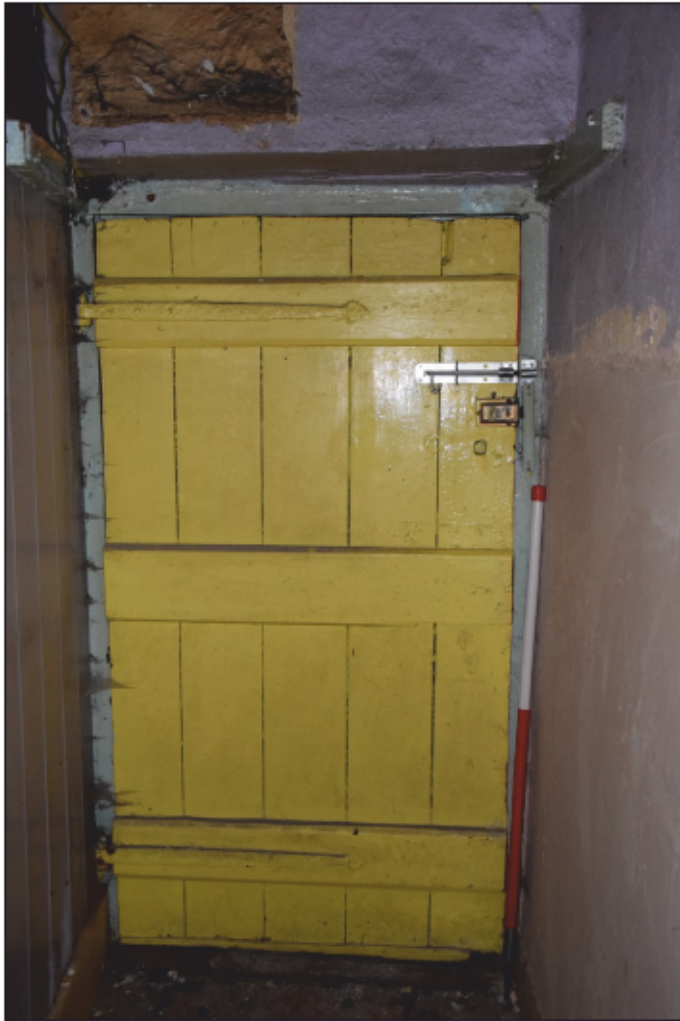
Photograph 25 (left): Old plank door at the north-east end of the passage

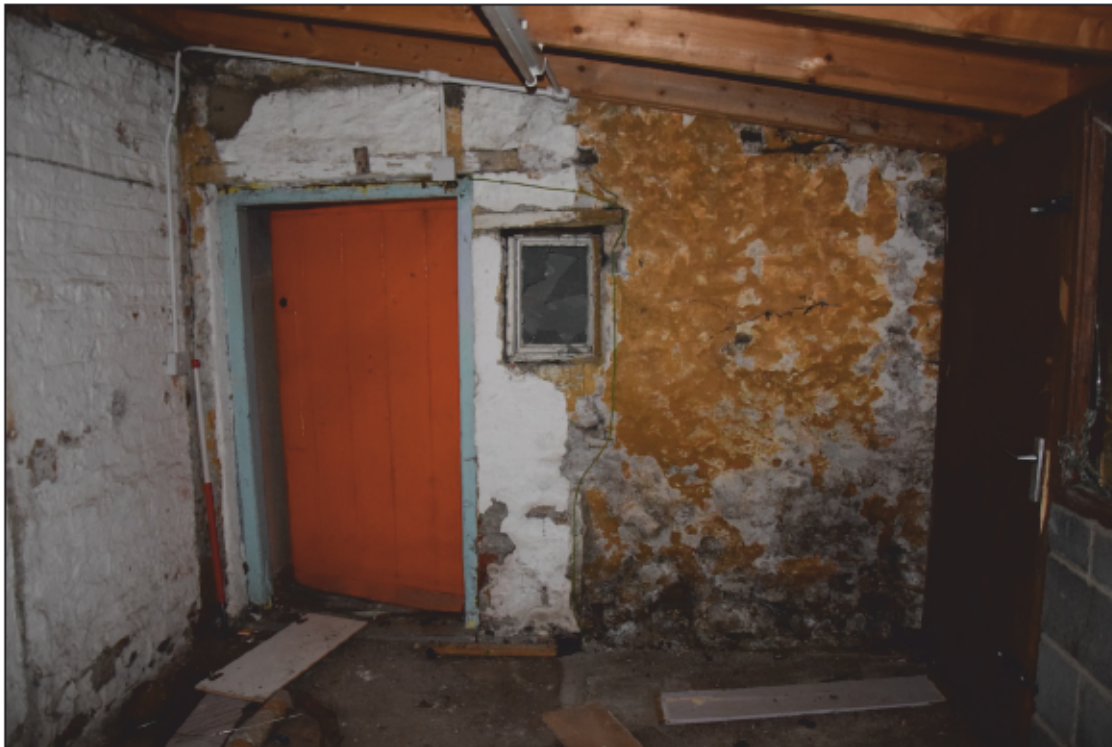
Photograph 26 (below): The north-east face of the outshut seen from inside the modern shed

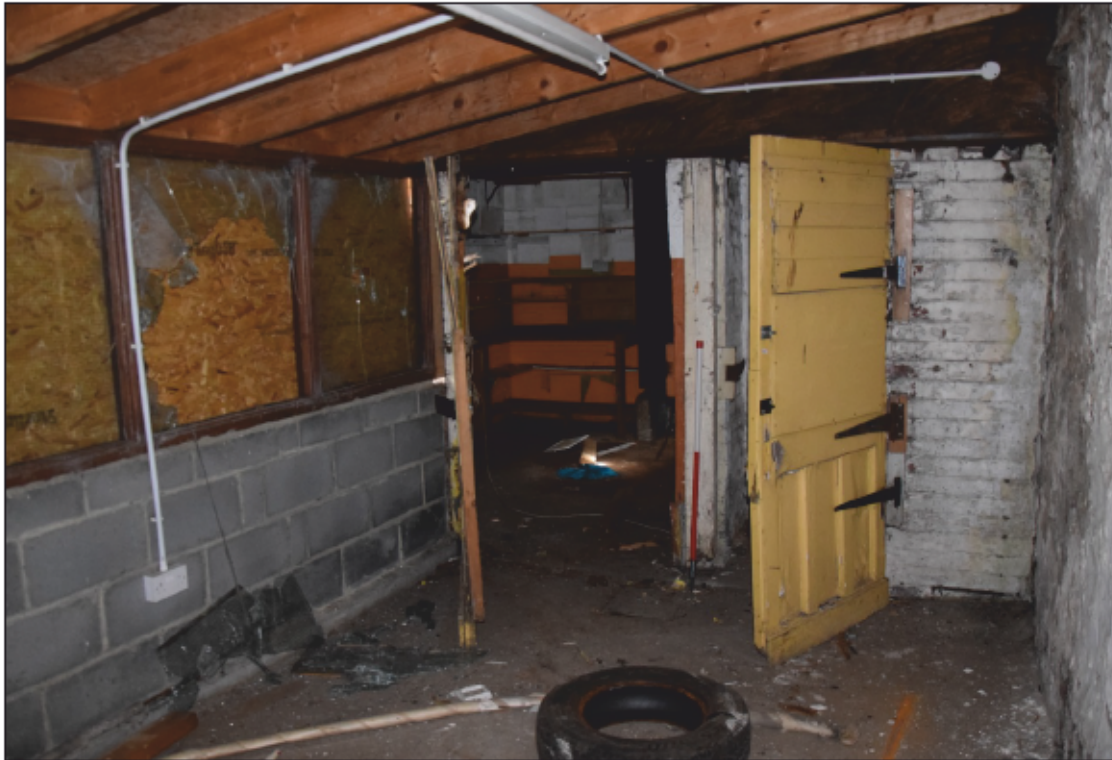
Photograph 27: Doors to the older workshop sheds seen from the later concrete structure. A view looking north
