ARCHAEOLOGICAL
SERVICES
DURHAM UNIVERSITY

Stag House Farm
Darlington

archaeological building recording

report 4804
June 2018

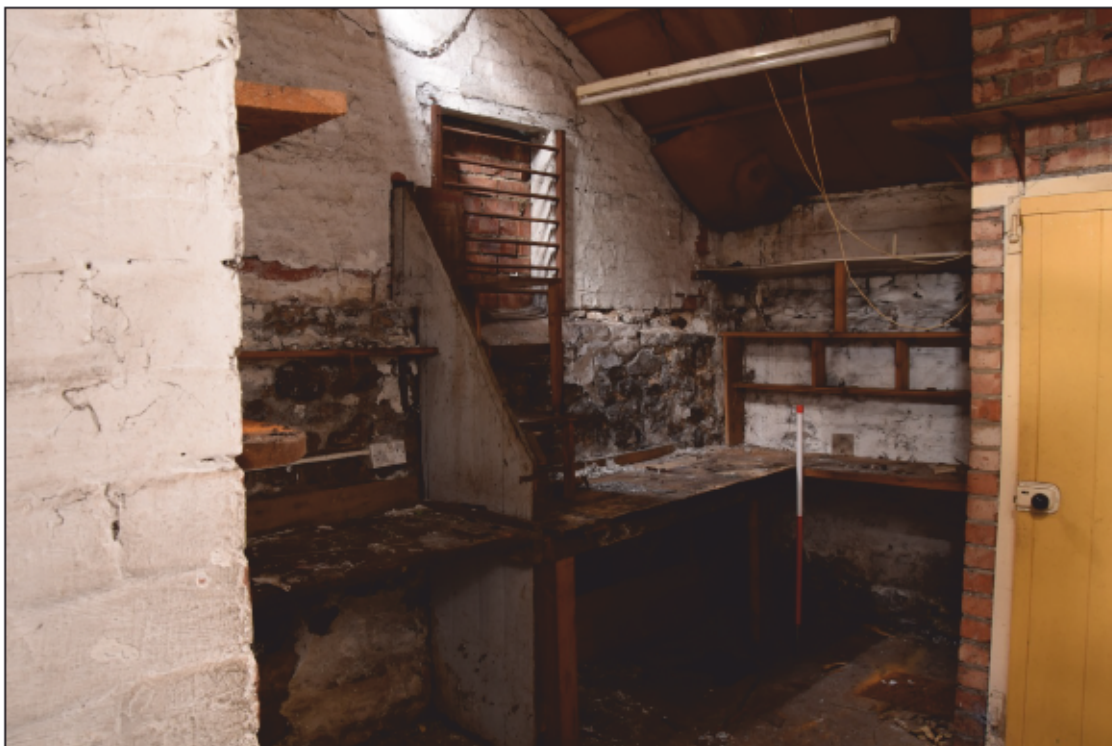
Photograph 28: The old shed at the south-east side; note the stonework of the lower walls, and the blocked window above

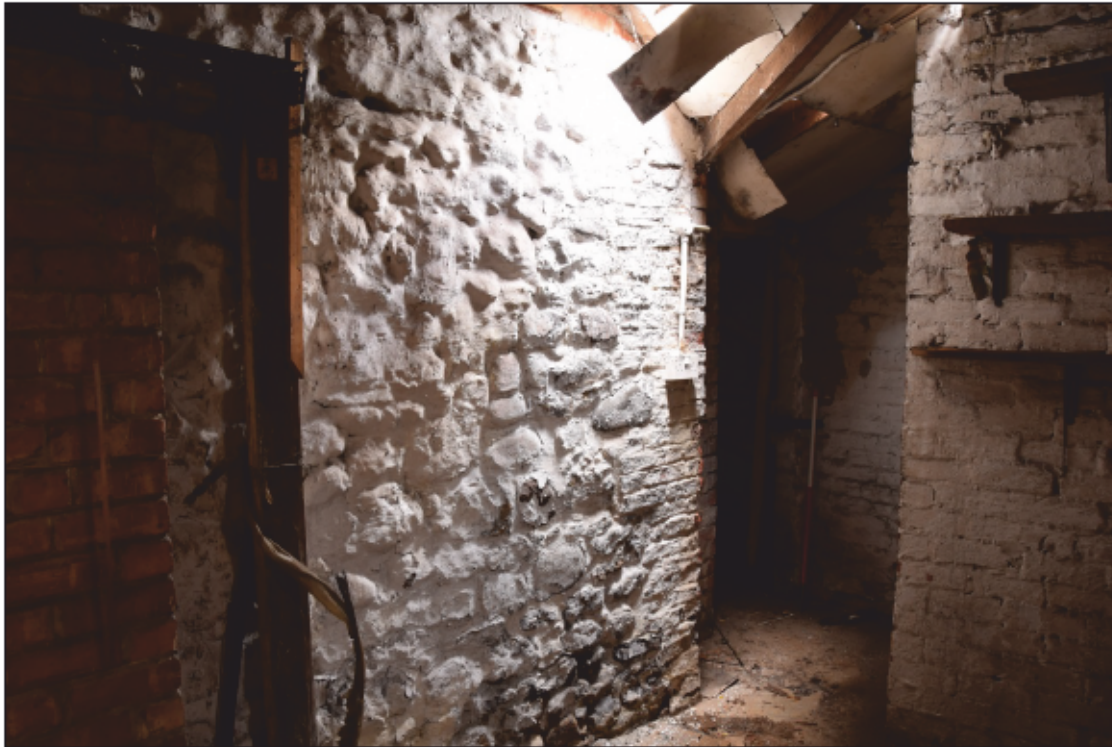
Photograph 29: The north corner of the house extension seen in the shed; note the brickwork at the angle

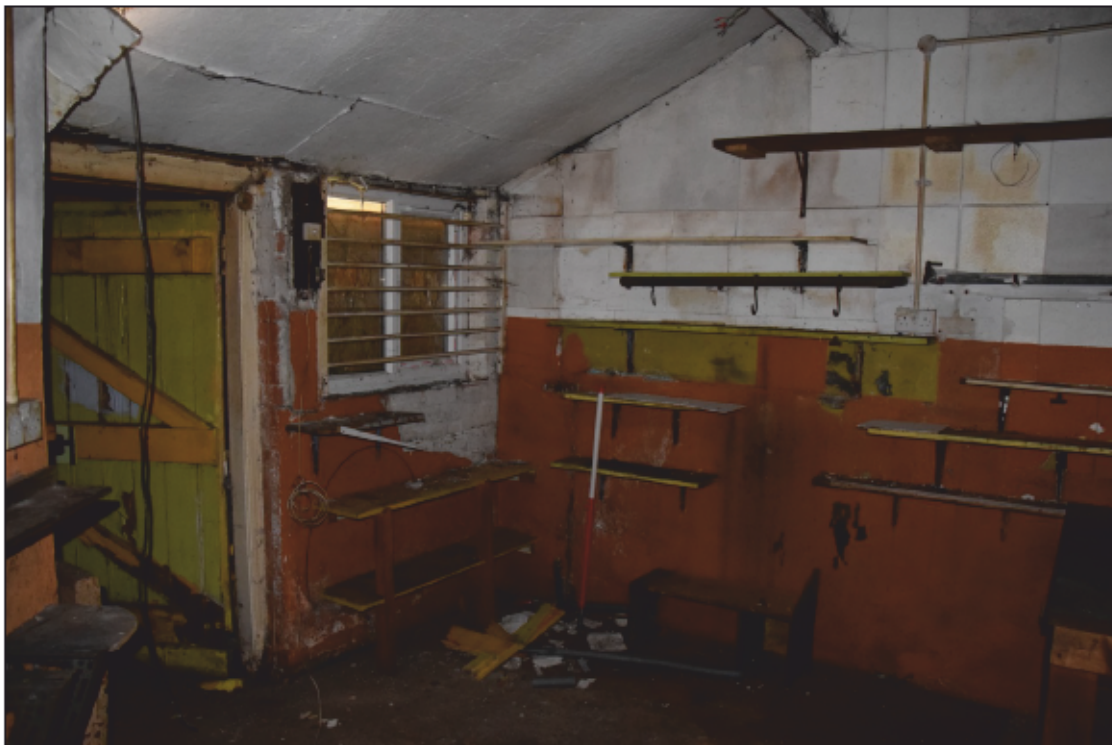
Photograph 30: The north-west shed

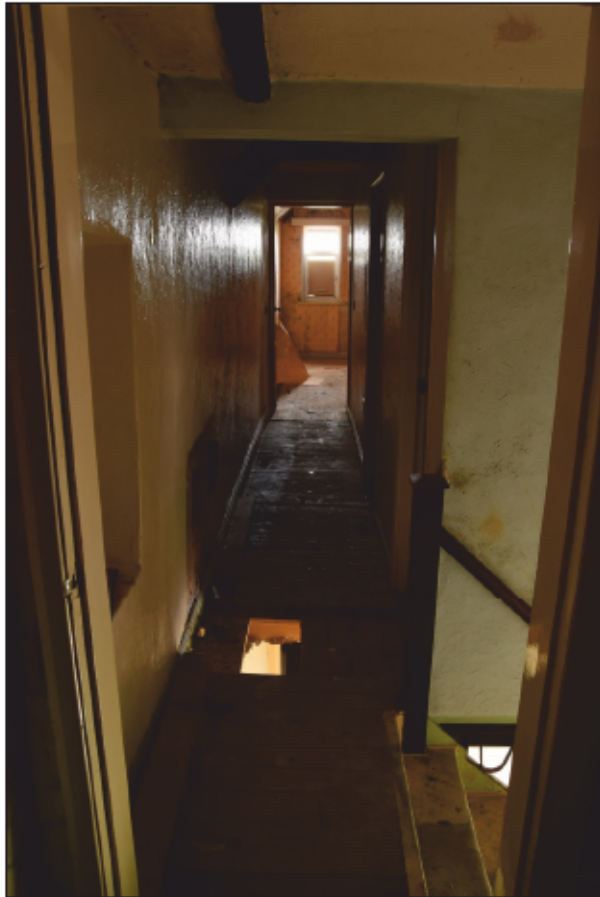
Photograph 31: The landing, seen from the south-west end

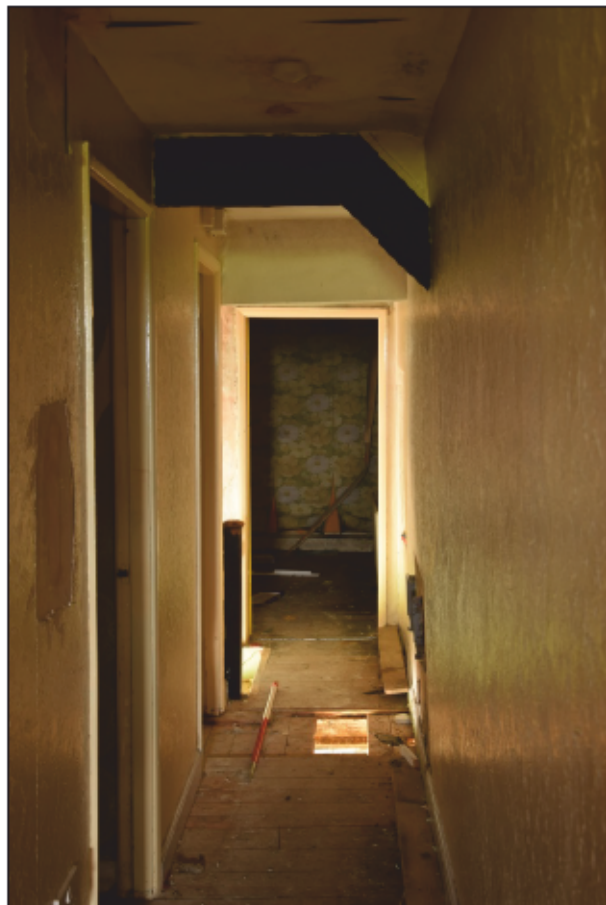
Photograph 32: The landing seen from the bedroom in the extension

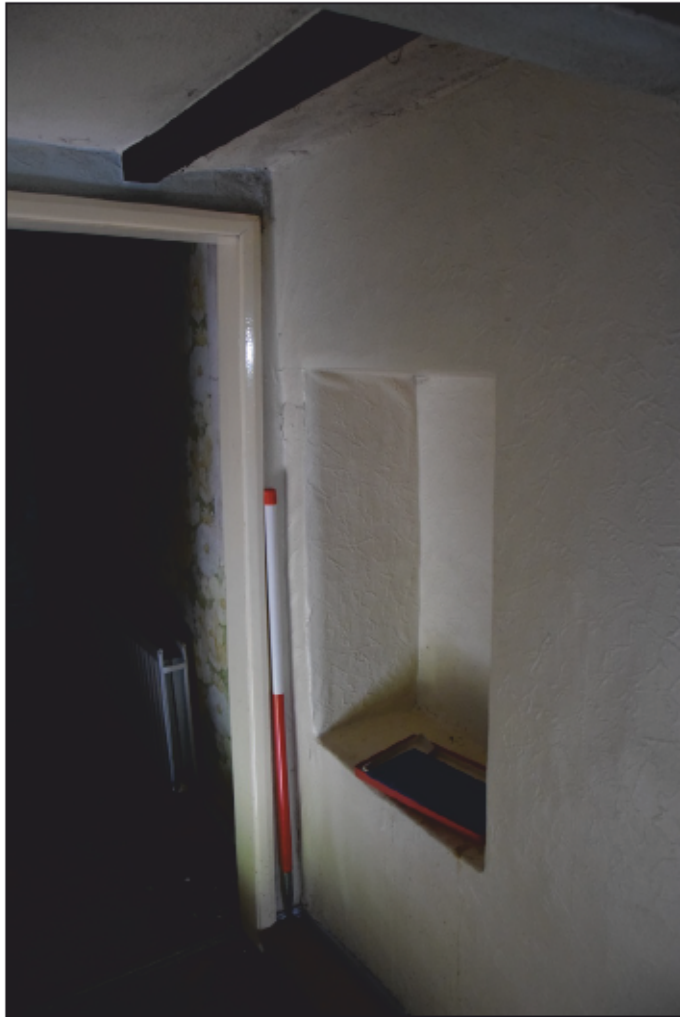
Photograph 33 (left): A blocked widow at the head of the staircase

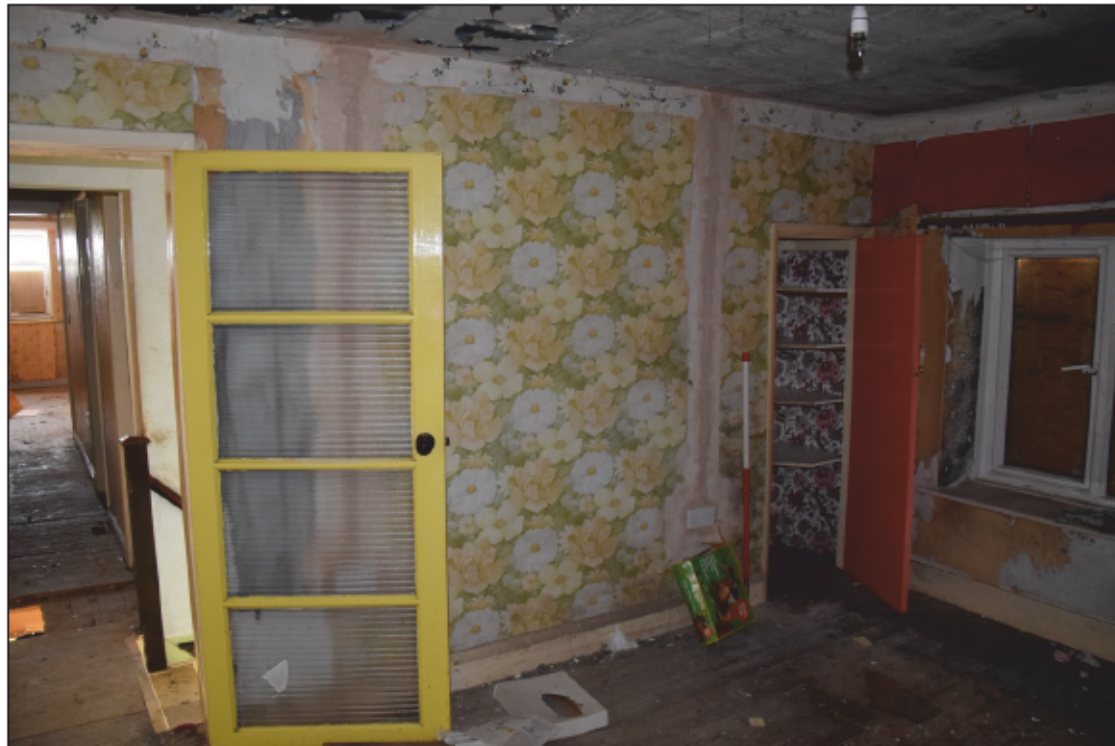
Photograph 34 (below): The bedroom at the south-west end of the old house

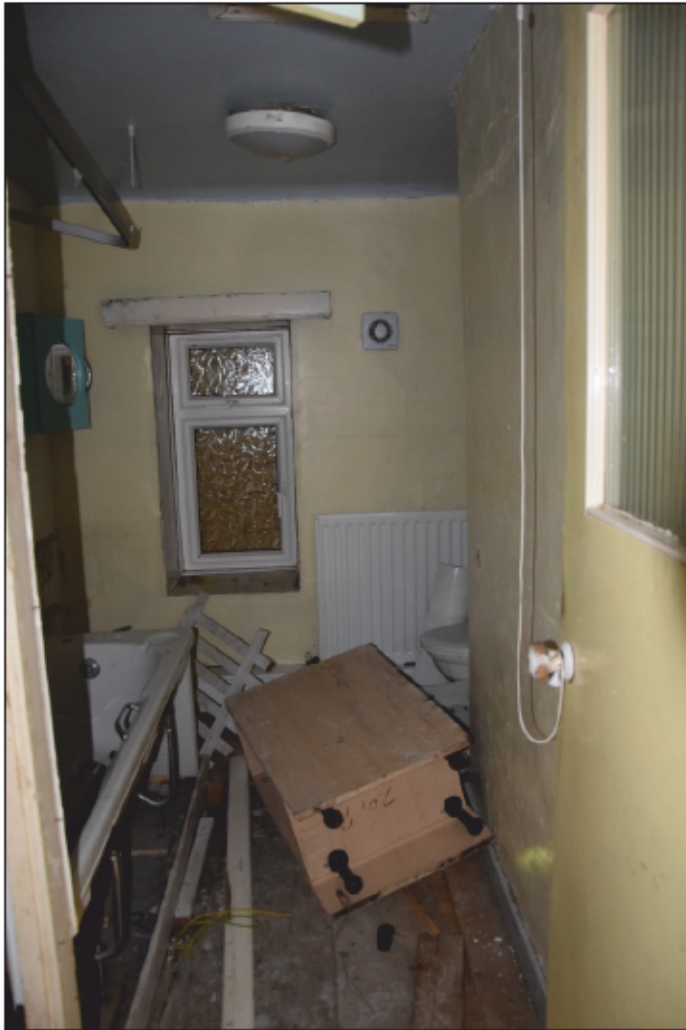
Photograph 35 (left): The bathroom, damaged by thieves

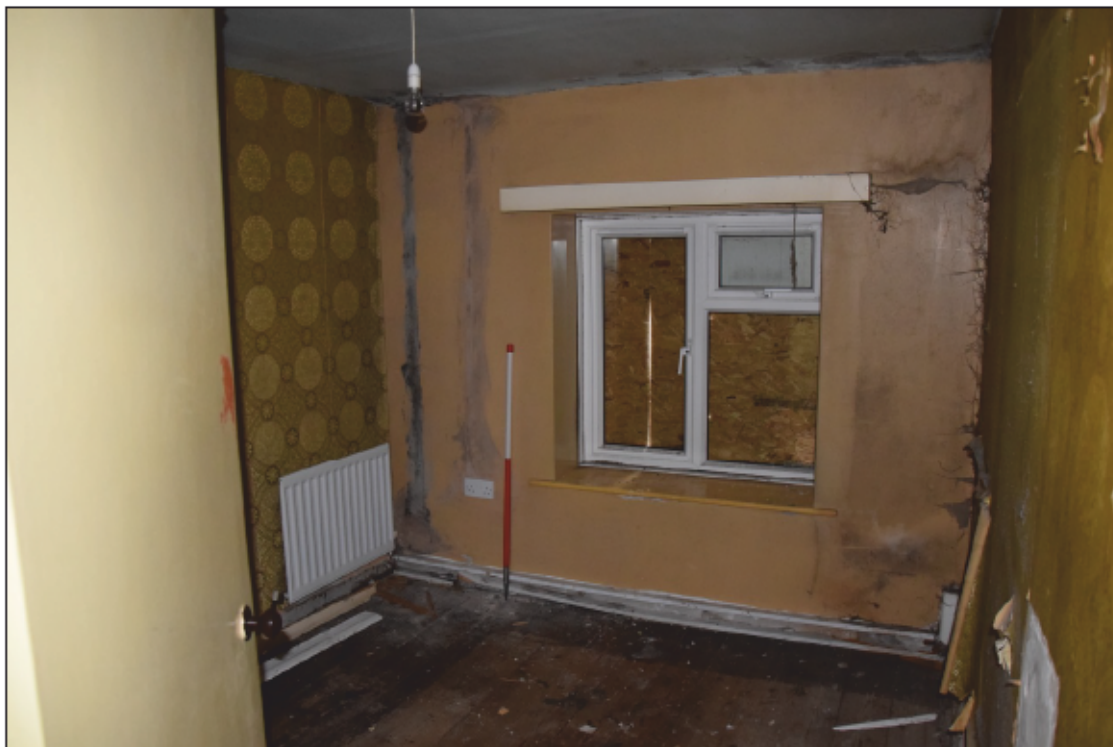
Photograph 36 (below): The middle bedroom

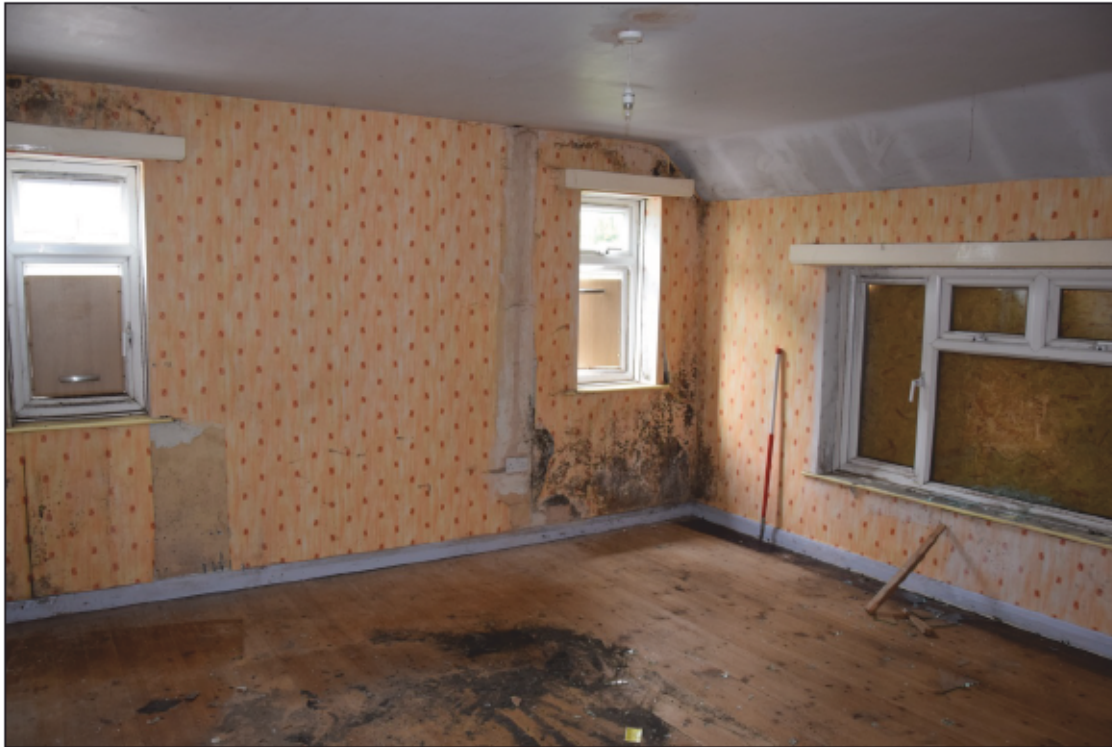
Photograph 37: The large north-east bedroom, with modern uPVC windows

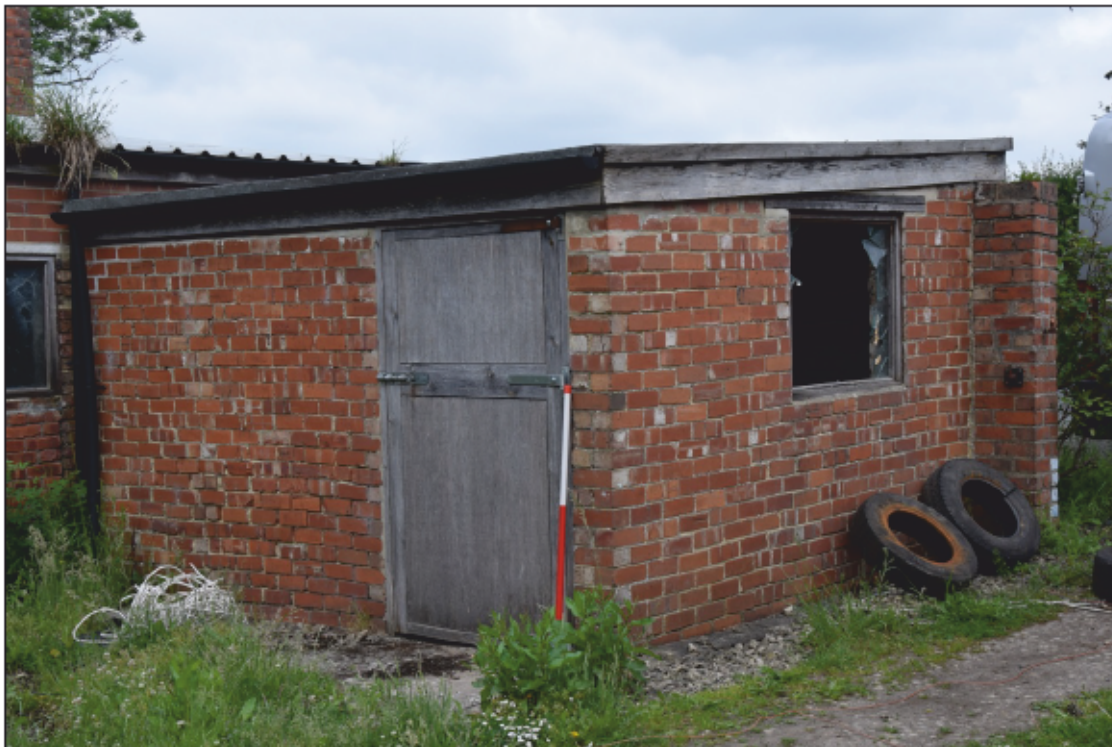
Photograph 38: The brick workshop seen from the yard

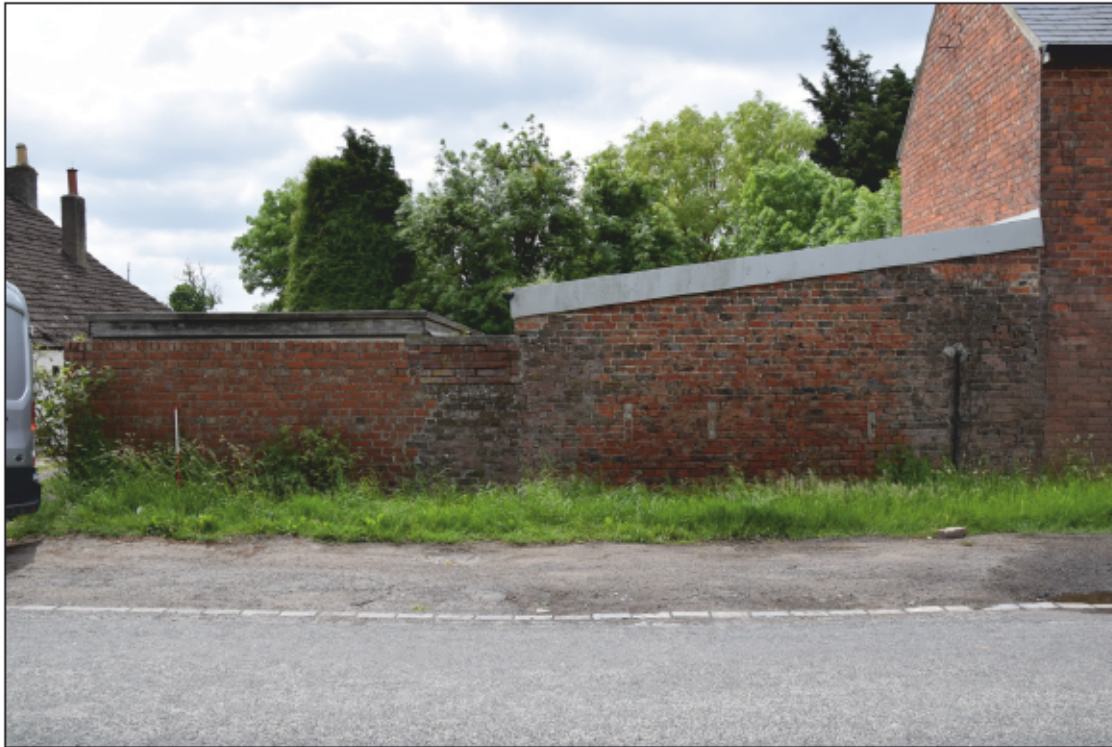
Photograph 39: The workshop, coal shed and byre seen from the other side of Newton Lane

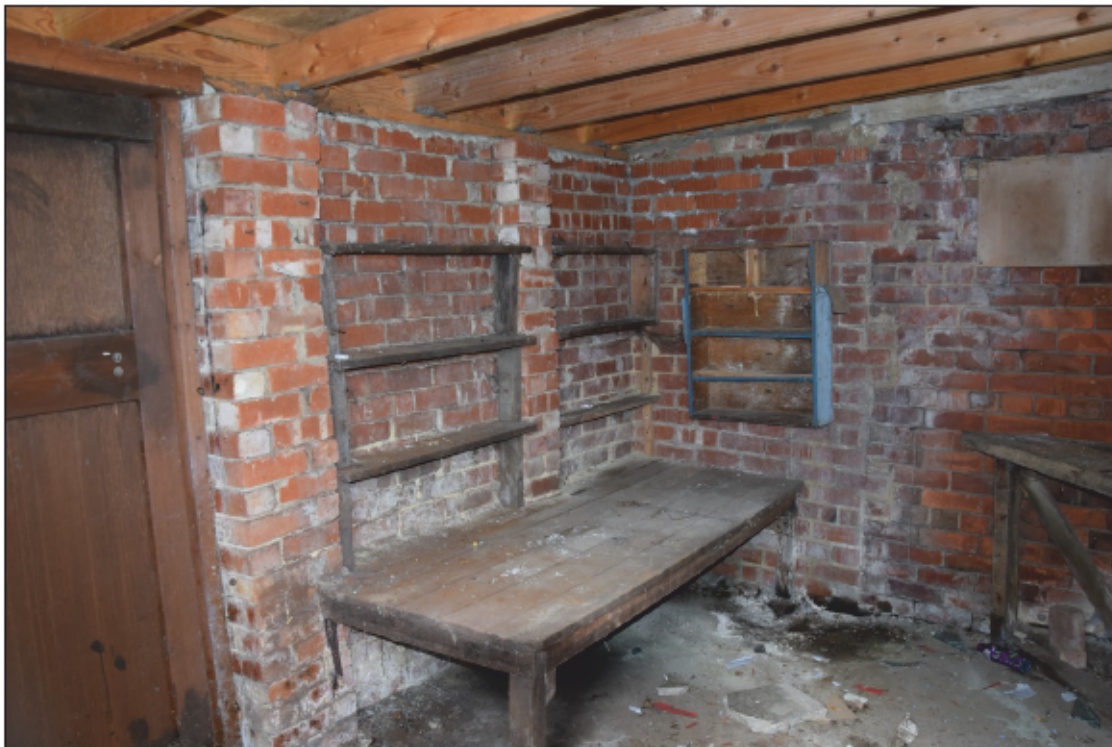
Photograph 40: Interior of the workshop

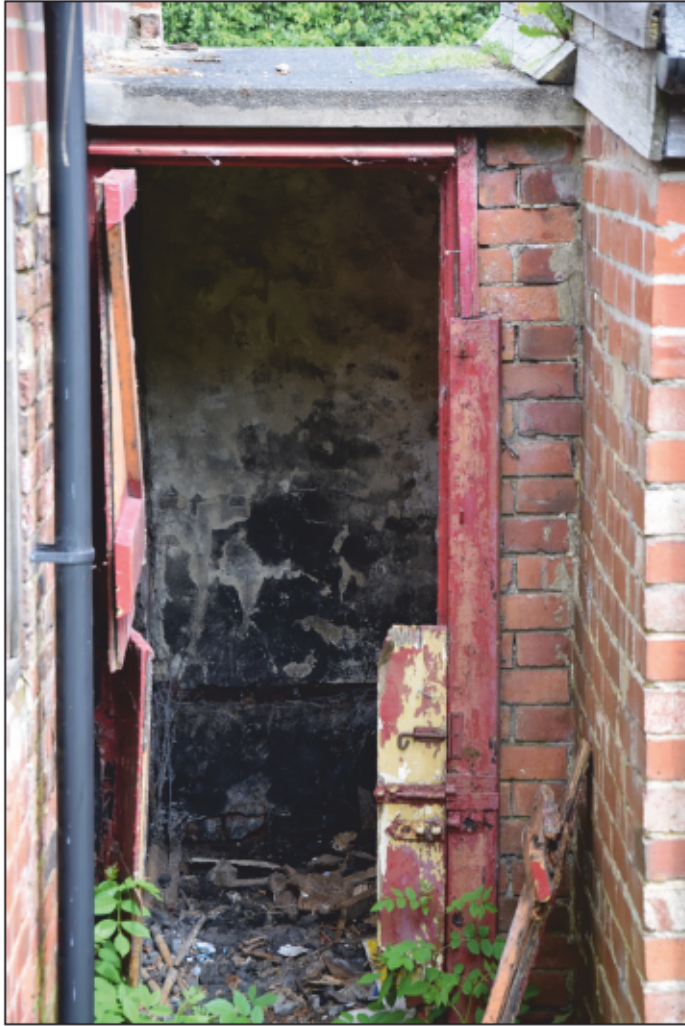
Photograph 41 (left): The coal shed. The mark of a timber privy seat can be seen in the back wall

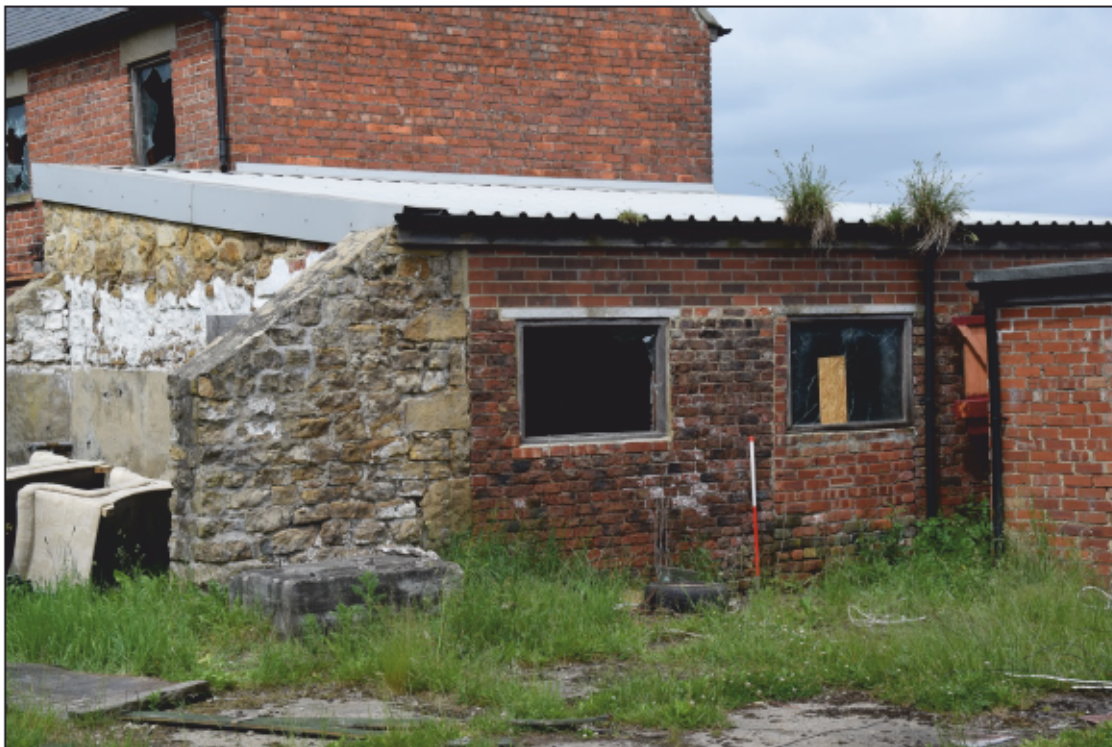
Photograph 42 (below): The byre and the end of the older stone building, seen from the yard

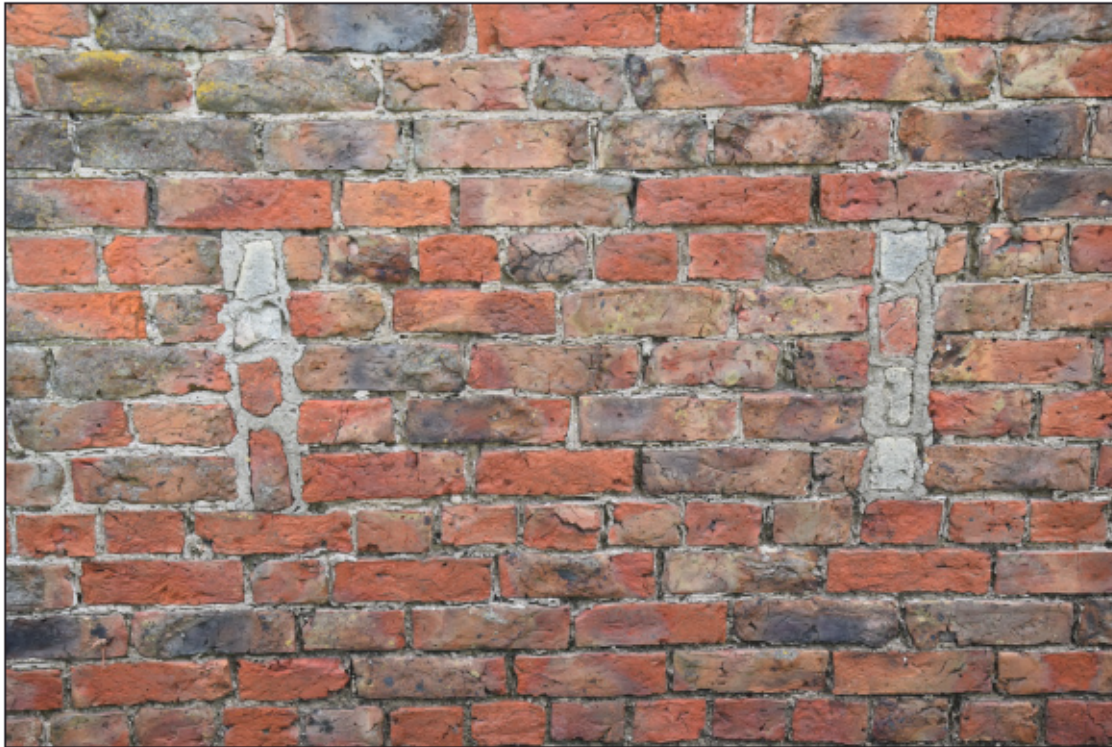
Photograph 43: Blocked breather slits in the north-east end of the brick byre

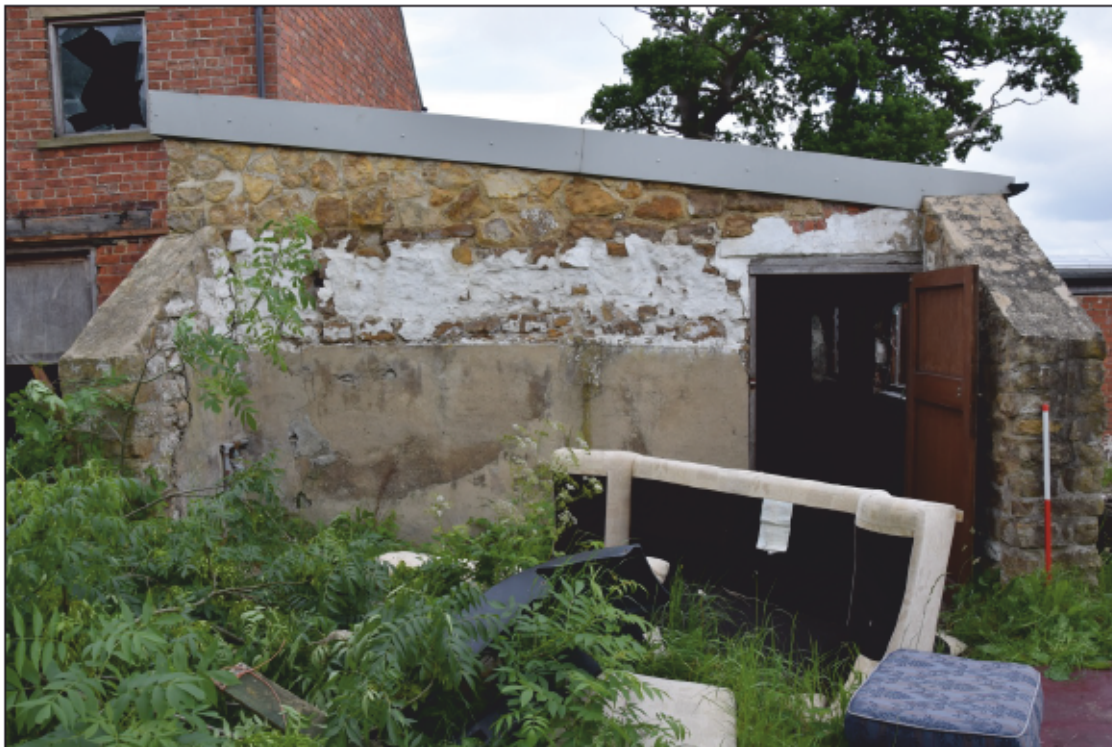
Photograph 44: The stump of the old stone building. Note the cement render beside the modern door to the byre

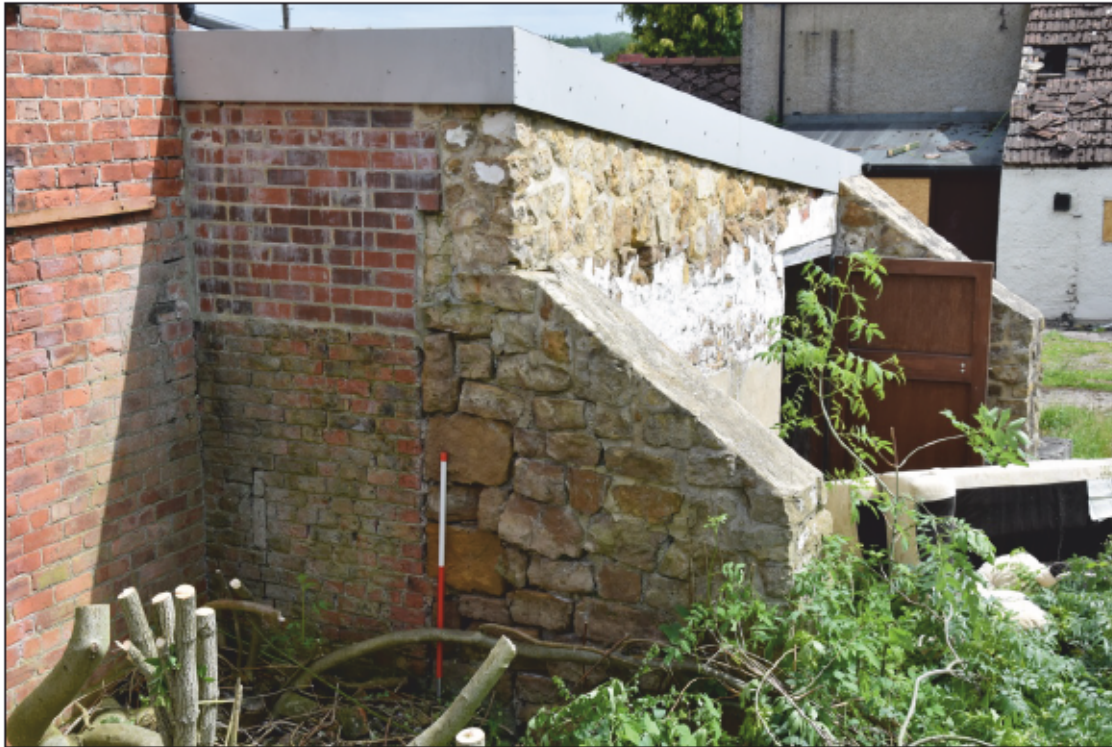
Photograph 45: The end of the stone building and the south corner of the brick byre; note the ventilator slit and the modern brickwork above

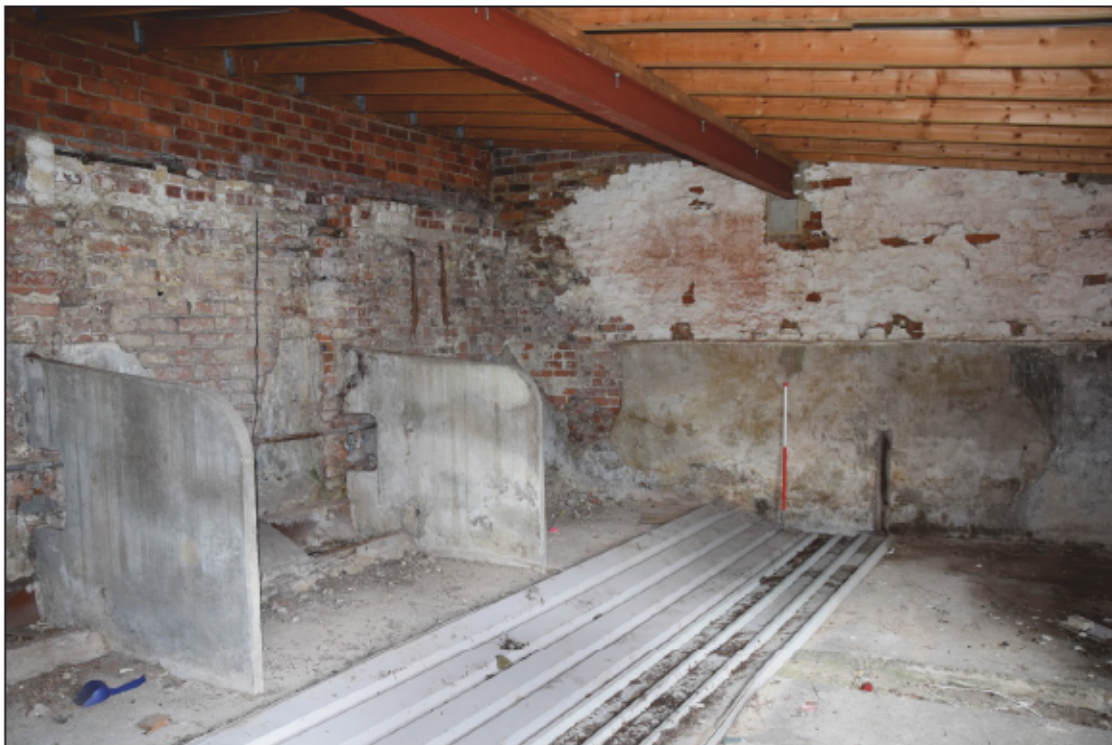
Photograph 46: Inside the brick byre; there is room for six cows here

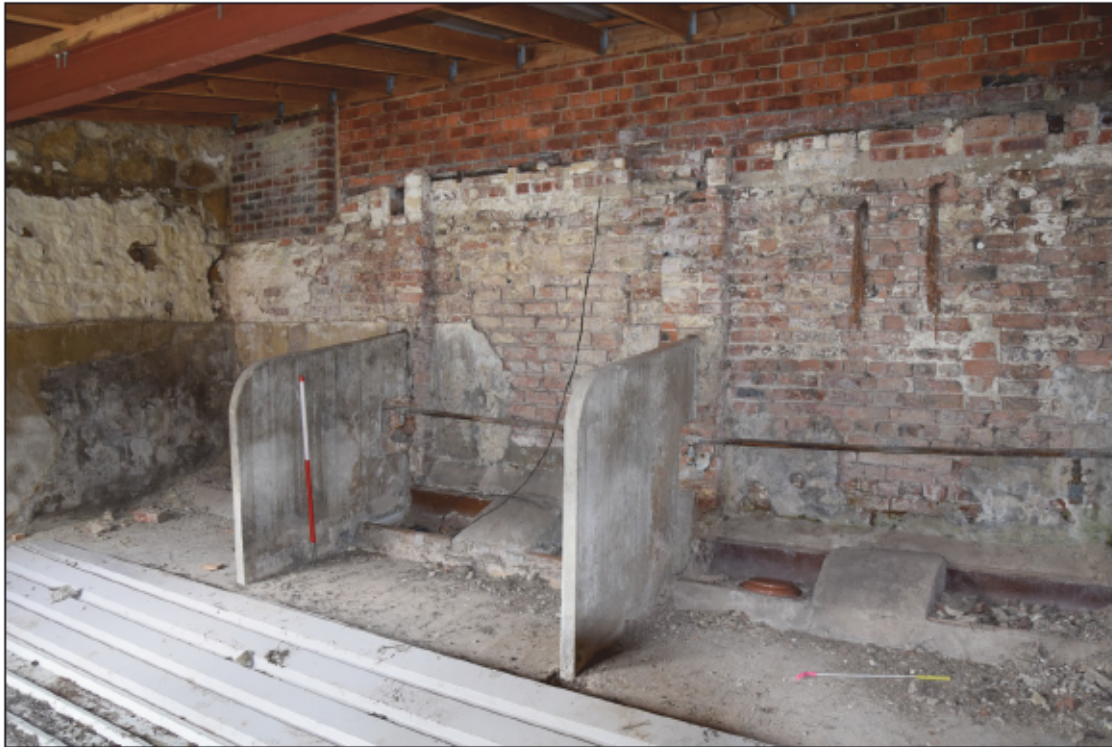
Photograph 47: Looking west in the brick byre

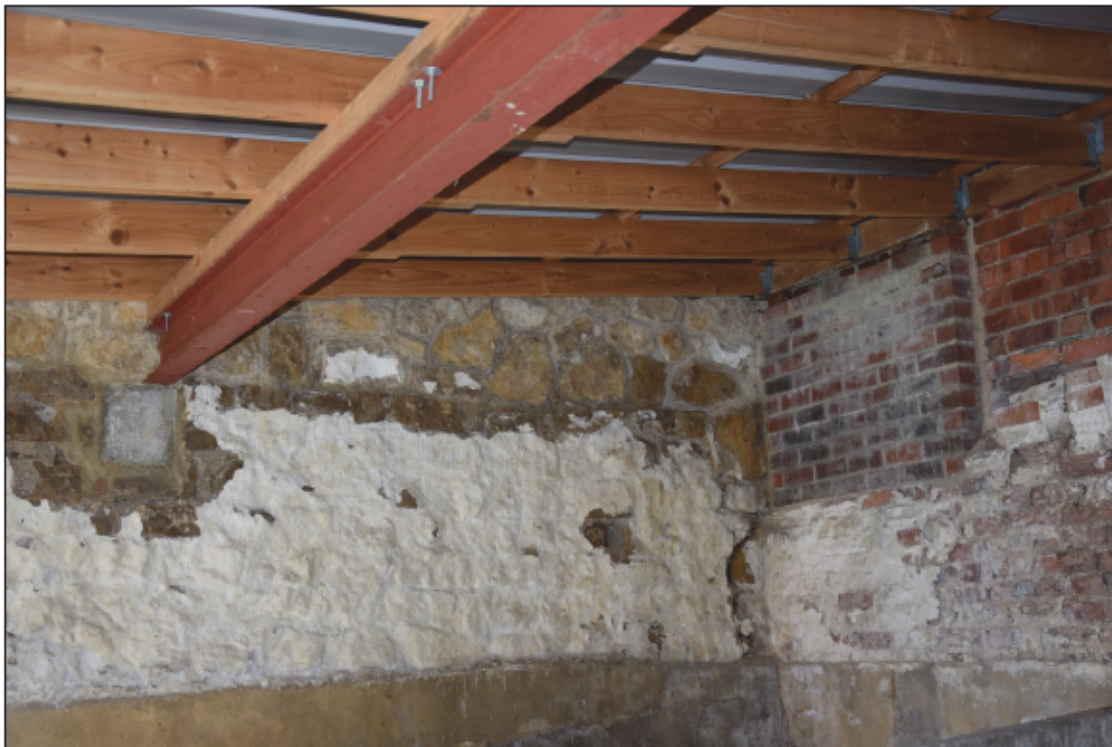
Photograph 48: Modern alterations and roof in the byre

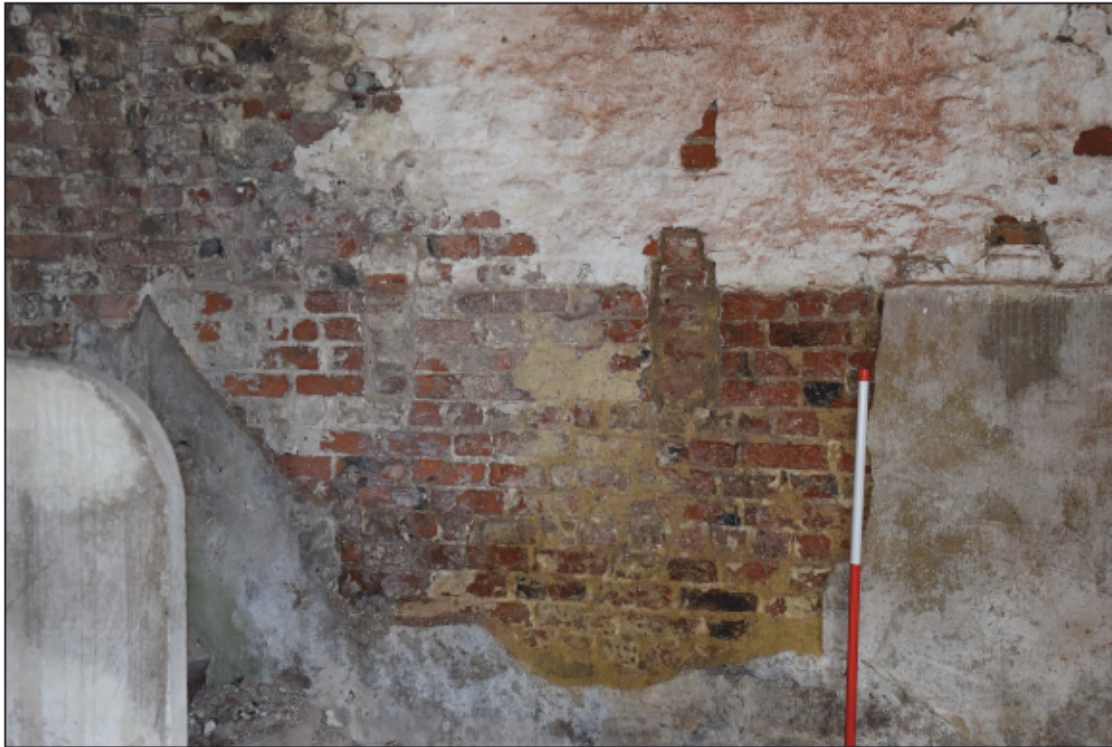
Photograph 49: Breather slits covered by 1960s cement render

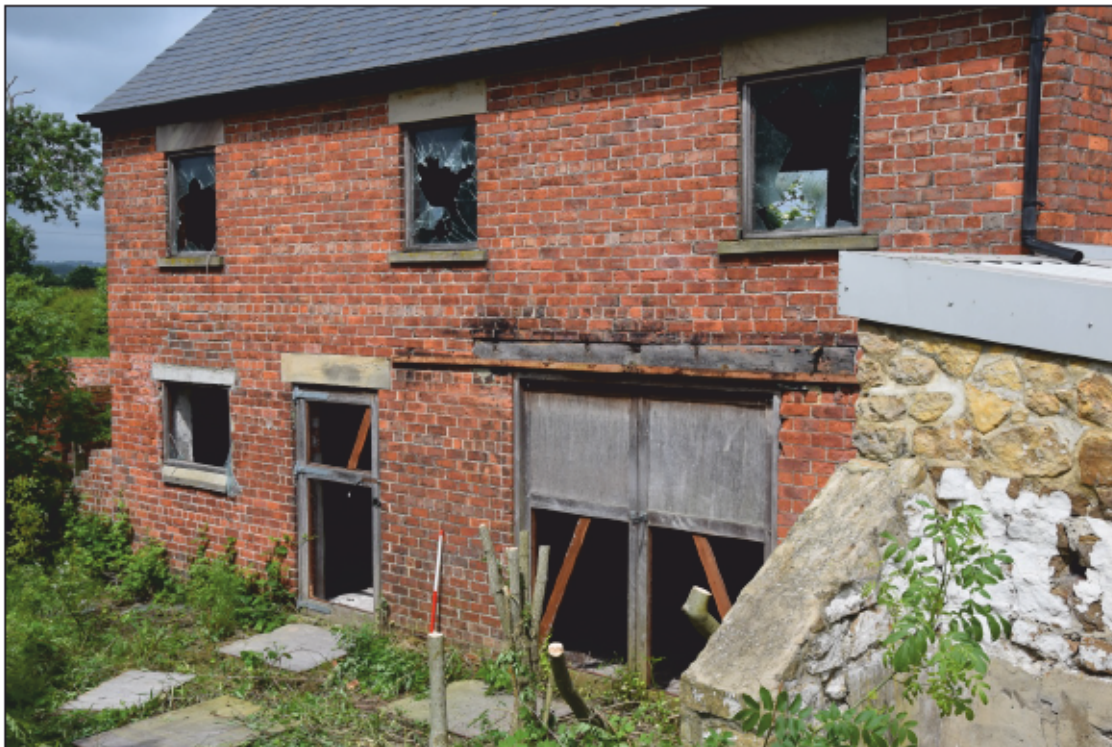
Photograph 50: The altered brick building at the north side

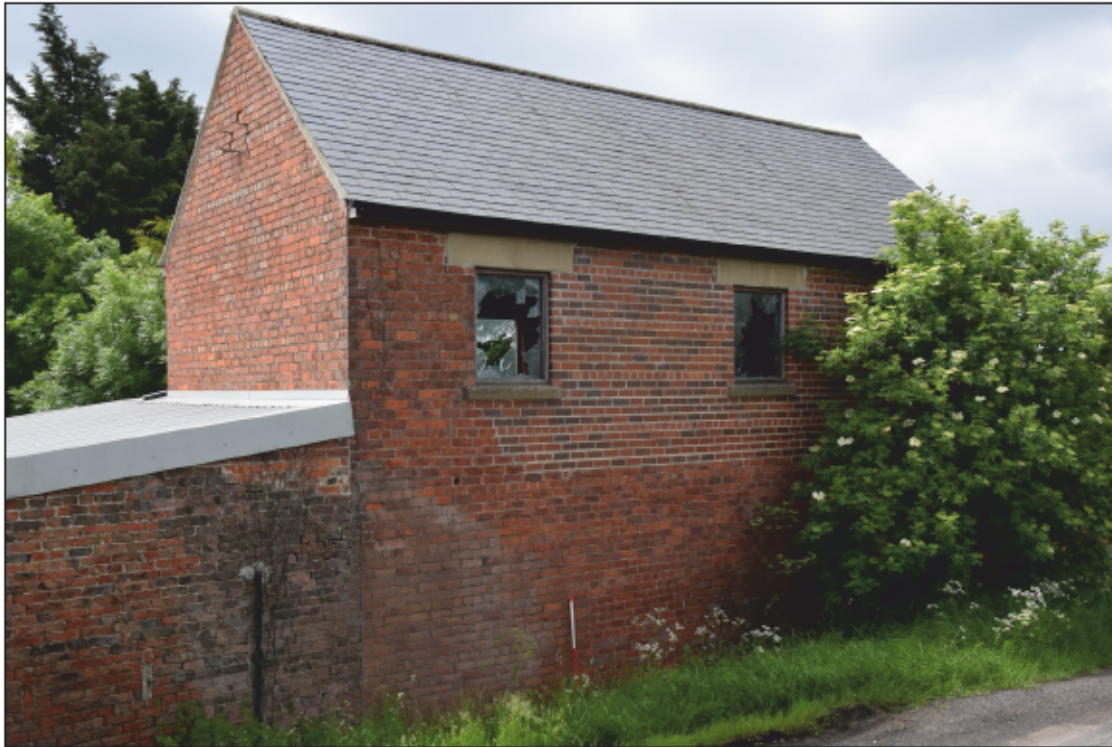
Photograph 51: The two-storey brick building seen from the east

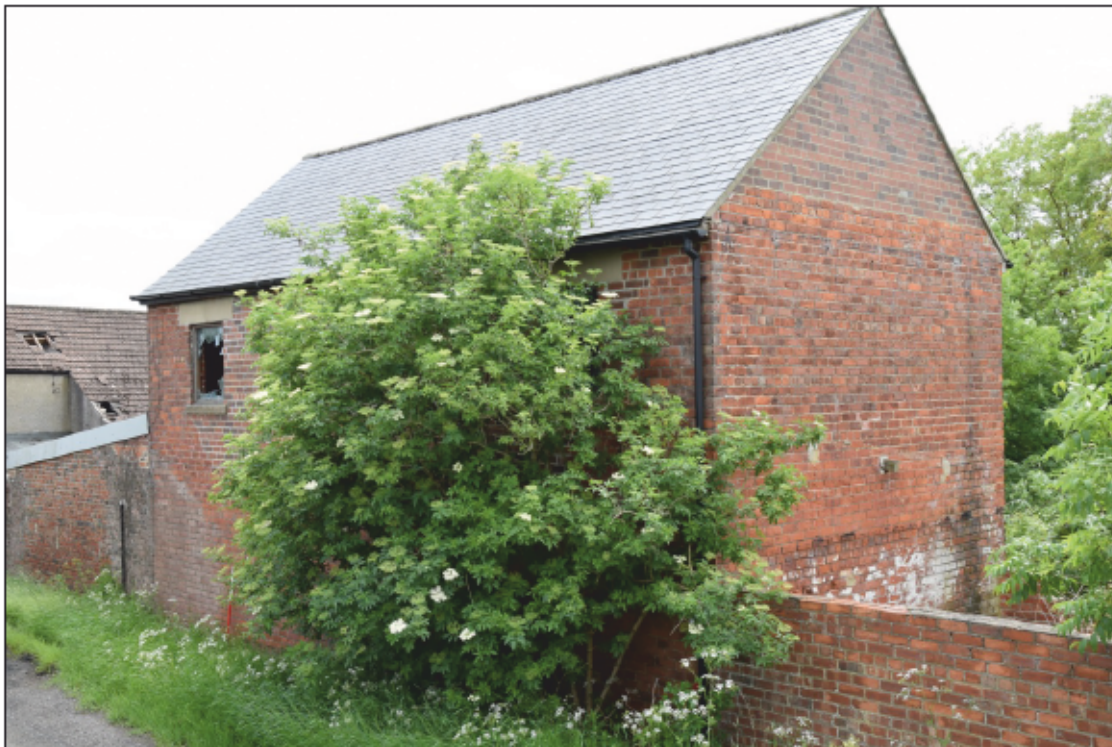
Photograph 52: The north-west gable, partly rebuilt

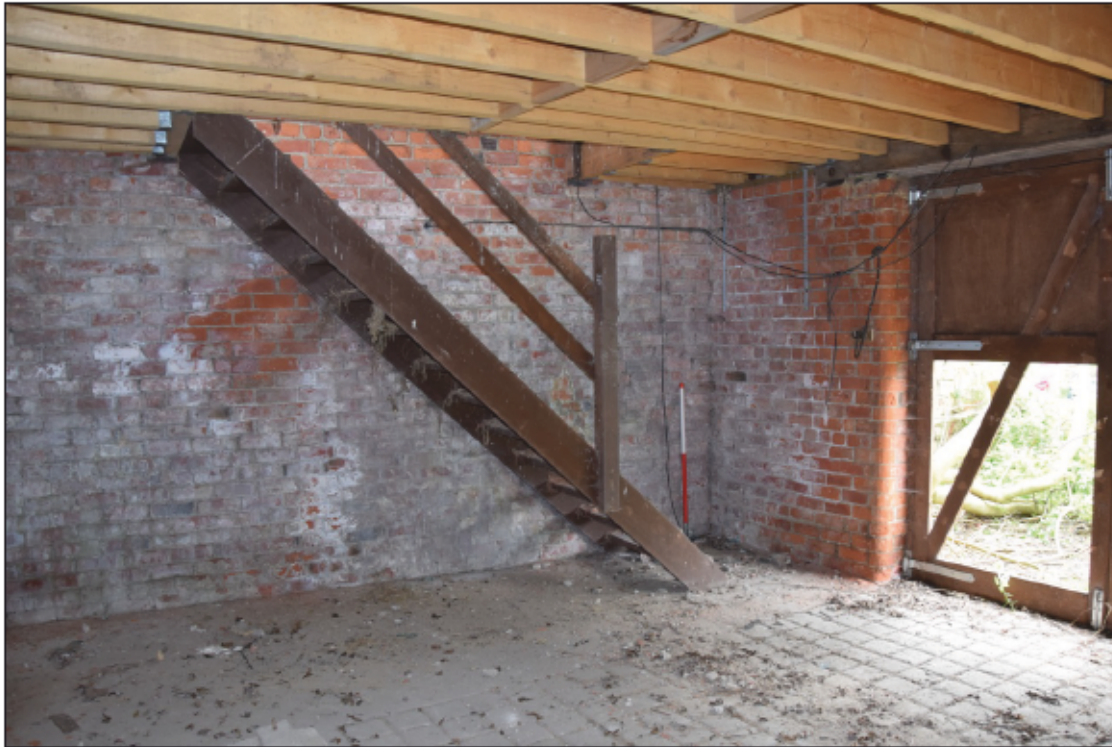
Photograph 53: The larger south-east room with the stairs

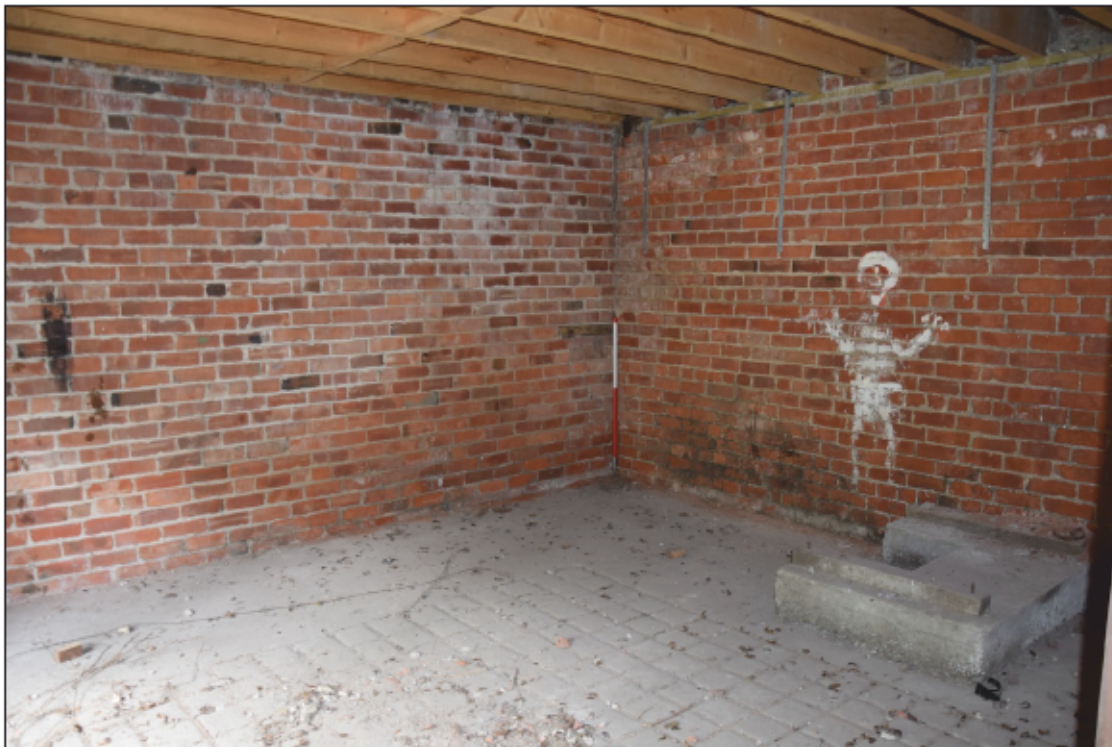
Photograph 54: Impressed concrete floor and machine plinth in the south-east room

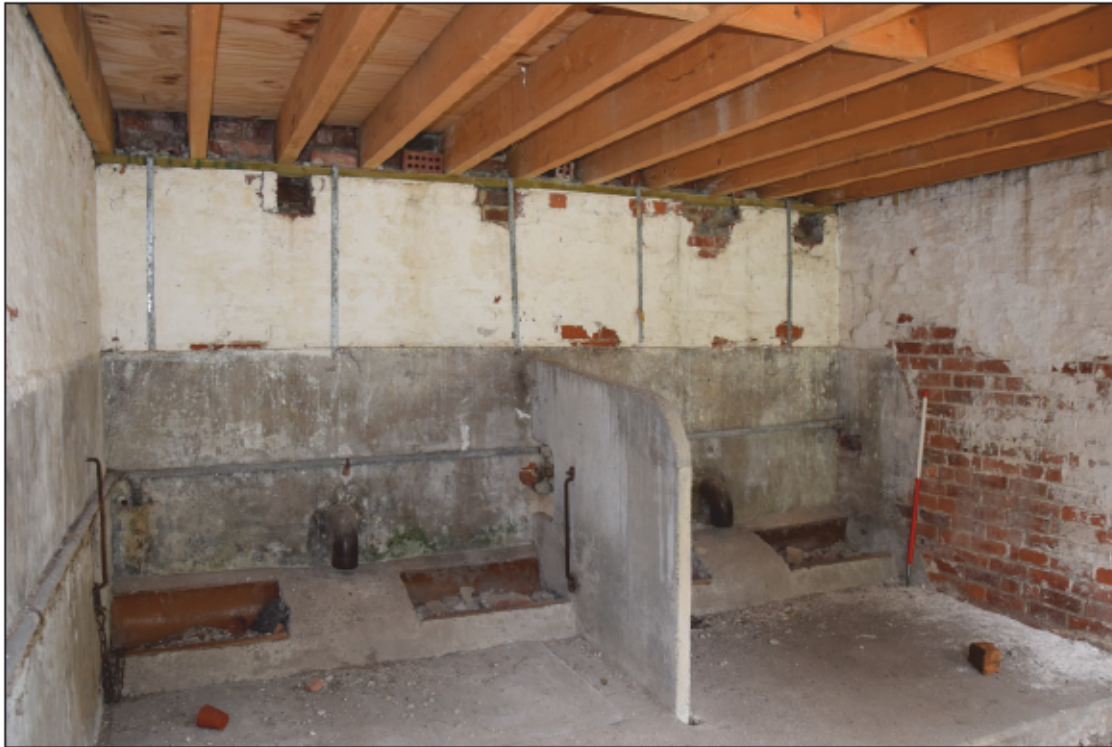
Photograph 55: Stalls in the small byre at the north-west end of the large building
