ARCHAEOLOGICAL
SERVICES
DURHAM UNIVERSITY

Stag House Farm
Darlington

archaeological building recording

report 4804
June 2018

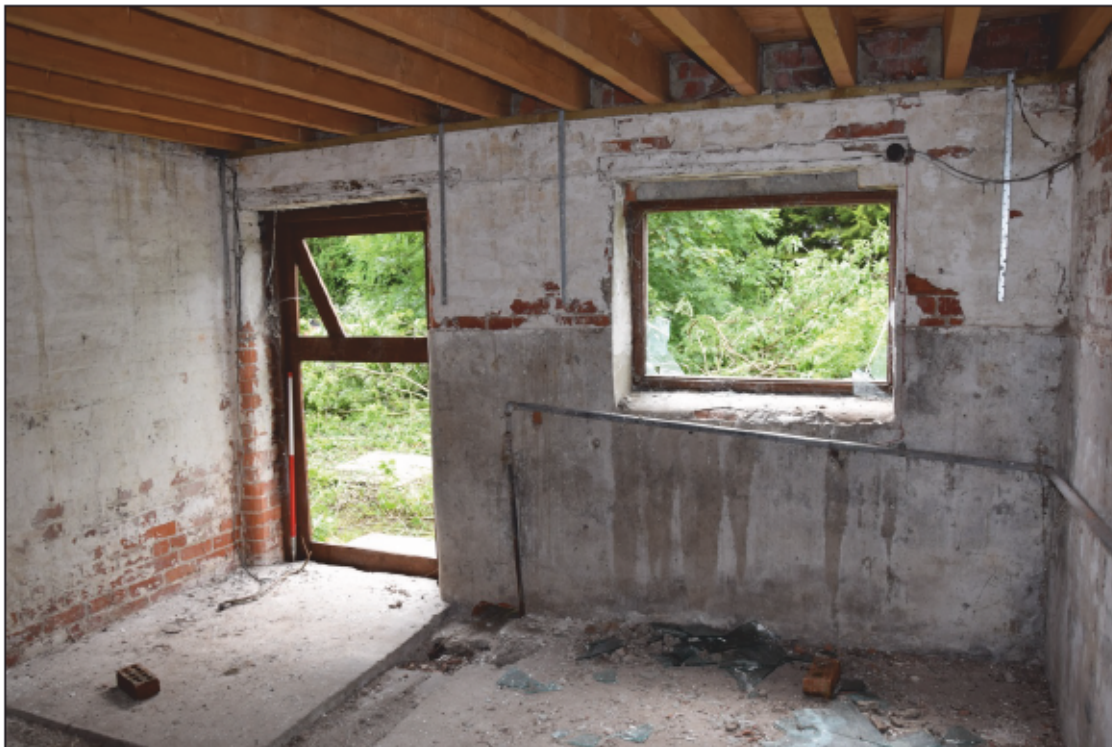
Photograph 56: Door and window in the north-west room

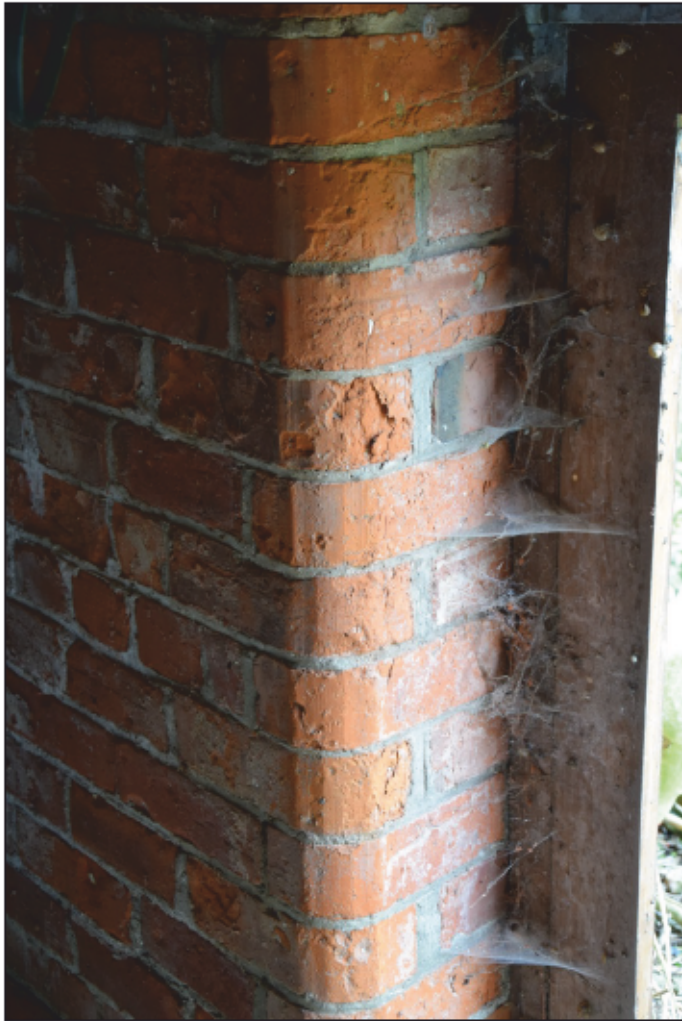
Photograph 57 (left): Detail of the rounded brick in the door jamb of the small byre

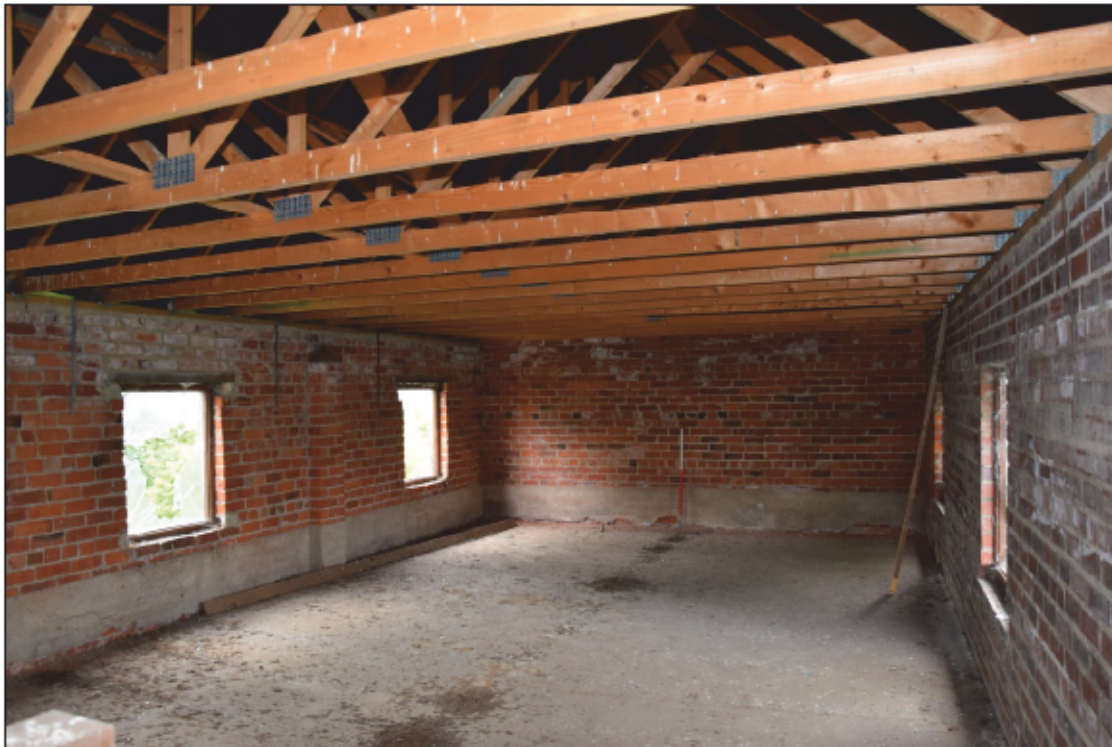
Photograph 58 (below): The first floor seen from the head of the stairs

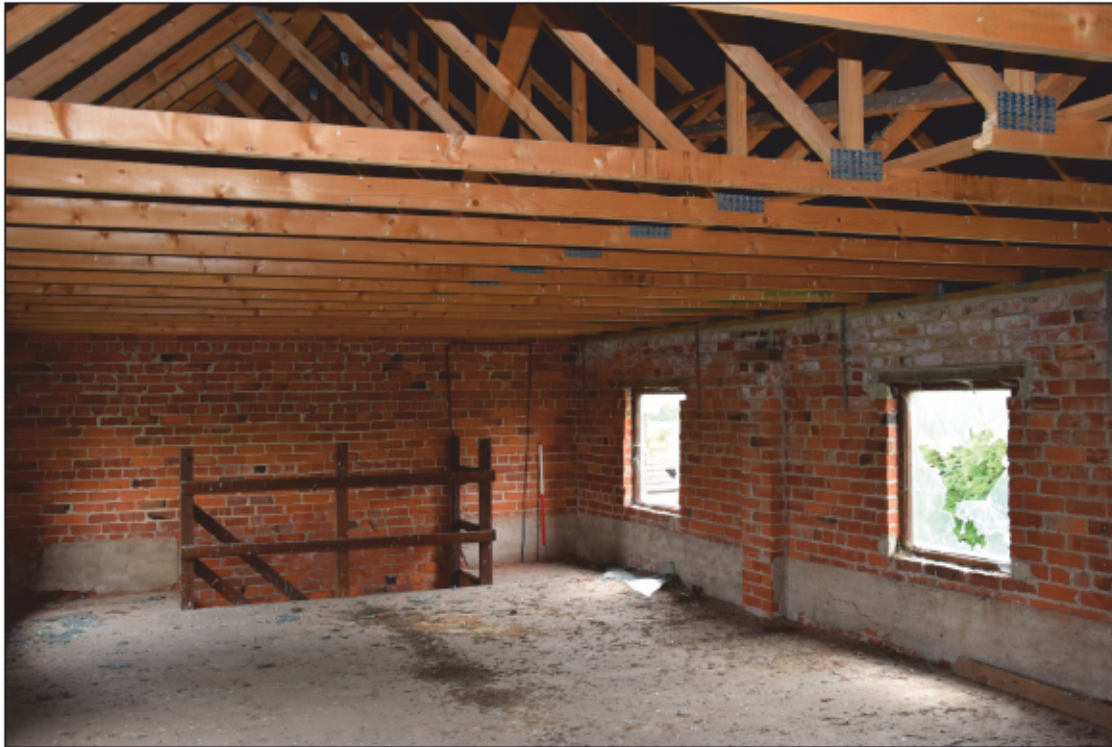
Photograph 59: The first floor seen from the north-west corner. Note the strip of cement render around the lower walls

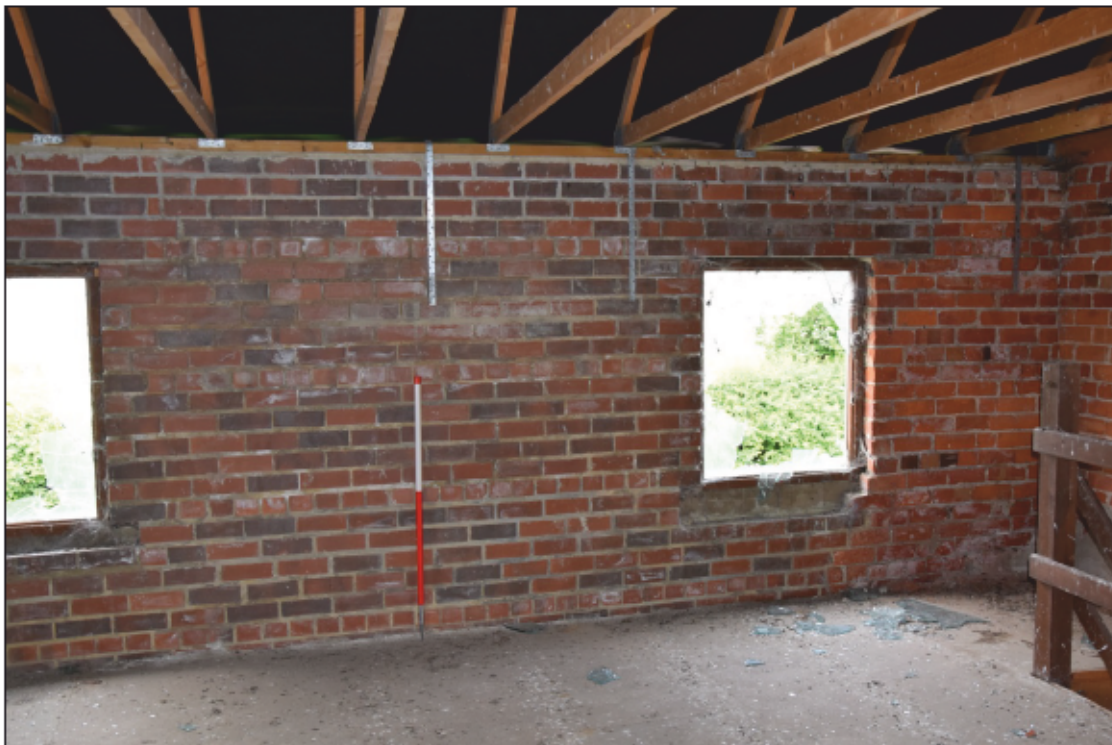
Photograph 60: New brickwork in the north-east wall

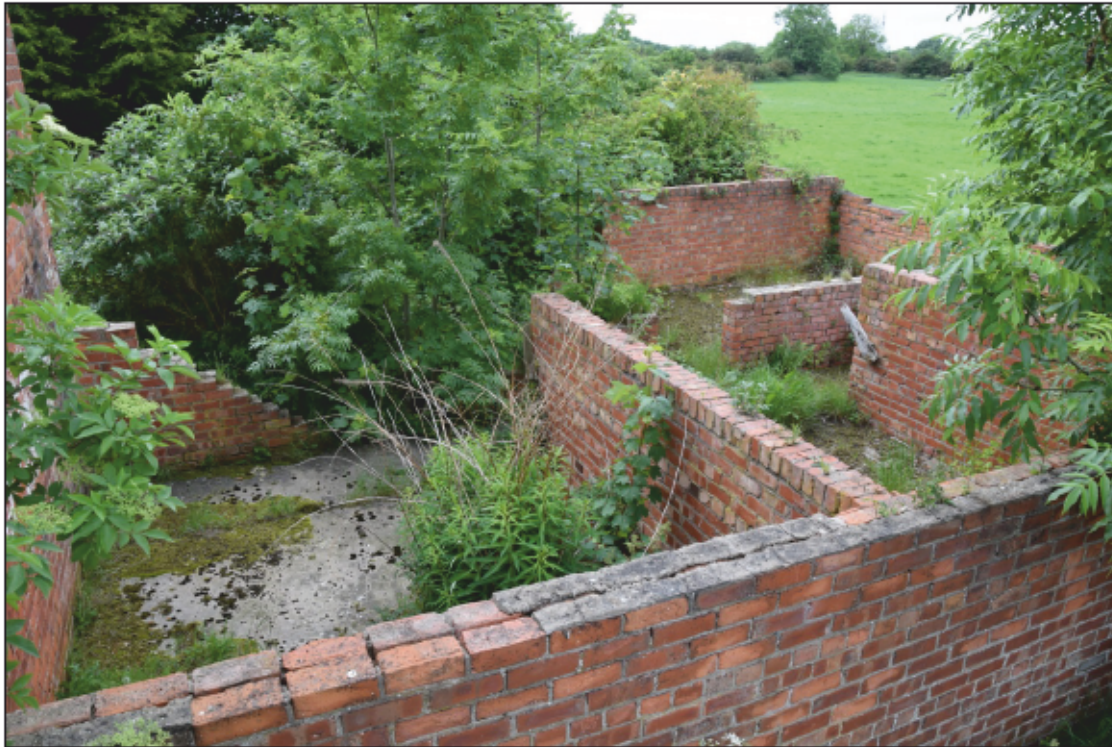
Photograph 61: Brick pens at the north end of the plot

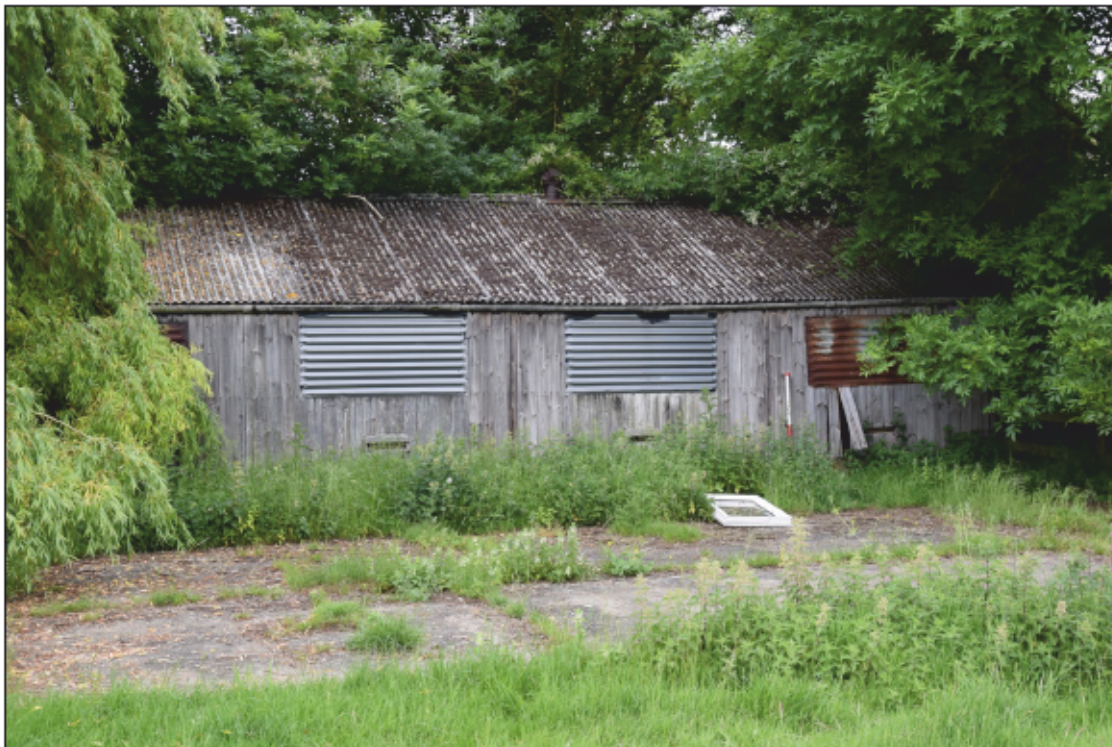
Photograph 62: The timber shed at the south-west side of the steading, with the floor of a similar building in front of it. A view looking north-east
