ARCHAEOLOGICAL
SERVICES
DURHAM UNIVERSITY

Church of St John the Evangelist
Rookhope
County Durham

archaeological building recording

report 4898
November 2018

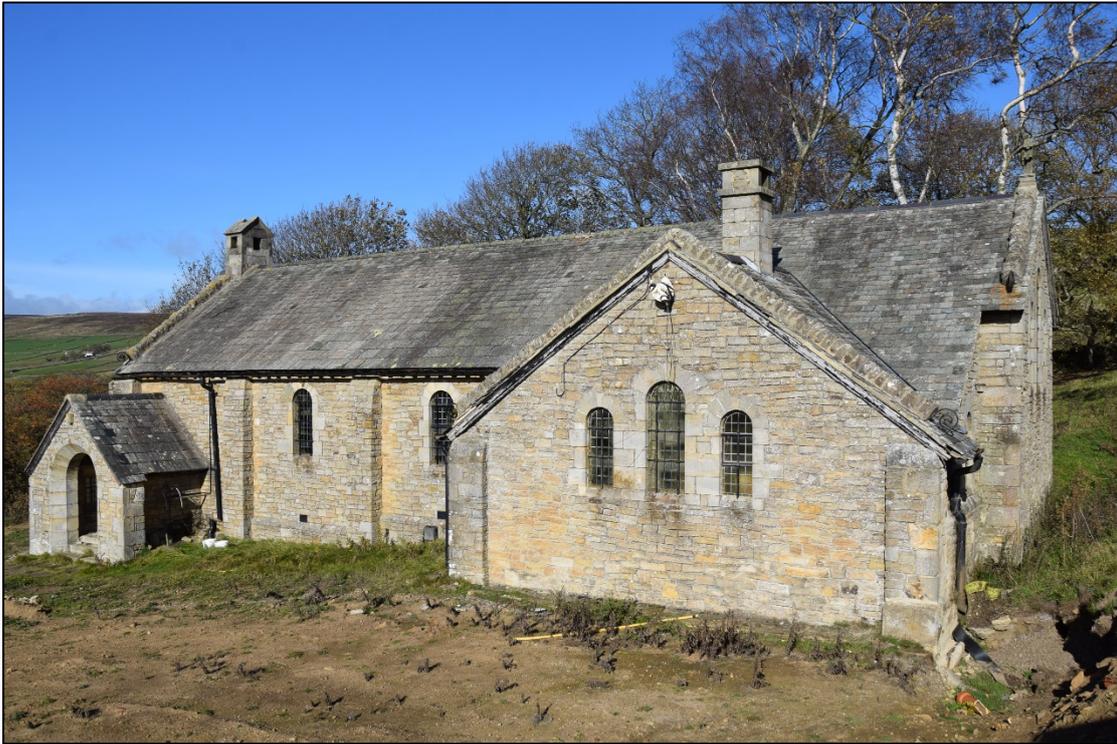
Photograph 3: The south face of the church. Note the recently-disturbed ground in the foreground. A bag at the peak of the gable covers recently-disconnected electric cables

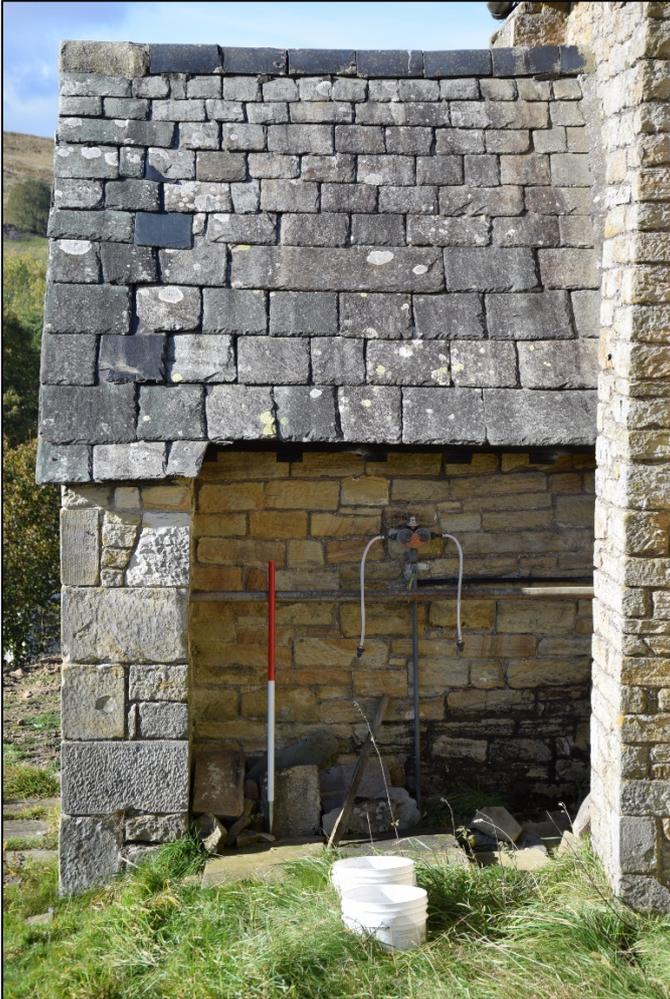
Photograph 5 (left): The east face of the porch, adapted for use as a store for the gas cylinders that supplied the heaters

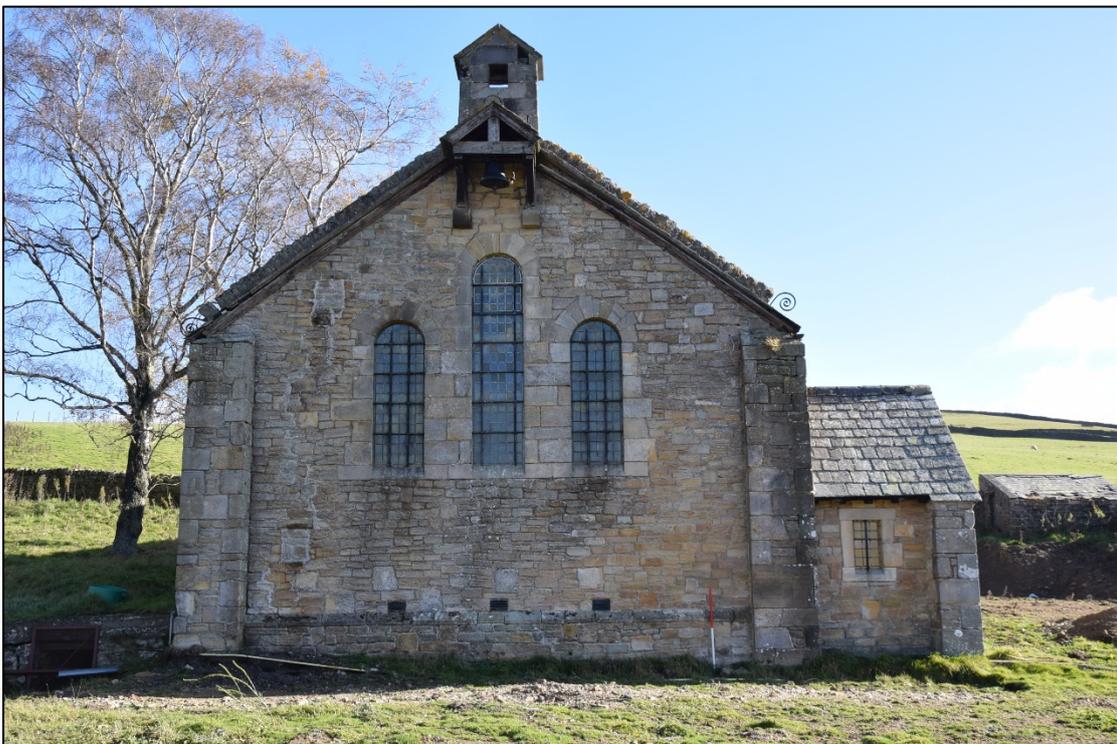
Photograph 16: The west end of the church, with signs of some recent excavation work in the grass

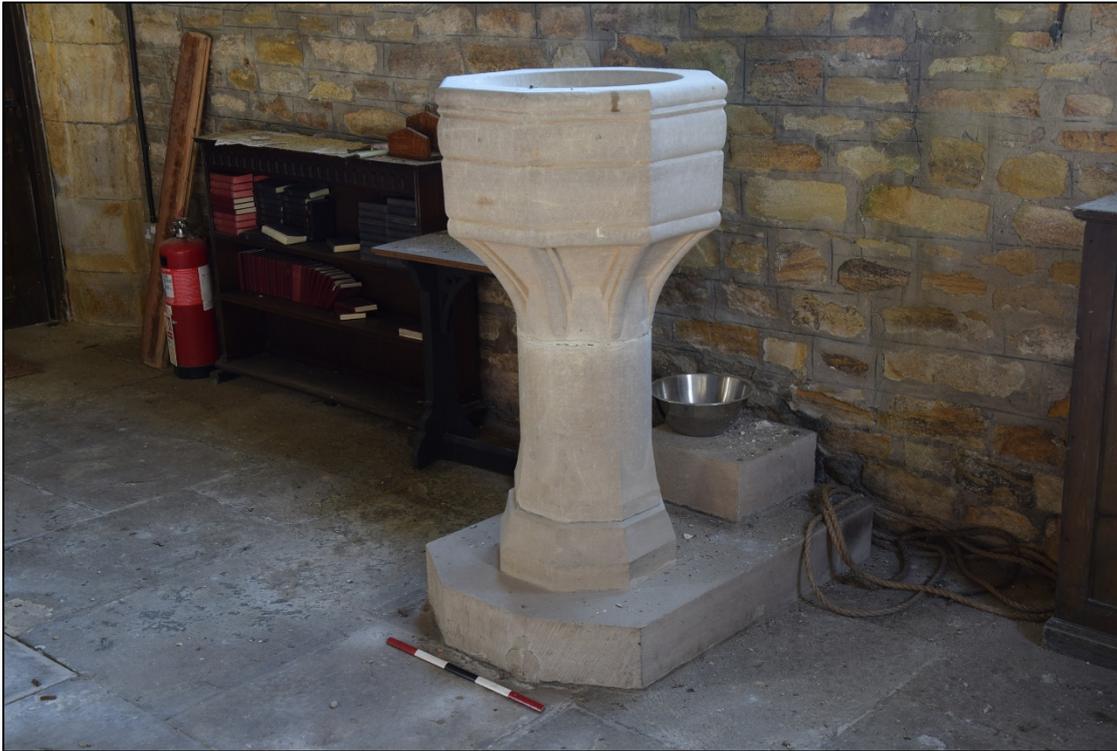
Photograph 27: The font, with the broken bell-rope beside it. The full width of the church is paved with stone flags at this end

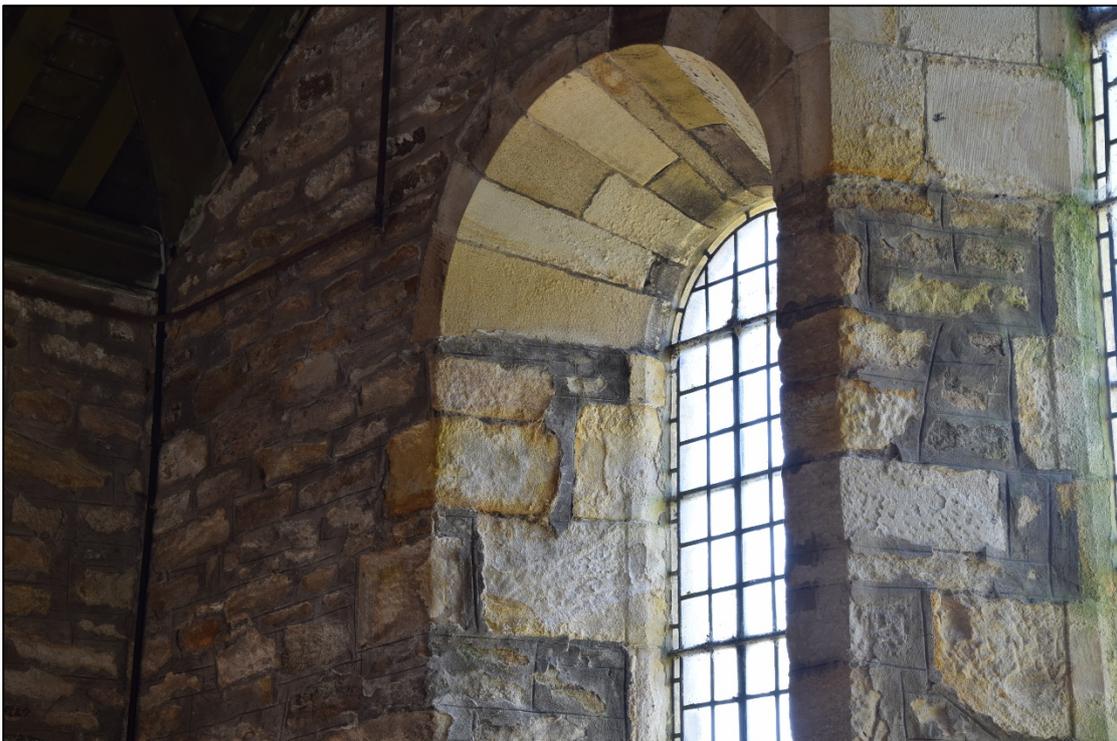
Photograph 28: Detail of the east window, showing damage to the surface of the stonework. The grey cement mortar can be seen clearly here

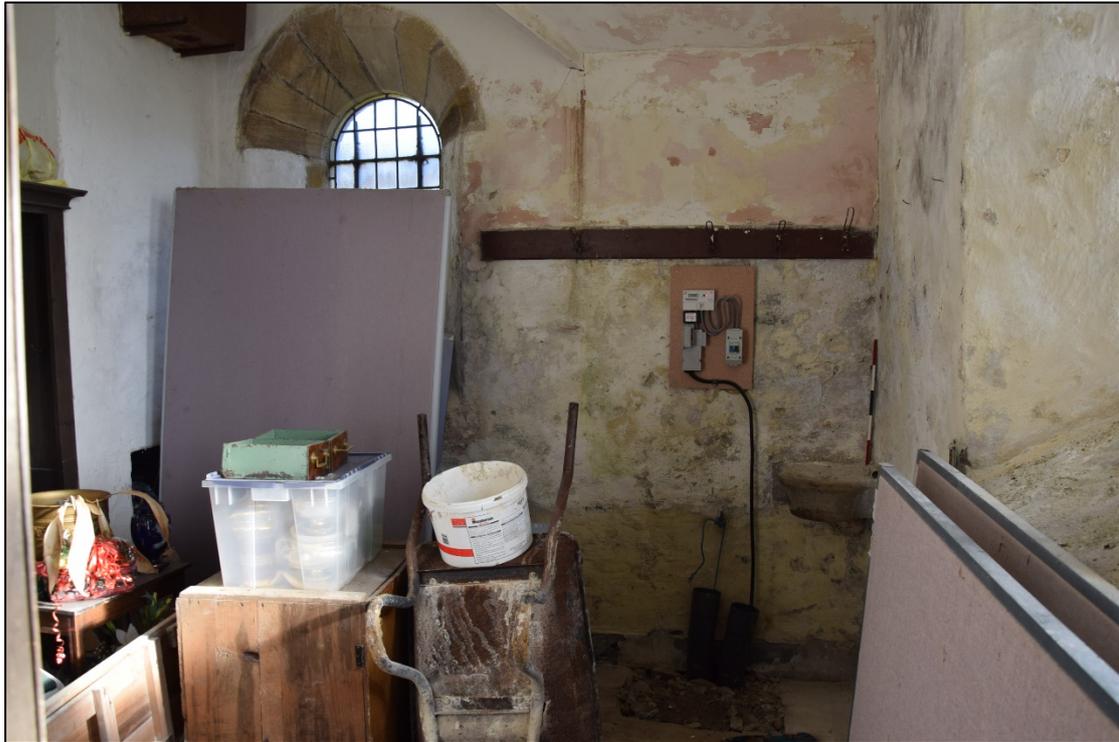
Photograph 39 (above): The east wall of the vestry, showing a recent hole for cable ducts and the damp-affected plasterwork
