ARCHAEOLOGICAL
SERVICES
DURHAM UNIVERSITY

Mount Pleasant Farm
Darlington
archaeological building recording

report 5030
April 2019

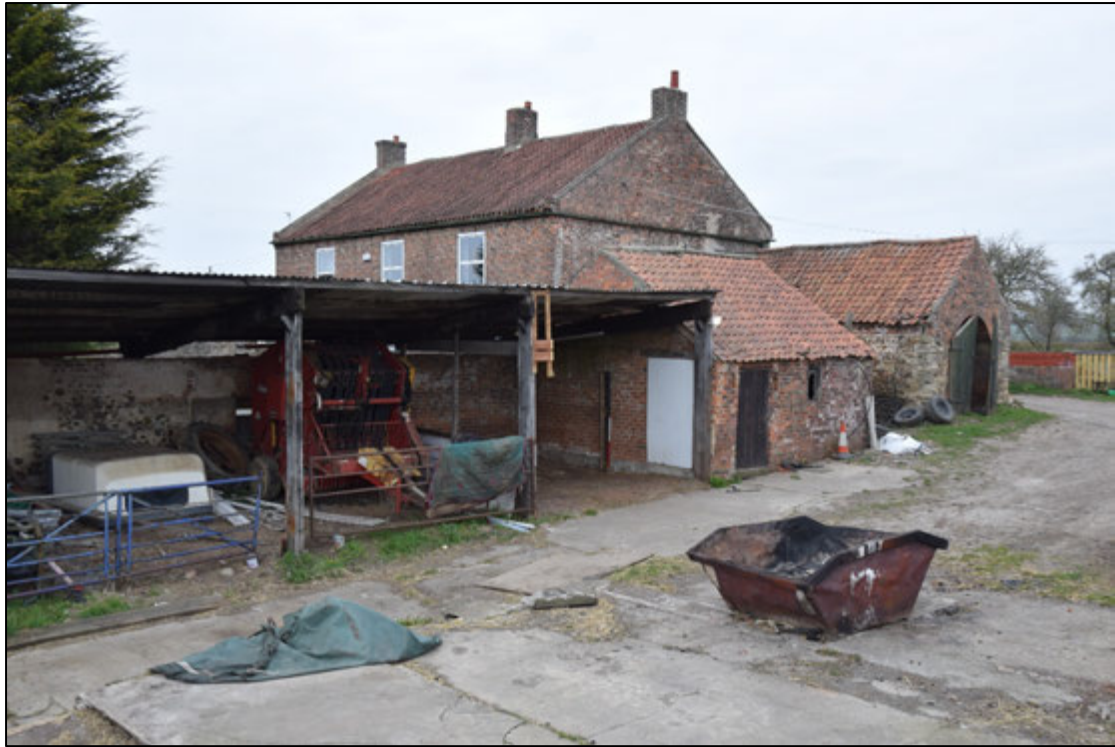
Photograph 3: A view over the yard from the south-east, with the remains of the stable building [C] in the foreground

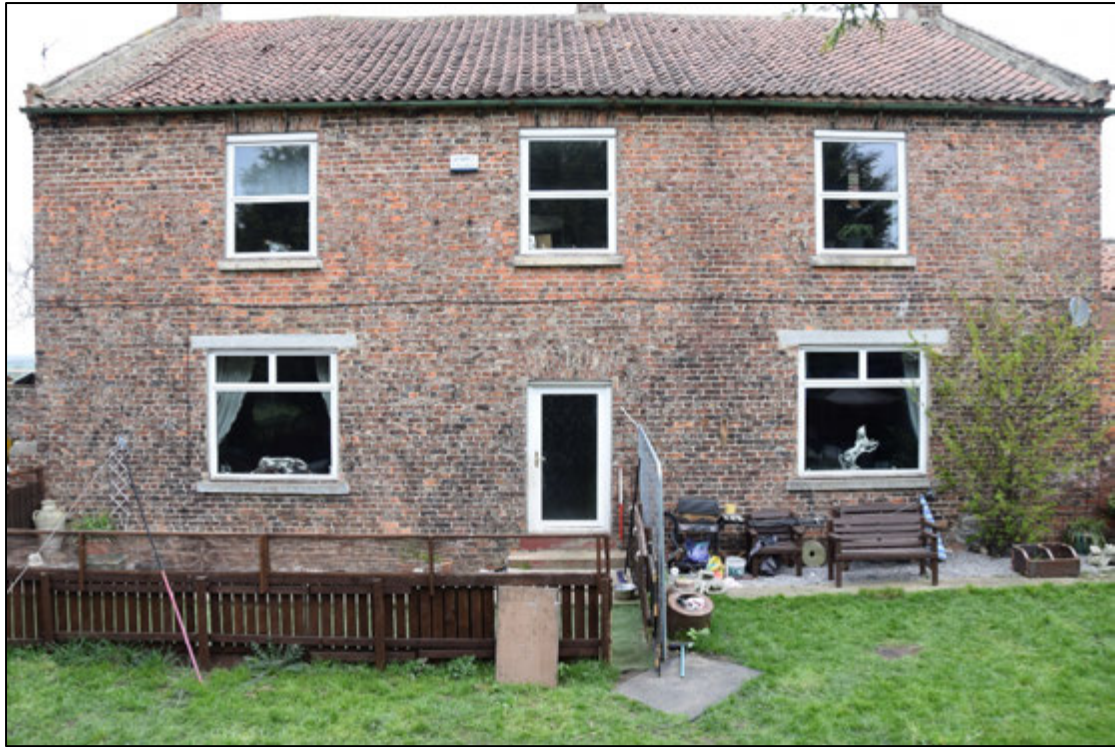
Photograph 5: The south face of the house, with new windows and door. The ground-floor windows have been widened

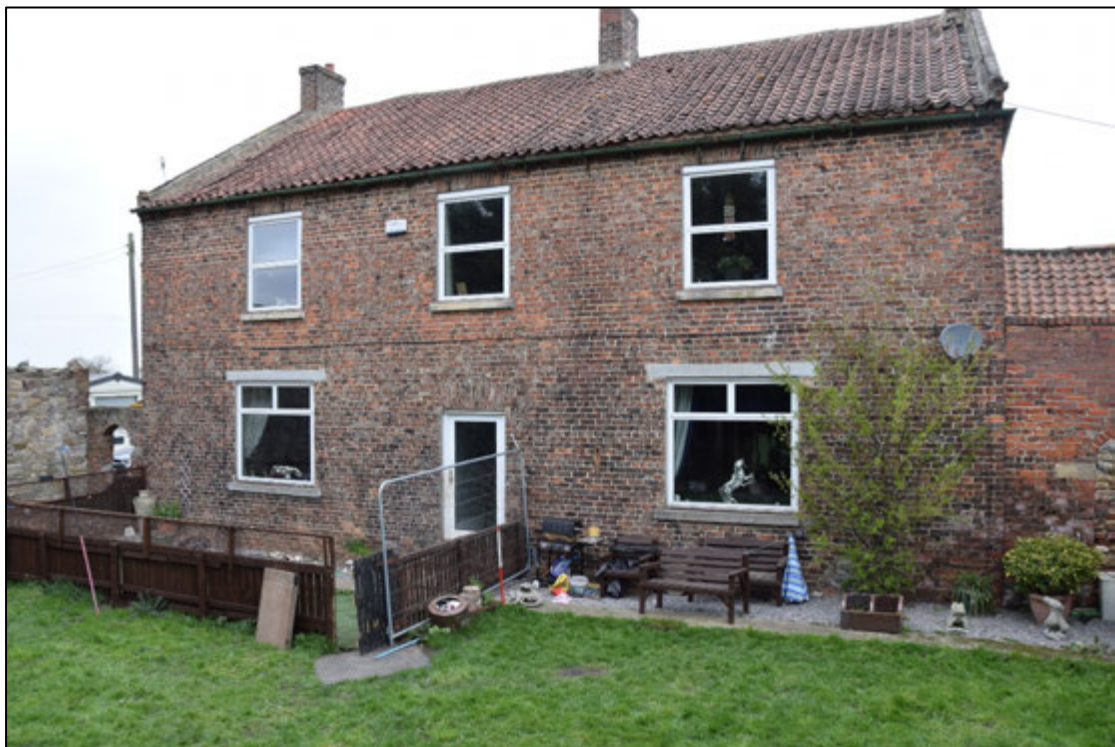
Photograph 6: An oblique view of the front of the house. Short sections of wall at either end separate the garden from the rest of the steading

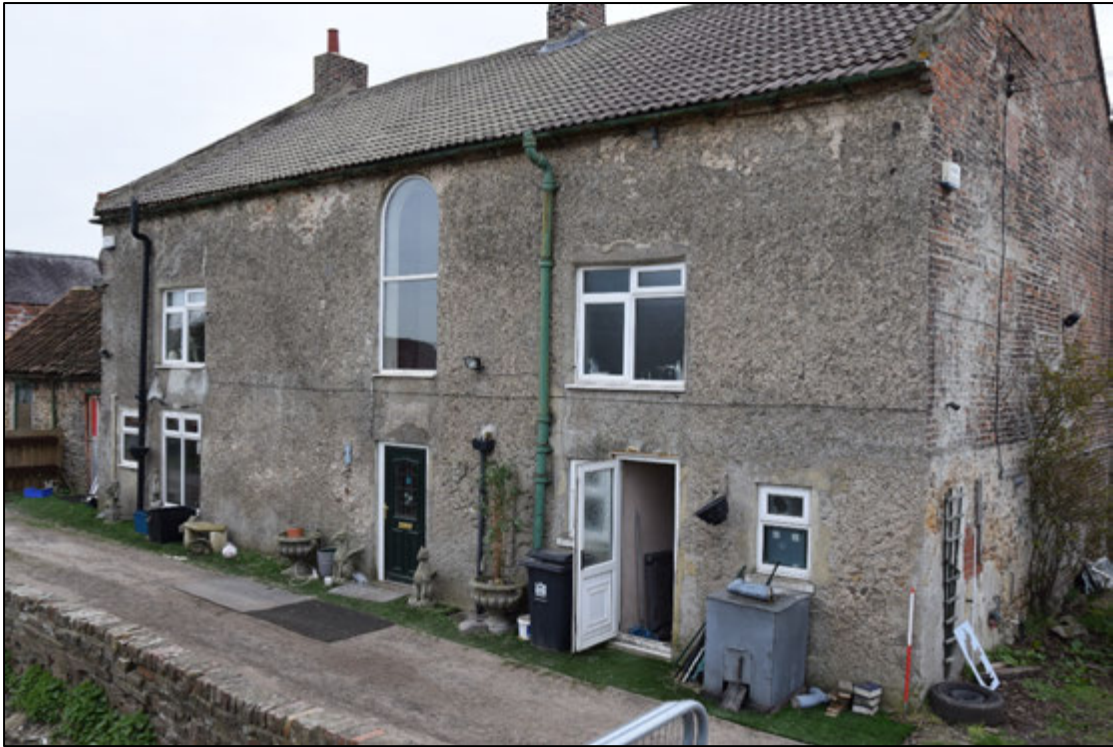
Photograph 7: The north wall of the house, covered with roughcast. Note the low windows on the first floor, reflecting the lower eaves of an earlier form

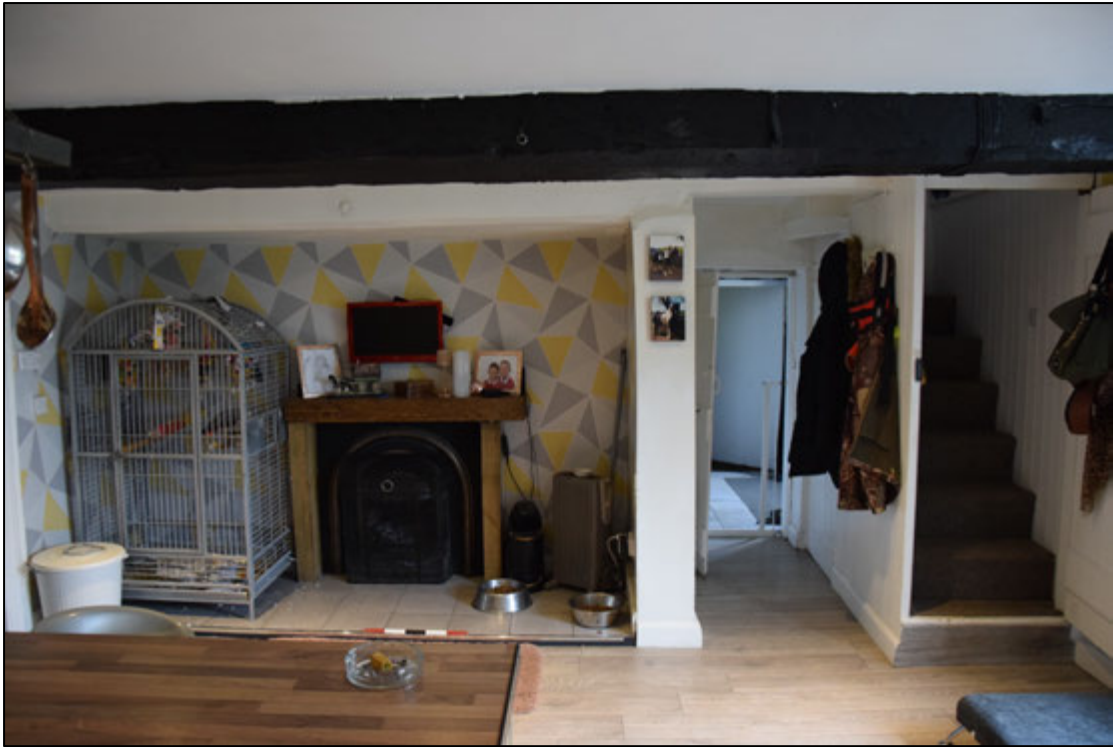
Photograph 11: A view looking west in the kitchen, room 1. The inglenook has a modern fireplace but the heck screen and fire beam are still in place, both covered with plaster. The wall at the left-hand end is a possible site for a fire window. The box stair rises to bedroom 9

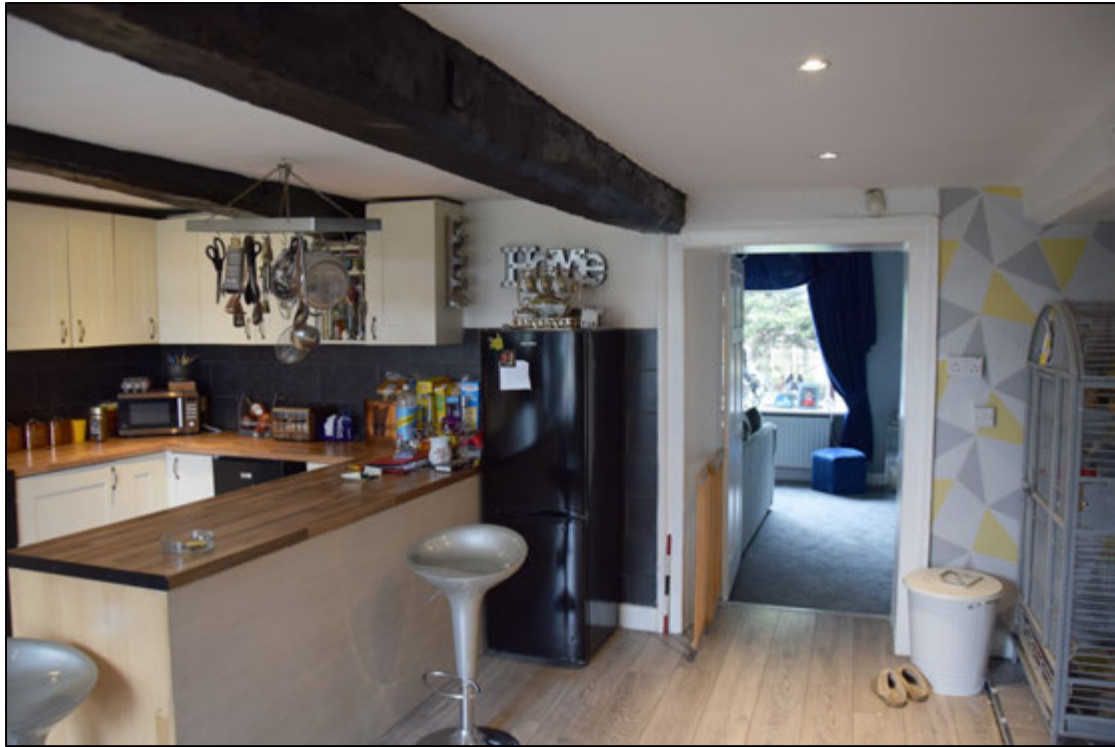
Photograph 13: The 19th-century door in the south wall of the kitchen is awkwardly placed in relation to the ceiling beam

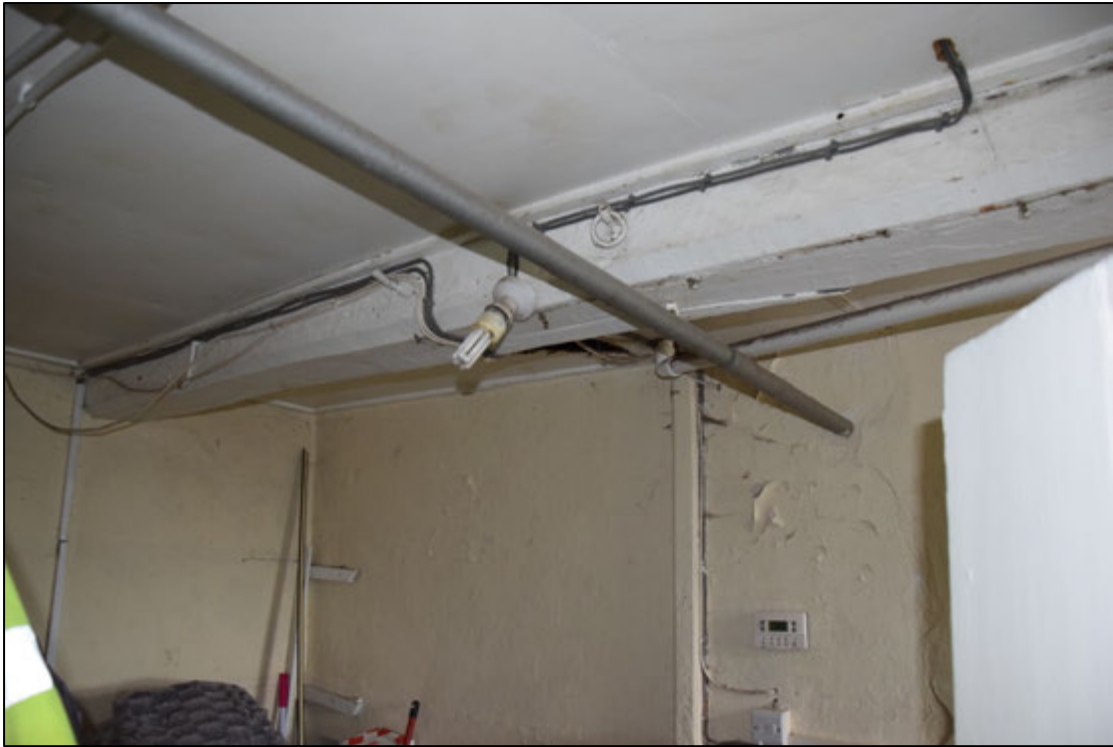
Photograph 17: A heavy ceiling beam with a rough chamfer in the store room 3, west of the old through-passage

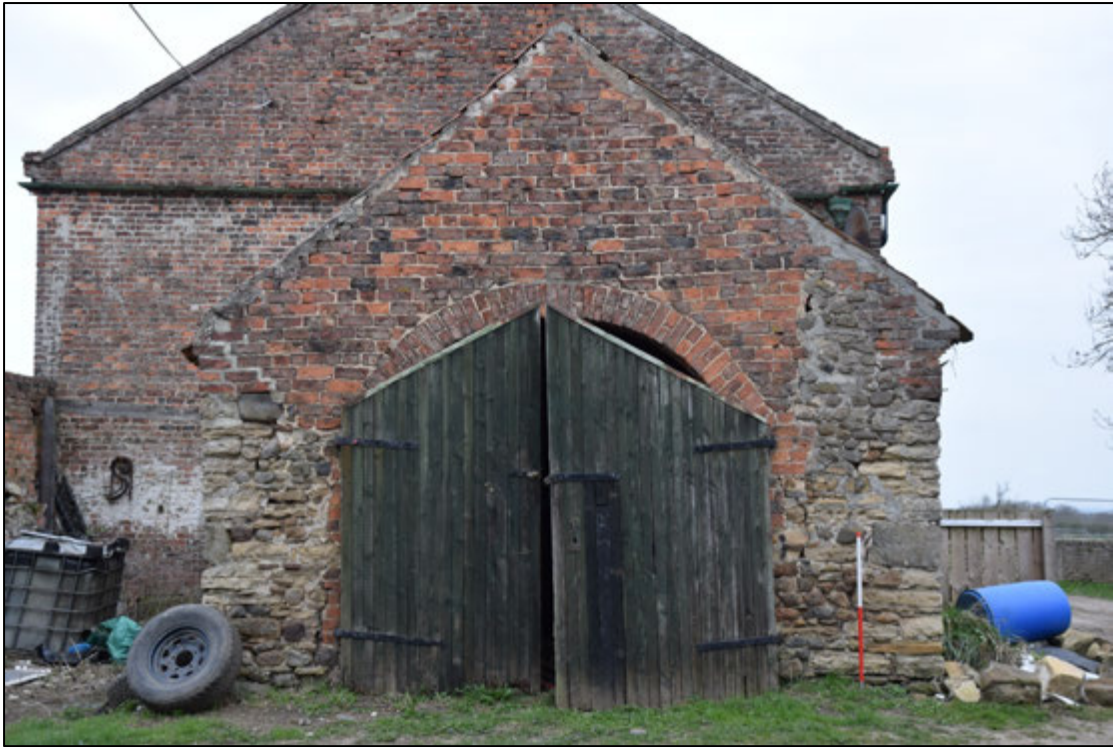
Photograph 37: The east end of the workshop was substantially rebuilt to accommodate the large double door. Note the occasional large stone blocks at the corners of the old walls

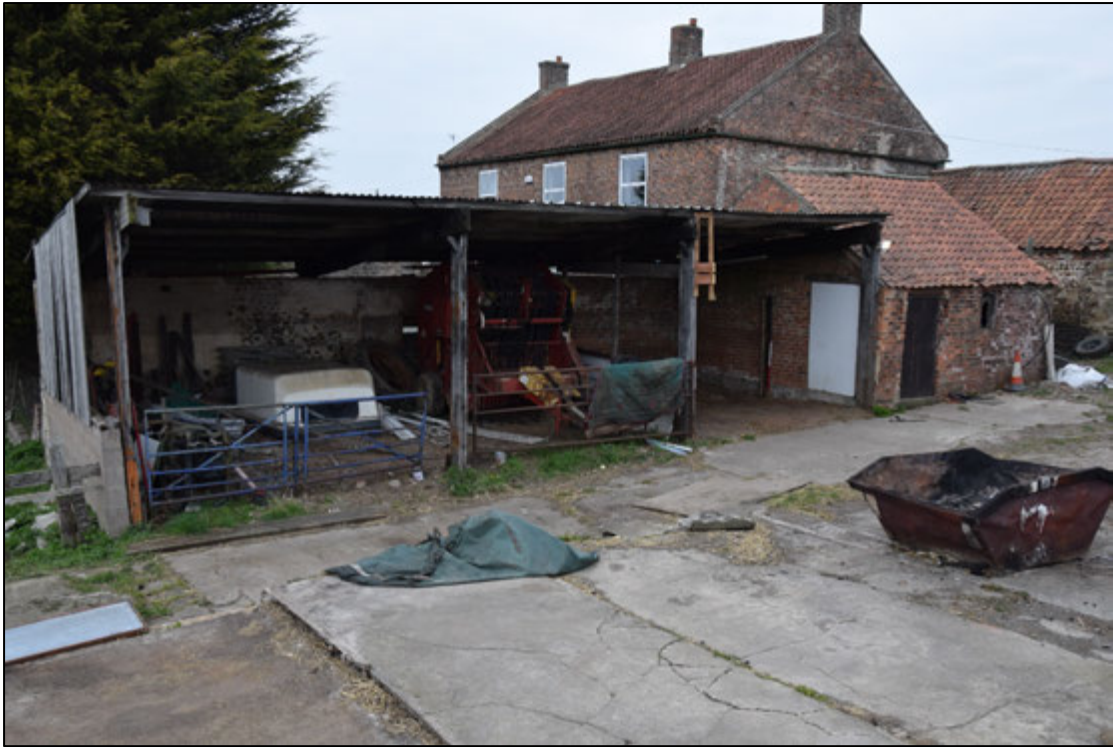
Photograph 43: The east face of the stable, most of which has been replaced by a simple open shelter. The wall with the white door is a modern addition

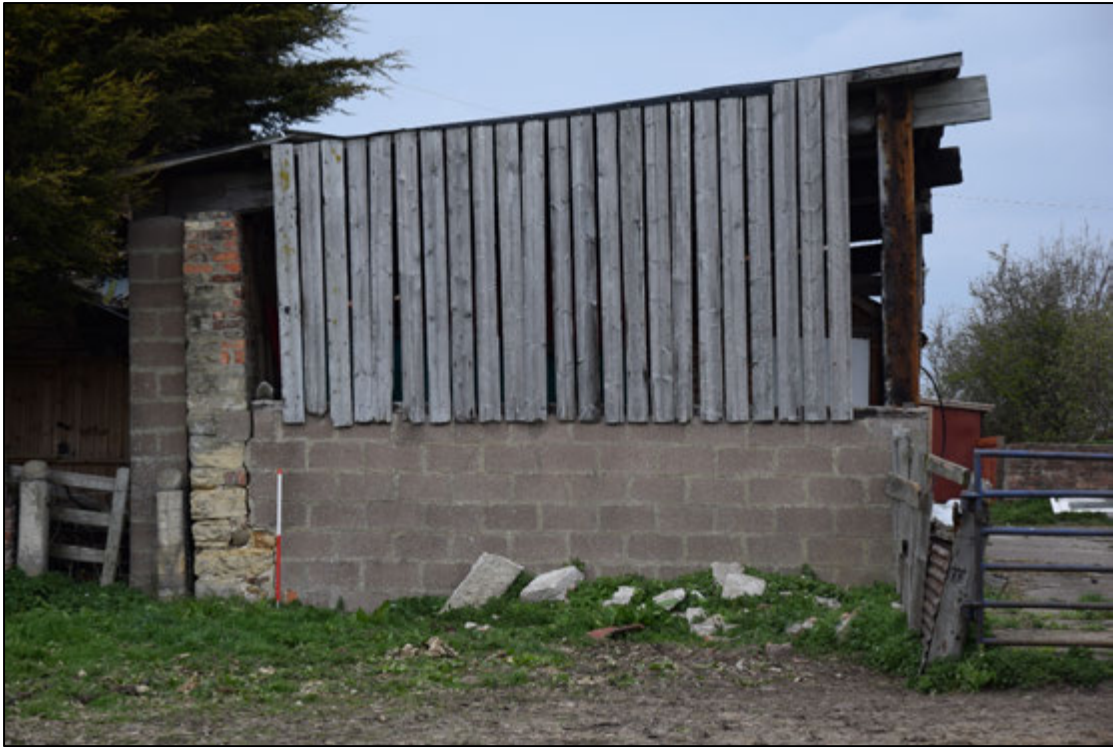
Photograph 47: The south end of the former stable. The only old masonry is the end of the wall beside the concrete pier at the left, which is built of brick over stone

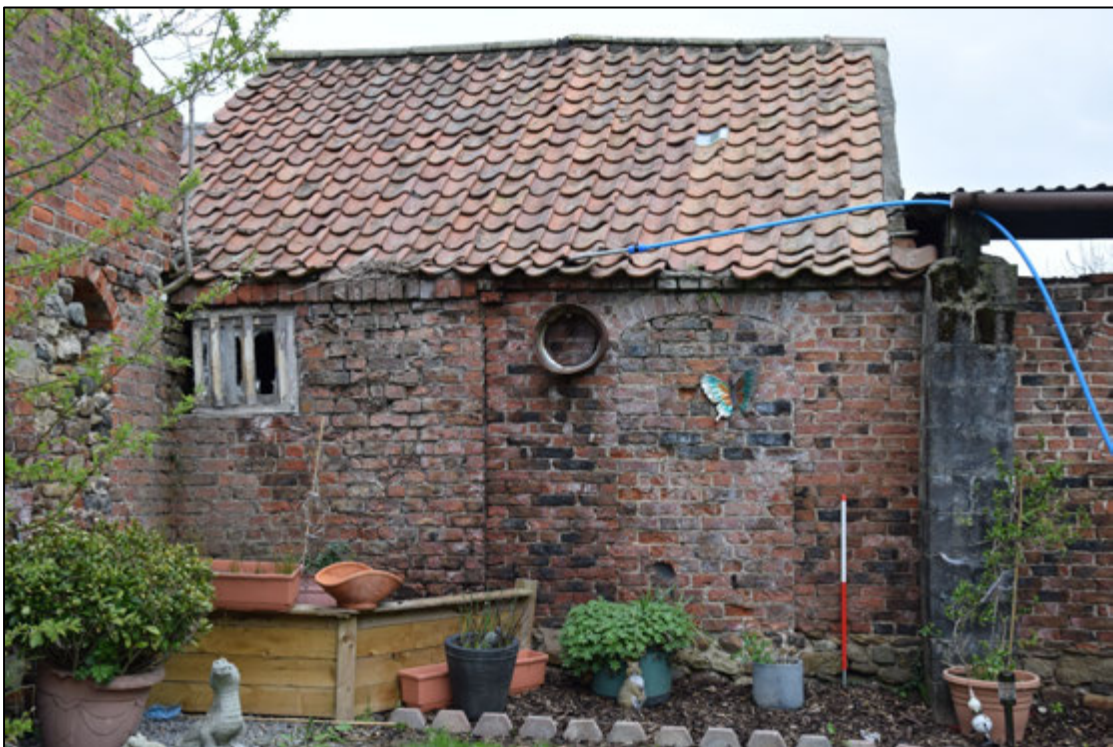
Photograph 48: The west face of the surviving section of the stable. The central straight joint shows that the northernmost bay, at the left, was formerly open on this side. The arch over the blocked door is the same shape as those further south and similar doors in the workshop and the screen walls

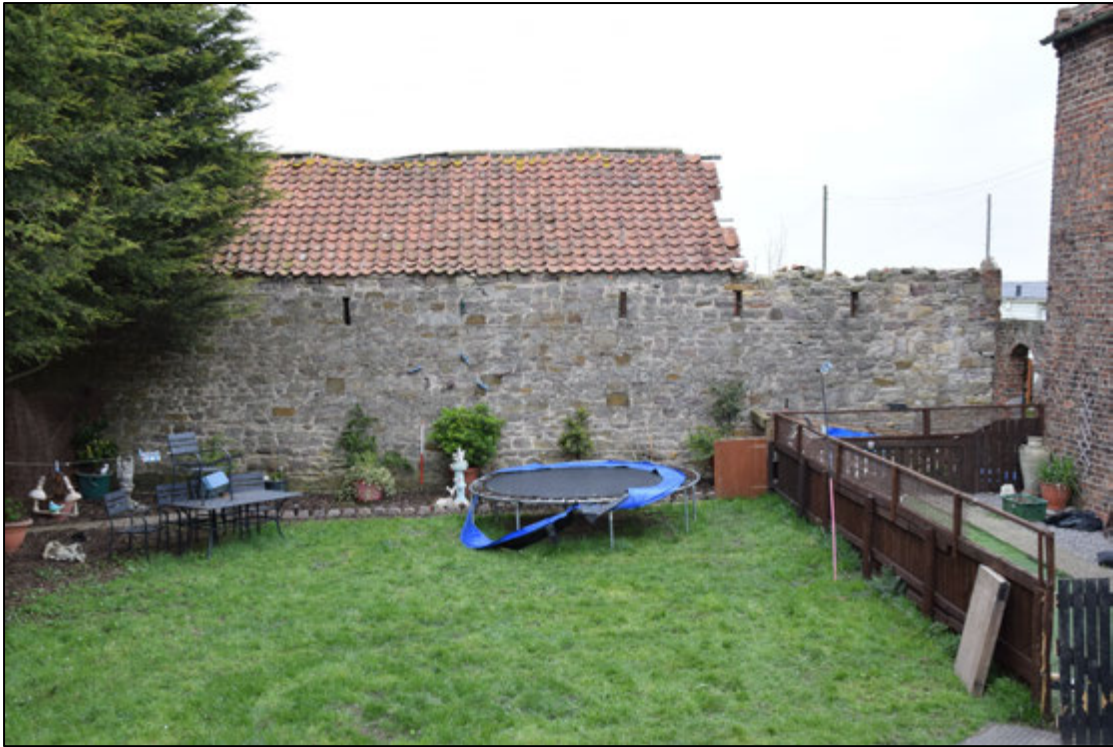
Photograph 59: The east wall of the barn, building D. Note the better quality of the stonework in this wall, which has no parallel elsewhere on the farmstead

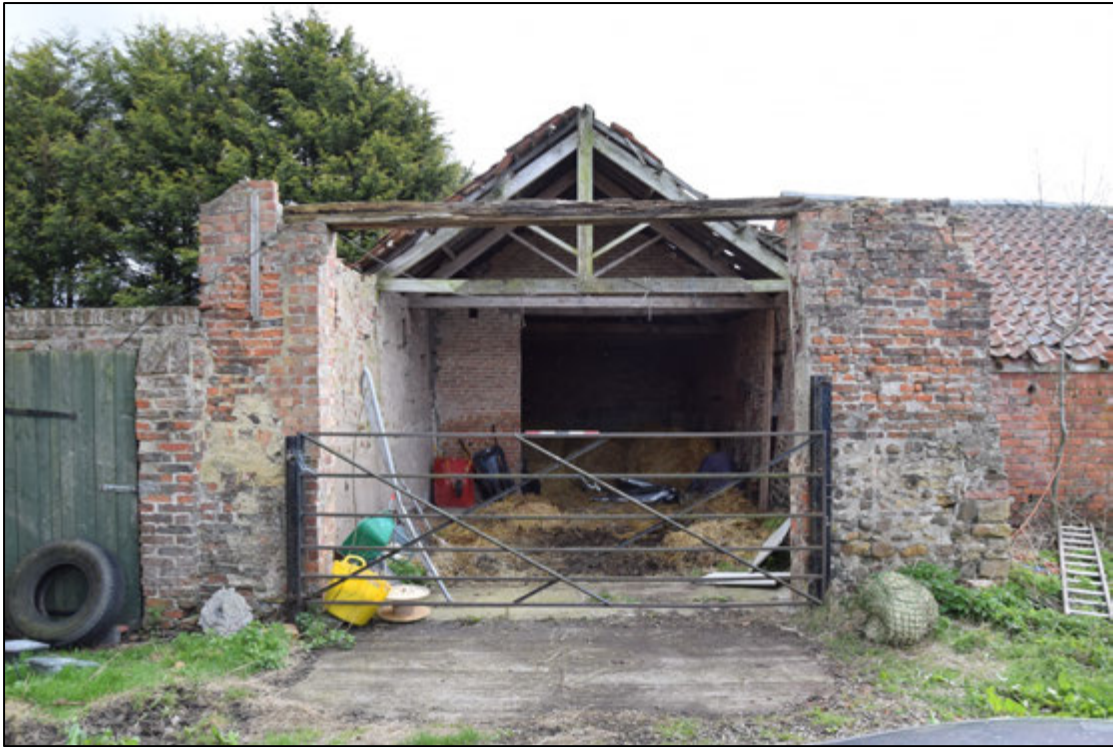
Photograph 61: The north end of the barn is largely gone. The simple agricultural roof trusses can be seen here

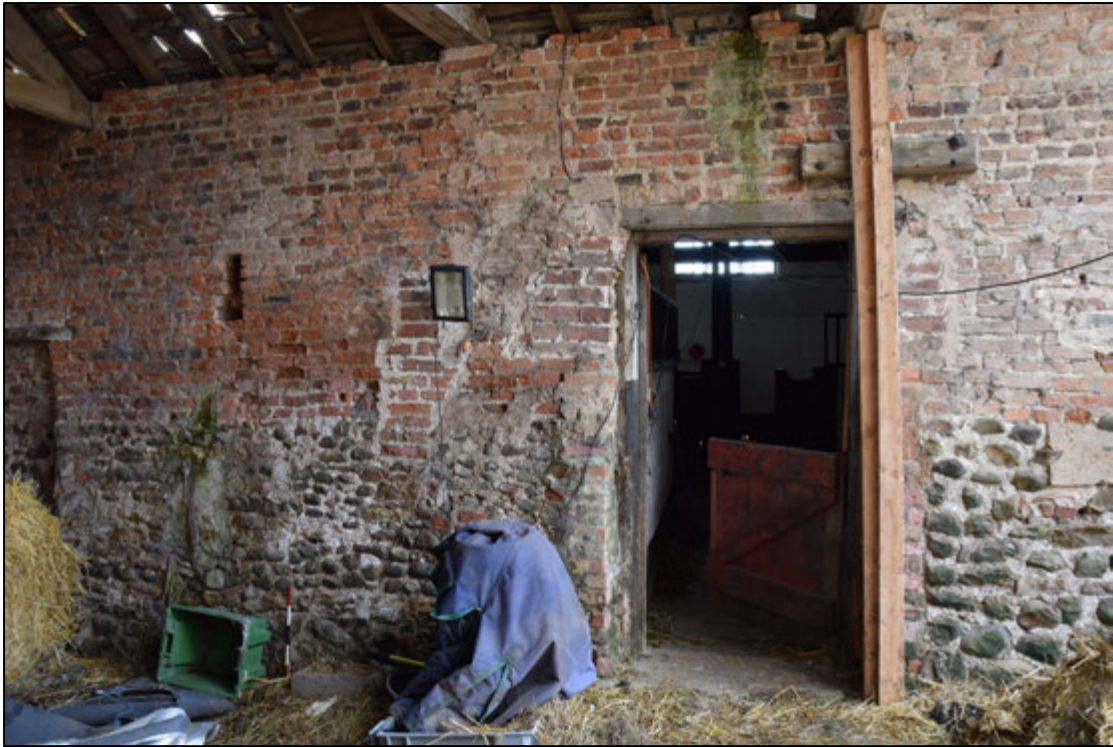
Photograph 69: Old stone and irregular brickwork, with extensive repairs, around the door to the stable building H

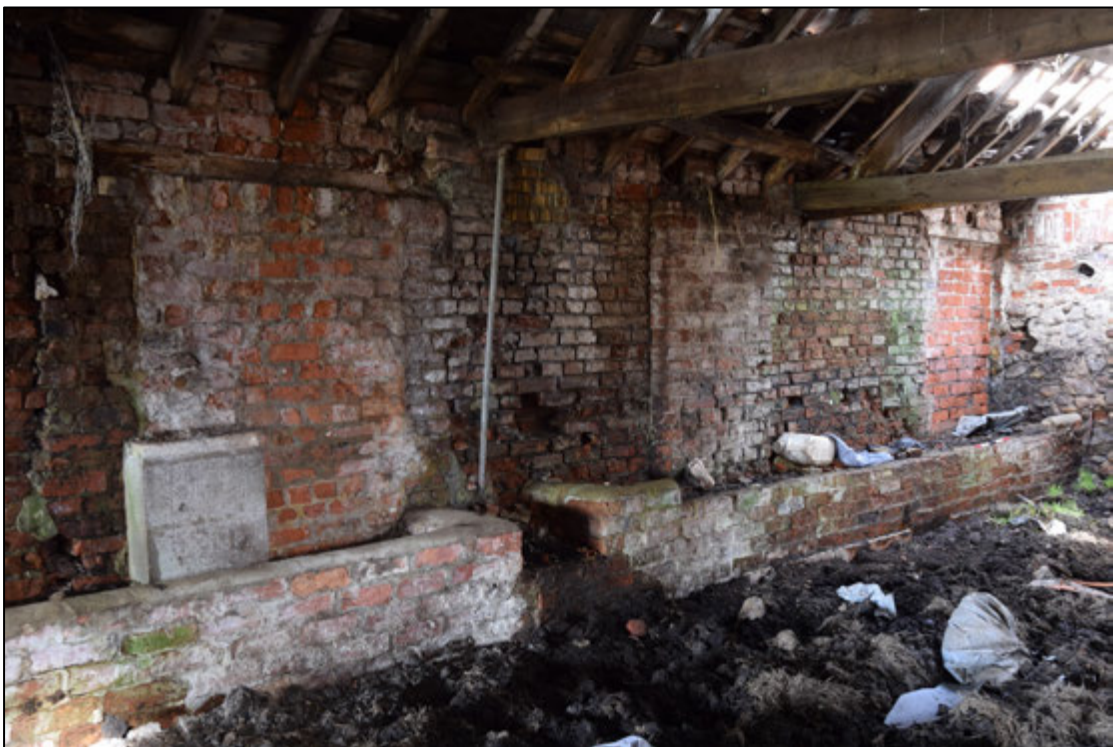
Photograph 76: Blocked doors and a brick trough in the north wall of the byre. The thicker section of wall, right of centre, is probably part of a pier from the vanished gin-gang

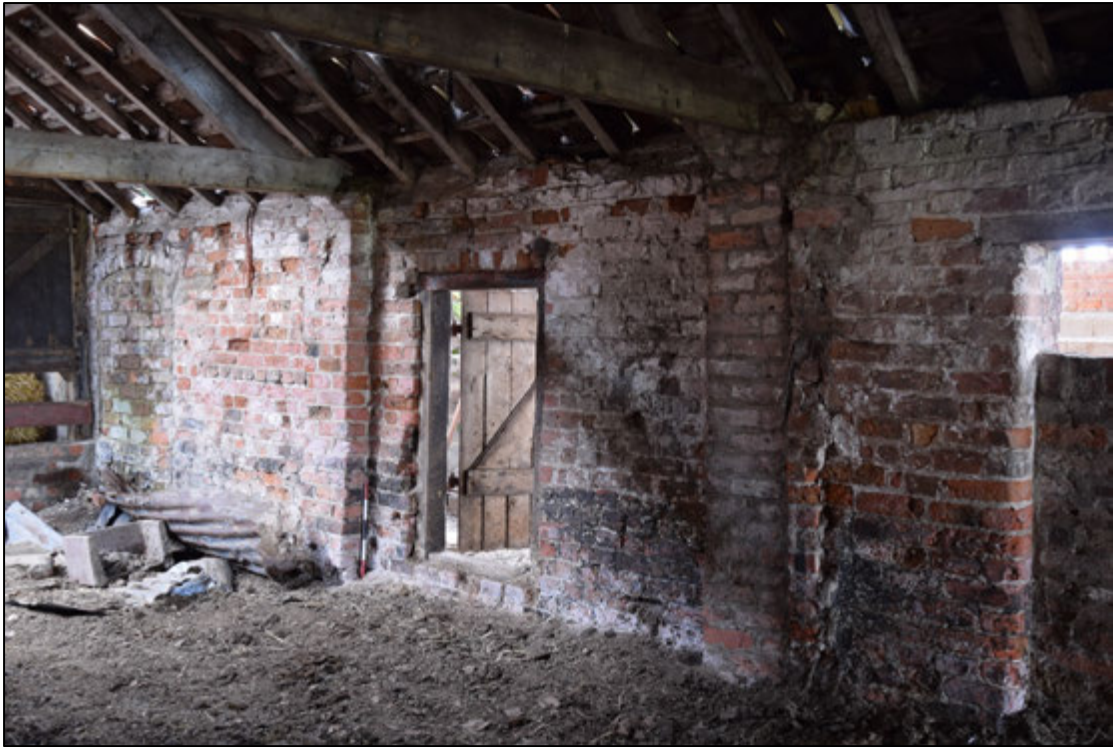
Photograph 77: The east end of the byre's south wall. Ragged brickwork right of the pier that carries the near roof truss marks the old east wall of the building. The door leads out onto a modern feeding gangway in building G

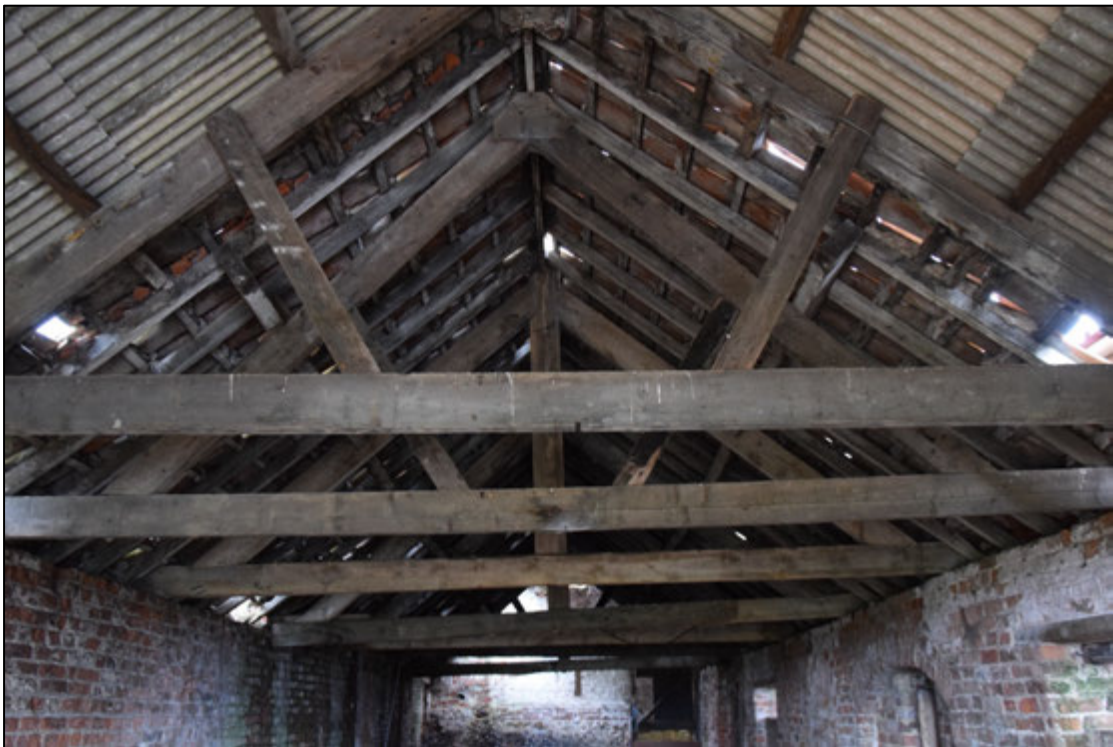
Photograph 82: Old roof trusses contrast with cruder examples in the foreground, at the west end of the byre
