ARCHAEOLOGICAL  
SERVICES  
DURHAM UNIVERSITY

Sheraton Hill Farm  
Sheraton  
County Durham

archaeological building recording

report 5050  
May 2019

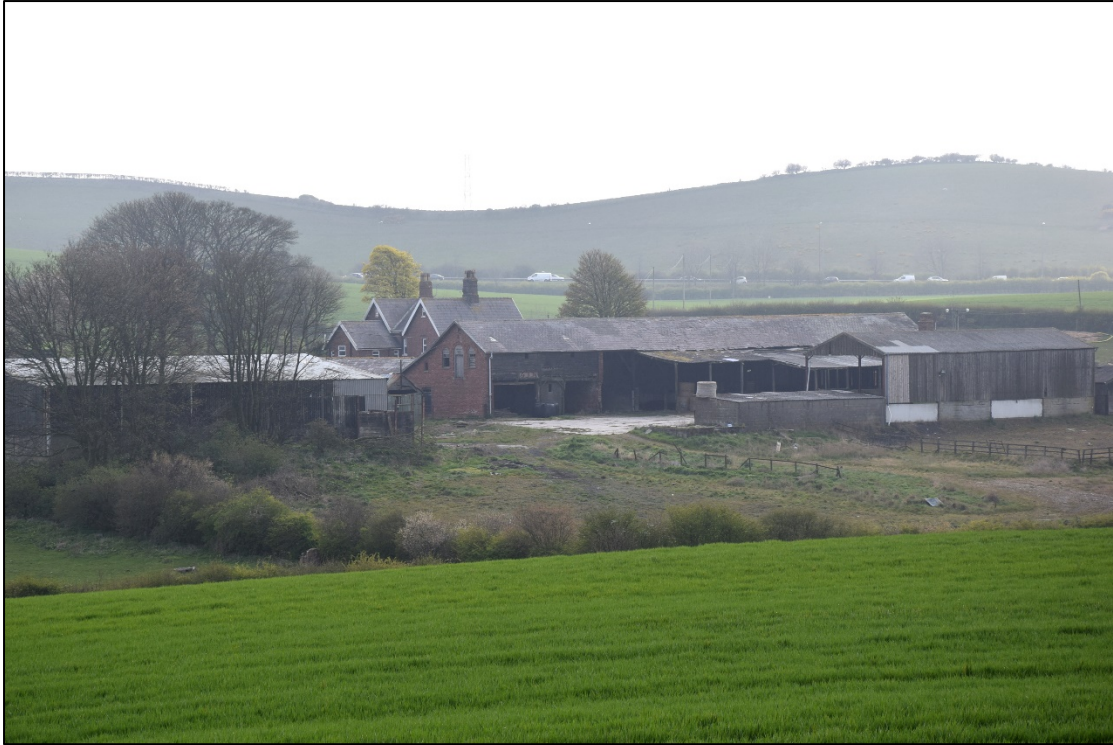
Photograph 1: A view looking south-west towards Sheraton Hill Farm from Bellows Burn Lane. The building described in this report is in the centre of the group, with the farm house behind

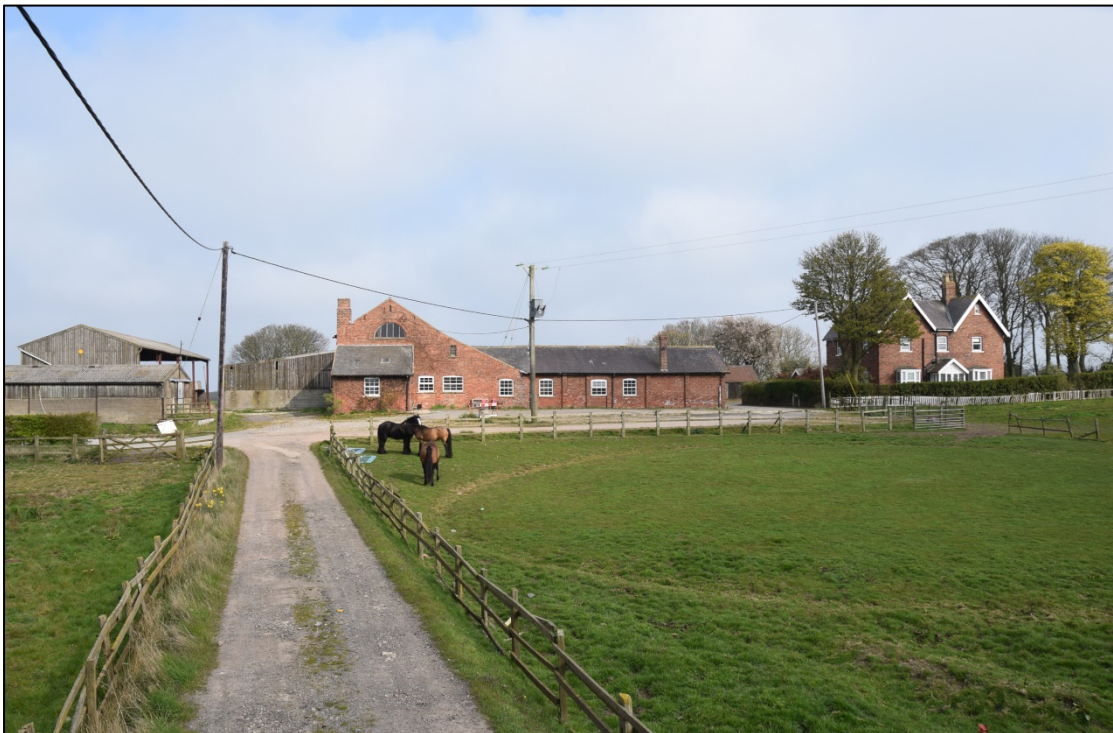
Photograph 2: The steading seen from the west. The later buildings at the left were used for straw and feed storage and stabling after the farm became an equestrian centre; note the lunge ring in the foreground

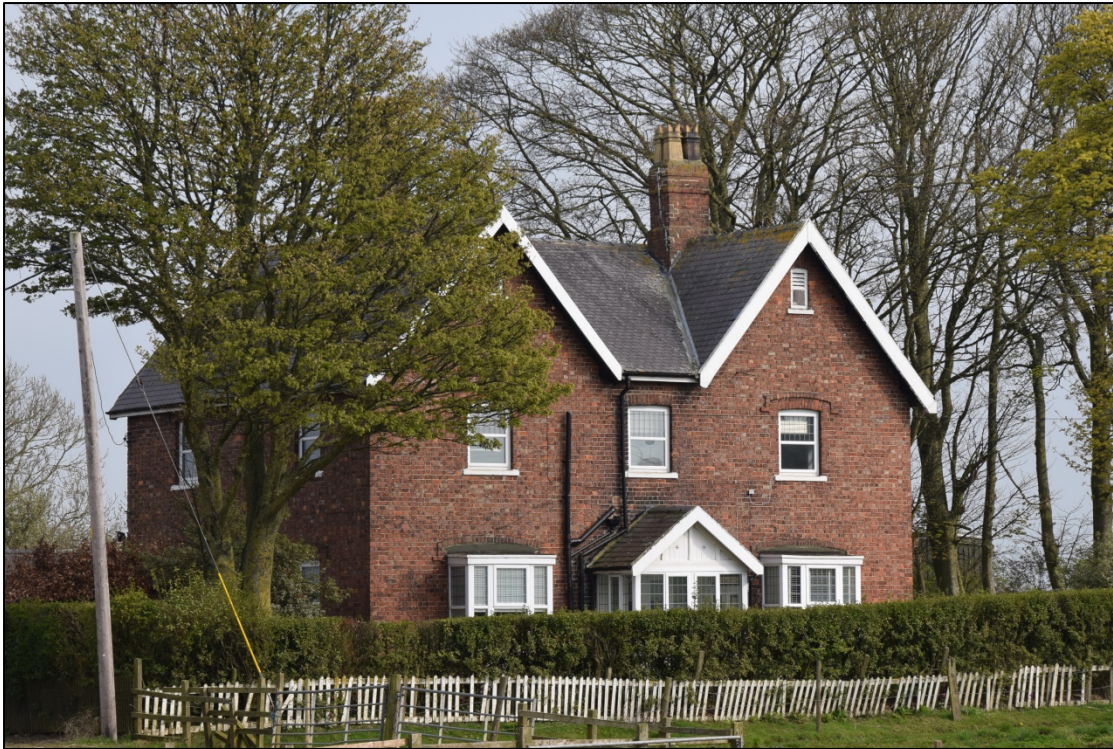
Photograph 3: The farmhouse is contemporary with the main building and shares some of its features, such as shallow arches over the windows

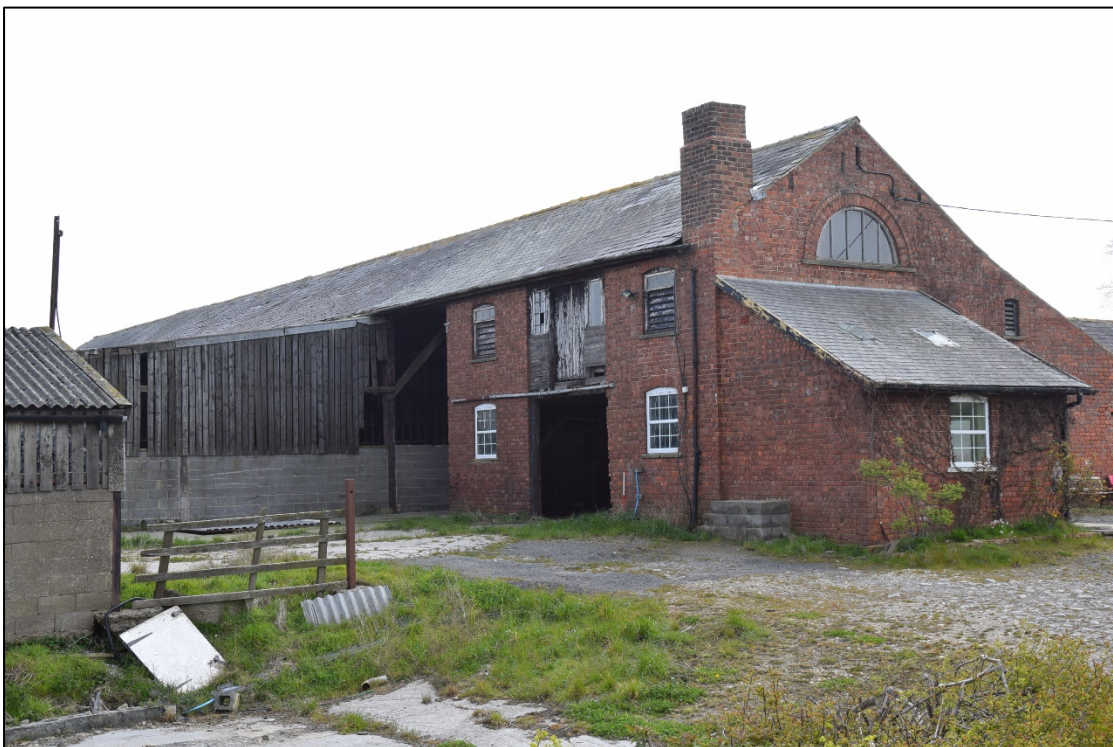
Photograph 4: The north-west corner of the main building, with the later pole barn left of centre

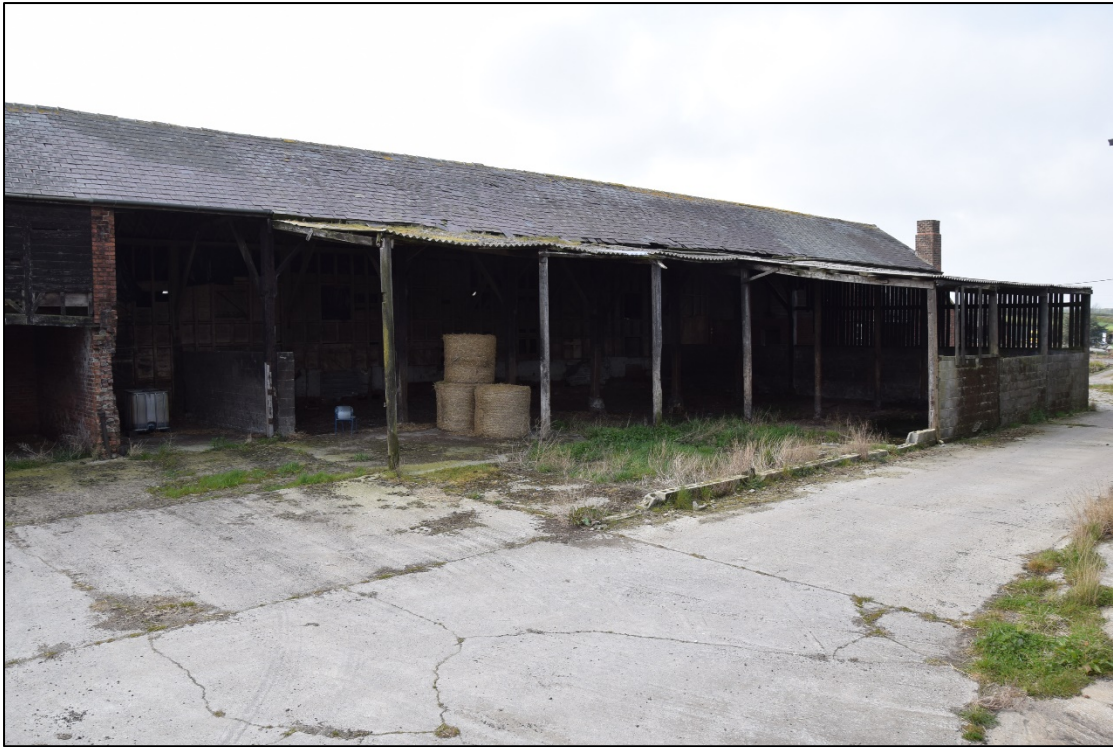
Photograph 5: The dilapidated pole barn [1], seen from the north-east

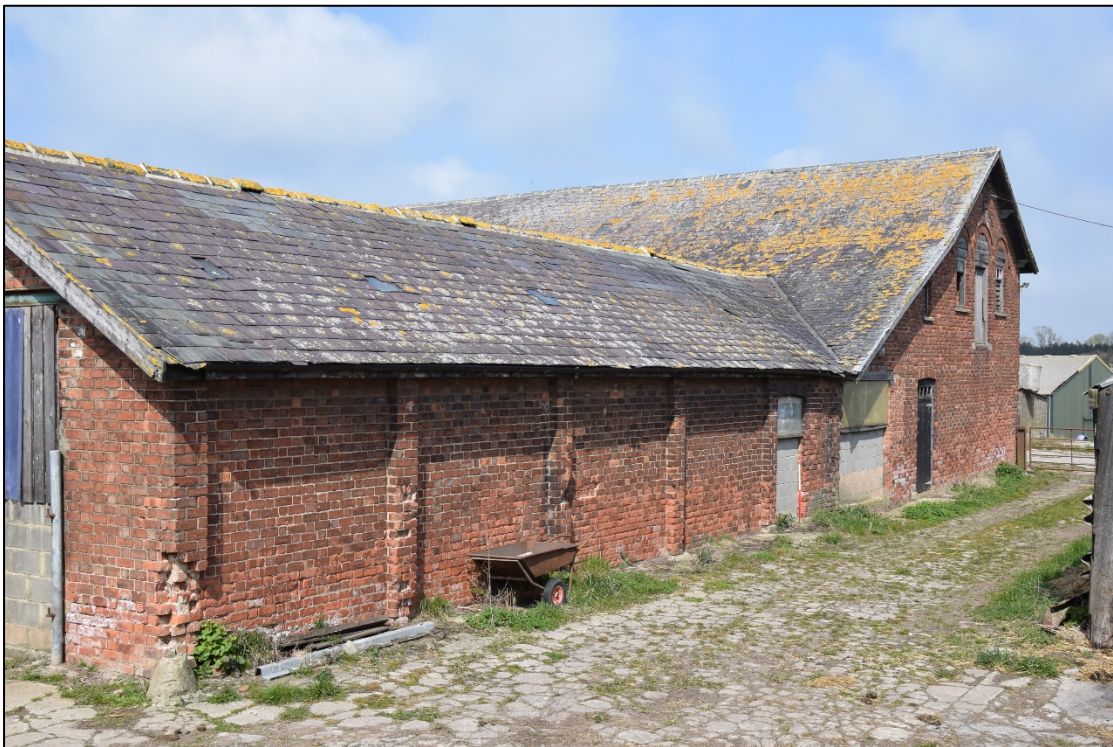
Photograph 6: The east end of the building, showing the first-floor door to the granary at the far end

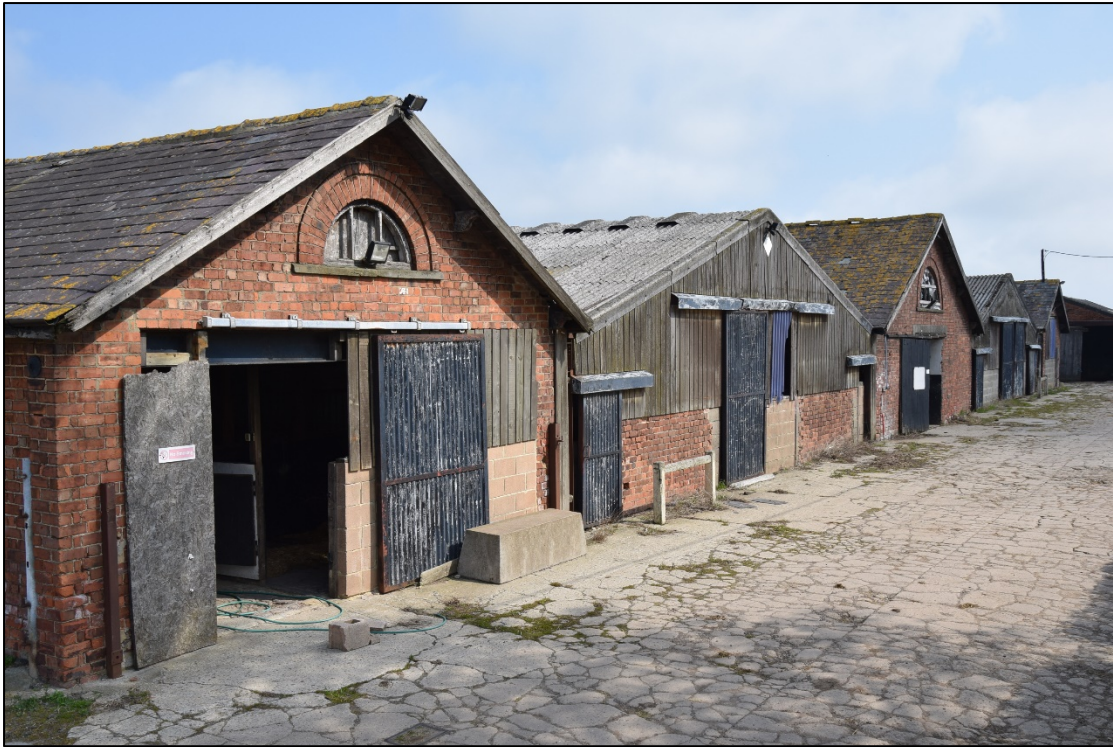
Photograph 7: The south face, with three original brick-built byres separated by later covered yards

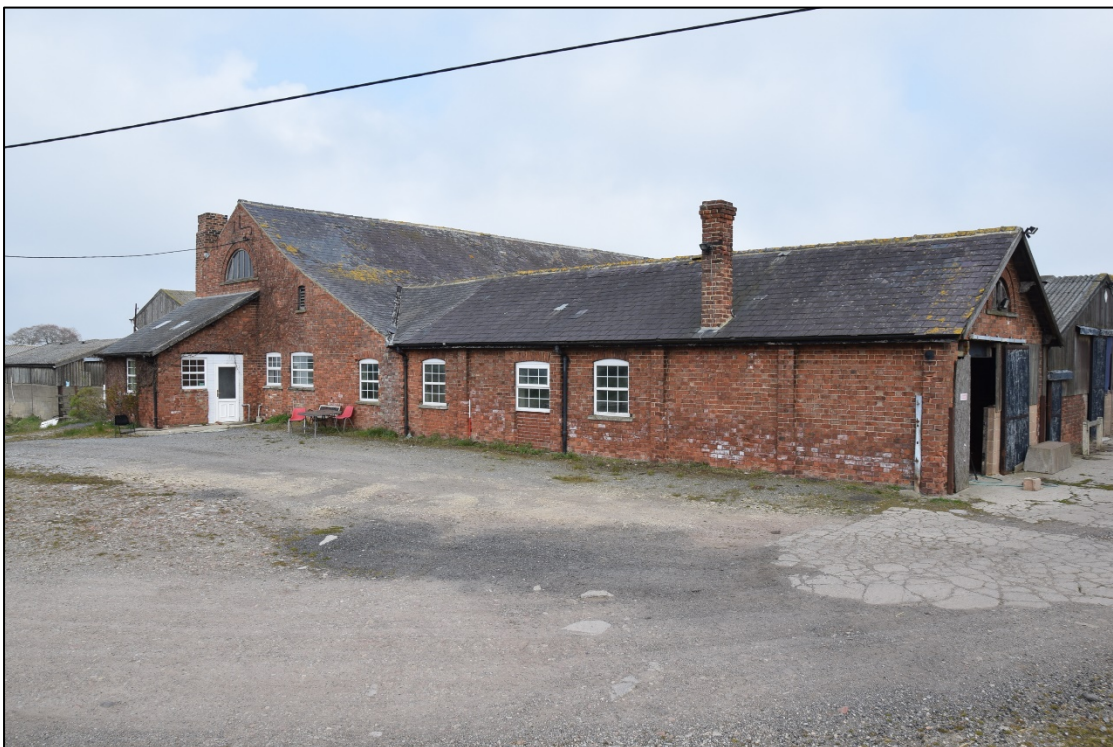
Photograph 8: The west face. Note the altered doors in the single-storey byre, the chimneys and the lean-to that formerly housed an engine

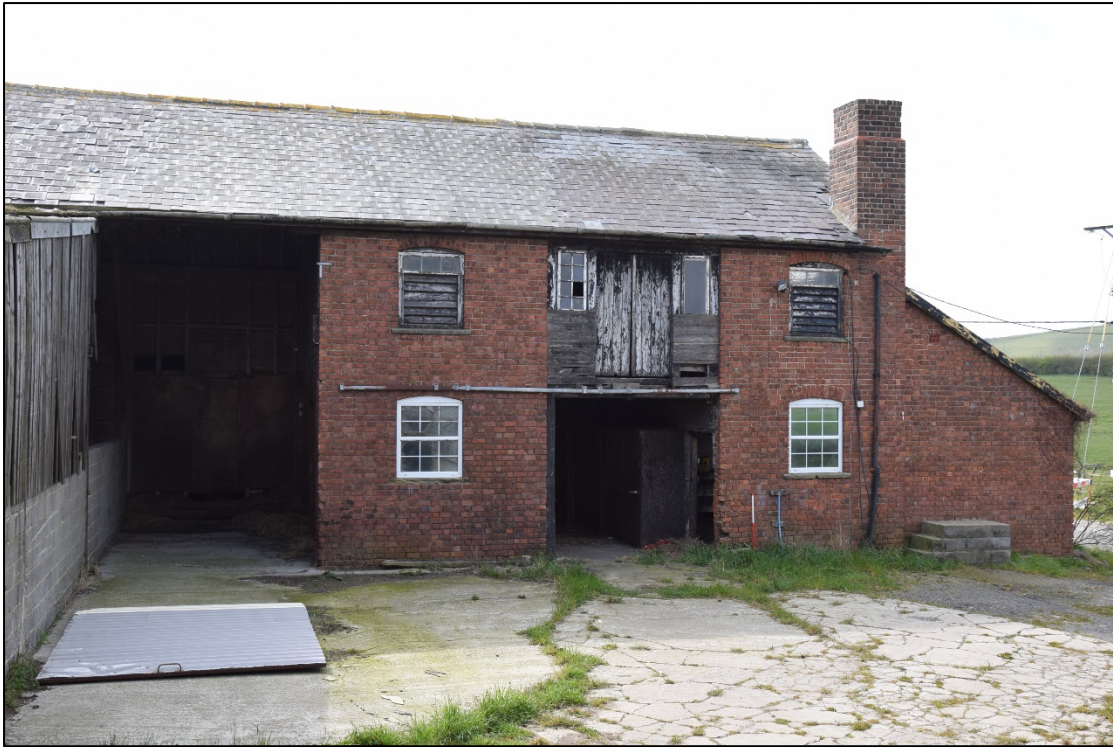
Photograph 9: The north face of the west block. The opening at the left is the end of the hay barn [9]. The chimney has been truncated and capped

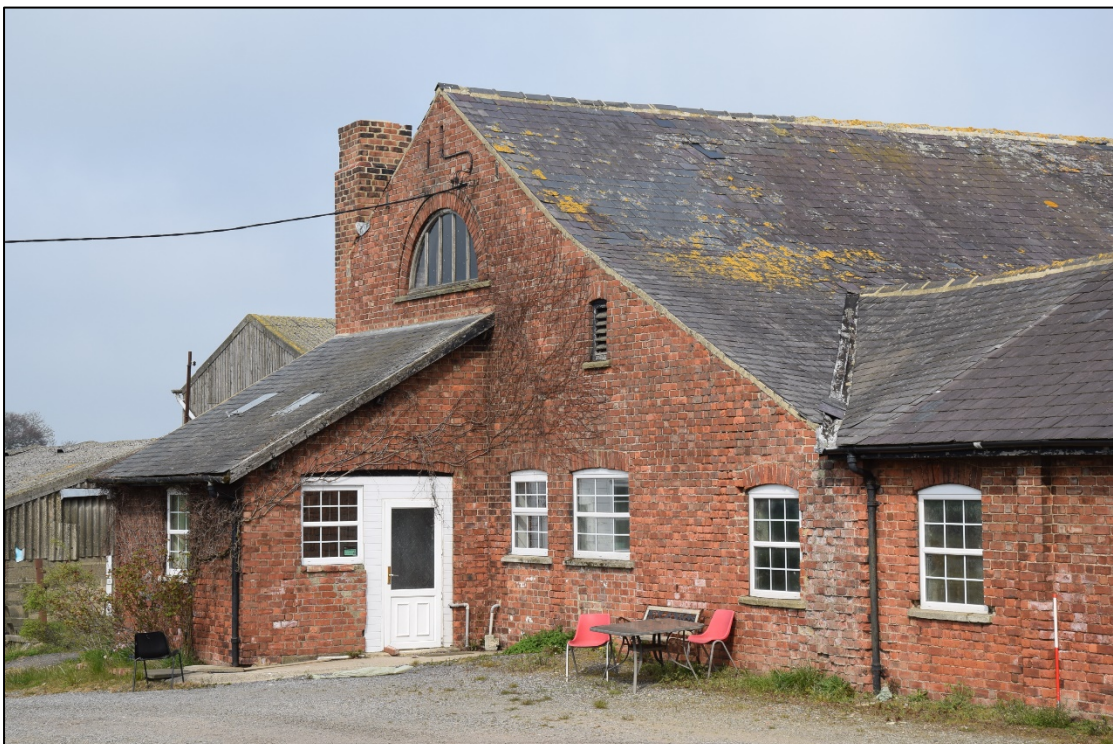
Photograph 10: The lean-to formerly had a wide door that filled most of its south wall. A view looking north-east

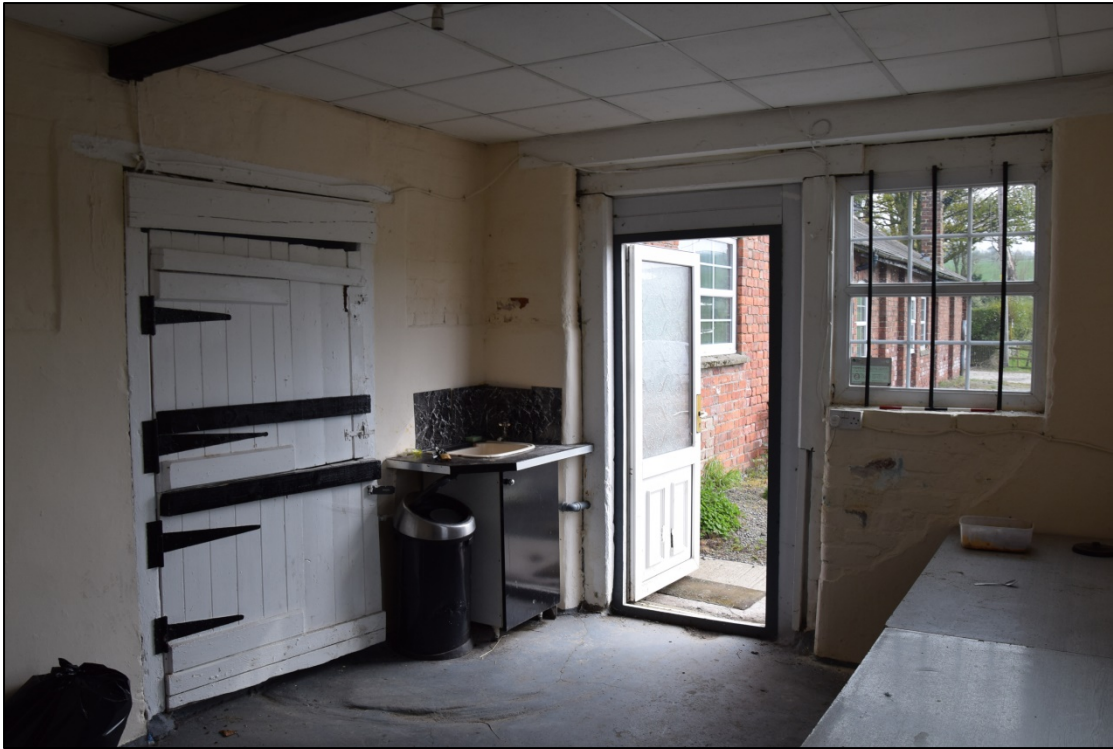
Photograph 11: The canteen [2], showing the door to the kitchen inside the main block

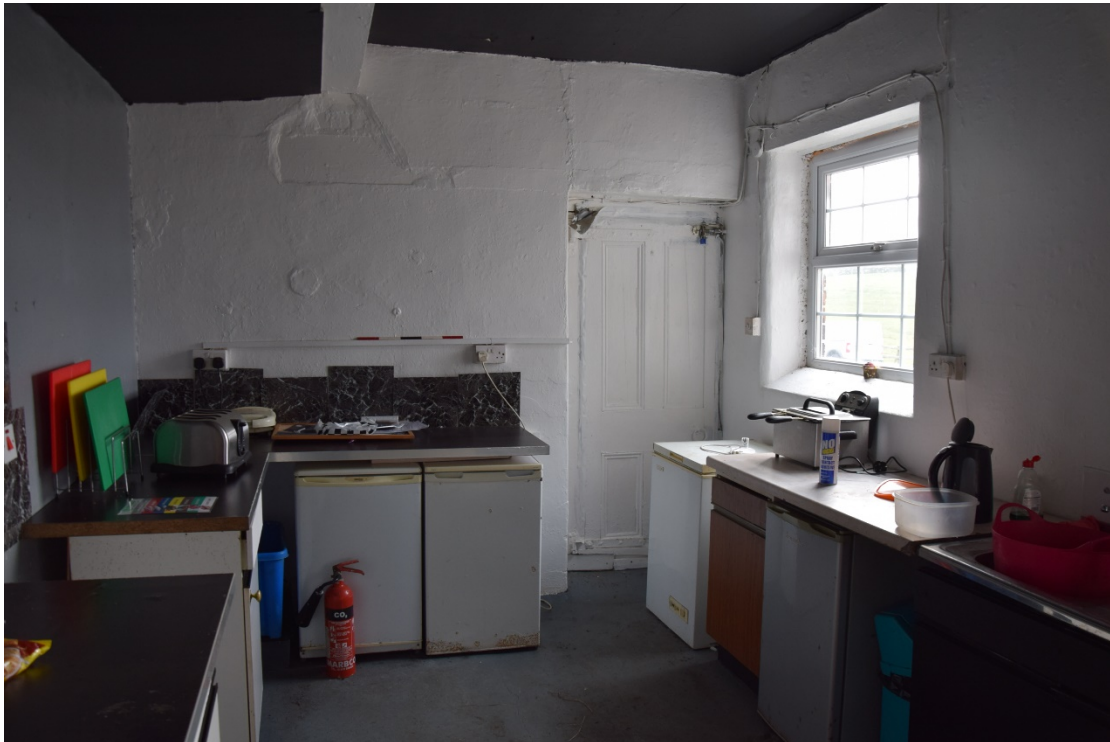
Photograph 12: A view looking south in the kitchen [3]. The door leads into the locker room [11]

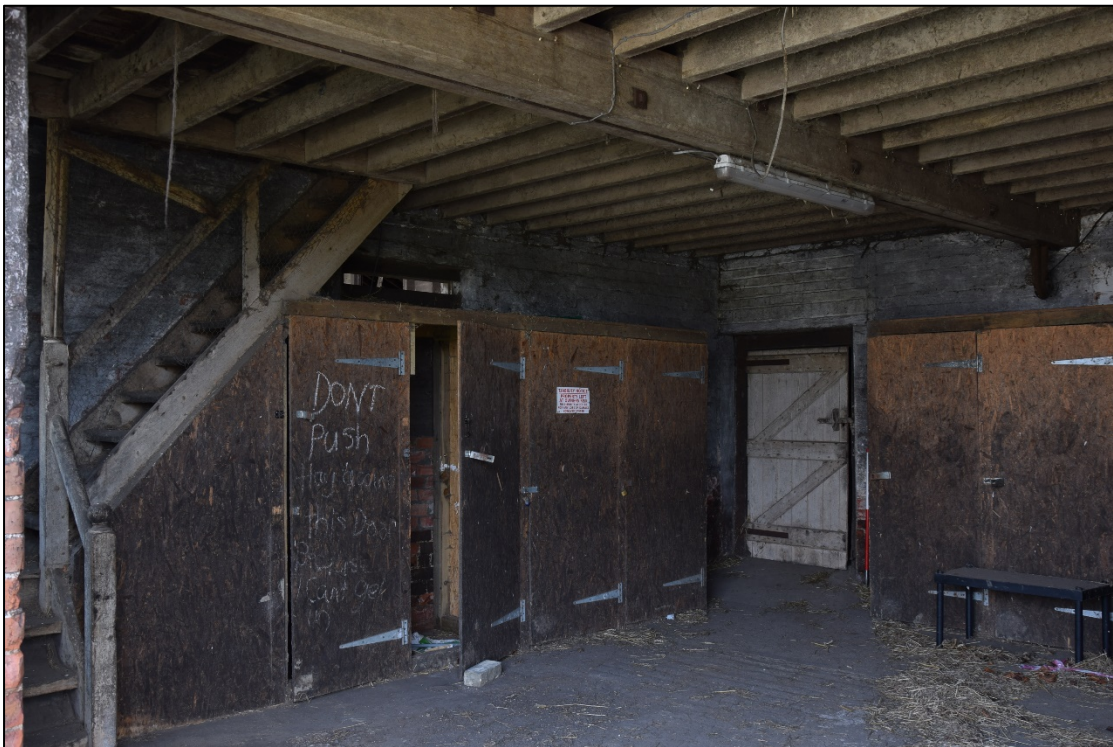
Photograph 14: The ground floor room [4] in the west block, showing the stairs and the door to the feeding passage [10]

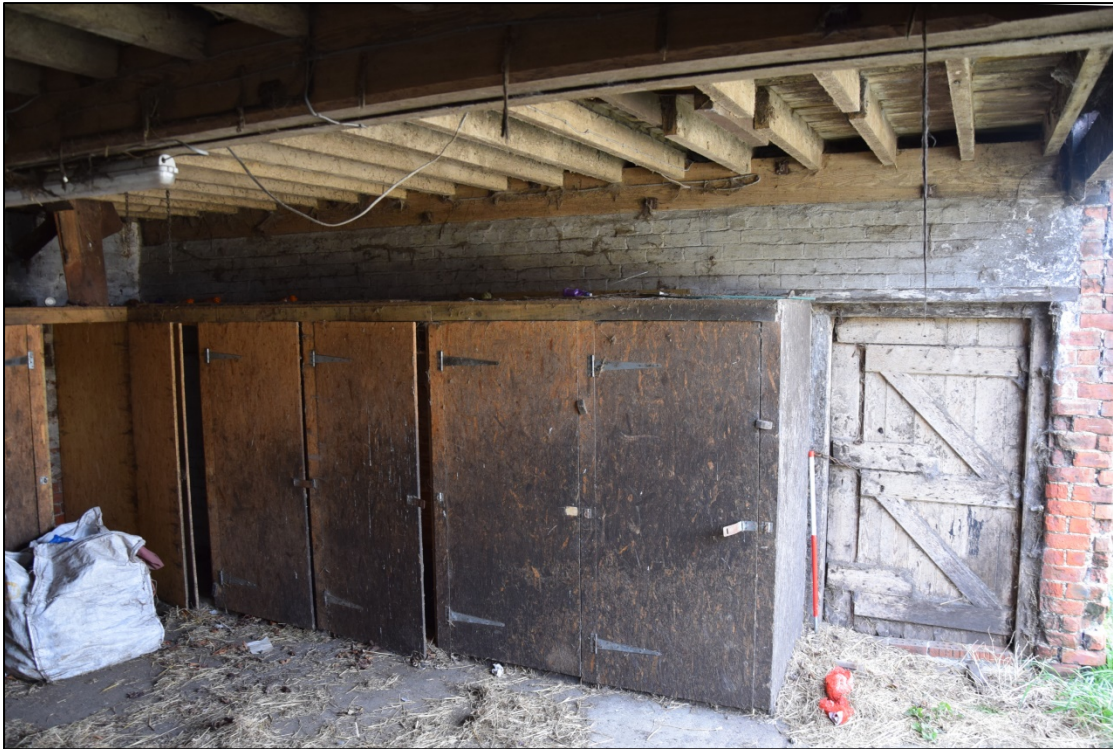
Photograph 15: Most of the west wall in [4] is concealed by lockers; the door leads to the small store room [5]

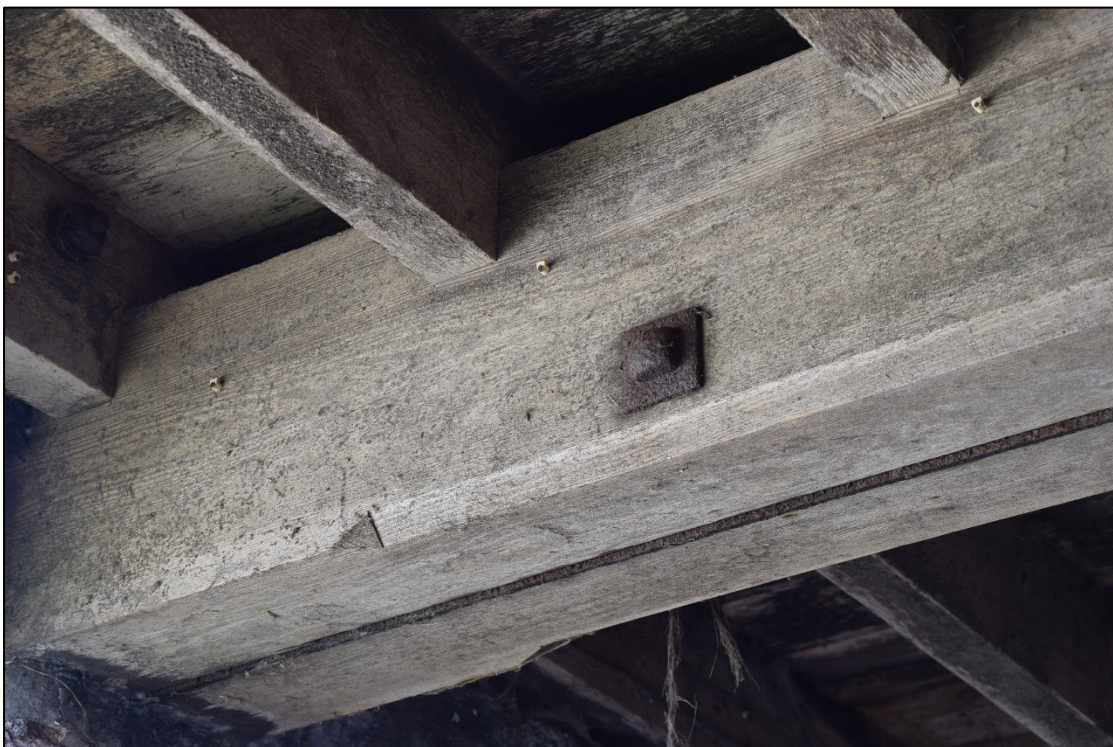
Photograph 16: Detail of the heavy flitched ceiling beam in room [4]

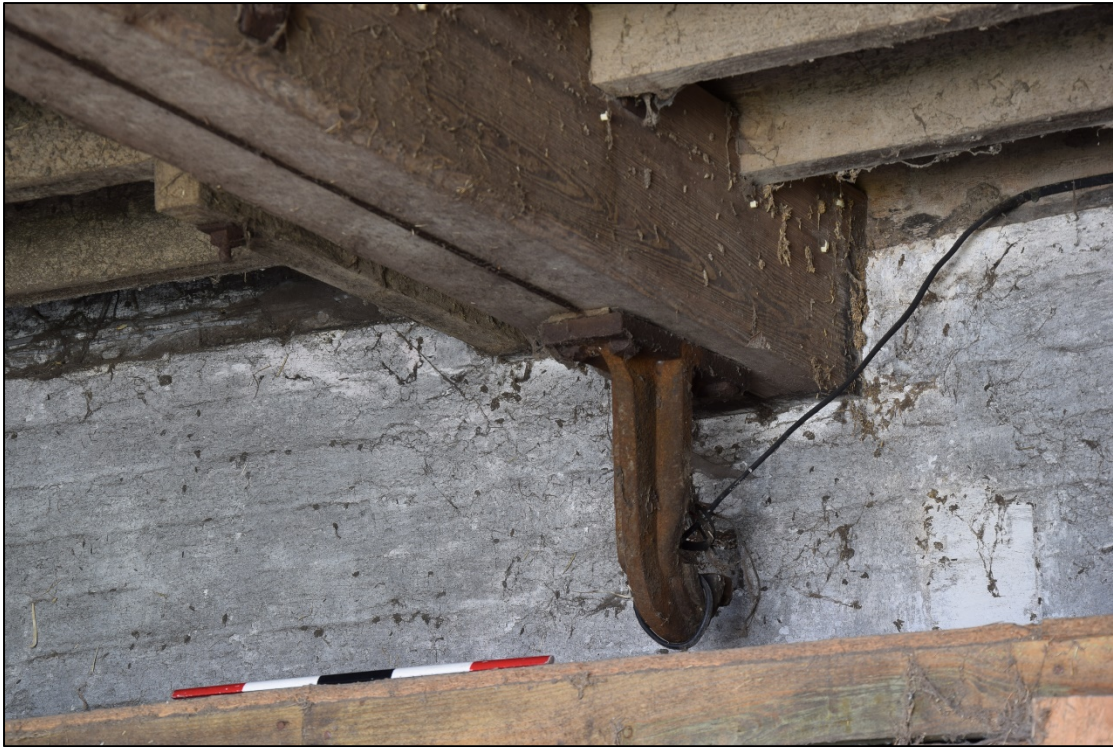
Photograph 17: An iron bracket at the south end of the ceiling beam in room [4]. This supported a bearing for a shaft that ran parallel with the wall

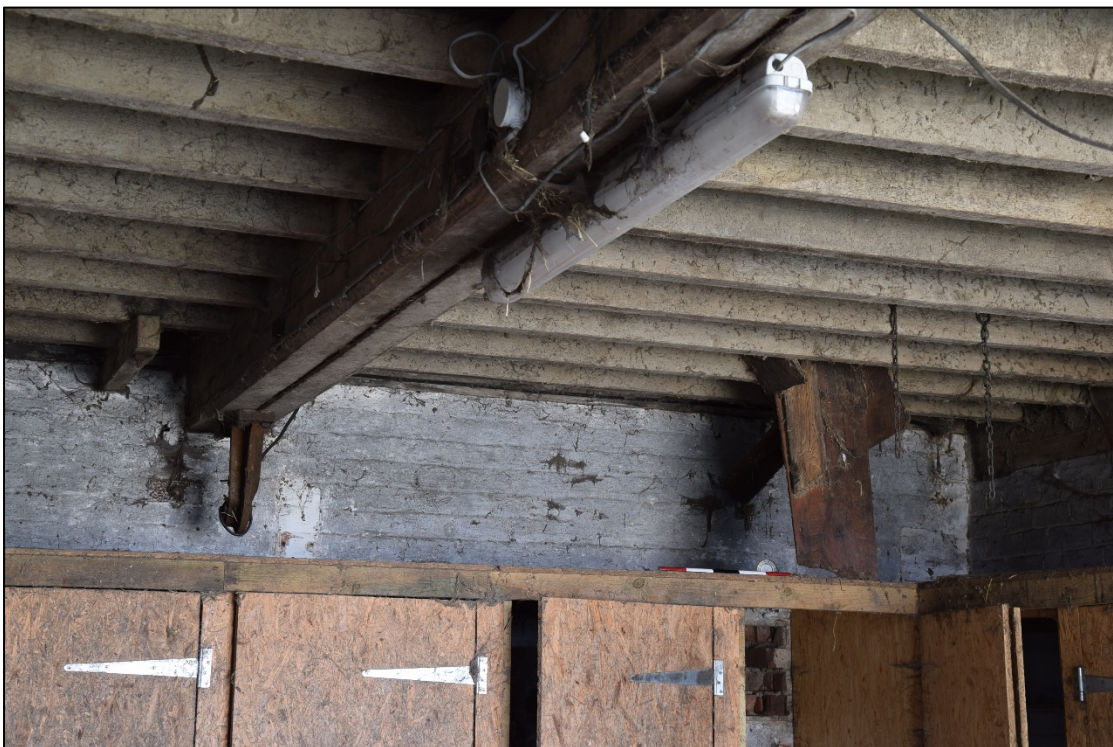
Photograph 18: The south-west corner of room [4], showing the beam, bracket and wooden chute from a first-floor hopper

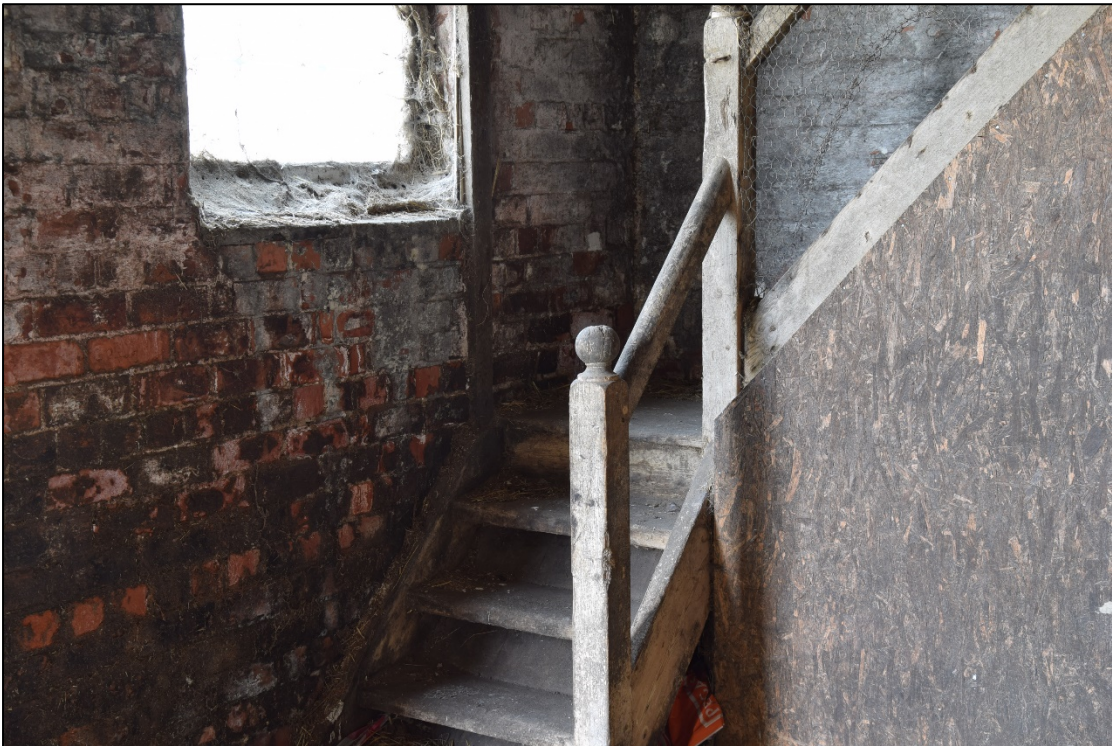
Photograph 20 (below): The staircase at the north-east corner of room [4]

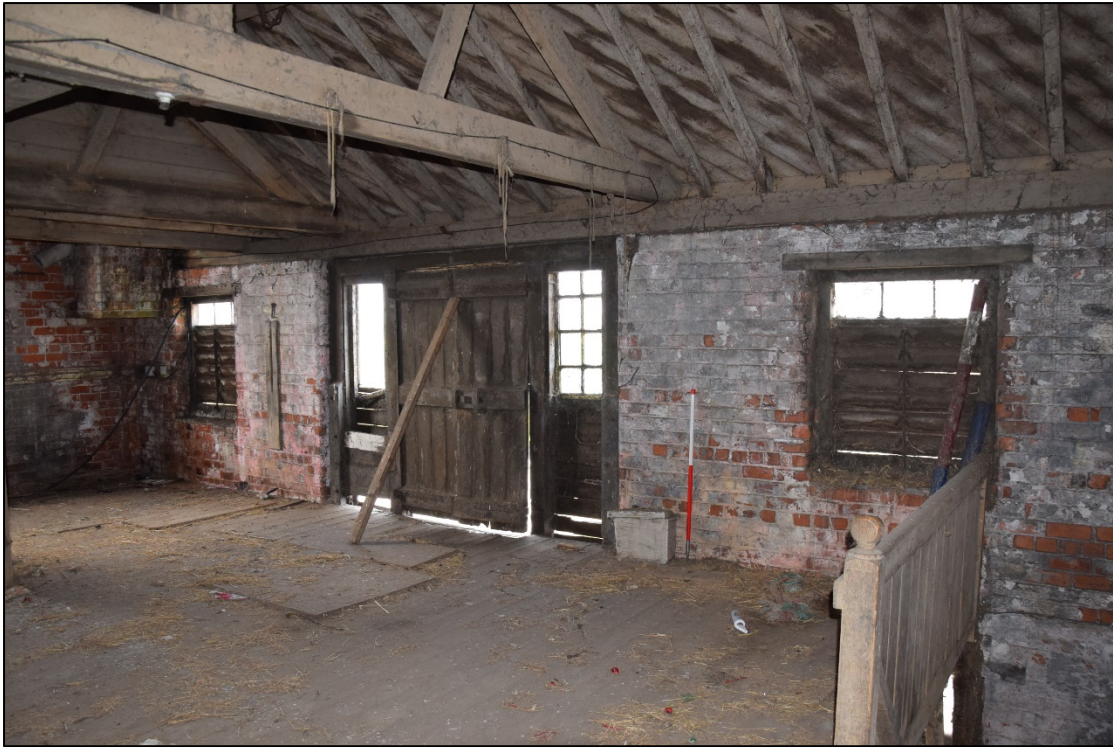
Photograph 21: The former machine room [6] on the first floor of the west block. A view looking north-west

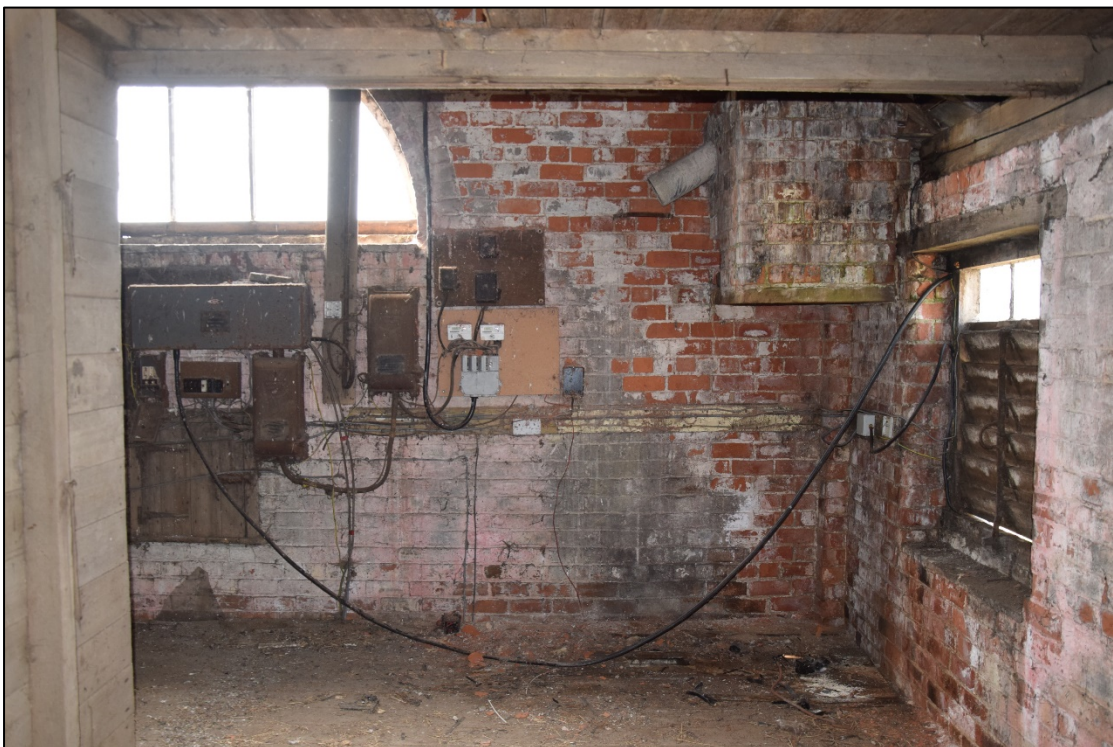
Photograph 22: The chimney and later electrical equipment at the north-west corner of room [6]

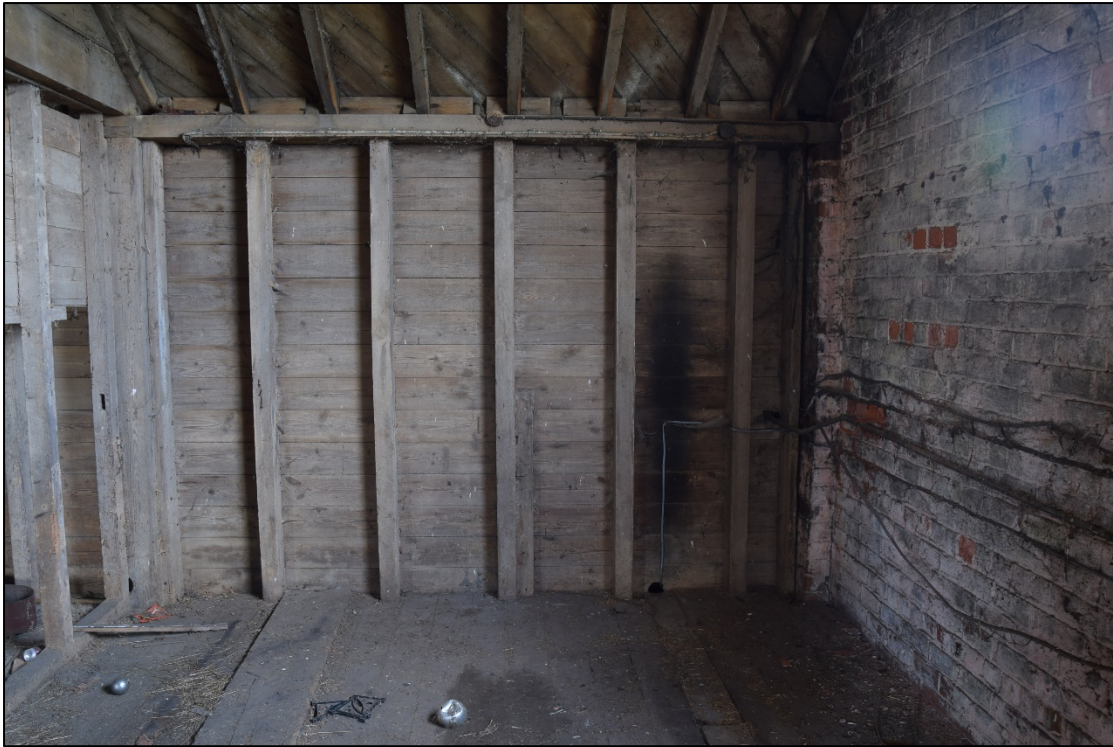
Photograph 23: An oil mark on the south wall of room [6] indicates the position of some vanished piece of machinery. The timber at the left is the side of a former hopper

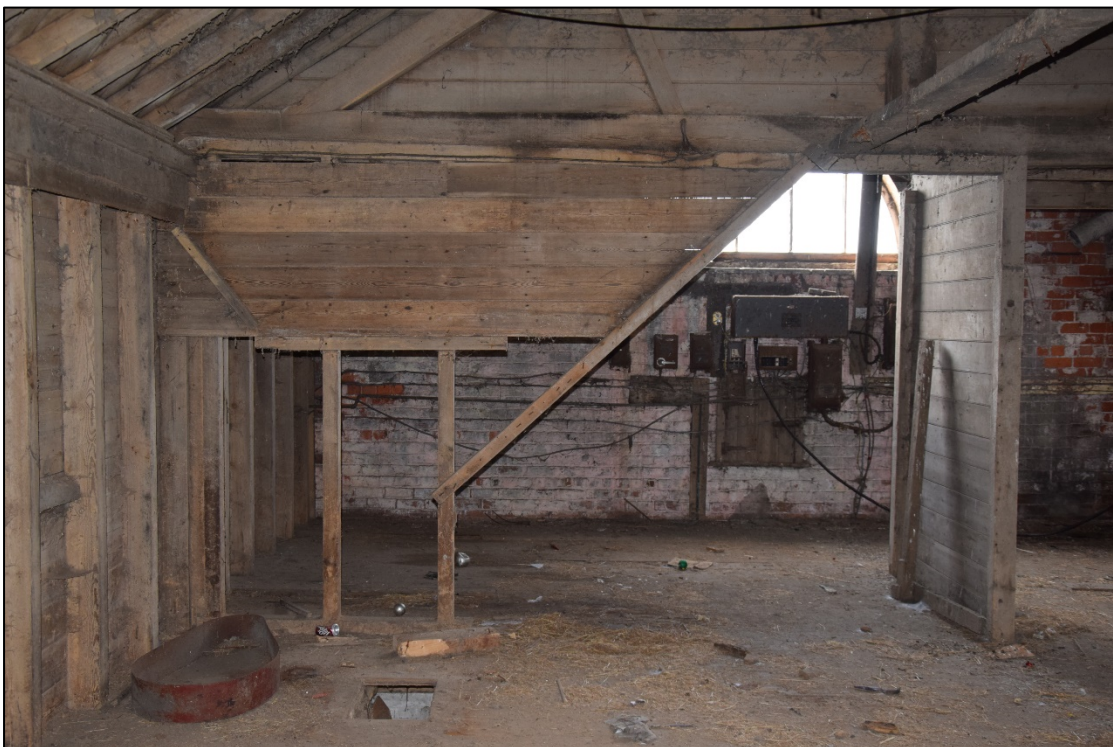
Photograph 24: A view looking west at the remains of the hopper in room [6]

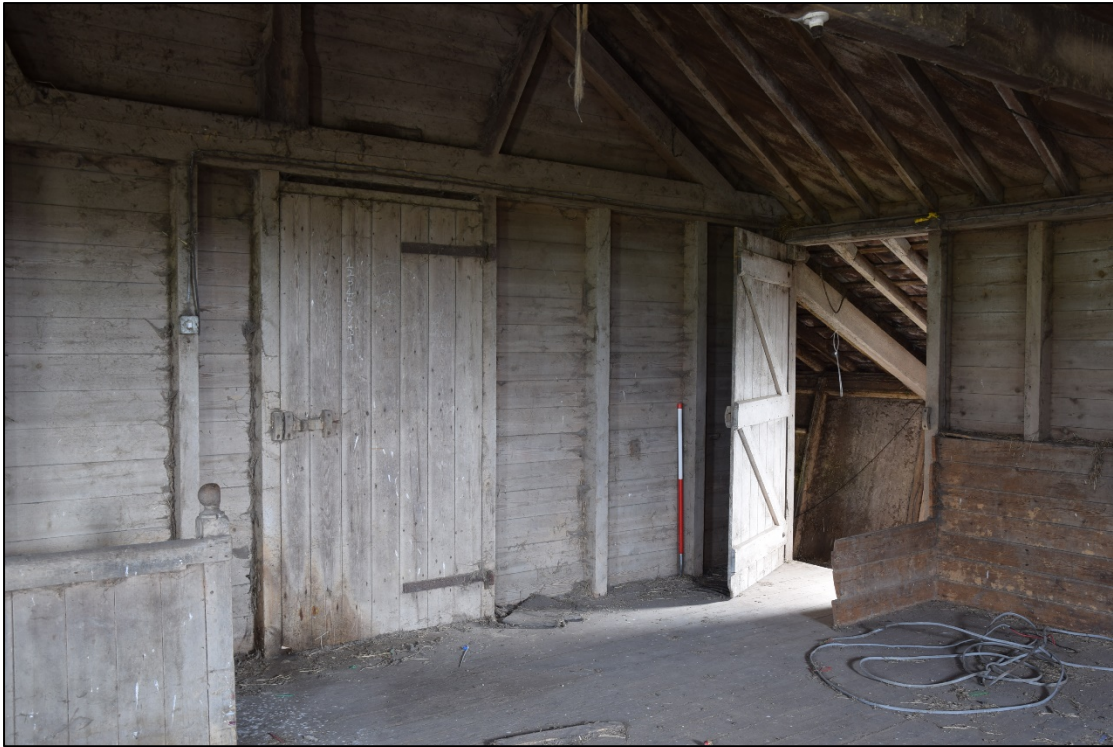
Photograph 25: The doors in the south-east corner of room [6], with the upper feeding passage beyond

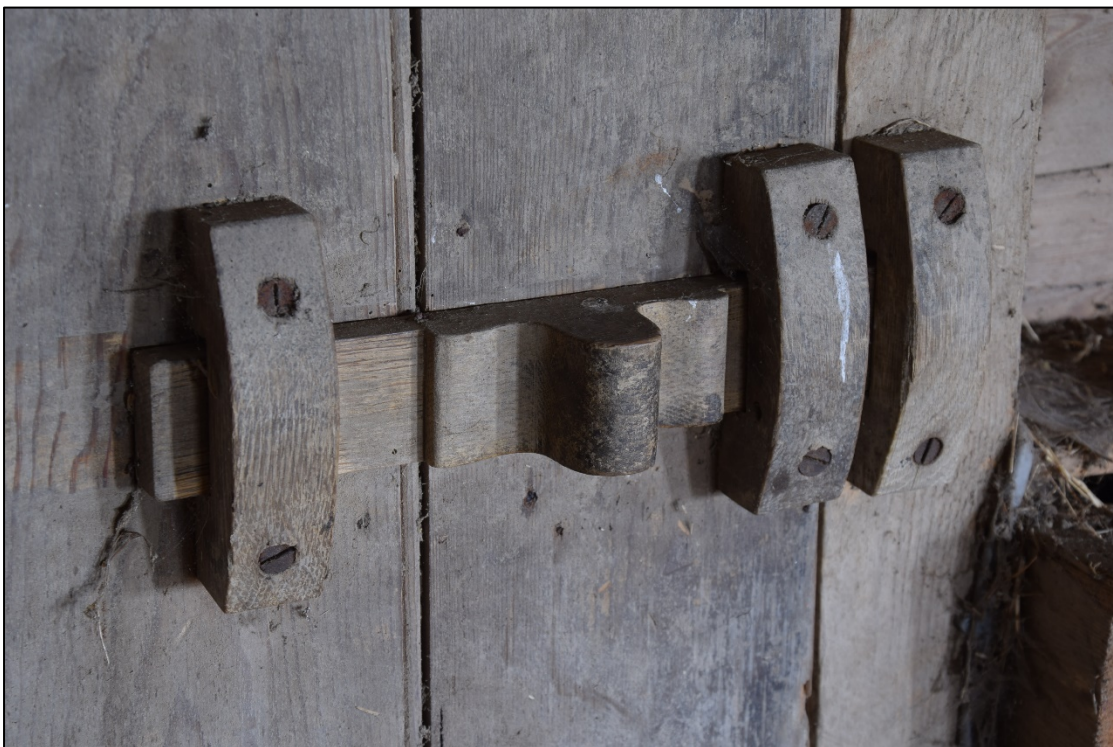
Photograph 26: High-quality joinery in the bolt of the door from [6] to the feeding passage

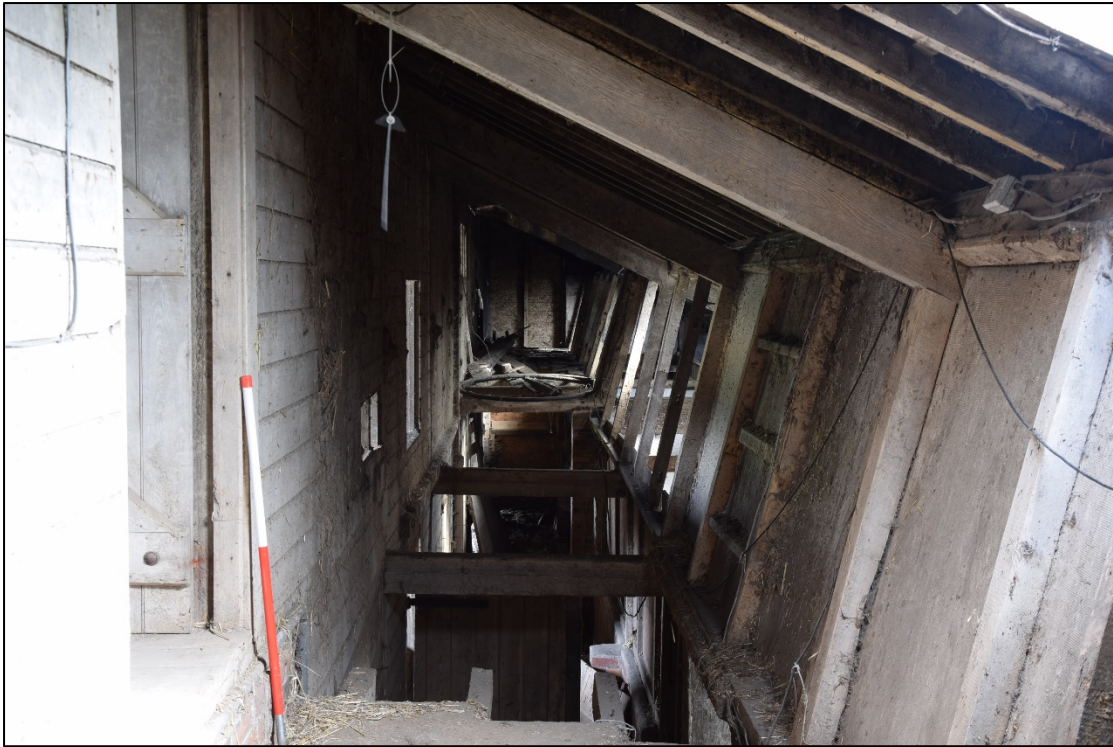
Photograph 27: The upper passage has lost most of its floor. A view looking east from the door to room [6]

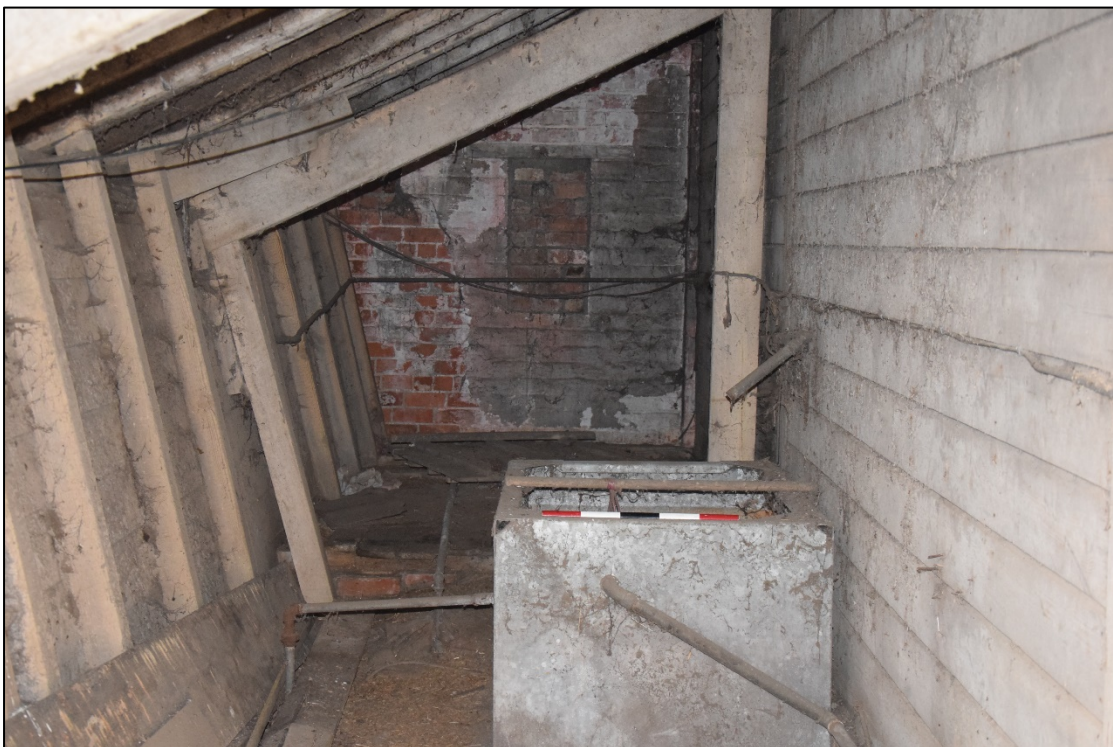
Photograph 28: A view looking west from the same position shows the blocked window at the end of the upper passage

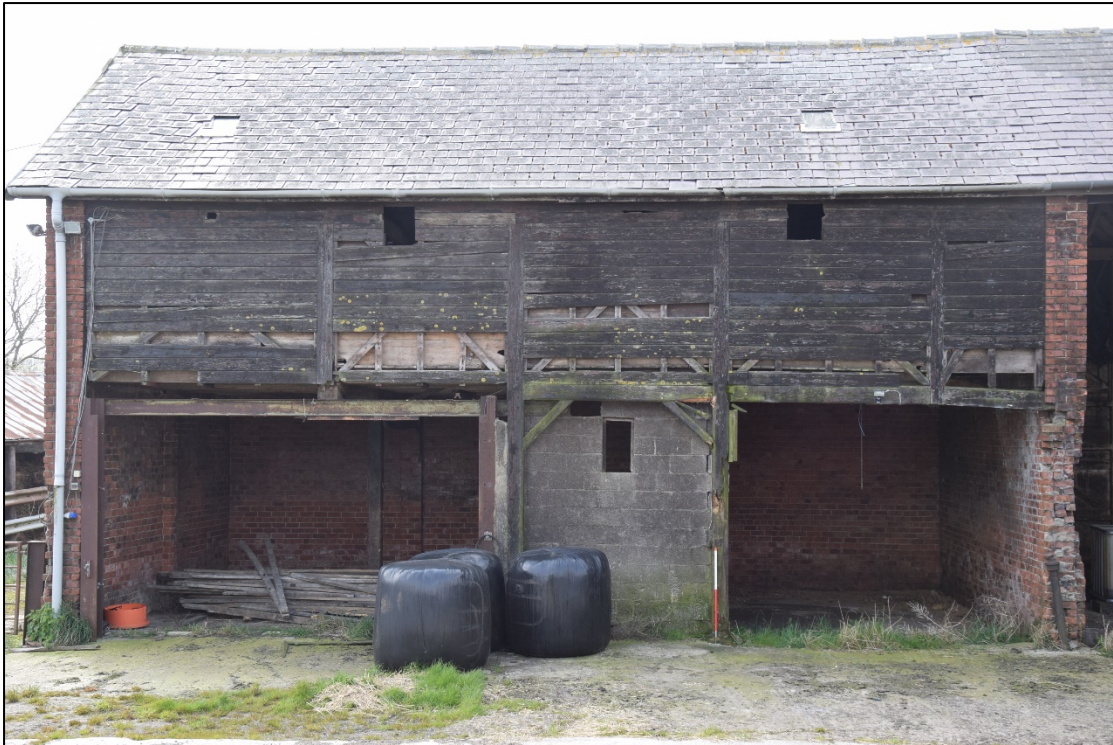
Photograph 29: The north face of the east block, with its timber-fronted granary
