ARCHAEOLOGICAL  
SERVICES  
DURHAM UNIVERSITY

Sheraton Hill Farm  
Sheraton  
County Durham

archaeological building recording

report 5050  
May 2019

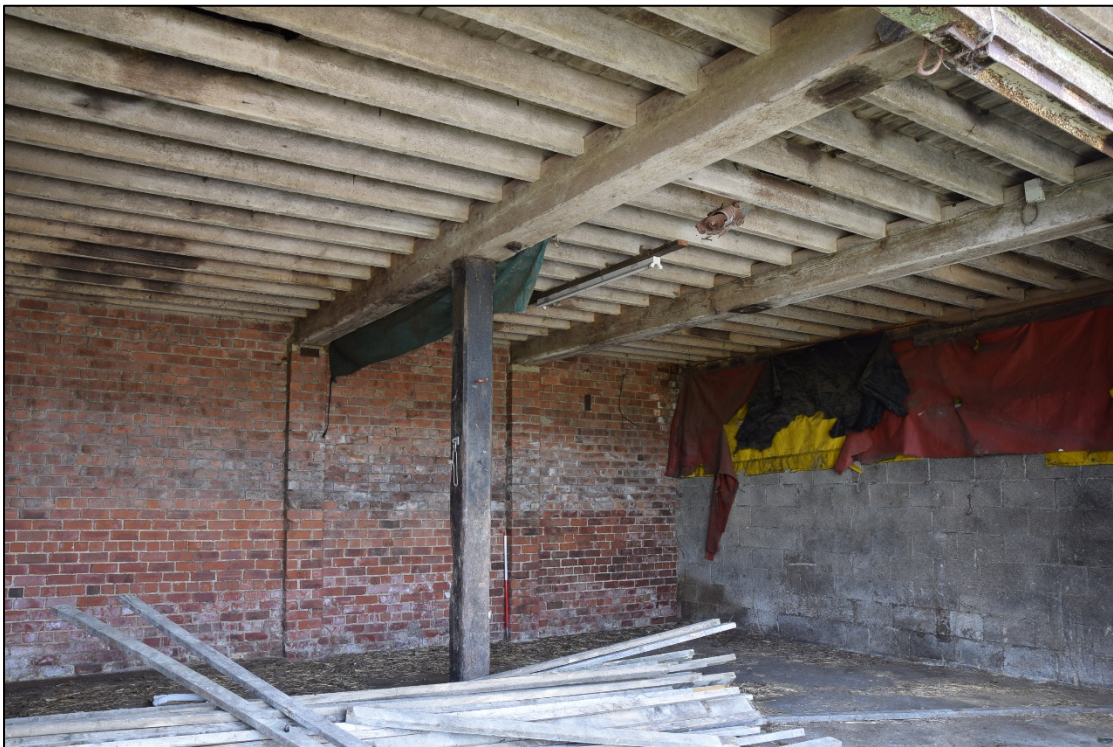
Photograph 30: The open-fronted shed [7] under the granary. Dark marks and mortices on the underside of the ceiling beams show the position of timber posts like the one in the centre of the picture

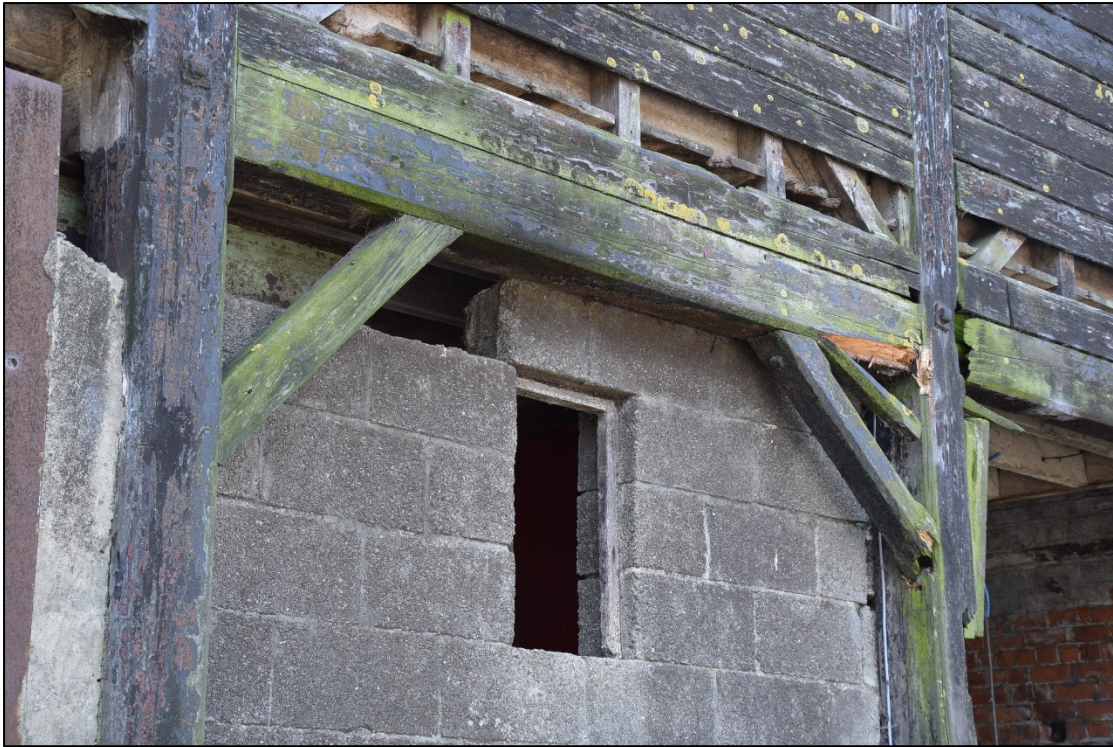
Photograph 31: The timberwork of the middle bay shows the same level of quality seen in other parts of the building

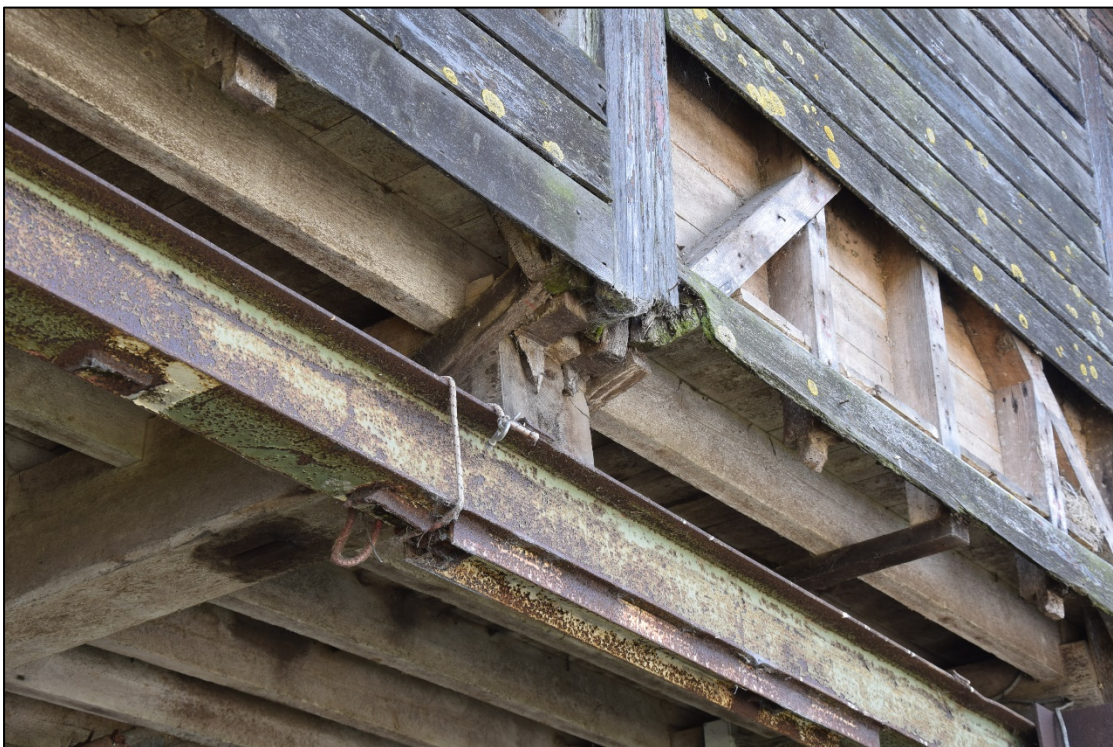
Photograph 32: Detail of the crude alteration made to create a wide opening at the east side of the shed [7]. The form of the double-skinned timber wall of the granary is clearly seen here. A view looking south-west

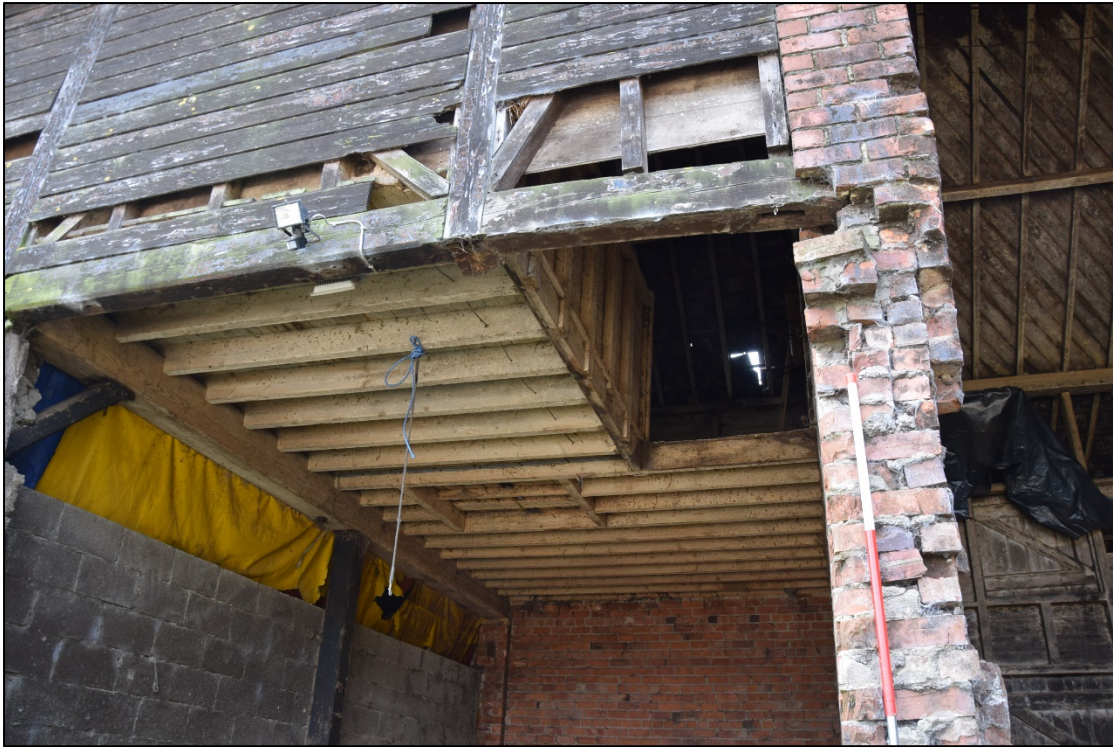
Photograph 33: A trapdoor and the opening for the original granary staircase in the west bay

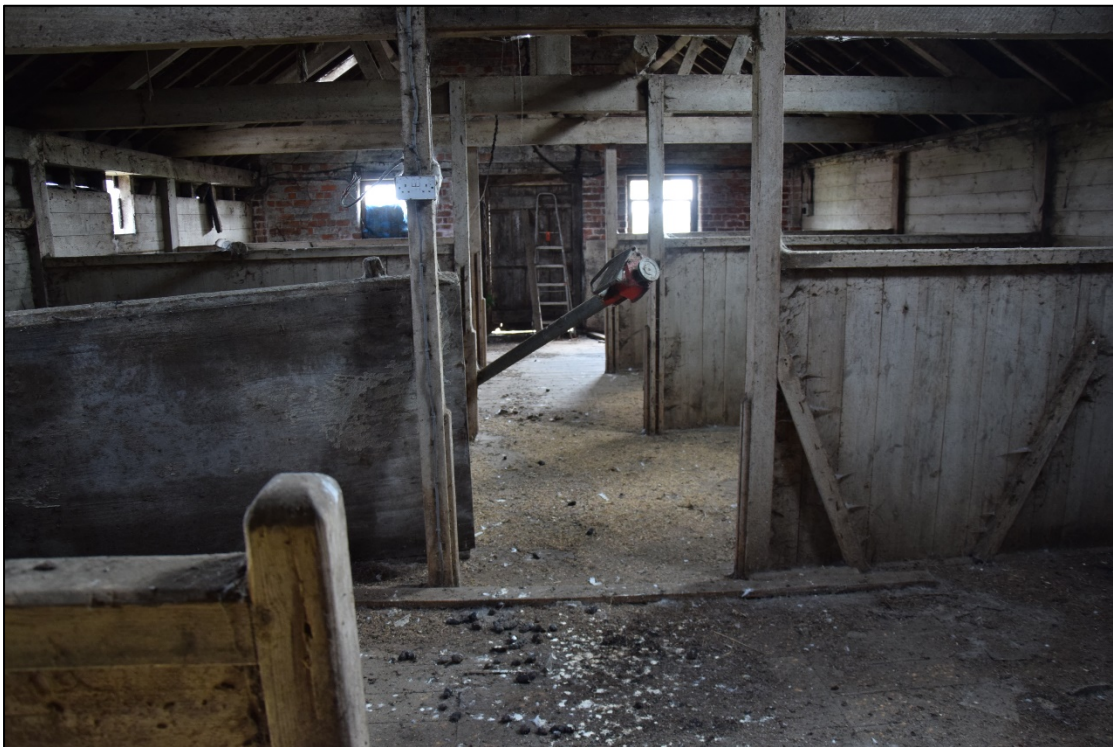
Photograph 34: The granary [7] seen from the east end

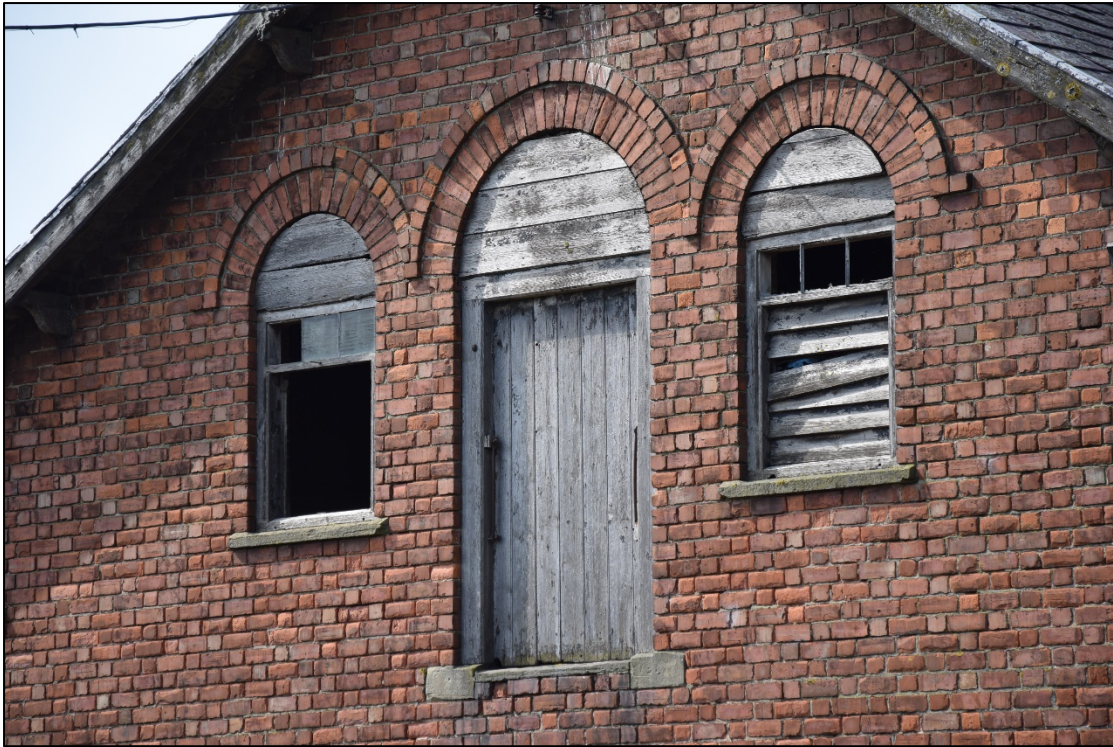
Photograph 35: The loading door and louvred windows at the east end of the granary [8]

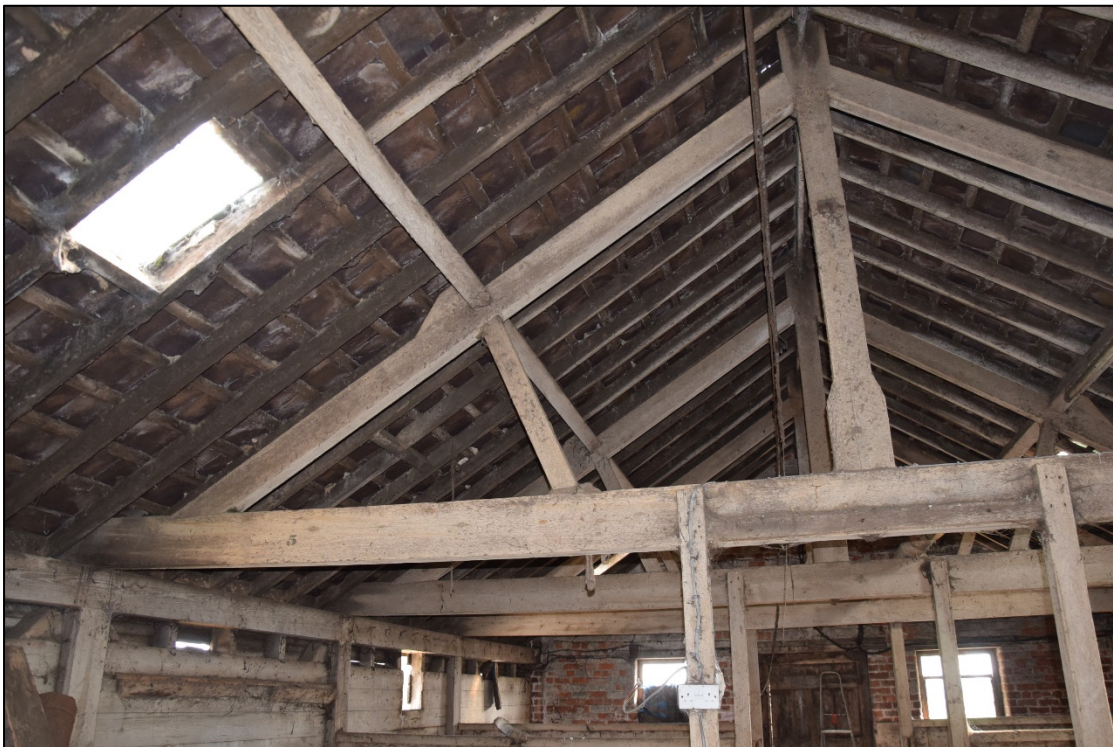
Photograph 36: The roof truss in the granary

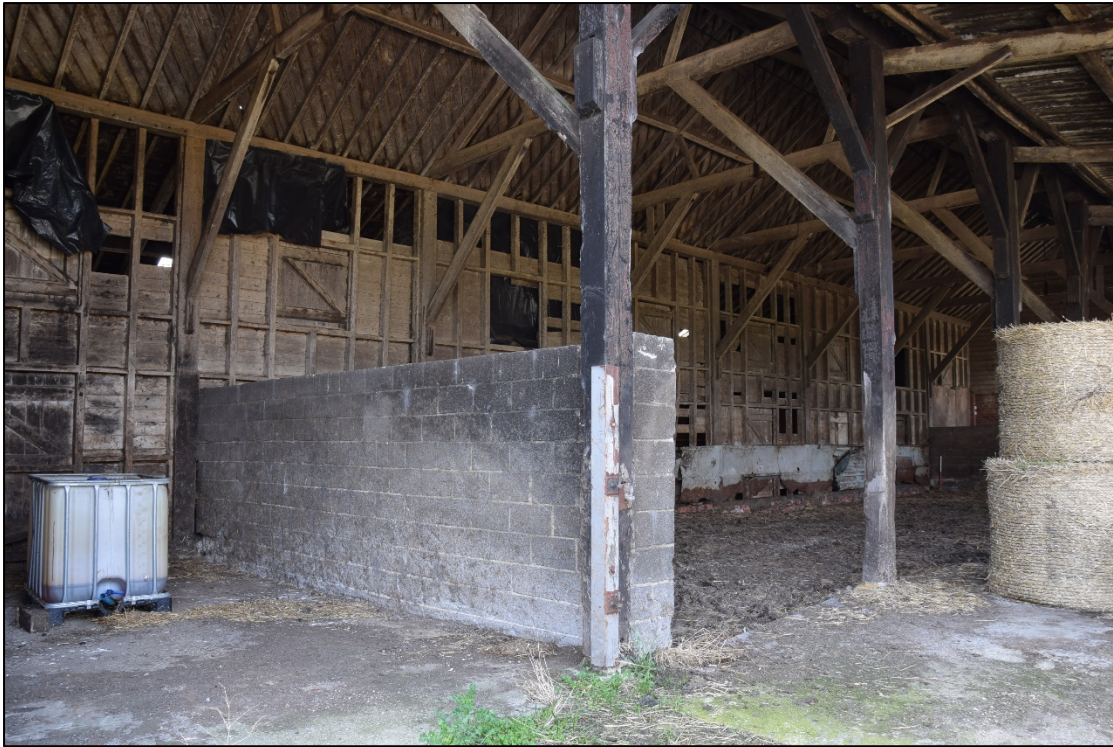
Photograph 37: A view looking south-west into the hay barn [9]. The concrete wall is part of the late pole barn [1]

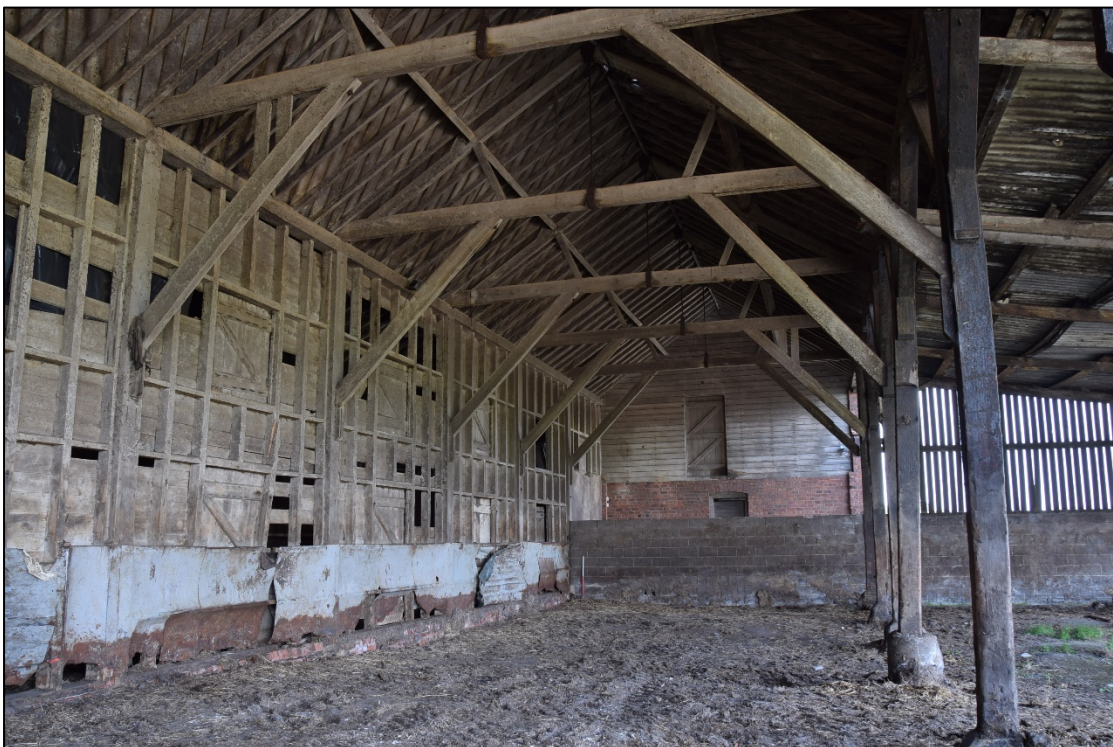
Photograph 38: The whole of the hay barn's south wall is timber and the opposite side was originally open to the yard

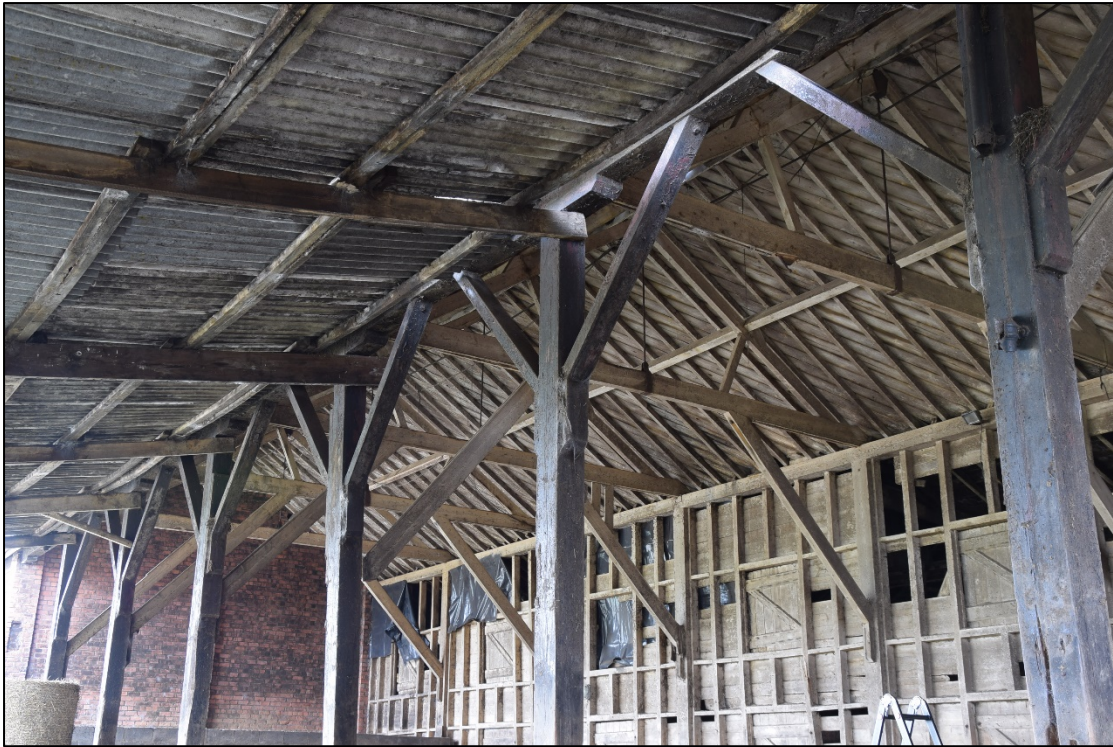
Photograph 39: Posts and braces on the north wall of the hay barn

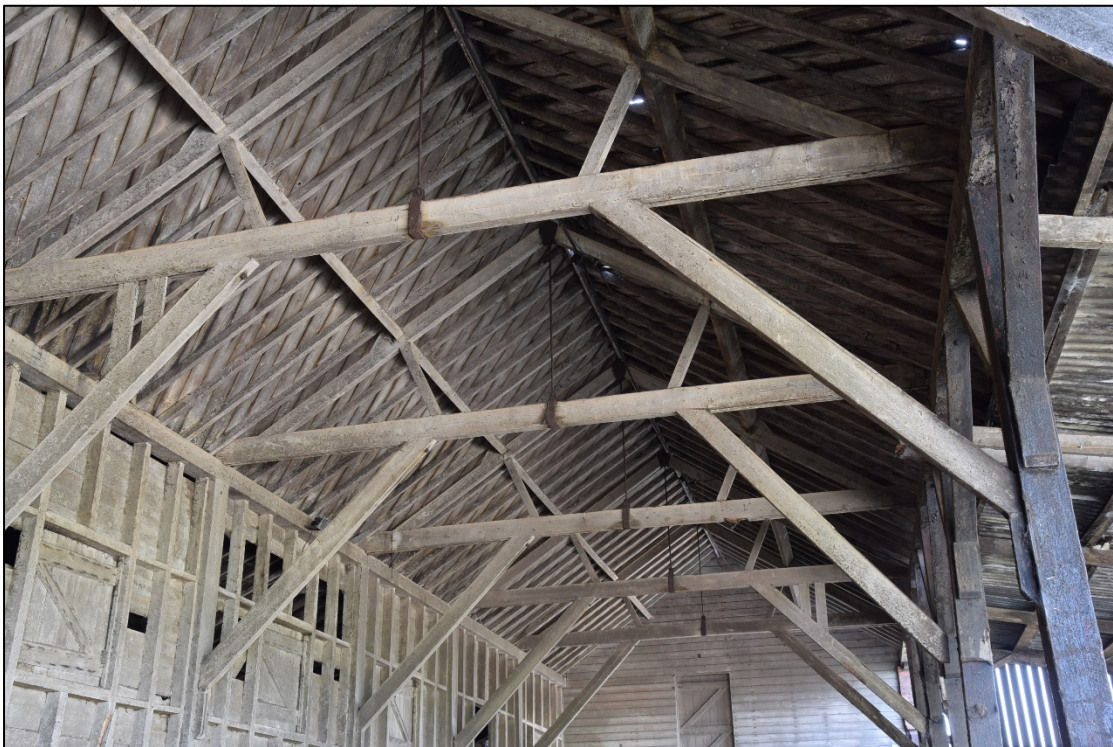
Photograph 40: Detail of the roof trusses in the barn [9]

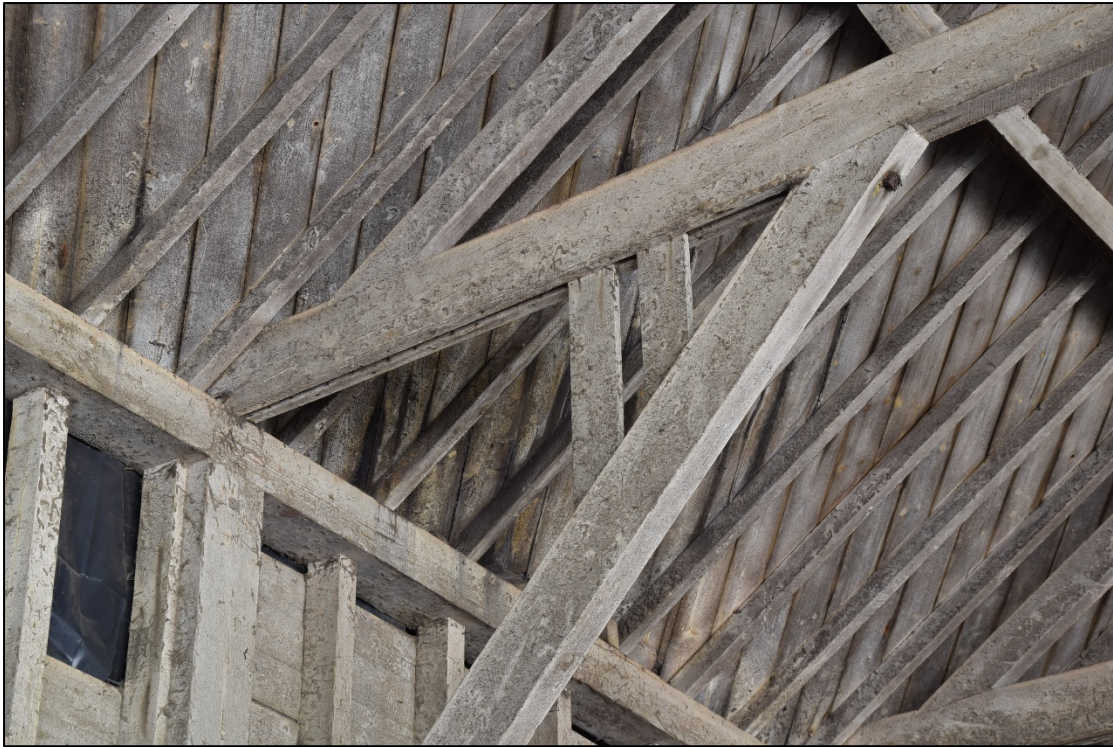
Photograph 41: Detail of the slots and plank partition below one of the tie beams in the barn

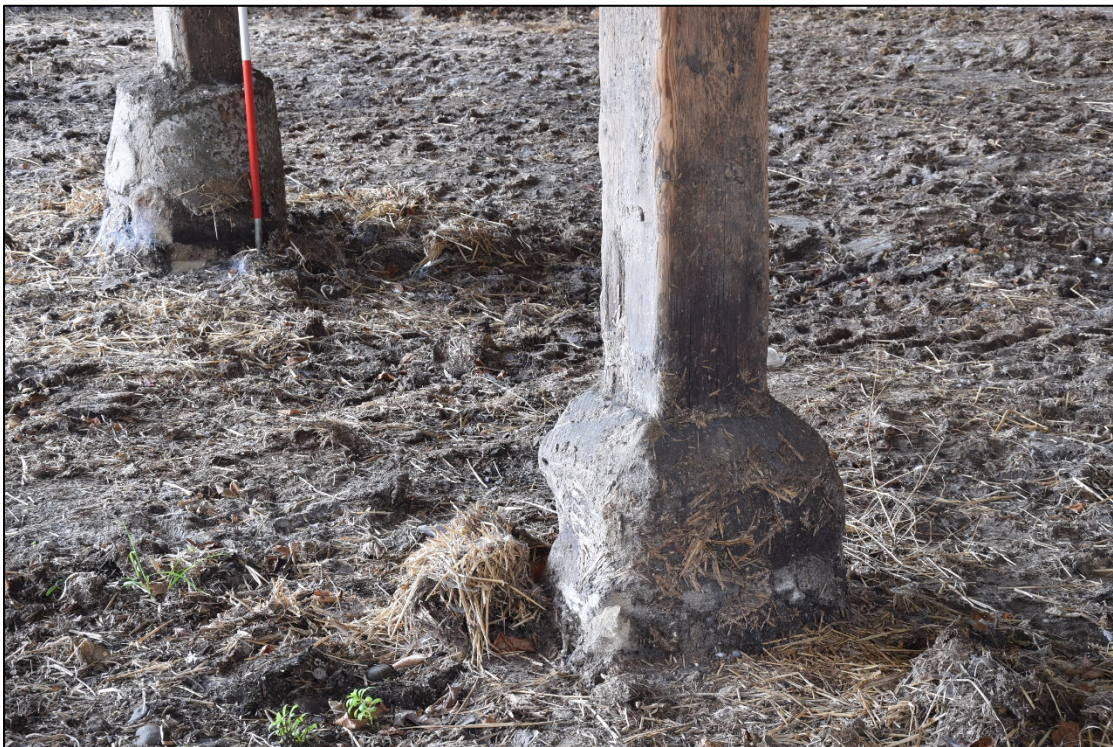
Photograph 42: The stone blocks supporting the timber columns on the north side of the barn; note the crude cement repair on the left

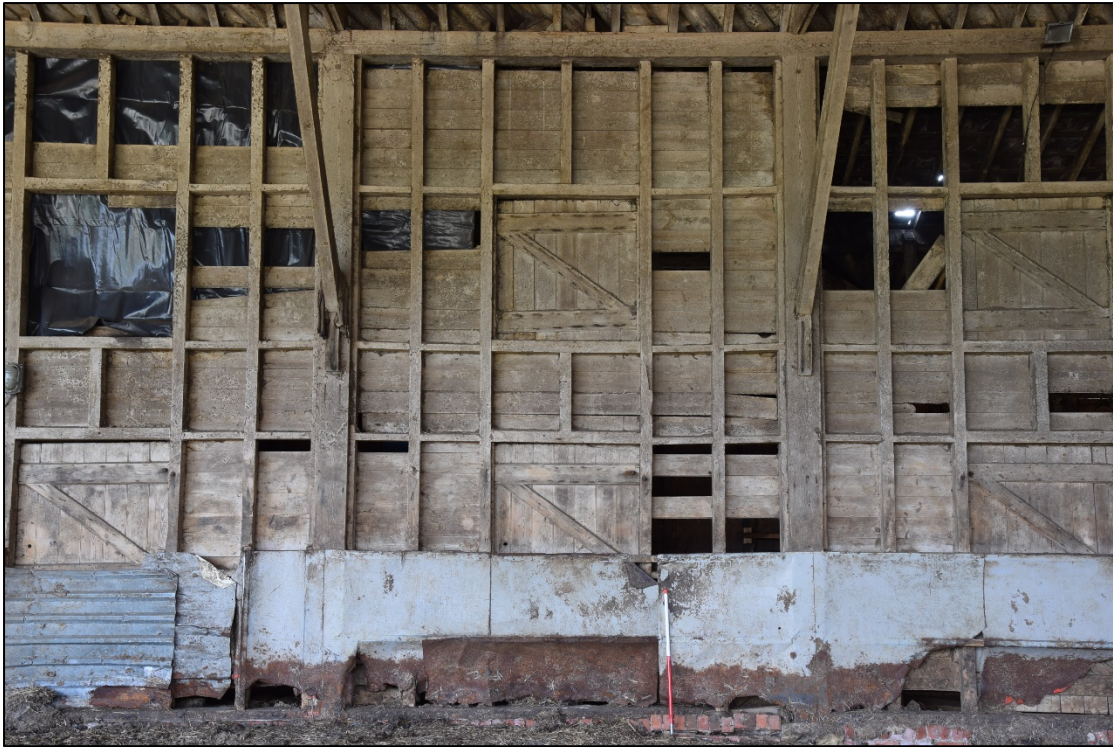
Photograph 43: A typical bay in the south wall, with upper and lower feeding doors. Steel sheets, installed when the building was used as a cow-house, cover the lower section of the face. The brick sleeper wall can be seen in the middle of this picture

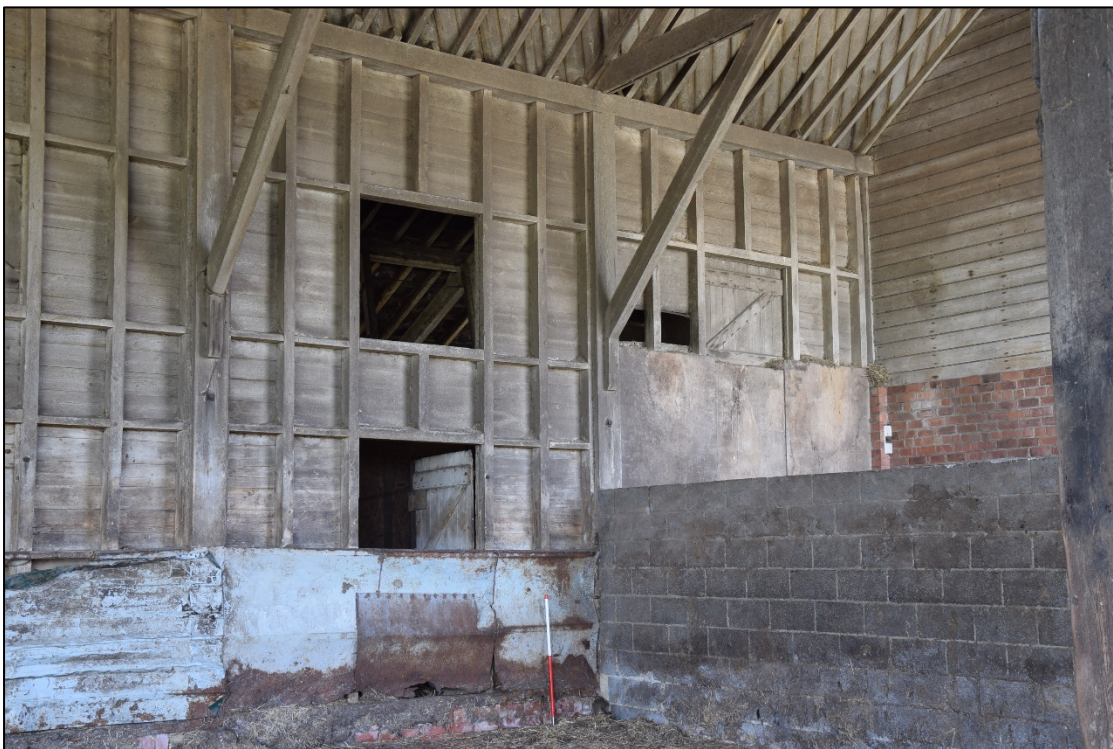
Photograph 44: Open feeding doors at the south-west corner of the hay barn. The brick and timber wall at the right is the end of the west block

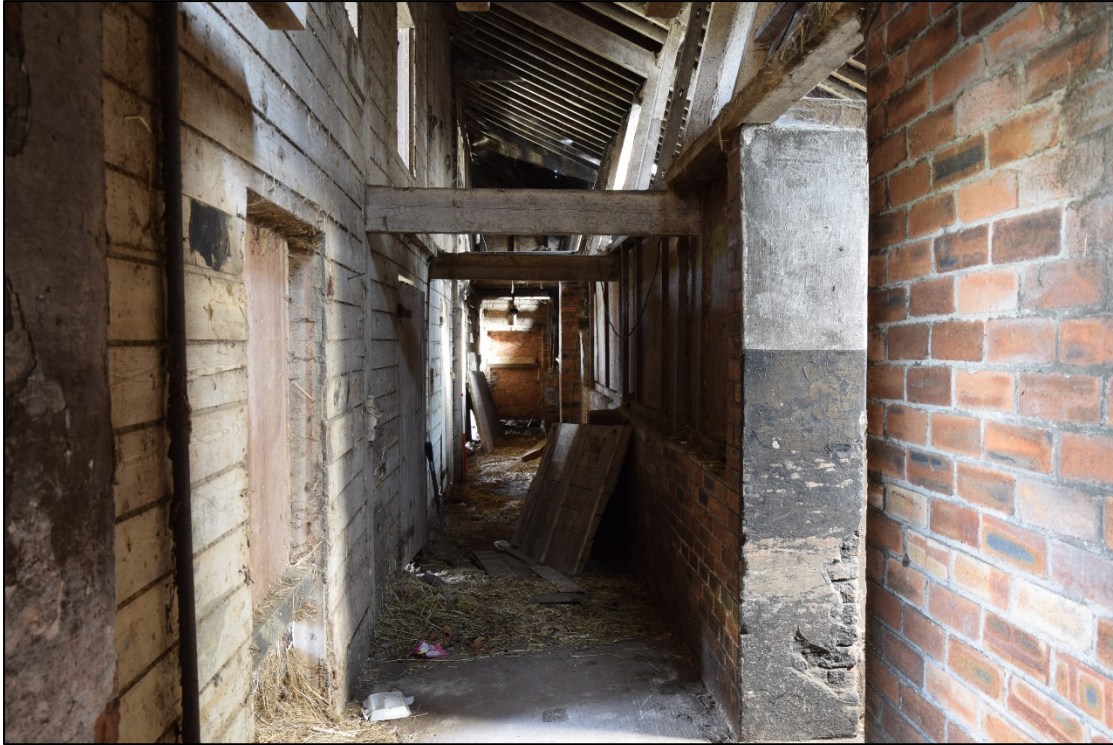
Photograph 45 (above): The feeding passage [10], seen from the west end

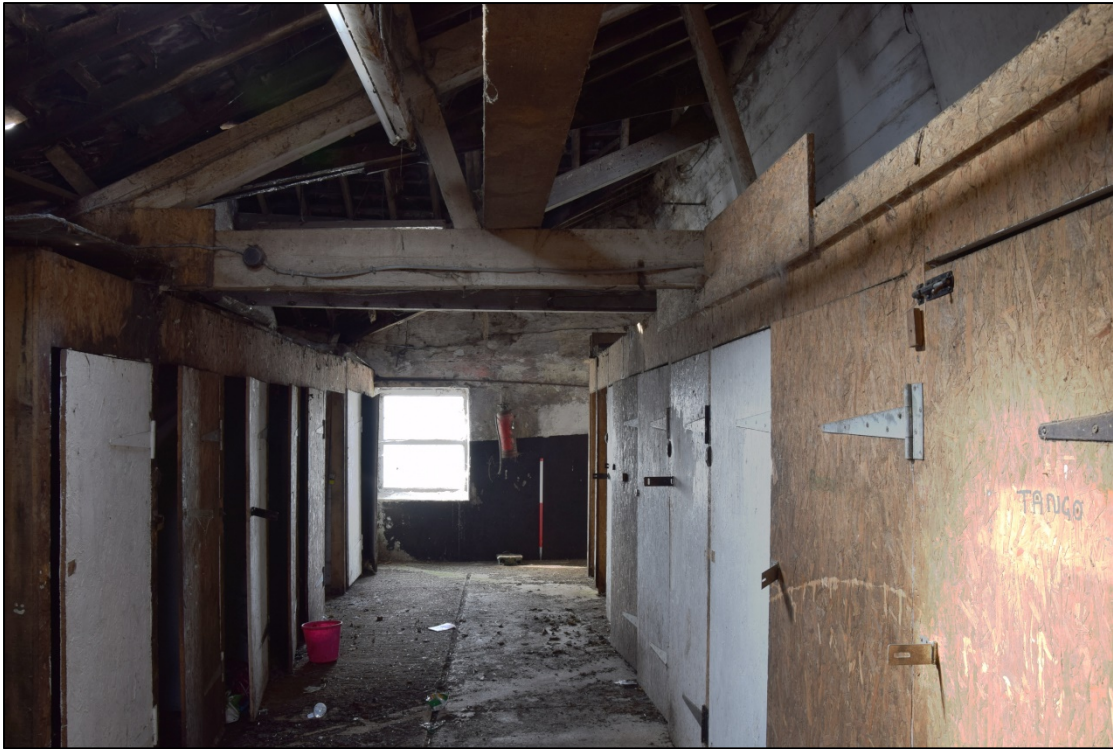
Photograph 47: Modern lockers cover the walls of the west stable [11]

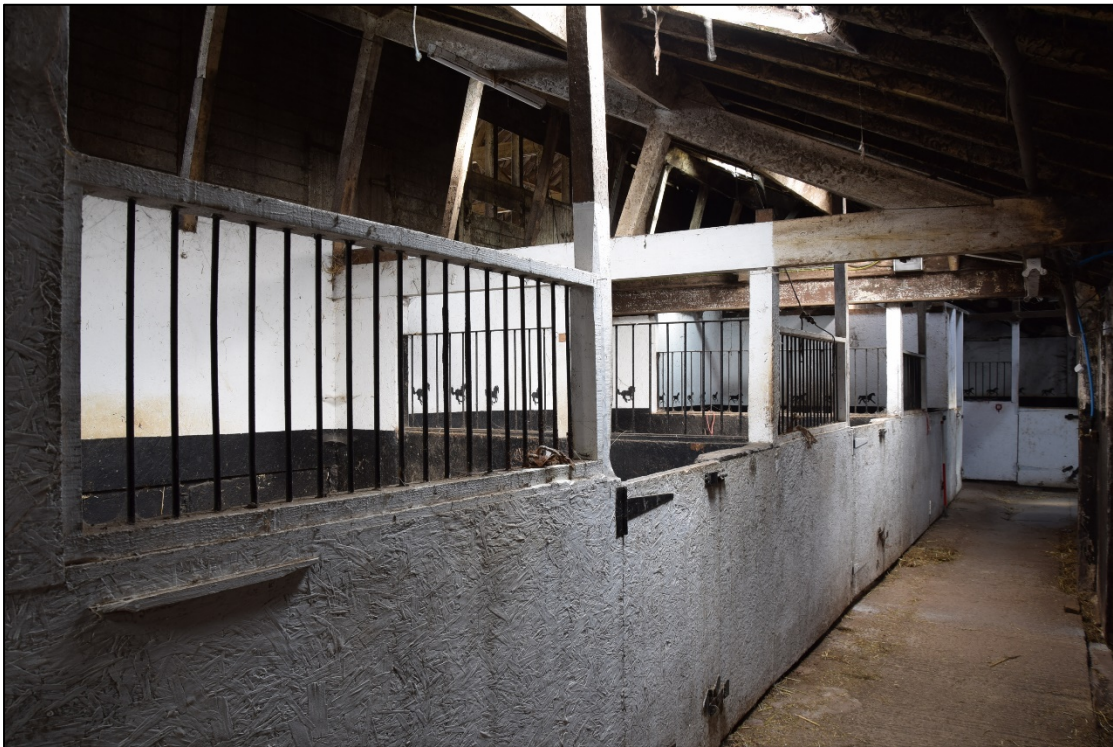
Photograph 48: Loose boxes in the east-west stable [12]; the upper feeding passage can be seen at the top

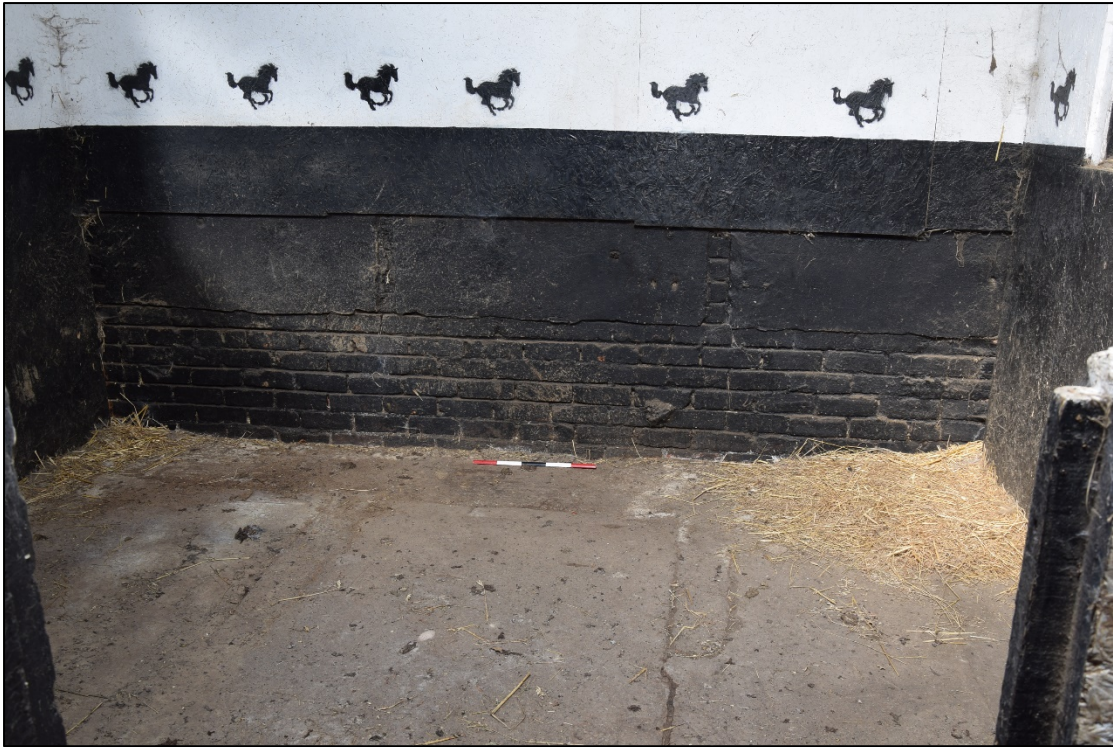
Photograph 49: The marks of old stall partitions can be seen in the floor and north wall of one of the loose boxes in [12]

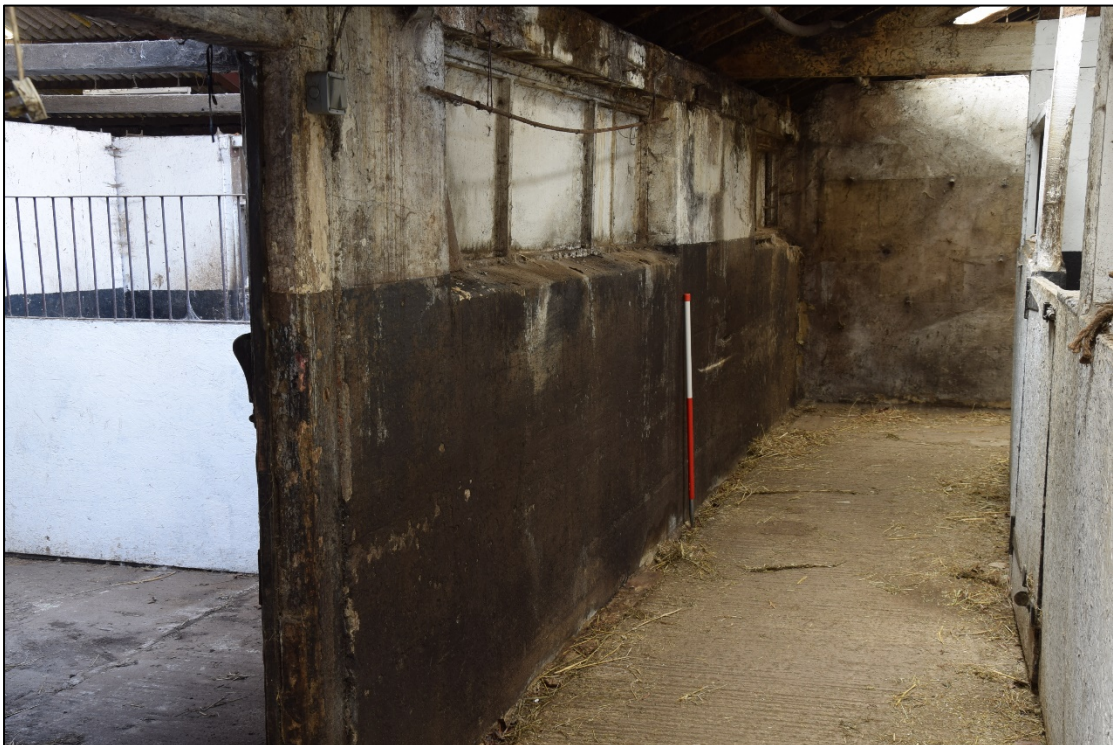
Photograph 50: A view looking south-west at the old north end of the west yard

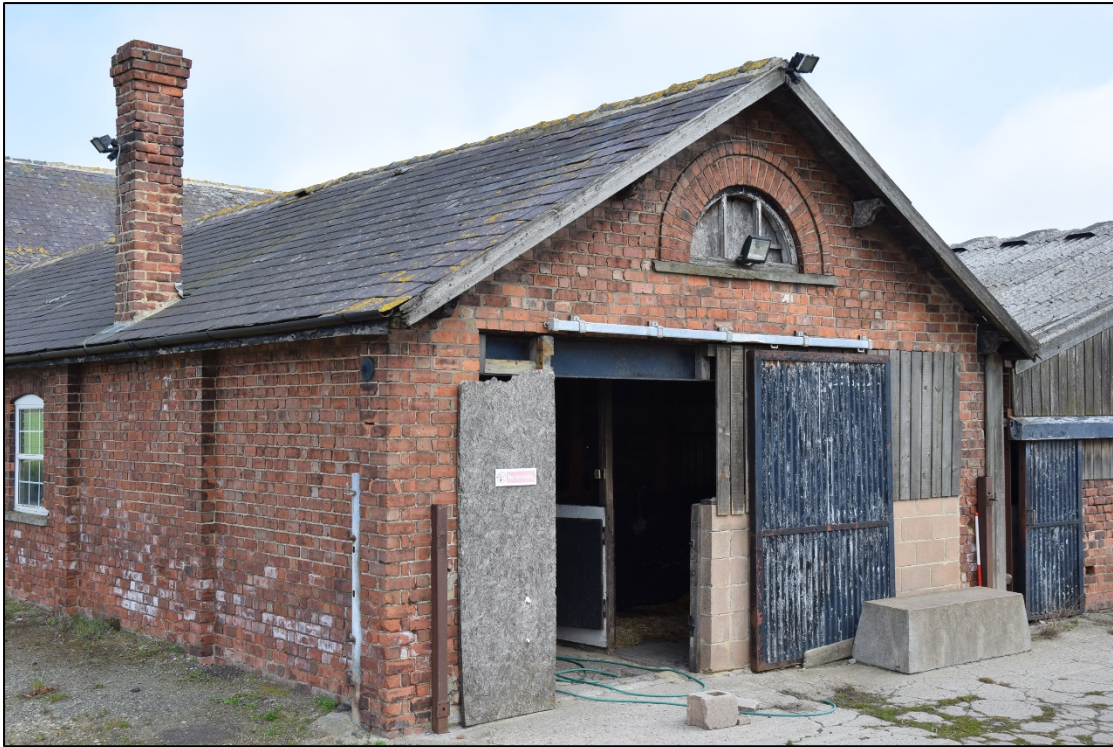
Photograph 51: The west range [13]. As on the other south faces, there are plain barge boards and shaped purlin ends

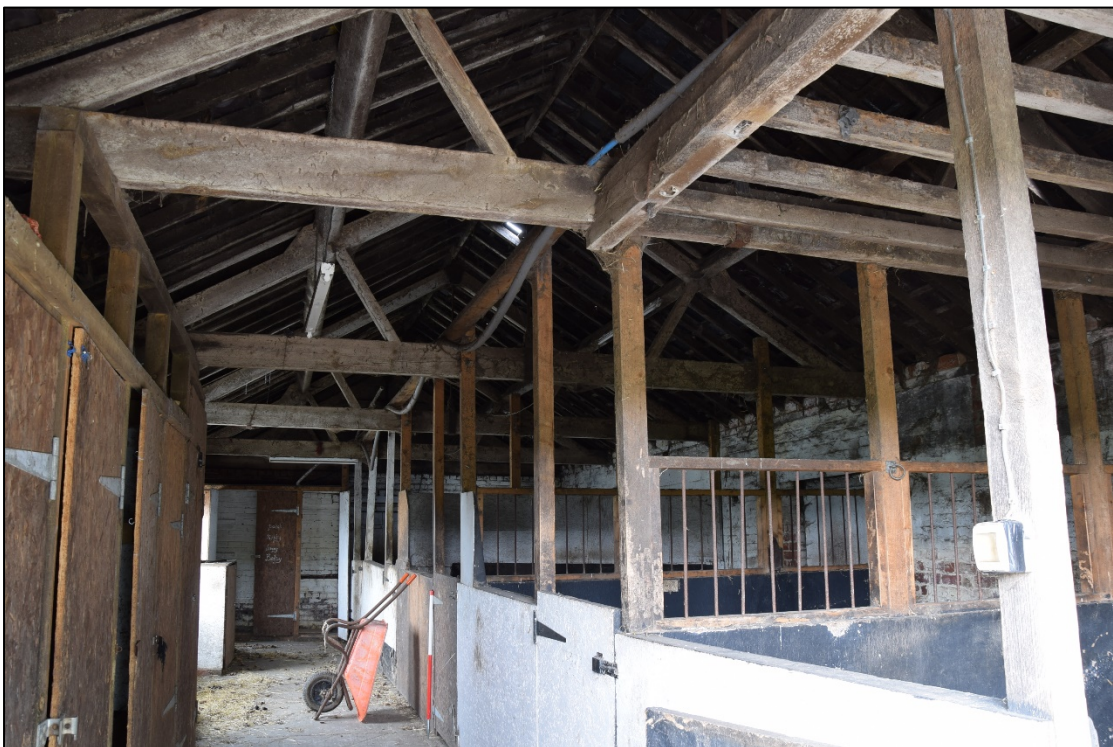
Photograph 52: The interior of the west range [13]. The scar of the lower part of the chimney is covered by one of the lockers at the left

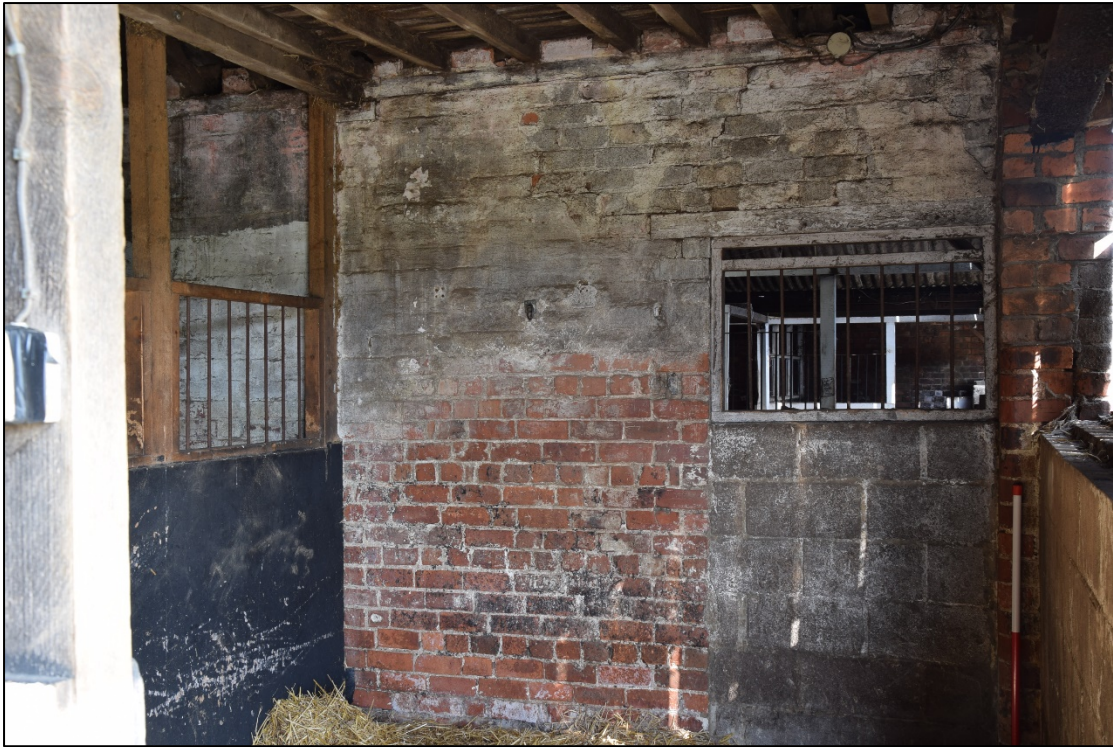
Photograph 53: A blocked door at the south-east corner of the byre [13]

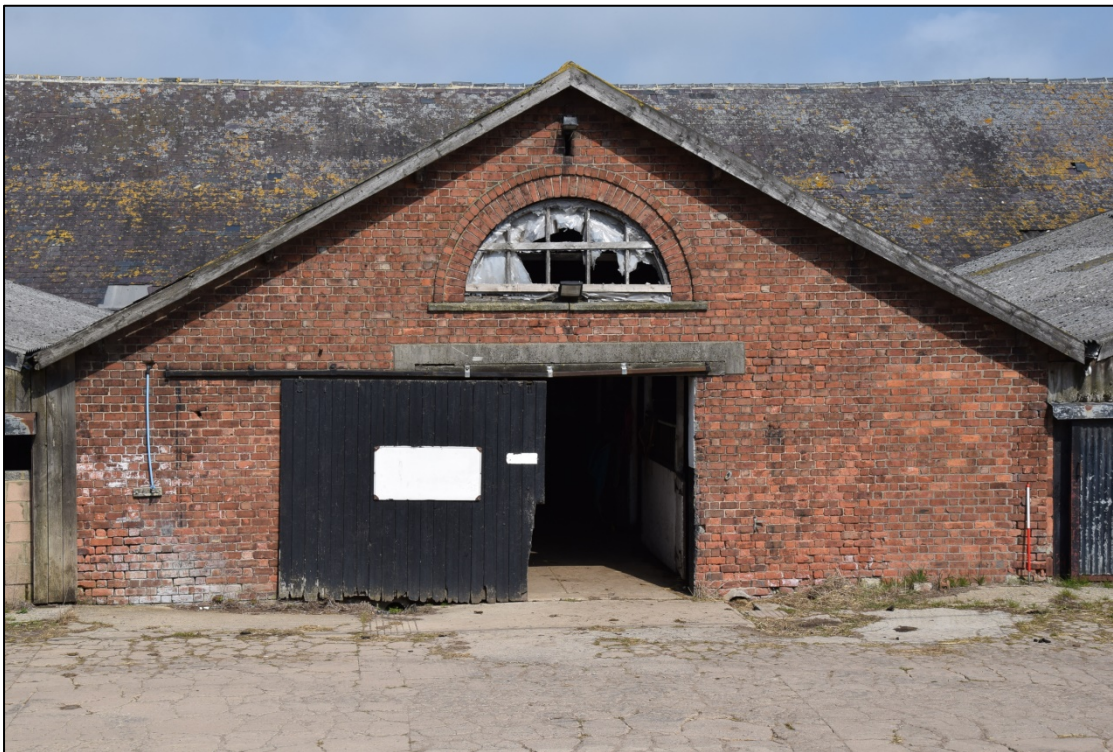
Photograph 54: The central range [14] is much larger than the other two

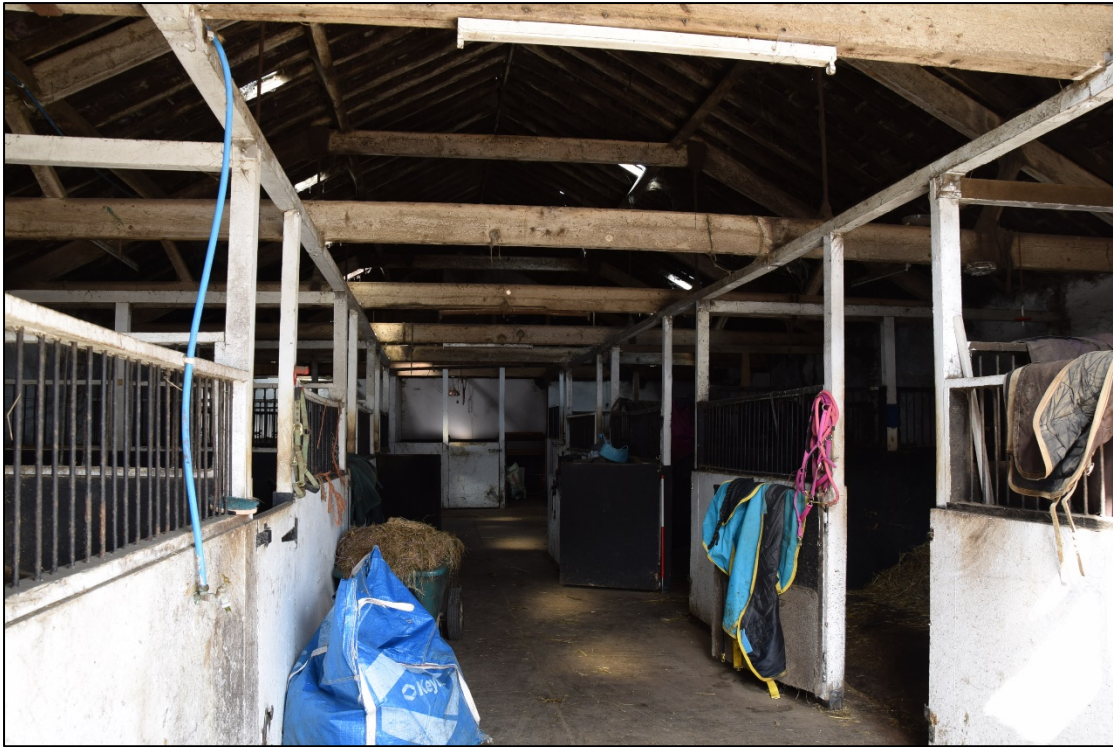
Photograph 55: The interior of the centre range [14], seen from the south end

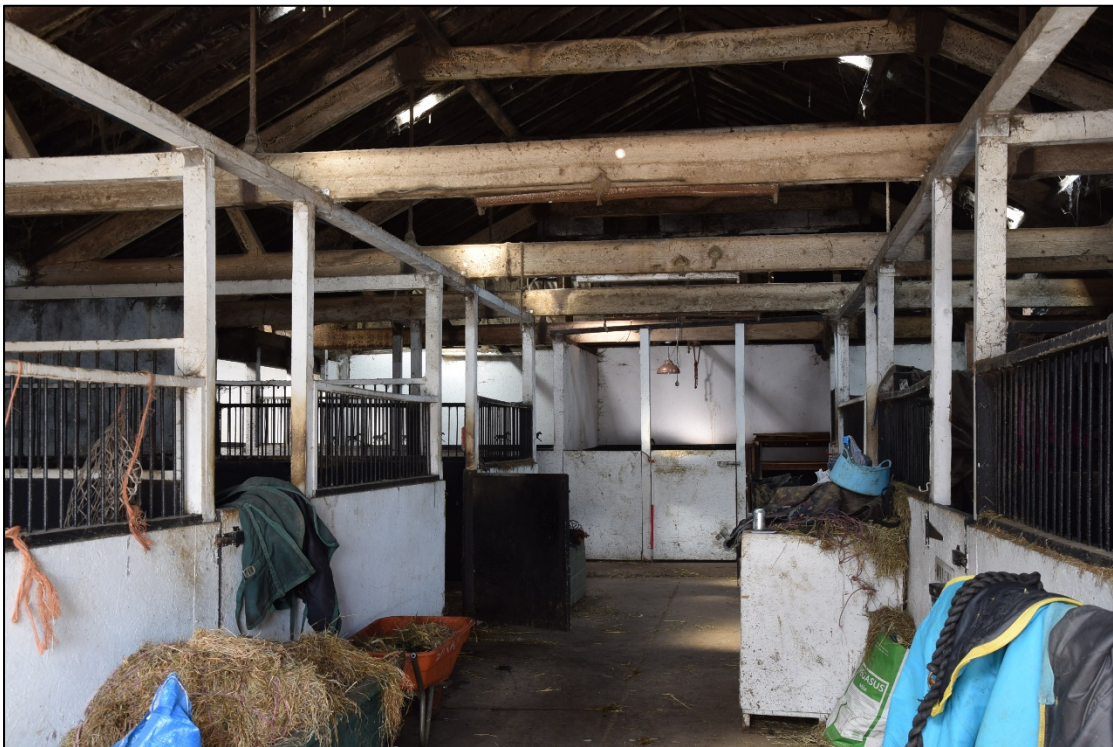
Photograph 56: The junction of the centre range [14] and the east-west stable [12]. A view looking north-west

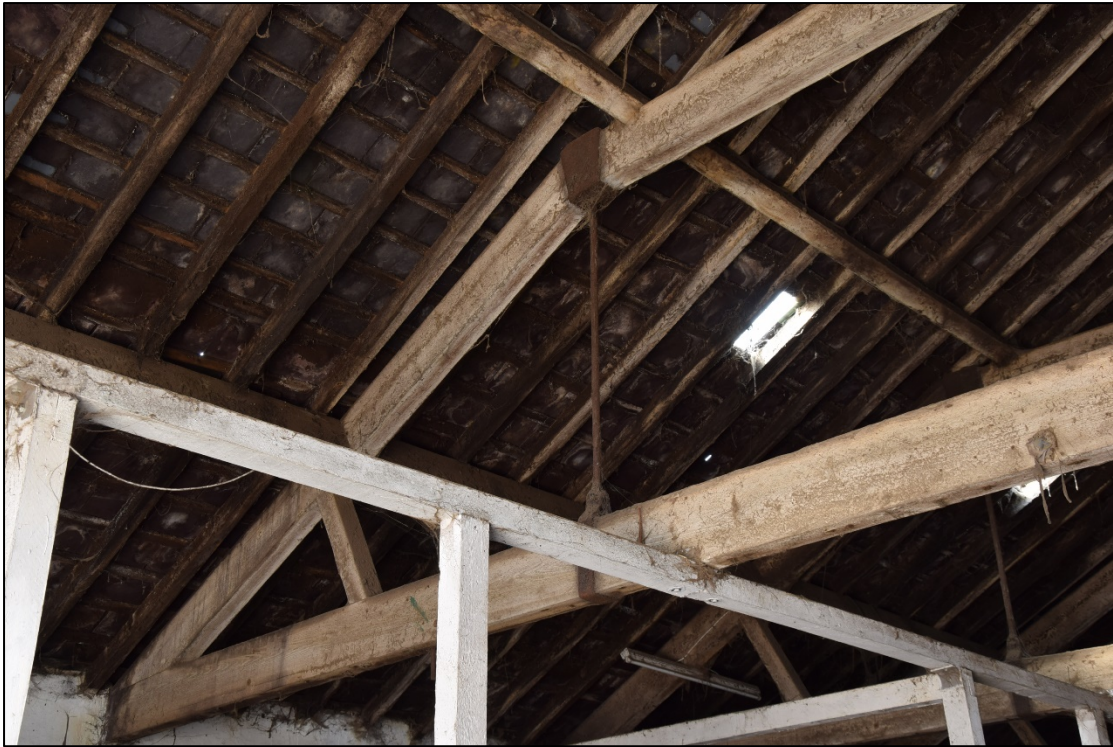
Photograph 57: Detail of one of the timber and iron roof trusses in the central range [13]
