ARCHAEOLOGICAL  
SERVICES  
DURHAM UNIVERSITY

Sheraton Hill Farm  
Sheraton  
County Durham

archaeological building recording

report 5050  
May 2019

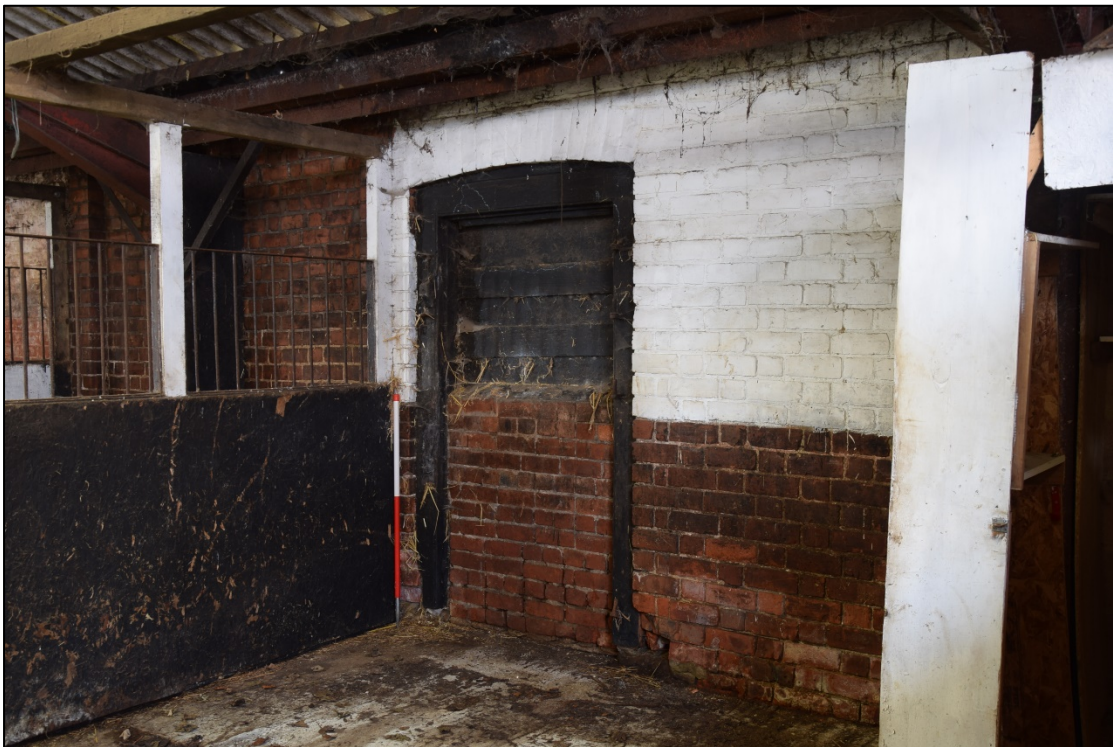
Photograph 58: One of the blocked doors in the east wall of the central range, with part of the steel frame of the covered yard [17]

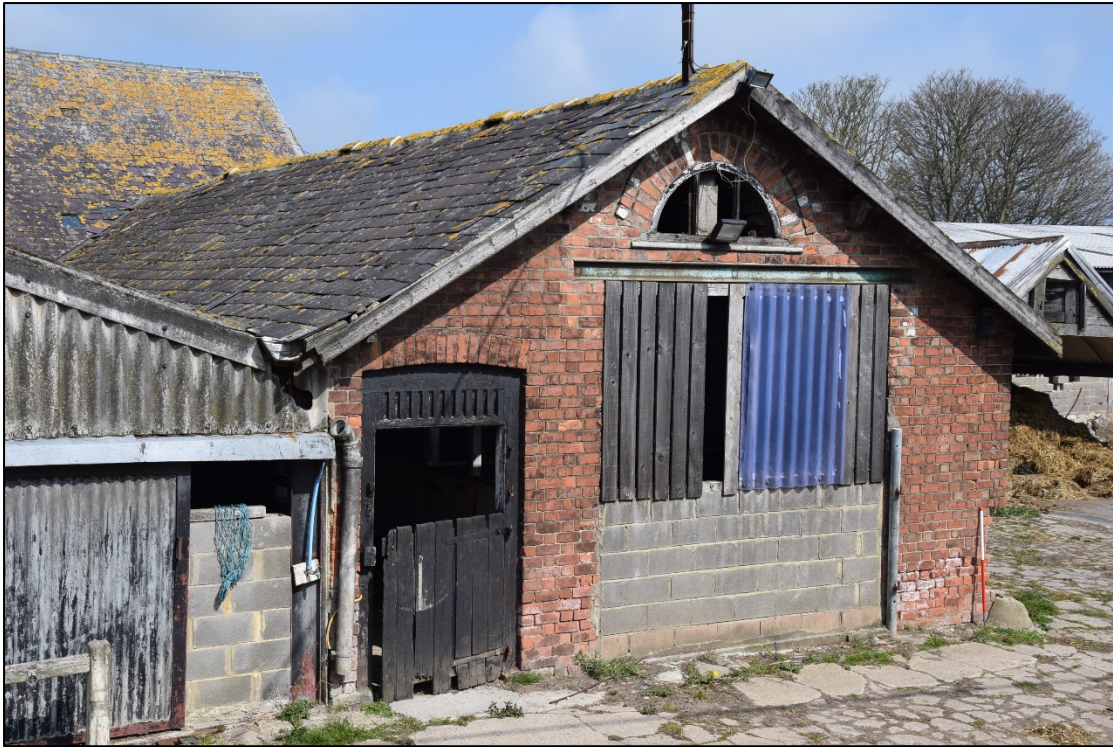
Photograph 59: The east range [15], with the old timber door frame

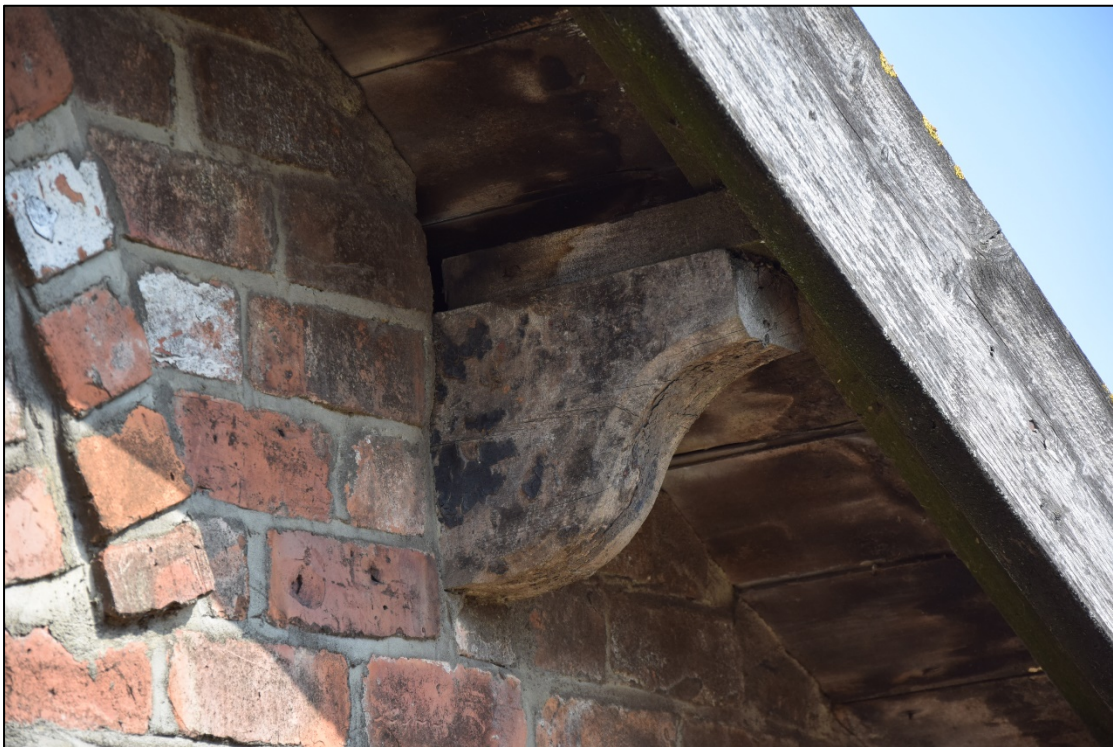
Photograph 60: Detail of one of the shaped purlin ends

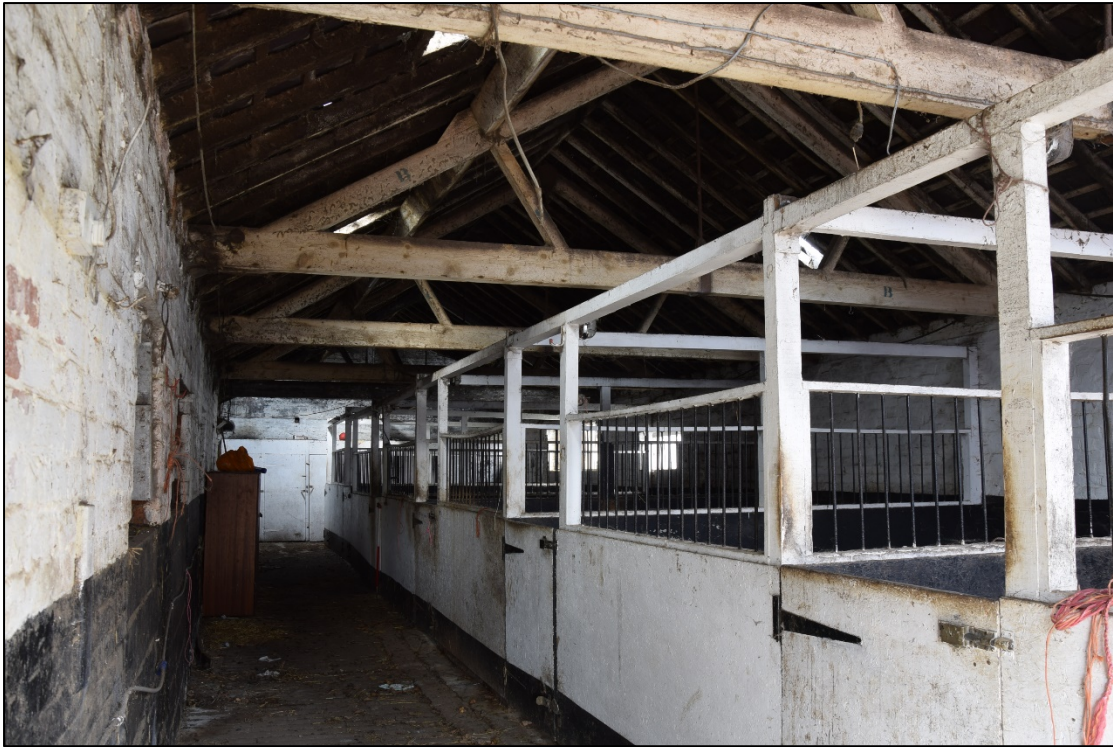
Photograph 61: The interior of the east range, with the wall of the granary block at the far end. Note the stencilled letters painted on the roof trusses

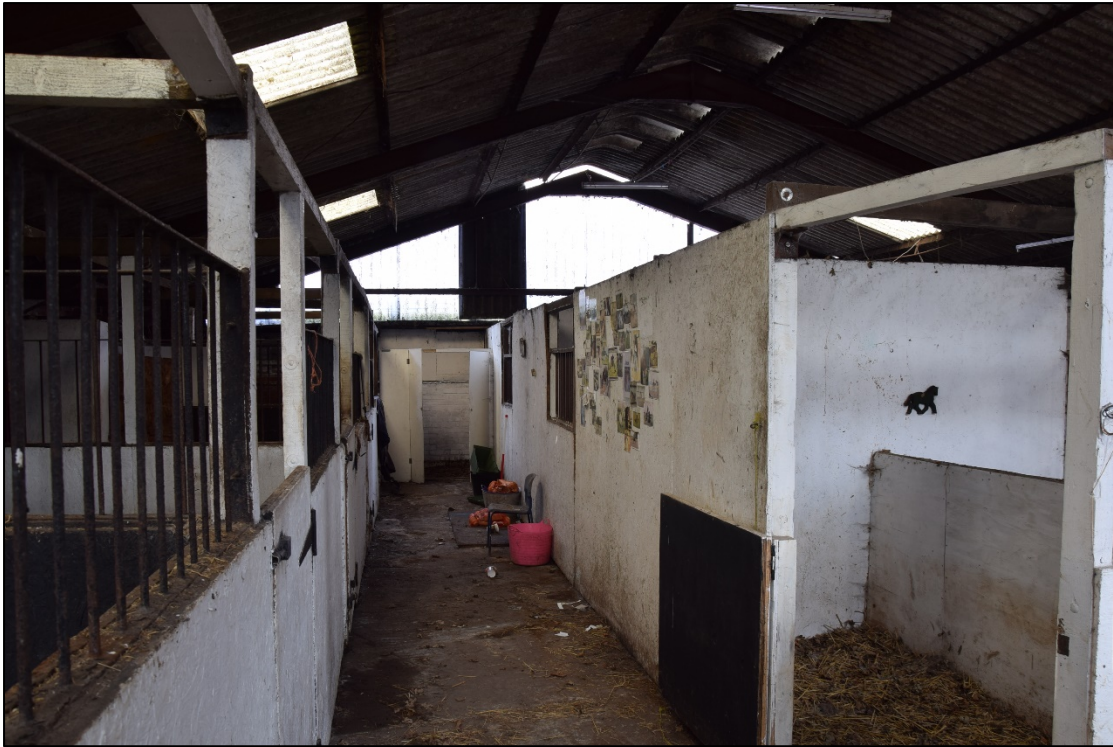
Photograph 63: The interior of the yard [16] is filled with loose boxes and lockers. A view looking north

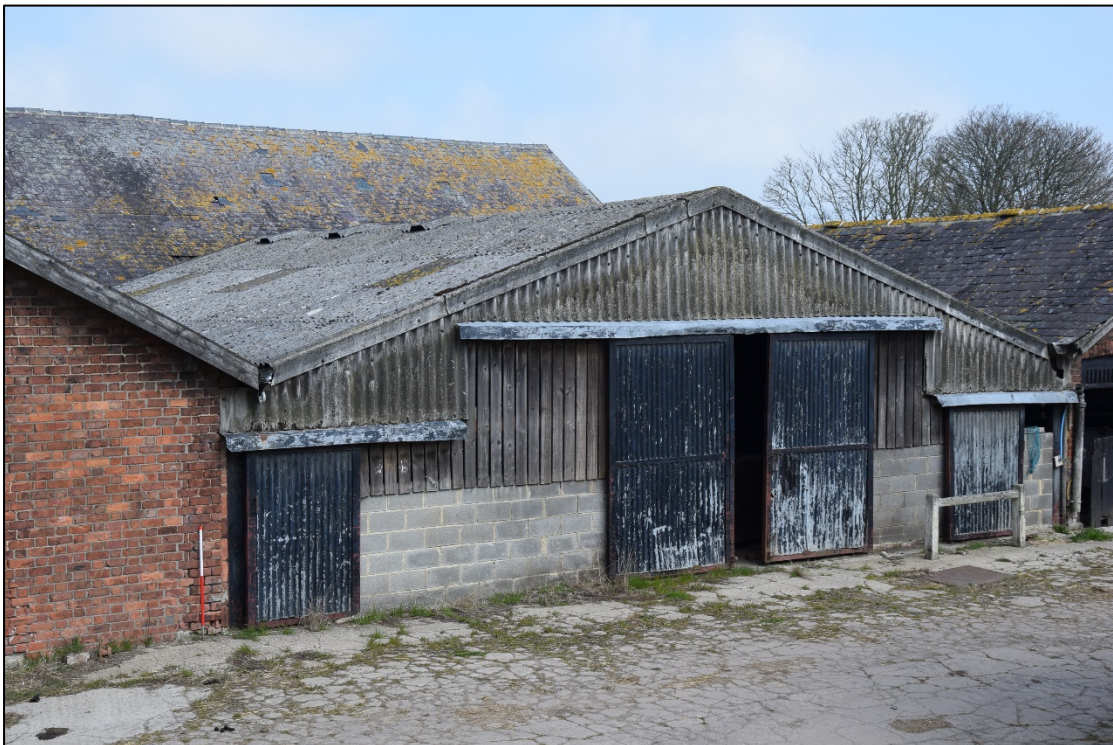
Photograph 64: The east yard [17]

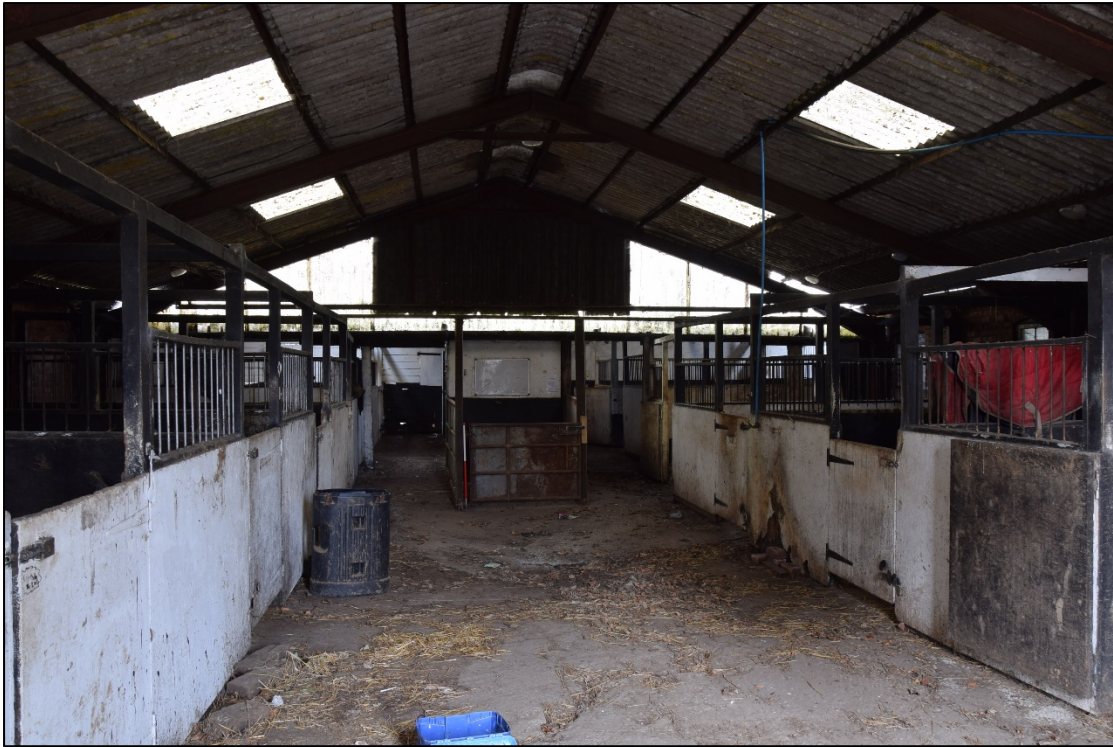
Photograph 65: A view looking north into the east yard

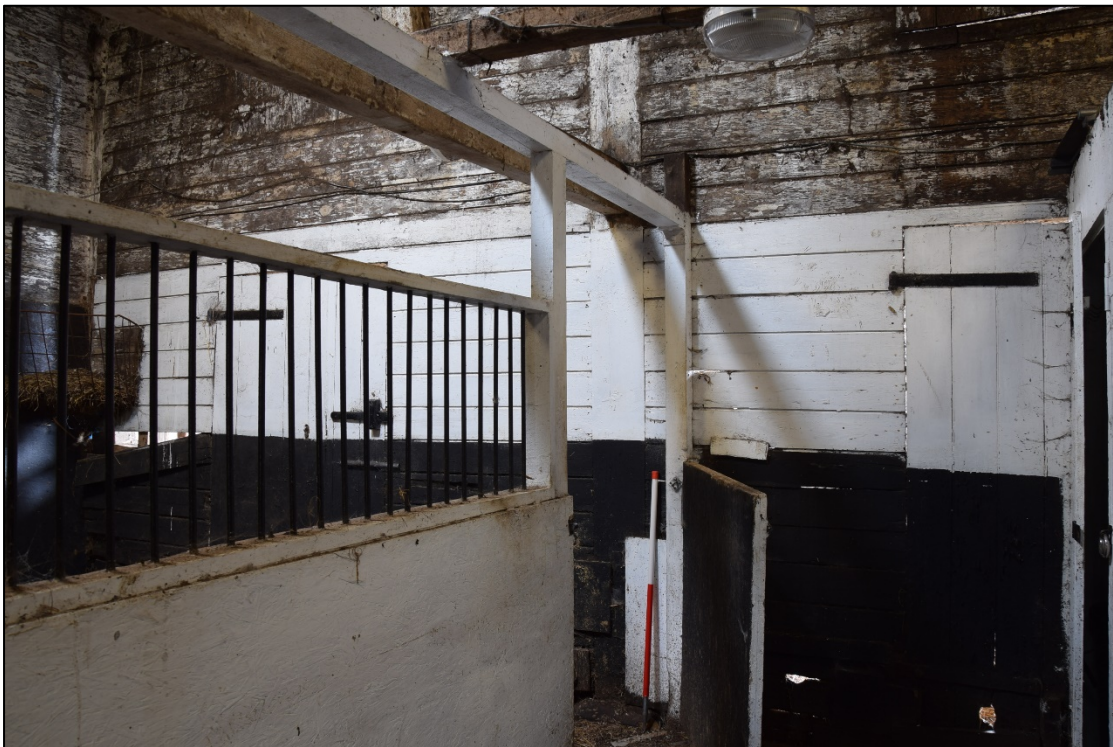
Photograph 66: Two of the feeding doors from the hay barn, seen at the north end of yard [17]
