ARCHAEOLOGICAL
SERVICES
DURHAM UNIVERSITY

Buildings at East Field House
Mickleton
Co Durham

archaeological building recording

report 5173
October 2019

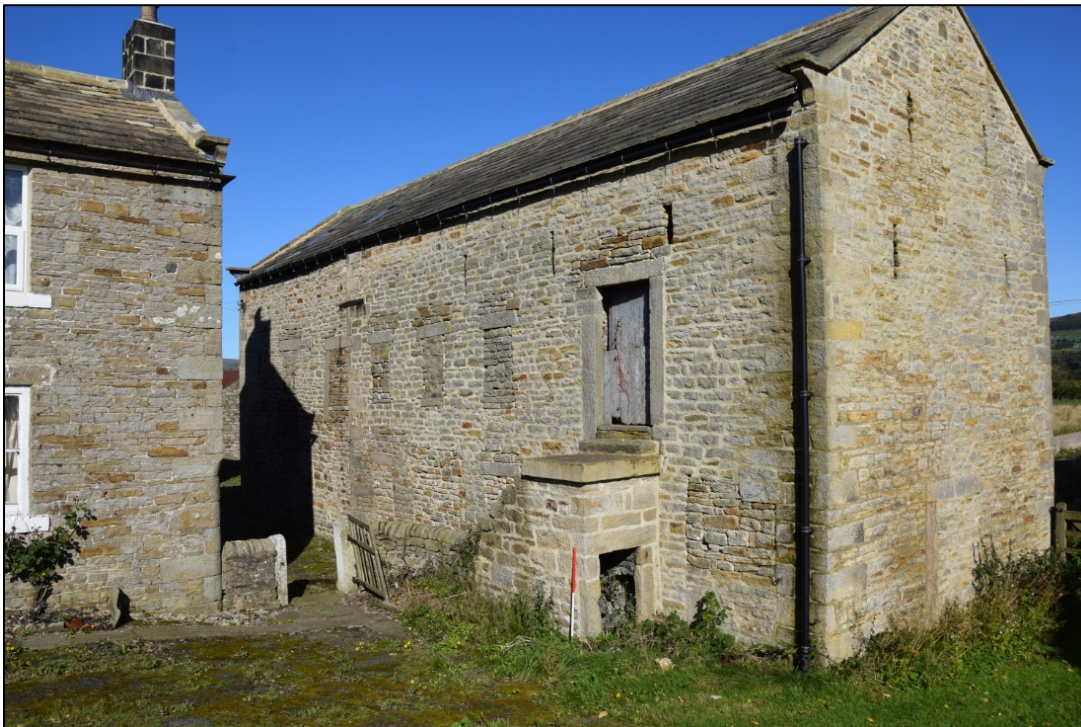
Photograph 4: Building 1. Note the placement of the blocked windows with reference to the floor height shown by the door. A dark line below the eaves, left of centre, is the iron strap that reinforces the junction between the older block and the extension at the far end

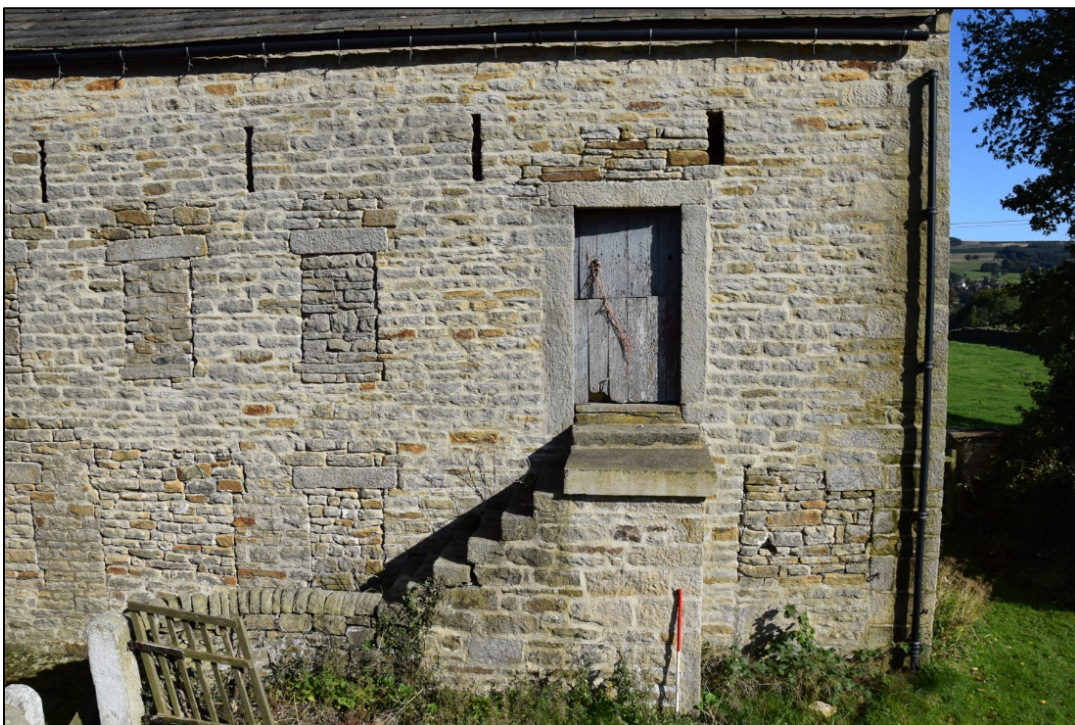
Photograph 6: The hay loft entrance near the south-east corner of building 1. Blocked doors can be seen to the right of the staircase and above the wooden gate

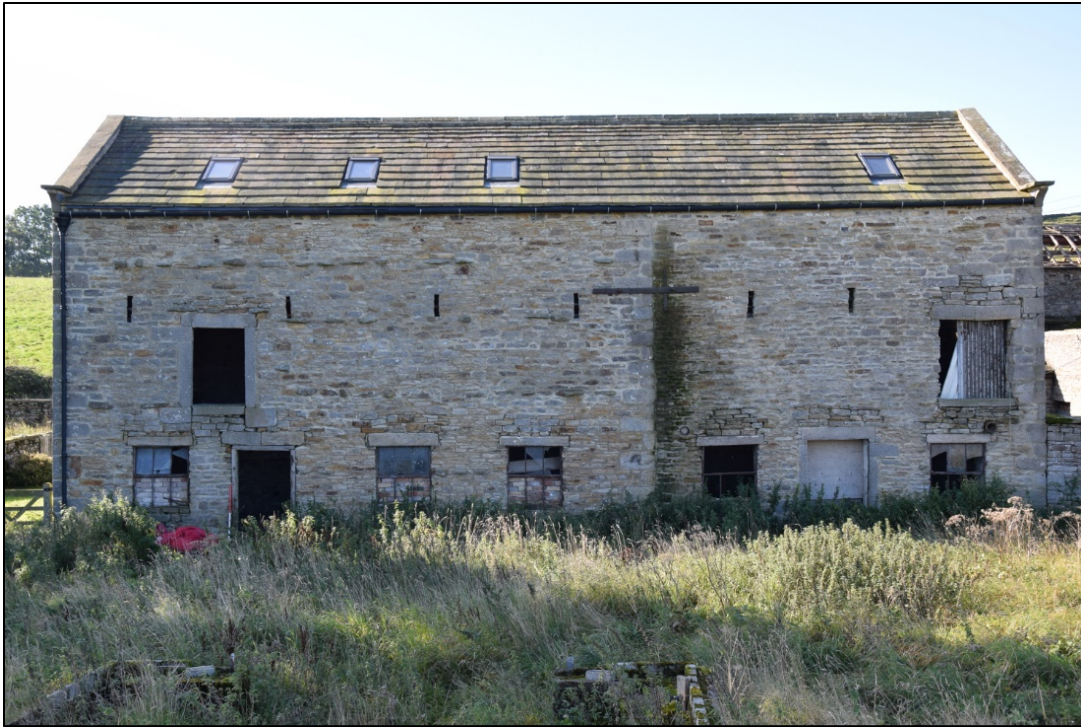
Photograph 9: The division between the two parts of building 1 is very clear in this view of the north face. The open stonework above the openings is the result of repair of the door and window lintels

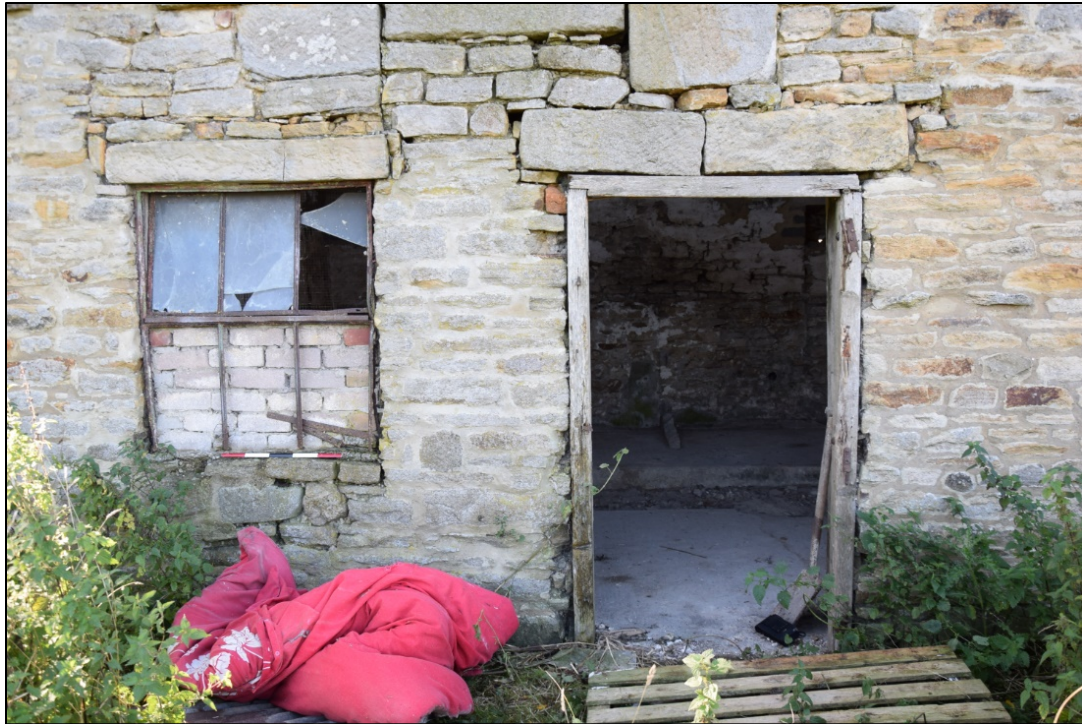
Photograph 11: Detail of the door and window at the east end of the north face. The loading door above has been altered

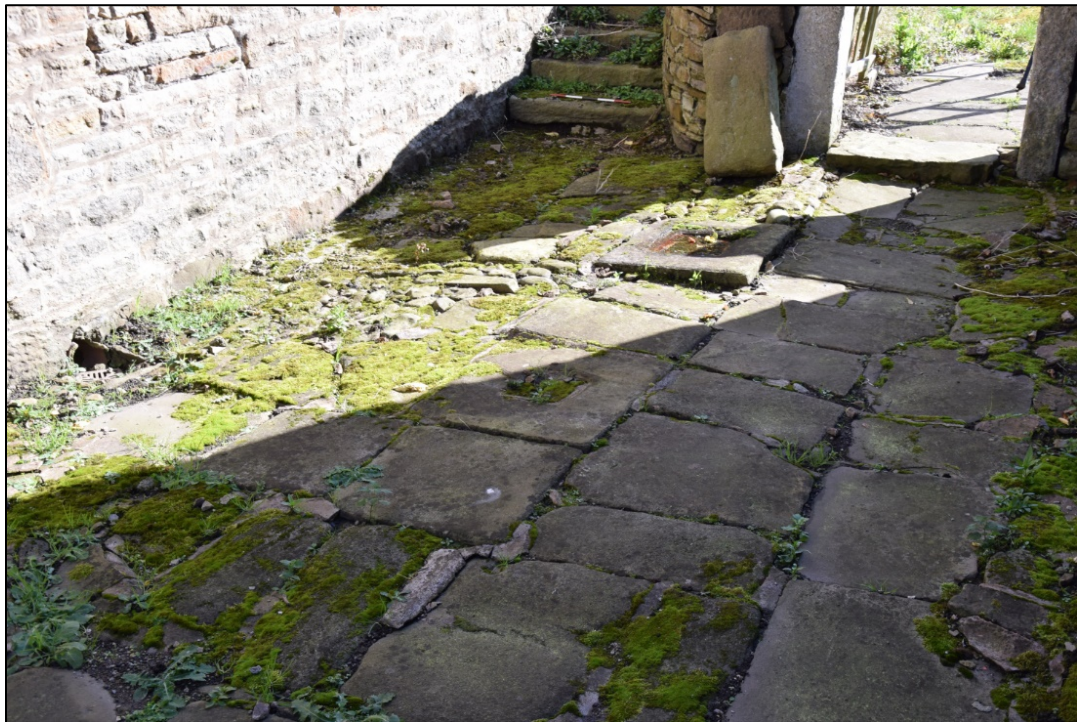
Photograph 14: The paved yard between building 1 and the eastern house has two recesses for uprights outside the old door, the blocking of which can be seen at the top left

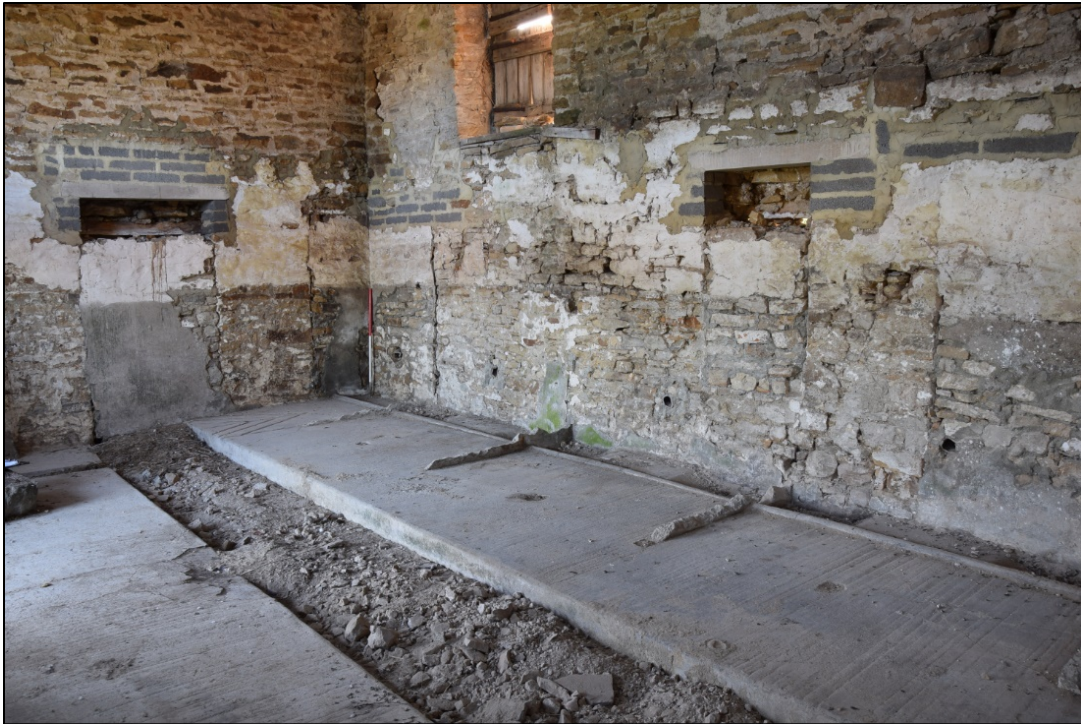
Photograph 15: Inside building 1 are the remains of 20th-century cow stalls and a large floor drain. Recent repairs to the door and window lintels can be seen. A view looking south-east

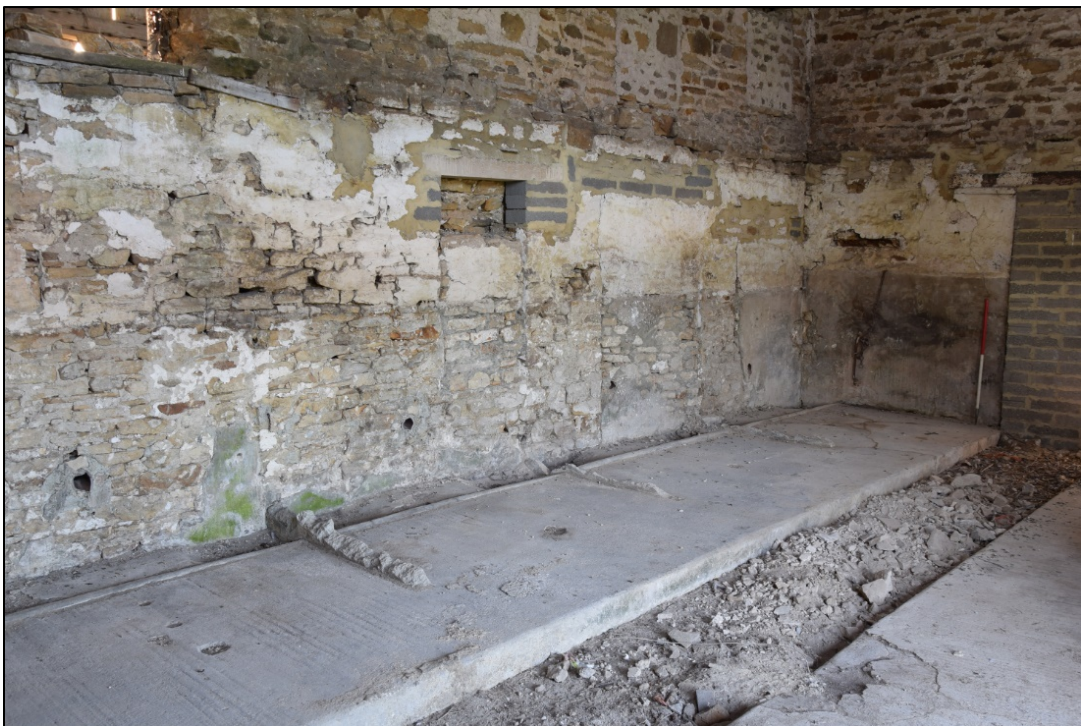
Photograph 16: A view looking south-west in the old part of the building. Older masonry fills the first-floor windows, above the recent repairs

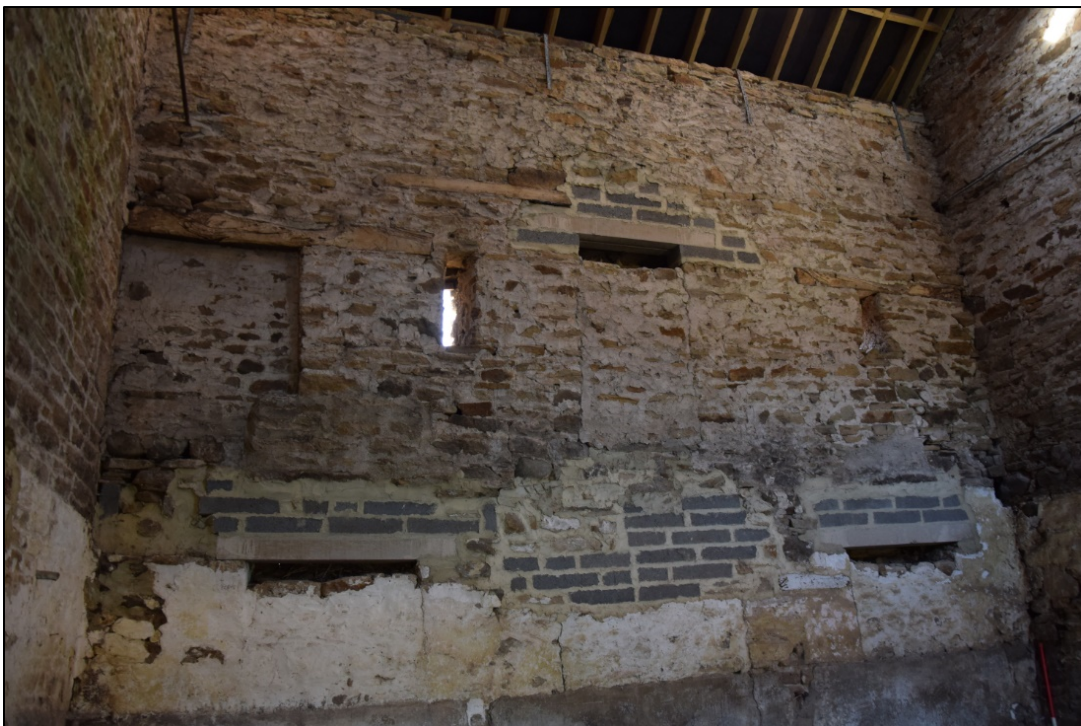
Photograph 22: Blocked openings, breathers and repairs in the upper floor of the south wall

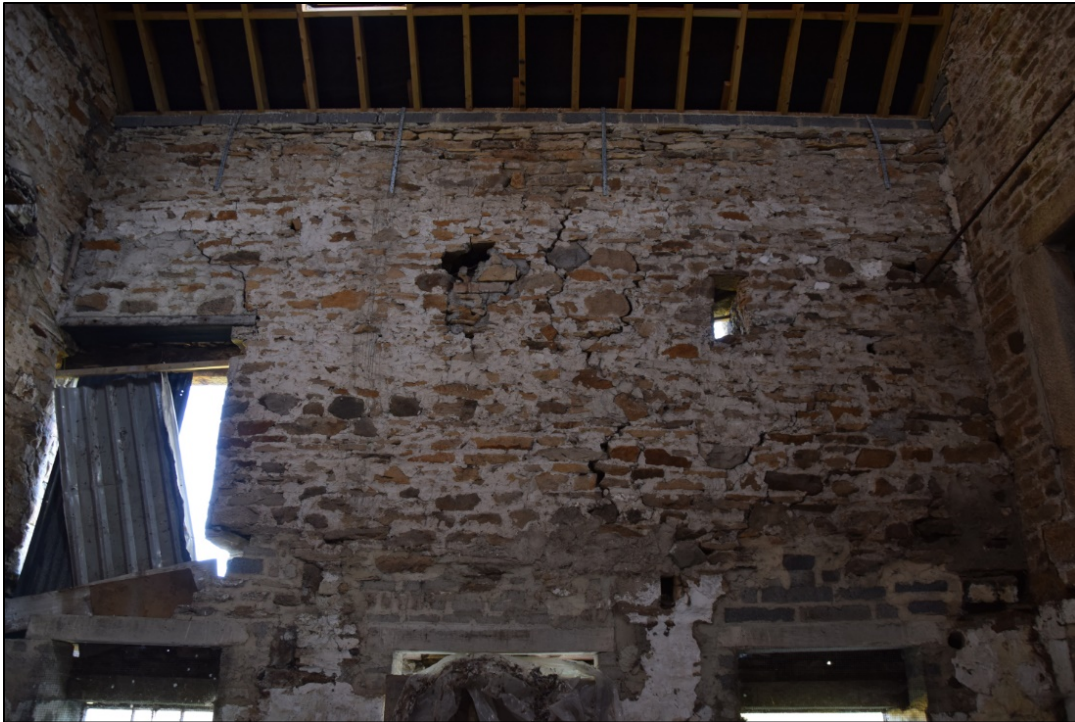
Photograph 25 (above): Settlement cracks can be seen in the north wall of the hay loft at the west end of building 1

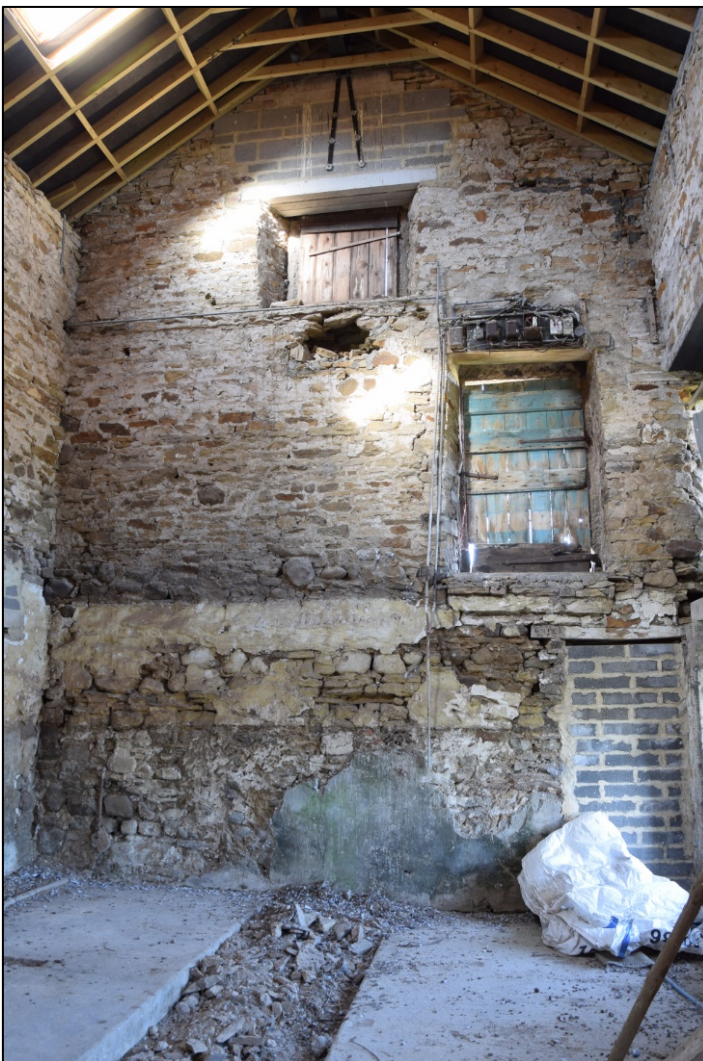
Photograph 26 (left): The west end of the building. The ground-floor door, forced through the wall at the corner, has a thin timber lintel. The door above is served by the external staircase. An apparent floor line below the upper door is an electric cable duct

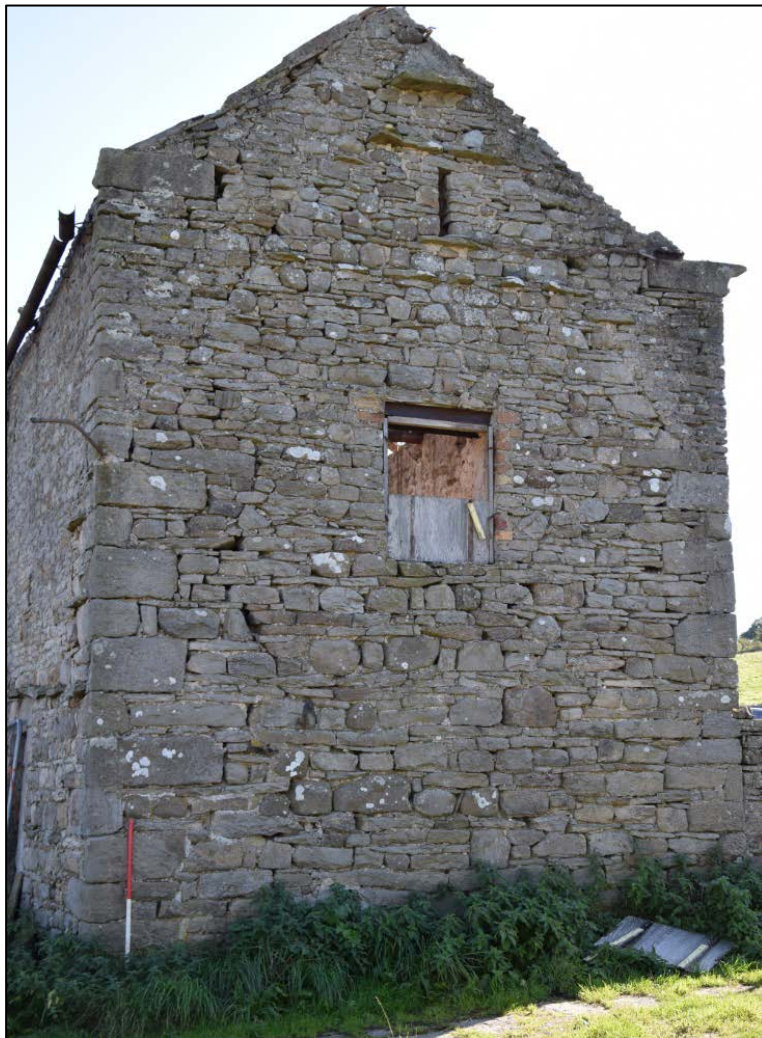
Photograph 30 (left):
The change from large
angle quoins can be
seen at both corners of
the building in this
view of the west end.
The character of the
masonry is different
above and below the
window

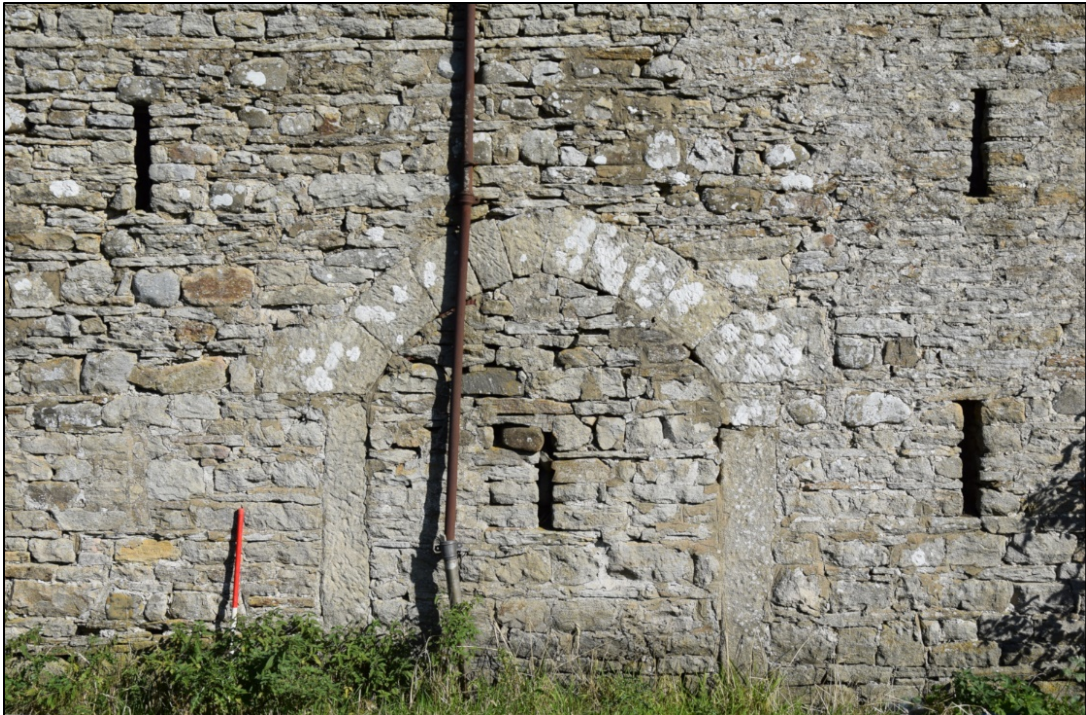
Photograph 33: Detail of the central door, with its unusual pointed arch. The break in the masonry runs diagonally above the right-hand side of the arch

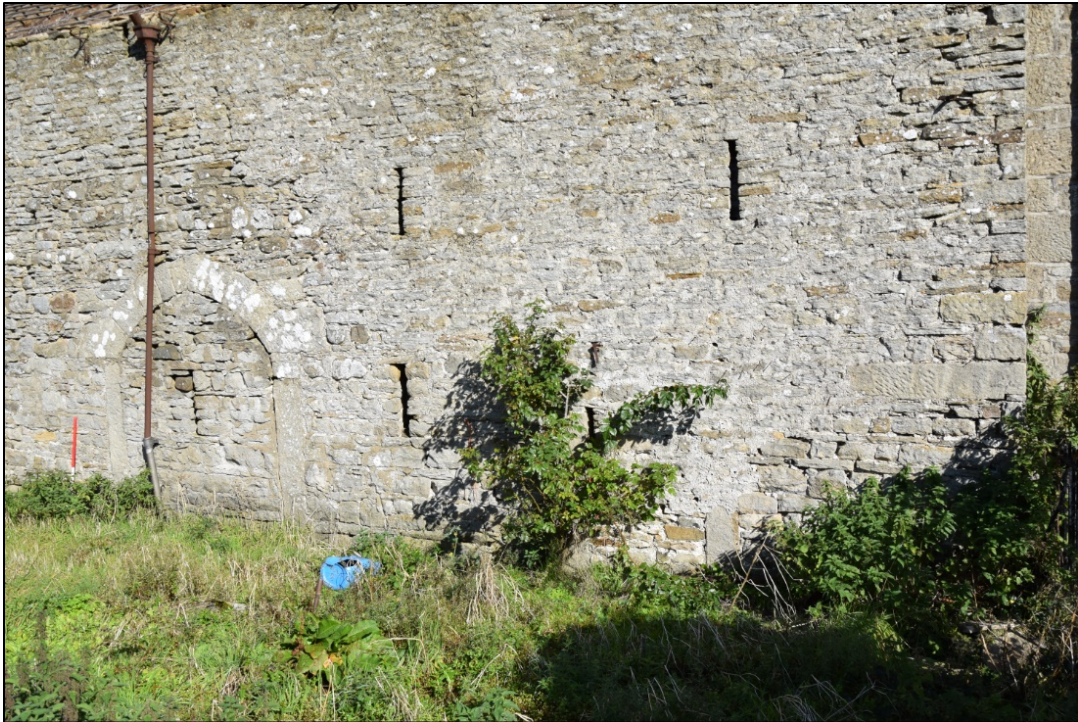
Photograph 35 (above):
The wall at the east end
of the south face is
almost wholly rebuilt.
The door jambs can be
seen as in Photo 32

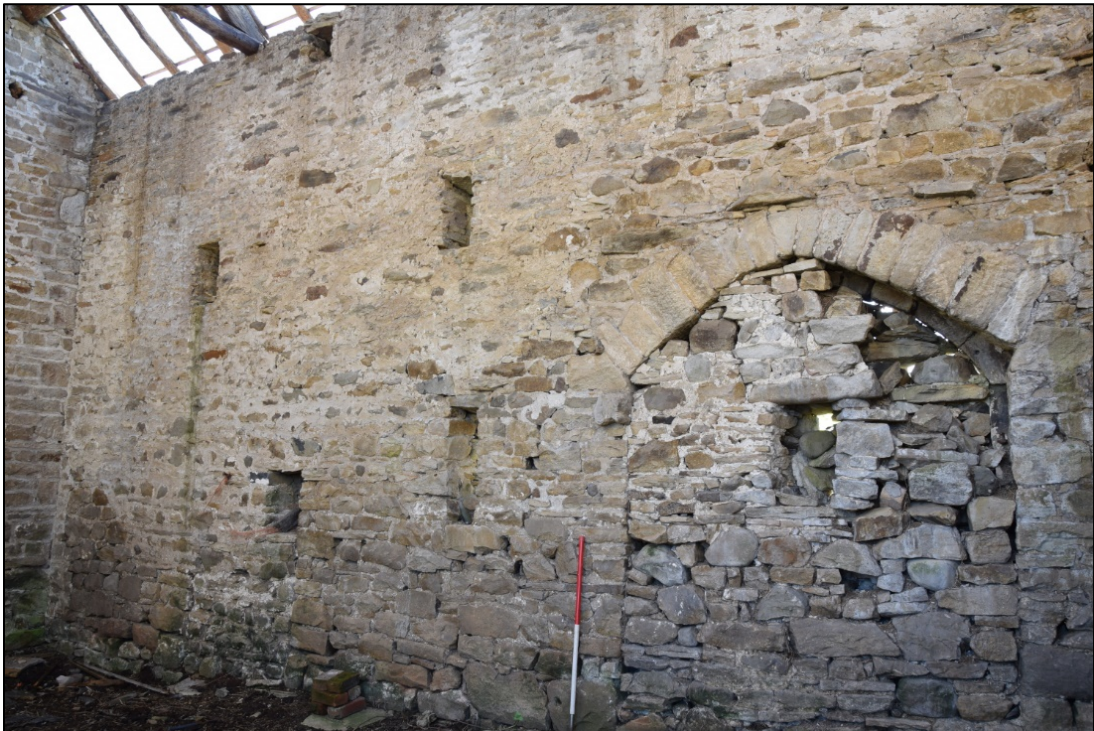
Photograph 40: The rebuilt south wall on the eastern part of the building. Note the change of masonry low down at the far corner

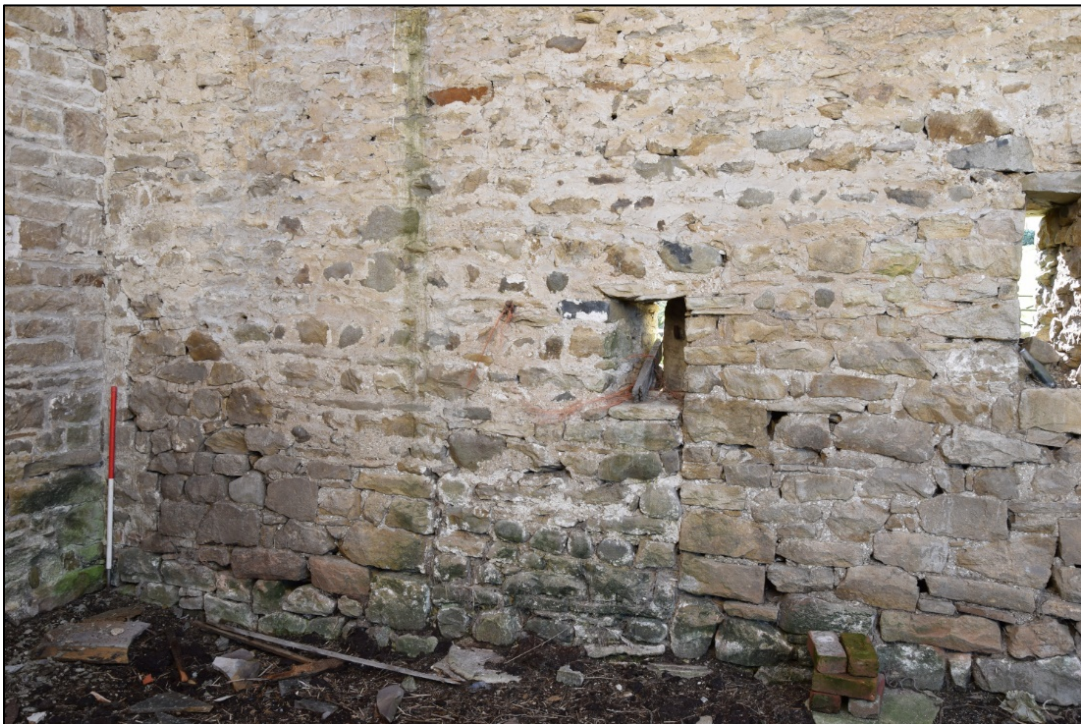
Photograph 42: The truncated blocked door at the south-east corner. The jamb can be seen in the low breather slit. Older masonry survives low down, beside the scale

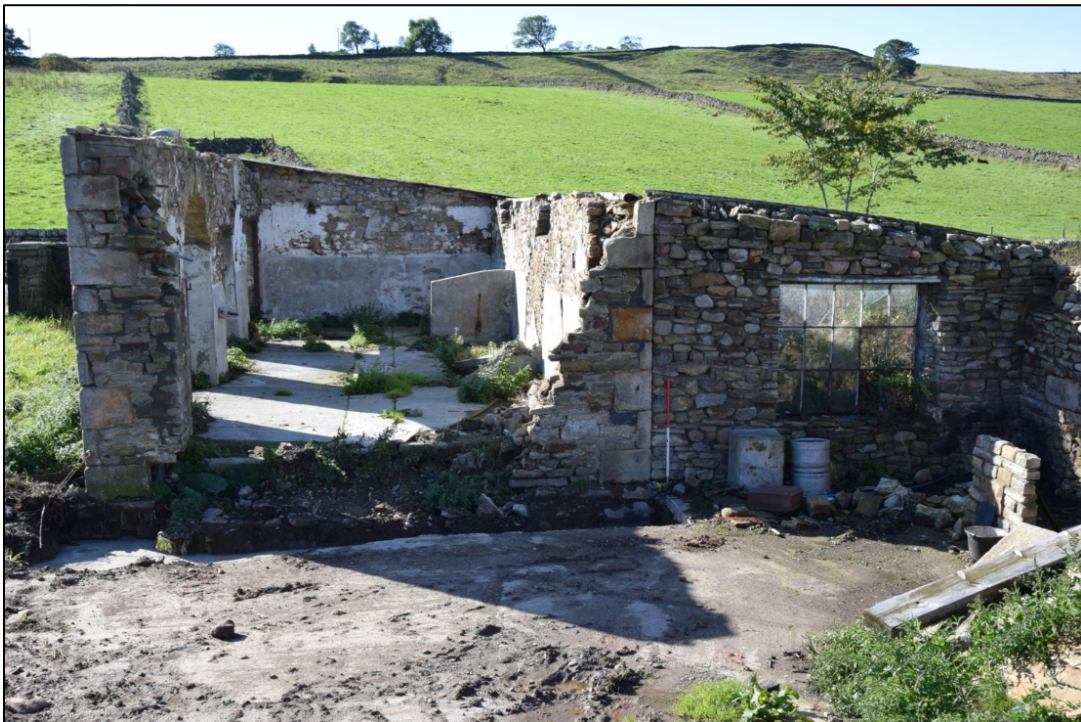
Photograph 50: Most of the north end of the building has been demolished. The wall with the window is what remains of an adjoining single-storey building

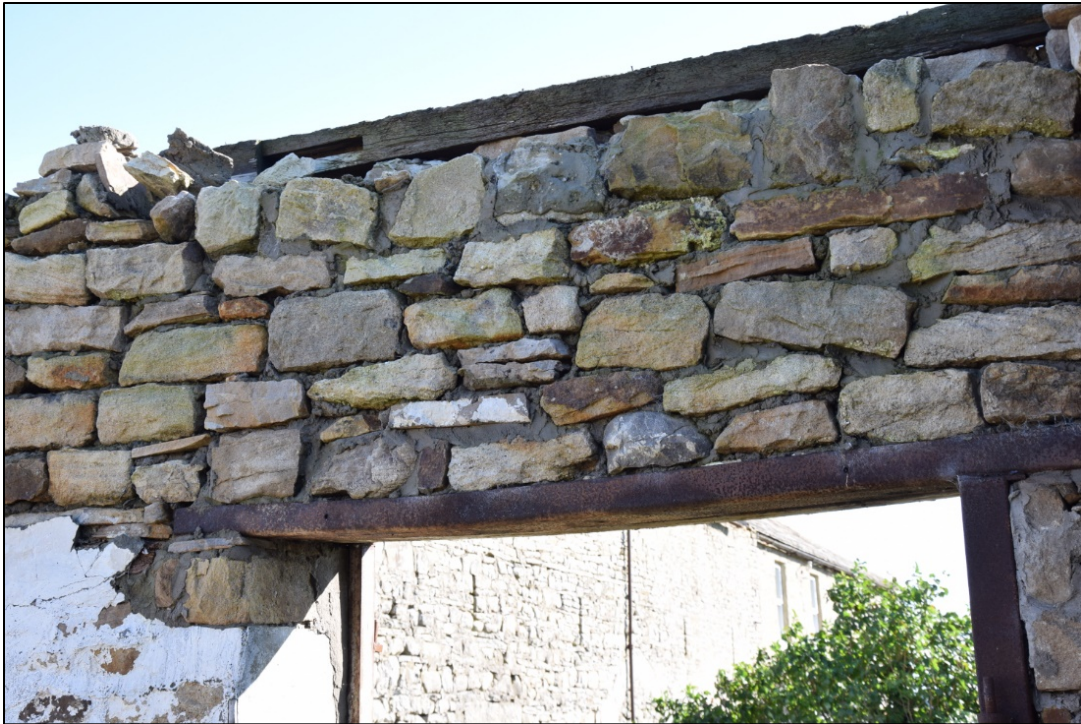
Photograph 59: Detail of steelwork and reset masonry above the south door

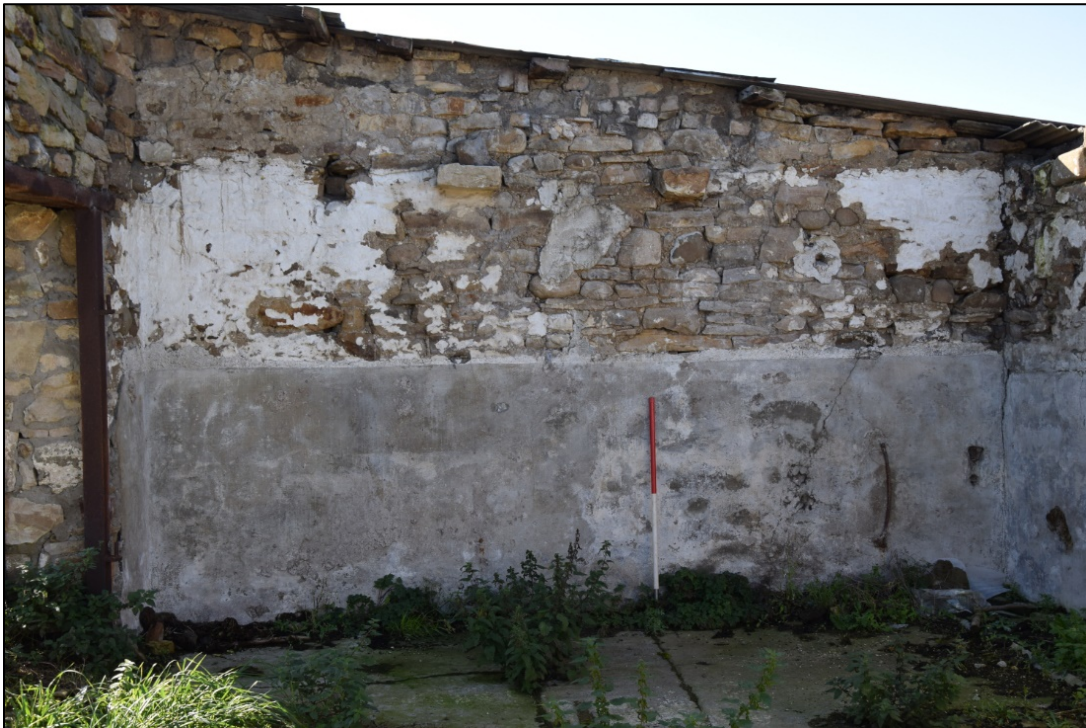
Photograph 62: Cement render on the south wall. The whitewash above indicates the line of the old ceiling
