ARCHAEOLOGICAL
SERVICES
DURHAM UNIVERSITY

The west curtain wall and mural tower
Auckland Castle
Bishop Auckland
County Durham

archaeological monitoring and recording

report 5175
October 2020

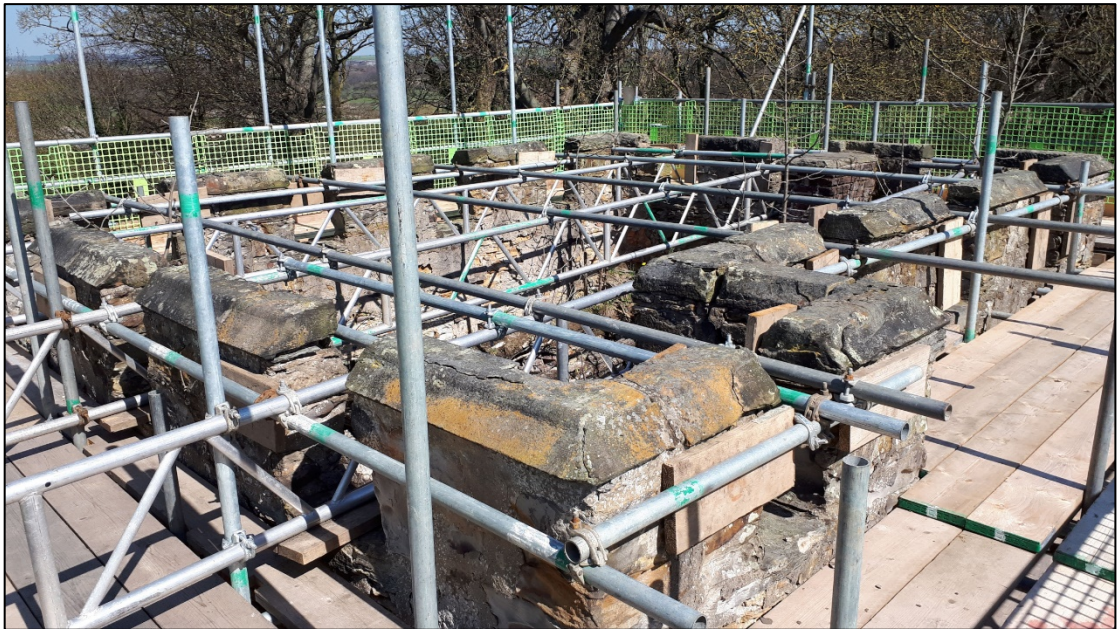
Photograph 16: Supporting scaffold in place around the tower's parapet at the start of the remedial work. A view looking north-east

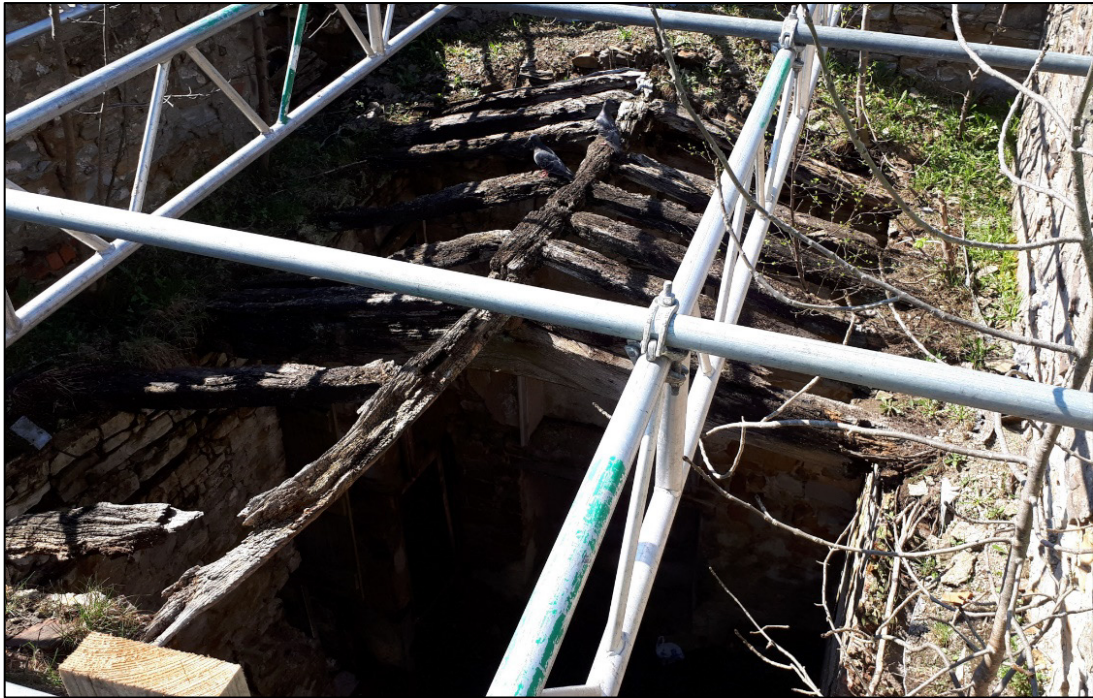
Photograph 17: The surviving roof timbers seen from the north-east corner of the building

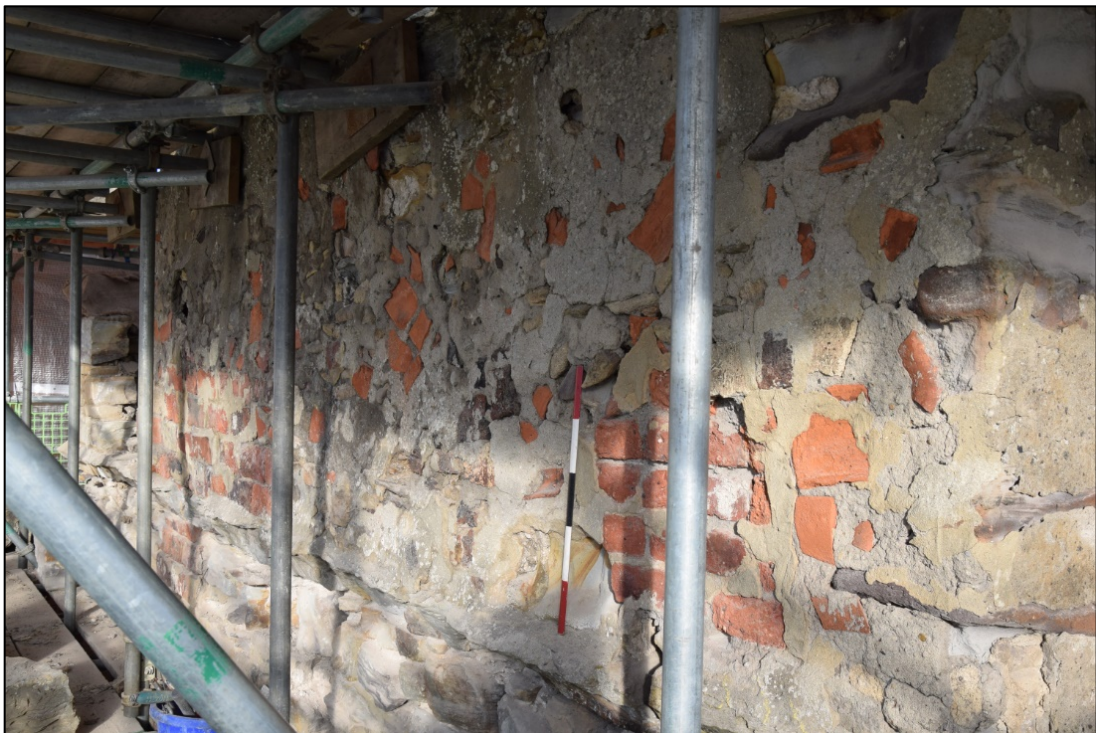
Photograph 26: Typical low-quality repair work in the upper part of the west face of the tower, with broken pantiles set in thick smears of mortar

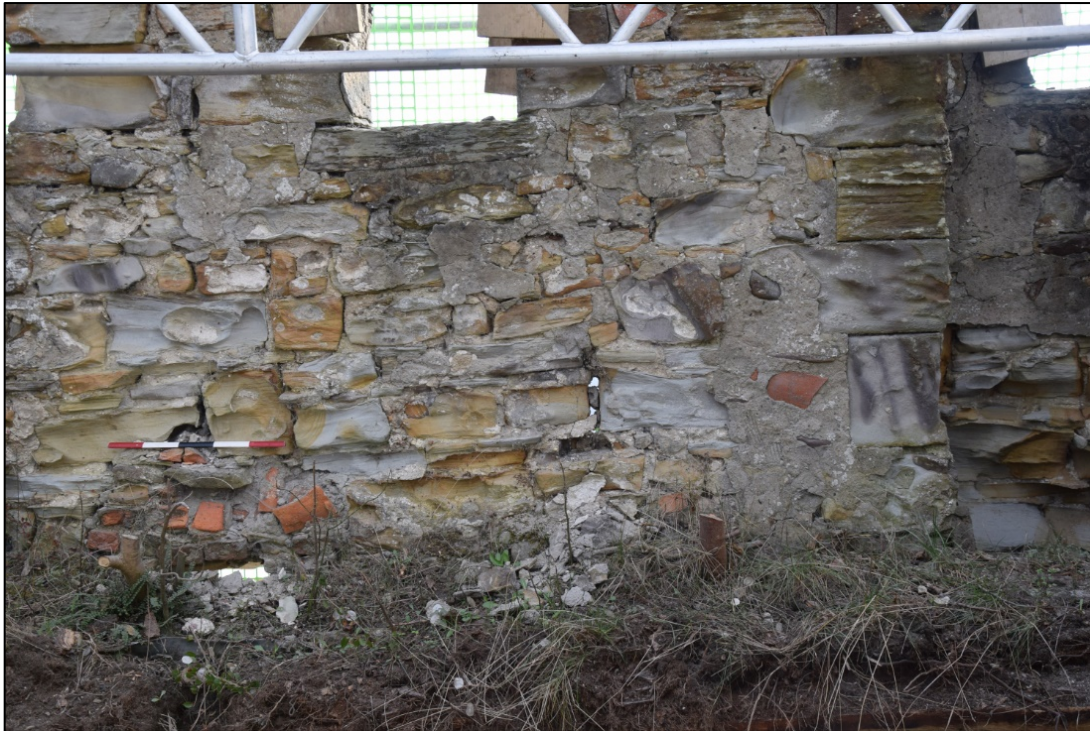
Photograph 27: Daylight is visible between the stones of the south parapet and there is another crude repair below the scale. Cement render covers the upper wall in the south block, at the extreme right

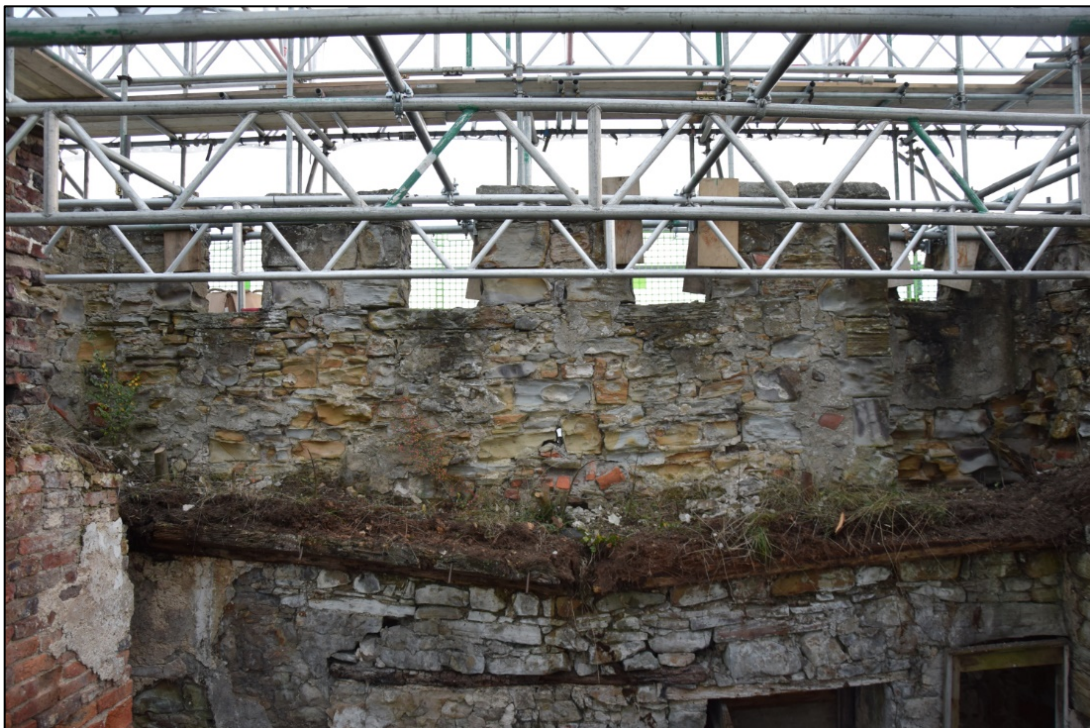
Photograph 28: The south wall. The severe deflection of the wall plate beams seems to have been caused in part by movement of masonry in the blocked opening under the decayed lintel at the bottom of the picture

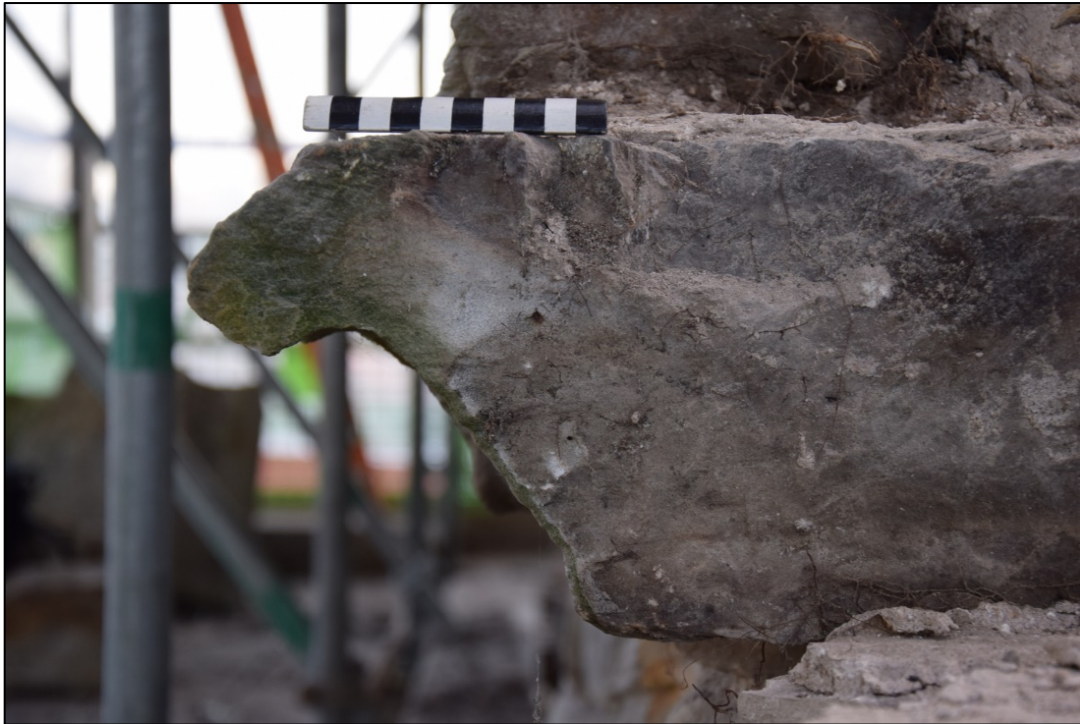
Photograph 29: One of the few undecayed sections of the string course

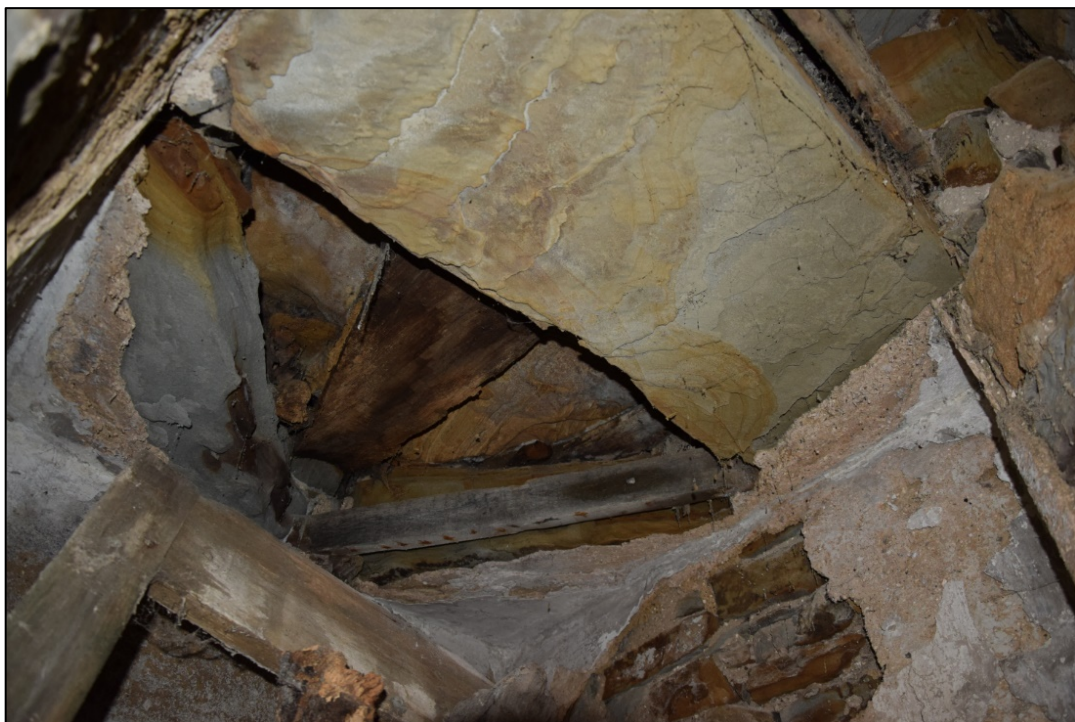
Photograph 43: First floor, south wall; the large blocked window at the centre of the wall. Note the plaster on the splay at the left. Above this, the blocking stonework has slipped forward. The right-hand side of the opening was lost when the doorway was created

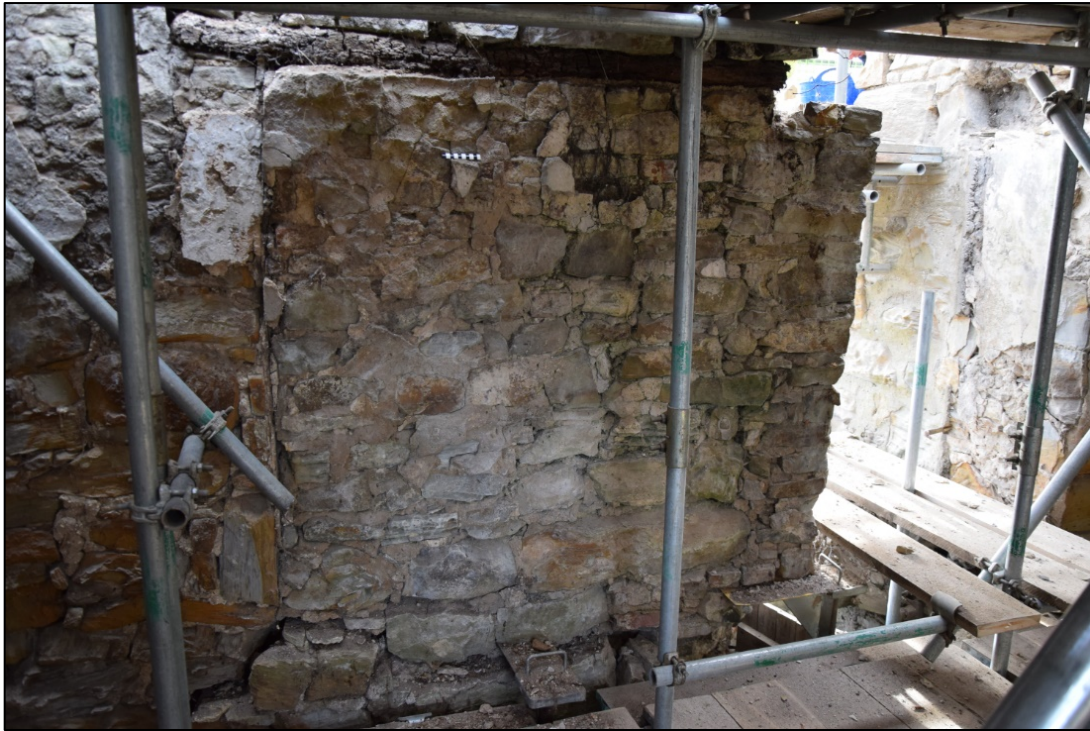
Photograph 44: The same wall after rebuilding, with a smaller window. The straight joint at the left continues below the new sill

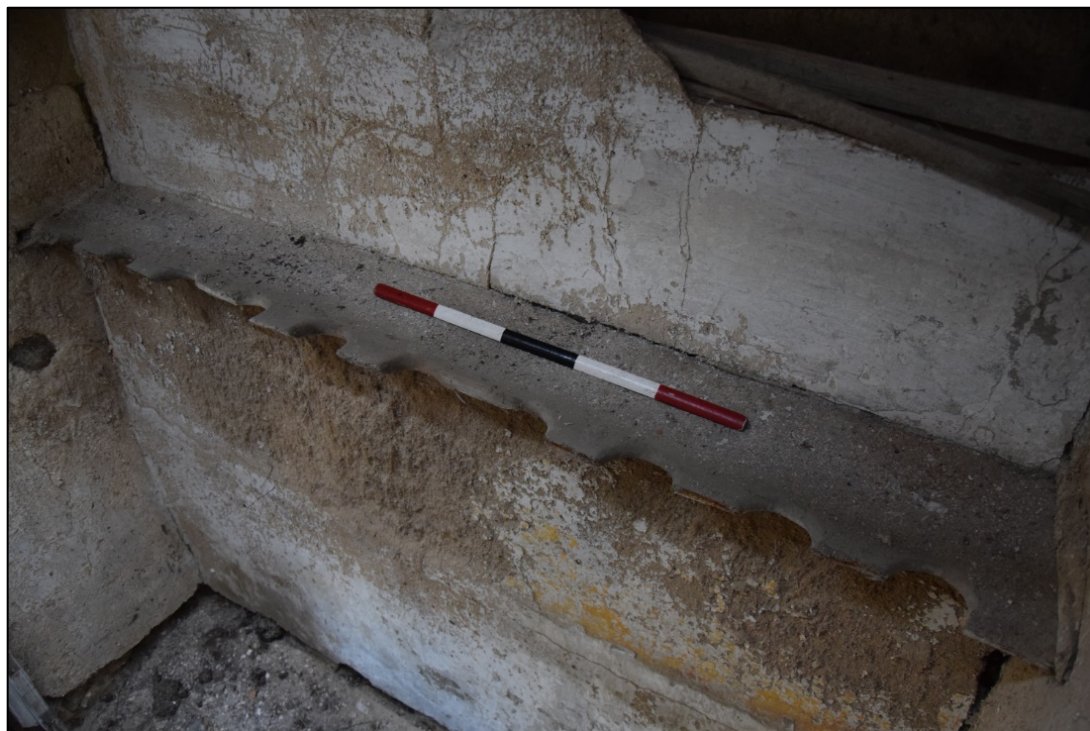
Photograph 46 (below): The remains of the shotgun rack in the upper window of the west wall

- 6.14 Two large windows occupy most of this wall (Photograph 45). The ground-floor one was left closed; the upper had been closed up to make a cupboard. This contained a broken shelf with ten holes in it, the remains of the gamekeeper's shotgun rack (Photograph 46). The window has been re-opened and the rack has been retained.

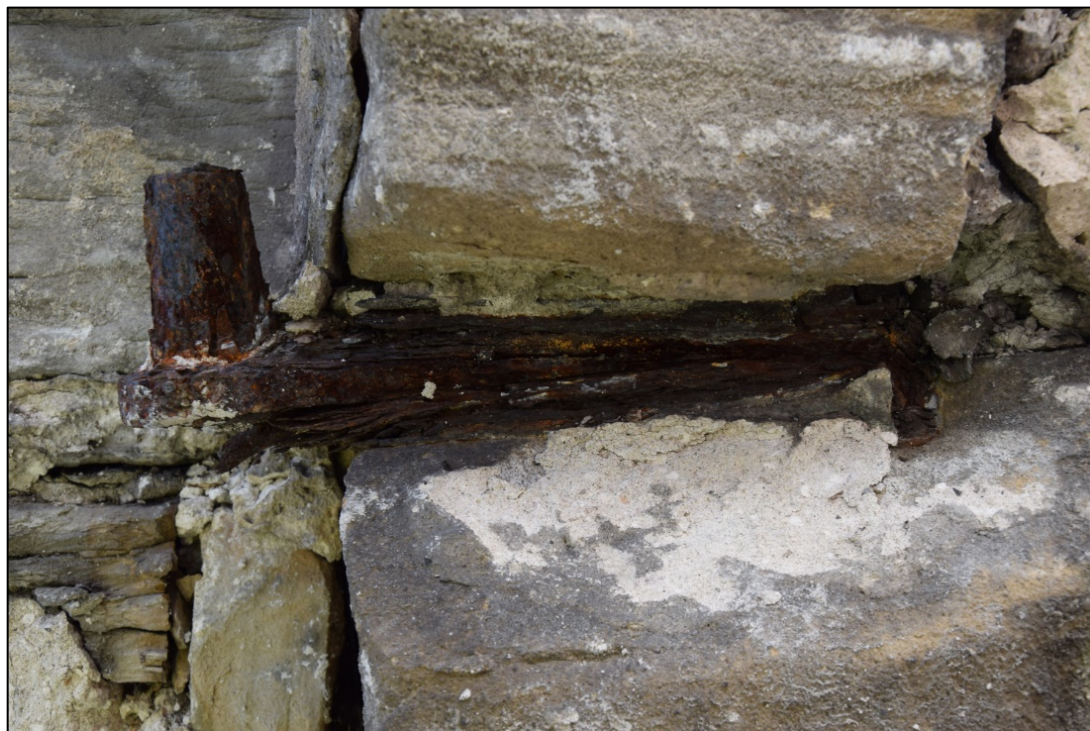
Photograph 50 (below): Detail of the upper pintle on the north side, showing how the stones have been forced apart by rust-jacking
