ARCHAEOLOGICAL  
SERVICES  
DURHAM UNIVERSITY

Former stackyard  
Hart  
Hartlepool

archaeological building recording

report 5448  
January 2021

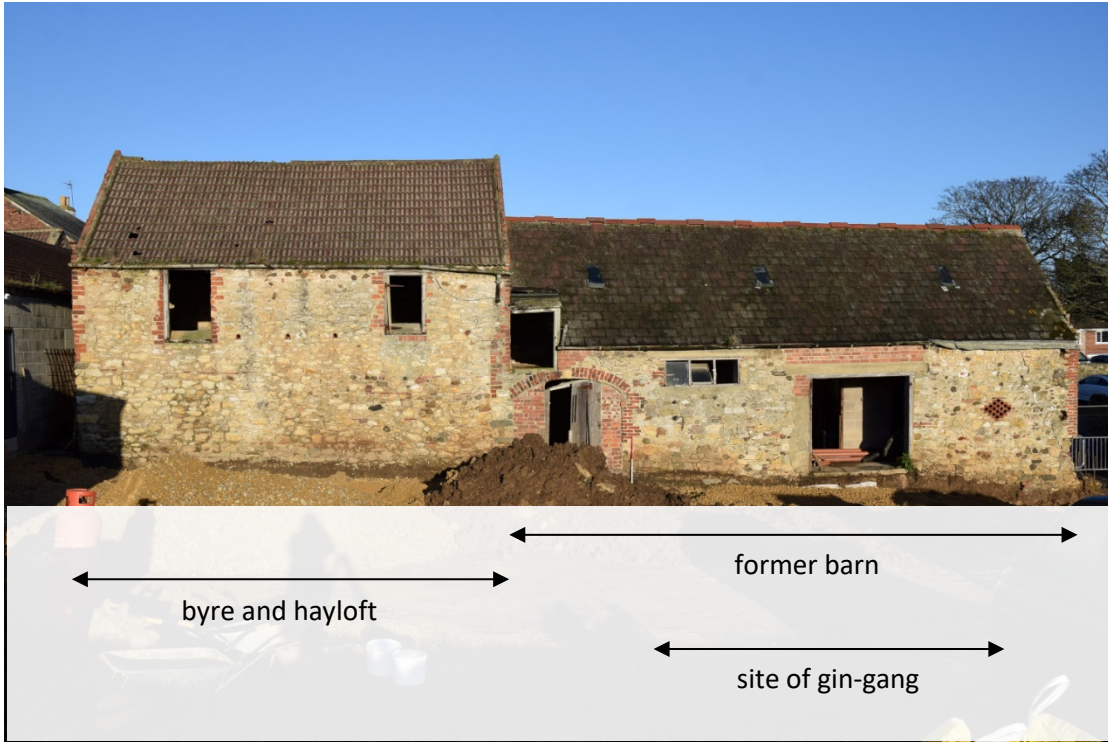
Photo 1: The south face of the buildings, seen from the old stackyard. There was formerly another small building at the east (right-hand) end

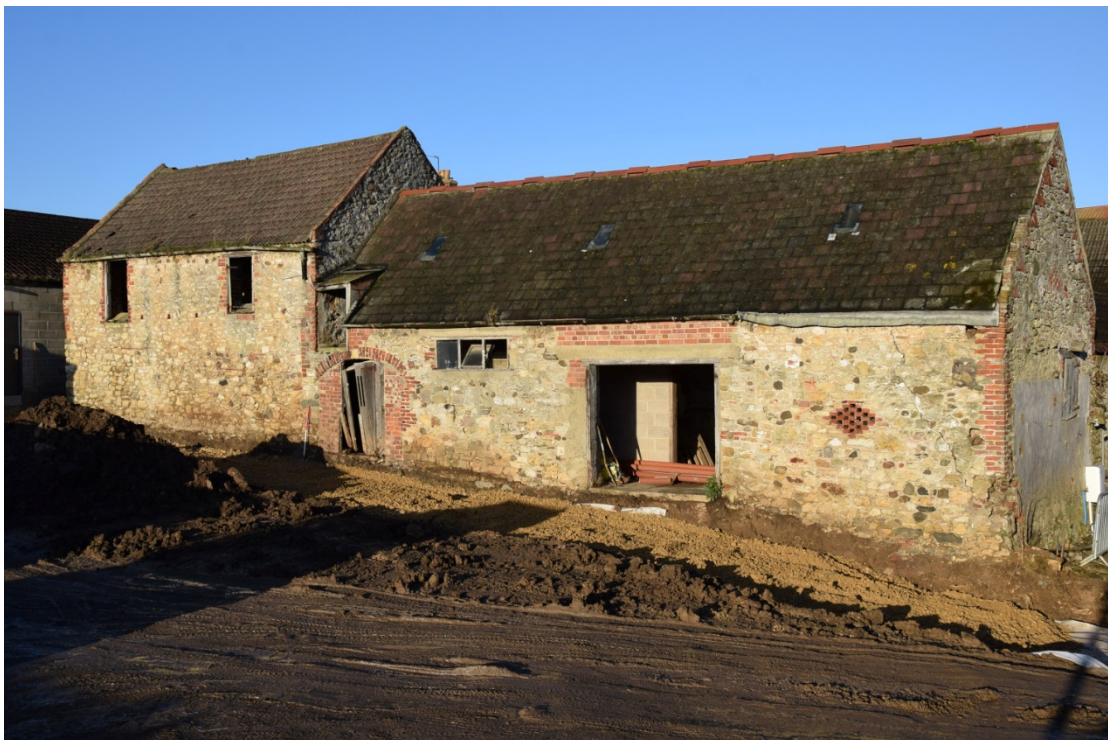
Photo 2: A view from the south-east side

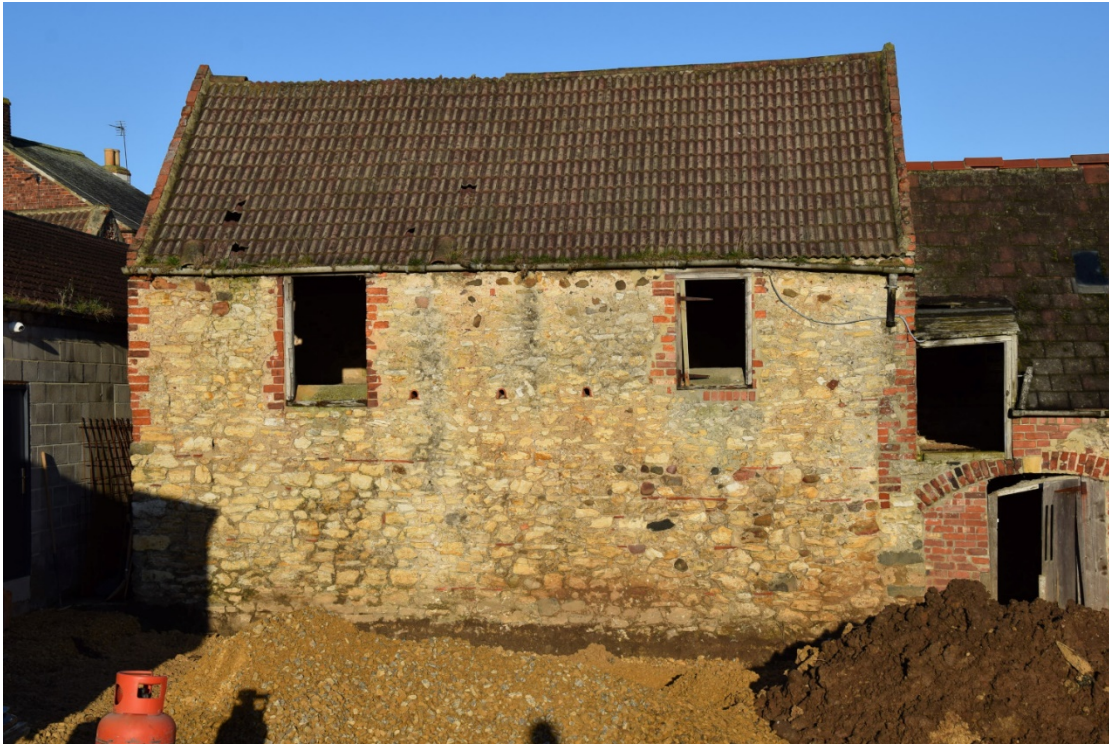
Photo 3: The face of the old byre and hayloft. The tall upper openings were used to pitch hay or straw from carts in the yard

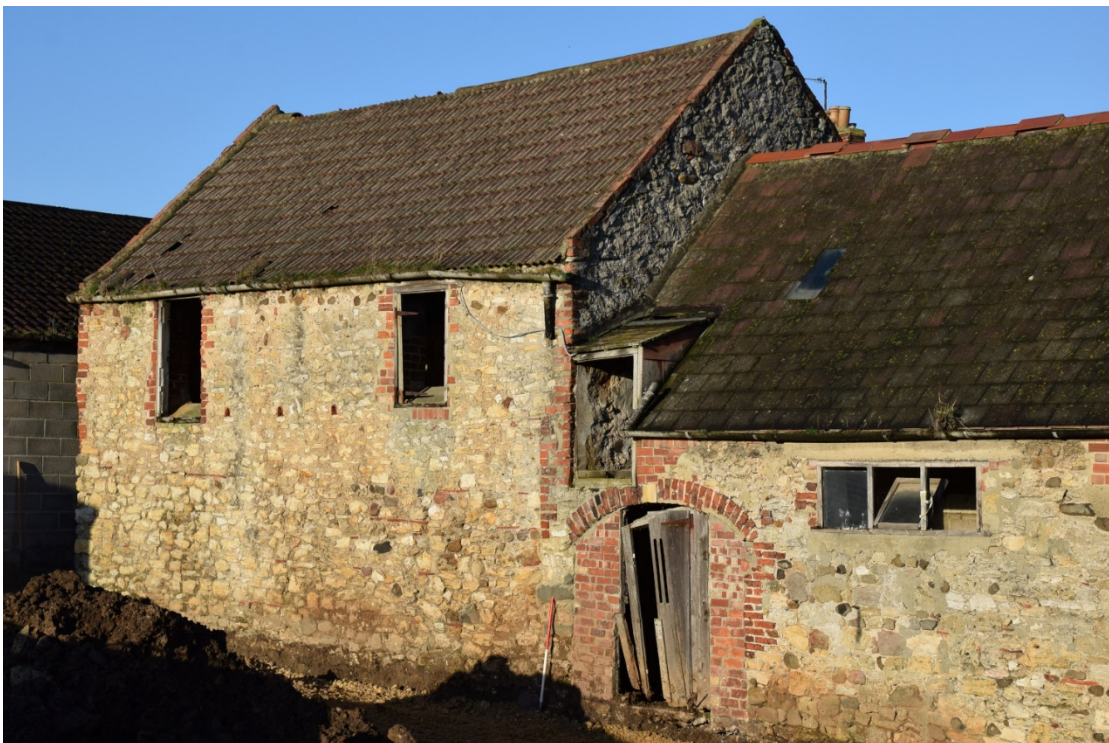
Photo 4: The lower pitching door at the south-east corner of the byre is a later alteration

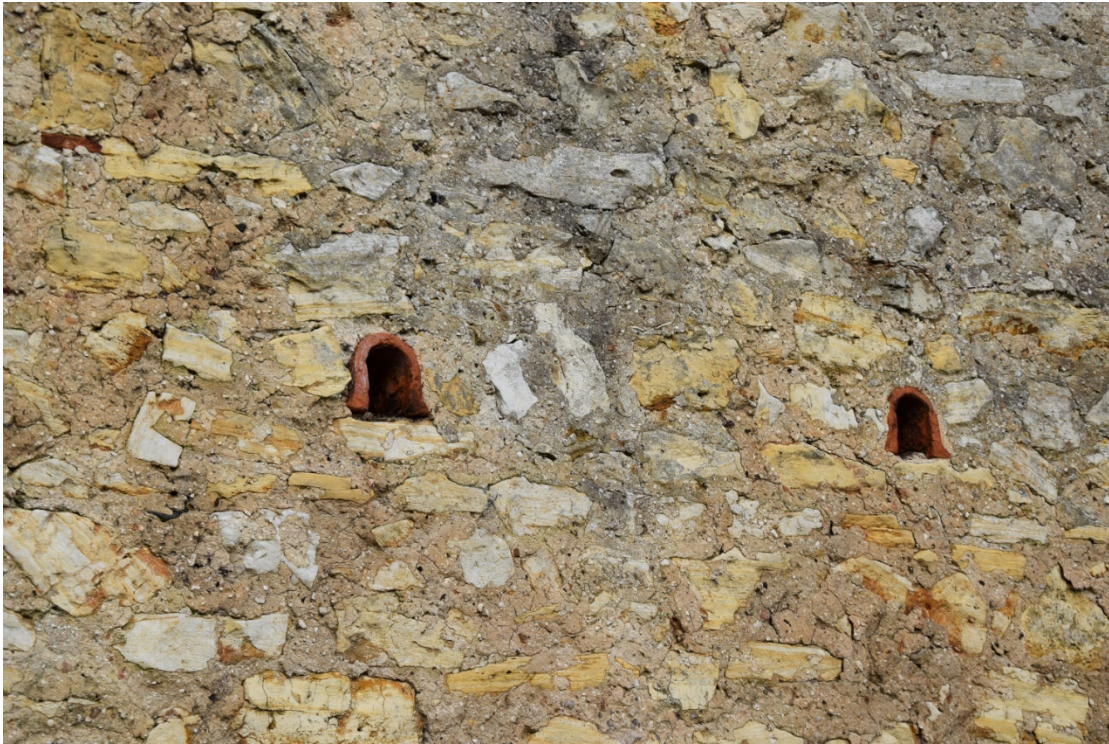
Photo 5 (above): Old horseshoe field drains used as ventilators for the byre

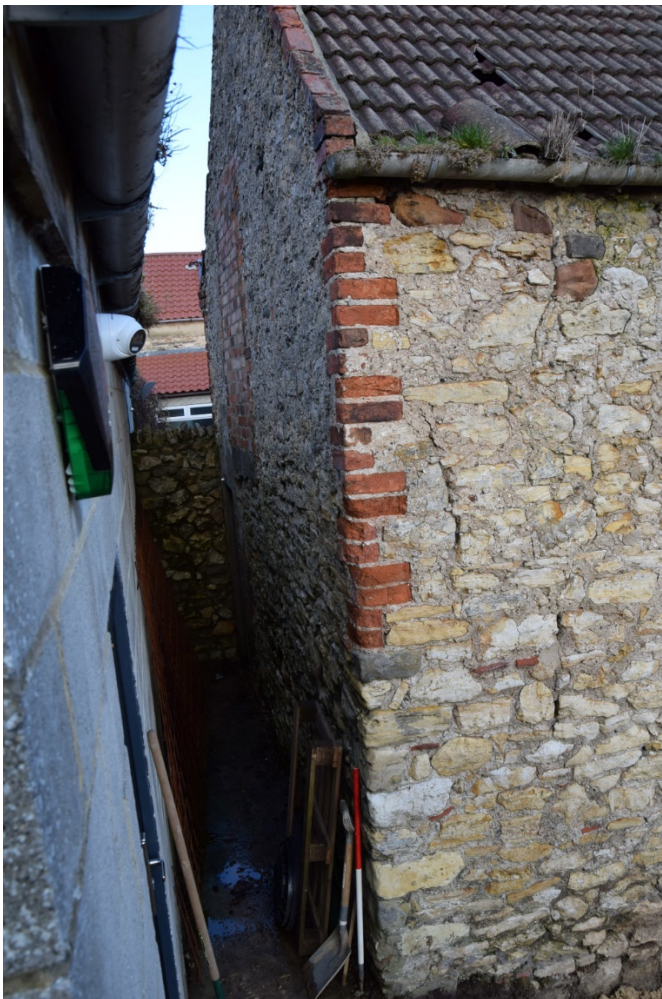
Photo 6 (left): The narrow gap between the byre and the long modern shed that forms the west side of the farmyard on the far side of the building

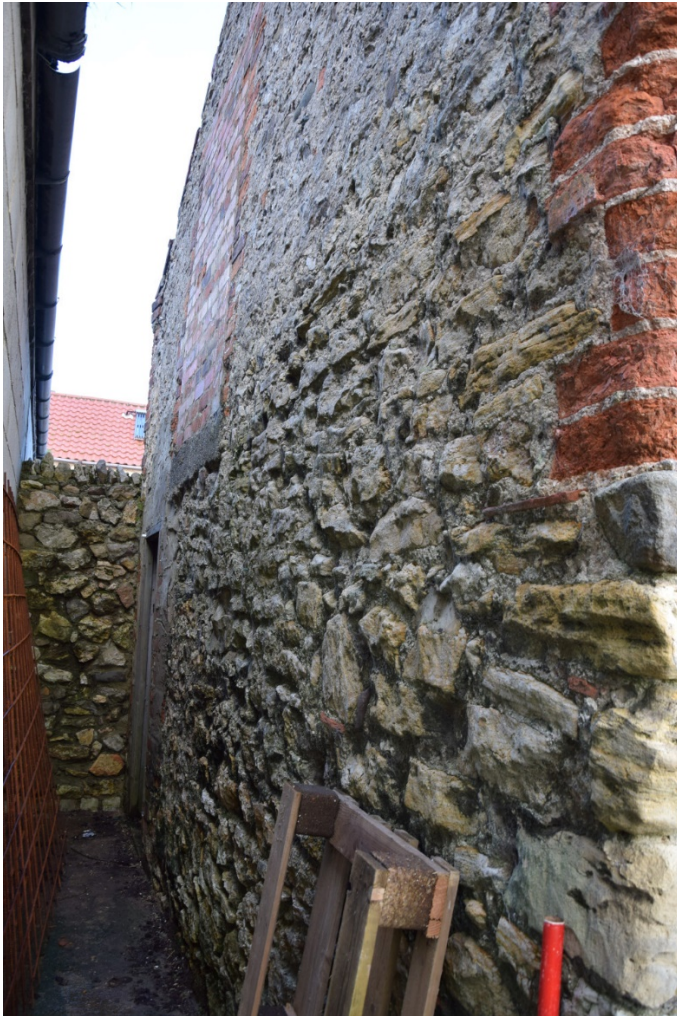
Photo 7 (left): The west end of the byre. A tall door to the loft is bricked up

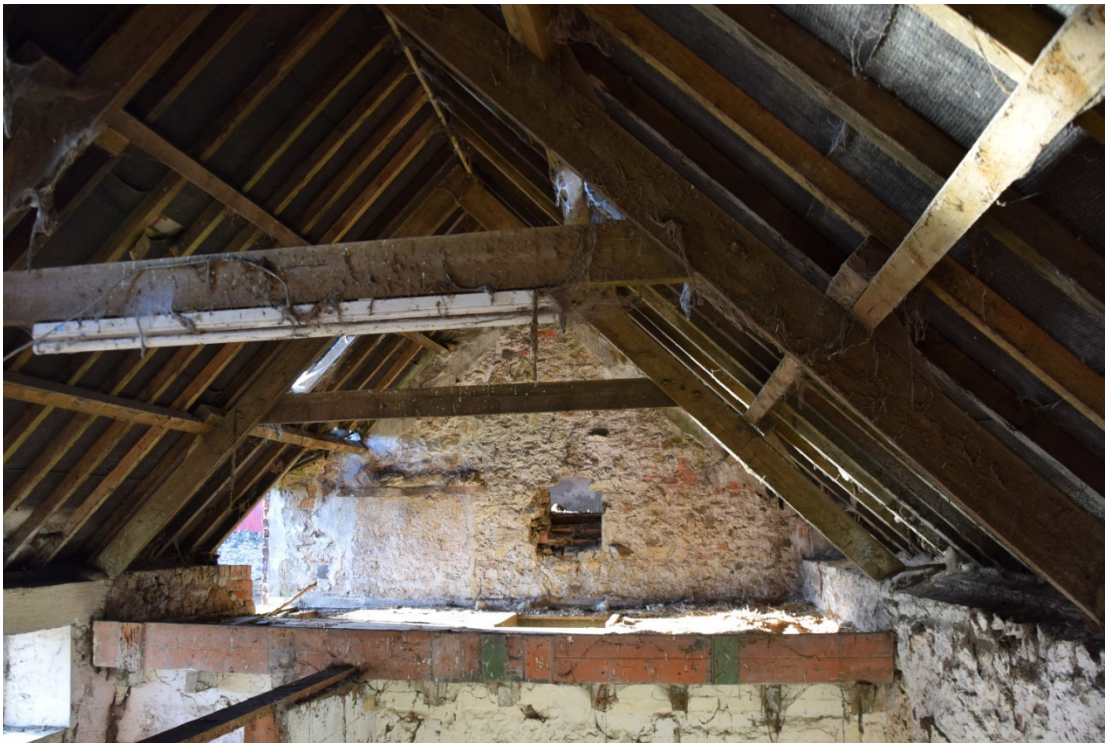
first-floor level inside the old barn (Photo 8). The blocked opening is not visible in the byre and it extends above and below the line of the hayloft floor. It may simply have been a recess.

Photo 8 (below): The east end of the loft, seen from the adjoining barn. Note the blocked opening at the left, which extends below the hayloft floor

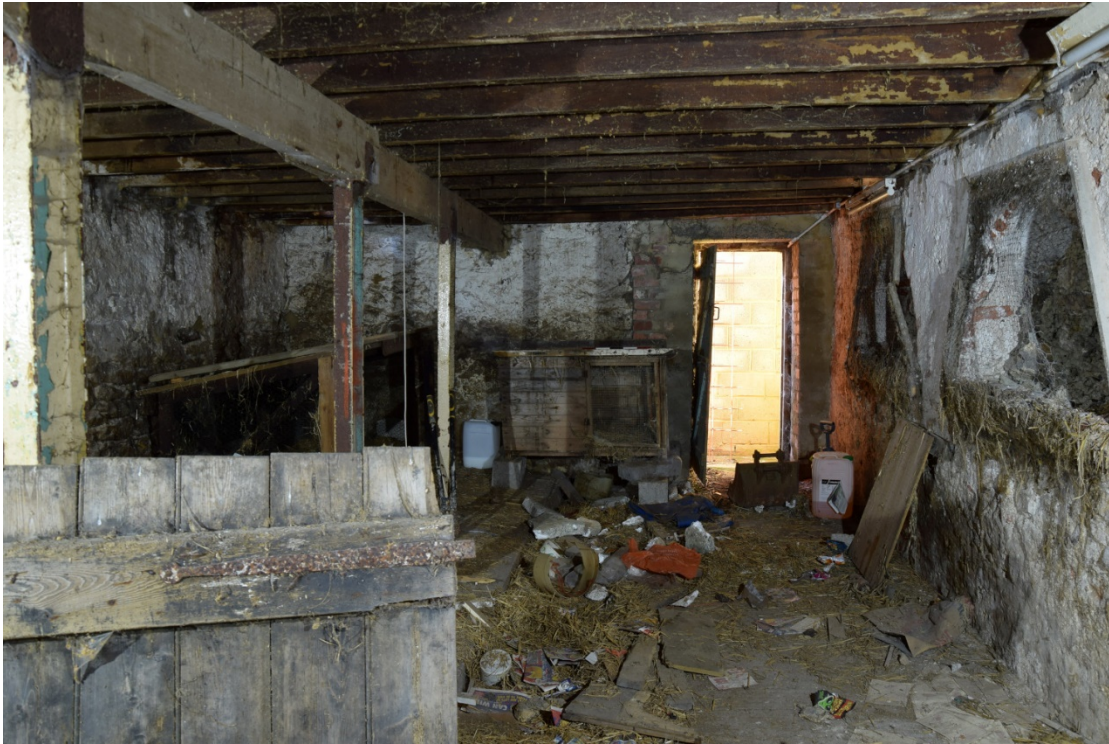
Photo 9: The byre, with steel I-beams supporting the main joist; at the left is a detached door from a stall. A view looking south-west

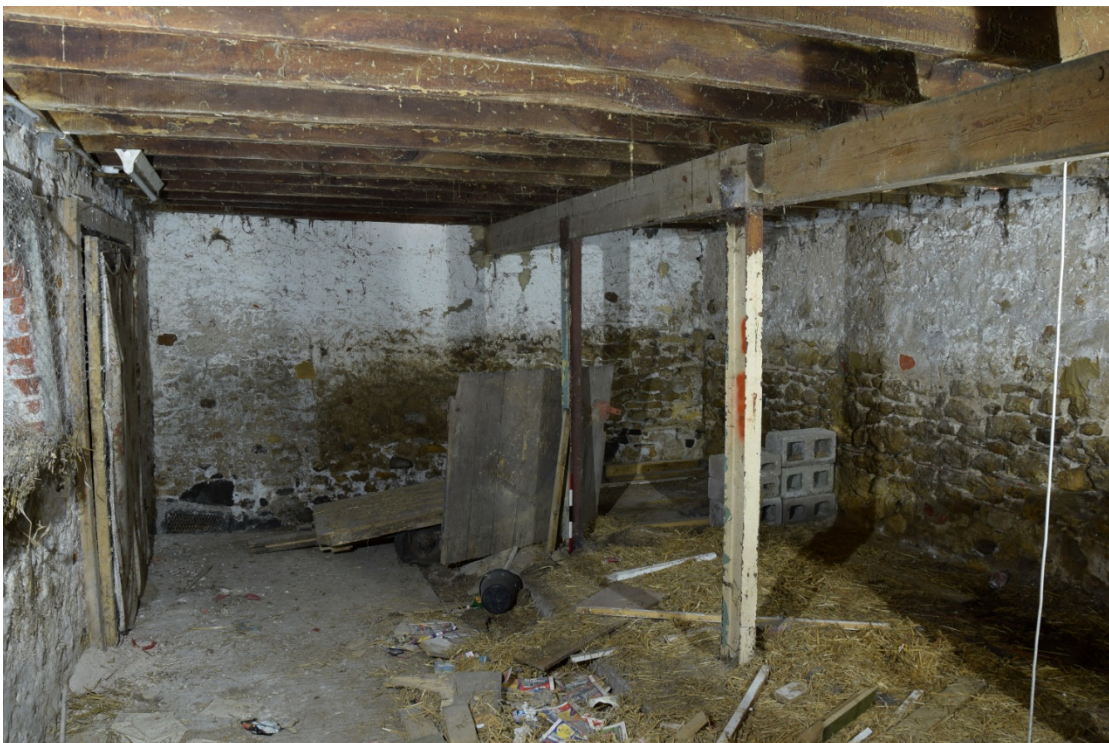
Photo 10: The interior of the byre seen from the north-west corner. The black bucket is lying in the drain at the back of the stalls

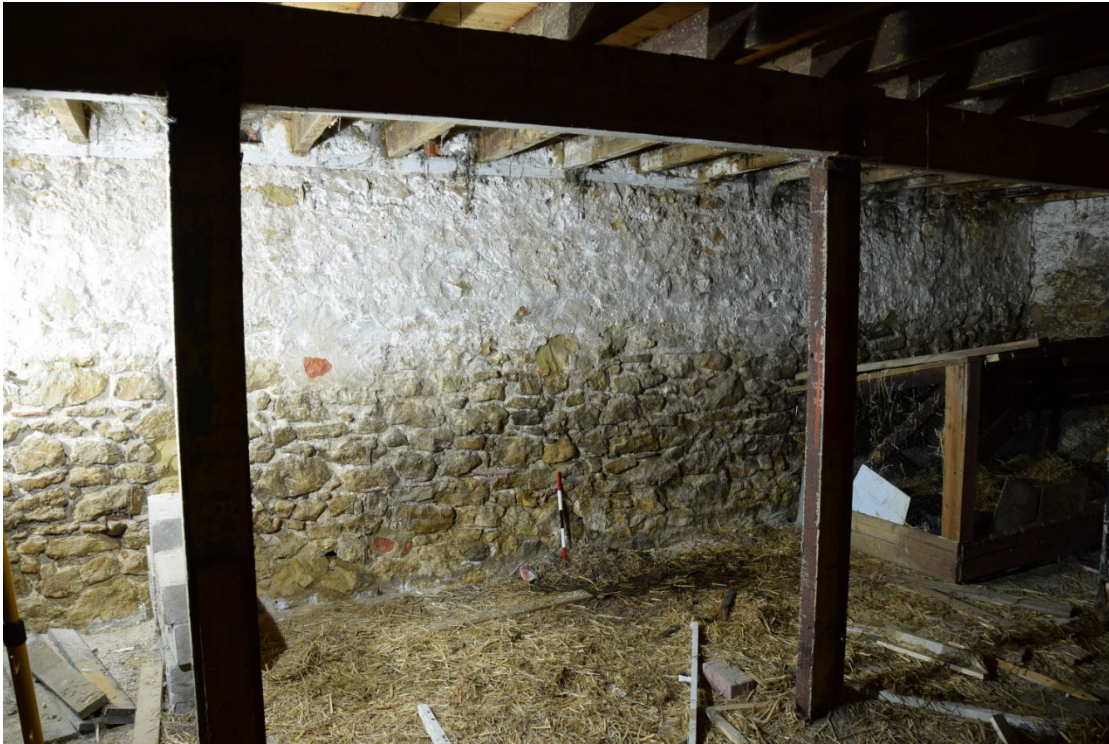
Photo 11: The south wall shows no trace of stall divisions and the ventilators between the joists are blocked up

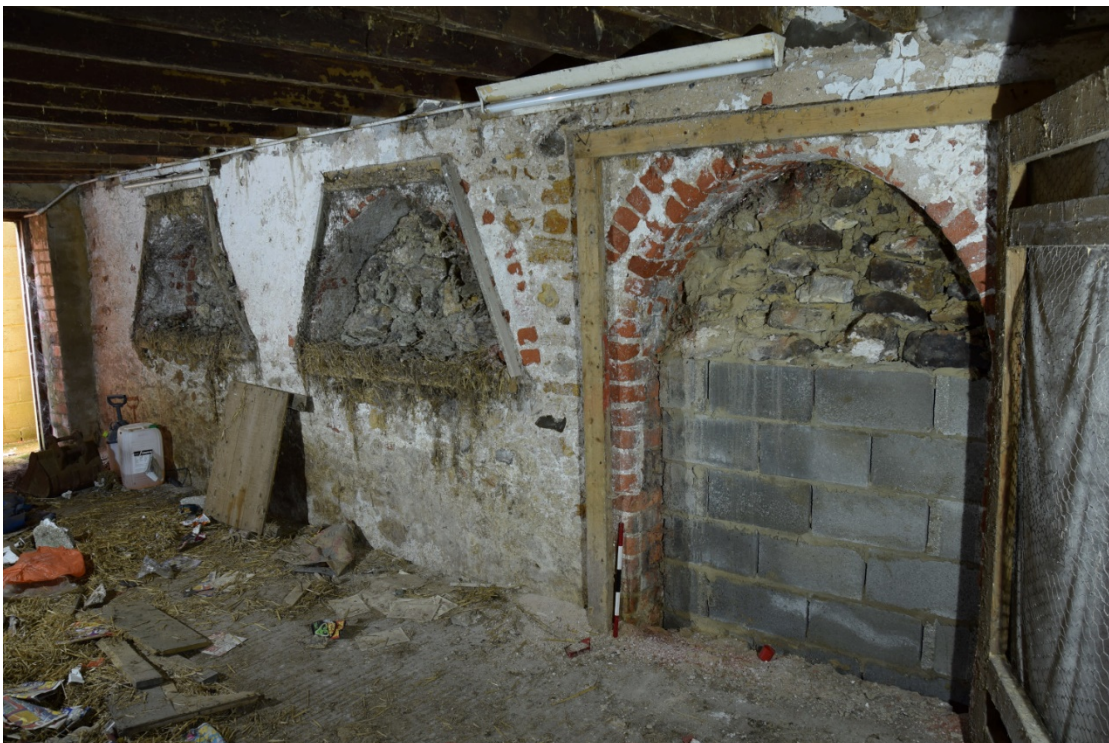
Photo 12: The north wall had two arched windows and a wide door from the yard, all now blocked up

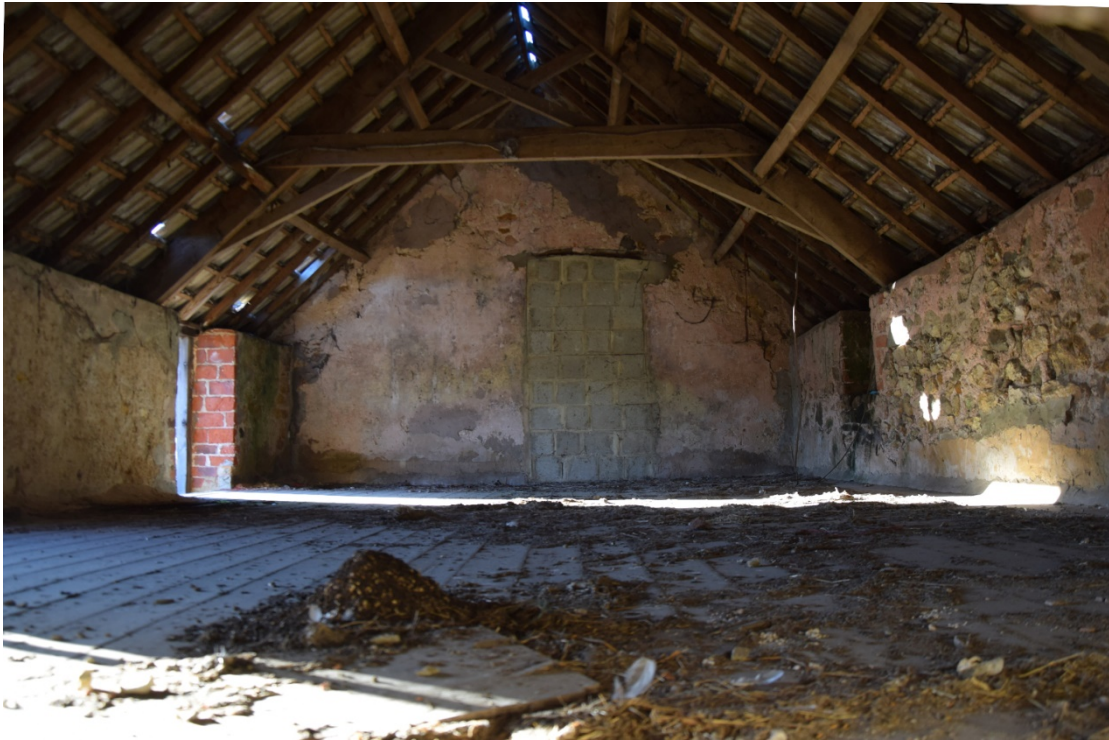
Photo 13: The hayloft, seen from the east end. The blocked door is the one seen in Photo 7

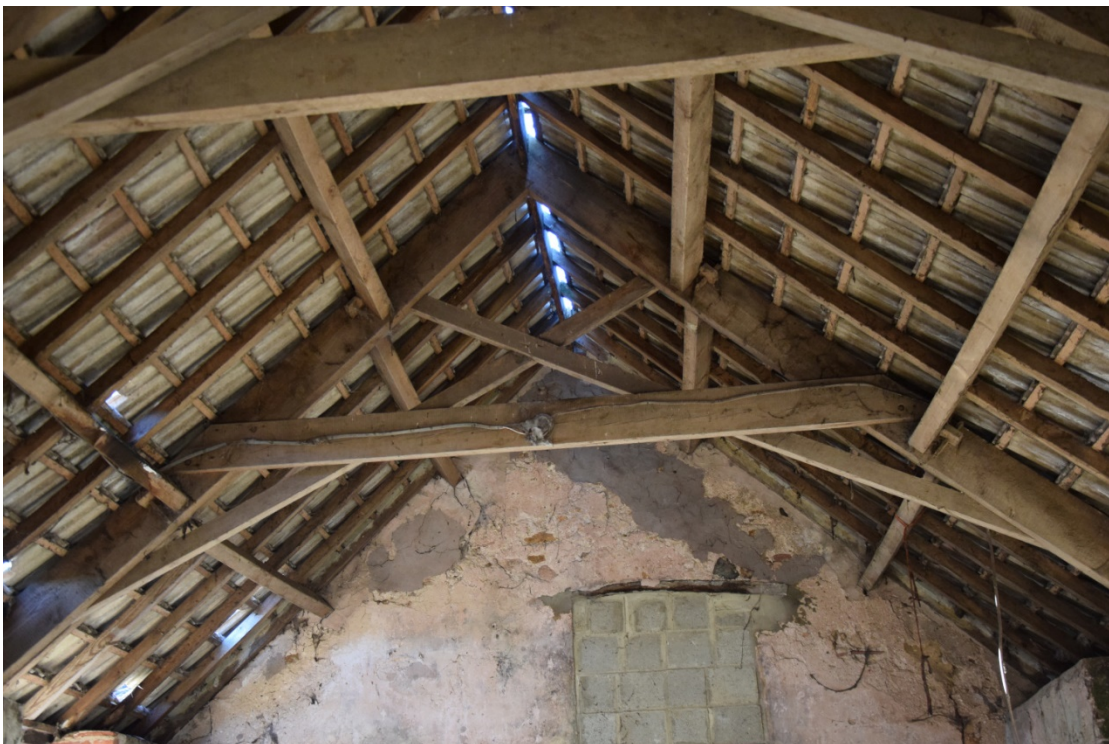
Photo 14: The roof trusses have small scissor braces above the collar beams

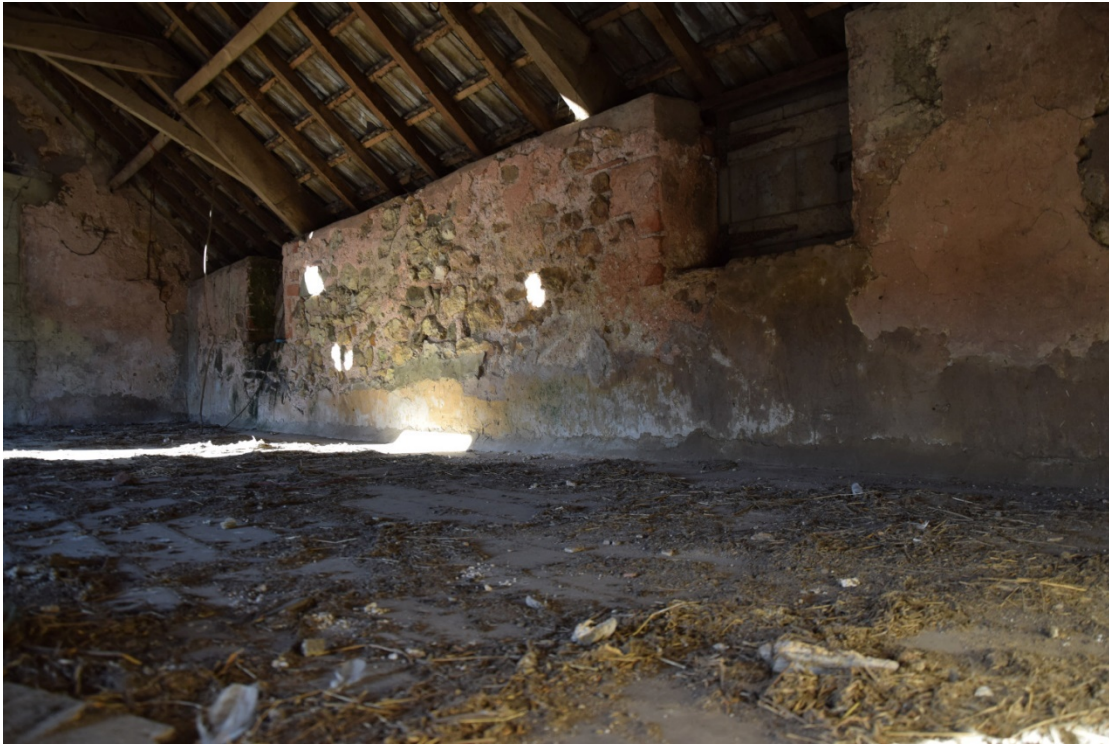
Photo 15: Small windows in the north wall of the loft

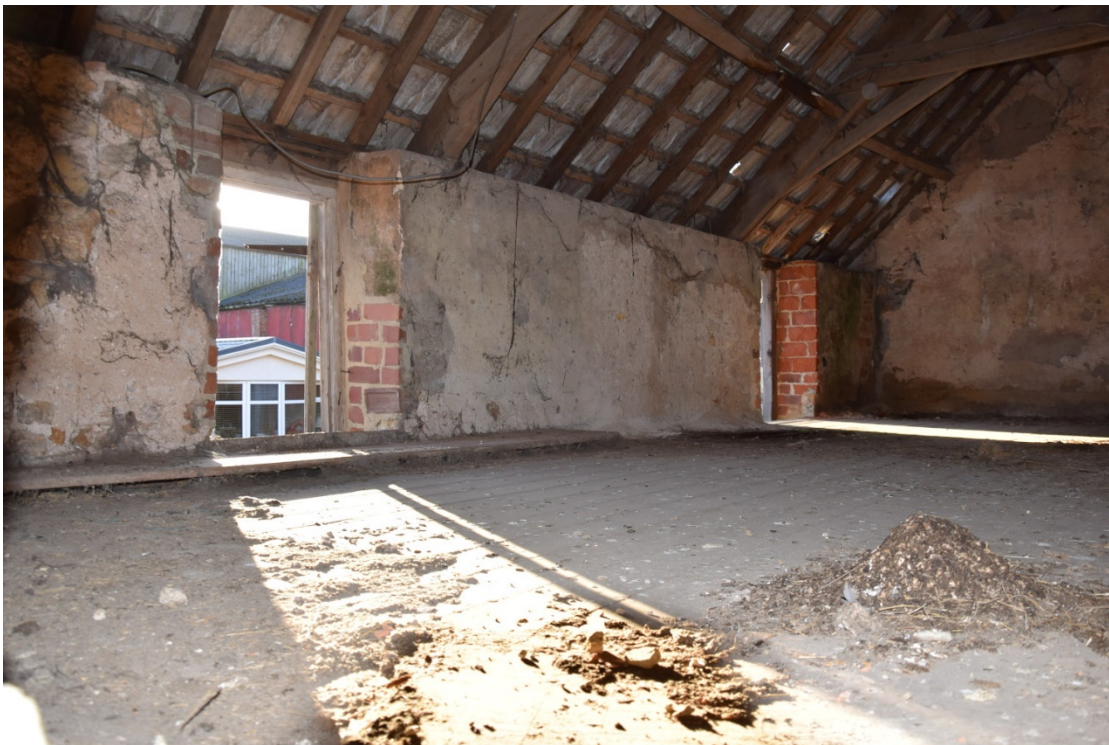
Photo 16: The larger pitching windows in the south wall have brick in their jambs

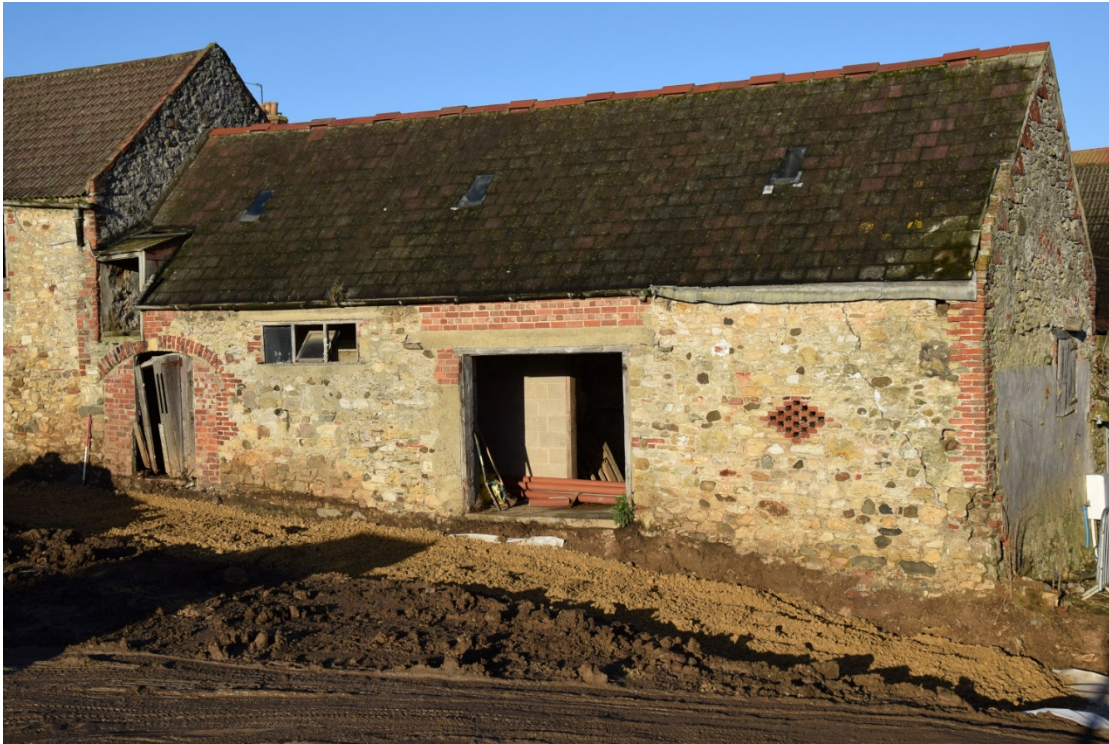
Photo 17: The old barn. The gin-gang joined this building where the big modern door is now

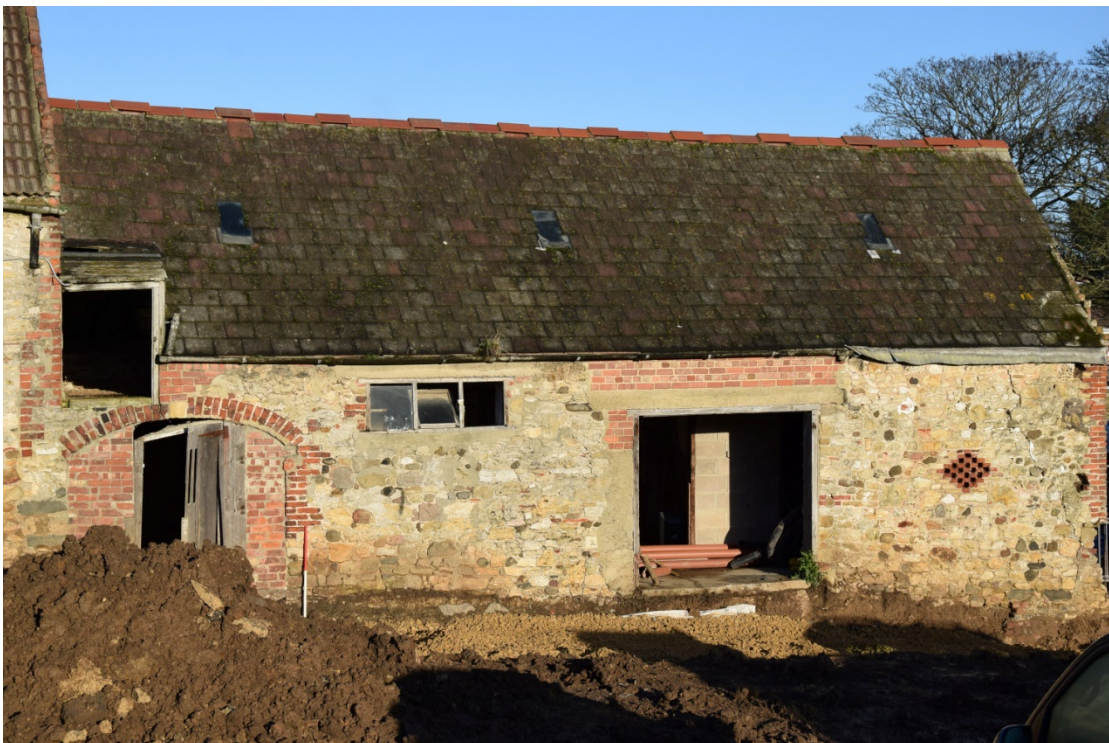
Photo 18: The barn seen from the south-west. The modern material of the roof is apparent here

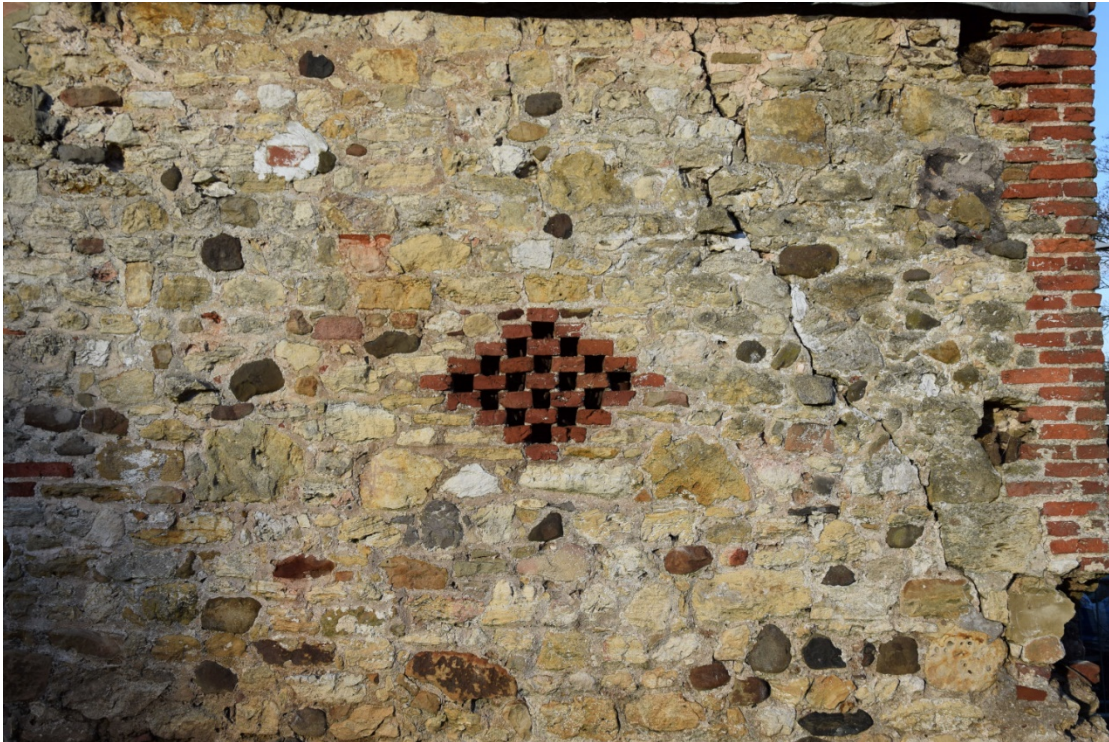
Photo 19: A large subsidence crack runs across the east end of the south face, above a brick ventilator

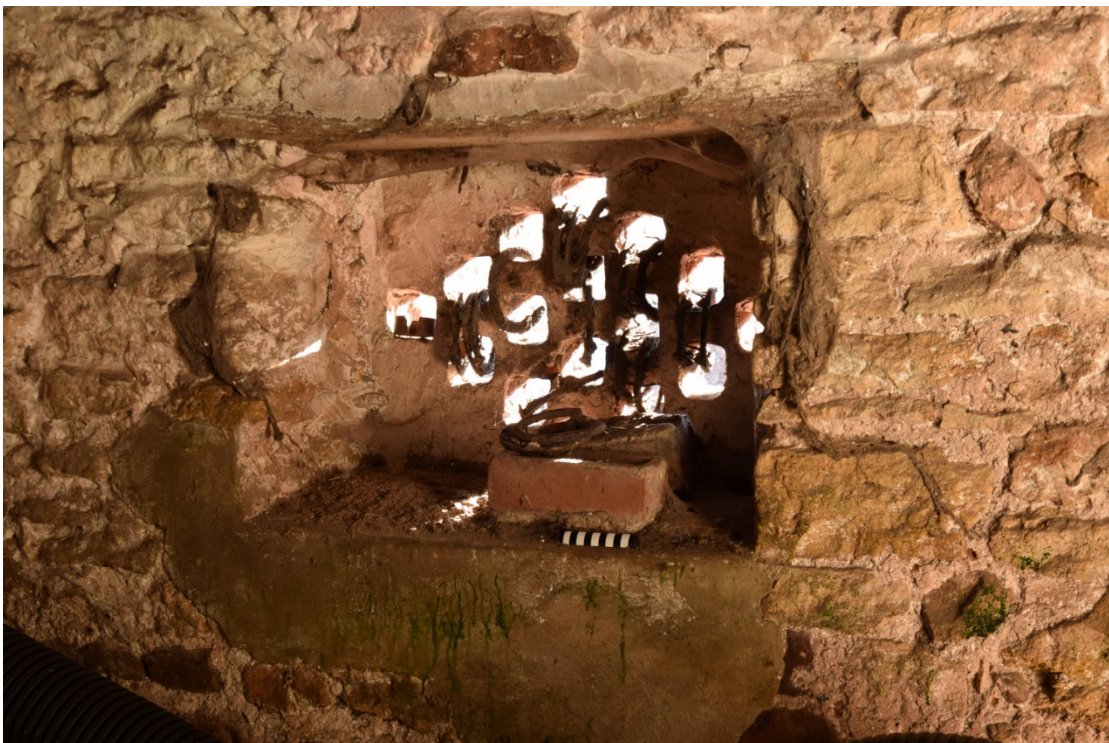
Photo 20: The inside of the ventilator

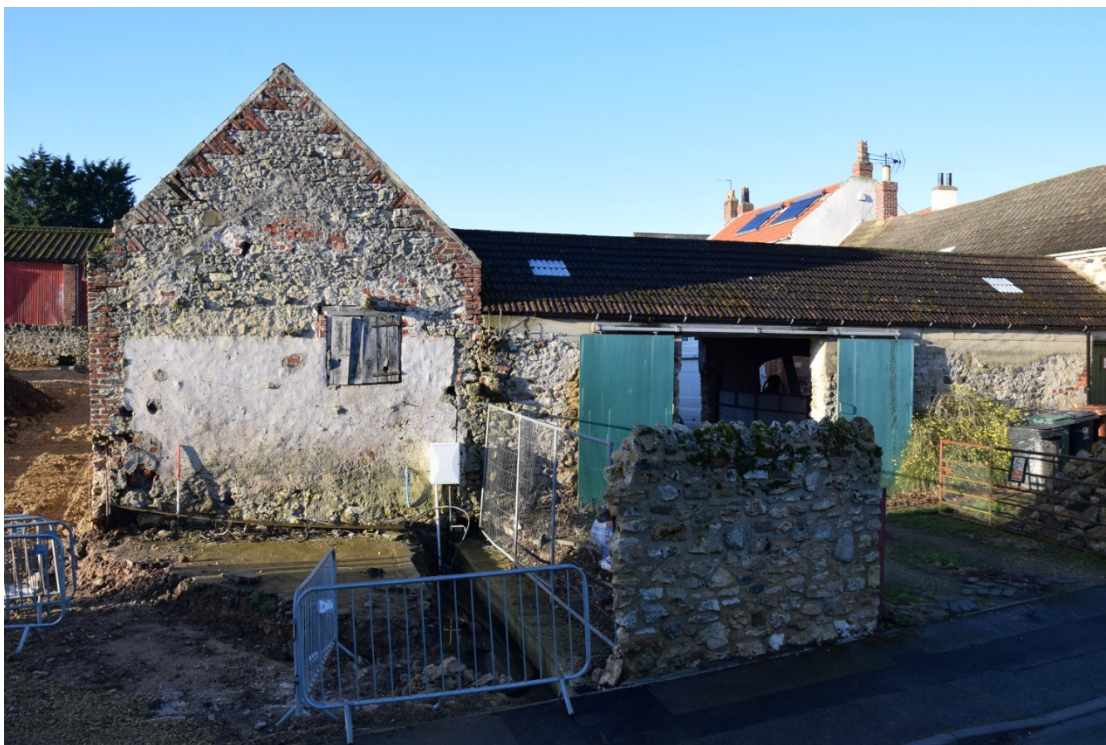
Photo 21 (above):  
The east face of  
the old yard with  
the end of the  
barn at the left. In  
the foreground  
are the remains  
of the third cell of  
the old range

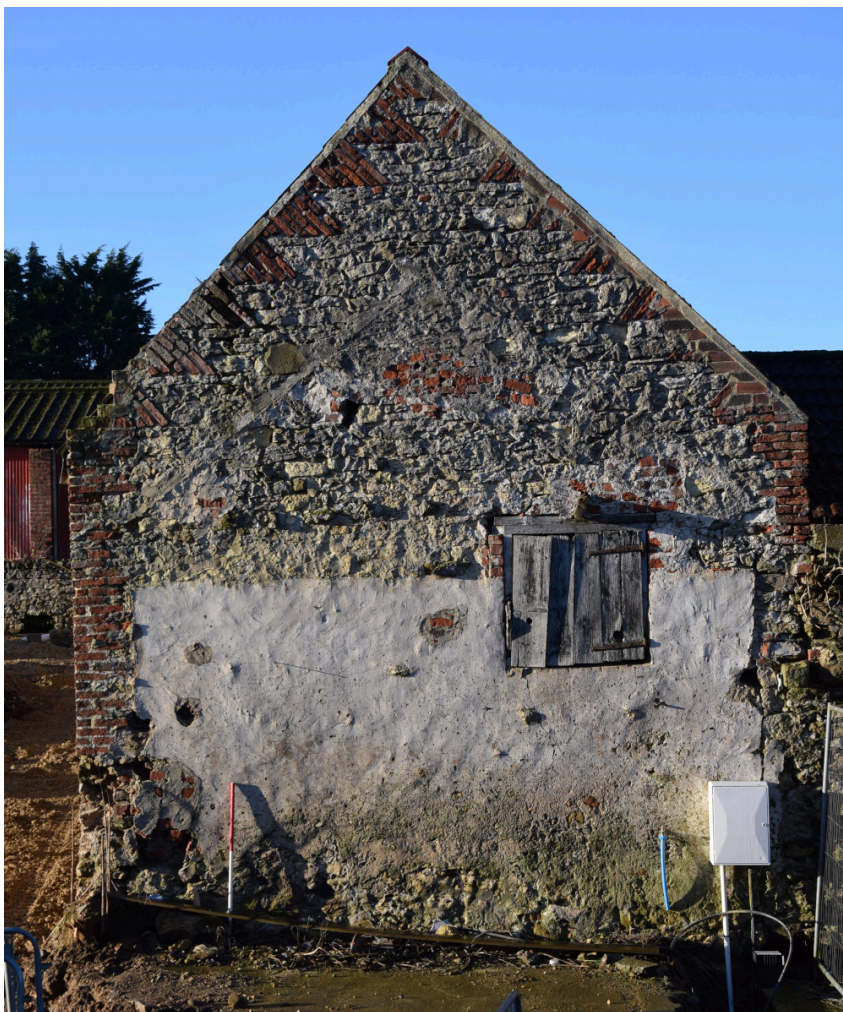
Photo 22 (left):  
The east end of  
the old barn. The  
tumbled-in  
brickwork of the  
gable is a feature  
typical of this  
region

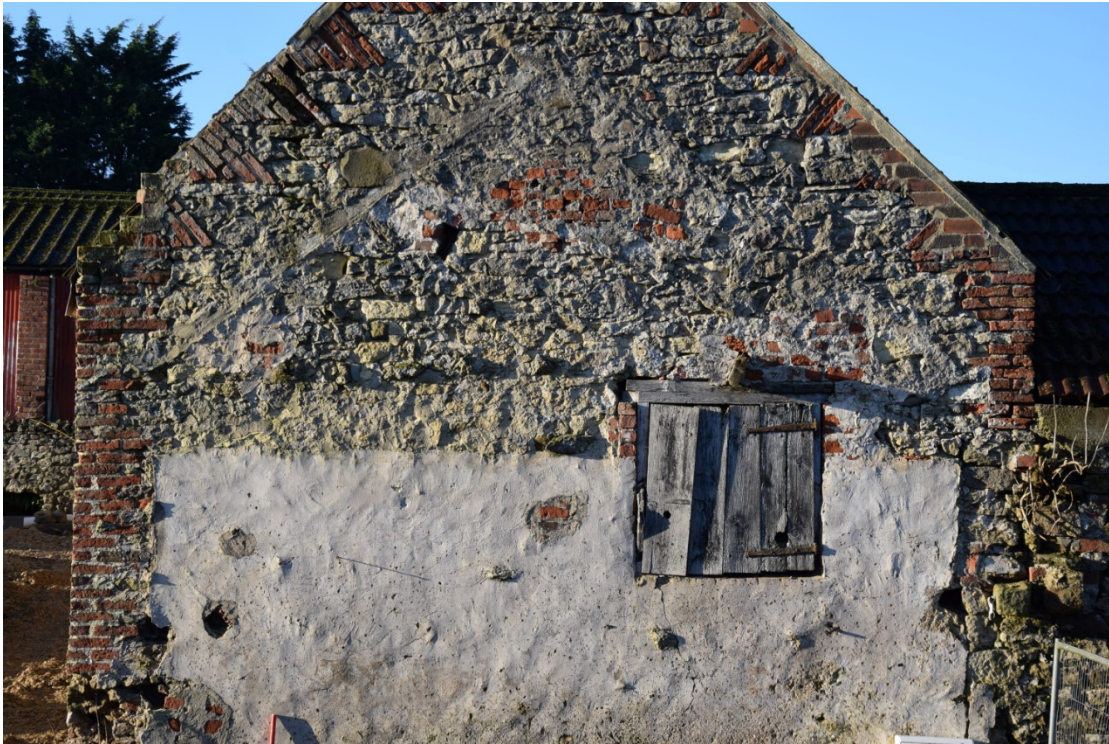
Photo 23: Detail of the east end, showing the roof line of the demolished third section above a blocked ventilator like that in Photo 19

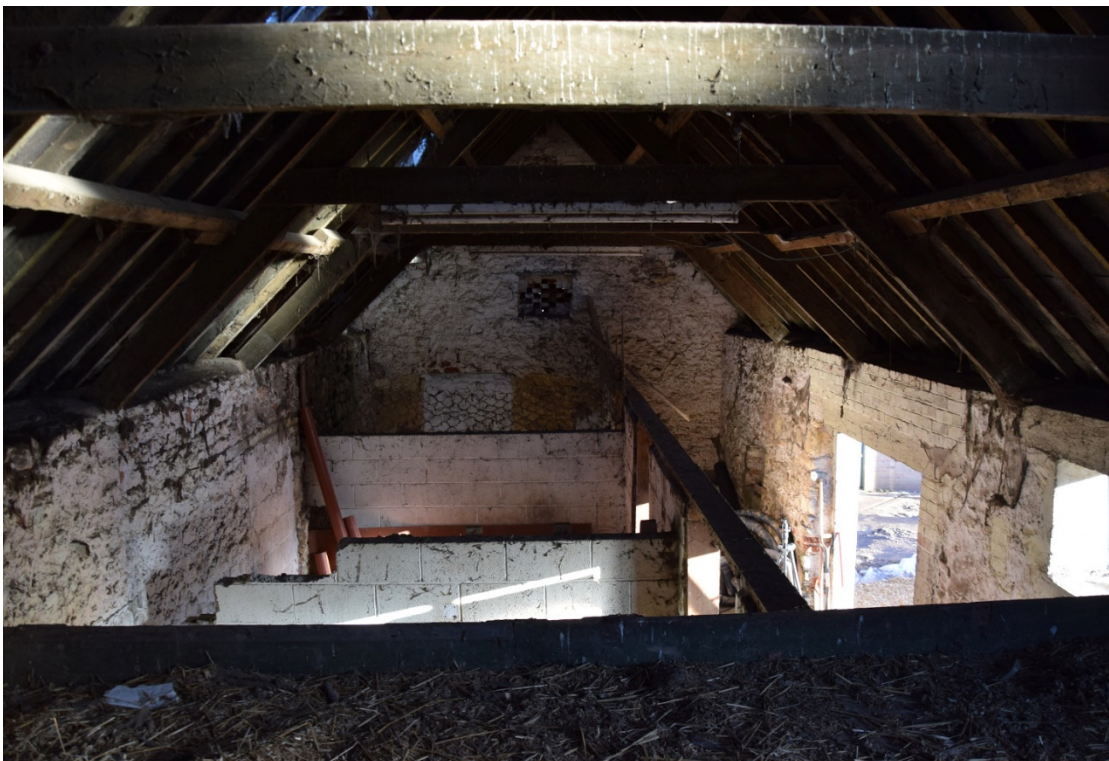
Photo 24: A view looking east in the old barn. The low walls are modern insertions

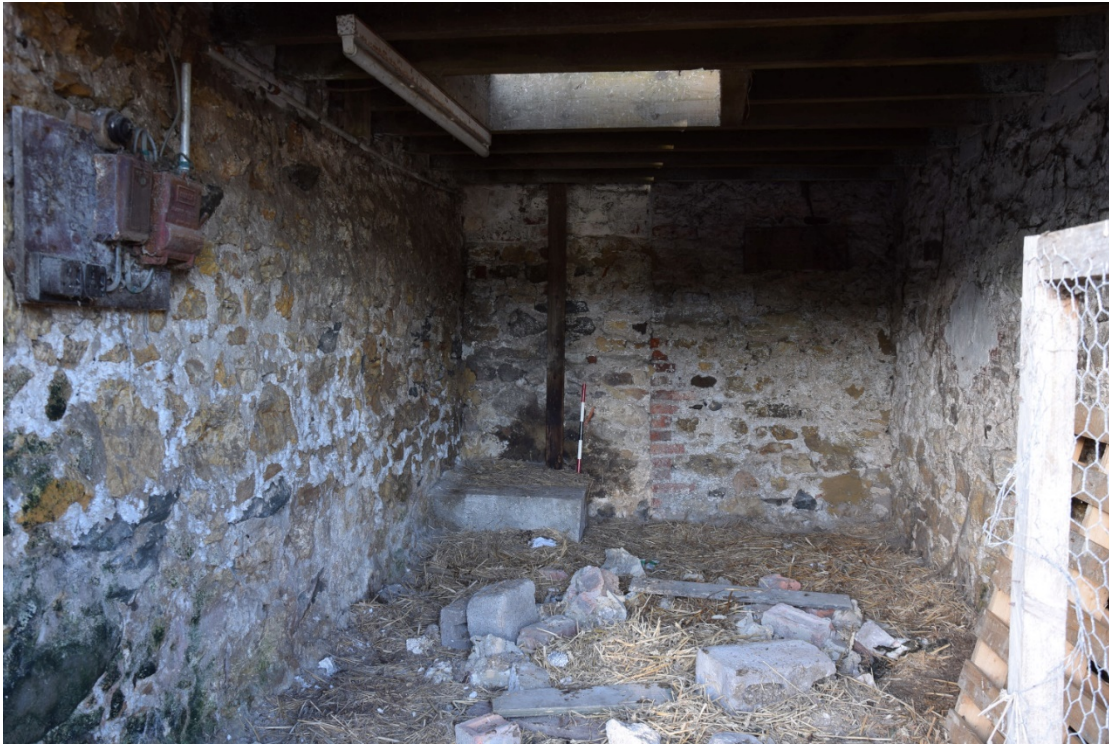
Photo 25: Looking north into the shed at the west end of the barn. Note the straight joint in the far wall

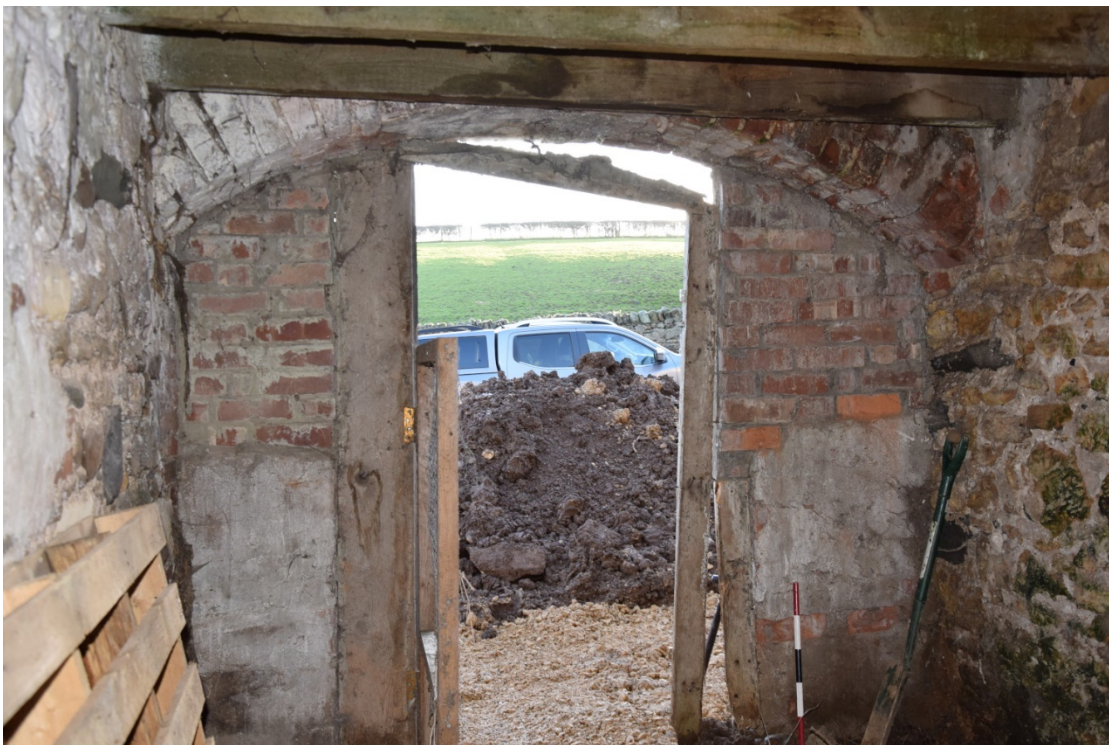
Photo 26: Modern brickwork reduces the size of the old arched door

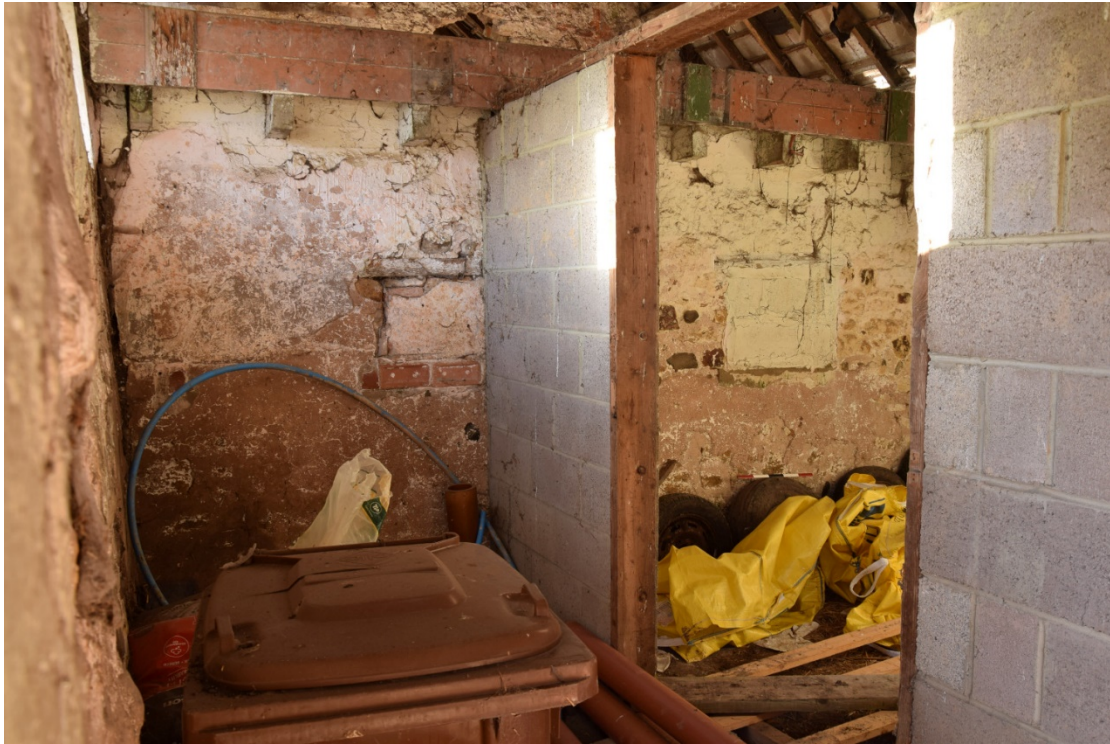
Photo 27: Two small blocked hatches in the wall between the shed and the main part of the old barn. A view looking north-west
