ARCHAEOLOGICAL  
SERVICES  
DURHAM UNIVERSITY

Former stackyard  
Hart  
Hartlepool

archaeological building recording

report 5448  
January 2021

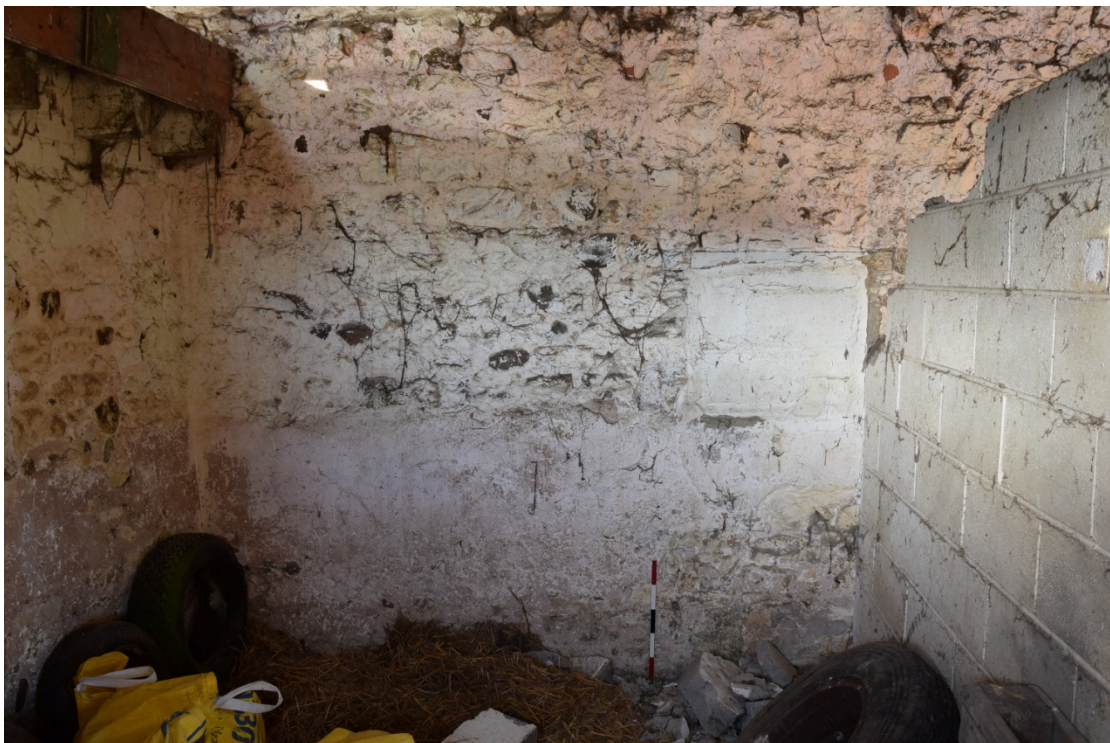
Photo 28: The western room in the barn, with a blocked opening in the north wall

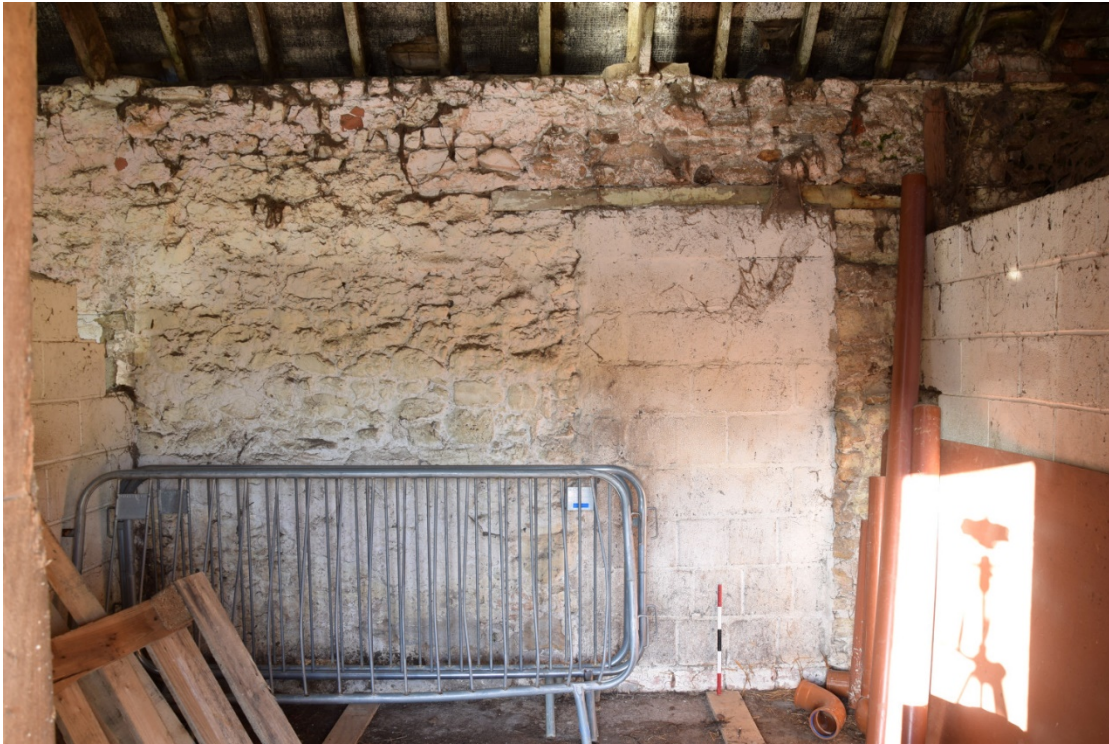
Photo 29: A blocked north door in the middle room

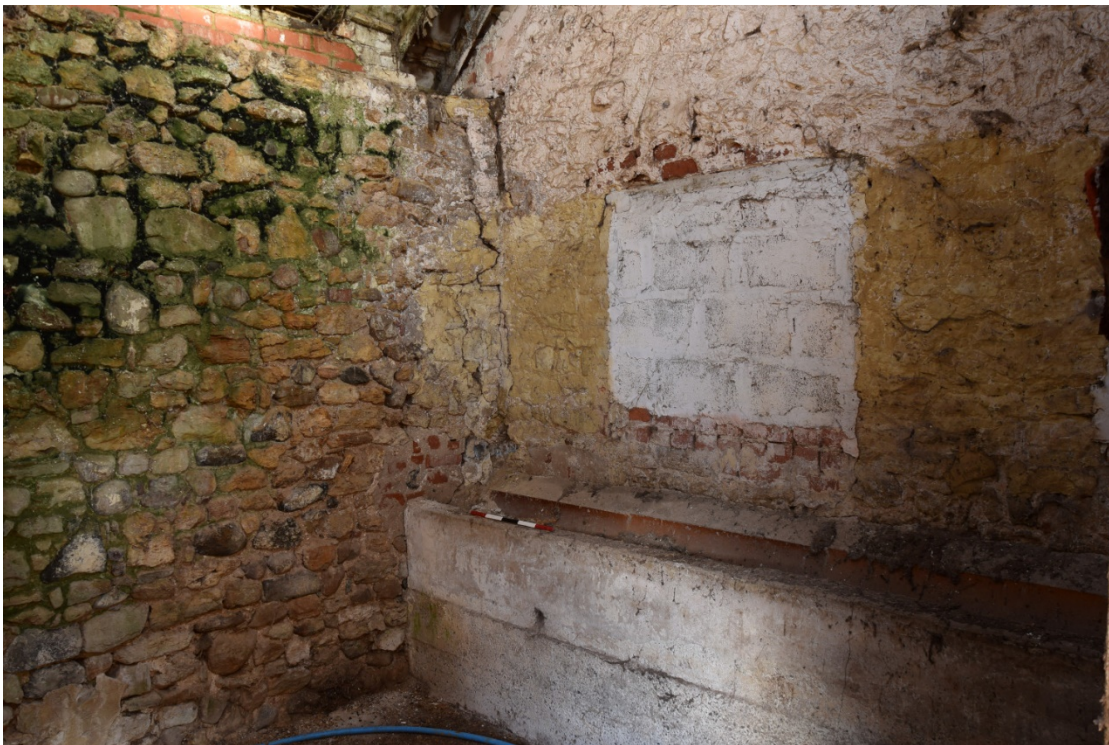
Photo 30: A modern trough runs across the east wall of the barn, below a blocked window

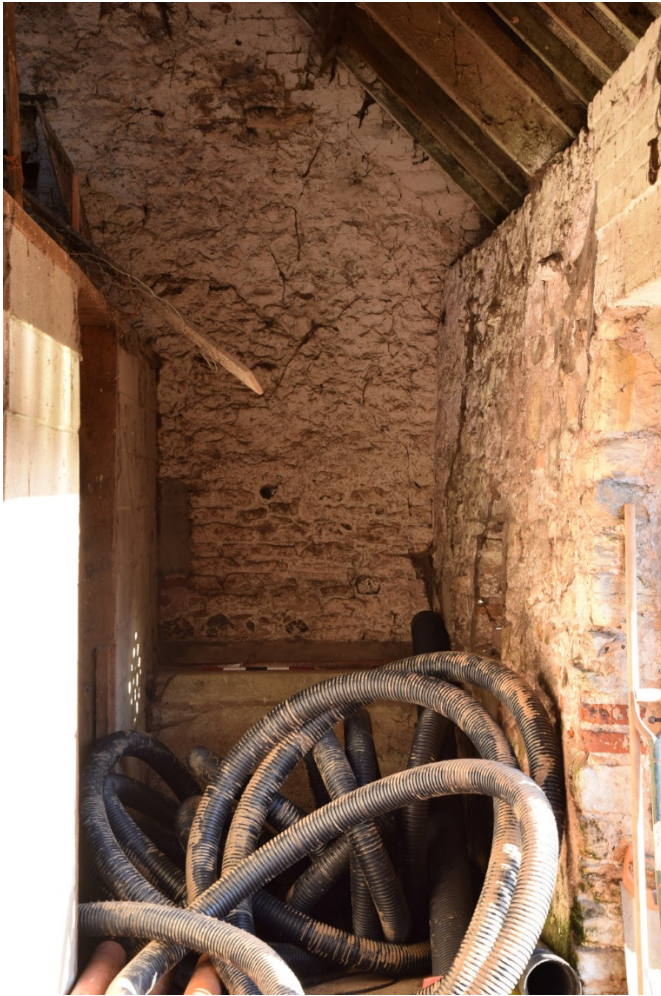
Photo 31 (left): Another blocked window in the east end is partly covered by the modern internal wall

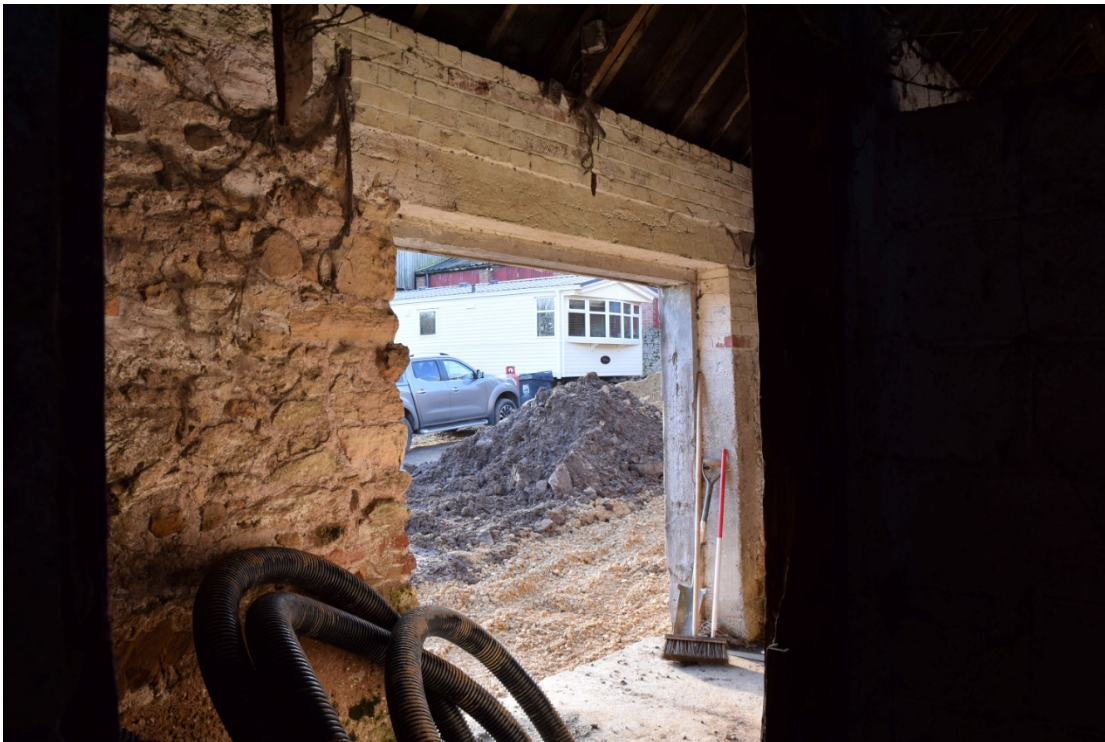
Photo 32 (below): Inside view of the large 1960s door in the south wall

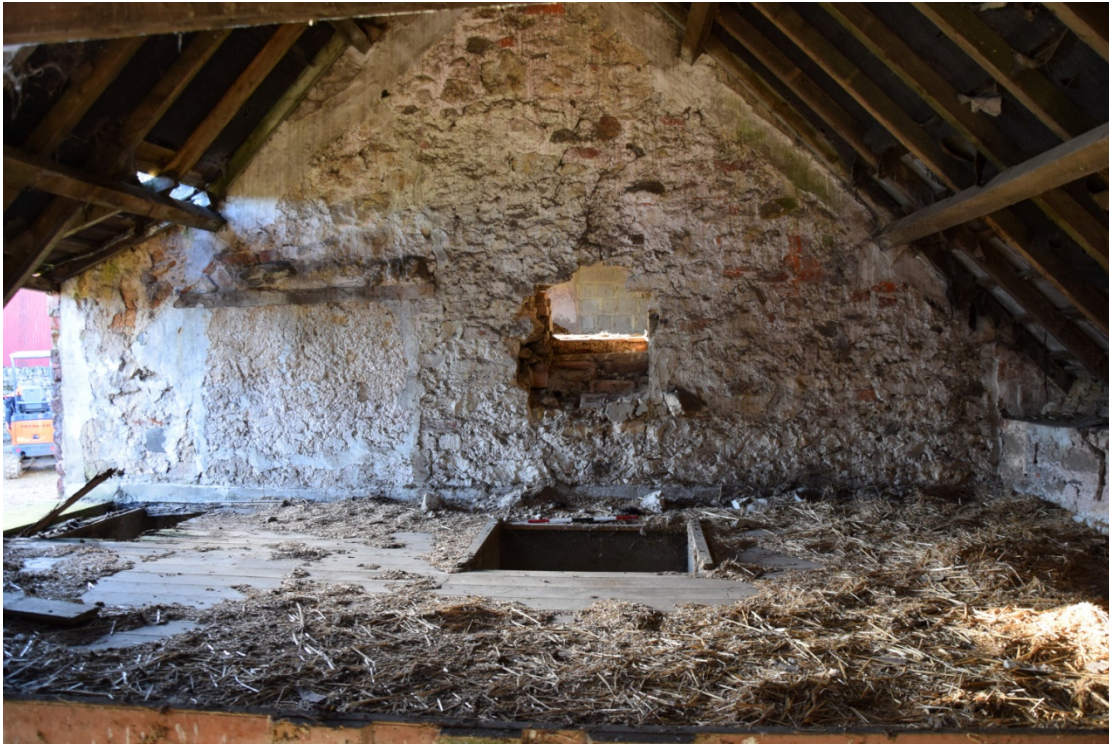
with its cheek of recent brick and asbestos cement board, is certainly not an early feature (Photos 33 & 34).

Photo 33: The loft over the shed at the west end of the barn

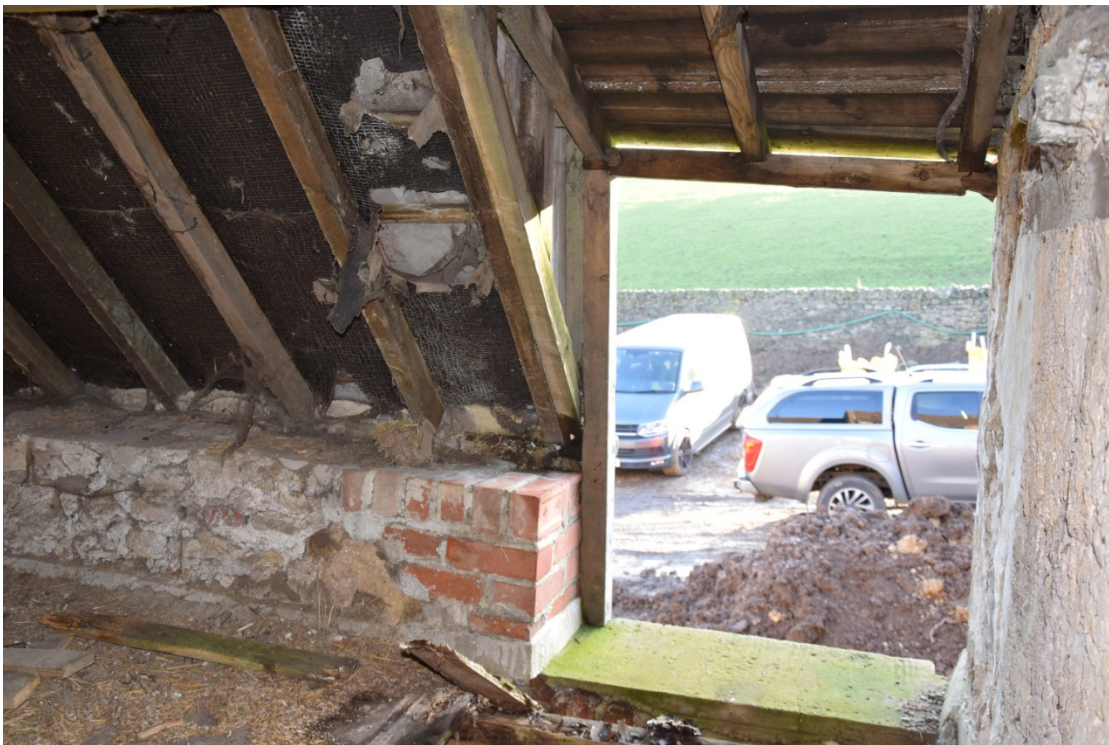
Photo 34: The modern pitching door at the south side of the small loft
