The Whitecross Monument  
Whitecross  
Hereford  
(NGR SO 493 407)

*Archaeological recording and monitoring of a Scheduled Ancient Monument.*

H.A.S 729  
SMR 5567  
August 2006

*Archaeological Investigations Ltd were commissioned by Hook Mason Architects on behalf of the client Herefordshire Council Environment to carry out archaeological recording and monitoring of repair works being carried out on the Whitecross monument. The monument had been damaged by a car crashing into it.*

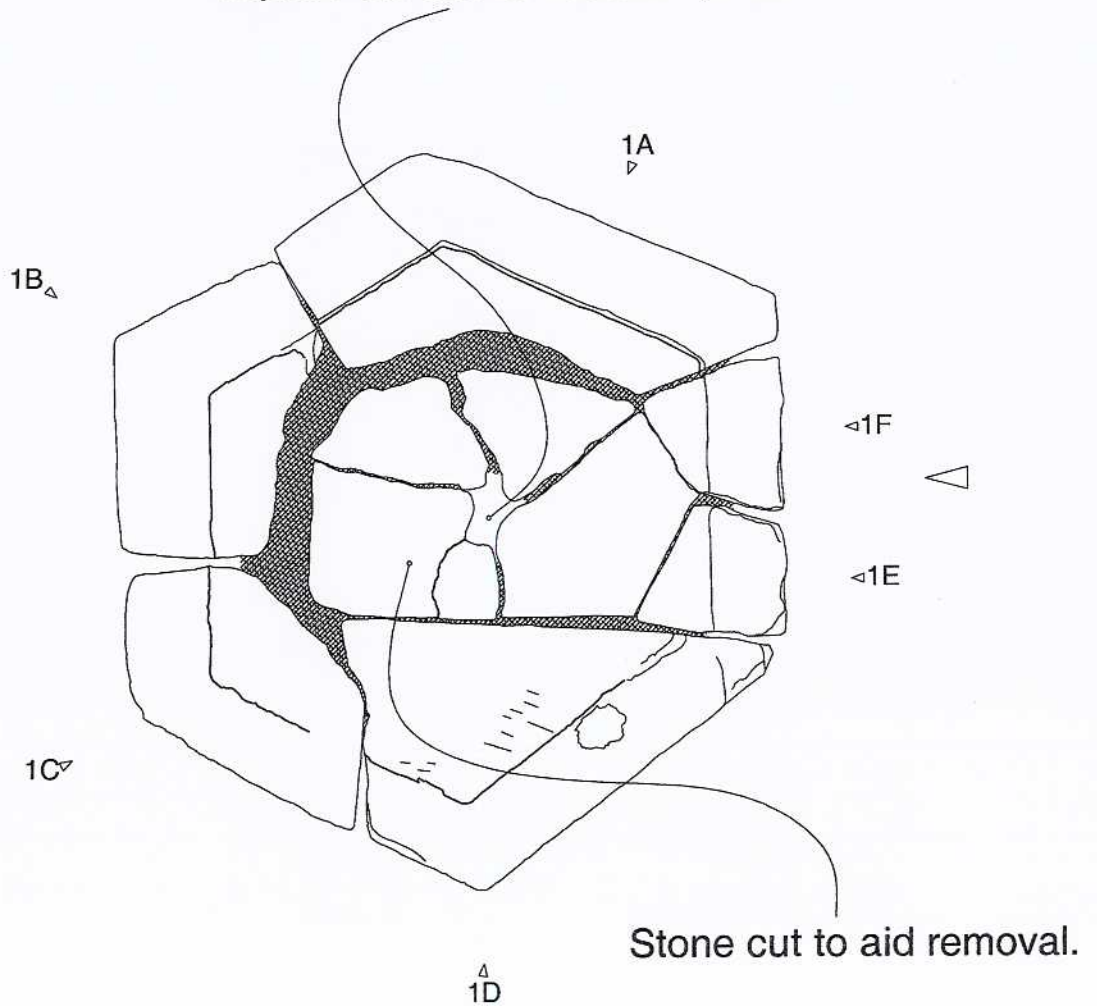
**STEP 1**

The top set of steps (step 1) consisted of a solid layer of six stones with no core work. The central stone (1E, 1F) on the top layer had to be cut to remove it (Fig 9). When the stone was removed a square socket hole was revealed cutting through it. The socket was less than 10cm square, and located centrally below the pedestal base (plate 2).

Stone cut to aid removal.

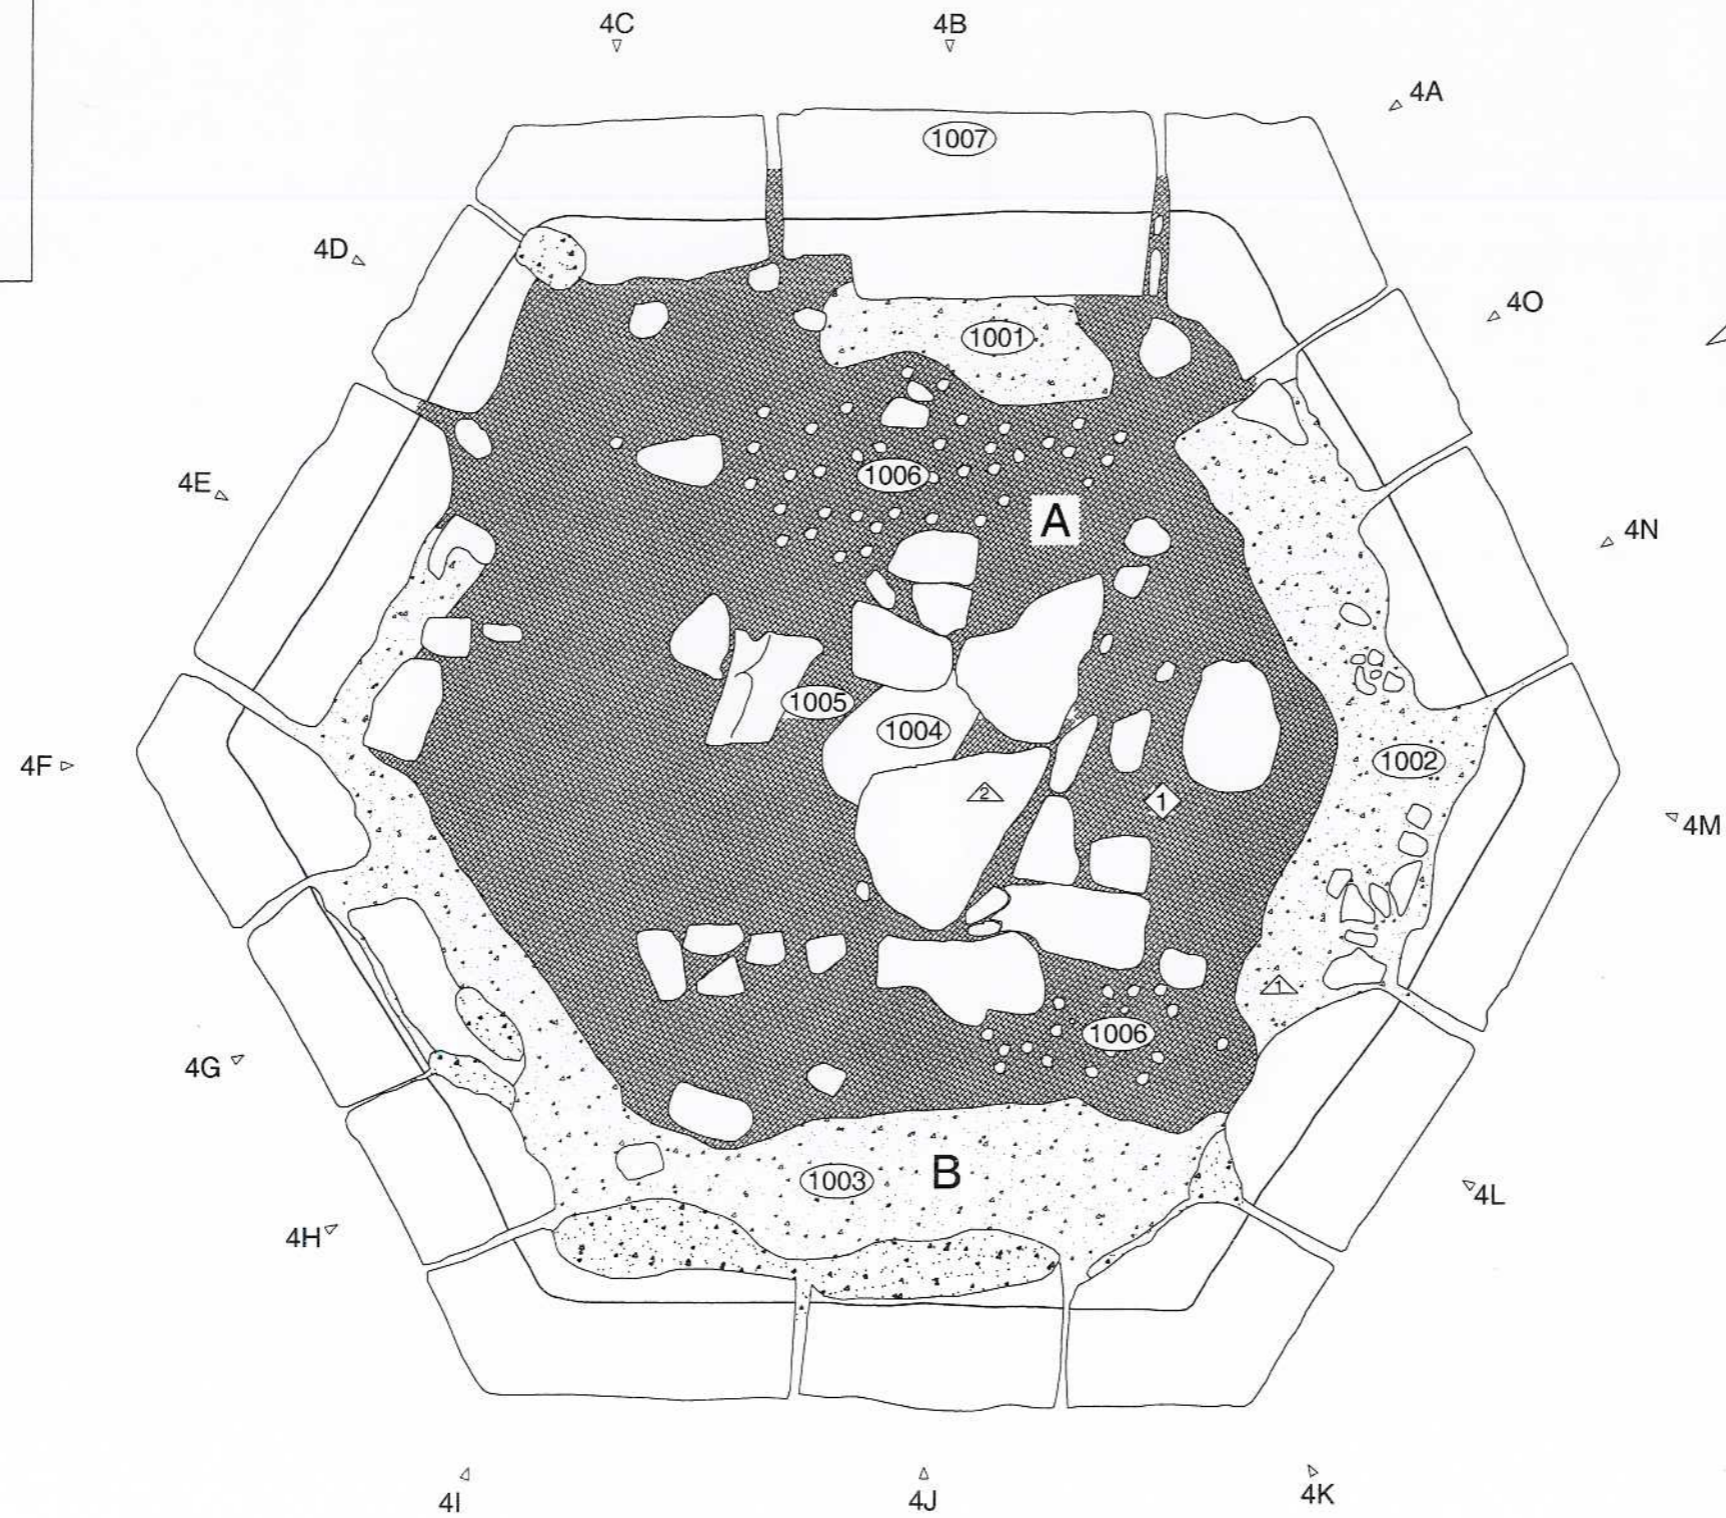
The fill enclosed within Step 4, fig 12

Once the pedestal and the newly cast concrete shaft had been set aside, the fourth layer of steps (step 4), was prepared for the next stage. The earth and stone fill within the monument was to be removed to a depth of 250mm and replaced with a concrete pad. Before the fill could be removed, it was cleaned off and examined for evidence that could give clues for dating, construction or previous repair, the top of the fill was then planned archaeologically along with the fourth layer of steps (Fig 12).

Overlying the exposed fill was a very compacted deposit of red-brown sand and frequent small pebbles (1006) used to bed the steps. It is interesting to note that this material was different to the materials used below in the construction of the monument and probably indicated a phase of repair or renovation.

The steps had been bedded on dark brown cement mortar (1001, 1002 and 1003) overlying the fill; within context 1002 was a single sherd of thick, cream glazed 19<sup>th</sup> century pottery. Also found within 1002 was a small (5x4x2cm) squared block of fine grained, grey-brown stone (small find No1). The stone had been smoothed on three faces, it had been roughly hand sawn on one face and there were two fine incised lines in the same position on two opposing faces that appear to be setting out lines, mortar has adhered to two sides of the stone where it appears to have been bonded to something - unknown. A sample of mortar was retained from context 1001 for possible future identification and dating purposes.

A= Mid brown Fine Sand- reddish Hue  
 B= Mid dark brown Fine Sand & Mortar

- ◇ = 180mm below this level.
- △ = 150mm below this level.
- ▲ = 400mm below level.

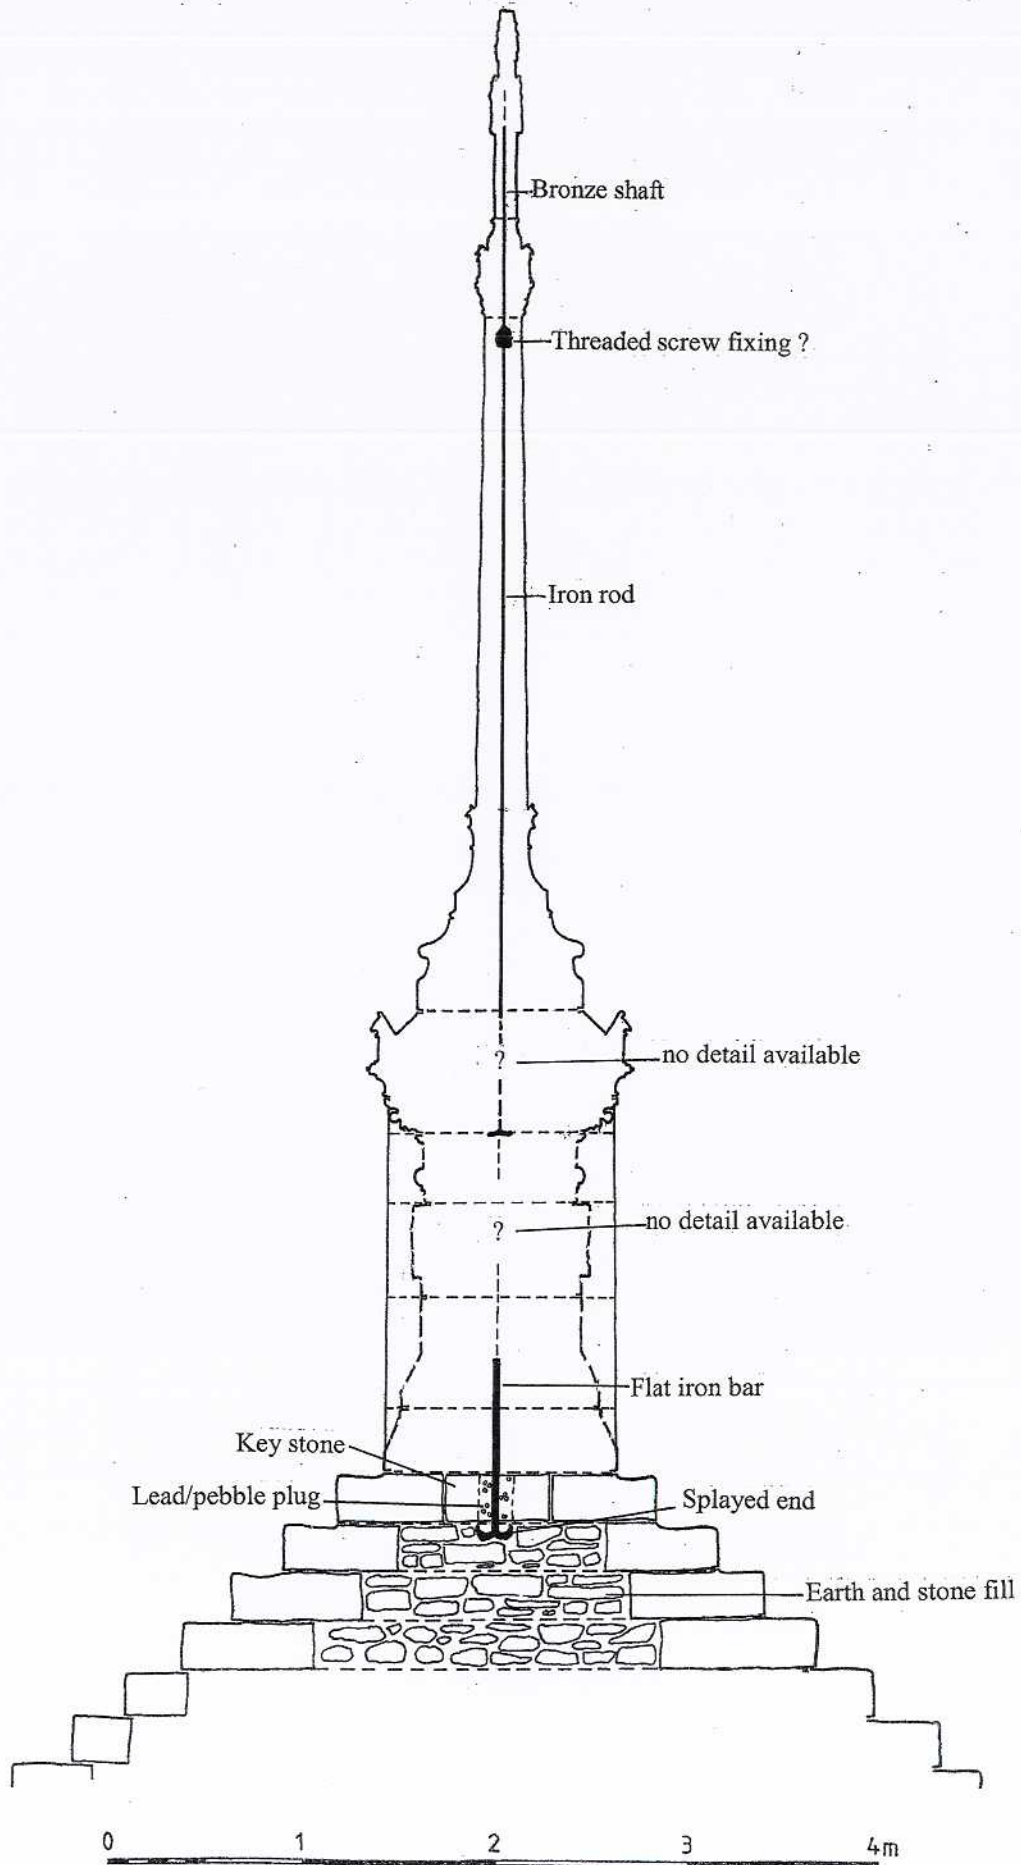
The monument would have had to be dismantled and re-built to accommodate the tie rod, figure 13 shows the cross section of the known internal details of the monument as it was prior to this stage of repairs, figure 14 shows a section of the monument as it has been rebuilt and figure 15 shows a plan of the monument and steps, locating steps which were removed and re set. Plates 6-35 show all the stones removed from steps 1-3.

Vertical section through the monument showing construction detail as it was before the repair works, Fig 13.

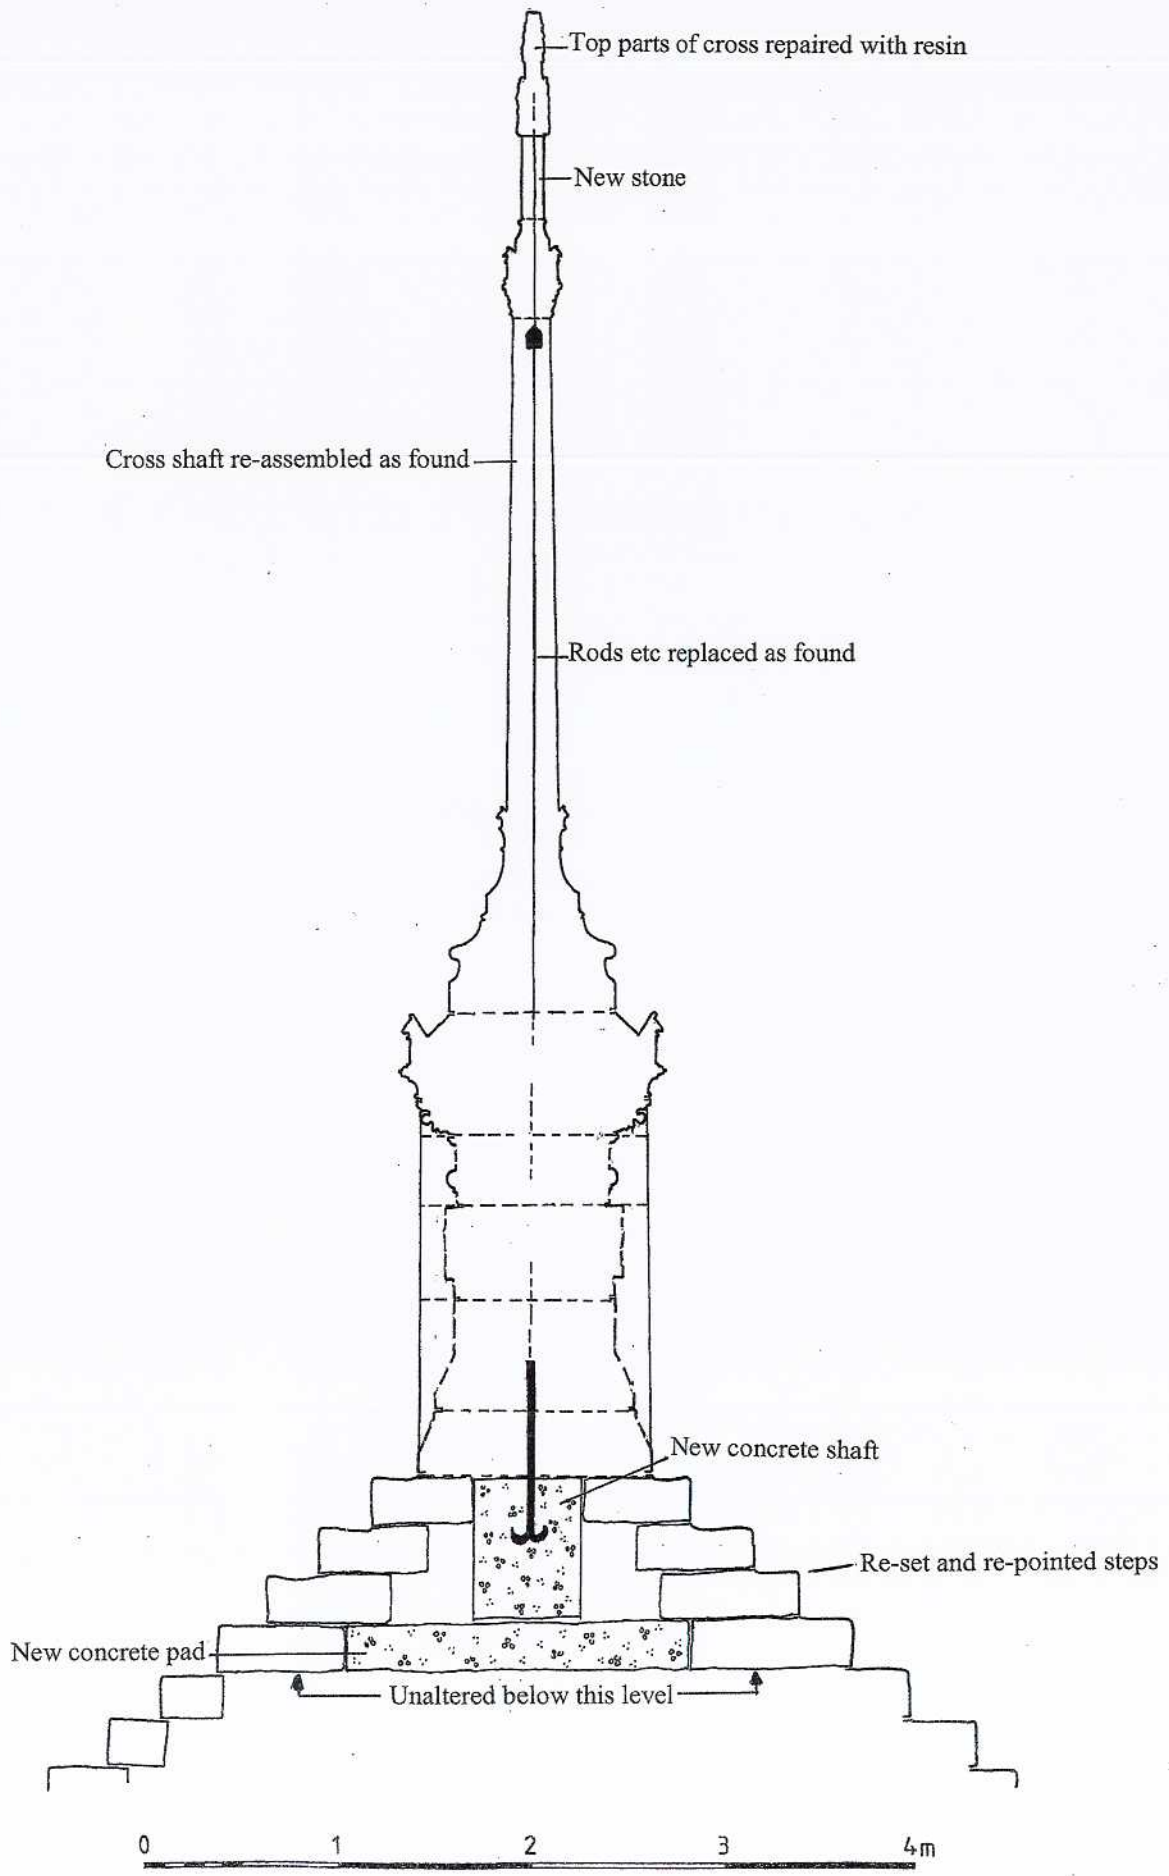
Vertical section through the monument showing details of the repair work, Fig 14.

The final stage of the work was to re-erect the shaft and cross. A new stainless steel rod was inserted as replacement for the iron, and the three sections of cross shaft and the cross were re-positioned on the top.

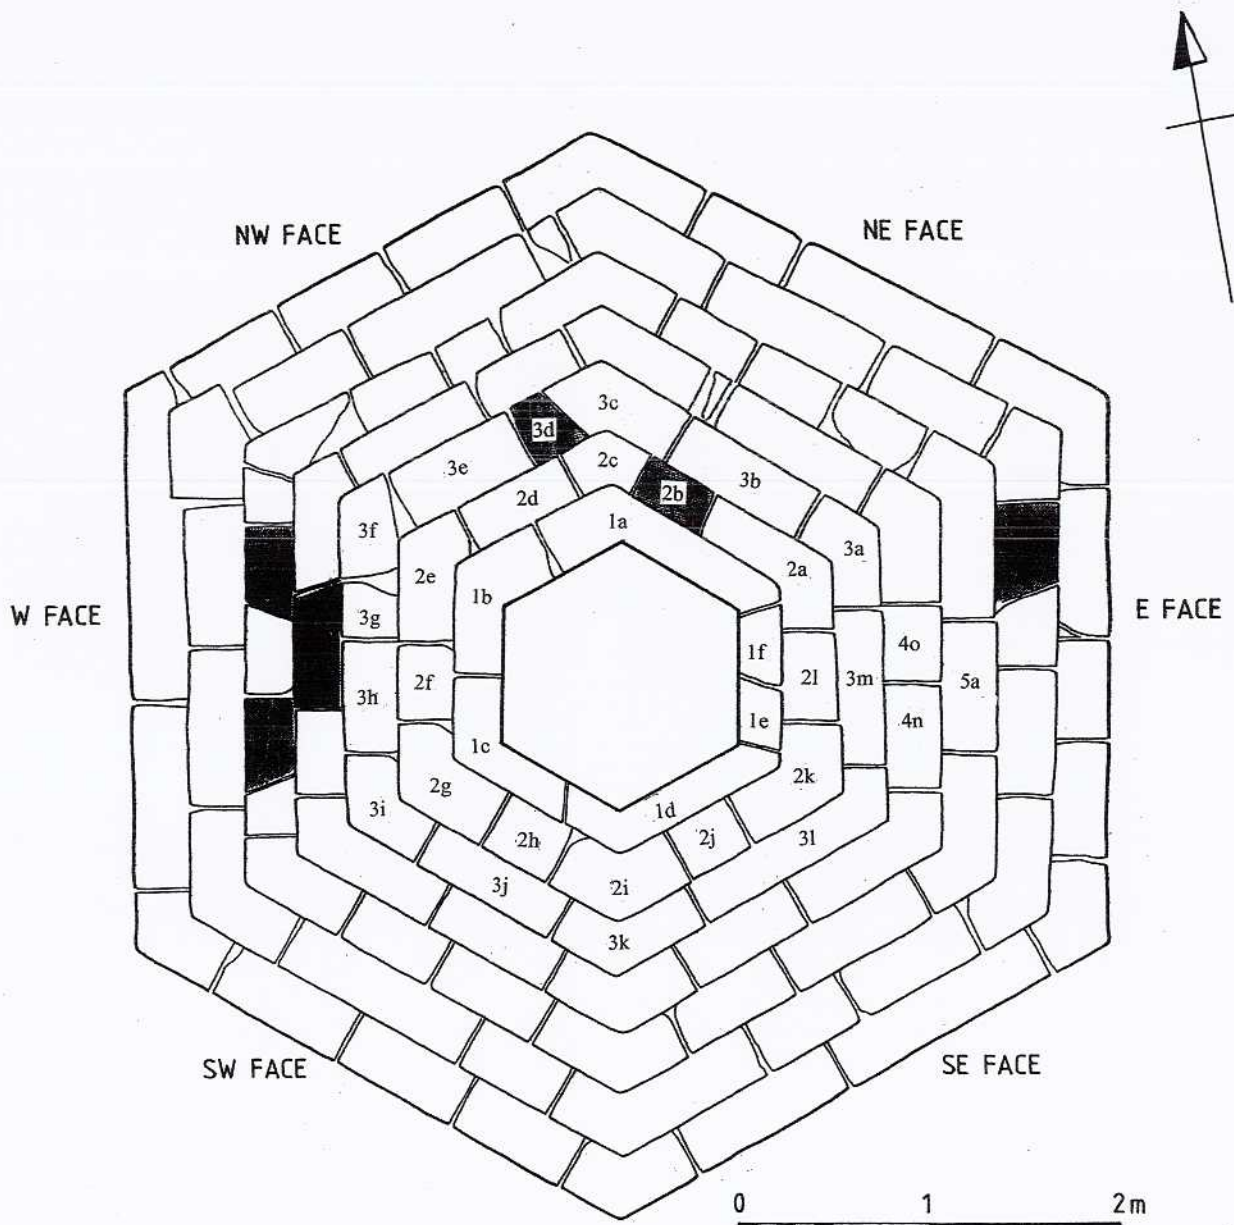
White Cross monument plan, Figure 15.

Numbered stones were removed and re-set in 2006

Masonry replaced in 1991

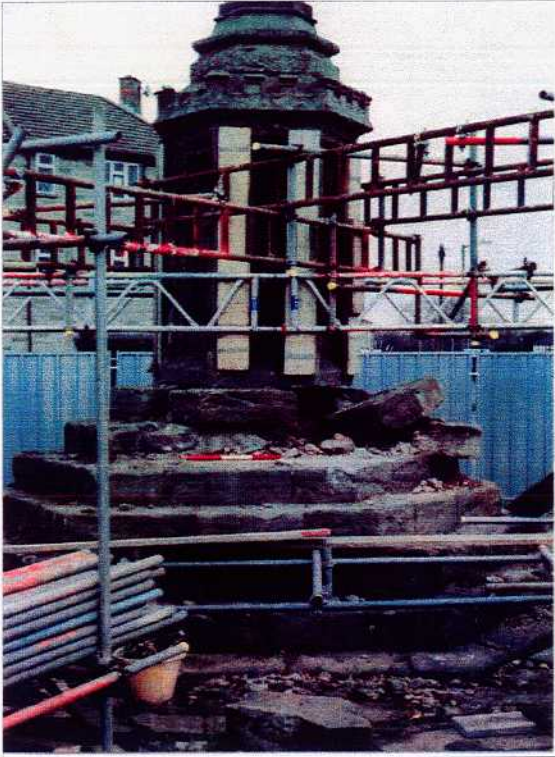
The top three sets of steps were removed as some of them had been damaged or displaced as a result of the accident (plate 1). The removal of the steps was observed by an experienced archaeologist who made photographic records and described the operation in notes in a site notebook, context sheets were also used for recording purposes.

Plate 1, Damage to the monument steps resulting from the accident.

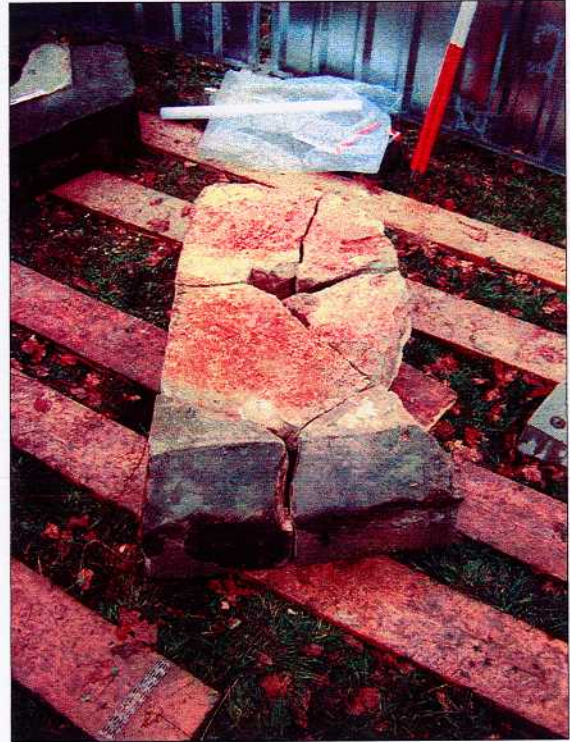
Plate 2, Broken "key stone" 1E/1F, with 10cm square socket hole in the centre.

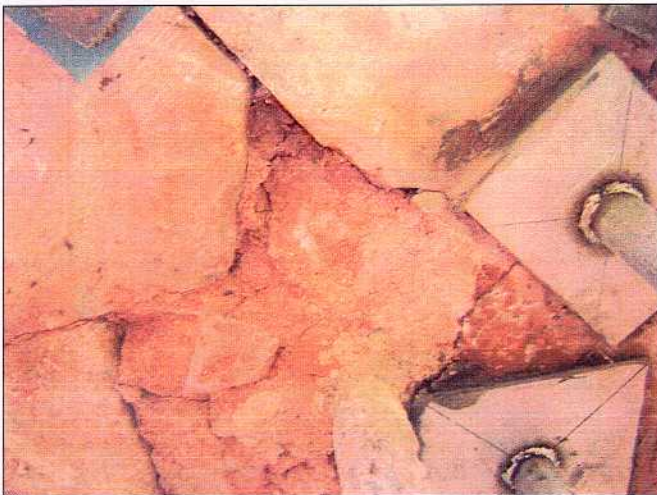
The iron rod observed within the cross shaft appeared to pass through the body of the hexagonal pediment. The rod projected from the pediment base by approximately 0.40m, carrying through the socket in the top step, into the middle of the second step. The bottom end of the iron rod had been deliberately splayed to form a wedge. Lead and rounded pebbles had been poured into the socket in the stone to fill the socket and provide a secure fix (plate 3).

A quick look at the underside of the pedestal base showed that at least the bottom section had been built using large wedge shaped blocks with a small amount of core work at the centre. The core work consisted of mortar and stone chips. No construction details of the pediment section were previously known (see plate 3).

Plate 3, Construction of hexagonal pediment, viewed from below, lead plug encasing iron rod at the bottom of the picture.

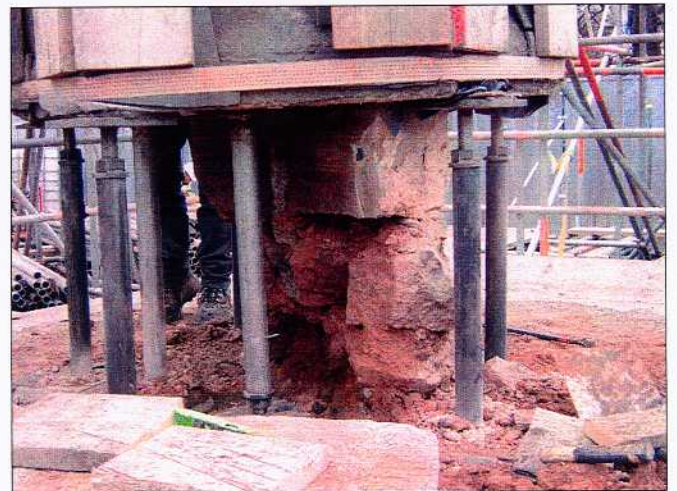
The pediment was supported during the removal of the steps using acro props, chocked with timbers to prevent movement. The removal of the steps exposed the core work inside the monument (Plate 4).

Plate 4, After partial removal of the key stone, exposing the iron tie rod and its securing lead/pebble plug.

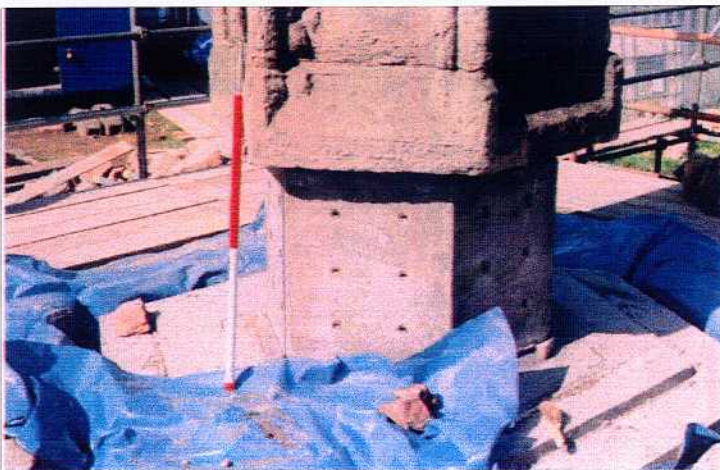
After the removal of the stone core work from the top three sets of steps, shuttering was constructed below the suspended pediment for the casting of a concrete shaft, which was cast onto the bottom of the pediment replacing the stone core work. The concrete shaft had to be covered to protect it from the weather and left to cure for two weeks. During the casting of the concrete shaft, bolts were inserted for attaching to steels to further stabilise the pedestal before it could be removed (Plate 5).

Plate 5, Cast concrete shaft with fixing/securing holes, on the bottom of the pediment, after being re-positioned on its new concrete pad.
