Rear of No 13 South Street
Leominster
Herefordshire
(NGR SO 485 580)

Archaeological building recording and watching brief.

Hereford Archaeology Series 769

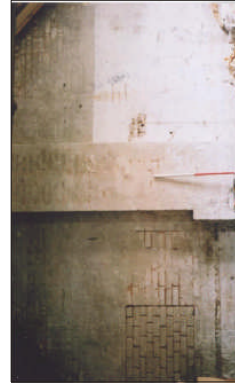
The first floor of the granary was accessed from the stairs near the north-east corner and the single compartment was also whitewashed throughout. The west wall had a central chimney breast and on the south side of it was a small original arch headed window, now blocked and painted over (Fig 16).

Plate 16. Original arch headed window to the south (left) of the chimney breast now blocked, in the west wall of the granary.

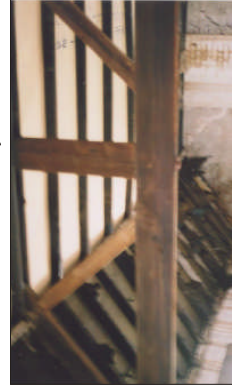
The south wall was without any features. The central truss was similar to, but not the same as the one in the cottage, the main difference being that the struts raked out from the tie beam and not from the King post (Plate 17). The floor was boarded, but from the top of the stairs to the east wall, a large amount of floor was missing or in a dangerous condition.

Plate 17. The truss in the granary, bolted from below, the raking struts lean out from the tie beam, not the king post as with the cottage truss.
