Mortimer's Cross Mill, Lucton Herefordshire

Archaeological survey and recording
November 2008

**Mortimer's Cross Mill, Lucton, Herefordshire:
an archaeological survey of the sluice gates, 2008**

For: English Heritage

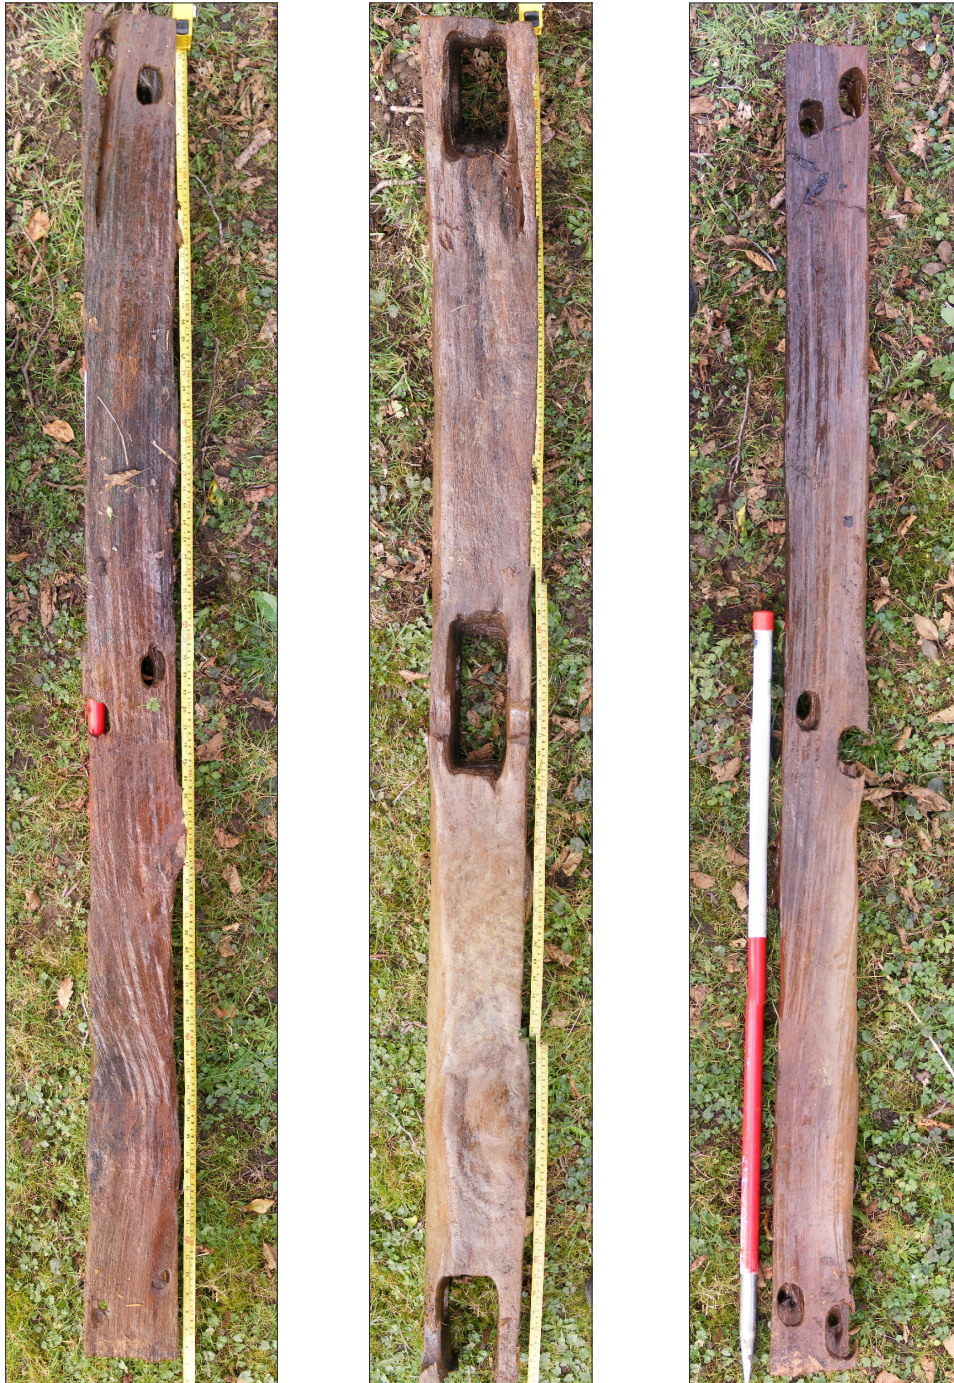
The main outer frame posts of the sluice are set into slots within the wing walls whilst being bolted and mortared into the upright position. They are keyed into a sleeper beam below the water level which in turn is keyed into a cut slot in the base of the sluice (see thumbnail 309 & 449). The lower beam represented the oldest part of the gate. The beam

sockets and peg holes did not reflect the size and shape of the main upright posts of the current sluice gate (see thumbnail 433).

Plate 1: the original bottom beam from the double sluice gate

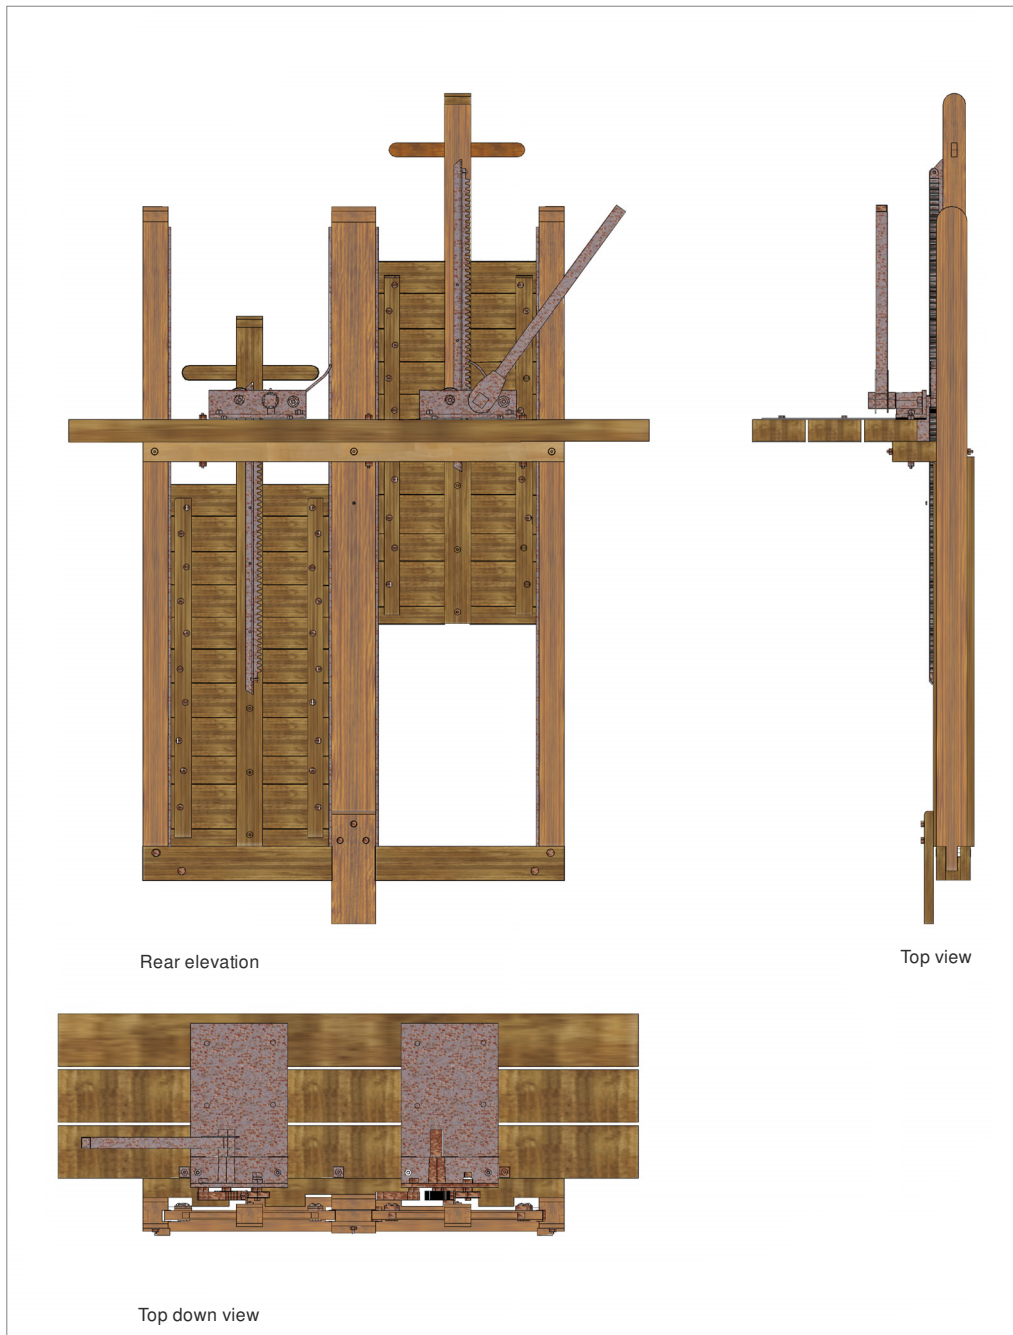
Figure 8: reconstruction of the double sluice gate

Some 200m north of the mill building a stone weir extends for c27m across the River Lugg, allowing water to be diverted south eastwards into the leat. Flow through the leat is regulated by a double sluice gate at the east end of the weir. The sluice has a cobbled stone base, stone wing-walls and two modern wooden slides. The upper gate consists of a double opening rising sluice gate with independently controlled ratchet lift operated gates (see Figure 8 and Figure 9).

The sluice gate was in a very poor condition when surveyed and displayed many repairs to the frame work and gates with the addition of inserted upright planks on the upstream face, replacing rotten parts of the frame work. The central post had completely rotted away from the lower beam and was held in place through the addition of a secondary bolted support block on the down stream face, embedded into the bed of the sluice (see thumbnail 222 & 439).

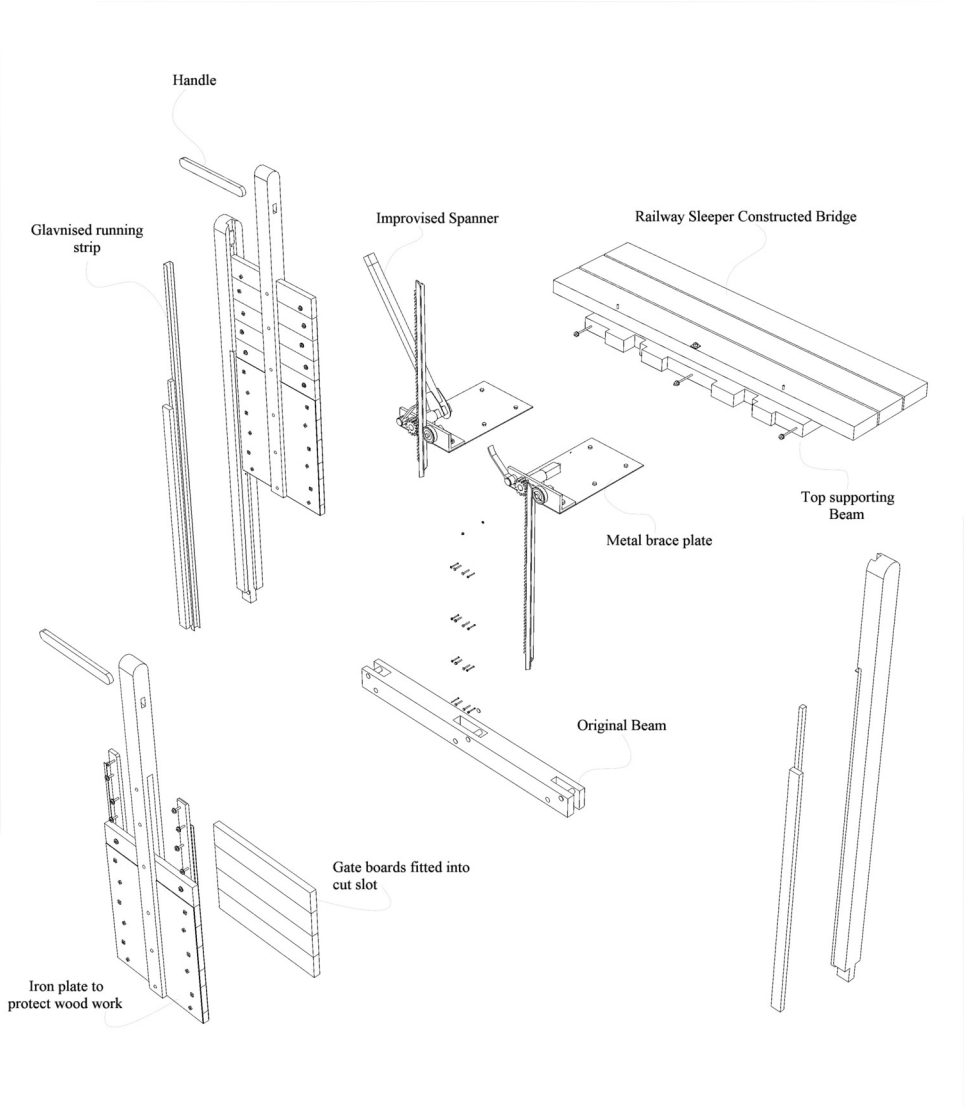
Figure 9: exploded view of the double sluice gate

The sluice gate spans an aperture of approximately 1.85m with the two gate openings being equal to 1.40m of the width of the sluice. The gates are constructed from vertically stacked oak boards (see thumbnail 20), keyed together with iron dowels, running in two perpendicular channels located within the main frame posts. The runner slots have galvanised 'u' section steel channel inserted into the uprights which are more importantly offset towards the flow of the water (see thumbnail 86), The gate boards are clamped between the slotted lifting handle and further strength is added through two vertical placed timbers bolted to the gate boards on the downstream face. In order to prevent damage from floating debris, an iron plate was fastened to the lower portion of the gates (see thumbnail 19).

Both gates are opened with a rack and ratchet operated lifting mechanism attached to the rear of the gate and bolted through a spreader plate to the access bridge (see thumbnail 192, 209 & 232). The lifting mechanism functions only when removing the gate from the water flow, the locking ratchet being used to keep the gate out of the water. Gravity is used to lower/close the gate.

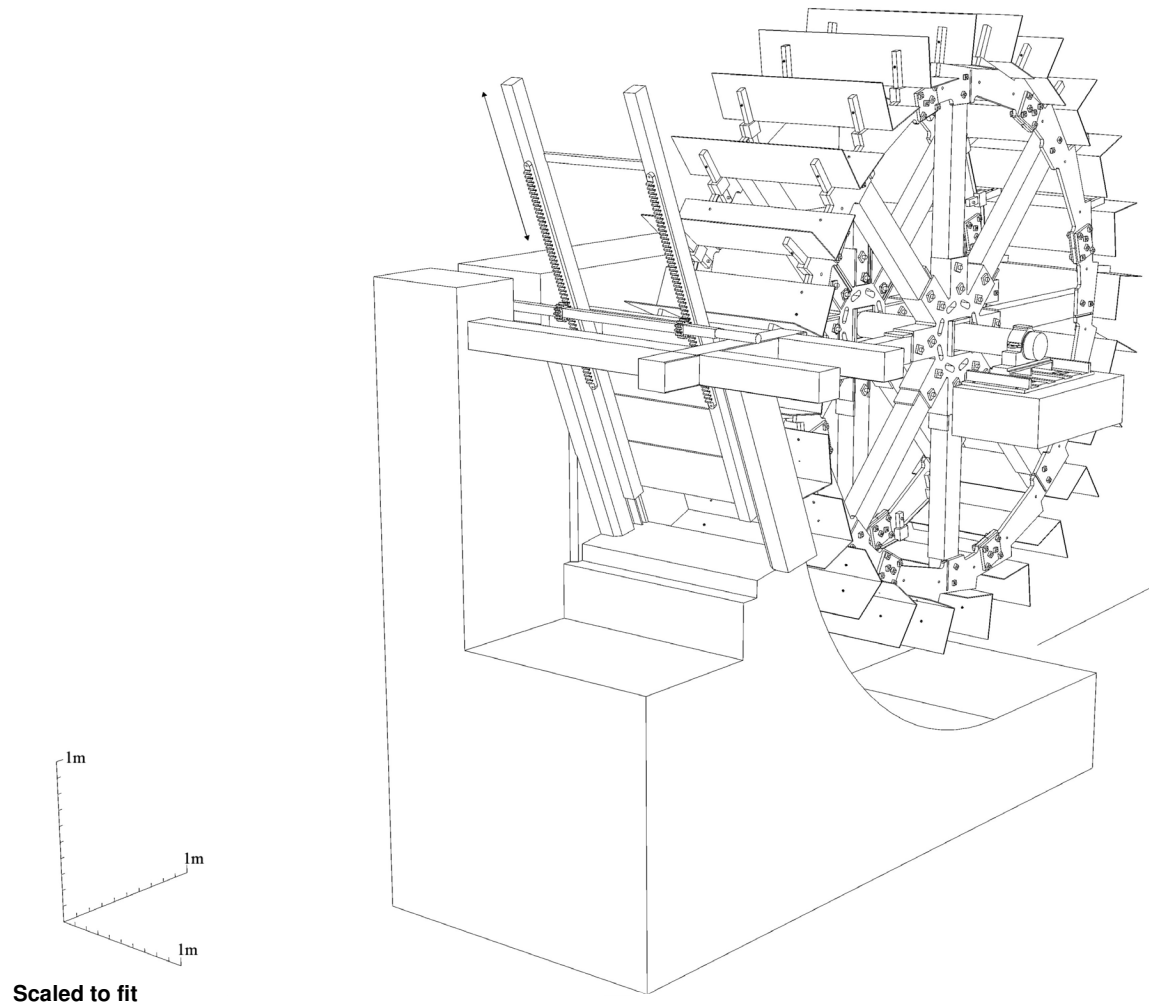
Figure 11: Isometric reconstruction of the Penstock Gate and water wheel

The penstock, a sluice operated from inside the mill, controlled the flow of water onto the wheel. The gate (see Figure 11) is controlled in a similar way to that of the double sluice gate through a rack and gear mechanism operated on a spindle controlled from within the mill building. The penstock consists of a sliding door, which moves over an aperture in a frame, which in turn is secured onto a wooden structure inserted before the water wheel (see Figure 11). A similar arrangement of galvanized channels were cut into the main frame support the gate and allowed free movement. Unlike the upper sluice gate the penstock gate sits at an angle of 21° off vertical on a sealing head to the flow of the race.
