**Archaeological recording of the cascade  
and brewhouse at Upper Lodge, Bushy Park,  
London Borough of Richmond, 2002-04**

**NGR: TQ 1462 7020**

**Report to the Royal Parks**

**October 2004**

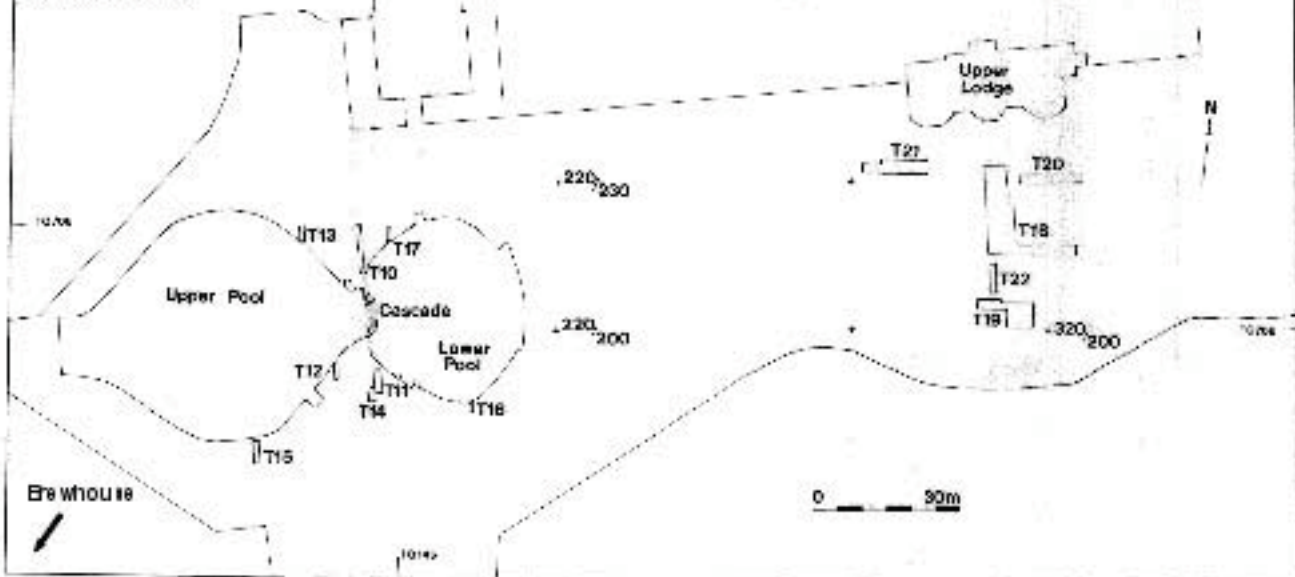
Fig. 6: cascade survey drawings, showing location of excavated trenches 2002-04

The present cascade is 9.75m wide falling over five steps. In elevation the top step is shown to be comprised of alternate sections of brick and stone. The four lower steps are all brick and comprise flattened semi-circles. The widths of the lower steps at their mid-points are not uniform, being approximately 0.65m, 0.5m, 0.65m and 0.8m from top to bottom, although the drops seem to be fairly uniform at around 0.35m. The discrepancy in step width is something that can be seen at other cascade sites where archaeological recording has been done. For example the different step width at the formal cascade at The Gnoll, Neath, South Wales (c. 1728), is complimented by differing steps heights and types that is considered a deliberate attempt at getting a variety of water falls over its 175m length (Currie et al 1994, 258-9). Although the Upper Lodge cascade is small by comparison, it is possible that step variation was considered a part of the design of early 18<sup>th</sup>-century cascades.

The survey identified a number of alterations to the original design. Firstly the dam retaining wall on the south side of the cascade is faced in yellow brick as opposed to red brick on the majority of the north side. The south wall is also presently longer than that on the north. The above ground length on the south being 11.4m compared with 9.4m on the north. Excavated evidence found in 1998 showed that the north wall had been truncated by later developments and the south wall had been refaced. What was not apparent before the survey was that the south wall projects further to the east than the north wall. Work on Trench 27 (see below) has shown that the original red brick wall had been refaced in yellow brick after a concrete skin was inserted between the two. On the north side of the cascade there is also a yellow brick section projecting about 0.6m from the line of the original wall. This extends for 2.8m from the north edge of the cascade and is also clearly a later alteration.

A indicates location of buttresses behind deteriorating walls to support dome of former grotto; B indicates thickness of original wall as indicated by excavation. For details of excavated trenches see Figs 6-8

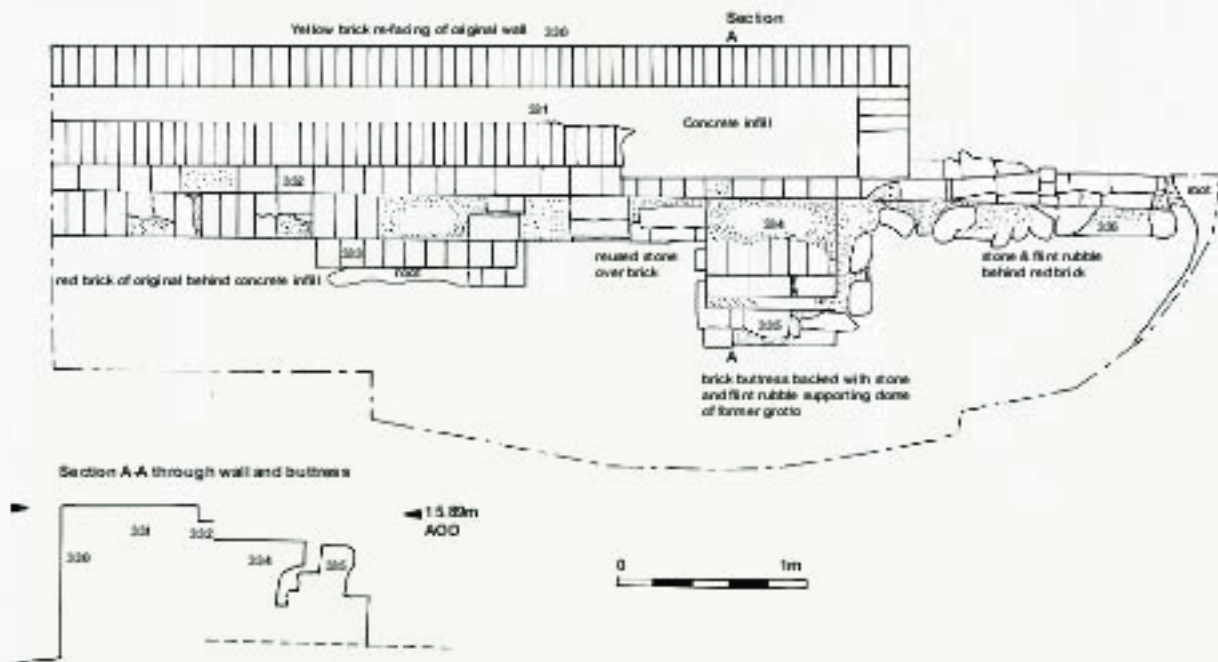
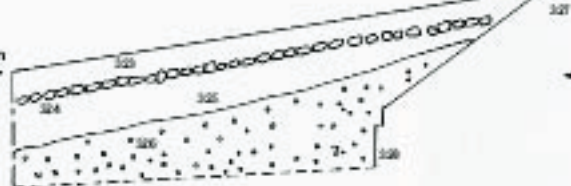
Trench 28, plan

This trench was excavated behind the cascade steps at its south end to determine the type of structure there so that its stability could be assessed. This trench was 2.25m N-S and 3m E-W. The back of the cascade comprised a sloping side of brick covered in a concrete render

[context 327]. It sloped back 1.2m into the upper pond before forming a vertical brick foundation [context 328].

Of interest in this trench was evidence for the make-up of the bottom of the pond. There was about 200mm of silt [context 323] within the pond at this point, but immediately beneath this was a 250mm thick layer of clay [context 325] with a single course of flint cobbles overlying it [context 324]. Underlying the clay was a gravel layer [context 326], which was thought to be redeposited 'natural' (undisturbed subsoil) for the locality. The clay layer was interpreted as a clay lining to the upper pond with a cobbled surface over.

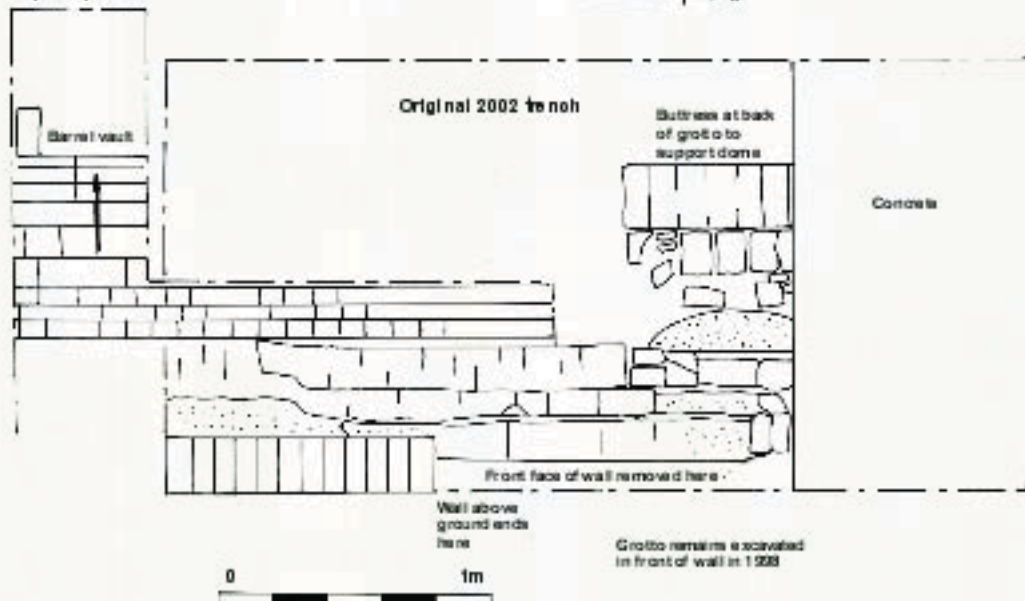
Fig.10: plan of remains behind North Grotto

The May 2002 trench was 3.2m N-S by 1.6m E-W. It showed that there was only a single course of brickwork surviving above ground from the dam retaining wall. This had been partly rebuilt in its upper courses. The original red brick wall survived buried behind to a width of 580mm. This had been truncated by a layer of modern concrete in the last 0.9m of the trench. The original brick wall was stepped at the back, and had the remains of a buried brick buttress attached on its west side. This was 620mm E-W and the same N-S but it appeared to be truncated on its north side by the above-mentioned layer of modern concrete.

The engineer's trench of October 2004 elaborated on these findings by digging to a depth of 1.3m at the south end of the original trench. This discovered a quarter barrel arch below the stepped foundations of the original dam retaining wall. This was probably attached as an additional support to the retaining wall.

Original trench excavated in May 2002. In Oct.2004 an engineer's trench was dug slightly to the south of the original and superimposed itself over part of the original, excavating deeper than in May 2004 to reveal quarter barrel vault acting as support to back of wall.

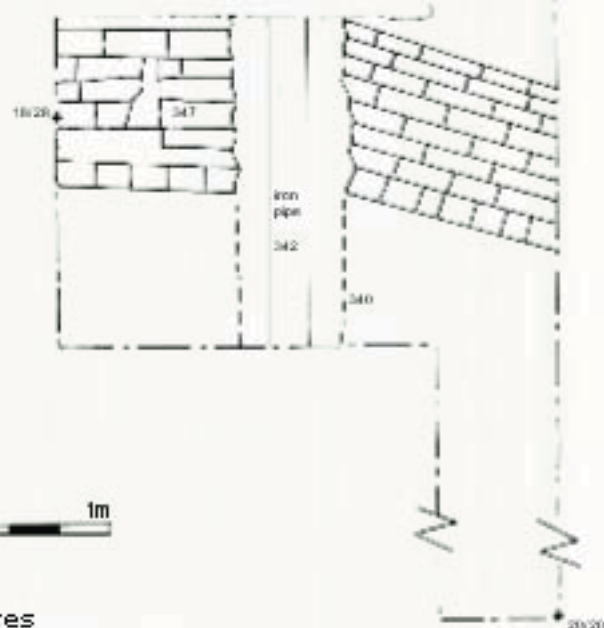
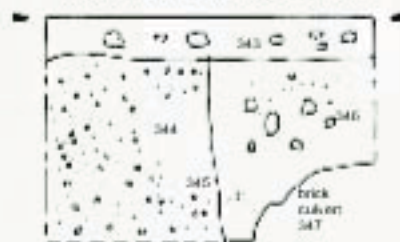
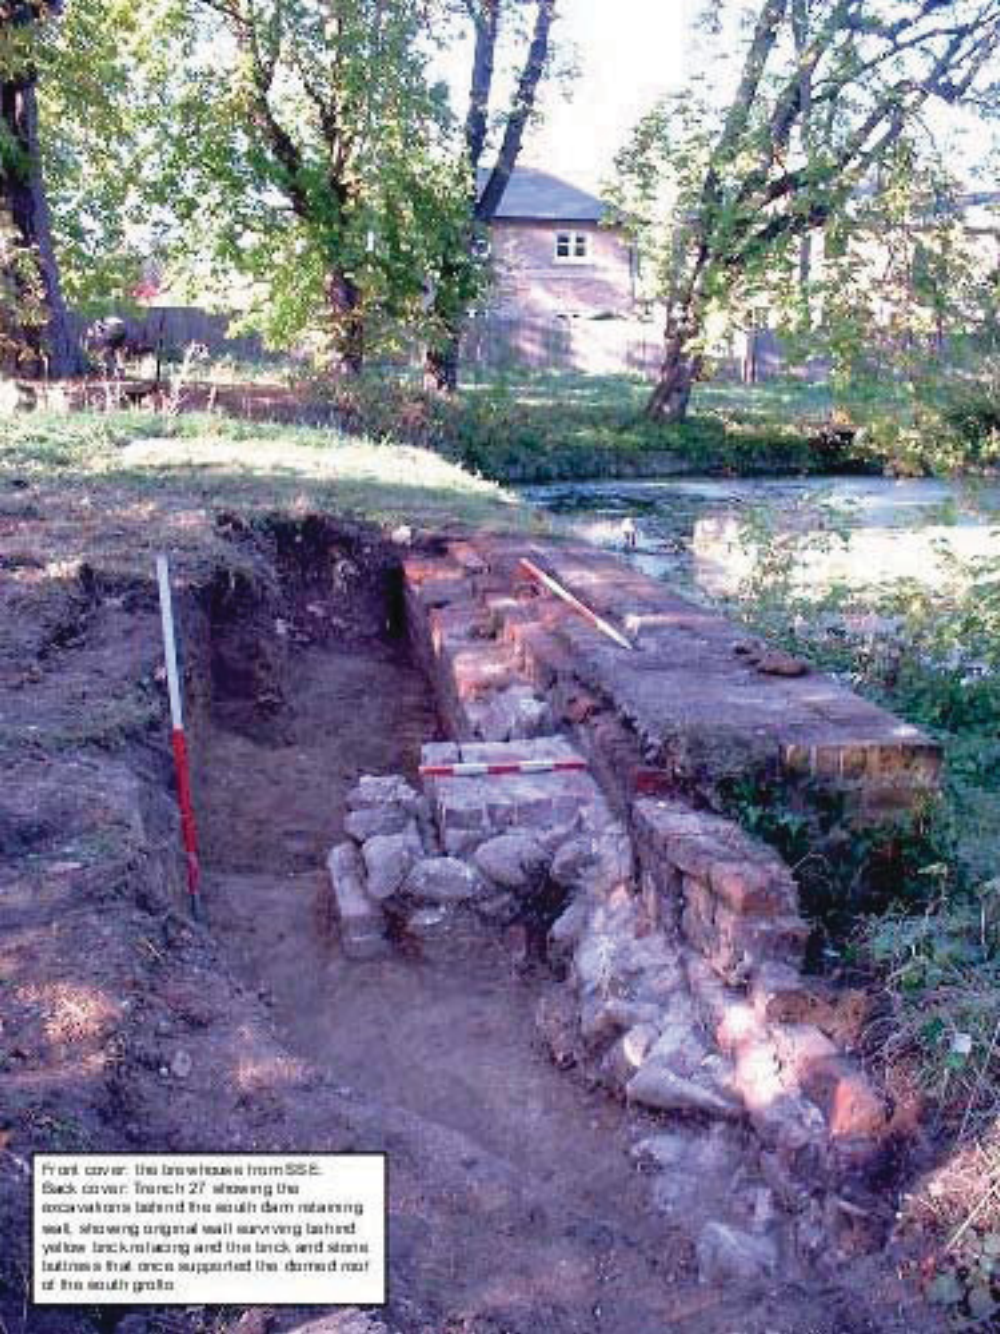
Fig. 11: brewhouse trenches with features

This was a long narrow trench along the east side of the brewhouse, 20m by 0.5m. Following the discovery of a brick culvert, the trench was extended westwards to explore this feature further. This culvert [context 347] was made of bricks of the type usual around 1700 and was therefore thought to be contemporary with the brewhouse. Within the extension it was noted that the culvert had been broken through by the iron pipe [context 342] seen in Trench 30 (see below).

The culvert had a semi-circular vault over short vertical sides with a flat bottom. The full extent was not excavated but the vault was about 300mm high and about 600mm wide. It was contained within a linear cut [context 345] that could be clearly seen in section. The culvert had been cut through on a N-S alignment by an iron pipe with a diameter of 175mm. The pipe was in cut [context 340] 400mm wide, the width of the break through the culvert. This break was such that it would seem that the culvert was no longer operational at the time the iron pipe was laid.

This trench was excavated along the north side of the Brewhouse across the present entrance. The purpose was to see if there was a cobbled floor or similar paved surface at the front of the building. No paved surface was seen, although a large bore red clay ceramic drain [context 355], 200mm in diameter, was found leaving the Brewhouse northwards in the direction of the Longford River.
