THE FORMER GARIBALDI PUBLIC HOUSE  
6, THE GREEN, CHALVEY  
SLOUGH SL1 2SN

AN HISTORIC BUILDING RECORD

Planning Application Reference: P/11098/003

COMPASS ARCHAEOLOGY  
250 YORK ROAD  
LONDON SW11 3SJ

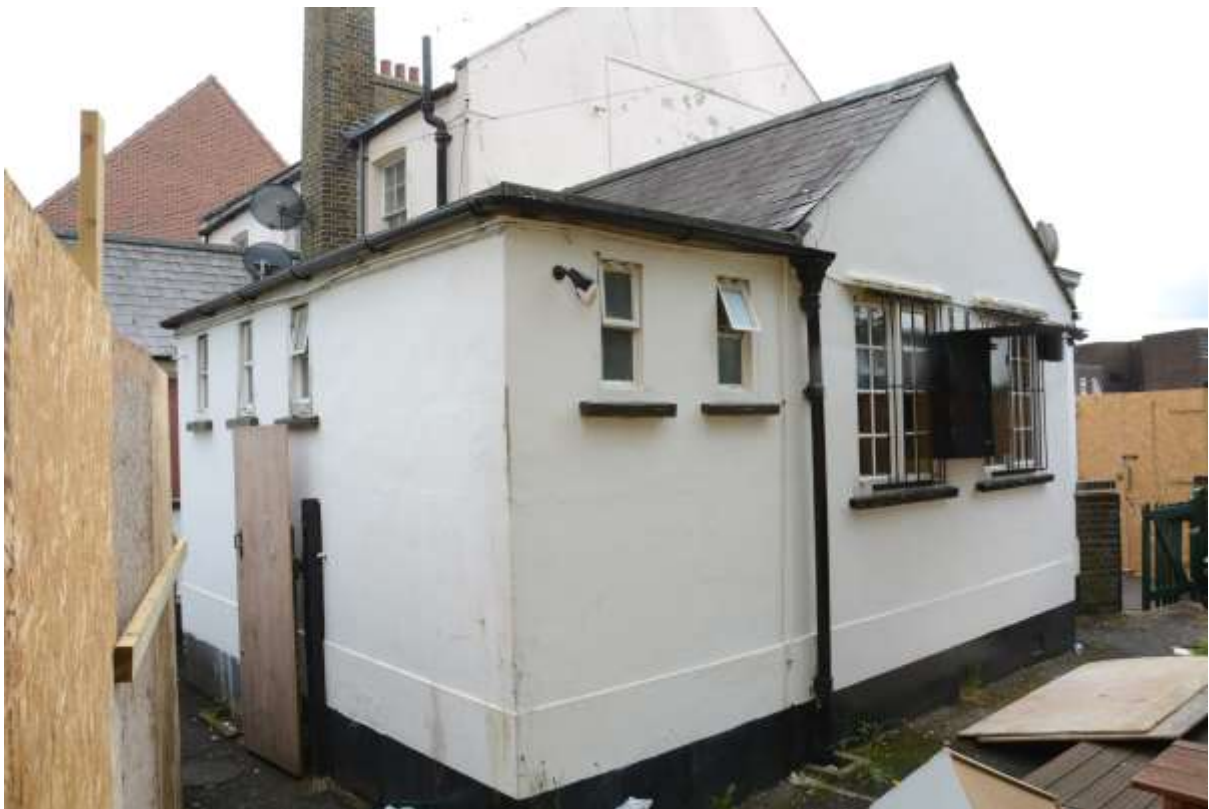
Fig.17: *The northwestern extensions to the property, view looking south. The toilet block to the left is probably an addition to the main pitched-roof central block, the junction discernible in the external rendering*

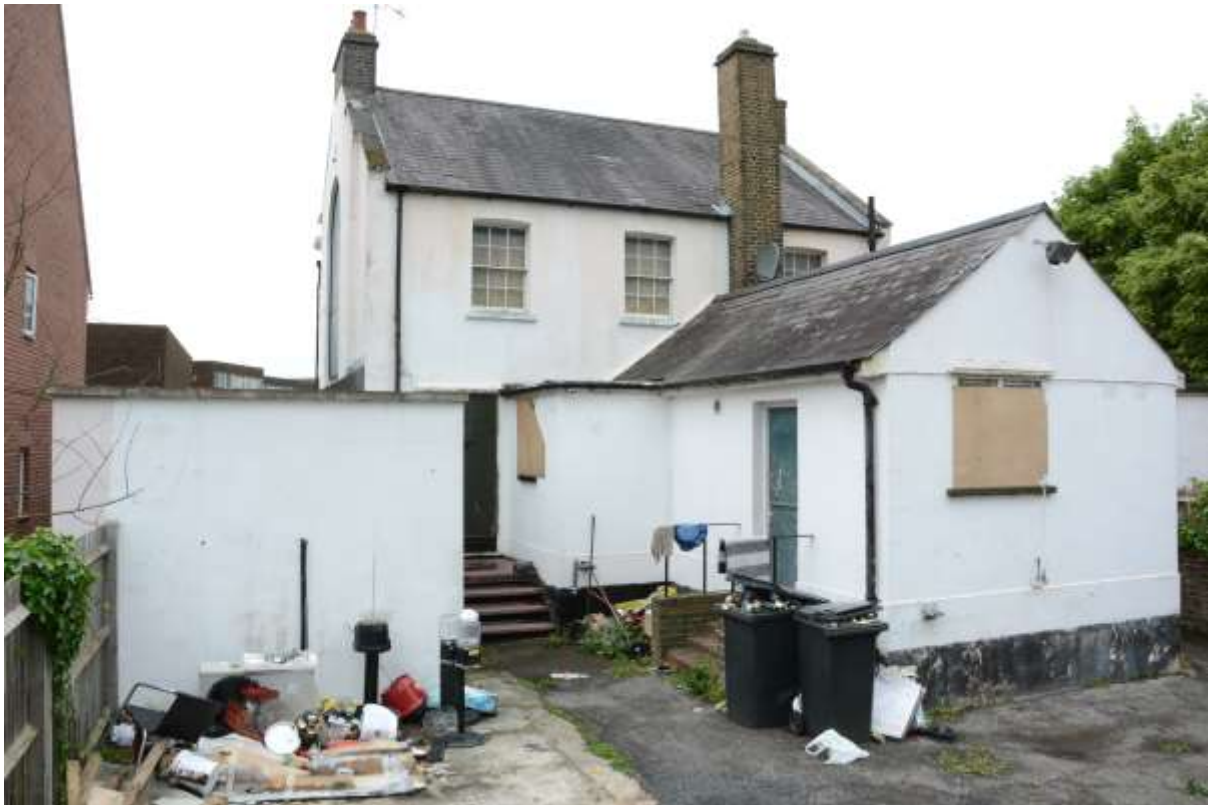
Fig.19: *General rear view looking WSW. The two flat-roofed structures are clearly additions – that to the left modern and the smaller in the centre c 1920s. However, the main gable-roofed kitchen block may also have been rebuilt as the original outline is much shorter. It may also be significant that one end of the stone sill below the central first-floor window has been cut at 45° to accommodate the roof slope*

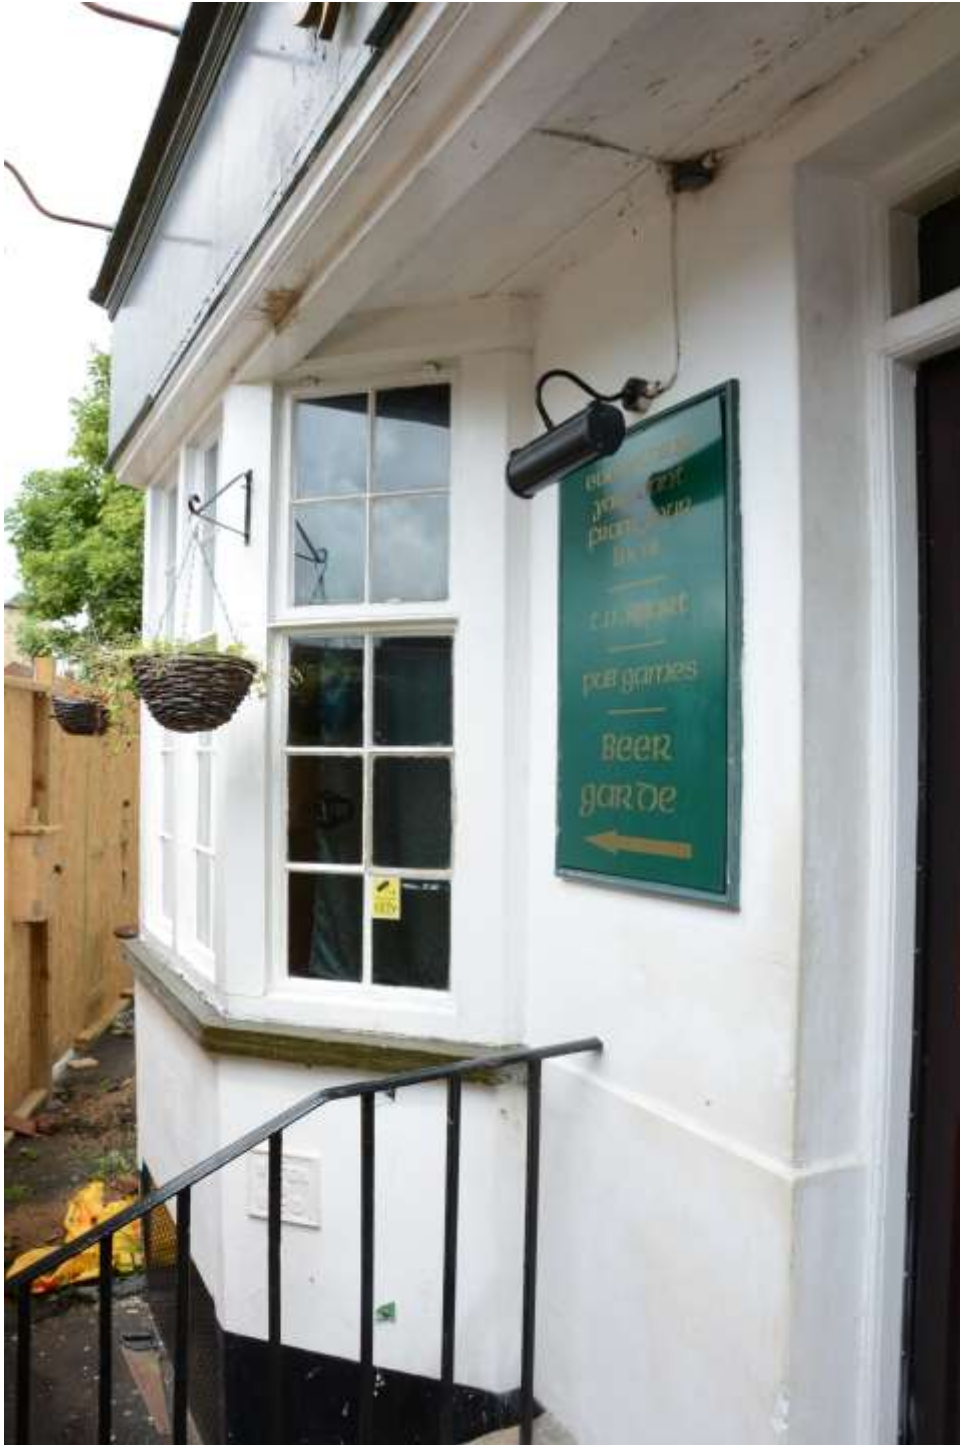
Fig.23: *The northwestern bay window and overlying canopy. Although within the original building it is possible that both these features were added in the earlier 20<sup>th</sup> century (cf. Fig.32, etc.)*

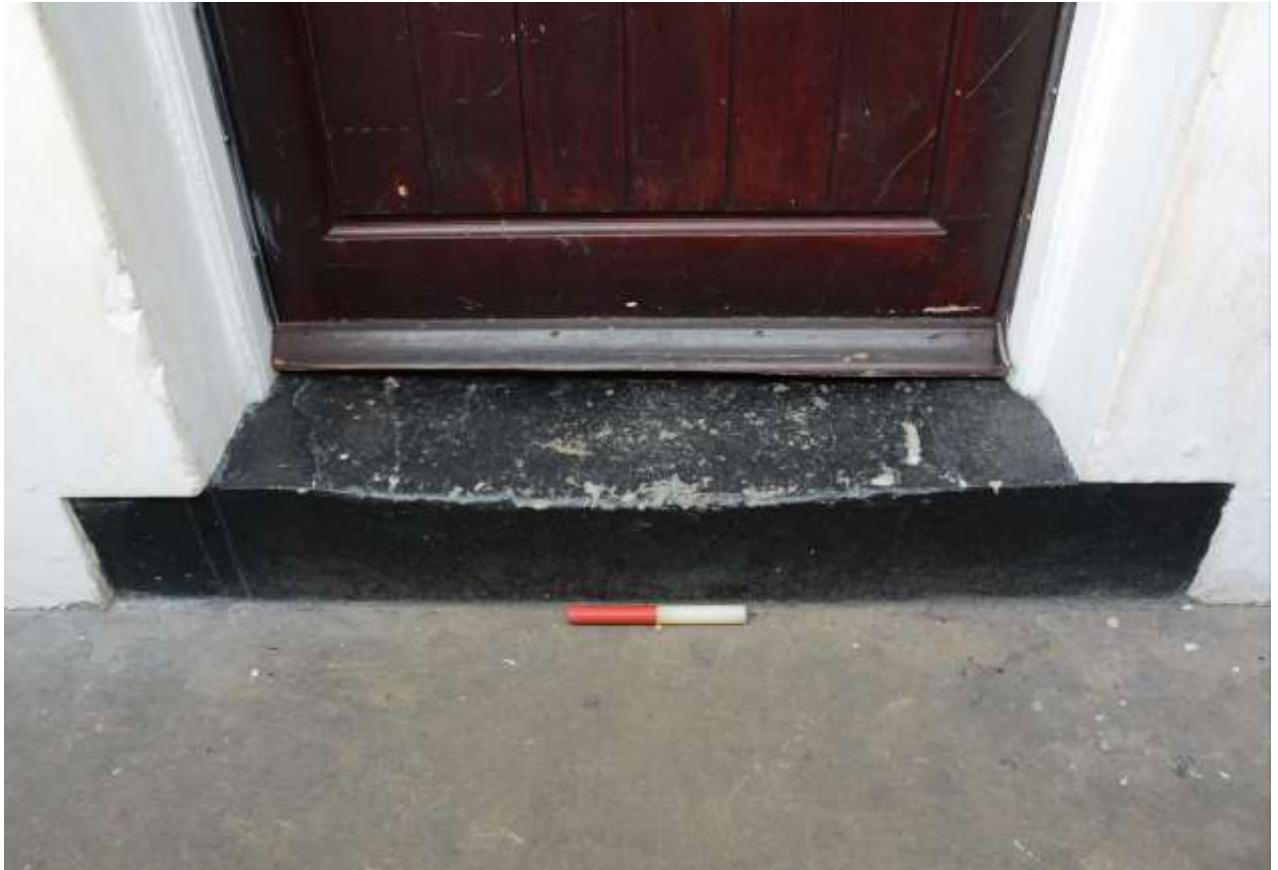
*Fig.24: Close-up view of the worn front entrance step (0.2m scale). Both ends are slightly recessed, indicating that the adjacent rendering is later – see also Figs 79 & 83 below*

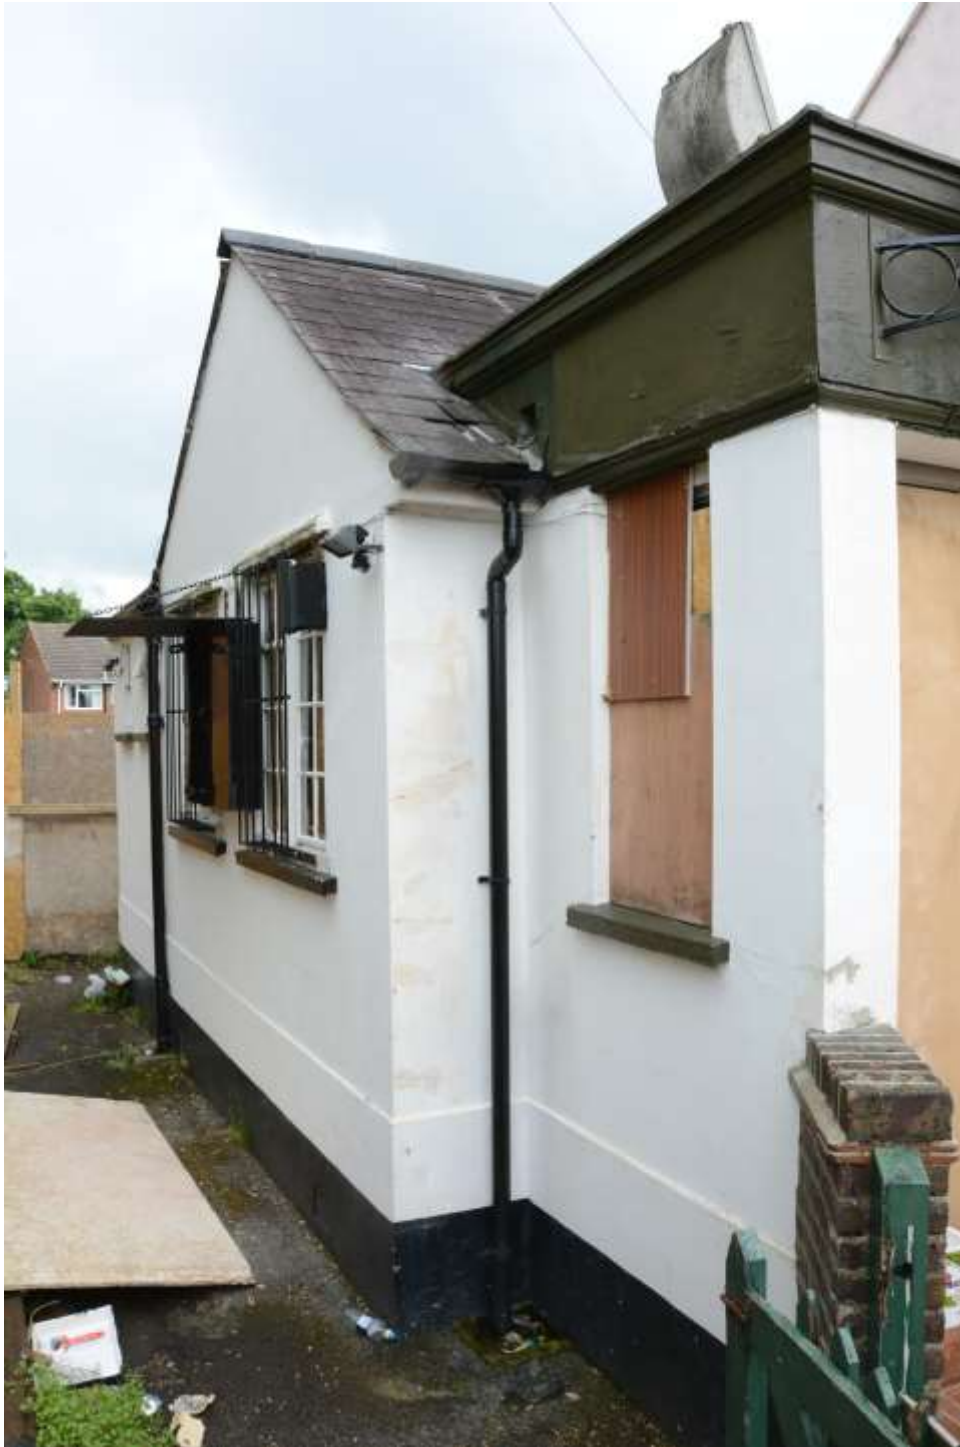
*Fig.26: The northwestern end of the property, showing what are probably two phases of extension – the central block with its pitched roof and the flat-roofed entrance lobby in the foreground*

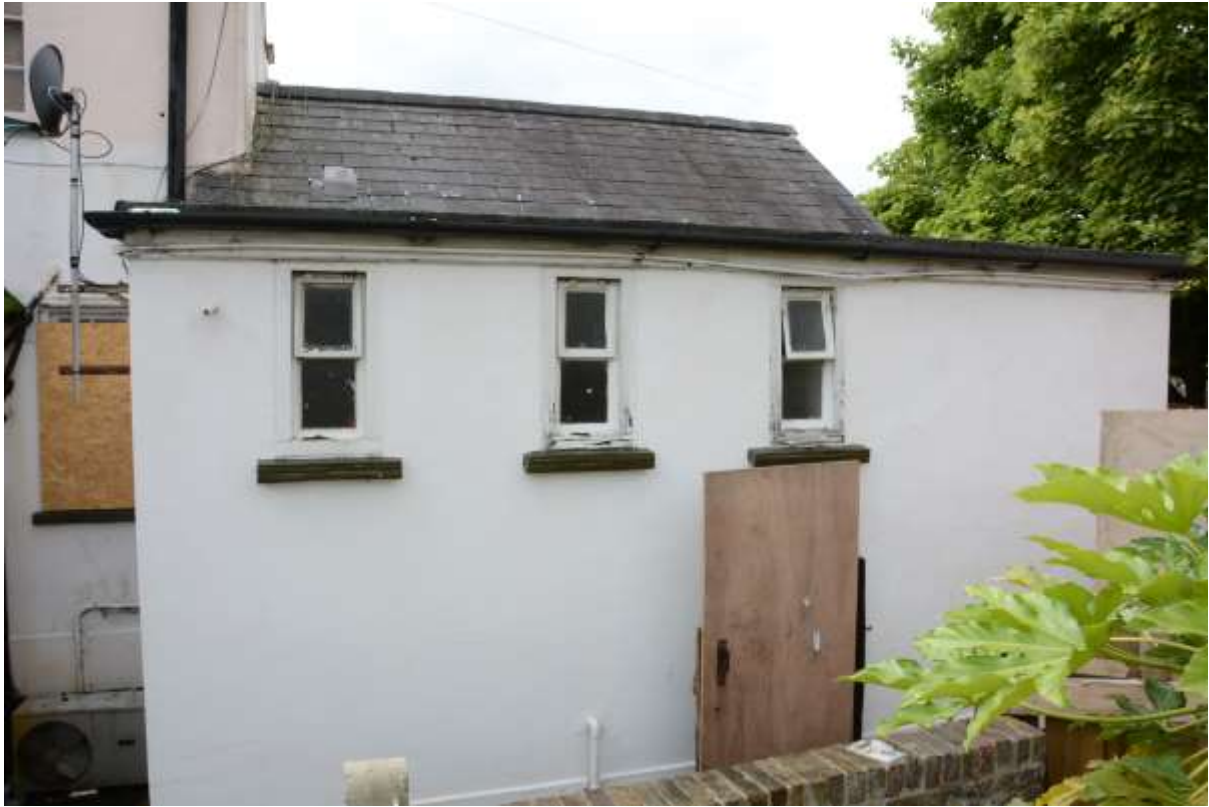
*Fig.28: The back (NW) wall of the rear toilet block, almost certainly a secondary extension to the single storey pitched roof structure in the background*

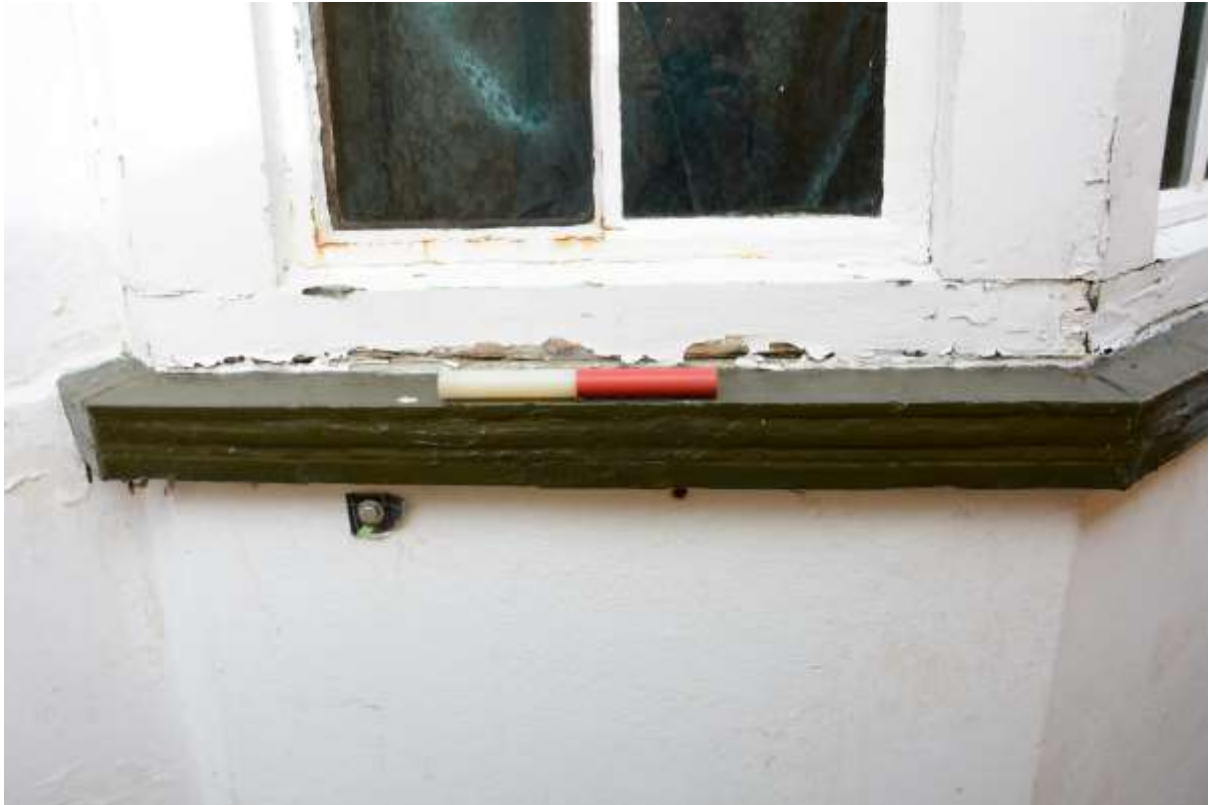
Fig.32: *Detail of the front/ northwestern bay window sill, showing the layered tile construction (0.2m scale)*

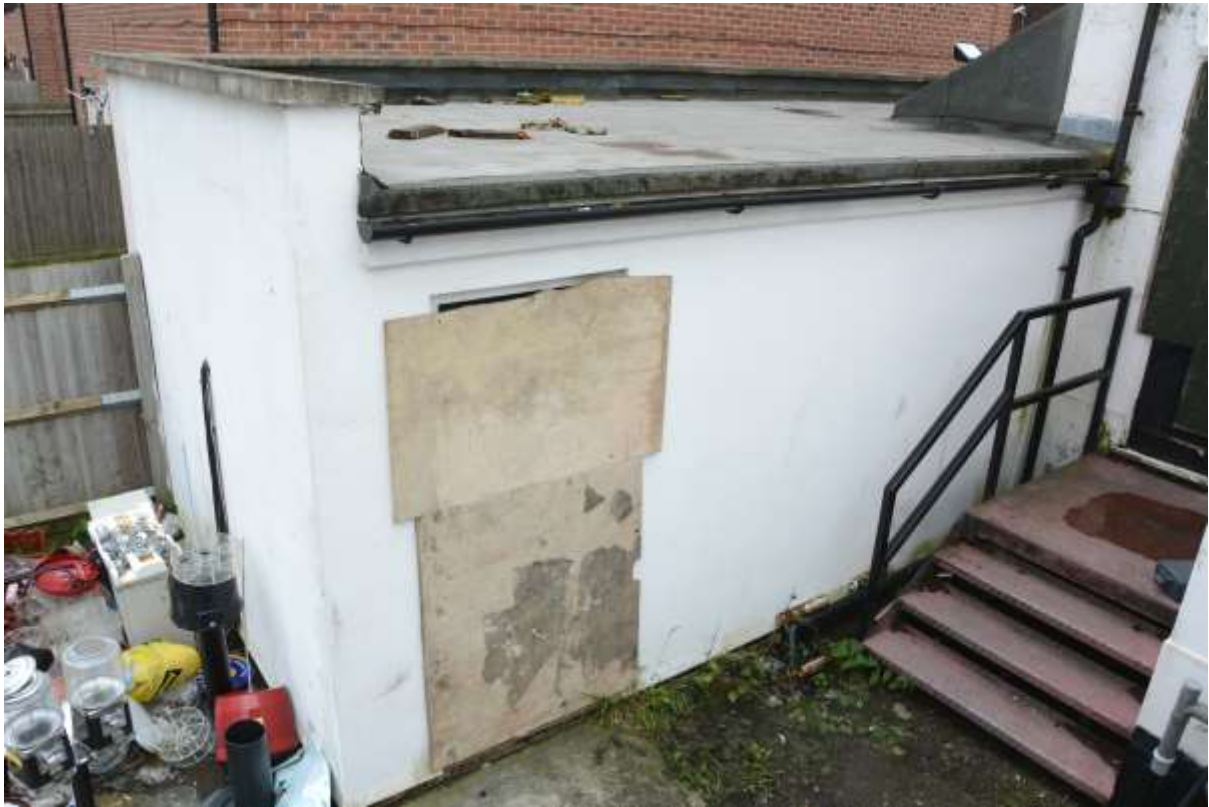
*Fig.36: The modern breeze-block built single storey extension at the eastern corner of the building. The fairly recent metal-framed steps to the right give access to the principal rooms, and suggest that the doorway here is also quite modern*

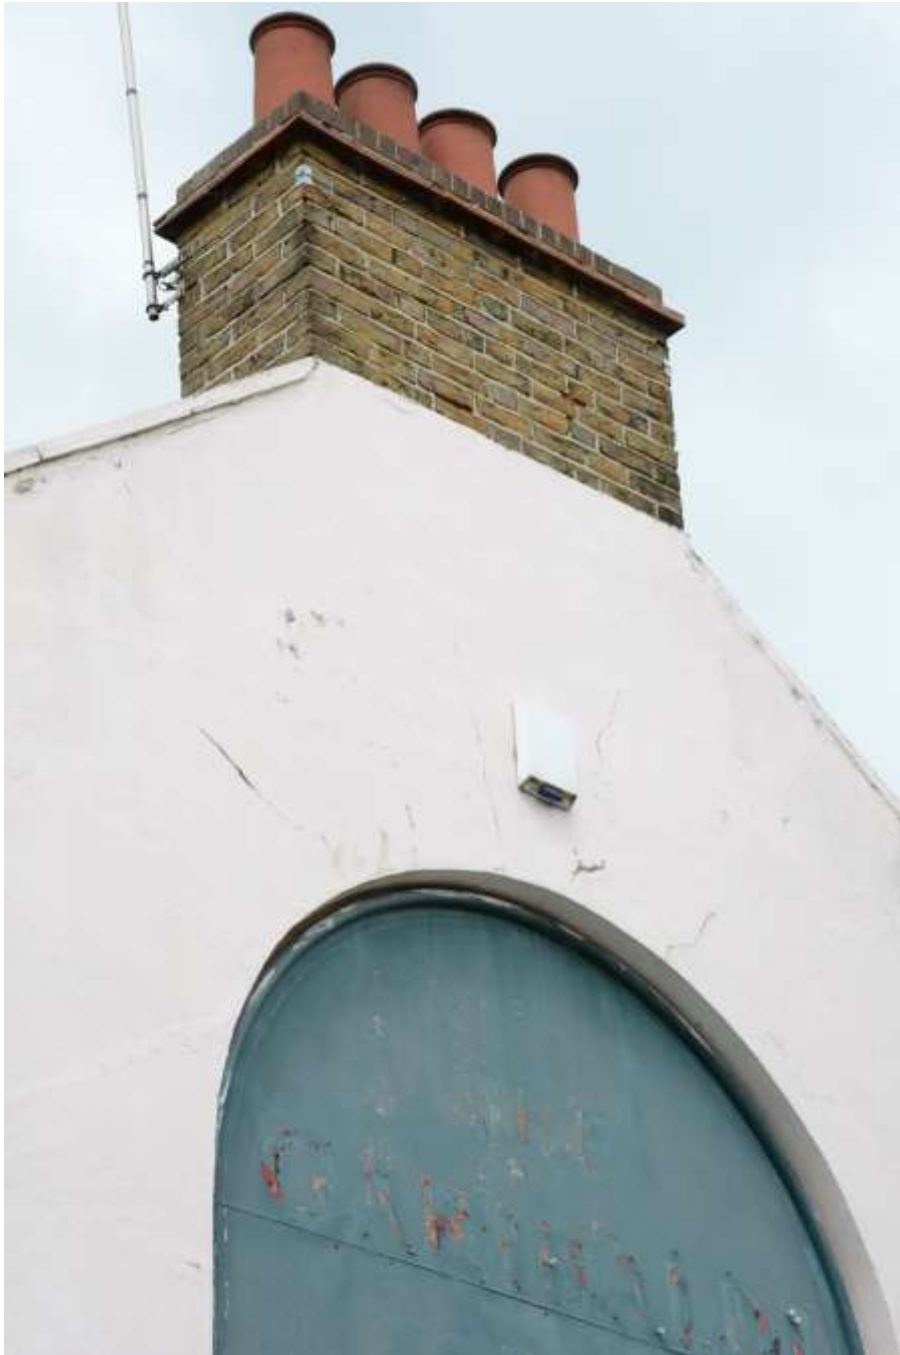
*Fig.43: Detail of the southeastern gable end and projecting chimney breasts. At the northwestern end these are flush with the wall, but the front chimney here was smaller (cf. Fig.113; also reflected in three rather than four pots)*

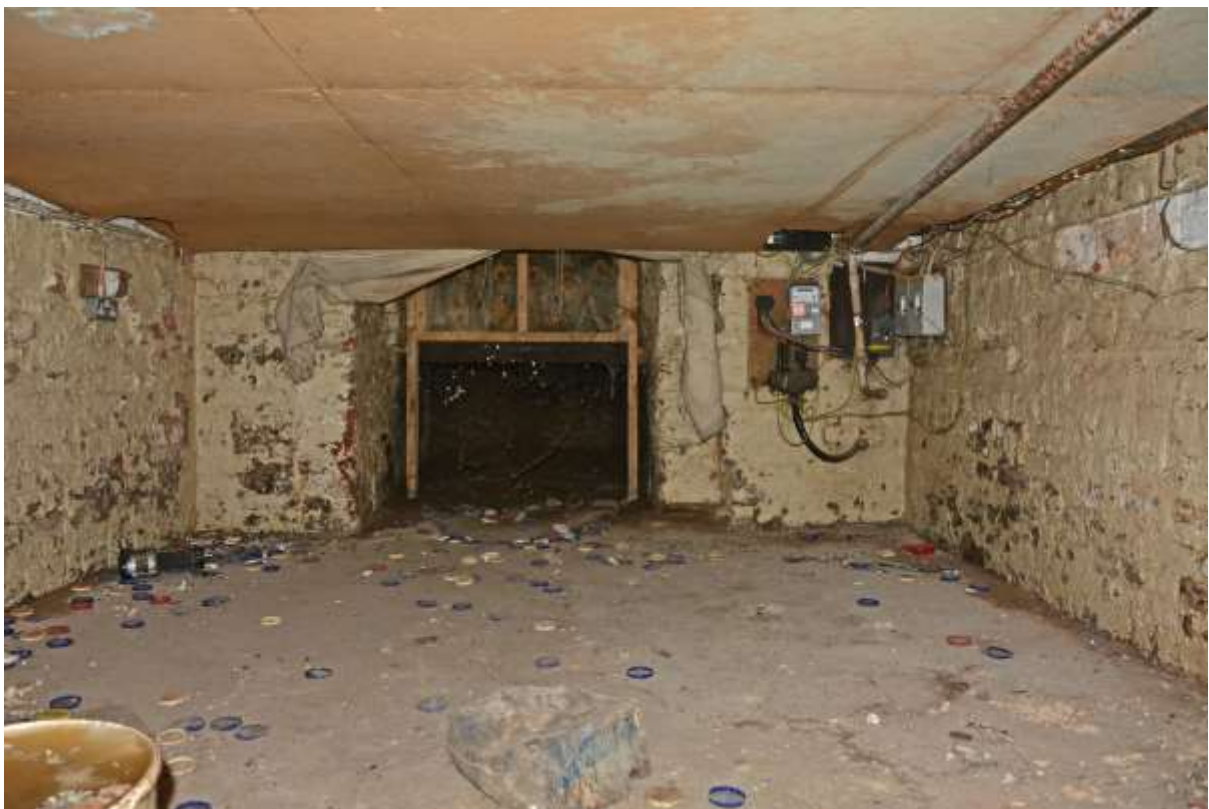
Fig.47: *The main cellar, looking towards the external access hatch at the front of the building. The headroom is very low, approximately 1.4m to the base of the overlying joists*

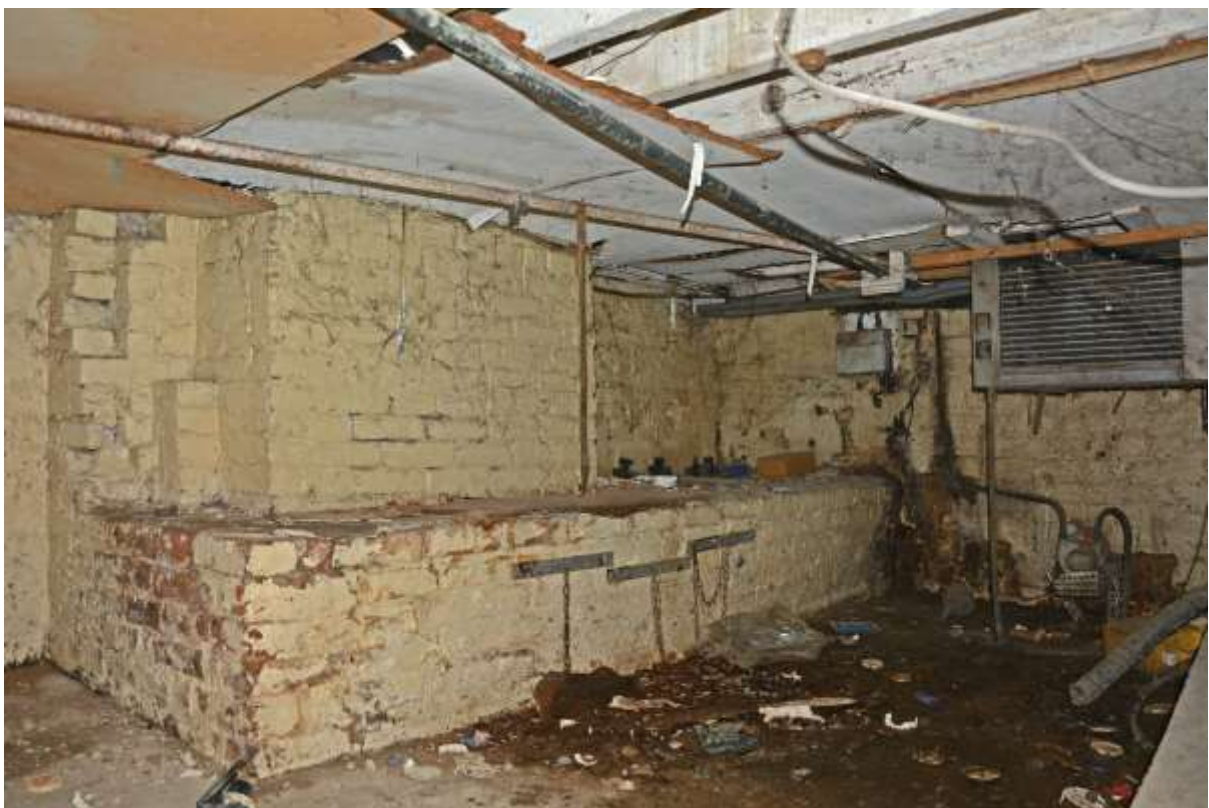
Fig.49: *View of the substantial brick base below the rear (northernmost) chimney stack. To the left of the frame this has evidently undergone some modification, although the reasons for this are not clear. There is no such base towards the front of the building to support the chimney stack there, but this appears to be a less substantial structure (see also Fig.115)*

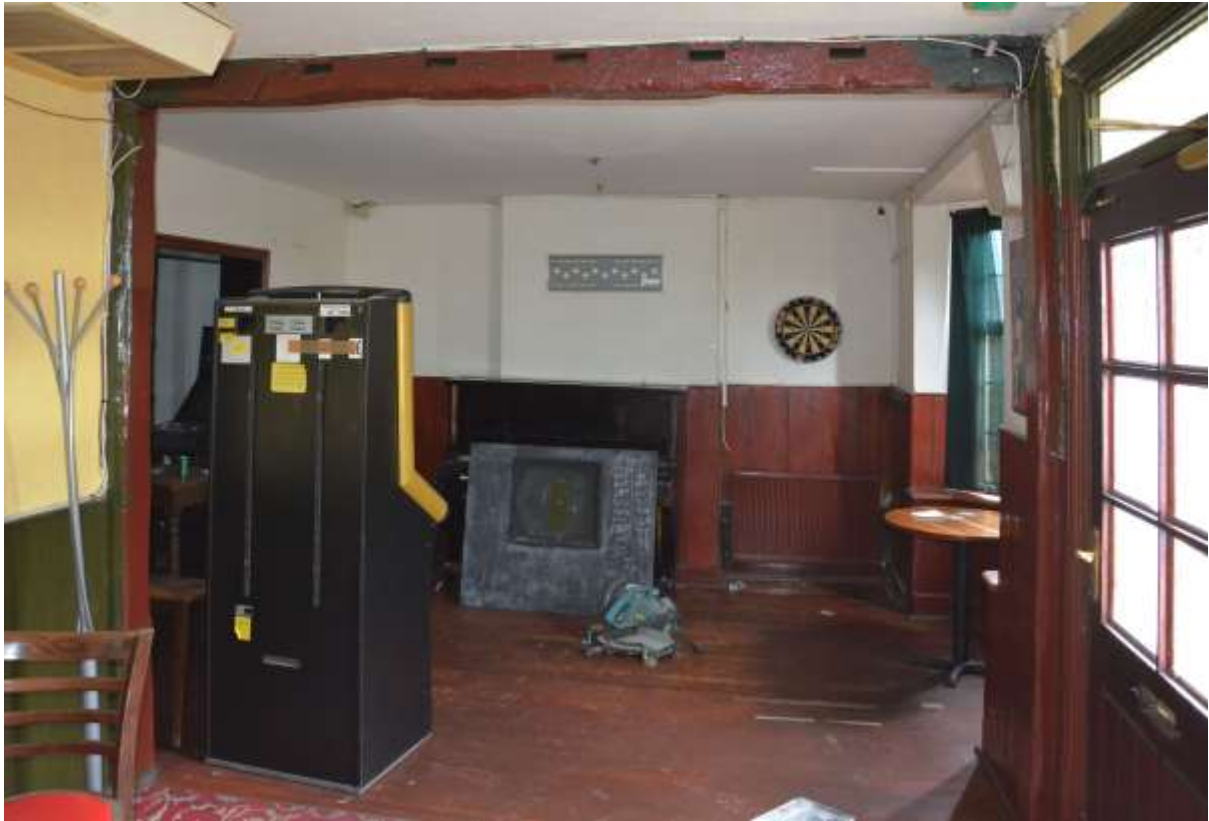
Fig.56: *The southeastern end of the bar. It is not clear whether the ceiling beam in the foreground (with mortice holes on this side only) is original, though it is assumed to follow the line of an original division*

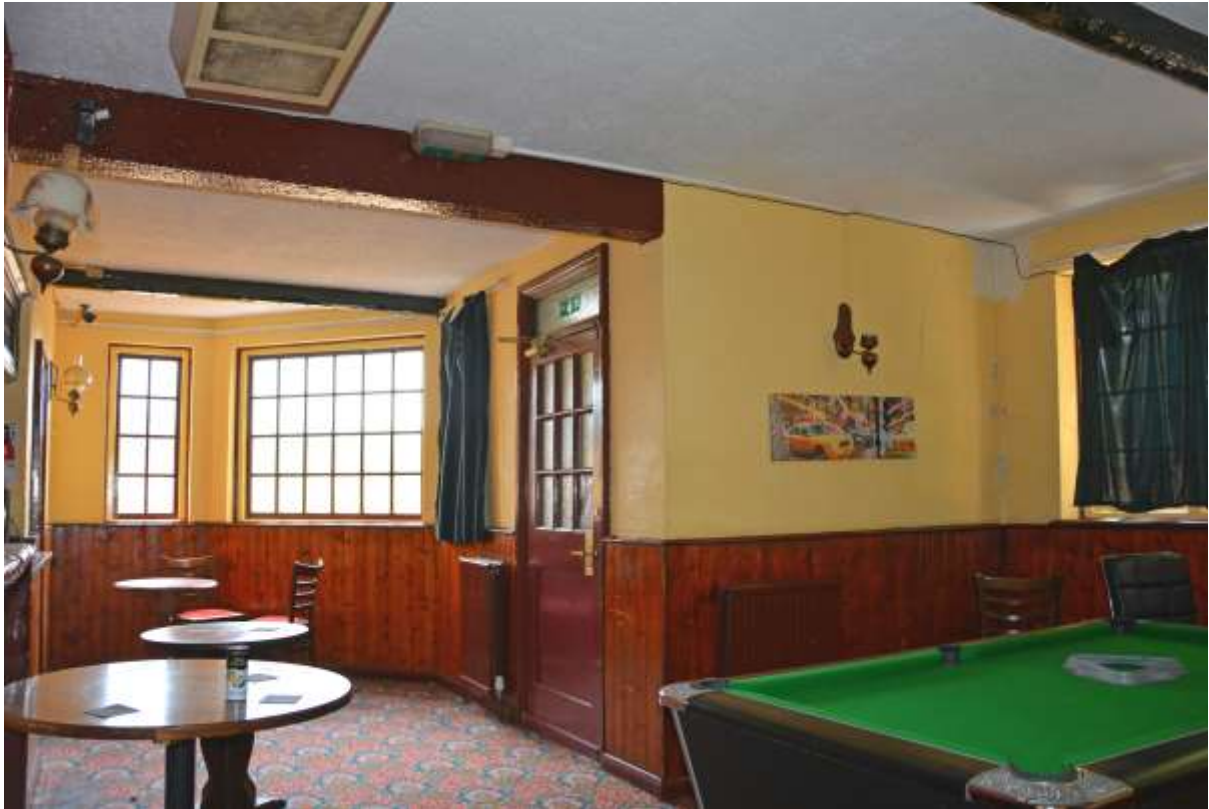
Fig.65: *The northwestern area, view towards the door to the entrance lobby. The large beam at top left may represent the division between two phases of earlier 20<sup>th</sup> century extension*

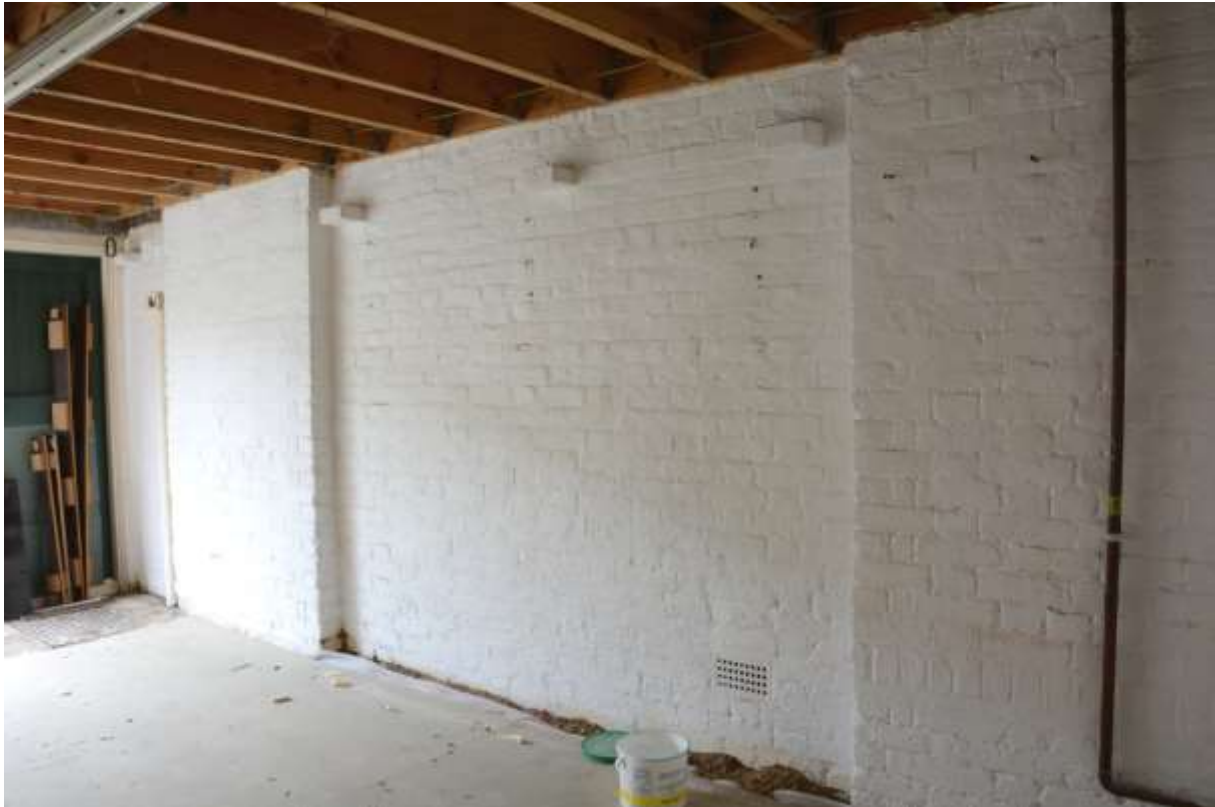
*Fig.75: The SE wall of the main building, with projecting chimney breasts and five corbels for an earlier roof (two beyond the further chimney breast; see Fig.76). The wall itself is not rendered, which may reflect the original building design – see above (5.3) for further discussion*

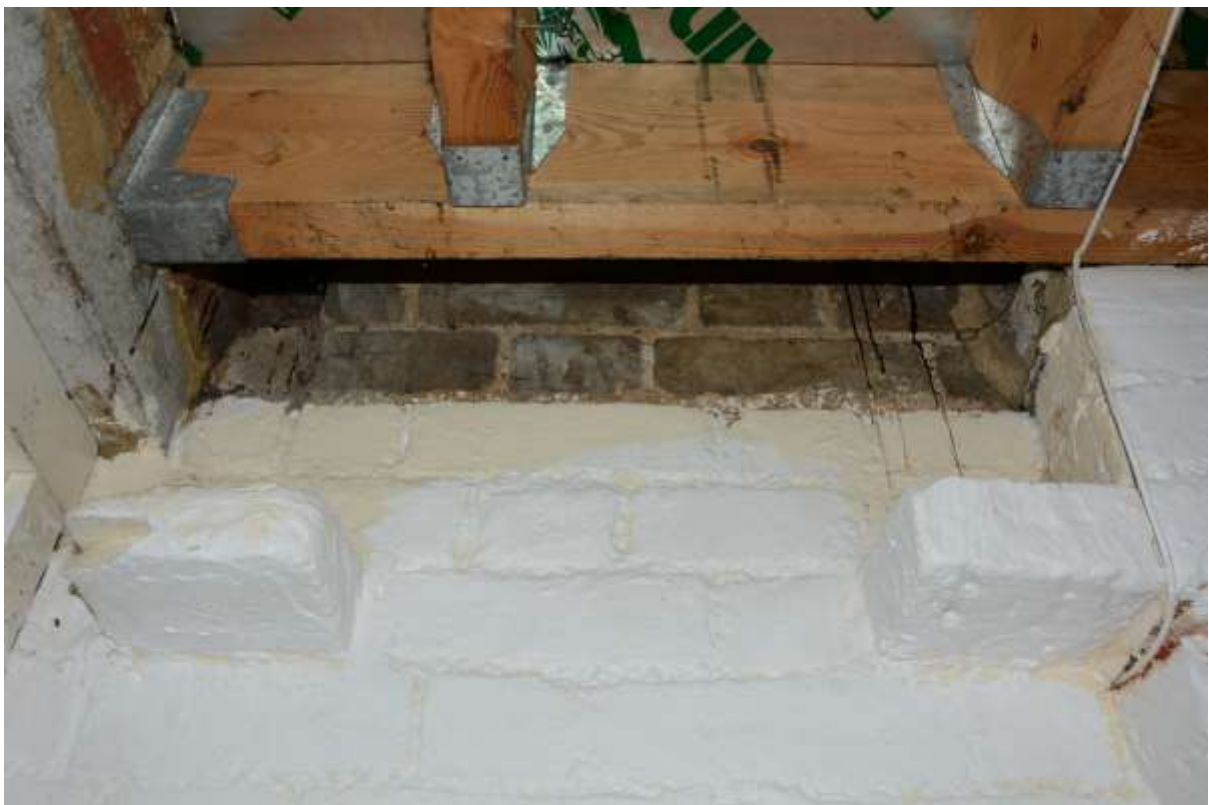
*Fig.76: Detail of the two corbels at the SW end of the main building wall. This also shows that the wall (at least in this area) was originally bare brick, neither painted nor rendered*

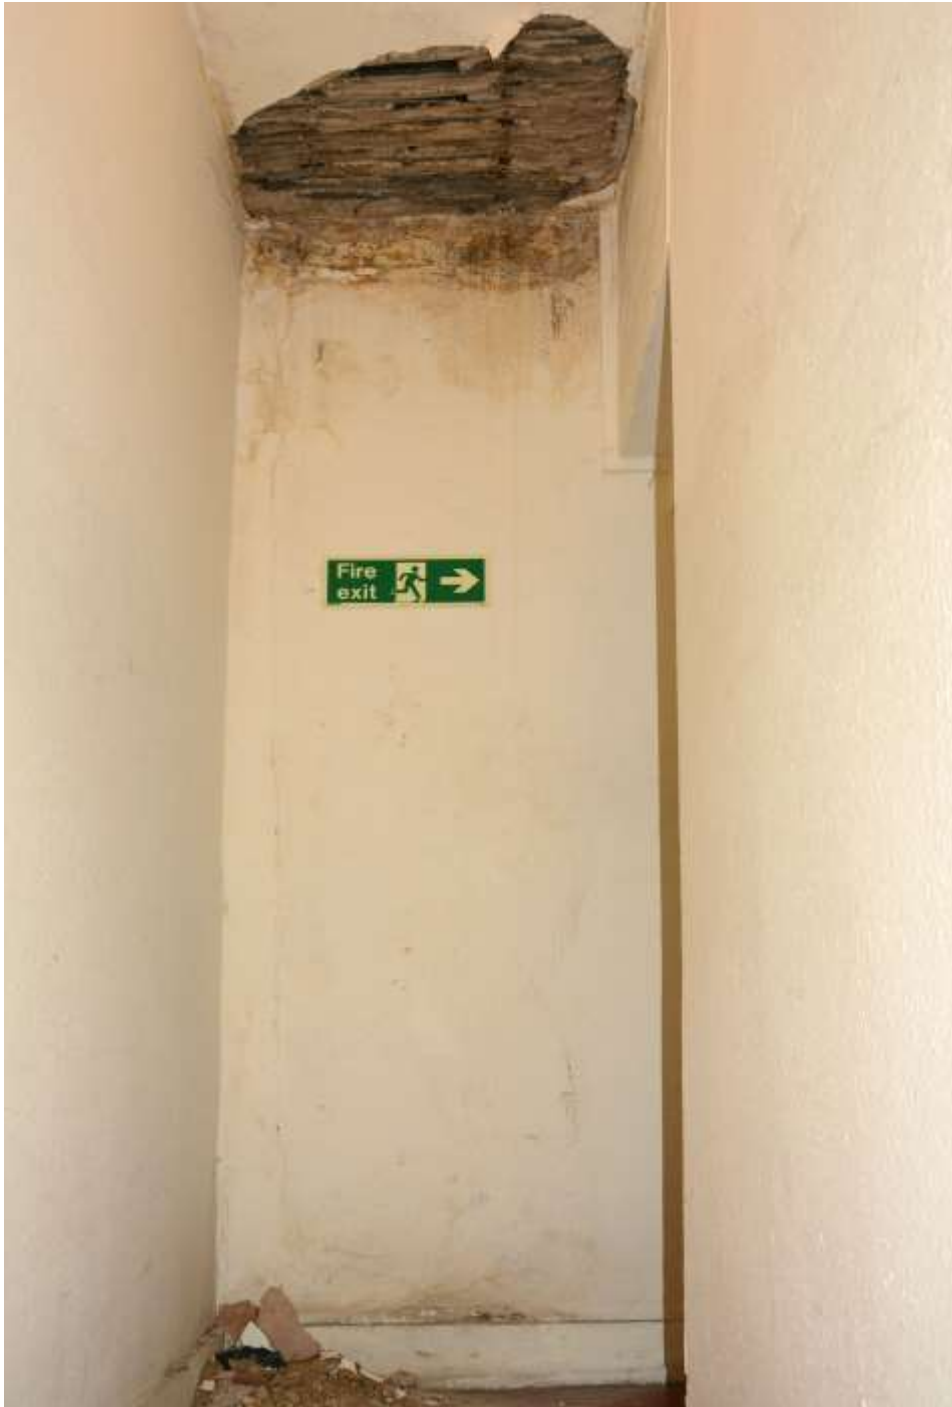
*Fig.88: The passageway leading to the stairs and first floor. At the northeastern end an area of ceiling plaster has broken away, exposing the underlying lath-and-plaster construction*

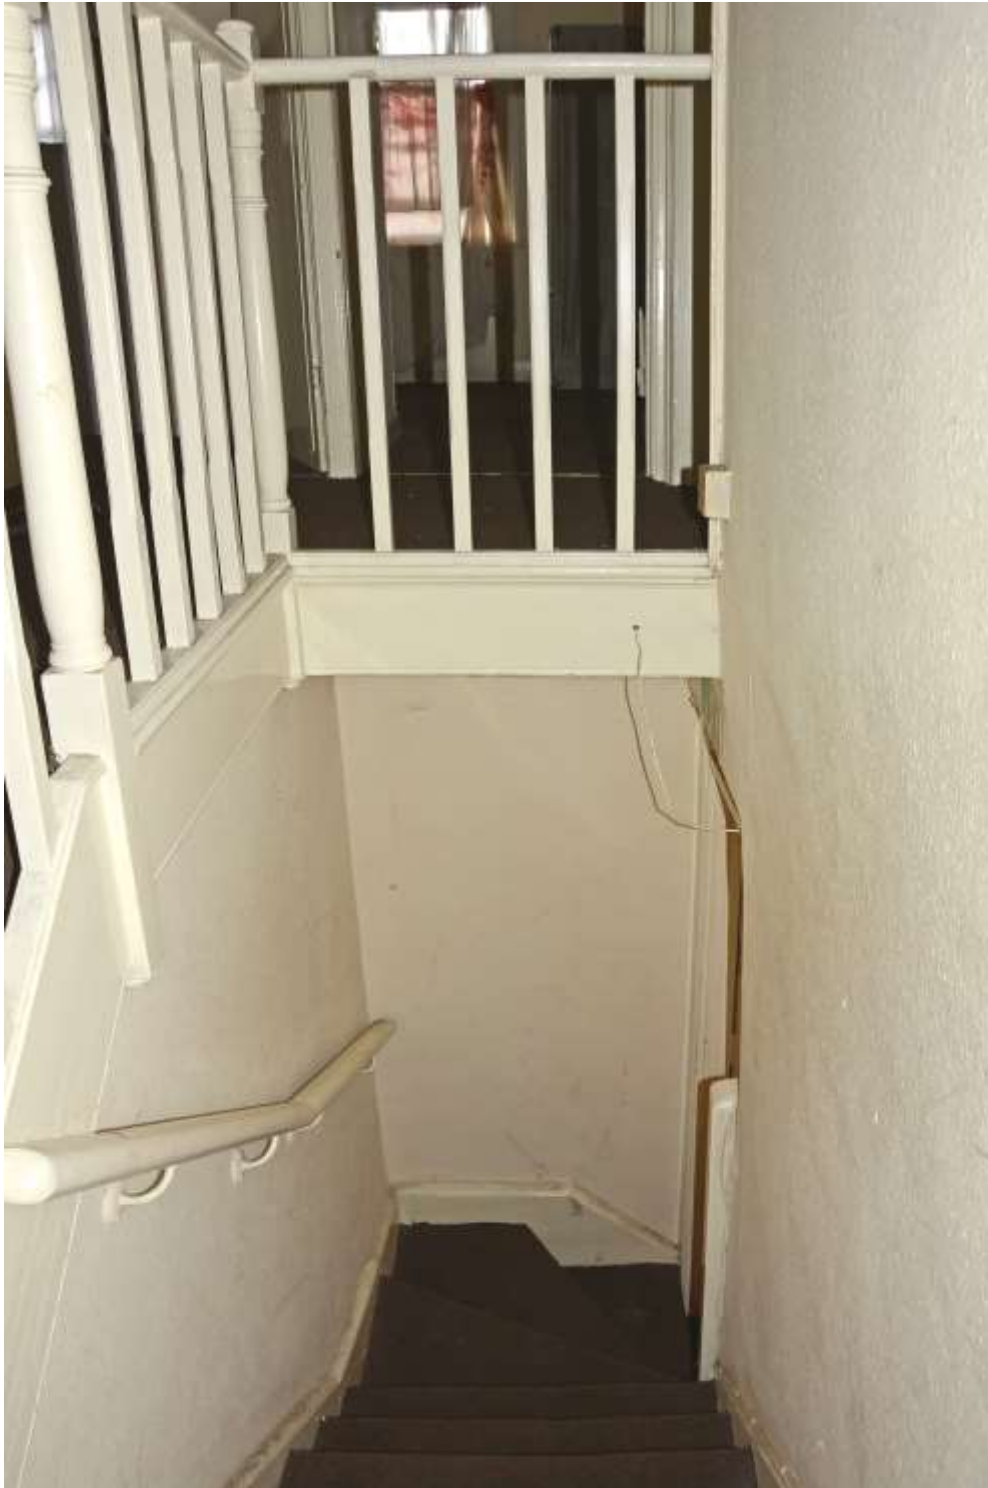
*Fig.91: View looking down the lower flight of stairs (compare with Fig.89). There is nothing to suggest that the staircase and balustrade are not original features of the building, although it may be that they were originally approached more directly than the passageway (Fig.88) that now exists*

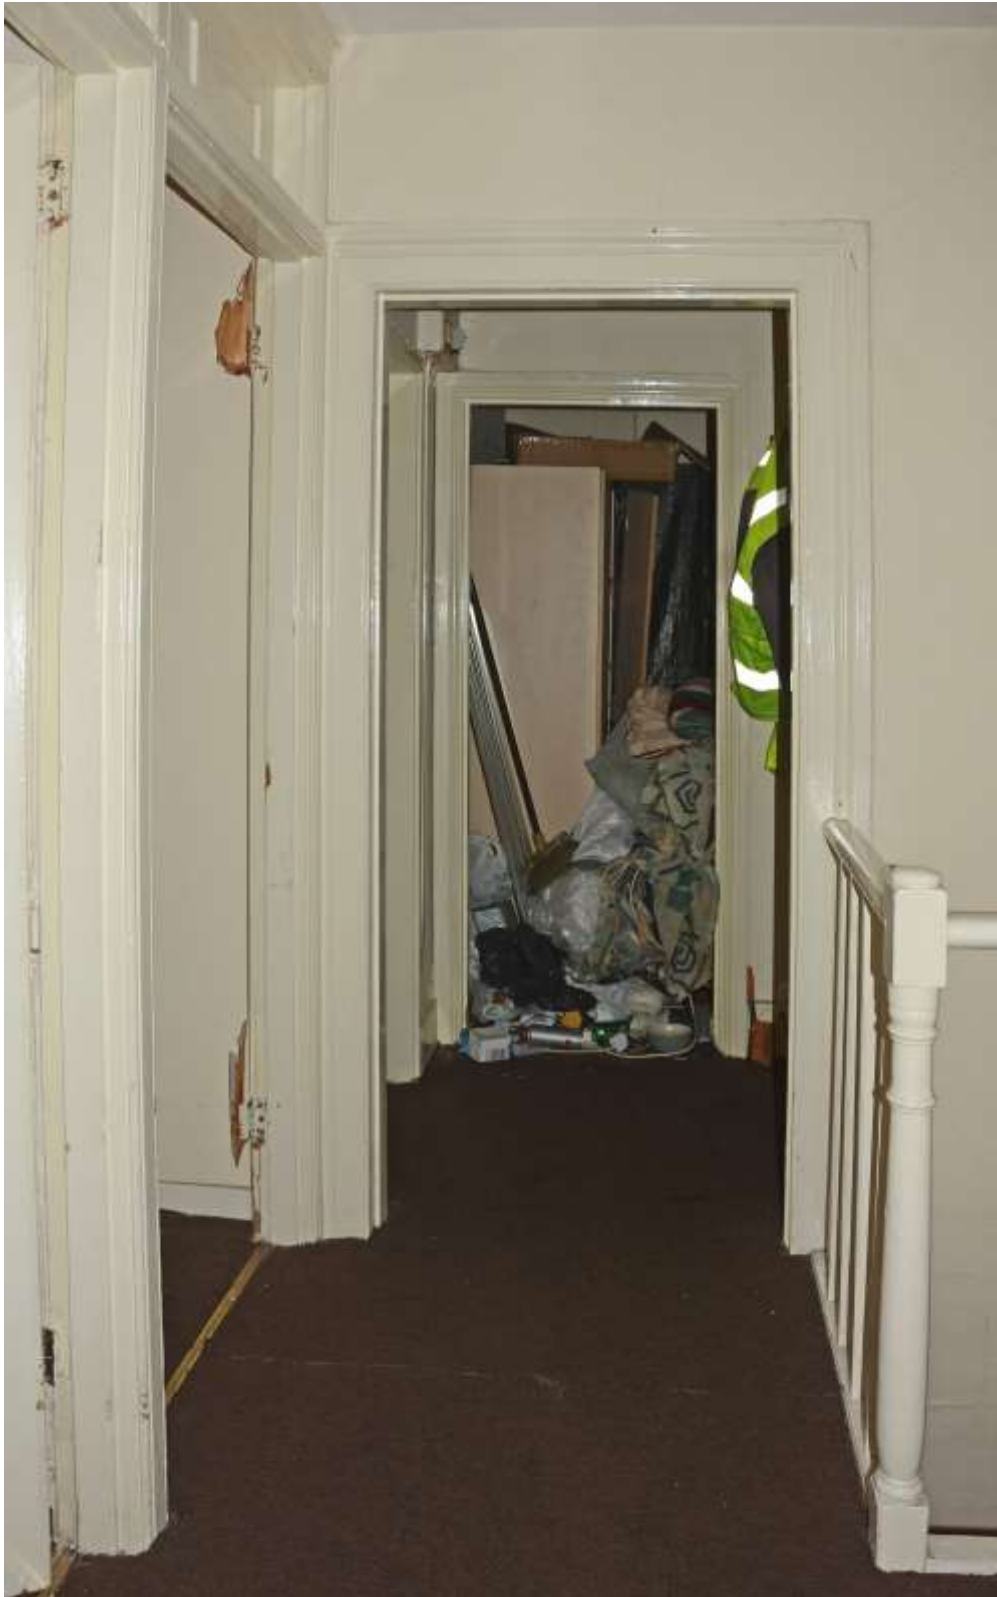
Fig.96: *The landing looking NW. Three different styles of joinery are visible around the doors in this picture: probable original moulding in the left foreground and at the end of the balustrade, framing around the cupboard to the rear as part of a later (?earlier 20<sup>th</sup> century) subdivision, and just visible between these the apparently modern frame of the northwestern bedroom door*

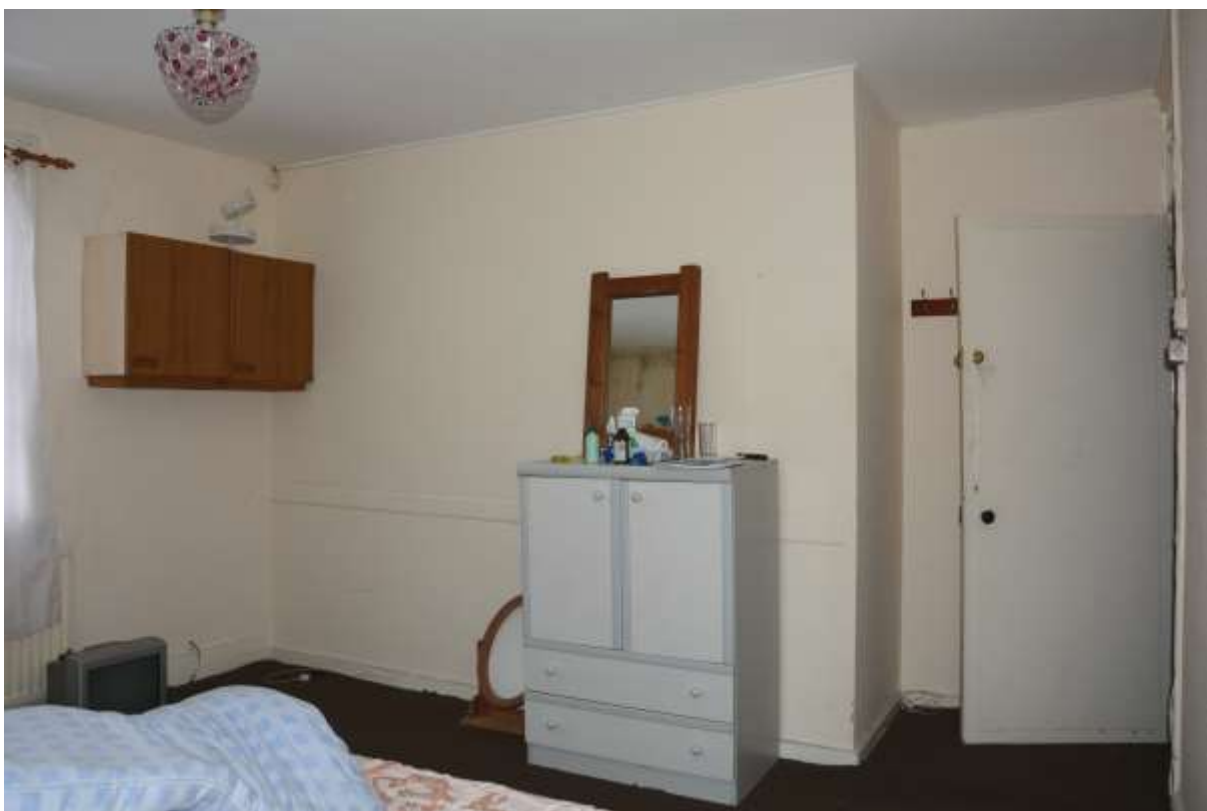
Fig.102: *The later NE wall of the principal front bedroom: note the apparently quite modern skirting – plain & much smaller – and also the beading at the top of the wall*
