THE FORMER GARIBALDI PUBLIC HOUSE  
6, THE GREEN, CHALVEY  
SLOUGH SL1 2SN

AN HISTORIC BUILDING RECORD

Planning Application Reference: P/11098/003

COMPASS ARCHAEOLOGY  
250 YORK ROAD  
LONDON SW11 3SJ

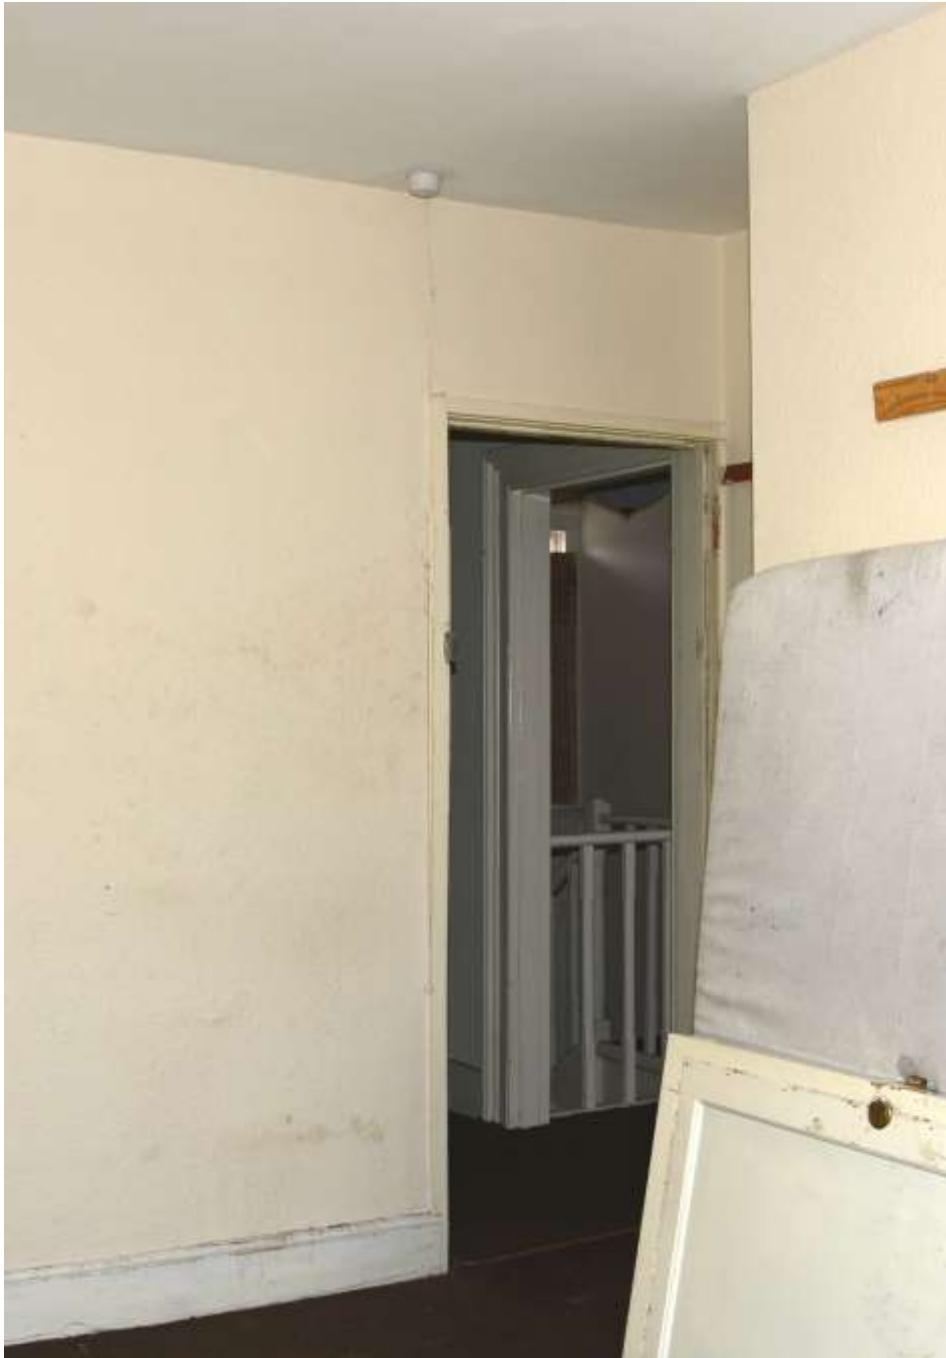
*Fig.107: The northwestern bedroom, looking back towards the landing. The doorframe appears quite modern – much simpler than elsewhere – and was presumably cut through when the small central room was created*

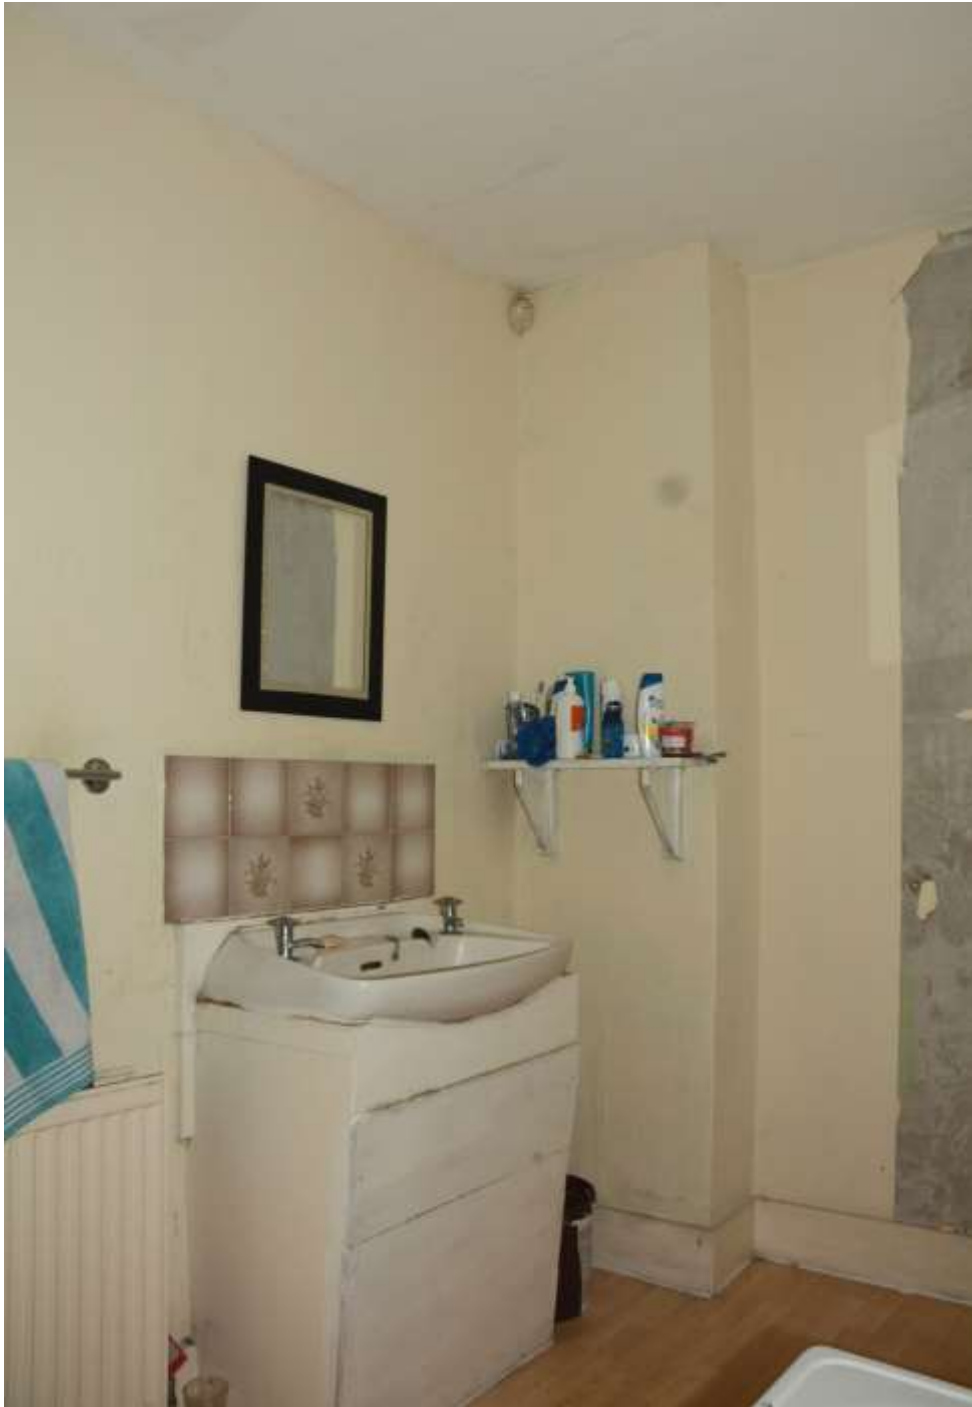
*Fig.110: The bathroom, looking toward the NW corner and one side of the chimney breast. It is likely that this room and the part of the adjacent landing and cupboard were formed out of one larger original bedroom, with a fireplace on the northwest wall*
