**THE DOVECOTE, BREAKSPEAR HOUSE,
BREAKSPEAR ROAD NORTH, HAREFIELD,
HILLINGDON, LONDON, HA6 1BN**

A LEVEL 3-4 HISTORIC BUILDING SURVEY

September 2011

Author: Emma Jeffery

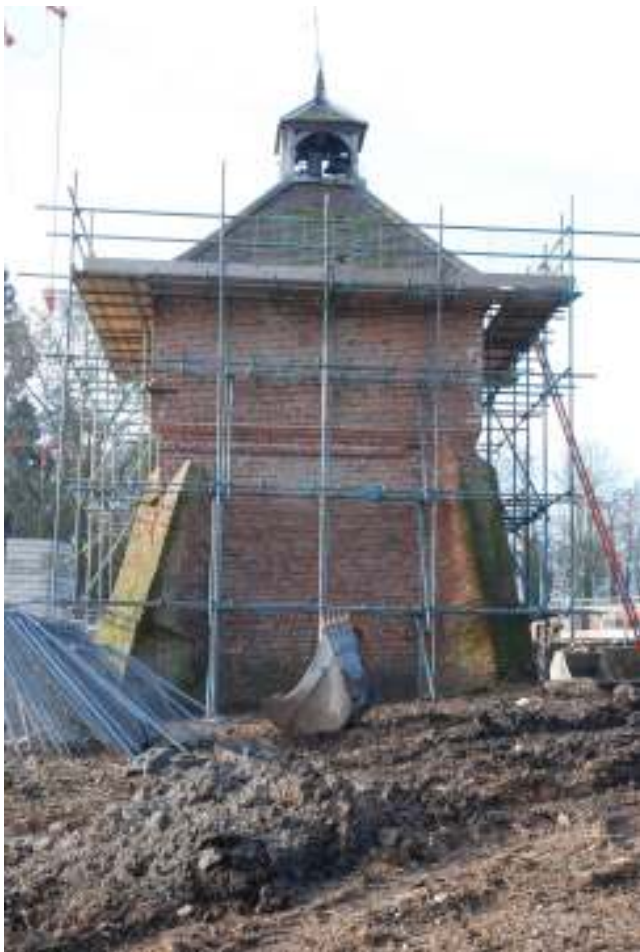
Fig. 20: Photograph of the exterior eastern wall of the dovecote. The original build was up to the lower part of the moulded courses of brickwork. Sadly, the blocked doorway is directly behind the machine bucket in this photograph.

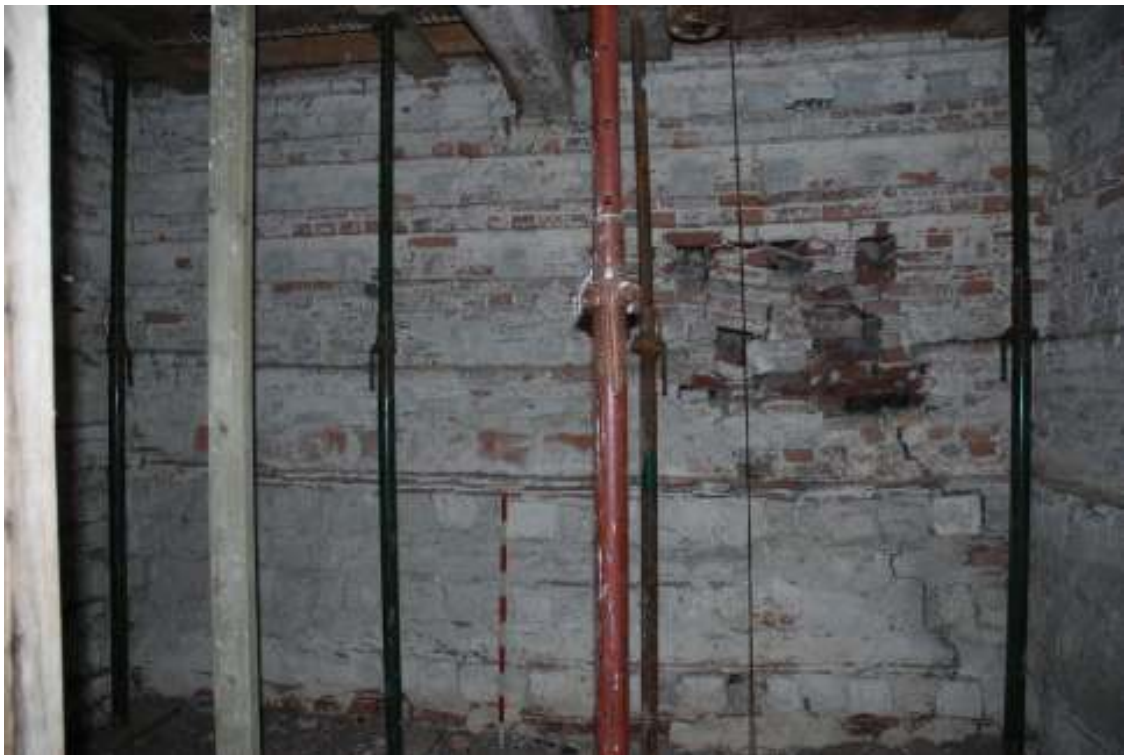
Fig. 25: Photograph of the interior northern wall of the dovecote – first floor. Original build up to c.200mm above the top of the scale, after which the nesting holes are distinctly different. A few unblocked holes are visible in the damaged area to the upper right of the photo.

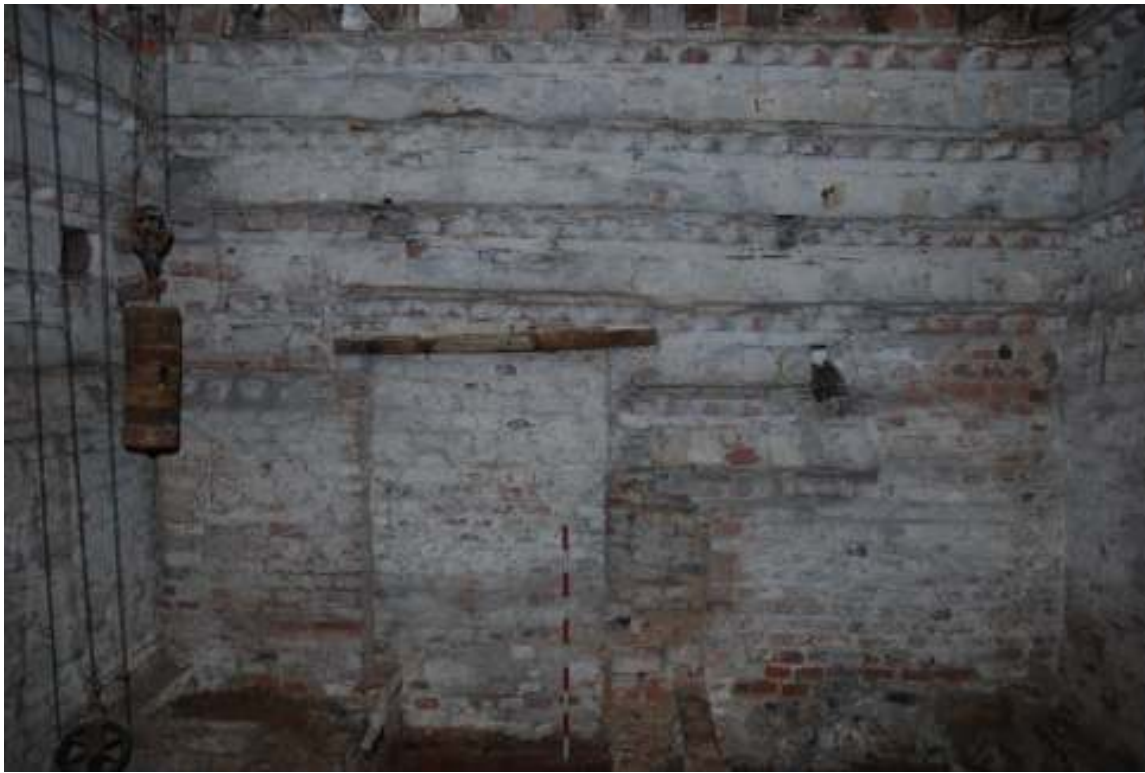
Fig. 26: Photograph of the interior eastern wall – ground floor. Original build visible from c.100mm above the scale (battered re-facing below this, with the original eastern doorway (now blocked-in). See fig. 47 for clear explanation of which parts are part of the later battered re-facing.

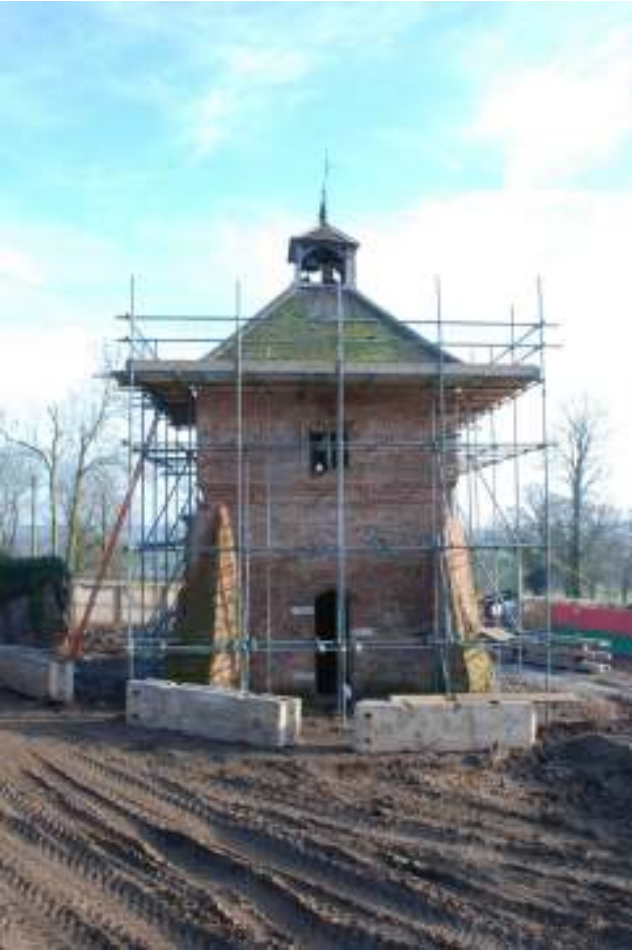
Fig. 30: Photograph of the exterior western wall of the dovecote. The apparent 'jettied' construction of the structure (with the part above the moulded courses clearly sticking out further than the lower part of the structure) provides a possible indication of an earlier timber jettied structure.

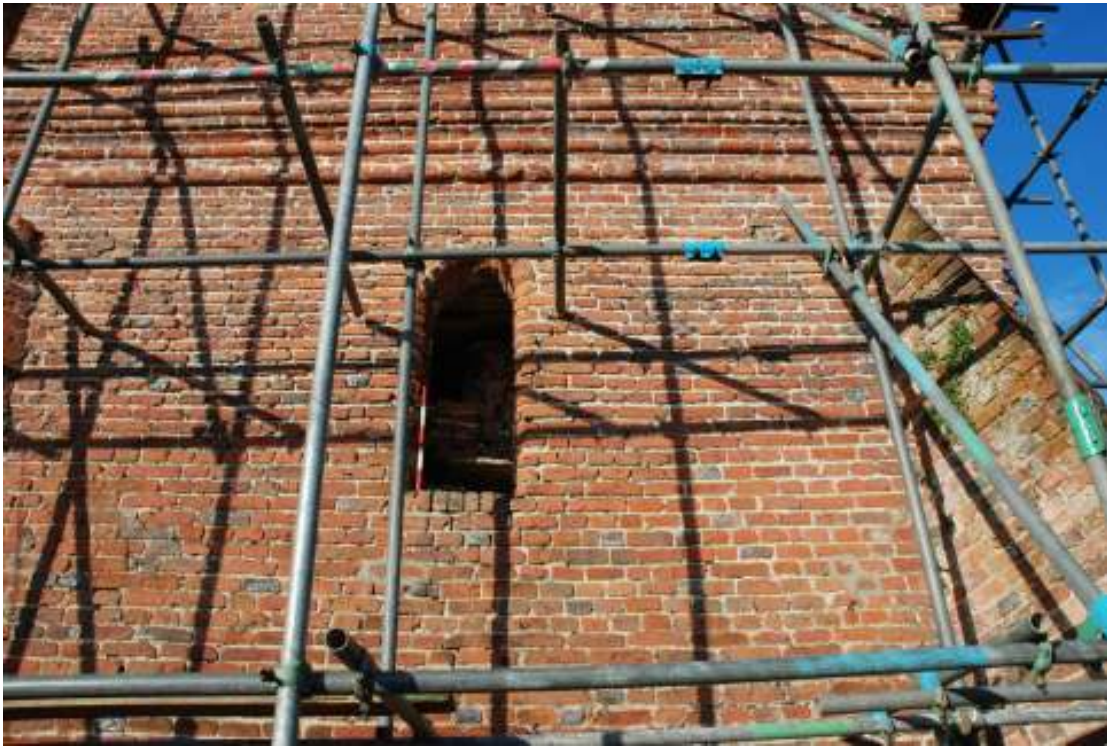
7.4 The window in the southern wall, approximately half-way up the present height of the dovecote, was also original. This window measures 0.5m in total width, by 1.28m in total height. It is topped with an arch, of a maximum height of 0.22m. The centre of this arch is slightly off-centre, *c.*0.27m from the western side, although this might have been caused by movement in the structure. The external surround to the window consists of chamfered bricks, of 45 – 50mm in width.

7.4.1 The window lies within the area of the original dovecote (i.e. below the moulded courses of brickwork). This suggests that it was an original feature. Furthermore, the timber lintel above the window (observed on the interior) runs through into the adjacent nesting holes, with the same mortar and brick and tile, etc, on the inside and outside, such that there is no evidence that it was inserted at a later date. It therefore seems likely that this timber lintel was also original, in a similar way to the timber lintel above the blocked eastern doorway.

Fig. 31: Photograph of the window in the southern wall of the dovecote (from the outside). This clearly lies within the area of the original build (i.e. beneath the moulded courses of brickwork), and there is no indication that it was inserted at a later date.

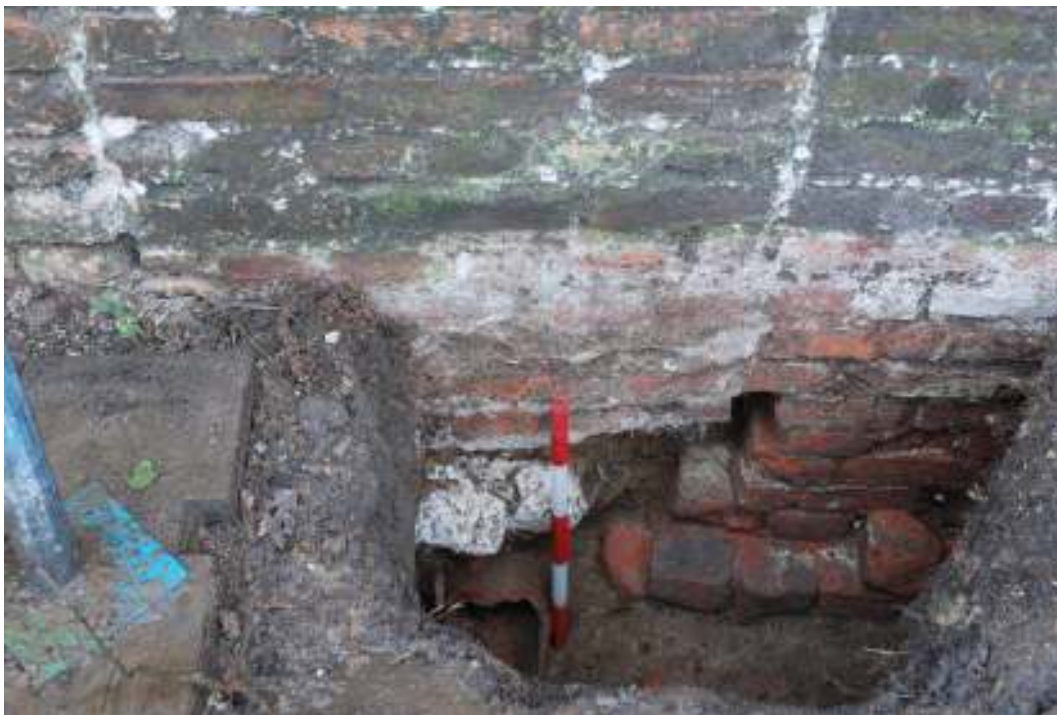
7.5.3 Small-scale excavations on the exterior side of the doorway (fig. 36) revealed the brick foundations for this doorway and the adjacent wall. There were up to six courses of brickwork below an offset course in the wall-face (stepping out *c.*100mm). This level also coincided with what may have been the base of a stone threshold across the doorway itself – the presence of this indicated by two courses of brickwork (*c.*0.6m beneath the present ground-surface) that were stepped back (to the north) with finished edges, further back than the brick foundations beneath this.

Fig. 36: Photograph of the small-scale excavation around the exterior of the eastern doorway. This shows the brick foundations and the two bricks with finished edges that may have formed the edge of some form of threshold into the dovecote.

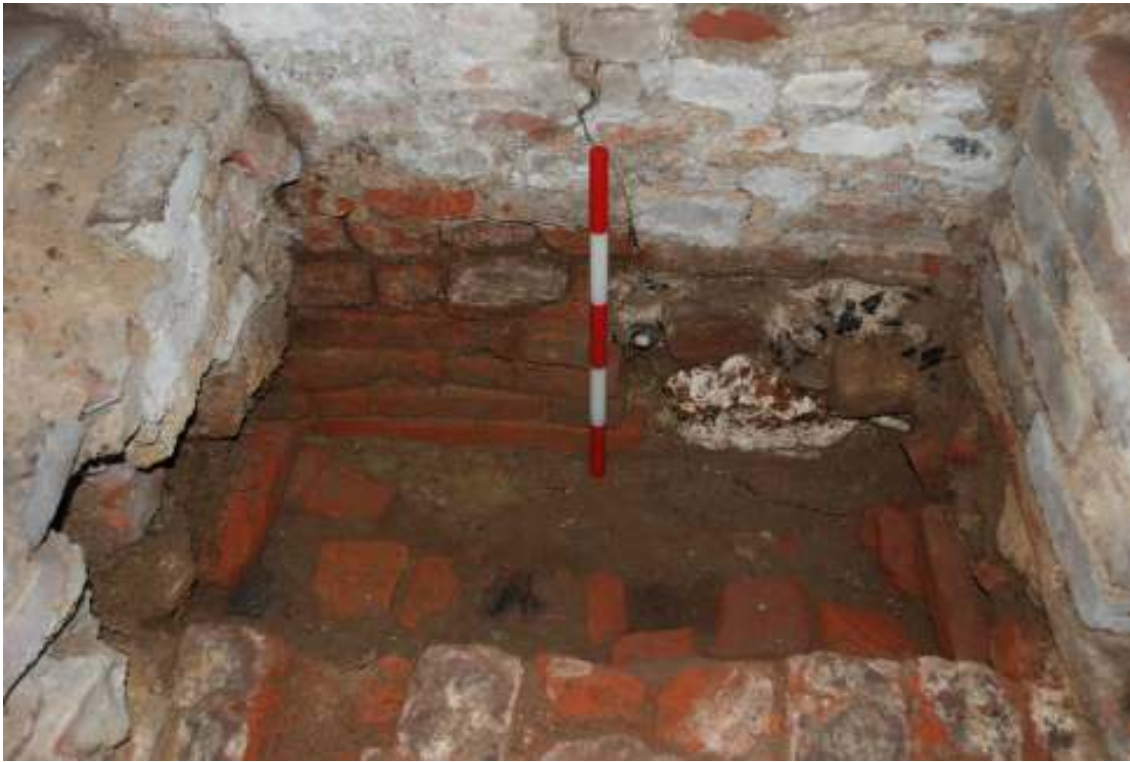
- 7.6.1** These brick foundations were *c.*0.3m in height (consisting of four courses of brickwork), and *c.*0.55 – 0.6m in width (north-south). It ran north from behind the ground-raising plinth on the southern side of the western doorway. The face of the brickwork was on a line with the western brick wall. It consisted of red bricks within a sandy matrix. Brick samples from this area of brick foundations were dated 1450-1700 (see appendix VI).

- 7.6.2** This is similar to the brick foundations uncovered in the excavation around the blocked-up eastern doorway (see fig. 36), and suggests that there may once have been a doorway in this western wall, earlier than the present doorway. There is no indication of this in the existing western wall, however this wall has been rebuilt from a level immediately above this brickwork and the adjacent chalk foundations to the north and south (see section 9).

Fig. 39: Photograph of the small area of brick foundations observed in the western wall, continuing to the left of the frame behind the much later ground-raising plinths. This is possibly evidence for an earlier door in this wall.

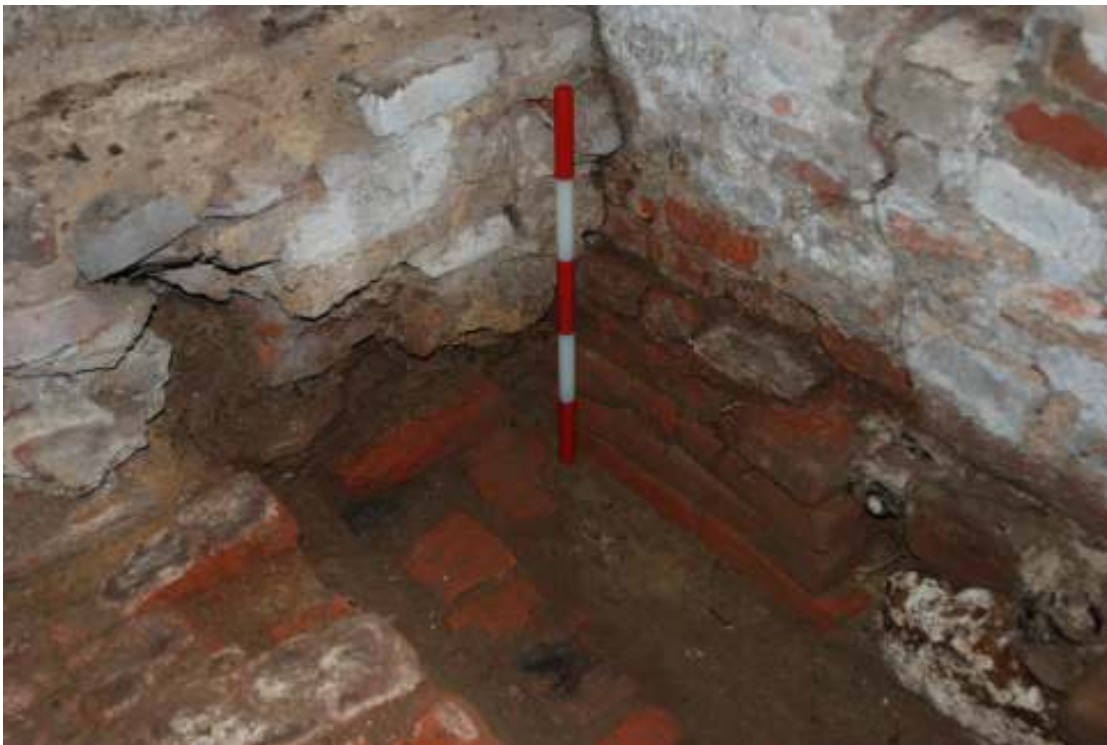
Fig. 40: Photograph of the small area of brick foundations observed in the western wall, looking south-west. This is possibly evidence for an earlier door in this wall.

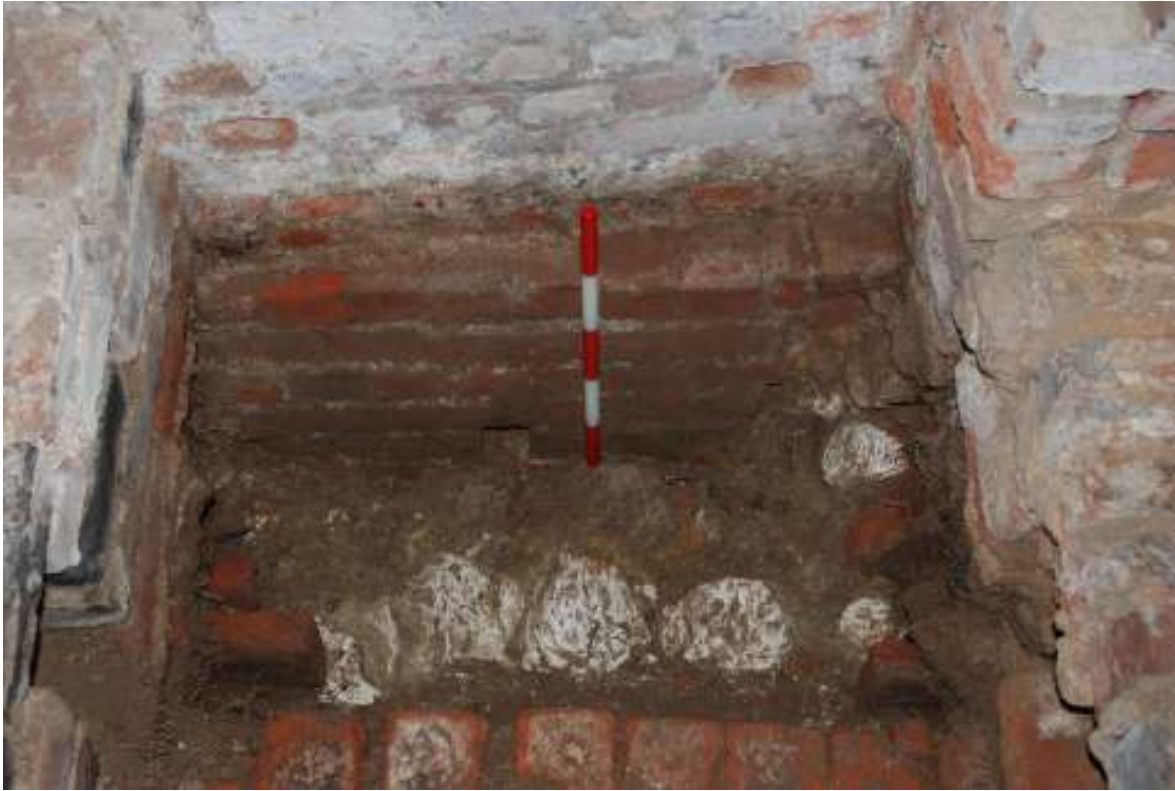
7.8.1 This chalk base lay just beneath the brick floor, *c.*50mm beneath the brick floor. It is therefore possible that it was not found elsewhere in the dovecote because it was at such a high level. This also suggests that the floor level in the original dovecote was relatively high (similar to, or just below, the level of the brick floor, *c.*81.71mOD). This seems to fit the level of the presumed stone threshold on the exterior of the eastern doorway (base at 81.74m OD, top of threshold at 81.86mOD).

Fig. 43: Photograph of the chalk foundations that appear to head underneath the brick floor, just under the eastern doorway. This may represent the chalk base of an earlier floor.

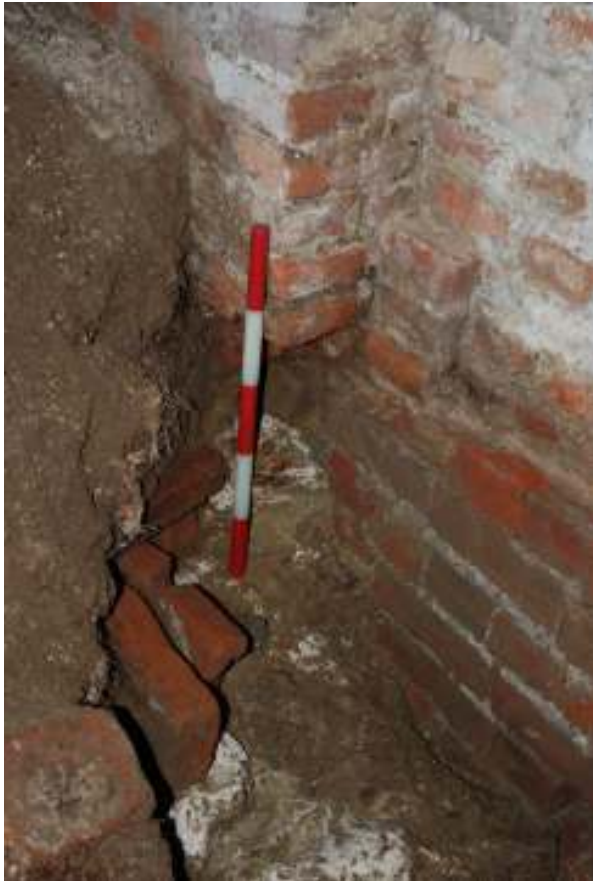
Fig. 45: Photograph of the northern side of the eastern doorway. This shows the 'gap' between the existing (re-faced) wall and the earlier wall, at the base of the wall.

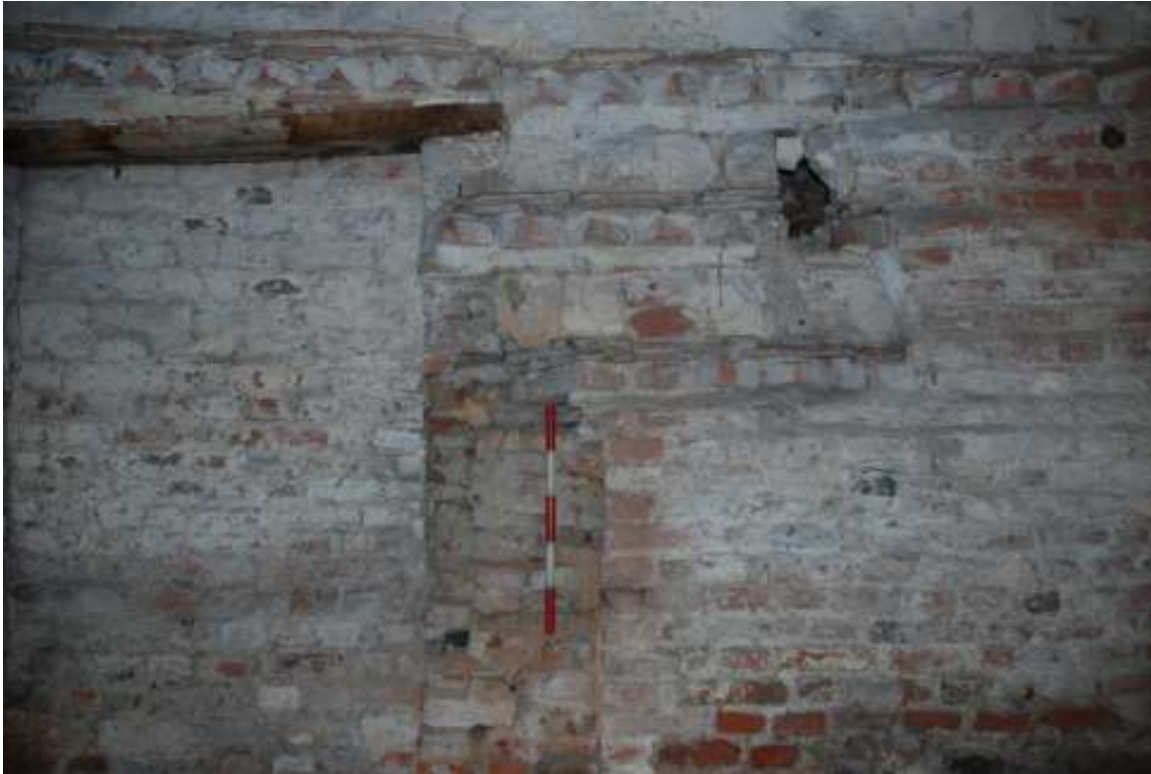
Fig. 46: Photograph of the southern side of the eastern doorway. This shows the small line of blocked nesting holes (just above the scale) that exist at this height in only this small area, before they are covered up by the re-facing (to the right of the photo).

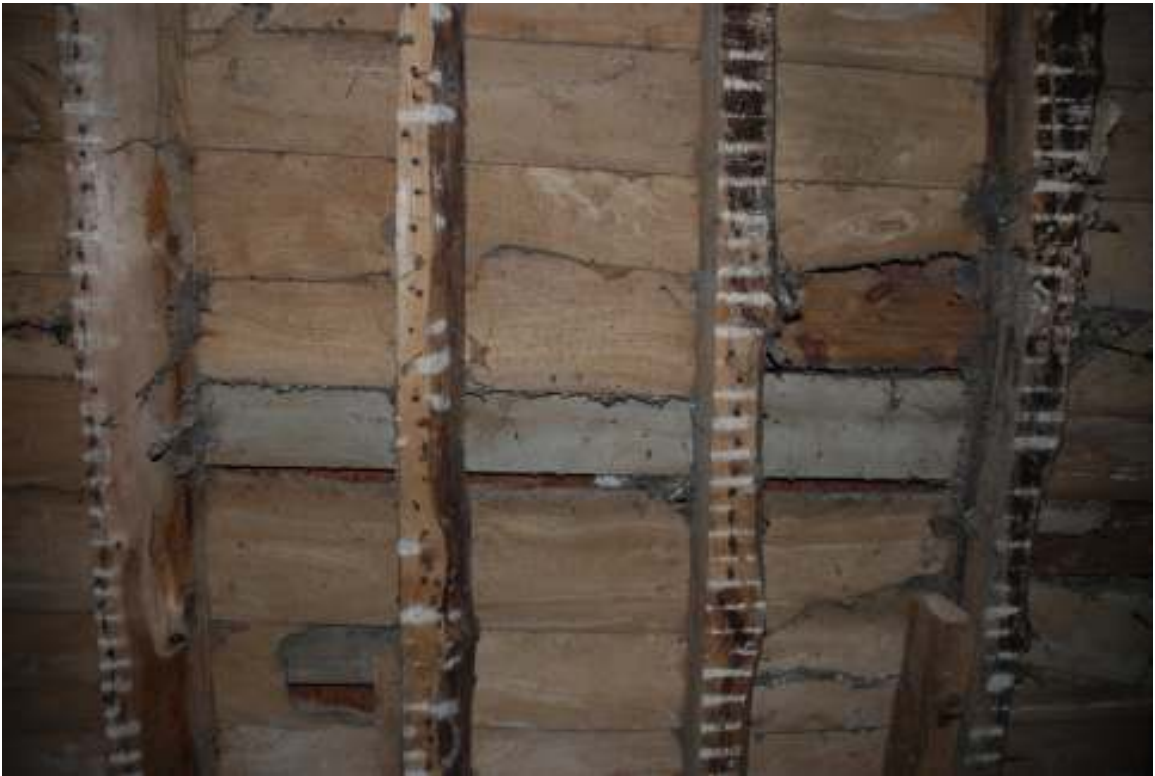
Fig. 111: Photograph showing beams with nails sticking out of them on the first floor (for the lath-and-plastering of the ceiling). The white lines visible horizontally across the beams are further evidence for the act of lath-and-plastering.

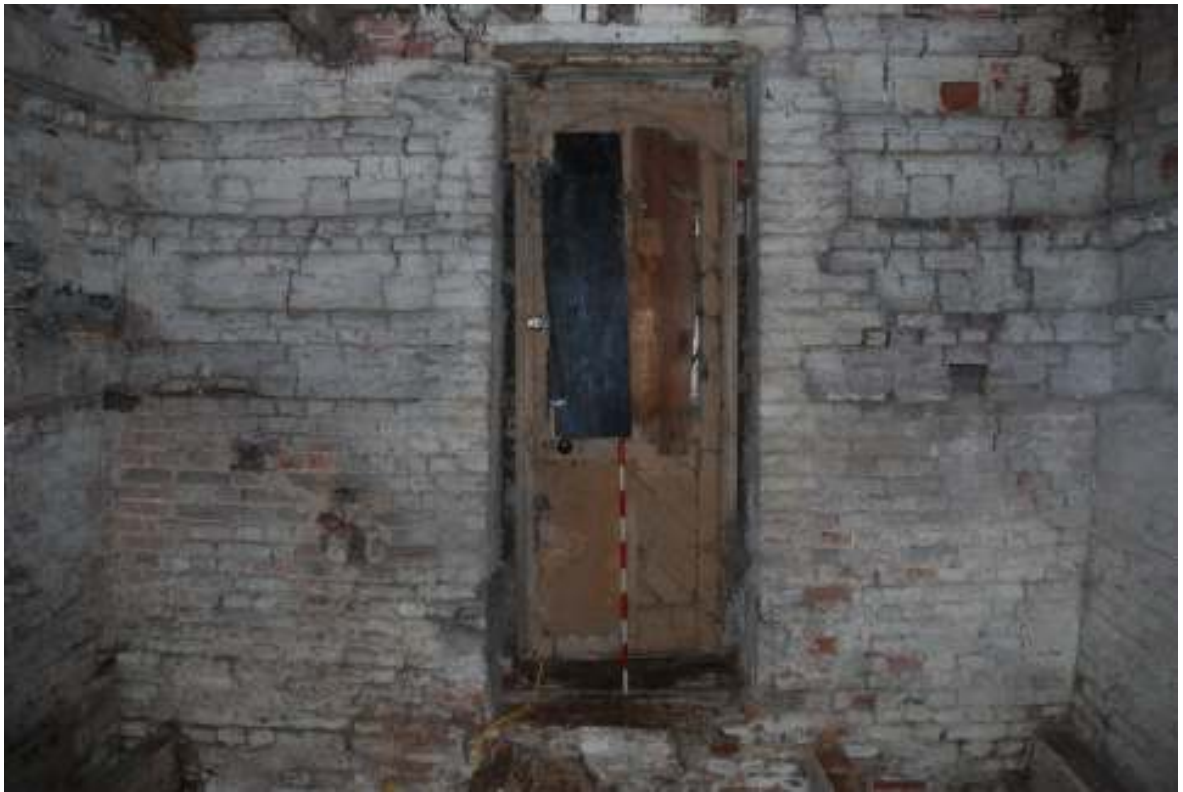
Fig. 125: Photograph of the interior of the western doorway. This clearly shows how it was inserted at a later date, with the nesting-holes surrounding the doorway having partially been cut away and bricked over.

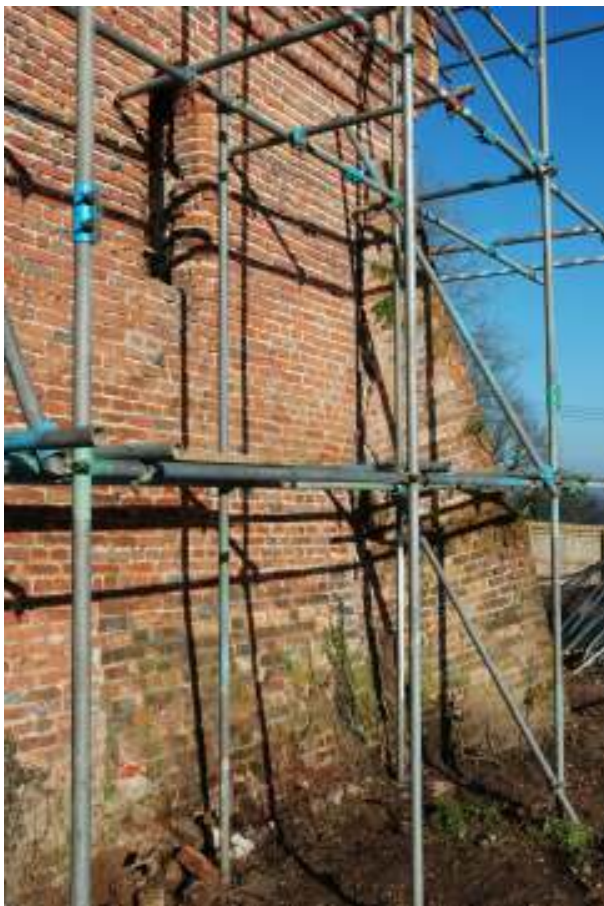
Fig. 130: Photograph of the patching on the southern wall of the dovecote.
